**An Archaeological Watching Brief  
at St Mary Magdalene Churchyard  
Holloway Road, LB Islington**

**Archaeological Watching Brief Report  
St Mary Magdalene Churchyard  
Holloway Road, LB Islington**

*This report presents the results of an archaeological watching brief carried out by Archaeology South-East at St Mary Magdalene Churchyard between 25<sup>th</sup> of April and 19<sup>th</sup> of May 2017. The fieldwork was commissioned by Arlington Builders Ltd in order to mitigate any damage to archaeological remains in the churchyard as a new service trench was excavated.*

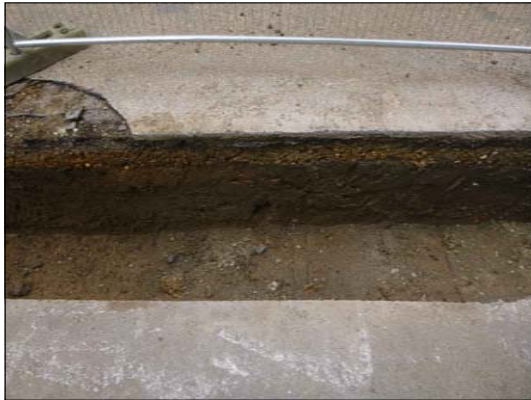
- 4.1.5 Overlying [1003], across the area monitored, was a dark grey-brown clayey silt [1002] up to 0.2m thick with small fragments of CBM and mortar which in turn was covered by 0.1m of levelling [1001] for the modern road surface [1000], itself formed of asphalt. These upper deposits were similar across the site though at times varied in thickness (described in each monitoring date separately below).

Representative stratigraphic sequence in the service trench

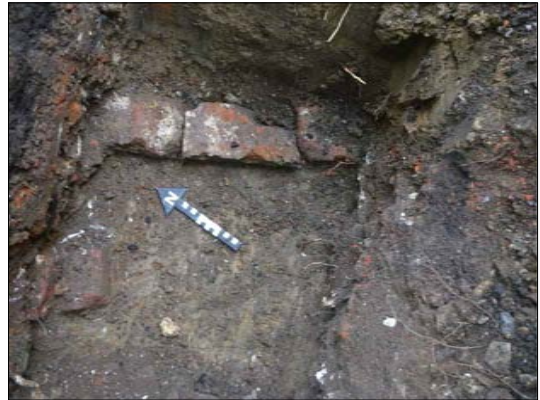
1005, looking north east

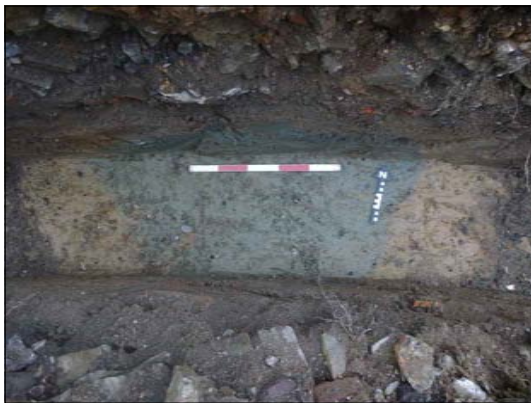
- 4.2.1 This area had few archaeological remains different from that previously monitored, with natural [1006] observed 0.64m BGL sealed by a similar sequence of deposits. One slight variation was the presence of broken York Stone slabs in the made ground [1002] in varying quantities for at least 12 linear metres towards the SW. No fragments were observed as being inscribed or otherwise identifiable as gravestones or ledgers.
- 4.2.2 The only feature recorded in this phase was potential cut [1010] which contained a silty fill [1009] located approximately where the trench turned south towards the school and at formation level. This fill had no finds and only occasional charcoal so though potentially a silted up ditch in the natural it is also possible it was a natural gully. This was sealed by made ground [1003]

1010, looking north east

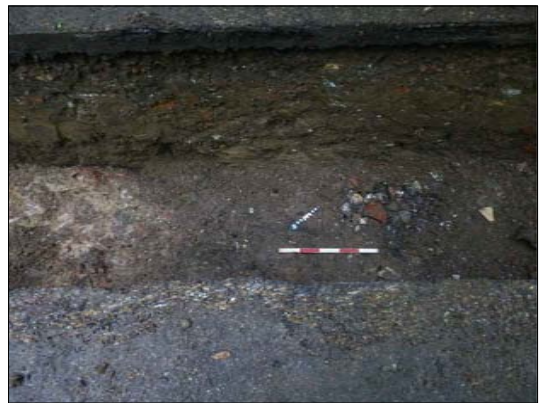
- 4.3.4 The first of these [1014], was at least 8 metres in length and cut the re-deposited natural [1003] at formation level and contained two fills [1015] and [1013]. [1013], the lower fill contained the largest assemblage of pottery on the site and, due to makers marks on one vessel, can be securely dated between the early 1820s to mid-1830s and can be characterised as domestic refuse. The pit itself was fairly steep sided cutting [1003] and likely at a similar angle into the natural below [1006], suggesting a possible original function of brickearth quarrying.

1014, looking north

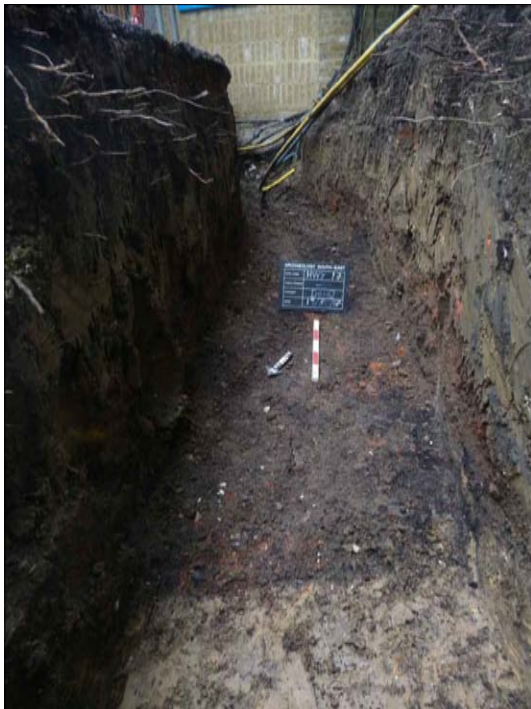
- 4.3.5 Close to the terminus of the trench at the Courtyard School, a second large possibly quarry pit was exposed [1018] whose fill contained similar refuse material and burnt lenses. Again this cut re-deposited brickearth [1003] and was sealed by [1002]. The top of the pit's fill [1017] was located at 0.9m BGL.

1018, looking north

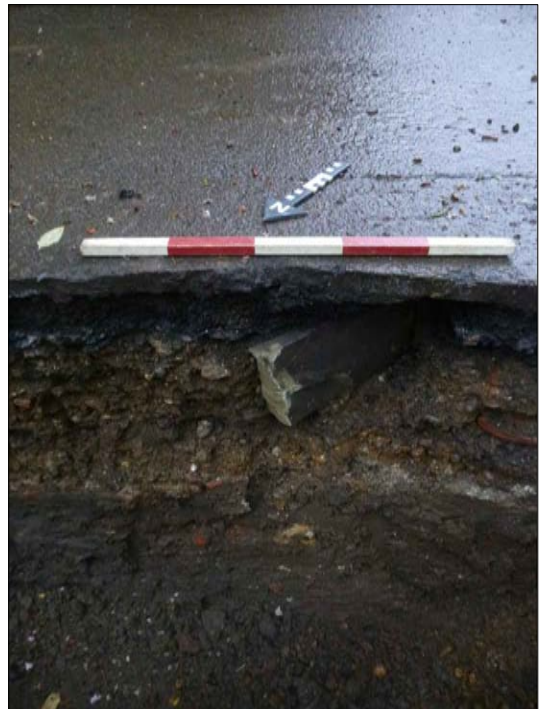
1016, looking north

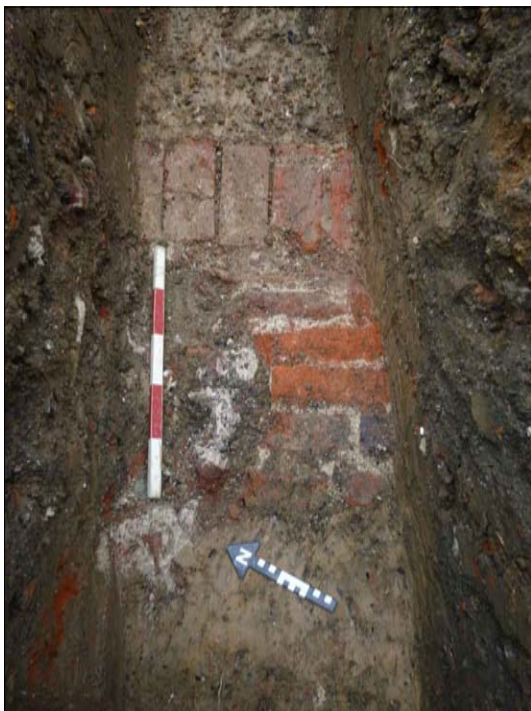
- 4.1.3 This [1003] layer (up to 0.4m thick in places) sealed in this part of the monitoring, a brick drain or culvert [1004] which cut the natural [1006] in NW-SE orientation. This ran in near alignment with the existing brick wall corner forming the southern boundary of the lane leading to the churchyard. The main structure of this drain, of which only the top surface was revealed at 0.79m BGL, was formed of at least 7 courses laid on edge forming a semi-circular top, with the addition of a single header course of bricks laid flat against these to the east. These bricks were of broad 18<sup>th</sup>-19<sup>th</sup> century date though the material in [1003] across the site in general dated up until the 1820s, suggesting, relatively, an earlier date for this brickwork.

1004, looking north
