Archaeological Watching Brief Report Nymans, Staplefield Lane Handcross, West Sussex

ASE Project No: 170647 Site Code: NYH17 ASE Report No: 2017298 OASIS id: archaeol6-289151

Archaeological Report Nymans, Staplefield Lane Handcross, West Sussex

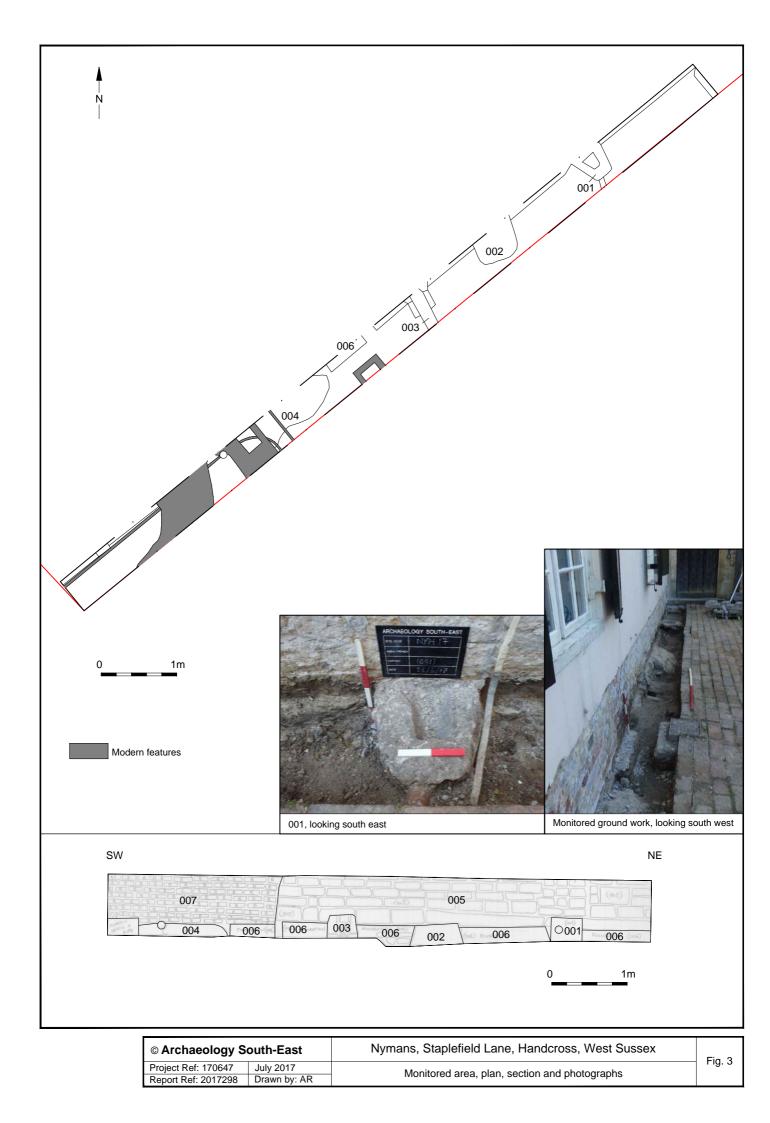
Context	Туре	Description	Max. Length m	Max. Width m	Deposit Thickness m
001	Masonry	Water collector	0.44	0.40	0.30
002	Masonry	Foundation wall	0.65	0.42	0.30
003	Masonry	Drain	0.23	0.08	0.30
004	Masonry	Foundation wall	1.10	0.38	0.18
005	Masonry	Wall	5.60	-	-
006	Masonry	Foundation wall	10.70	-	0.16 to 0.22
007	Masonry	Wall	5.10	-	-

- 4.2 Several walls and drainage features were identified within the trench.
- 4.3 Contexts (002) and (004) may represent the remains of foundation walls belonging to earlier buildings.
- 4.4 Water collector (001) and drain (003) had fallen into disuse (probably when the extension to the main house was built) and lay buried under the bricks of the courtyard.
- 4.5 Walls (005) and (007) represent two different phases of the main building with (007) possibly representing the earliest phase.
- 4.6 Foundation wall (006) was visible in almost the whole section and jutted out by about 0.08m under the walls of the main building (005) and (007).

- 6.2 Walls (002) and (004) appear to be the oldest features in the trench and could represent the remains of foundations belonging to earlier buildings. No detailed plan could however be matched and the walls could not be identified with any certainty.

- 6.3 The water collector (001) had fallen into disuse and was covered by the bricks of the courtyard. It was abutting the foundation wall of the main building (006) and was adjacent to another possible building extension visible because of the straight joint that came down the wall.

- 6.4 The drain (003) was also abutting the foundation wall of the main building (006) and probably fell into disuse when the house was extended. It was then covered by the bricks of the courtyard.

- 6.5 The wall of the main building consisted of foundation wall (006), that jutted out about 0.08m under the original wall (007) made of bricks on the eastern side and the extension wall (005) made of stone on the western side.
