**HARRIS BROS. GARAGE, BOREHAM HILL, HAILSHAM,  
EAST SUSSEX, BN27 4SQ**

**HISTORIC BUILDINGS RECORD**

**Commissioned by Baker Architectural  
on behalf of Mr Michael Southouse**

**ASE Project No: 6758**

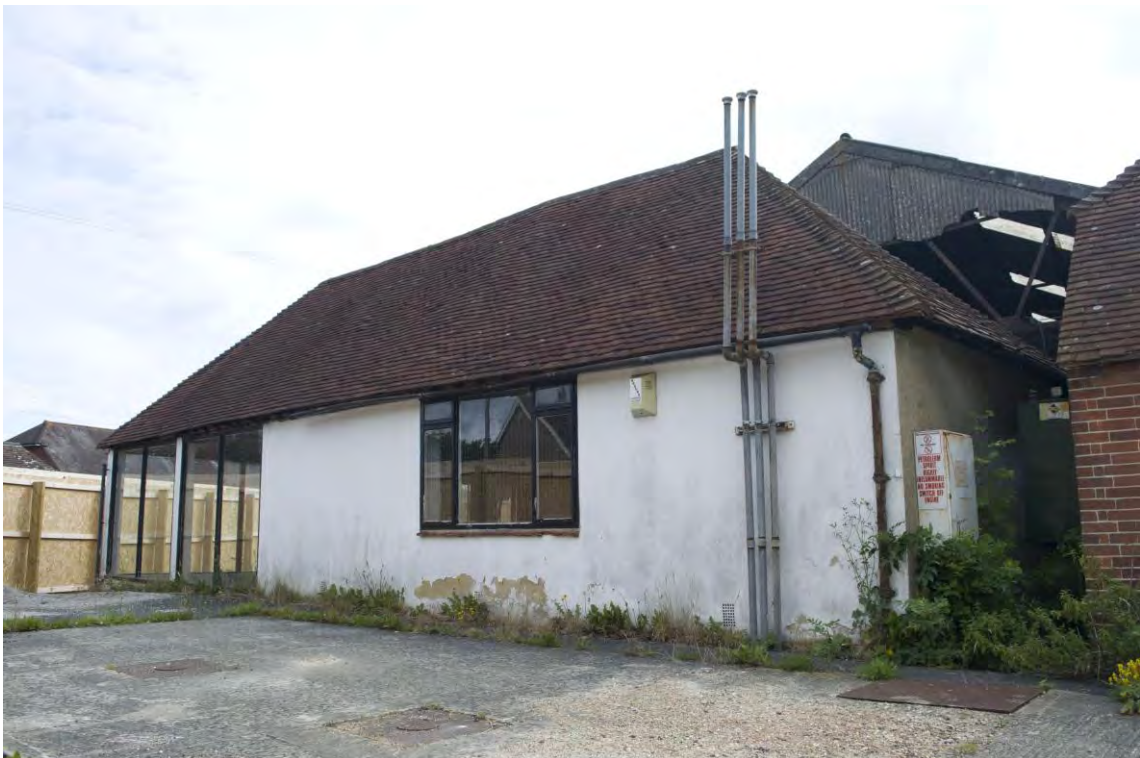
Plate 2 General view of Range 1, facing north-east (4)

- 5.2.2 The structure (Plate 2), which is rectangular on plan is orientated north – south. It is situated adjacent to the western site boundary and adjoins Range 3 on its east side. The range is constructed in a combination of orange brick, concrete blockwork and timber-framing, all of which has been cement-rendered externally. The roof is hipped with overhanging eaves and is covered with tile. The timber-framing and sole plates, which would have originally formed the north, south and west elevations, have been replaced with concrete blockwork. The only original wall components to remain, include, an orange brick dwarf wall around the perimeter, and the wall plates on each side. Redundant mortices and peg holes, visible within the wall plates that frame the west and north elevations, identify that these sides of the structure were originally closed. The majority of the north end of the west elevation, and the entirety of the north elevation, are dominated by modern full-height, timber-framed glazing, which form the display windows that served the building's most recent function as a classic car showroom. The south elevation is plain, with no openings. Carpentry marking on the external face of the west wall plate, identifies that the bays were numbered from north to south.

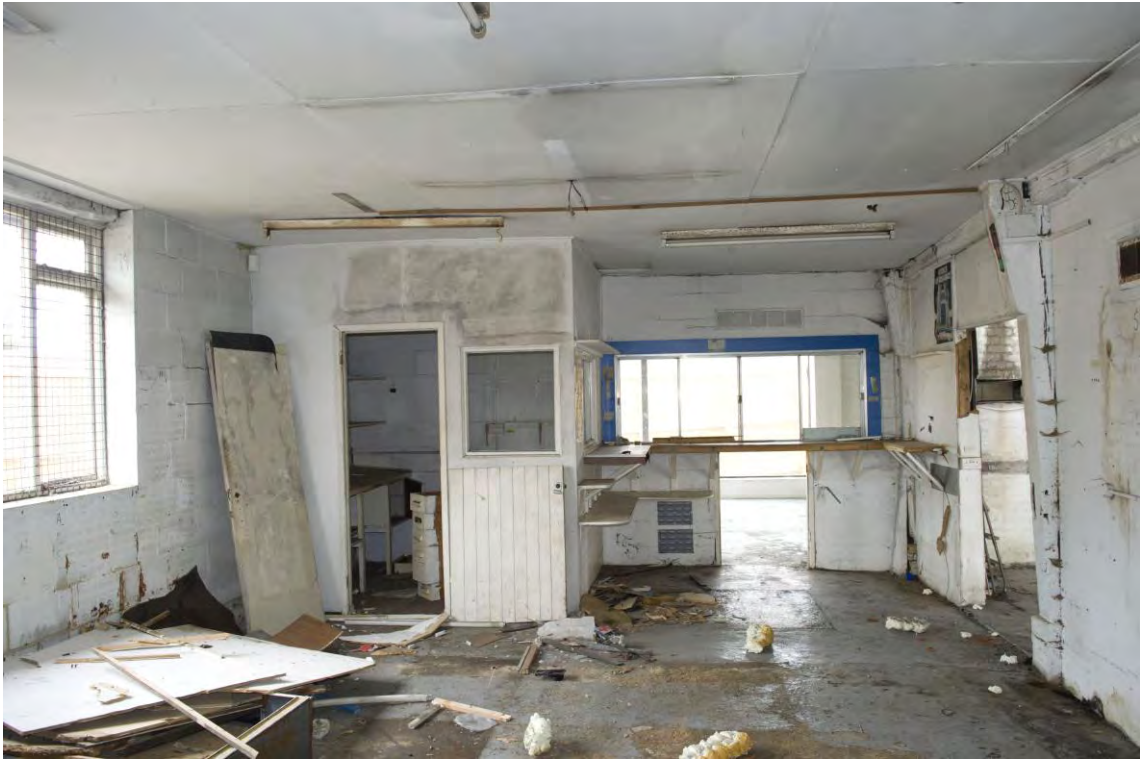
Plate 3 Internal view of the partitioning within Range 1, facing north (26)

- 5.2.3 Internally, the structure's original open character has been diluted by modern finishes and the insertion of a lightweight stud wall, dividing the building in two between Bays 2 and 3 (Plate 3). The partition wall articulates southwards, creating an ephemeral office space on the western side of Bay 3. Despite this modern addition, the original five bay arrangement has been visually retained by the retention of the posts which support the east wall (Plate 4). All remain *in situ* except for the post dividing Bays 1 and 2; presumably this was removed to enable cars into the interior in more recent years. The location of the post is evidenced by a redundant mortice on the underside of the wall plate, in line with the tie beam in this location. A steel joist has since been inserted below the wall plate on this side (Plate 5), to provide steel support originally afforded by the missing post. The east wall of the building has been infilled at its southern end, between Bays 3 to 5, with modern plasterboard partition walls, clad on its eastern face with vertical softwood weatherboarding. Presumably this infill was added to separate the interior from that of the adjacent range. Due to the infill, the southern end of the structure is now accessed through two inserted modern doorways, set within Bays 3 and 5.

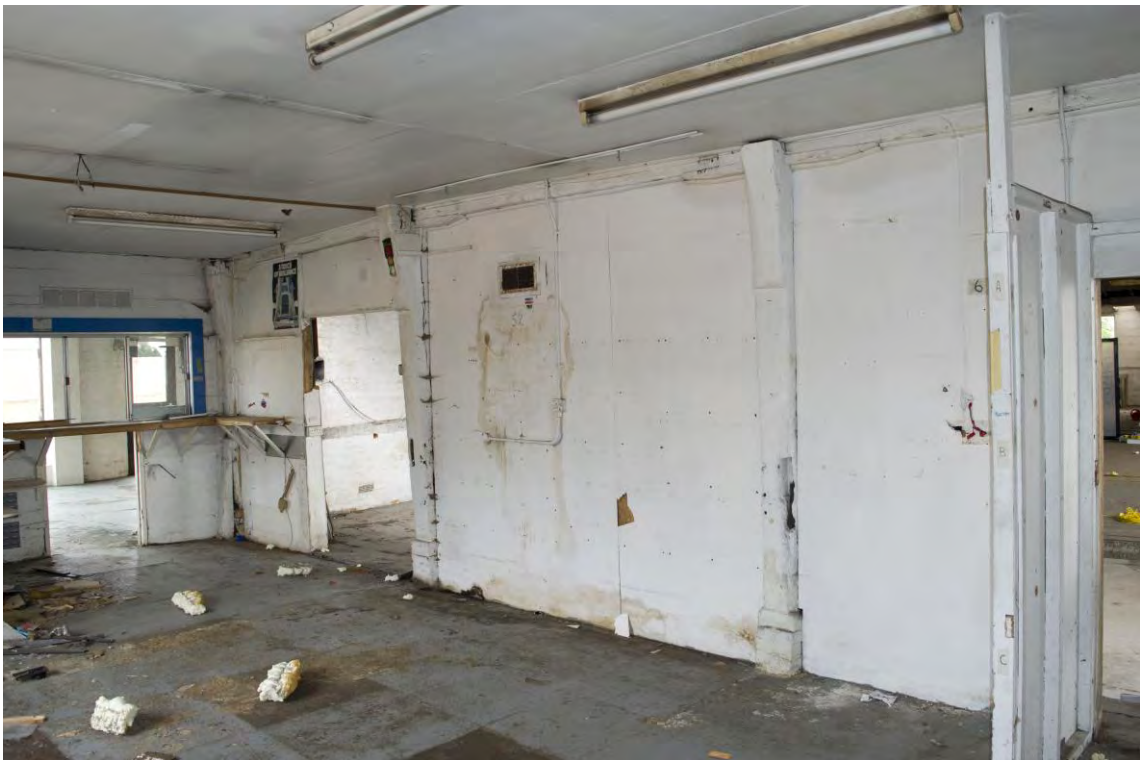
Plate 4 Interior of Range 1, note the bay divisions, facing north-east (29)

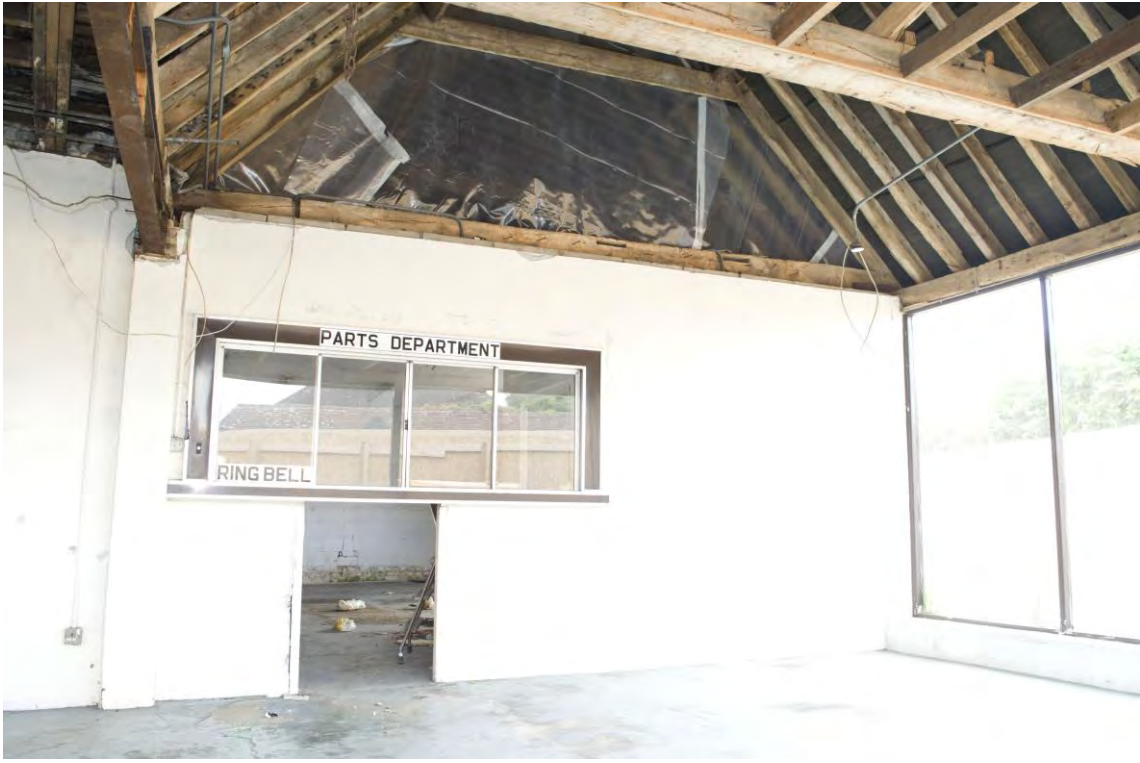
Plate 5 Northern end of Range 1, note the steel joist used to support the east elevation, facing south-west (38)

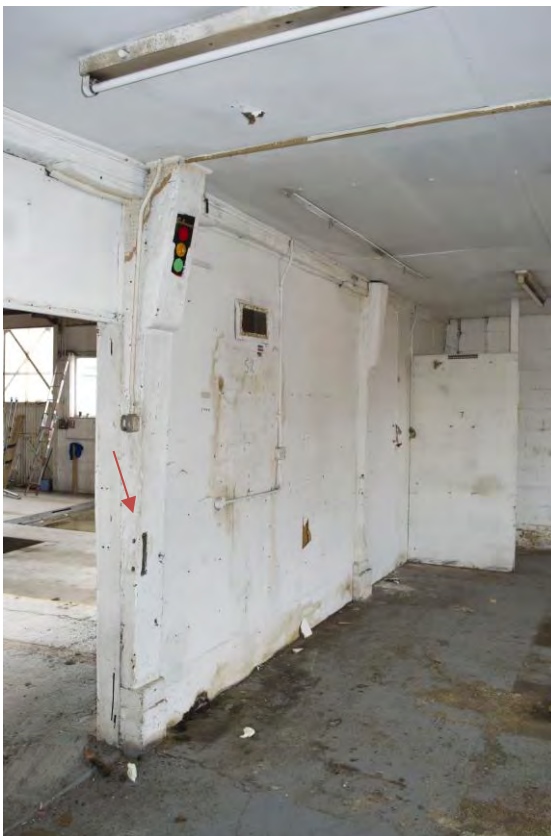
Plate 6 Detail of the posts within the east elevation of Range 1, note the redundant mortices for partitions, facing south-east (28)

- 5.2.4 The spacing of each post, indicates a regular bay length of approximately 3m. Each post rests upon a timber sill and low brick plinth (Plate 6). The regularly-spaced posts have rounded jowls, commonly found in agricultural buildings from the 18<sup>th</sup> century and into the early 19<sup>th</sup> century (Martin & Martin 2006, 60). The remaining three posts all display redundant mortices on their west face for a horizontal beam, indicating internal partitioning within the building's interior, which has since been removed. Evidence of internal bay divisions provides physical evidence that the structure was used as a shelter shed, as opposed to a cart shed, which would have typically had a similar open-fronted arrangement but would often, though not always, face away from the farmyard and onto access routes.

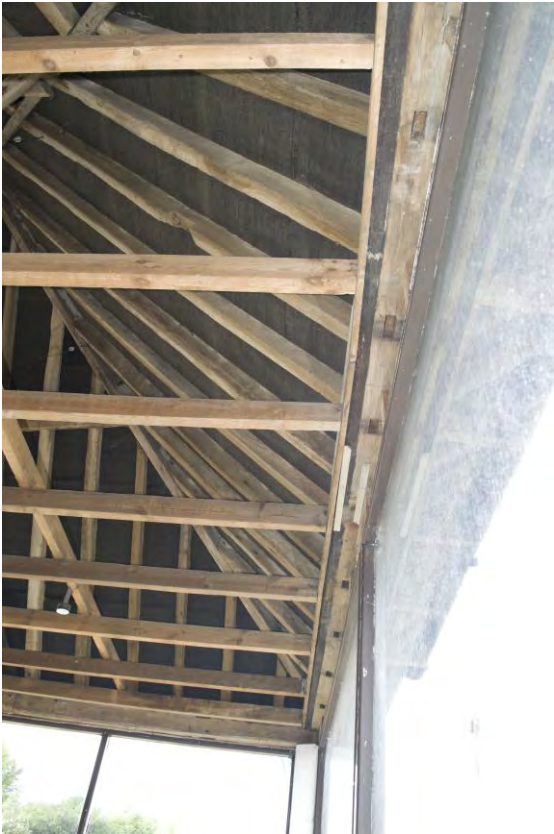
Plate 7 Detail of the redundant mortices within the wall-plate framing the north elevation of Range 1, facing west (40)

north (Plate 7) and west wall plates indicate these walls were filled with timber framing, which is likely to have been weatherboarded. The east wall plate shows no such signs of reworking and the absence of redundant mortices highlight that this side was open-fronted.

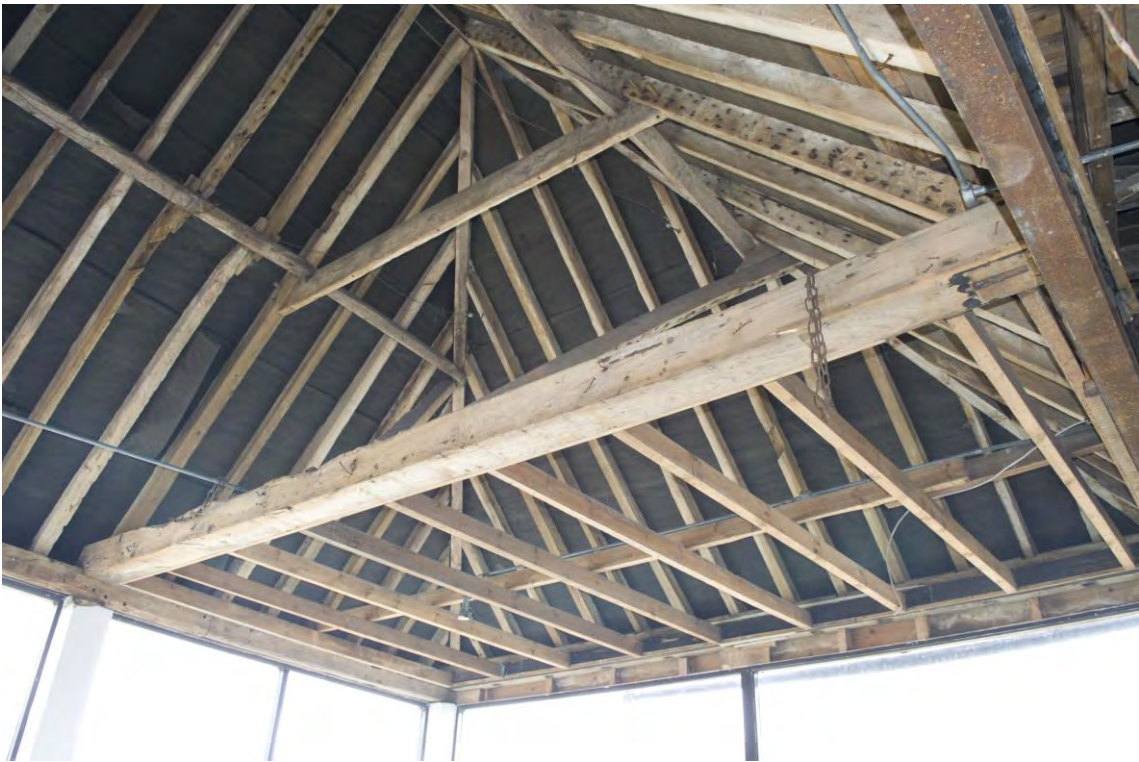
Plate 8 View of the Range 1 roof, facing north-west (36)

- 5.2.6 The roof is of side-purlin construction, with jointed and pegged collars above each bay division, and paired raking struts which are inclined towards the hip, supporting each roof terminal to the north and south (Plate 8). The common rafters meet at a slim ridge board, a construction feature commensurate with the supposed mid-19<sup>th</sup> century date. The roof construction is formed by a combination of reused and hedgerow timbers. Reused timbers comprise, square-section rafters and fairly substantial tie beams. Redundant mortices and stapling visible on both the earlier rafters and tie beams are indicative of their reuse and additionally provides evidence that they are not original to this structure. The removal of modern materials revealed that the tie-beams had been reused from an earlier structure. All have chamfering to a greater or lesser degree to their arrises (Plate 9), whereas those separating Bays 3 and 4, and 5 and 6 also have redundant mortices for floor joists (Plate 10). The remaining rafters comprise both nailed slender sawn and hedgerow timbers, both the material and method of construction being typical of a 19<sup>th</sup> century date. Iron strapwork securing the tie beam and wall plate, above Bays 1 and 2, is also common in timber frame construction in the late 18<sup>th</sup> and 19<sup>th</sup> centuries.

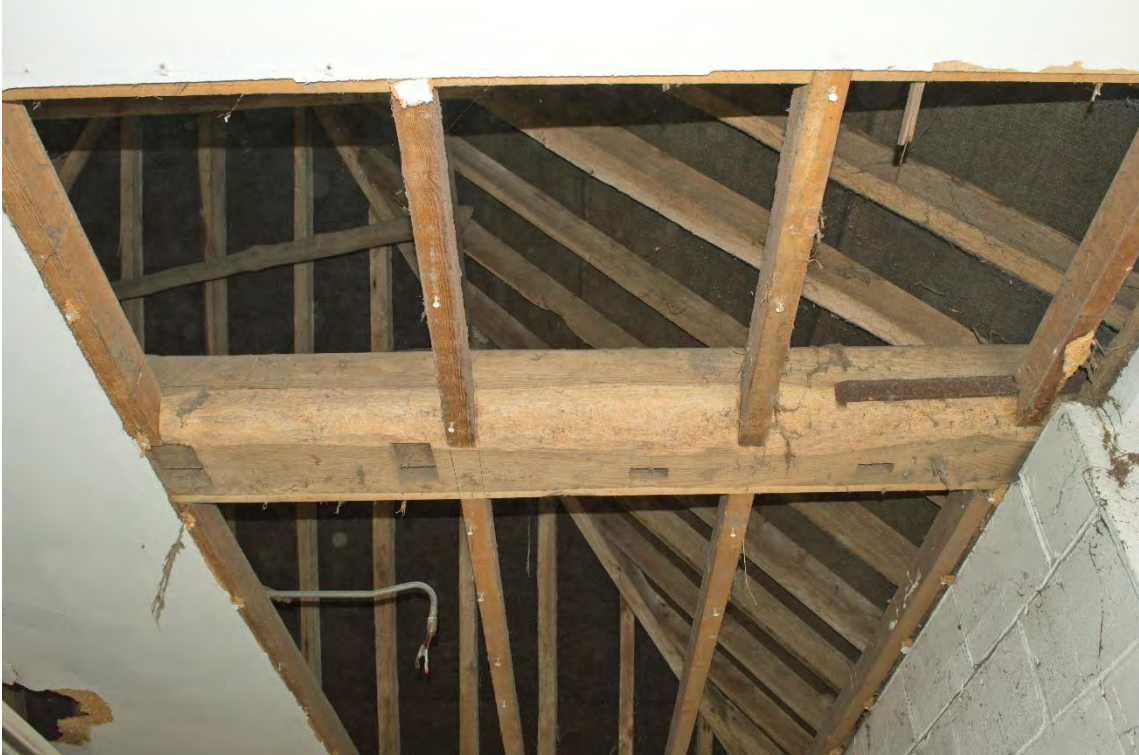
Plate 9 Detail of the chamfered edging to the southernmost tie beams within Range 1, facing south (79)

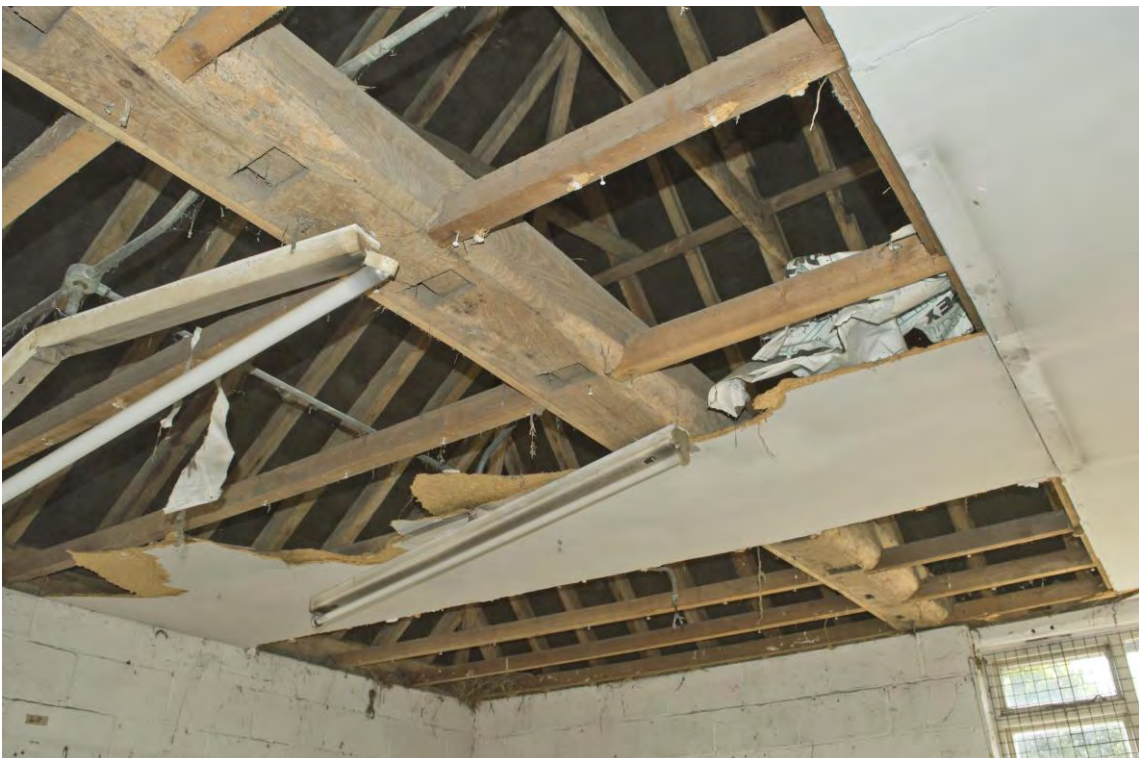
Plate 10 Detail of the redundant mortices within the southernmost tie beams within Range 1, facing south-west (78)

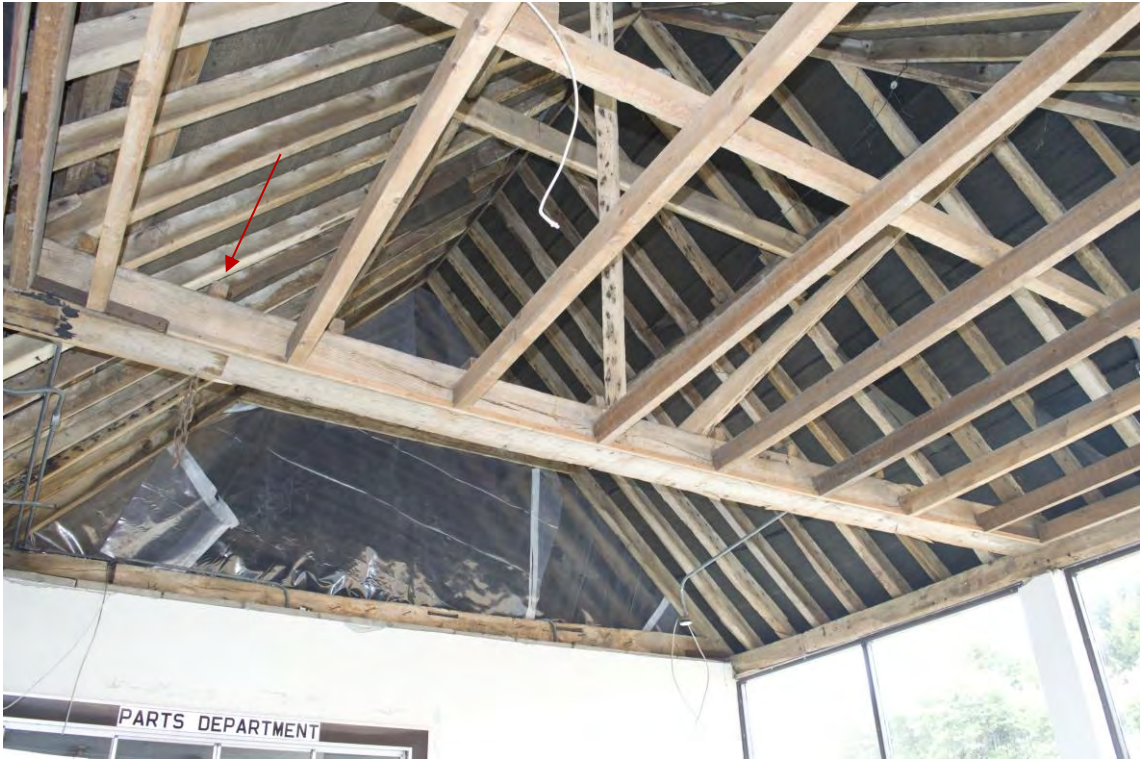
Plate 11 Detail of the retained floor joist sections above the tie-beam separating Bays 1 and 2 within Range 1, facing south-west (37)

- 5.2.7 A modern ceiling, clad with plasterboard, has been added above Bays 3 to 5. The studwork of a modern ceiling is also visible above Bay 1. Although both ceilings are of modern construction, it appears parts of the building were originally floored at roof level. This is evidenced by a series of redundant slender floor joist sections (Plate 11), lain over the top of the tie beam separating Bays 1 and 2. It is unclear how far these joists extended to the north and south and so it is not possible to indicate if the floor extended across the entire structure. It is likely that the floored roof space served as a loft for hay storage, as was common in shelter sheds. A pair of chains, secured to the east and west ends of the tie beam dividing Bays 1 and 2, are possible remains of a pulley system used to lift hay to the loft.

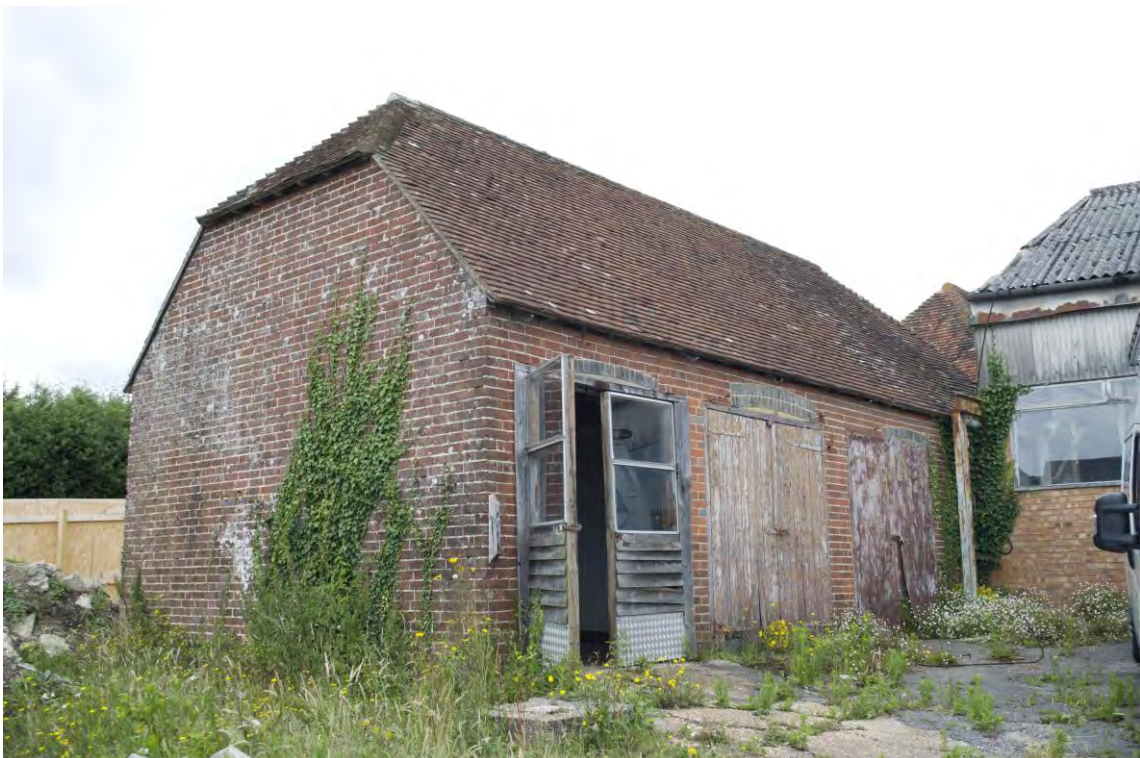
Plate 12 General view of principal elevation of Range 2, facing north-west (65)

- 5.3.2 The northern end of the east elevation has been internalised with its joining to Range 3 during the mid-/late 20<sup>th</sup> century, and is now constructed in stretcher-bonded pink-orange brickwork. The remainder of the elevation is dominated by three regularly-spaced double doors, all of modern construction. Each doorway has utilised and truncated an original openings in the same location. The original arrangement, from

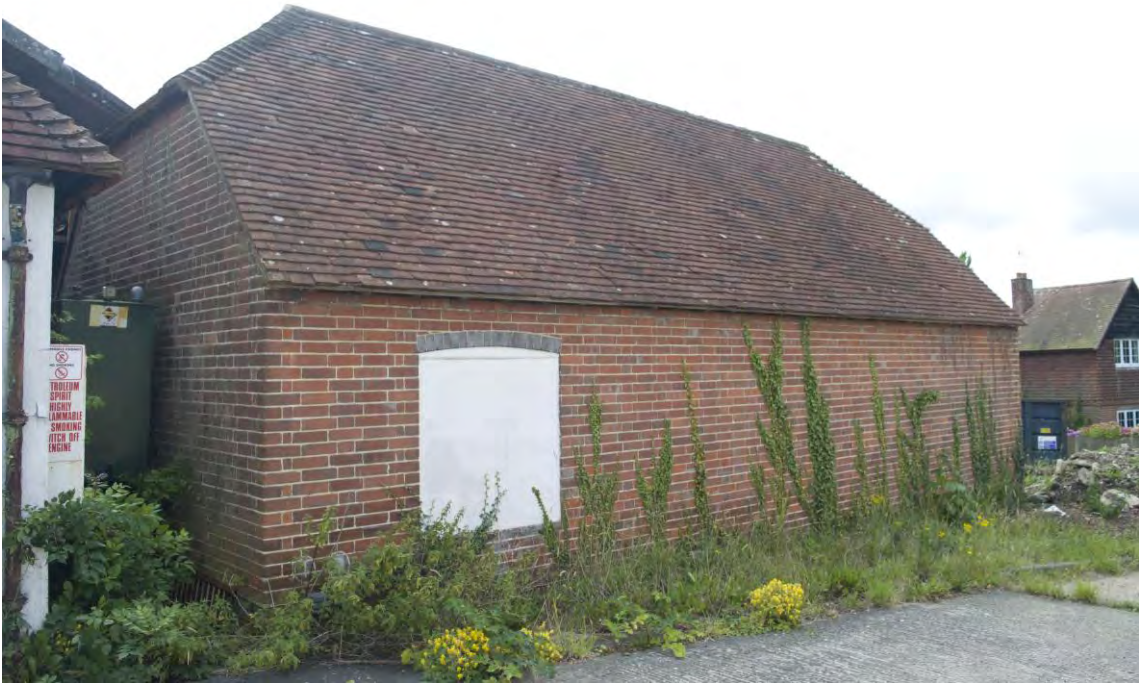
Plate 13 View of the rear elevation of Range 2, facing south-east (5)

5.3.3 The rear (west) elevation (Plate 13) contains a single blocked window at its north end. The arched head matches those to the east, and unlike its eastern counterparts, this window has retained its original proportions. This elevation contains a number of red bricks displaying grey 'kiss' marks resulting from the firing process, a feature characteristic of 19<sup>th</sup> century brickwork.

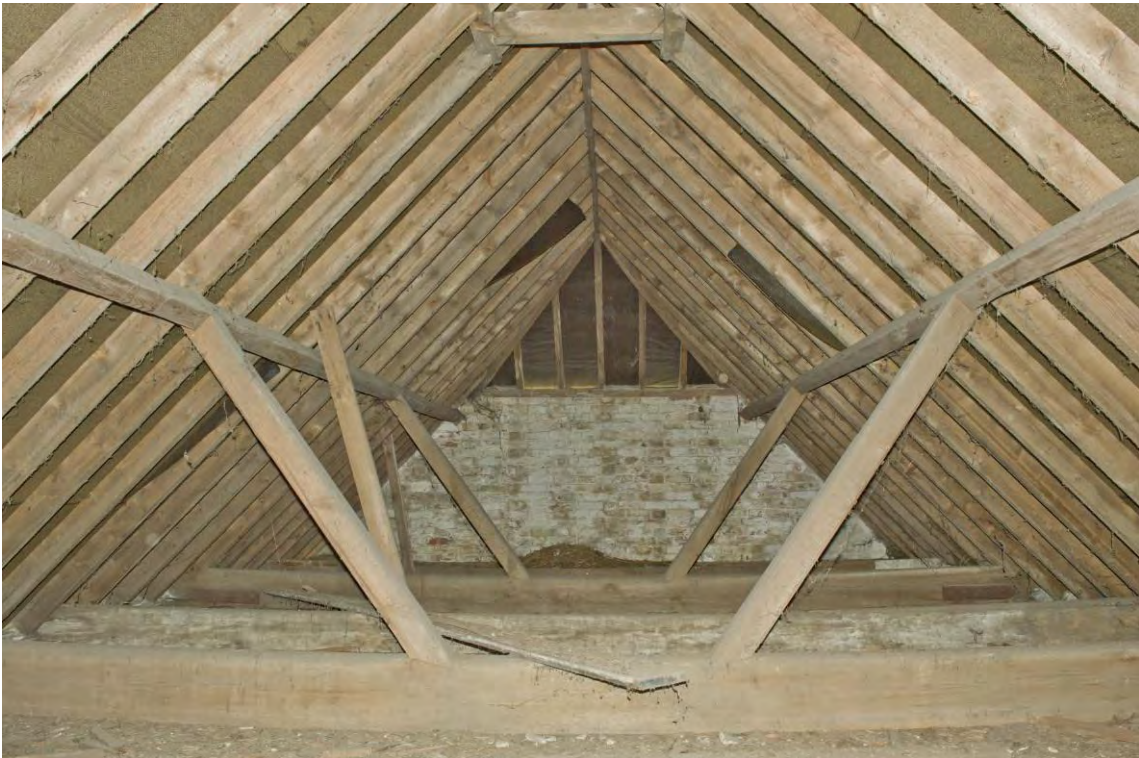
Plate 14 View of the roof construction above Range 2, facing south (95)

5.3.5 Internally, the building has a concrete screed floor and the outer walls have been painted in modern acrylic paint. Until most recently the interior had been ceiled with modern softwood boarding prohibiting access to the roof. The roof was subsequently recorded following the removal of this boarding. The roof is divided into four equal bays by straight tie-beams. From the tie-beams, raking queen struts extend to support a purlin in each roof pitch (Plate 14). The common rafters, which ride over the backs of the purlins, meet a slim ridge board. The ridge board is interrupted at its centre by framing for a roof vent (Plate 15), consistent with its supposed function as an animal shelter. Unlike Range 1, the roof timbers show no signs of reuse. The rafters comprise regular nailed slender sawn timbers, both the material and method of construction being typical of a 19<sup>th</sup> century date.

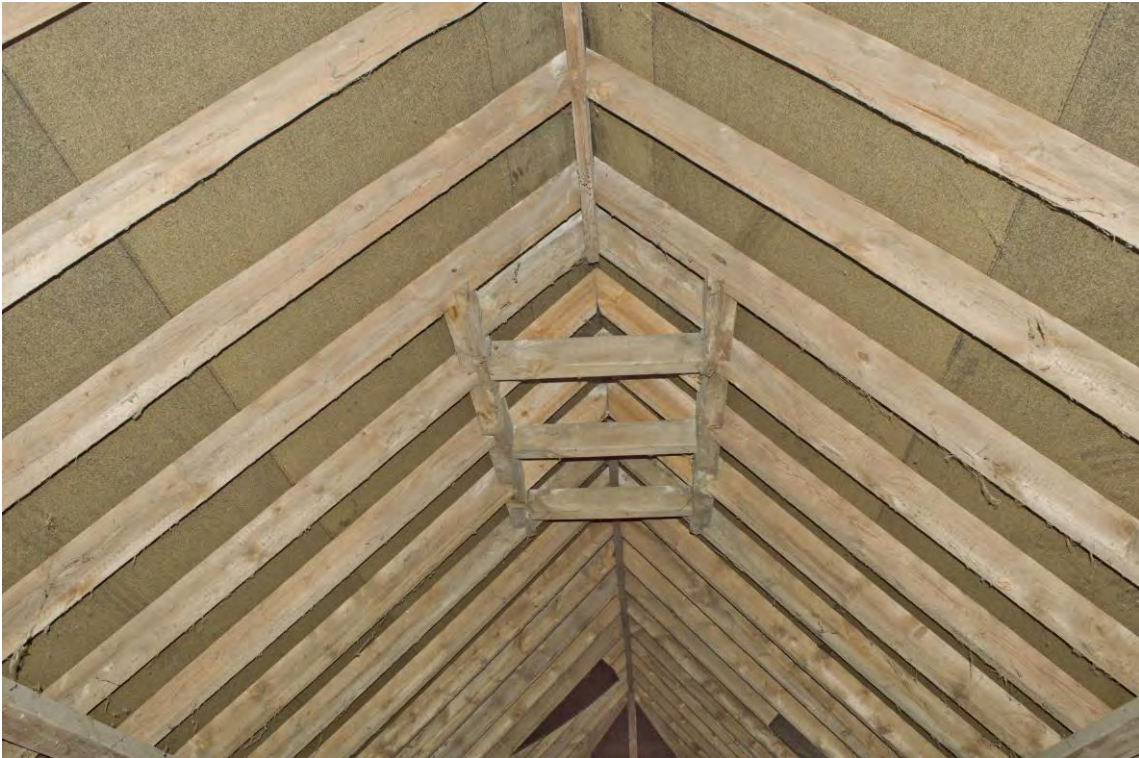
Plate 15 Detail of the central roof vent (now blocked) in Range 2, facing south (96)

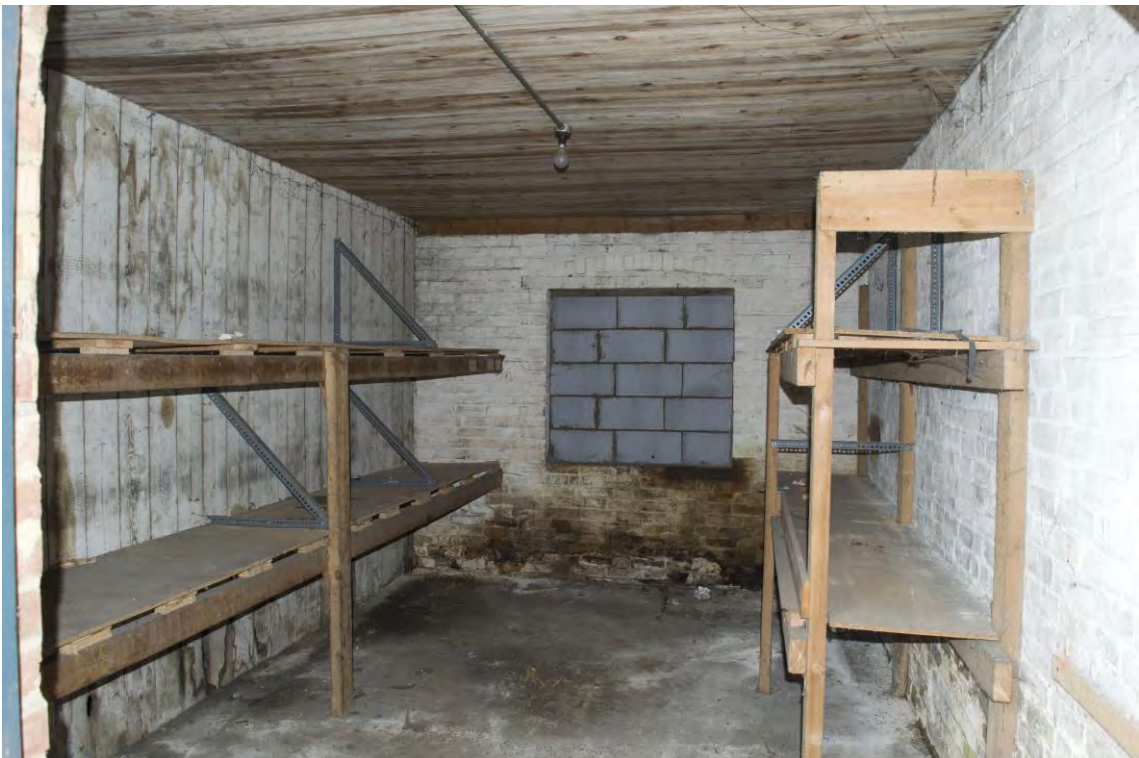
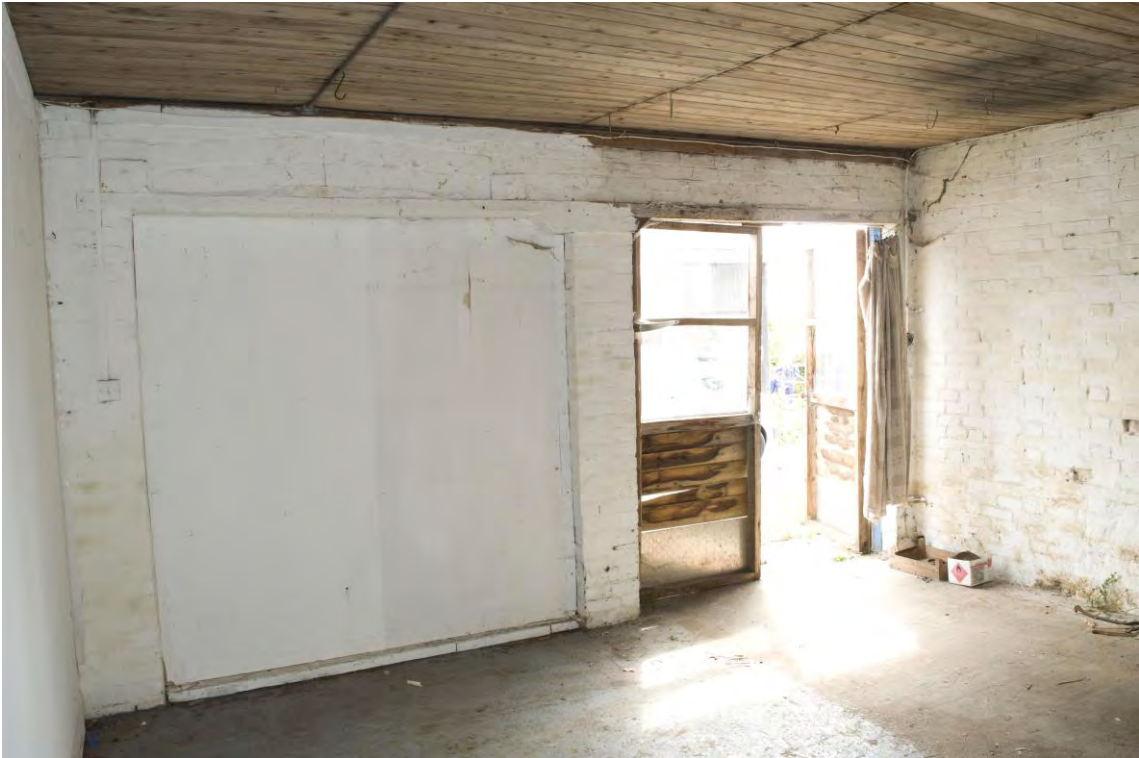
Plate 16 Northern partition within Range 2, facing west (43)

Plate 17 Southern end of Range 2, facing south-east (47)

5.3.6 The interior is presently divided into three areas using a combination of nailed softwood boarding and plasterboard panelling (Plates 16 and 17), all of a relatively recent date. It was not possible to discern with certainty whether the building was originally partitioned due to the covering of original fabric. However, the window and door arrangement would indicate a single central partition, evidence of which can no longer be seen. The general construction is typical of a 19<sup>th</sup> century ancillary building, perhaps originally serving as stabling.

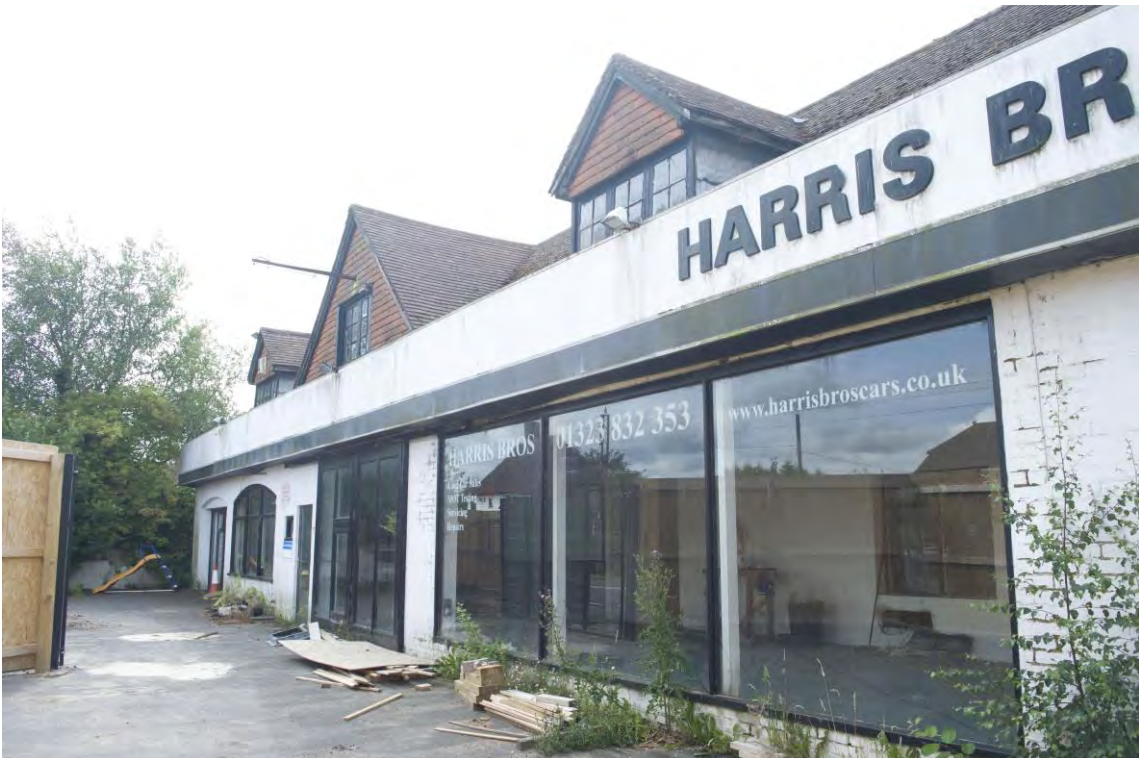
Plate 18 General view of the principal range of Range 3, facing south-east (8)

- 5.4.2 The principal elevation (Plate 18) faces north onto the forecourt and Boreham Street. This elevation is constructed in large stretcher-bonded bricks, painted with modern acrylic paint. The roof is pitched and covered with tiles. The northern roof pitch is interrupted by two gabled dormer windows between which is a gable with attic door opening, set off-centre to the east. Each dormer window has rendered sides and a tile-hung gable. The central doorway contains a redundant signage bracket. The eaves are boxed-in with plyboard, the west end of which is fixed with a wooden sign reading 'Harris Bros'. The elevation is punctuated by a pair of modern full-height openings and a pair of pedestrian doors at its west end. All are of modern construction, except for the far western door which contains a shallow arched brick head, consistent with an early 20<sup>th</sup> century date. The eastern end contains two original arched openings (Plate 19), comprising a window and large vehicle entrance. The windows is fitting with timber-framed glazing and topped with a two tiered brick header. The doorway is treated in a similar manner, although the glazed door and window arrangement comprise modern insertions.

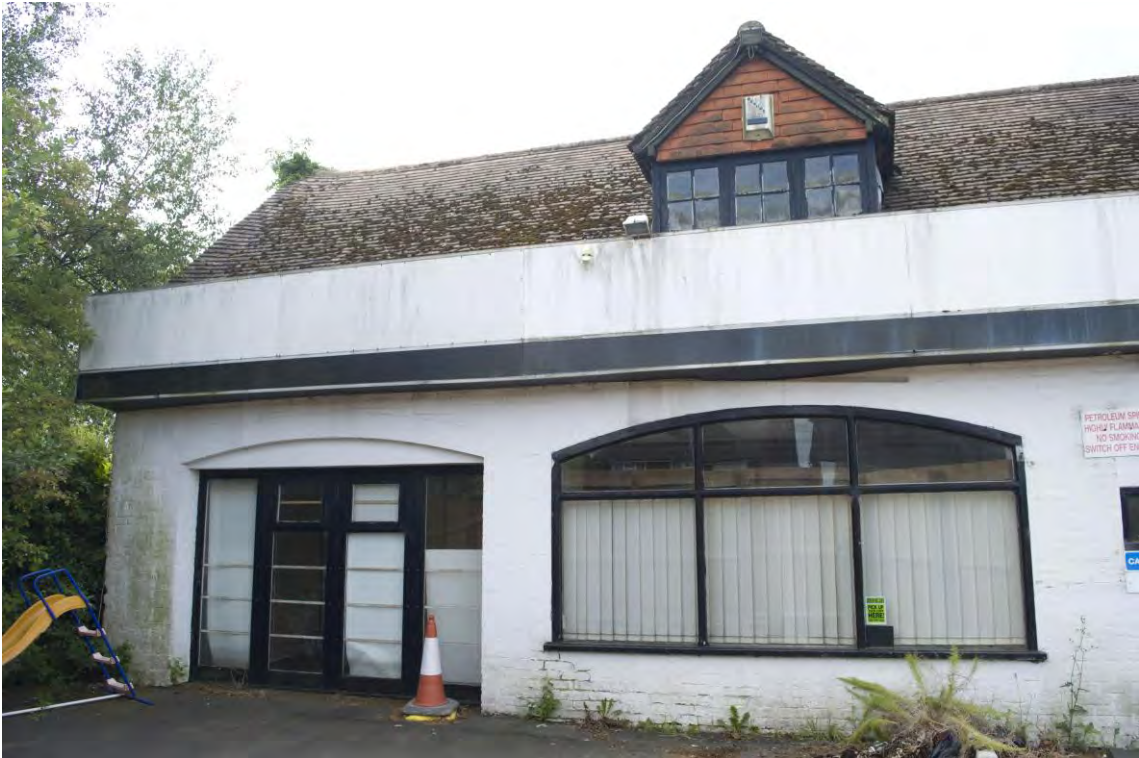
Plate 19 Detail of the original arched openings within the east end of the north elevation of Range 3, facing south (11)

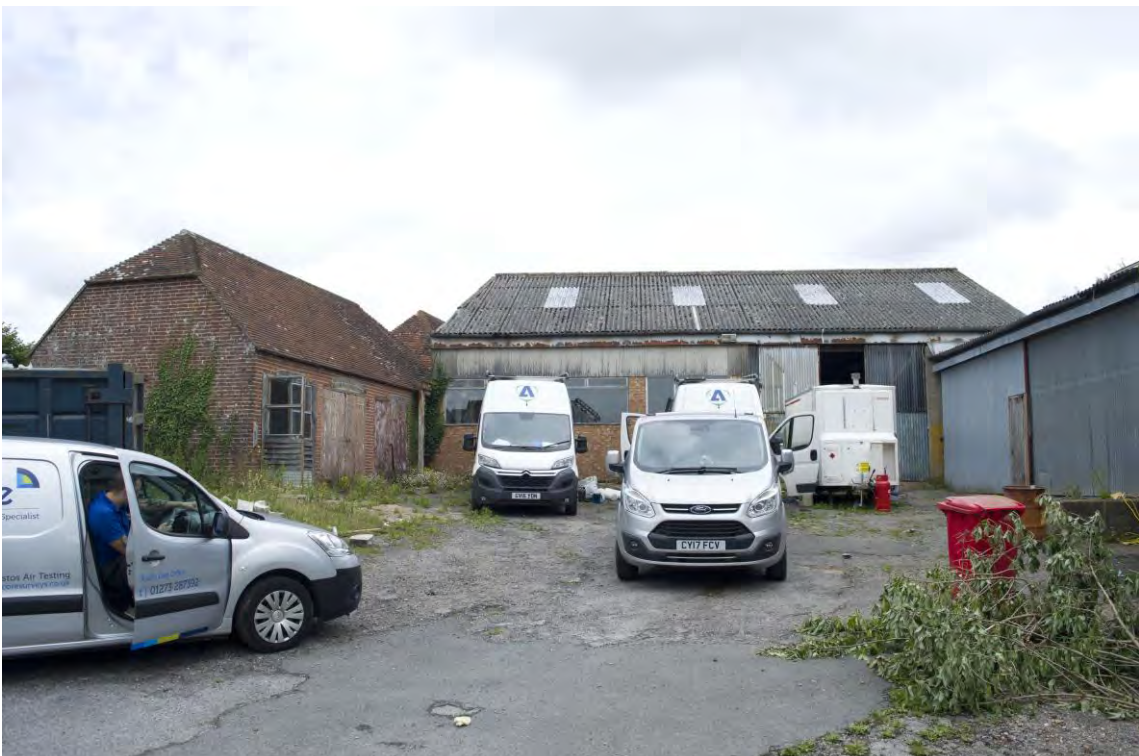
Plate 20 South elevation of Range 3 (southern extension), facing north (17)

- 5.4.3 The south elevation, belonging to the secondary phase of development, is constructed in a combination of pink-orange brickwork, laid in stretcher bond, clad with corrugated steel and asbestos cement sheeting (Plate 20). The western end contains three modern large windows. The eastern end contains a substantial opening for vehicles and pedestrians. The roof is pitched, gabled to the east and west and covered with corrugated asbestos cement sheeting.

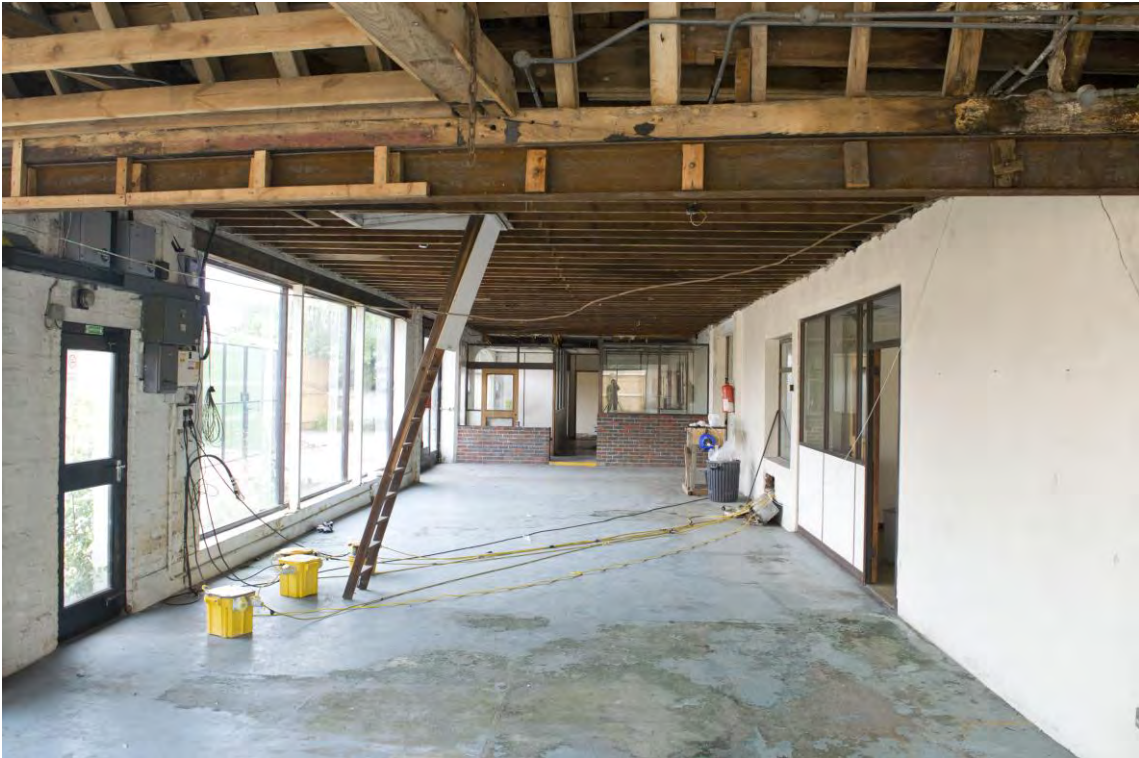
Plate 21 Interior ground floor view of the northern half of Range 3, facing east (59)

- 5.4.5 Internally the building is divided into the original north range and the large southern extension, by a stretcher-bonded brick wall. The north range, constructed as an early 20<sup>th</sup> century garage, continued in use until recently as a car showroom. The narrow rectangular structure includes accommodation at ground level and within the roof. The ground floor is predominantly open-plan (Plate 21), except for the east end which has been infilled with brick and plasterboard partitions. This is all of modern construction and inserted to provide toilet and office facilities. The dividing wall to the south has been rendered, and as such it was not possible to discern the location of any original room partitions. The floor comprises a continuous cement screed. The absence of brick footings within the floor indicates that the range is likely to have been open originally. The floor joists have been made visible at attic level, due to the stripping of modern materials (completed as part of asbestos removal works).

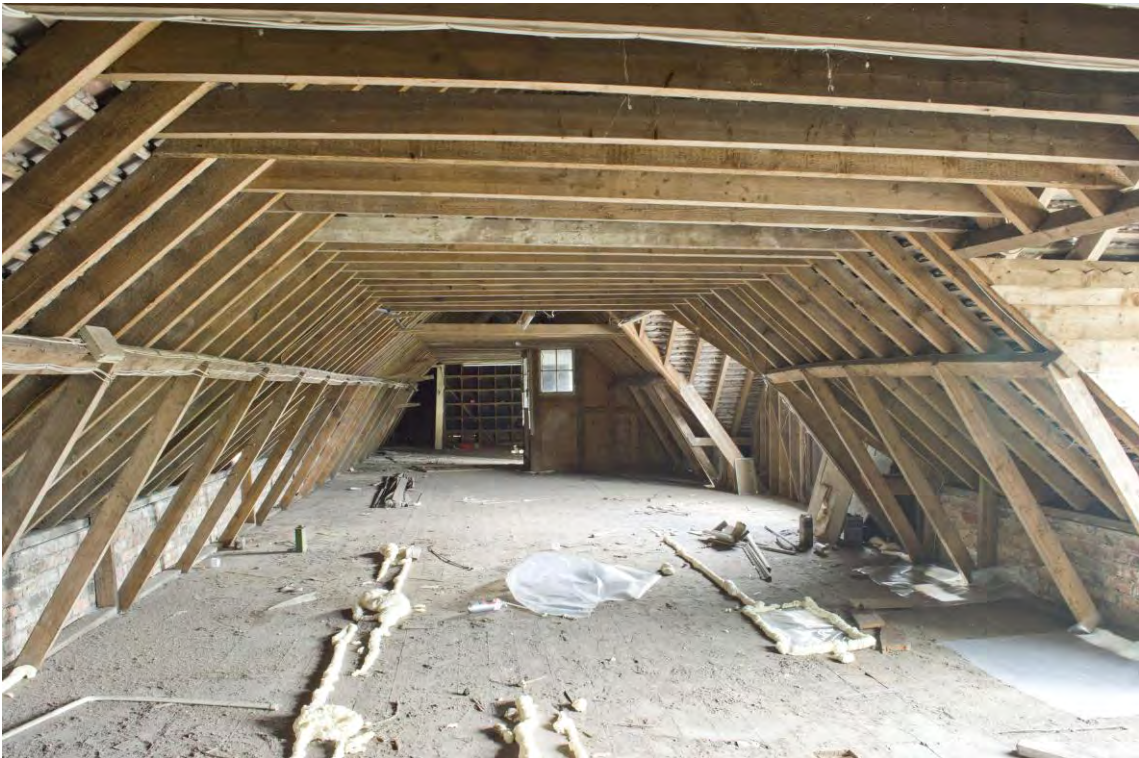
Plate 22 Attic of the northern half of Range 3, facing west (73)

- 5.4.6 The attic (Plate 22) is accessed through a small hatch at the west end. The small entrance indicates that this area was predominantly used for storage, with large items transported through the external doorway to the north. The attic space is open, partitioned only around the west dormer windows by lightweight timber boarding. The dormer windows (Plate 23) retain an original arrangement of three, six-pane, timber-framed opening casements, with scrolled catches and stays. The central two-leaf loading door contains 12 upper glazed lights and is boarded at its lower level (Plate 24). The roof is made up of softwood timbers and is of a nailed construction; typical of an early to mid-20<sup>th</sup> century date. The roof is of common-rafter type with a single purlin in each roof pitch supported by struts which extend from the front and

back walls. There is a nailed collar to each pair of rafters, which is set at a high level to allow the roof-space to be used. A timber shelving unit is located at the western end of the structure which retains labelling relating to car maintenance equipment.

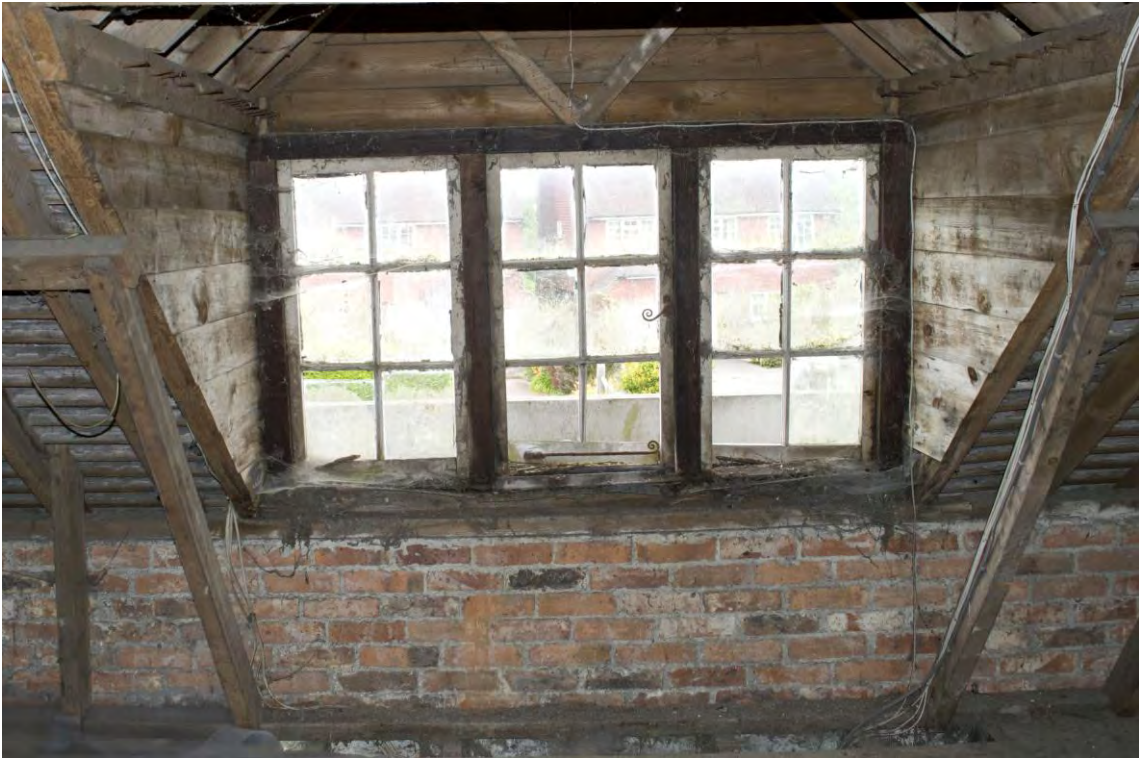
Plate 23 Detail of the dormer windows within the attic above the northern half of Range 3, facing north (72)

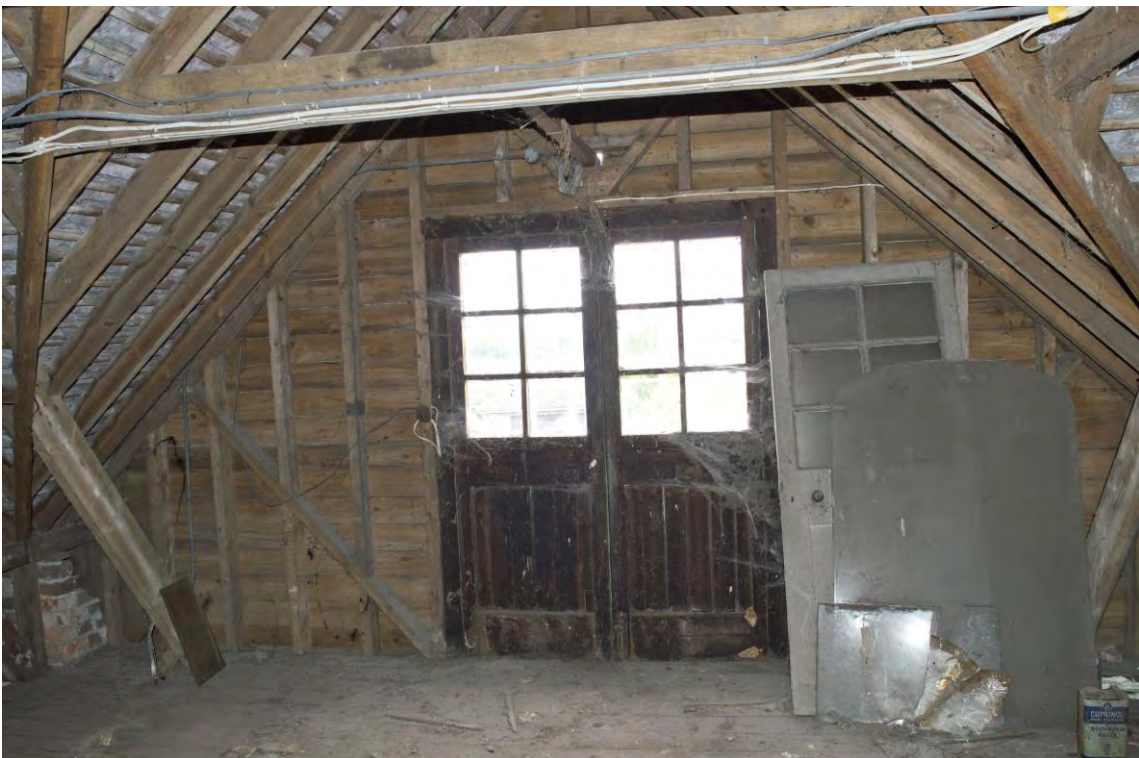
Plate 24 Detail of the central loading door within the attic above the northern half of Range 3, facing north (71)
