**HARRIS BROS. GARAGE, BOREHAM HILL, HAILSHAM,  
EAST SUSSEX, BN27 4SQ**

**HISTORIC BUILDINGS RECORD**

**Commissioned by Baker Architectural  
on behalf of Mr Michael Southouse**

**ASE Project No: 6758**

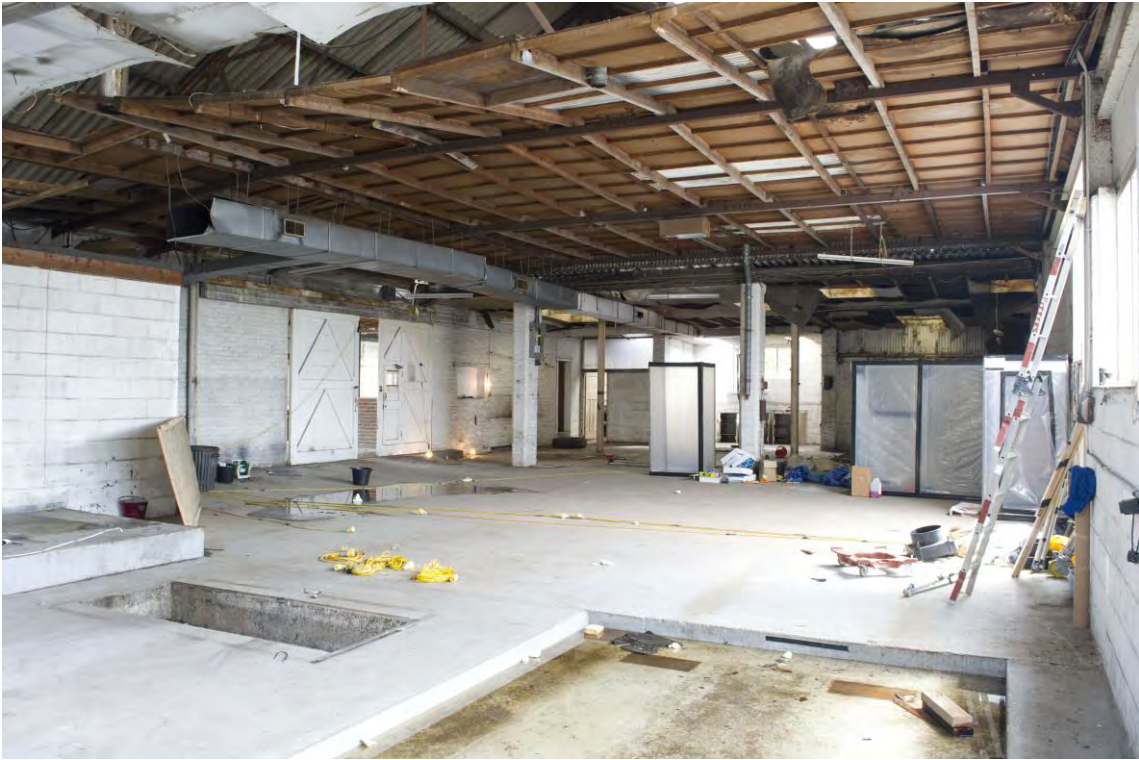
Plate 25 General view of the southern extension of Range 3, facing north-east (50)

5.4.7 The southern range, comprising a mid-/late 20<sup>th</sup> century extension, extends over a single level and is predominantly open-plan (Plate 25). The far eastern end of the appears to pre-date the remainder of the extension, formerly comprising an open-fronted workshop (open to the west) (Plate 26). The interior is divided into three bays by a series of brick piers and I-section steel joists. The underside of the roof above this end is clad with asbestos cement sheeting, which joins awkwardly with the timber boarding above the remainder of the western half of the structure. A flat-roofed, stretcher-bonded brick structure, fills its south-east corner. The block contains two separate toilets. The northern opening is a later insertion, whereas the southern doorway is a modern opening within an original wider opening, the dimensions of which can be seen in the soldier head lintel. The remainder of the original opening has been filled with concrete blocks. The opposing north-east corner has been infilled with a concrete block construction, containing an office. The east wall is constructed in concrete blockwork, filled with a modern high-set window, suggesting this end was originally open. A single personnel door and window has been inserted into the south dividing wall, although the window has been latterly blocked. The south wall is constructed in brown-orange bricks, laid in English bond, and is of early 20<sup>th</sup> century date, indicating that this wall predates those surrounding it. The southern bay contains a sunken inspection pit within a concrete screed floor, which extends throughout. A metal pulley crane mechanism is suspended between the southern wall and central steel joist above the pit; the style of this is consistent with an early/mid-20<sup>th</sup> century date.

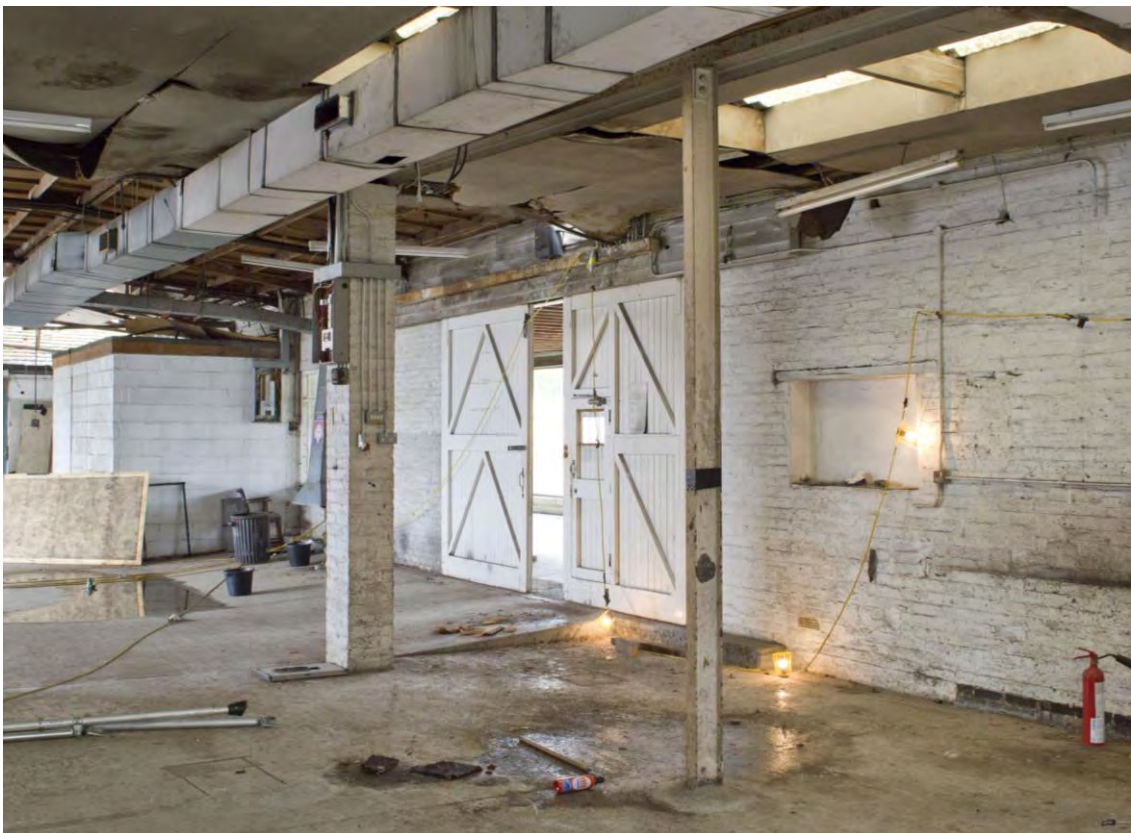
Plate 28 Detail of the sliding double doors providing access between the northern and southern halves of Range 3, facing north-east (54)

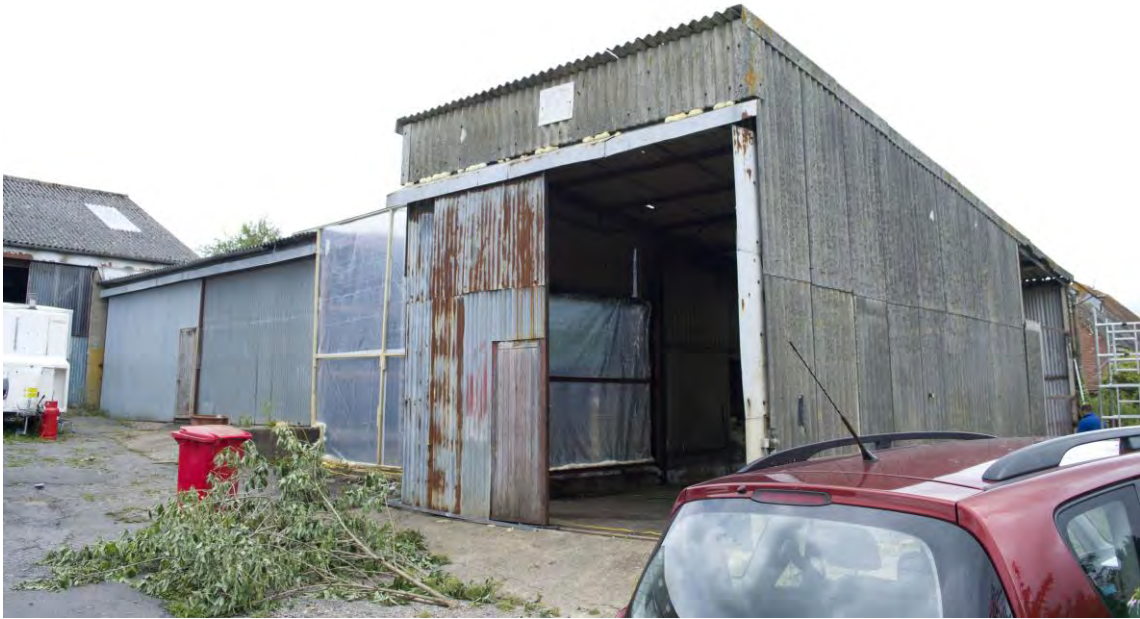
Plate 29 General view of Range 4, facing north-east (24)

5.5.2 The exterior of the L-shaped, northern half of the range comprises a double-height single storey structure. The external elevations are constructed with a modern steel frame, clad with corrugated steel sheeting. The east and west elevations are predominantly plain, with the north and south elevations obscured by the southern side of Range 3 and the adjoining southern half of Range 4. The west elevation is broken only by a rudimentary single-leaf wooden boarded door. The roof is flat and made of the same corrugated steel sheeting as the walls. The structure sits on a raised concrete platform, which forms a concrete plinth around the perimeter. The doorway is accessed via a cement ramp.

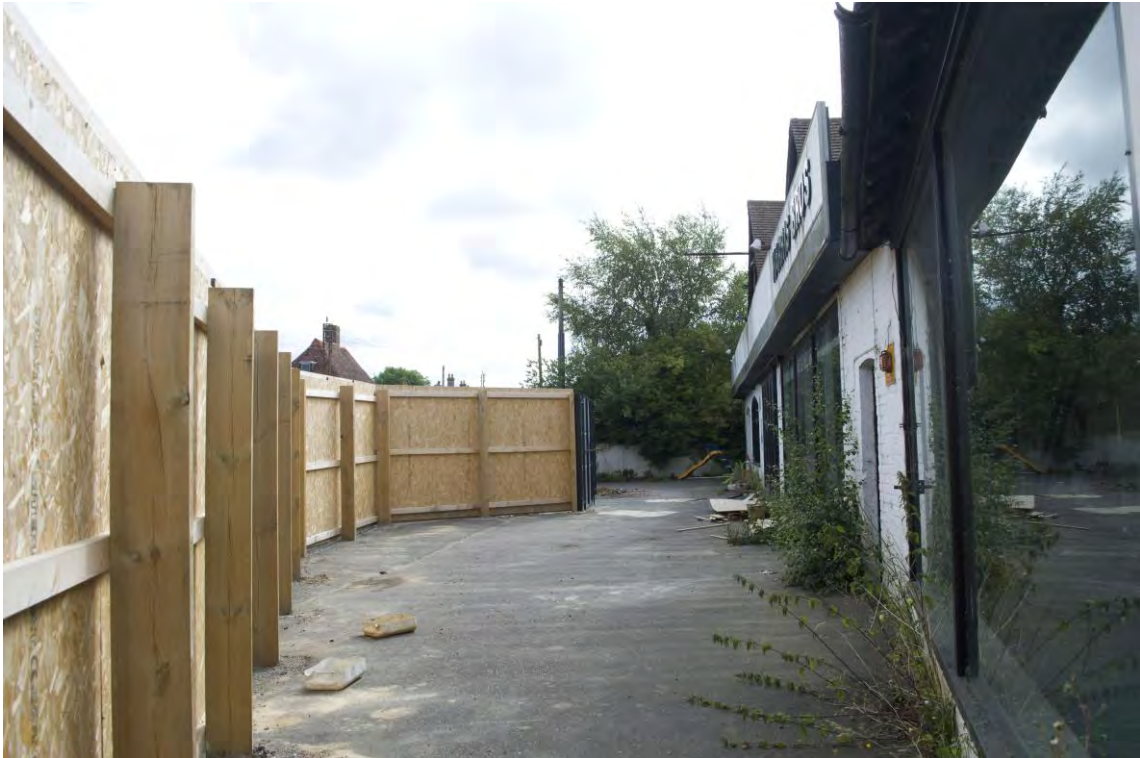
Plate 31 Area of the northern underground petrol tank within the forecourt, facing east (7)

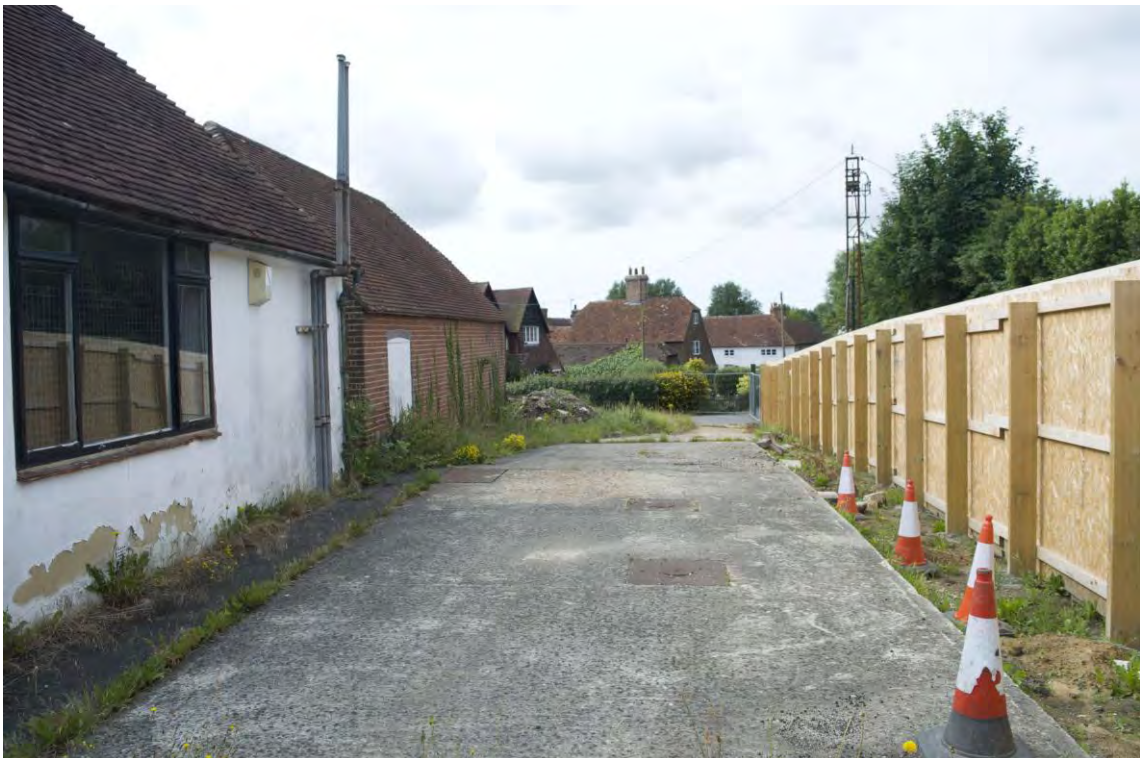
Plate 32 Area of the western underground petrol tank adjacent the west elevation of Range 1, facing south (6)

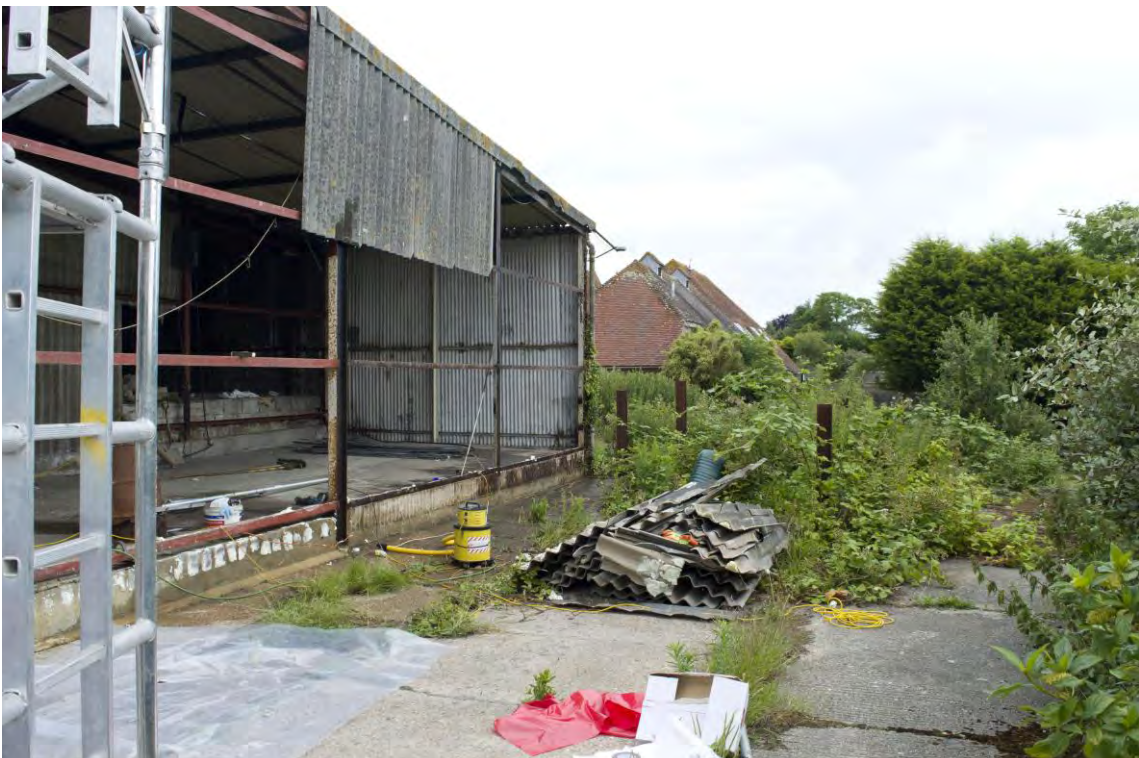
Plate 34 Concrete hardstanding and steel uprights found within the formerly developed south-east corner of the site, facing east (64)
