**Archaeological Watching Brief Report
Recording of an Exposed Cobbled Path
Scotney Castle, Lamberhurst
Kent**

**ASE Project No: 170618
Site Code: CGP17
ASE Report No: 2017287
OASIS ID: archaeol6-290253**

Prepared by:	Naomi Humphreys	Archaeologist	
Reviewed and approved by:	Dan Swift	Project Manager	
Date of Issue:	July 2017		
Revision:	1

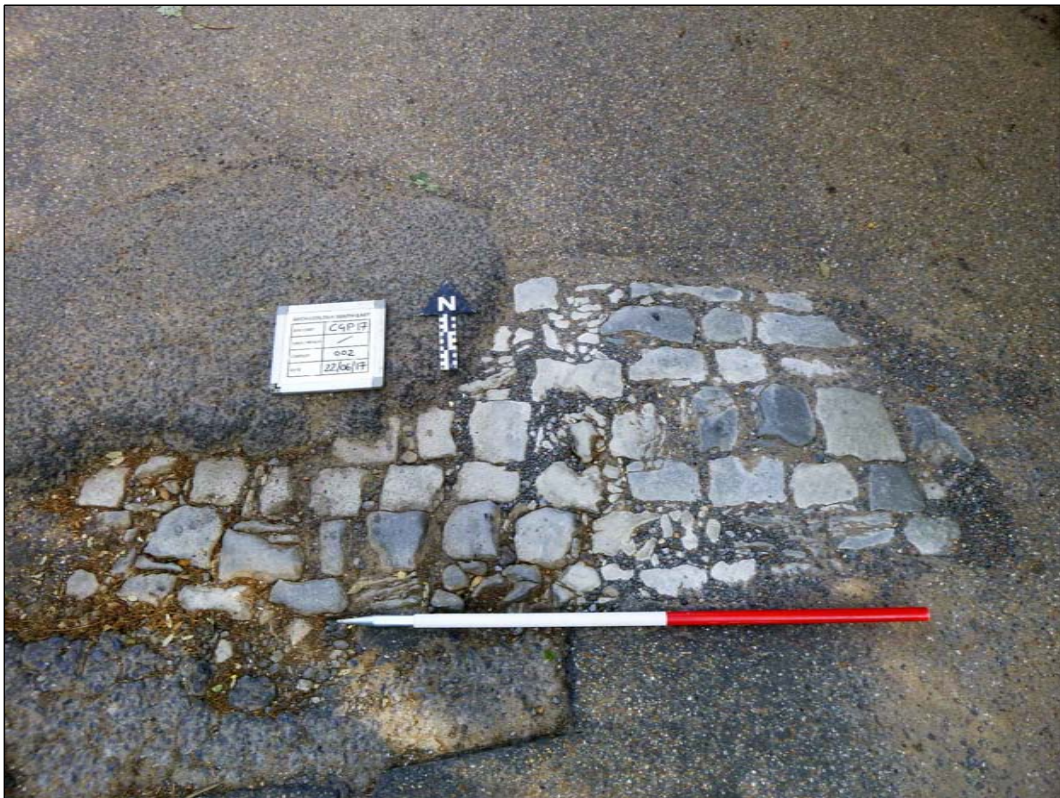
© Archaeology South-East		Scotney Castle: Cobbled Path, Scotney Castle, Lamberhurst, Kent	Fig. 3
Project Ref: 170618	June 2017	Plan and photo of exposed cobbled path	
Report Ref: 2017287	Drawn by: NH

- 5.1.1 A c.2.0m x c.0.85m area of a stone cobbled path was left exposed as a result of damage to the overlying tarmac road.
- 5.1.2 The cobbles comprise of irregularly shaped (although broadly rectangular) stones of varying sizes laid in courses which run east to west. Some of the larger cobbles appear to have split *in situ*. Smaller irregular stone gravels infill the gaps between the larger cobbles (Figure 3).

Cobbled path [002], looking north

- 5.2.1 Cobbled path [002] survives at a height of 64.69mAOD beneath a c.0.25-0.45 layer of tarmac road surface [001]. The tarmac appears to have been previously repaired in this area.
- 5.2.2 It is likely that the remainder of the cobbled surface in this area survives beneath the surrounding tarmac road.
- 5.2.3 The cobbled surface is at risk of damage from traffic which currently uses the access road.
- 5.2.4 Plans to repair the tarmac road in this locality seeks to protect the cobbled surface by creating a small hump in the road which will cover the currently exposed path.
