**Archaeological Watching Brief Report
Petworth Real Tennis Club, Estate Yard
Petworth House, Petworth, GU28 0DU**

ASE Project No: 170582

Site Code: TPP17

ASE Report No: 2017351

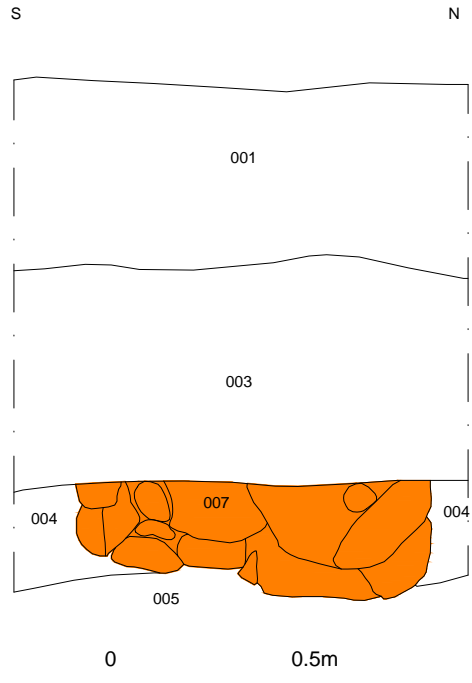
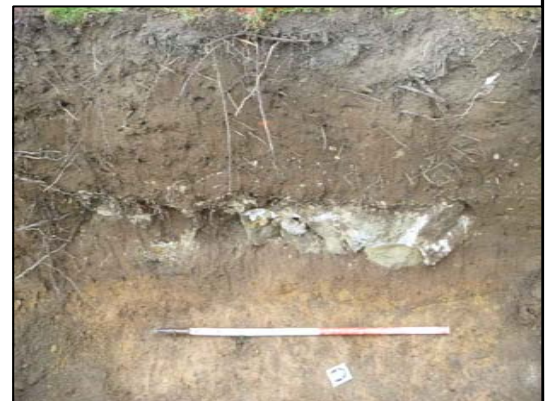
© Archaeology South-East		Petworth House, Real Tennis Courts, Petworth, West Sussex	Fig. 3
Project Ref: 170582	August 2017	Trench 4, section and photograph	
Report Ref: 2017351	Drawn by: AR

- 4.3.4 At 11.79m from the north end of trench 4, the fragmentary remains of a wall footing [007] were visible in the east facing section, apparently cut through [004] (although there was no visible wall cut) and buried by [003]. It measured 0.93m wide and 0.35m high. It had been previously truncated, and consisted of random coursing of stone blocks of varying sizes (measurements taken were 250mm x 190mm x 110mm, 300mm x 260mm x 150mm and 400mm x

350mm x 70mm). They were bonded by an off white/ grey limestone mortar with frequent crushed stone inclusions. The footing was capped by light brownish-yellow, coarse sandstone mortar with moderate crushed stone inclusions. No associated finds were recovered.

007, looking north west

- 6.3.1 The general research aims, with regard to determining the presence or absence of archaeological remains, assessing the character of remains, recording their extent and preservation were met, although the fragmentary remains of the single encountered feature, a stone wall footing, remain undated by associated finds. Any further research should perhaps be focussed on the date and function of the wall footing in relation to the historic property.
- 6.3.2 It was clear that previous groundworks/demolition have caused quite extensive truncation to the site, although an apparently intact subsoil horizon survived.
