**RAMSGATE SWIMMING POOL, NEWINGTON ROAD,
RAMSGATE, KENT, CT11 0QX**

Historic Building and Archaeological Watching Brief

**Project no. 170216
Report No. 2017348
Site Code. RSP17
OASIS ID. Archaeol6-292988**

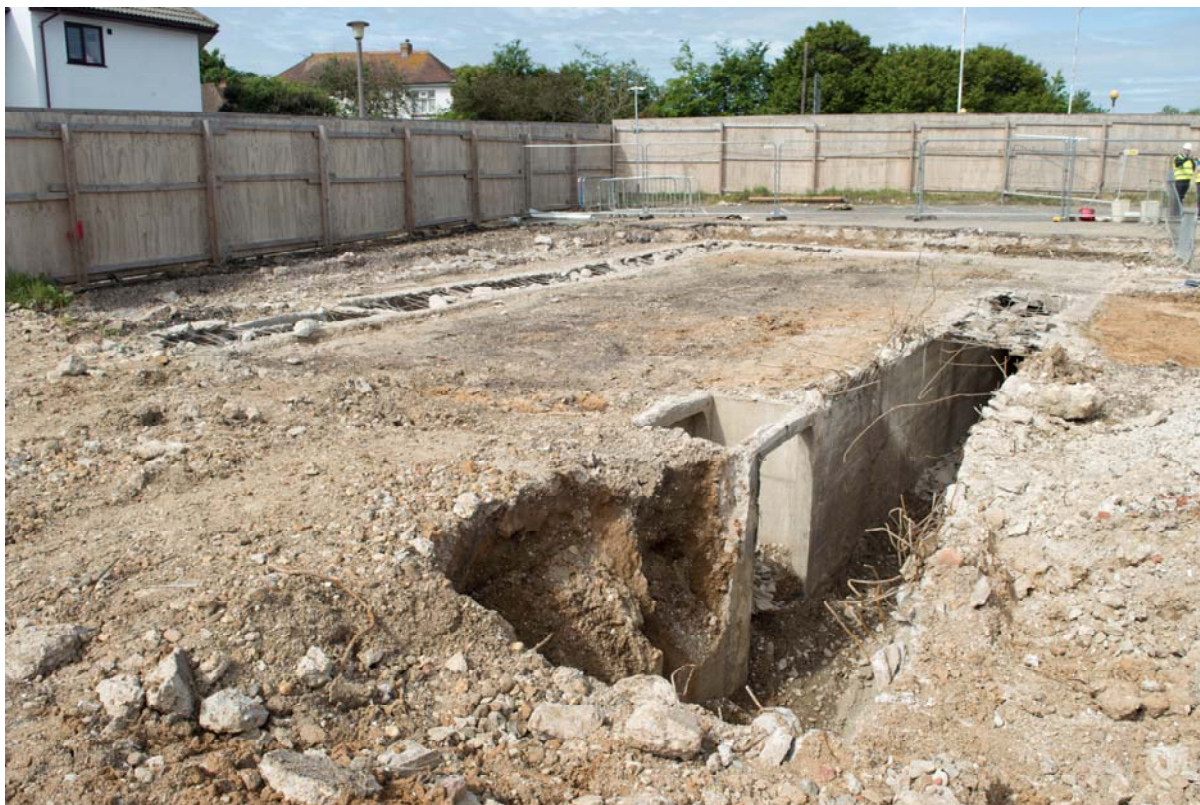
Plate 1: Partially excavated ARP shelter, facing south-west (RSP17-0002)

- 4.2 The structure is located at the south-west of the site. It is rectangular in shape and is aligned approximately east to west. The structure consists of four connected trenches 2.17 m deep laid out in a rectangular circuit (Plate 1). The trenches are floored with concrete screed and lined with reinforced concrete cast in situ, approximately 20 cm thick and tied into a flat concrete roof (Plate 2). The majority of the structure remains intact, however the eastern end has been truncated by the construction of a swimming pool in the 1970s, leaving only the floor slab and the lower part of the walls.

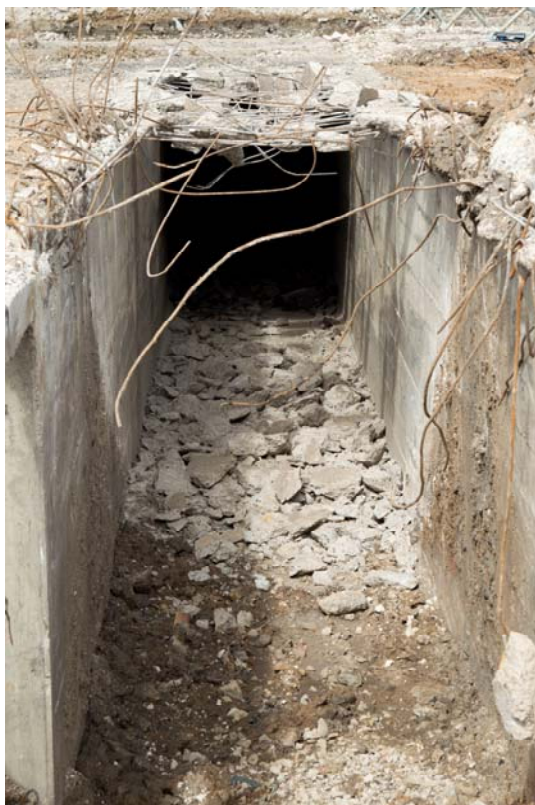
Plate 2: North trench of ARP shelter, showing construction of the structure, facing west (RSP17-0012)

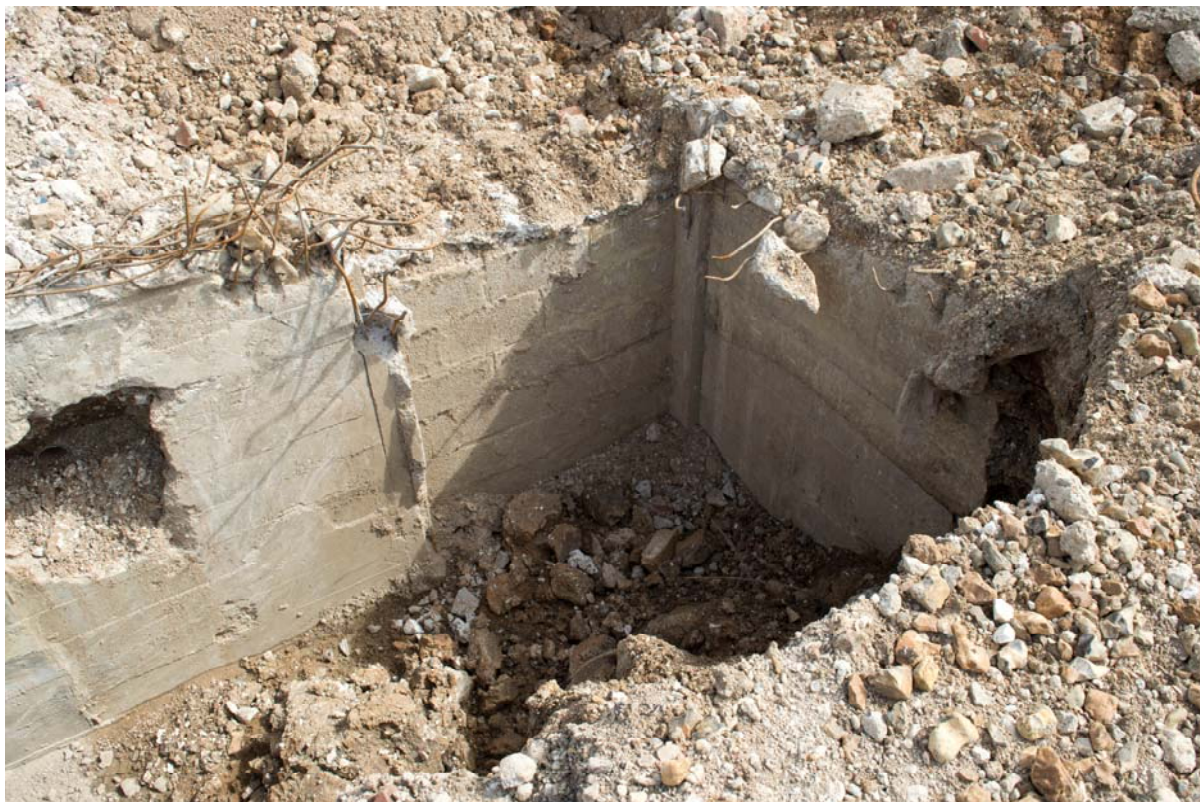
Plate 3: Blocked opening at north east corner of ARP shelter, facing north (RSP17-0007)

- 4.3 The structure has four openings, all of which are blocked. An opening at the north east corner of the structure leads north, however it has been blocked with a large amount of concrete (Plate 3). No structure survives beyond the blocked opening. The south wall of the north trench contains a similar opening, formed with a pre-cast concrete doorframe. The doorway opens into a small vestibule and another doorway, blocked with precast concrete panels (Plate 4).

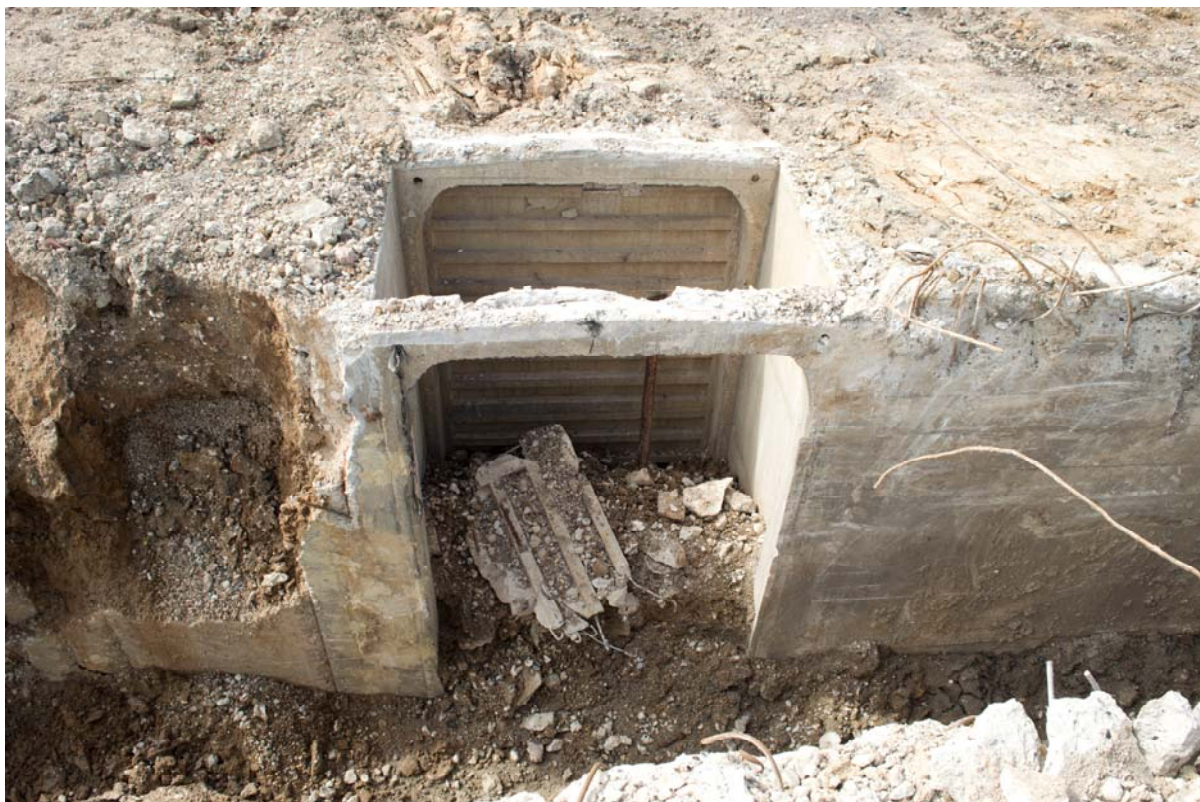
Plate 4: Blocked opening on south side of north trench with precast door frames, facing south (RSP17-0007)

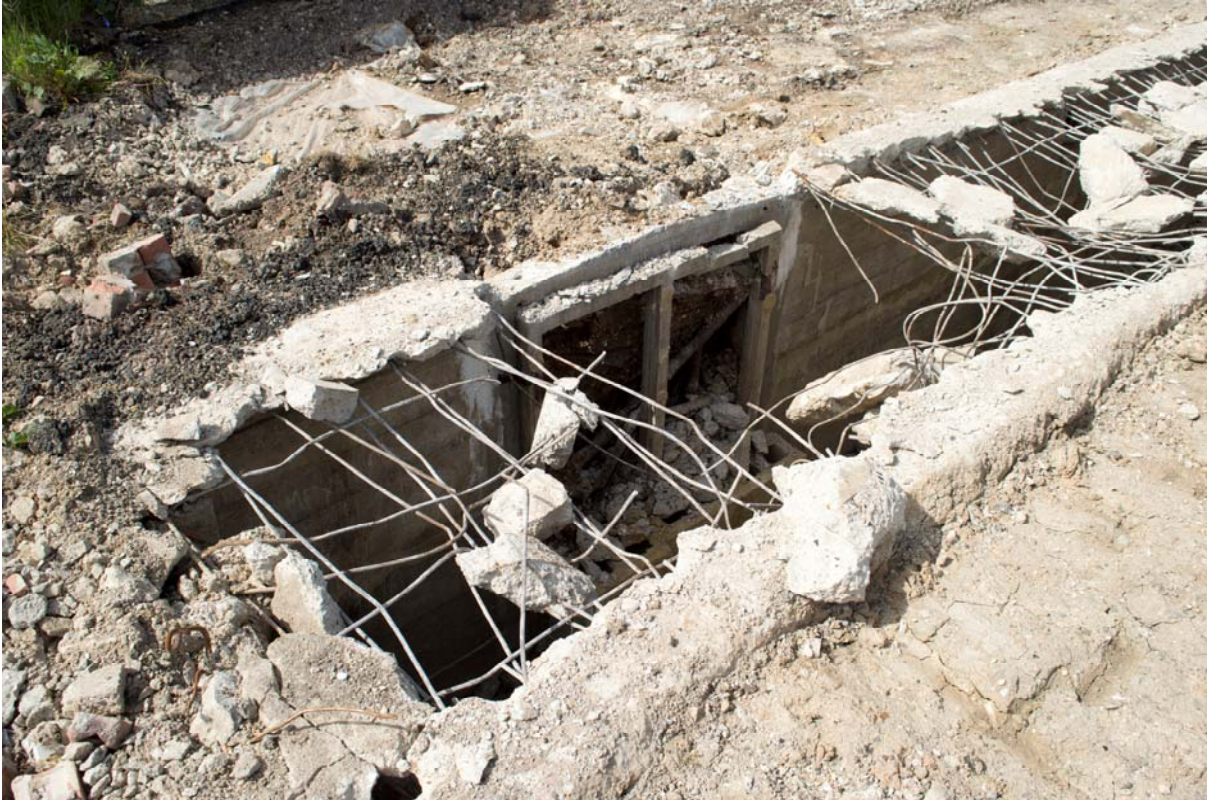
Plate 5: Blocked opening on east end of south trench, facing south-west (RSP17-0022)

- 4.4 There are two further openings on the south wall of the south trench. Towards the east end of the trench there is a precast concrete doorway (Plate 5). Beyond the doorway the floor slab continues for approximately 1.3 m before being truncated. The opening at the eastern end contains no doorway and is simply blocked with a series of upright railway sleepers (Plate 6). Any structures associated with the openings appears to have been removed and backfilled but it is likely that some or all of them served as entrances to the structure.

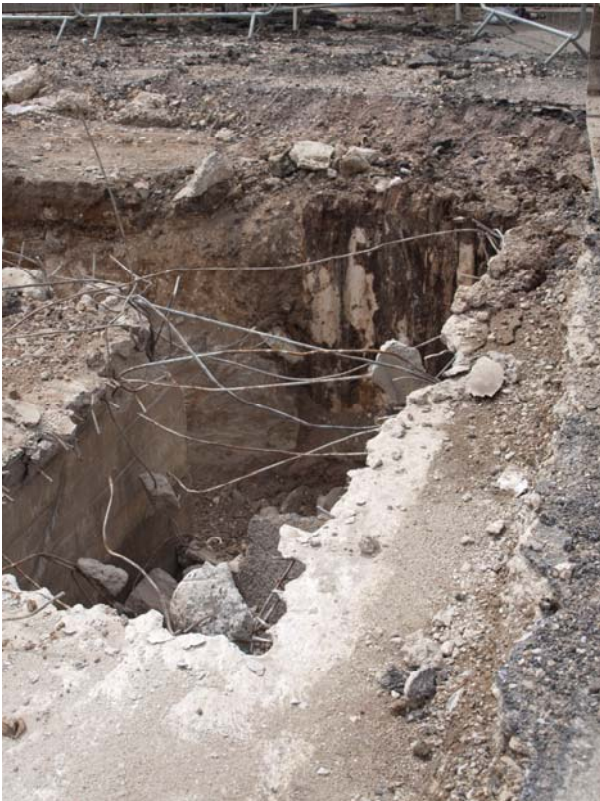
Plate 6: Blocked opening in south-west corner of the shelter, facing south (RSP17-0081)

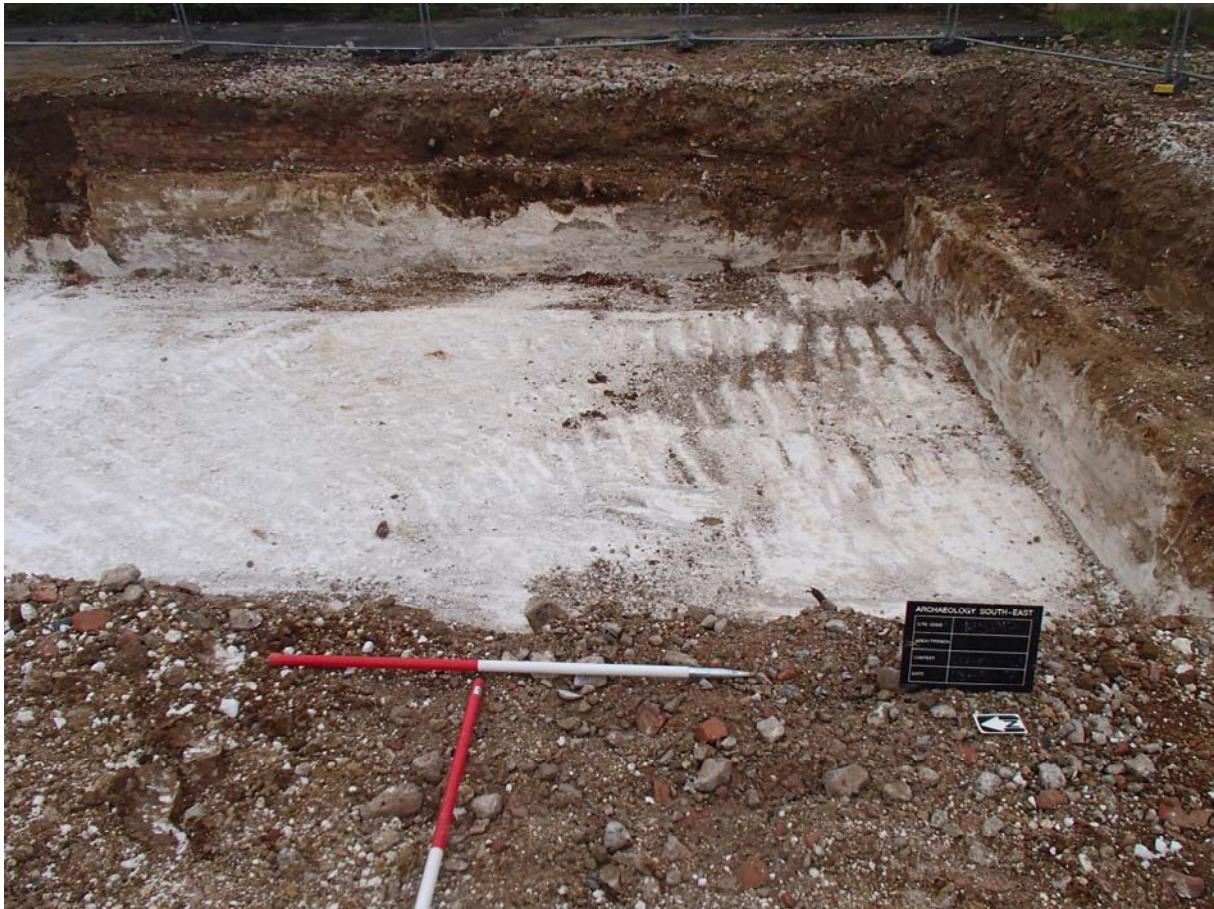
Plate 7: Soakaway 2, brick wall visible at far end, facing east (RSP17-0106)

- 5.1.1 The archaeological watching brief observed the excavation of two soakaways at the northern end of the site and ground reduction at the southern end of the site in preparation for the subsequent excavation of foundation trenches.
- 5.1.2 The excavation of the soakaways (Figure 2) revealed no significant archaeological deposits. Natural chalk [1002] was encountered at a depth of c.600mm. The natural chalk was overlain by made ground [1001], which covered most of the site.
- 5.1.3 Along the eastern edge of soakaway 2 was a short, truncated stretch of modern wall made from fletton bricks (Plate 7).
- 5.1.4 Other than the air raid precaution shelter discussed in section 4.0 above, the ground reduction and excavation of foundation trenches undertaken at the southern end of the site revealed no archaeological deposits, features or finds.
