**Archaeological Watching Brief**

**Service Chamber and Cable Trench  
at  
Prittlewell Priory (Scheduled Monument)  
Southend-on-Sea  
Essex**

**Site code: SOPP17  
ASE Project No: 170549  
ASE Report No: 2017435**

**November 2017**

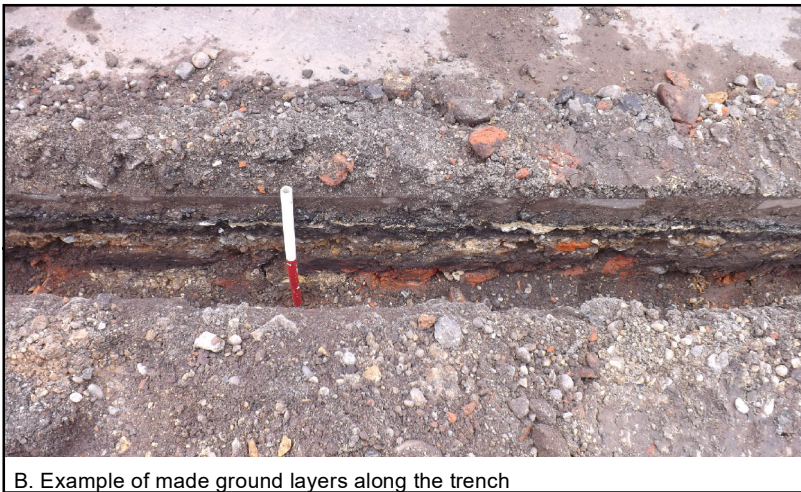
- Context [04] – Made-ground. Silty clay, dark brownish grey with frequent pieces of broken brick and tile.
  - Context [05] – Disturbed Ground. Grey brown sandy clay with frequent patches of sorted gravels and orange sand. Greater than 0.2m thick.

B. Example of made ground layers along the trench

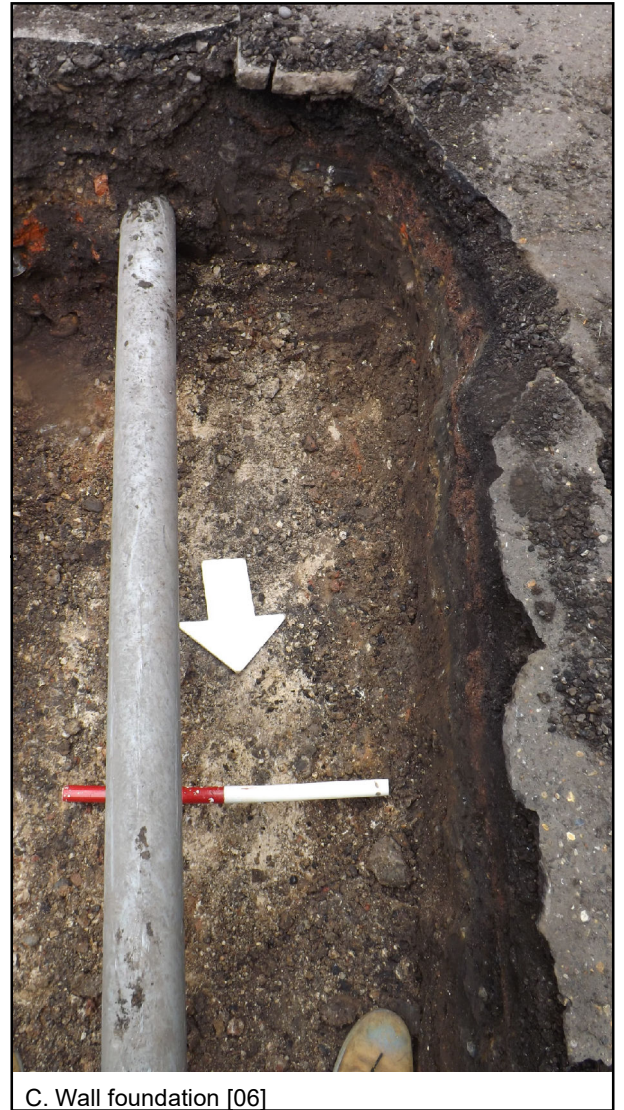
- Context [06] – Wall. At base of inspection chamber.
- 4.3 Context [06] comprised the upper surface of a wall or wall foundation, 0.8m wide (Fig. 4). This feature was located at the very base of the inspection chamber cut and, as such, was left *in situ*. It was below the level of the 2010 ducting, which limited access to the feature and explains why it has not been previously recorded. The upper surface exposed comprised flint rubble in a loose yellowish grey sandy mortar. It was orientated roughly north to south and no clear curvature was visible on the exposed section. This feature may be a wall foundation or the surviving base of a wall, the upper parts of which have been demolished.

- 4.4 The date of wall [06] is unknown and there is no clear correlation between the feature and the historic plans of the site. The construction materials would perhaps suggest a medieval date is possible as the excavated walls of the church are of flint rubble and mortar.

A. Wall foundation [06]

C. Wall foundation [06]

5.4.2 The remains of the wall [06] cannot be definitively dated, but their construction is similar to that of other elements of the medieval priory buildings that have been excavated on the site previously. Therefore, it is possible they are of a similar medieval date. Given the constrained size of the works, an interpretation of the wall in relation to the known plan of the priory is uncertain.

5.5.1 The archaeological monitoring at Prittlewell Priory identified a single wall of possible medieval date at the base of the trench (0.5m BPSL). This wall has been preserved *in situ*. No other archaeological remains were recorded along the length of the trench, as the groundworks did not extend below made and/or disturbed ground deposits.
