**FORMER POLICE STATION, 43 SPARROWS HERNE, BUSHEY,
HERTFORDSHIRE, WD23 1AF**

Historic Buildings Record

**ASE Project No: 170859
Site Code: BPS17**

**ASE Report No: 2017464
OASIS id: archaeol6-300376**

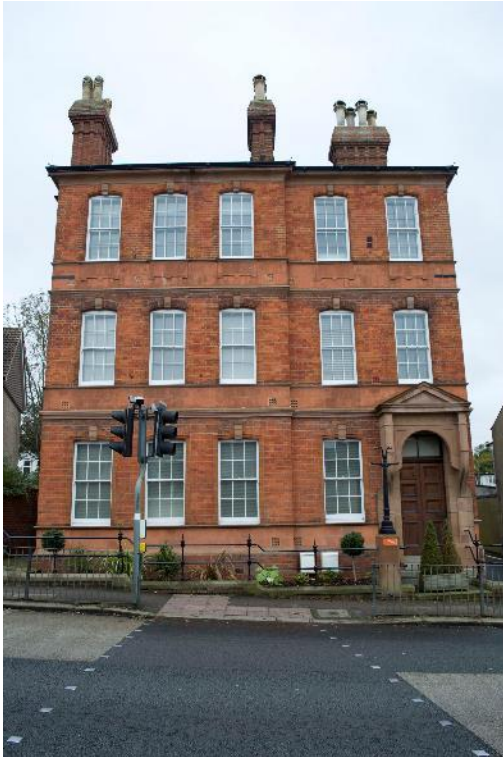
Plate 1: Station, Range 1, north-east elevation, facing south-west (170859_0020)

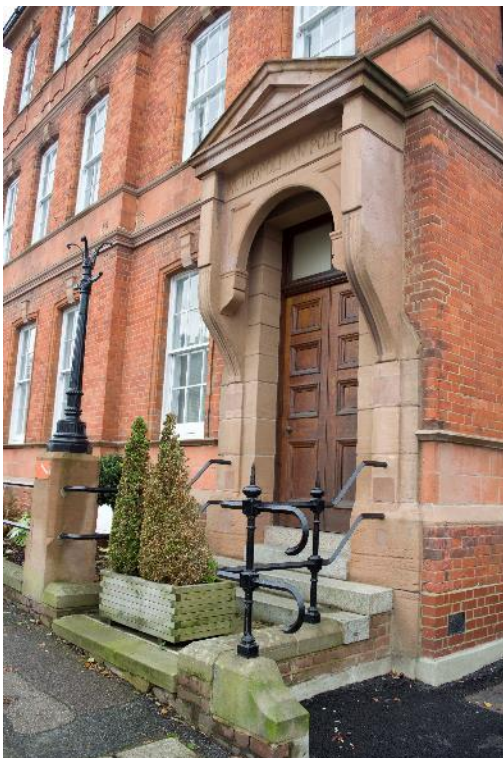
Plate 2: Station, Range 1, principal doorway within the north-east elevation, facing south-east (170859_0040)

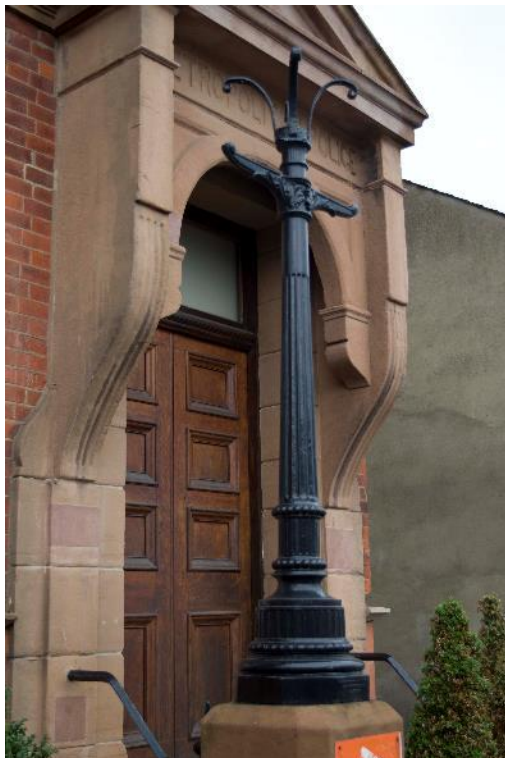
The column is fluted and also bears leaf motifs and a manufacturer's mark reading 'W. Macfarlane Co. Glasgow'. This foundry was one of the most important 19th century Scottish ornamental iron works and operated between 1817 and 1885, identifying the standard as an original feature. The south-east end contains a wide gate with lock, supported either side by curved back stays. This entrance provides access to the rear of the site, via the south-east elevation.

Plate 4: Detail of an original street-lamp standard fronting the station's north-east elevation, facing north-west (170859_0043)

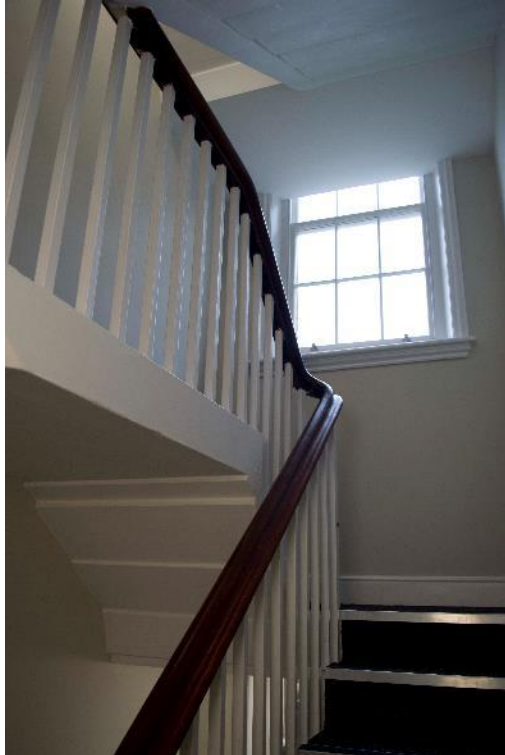
Plate 17: Station, Range 1, detail of truncated first floor stairwell window, facing south-east (170859_0004)

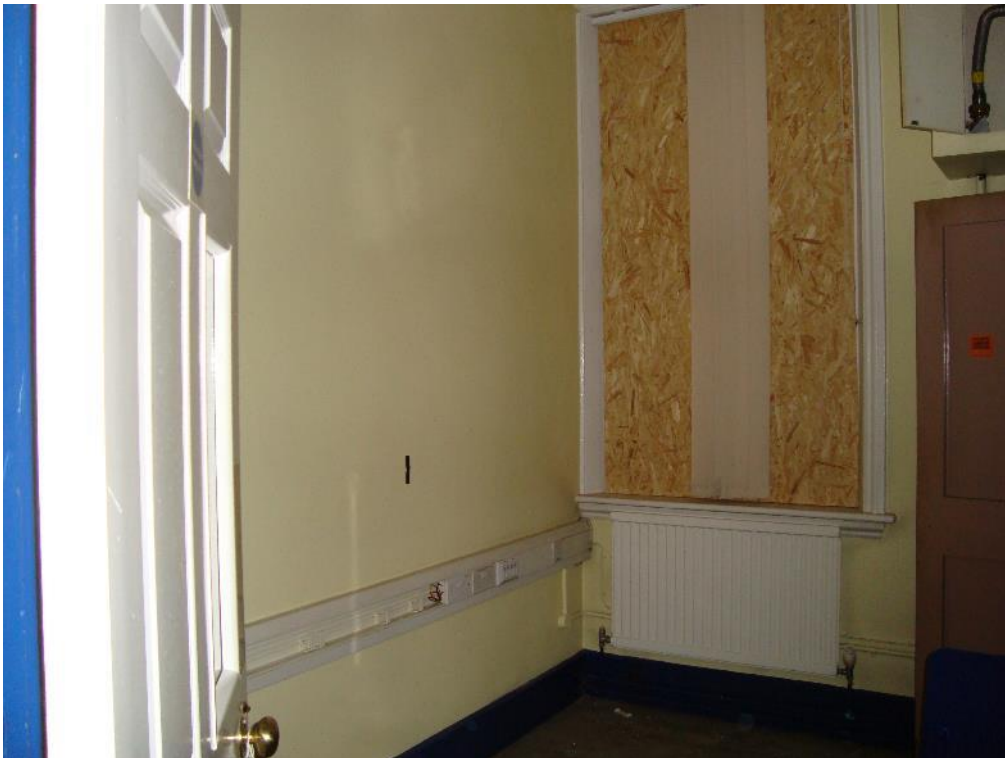
Plate 20: Station, Range 1, Room 3 interior noting inserted partition wall (left), facing west (CgMs_0107)

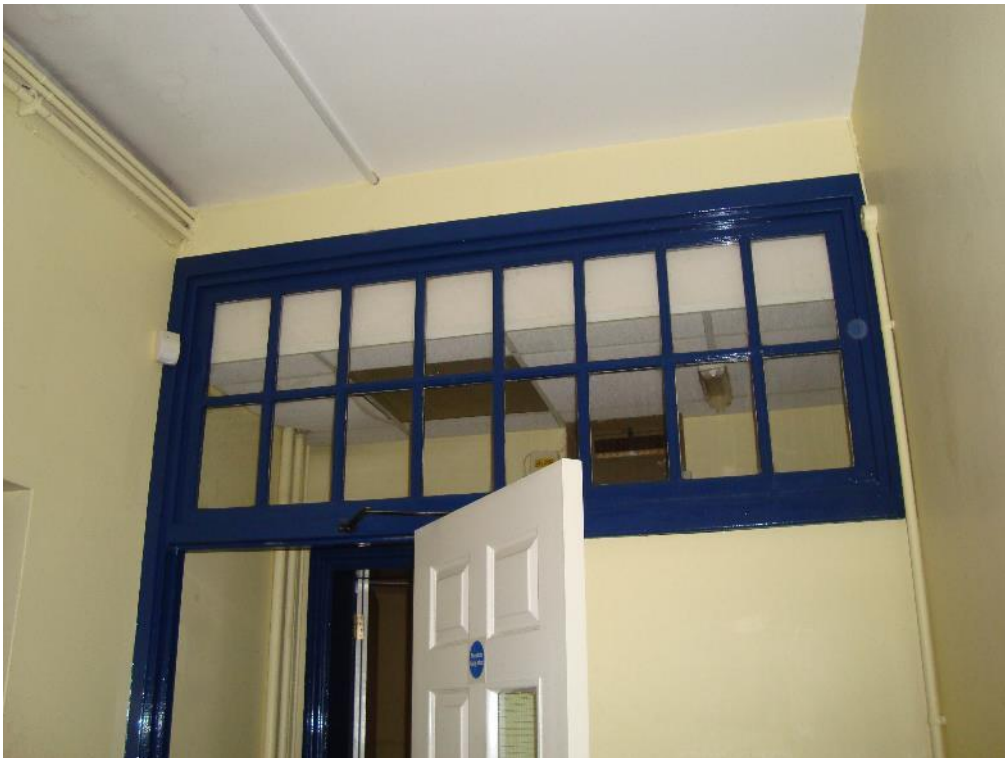
Plate 22: Station, Range 1, Room 3, detail of glazed partition separating the room from the inserted corridor, facing south-east (CgMs_0109)

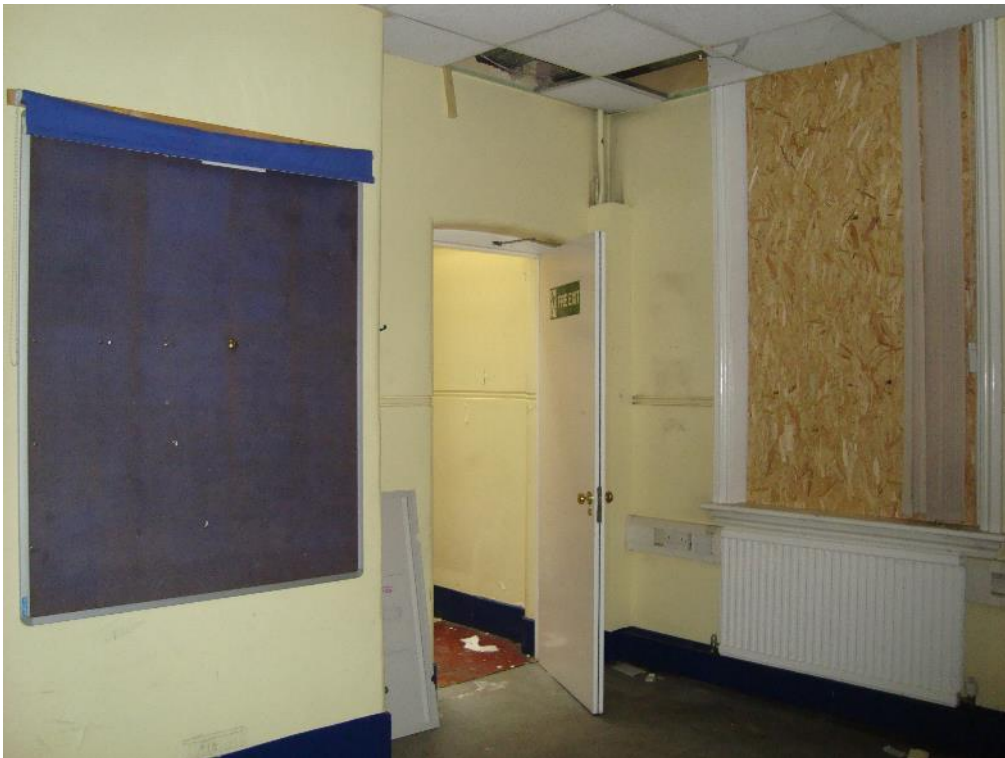
- 6.2.9 Room 5 occupied the south-west end of the Occasional Court, and served as an office in 2013. The modern linoleum observed elsewhere continued in this room, as did the inserted panelling. All walls were detailed with the integral dado, including a replica finish on the inserted partition wall to the north-east. Matching plain skirtings continued around each wall. The room was lit from a single window within the north-west wall, displaying all the characteristics described within Room 2. The south-west wall (Plate 24) was dominated by a large chimneystack with rounded jambs, the fireplace of which had been blocked. A doorway within the south-east wall originally provided access into the adjoining extension, however later became an external doorway following the demolition of this range. The doorway appears to have retained its original moulded architrave. The door itself was of four flush panel type. The north-west end of the south-west wall contained a single doorway which provided access into Range 2. The doorway comprised a shallow arched lintel and rounded jambs. The door itself was modern.

Plate 24: Station, Range 1, Room 5, note chimney stack and bull-nosing to the door jambs, facing west (CgMc_0104)

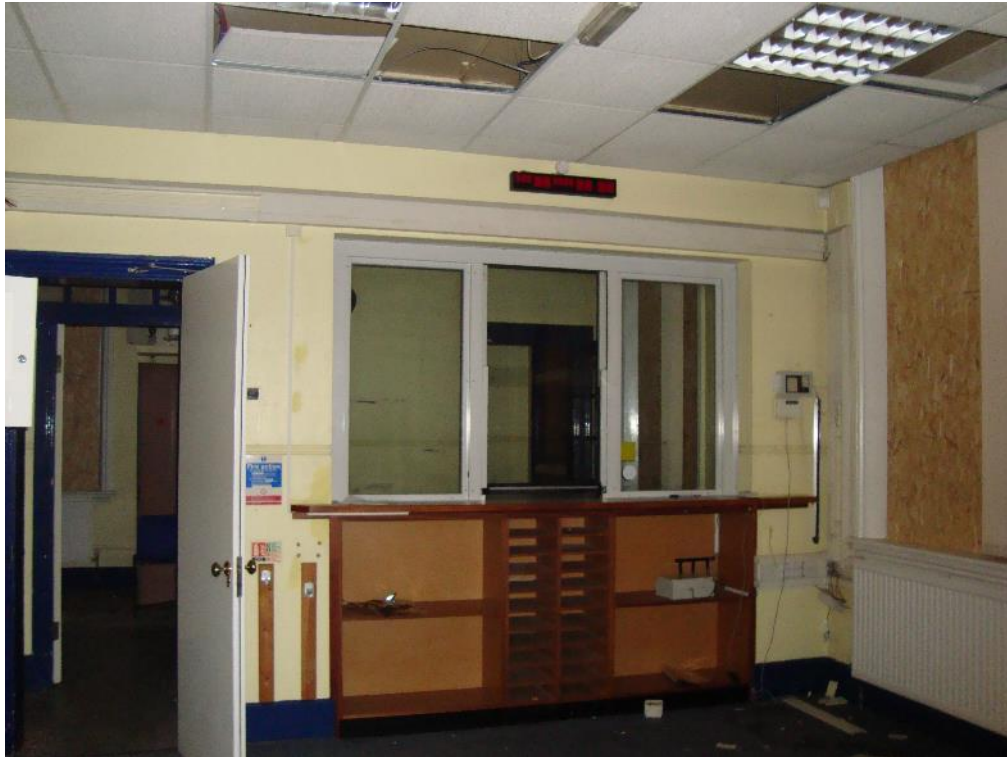
- 6.2.10 Room 6 (Plate 25) retained its original use as an office. The floor and ceiling coverings were as elsewhere. The room was lit from the north-east via three substantial windows (Plate 26), each set within moulded architraves with deep reveals and cills. A dado rail continued unbroken around all but the north-west wall, broken only by the inserted counter. The south-east wall contained a centrally located vent at its base, indicating the location of the externally protruding chimneystack in this location. It is likely this area comprised a fireplace but no evidence can be seen from the photographs. Two doorways were set within the south-west wall. The door to the north-west end led through to a store which was lit from a single window to the south-west side (as elsewhere). The doorway retained an original moulded architrave; the nature of the door cannot be ascertained from the photographs. The doorway set to the south-east end of the office provided access to the external side entrance and circulation area. The nature of the opening is not visible in the photographs.

Plate 25: Station, Range 1, Room 6, note inserted enquiry counter, facing north-west (CgMs_0125)

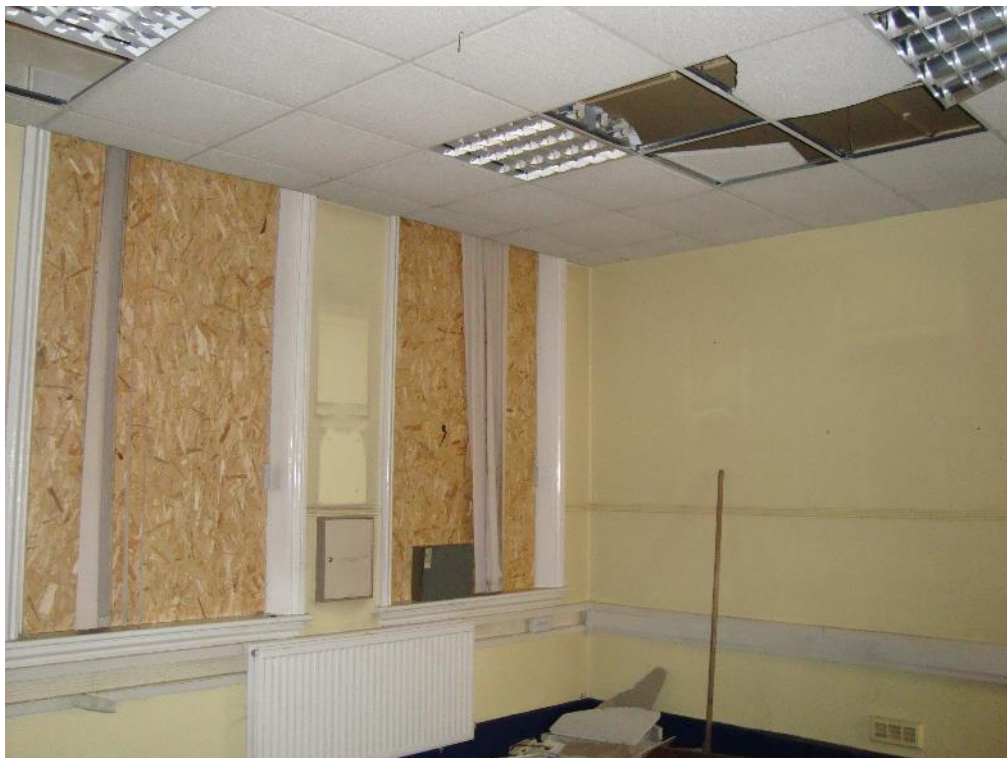
Plate 26: Station, Range 1, Room 6, window architrave detailing, facing south (CgMs_0124)

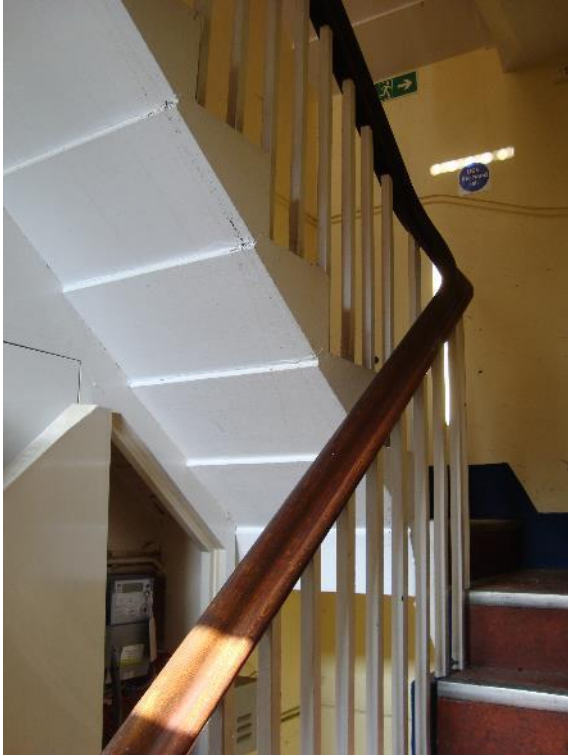
- 6.2.11 This area appears relatively consistent with its present description (Plate 27), containing the same south-east – north-west orientated staircase and side entrance within the south-east wall. One change noted was the creation of an understair cupboard within the western corner: existing plans show two inset utility cupboards along the south-west wall in 2013. The south-west wall at the foot of the stairwell also formerly contained an opening into the adjoining extension (Range 3). The doorway contained a shallow arched lintel of alternating stretchers and tiered headers (as seen from Range 3) and a modern door. The stairs themselves were covered with linoleum and the plastered walls retained their original dado rail (Plate 28), now covered, and a high-set plain skirting.

Plate 27: Station, Range 1, Room 8, south-east side entrance, facing south-west (CgMs_0134)

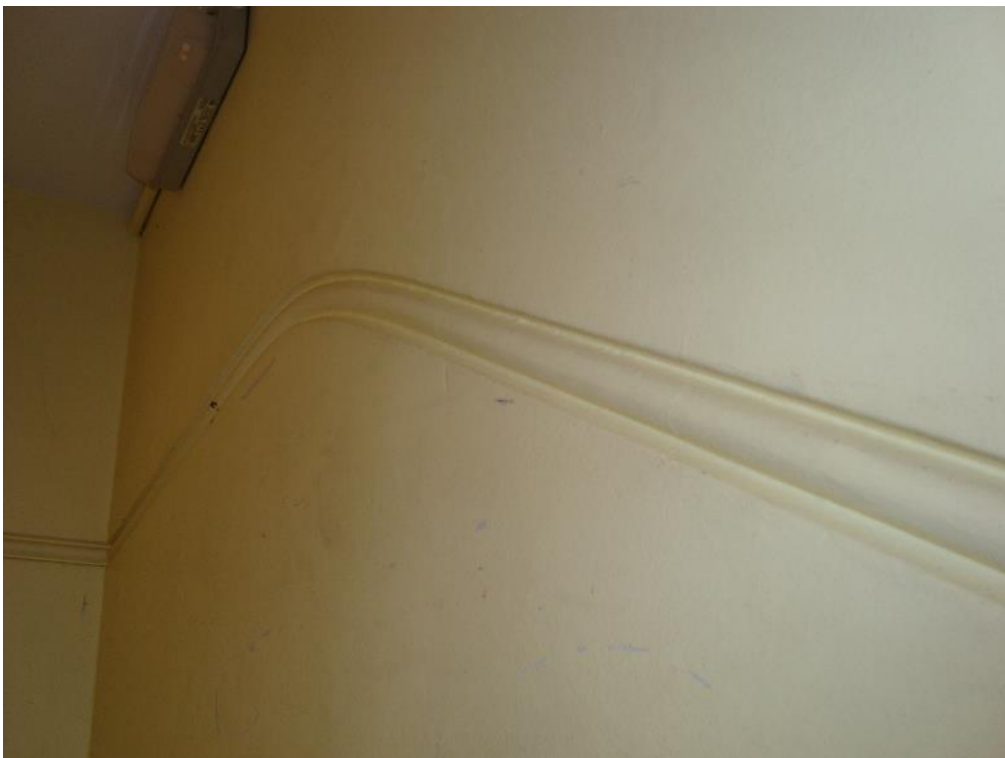
Plate 28: Station, Range 1, Room 8, integral dado rail detailing, facing north (CgMs_0136)

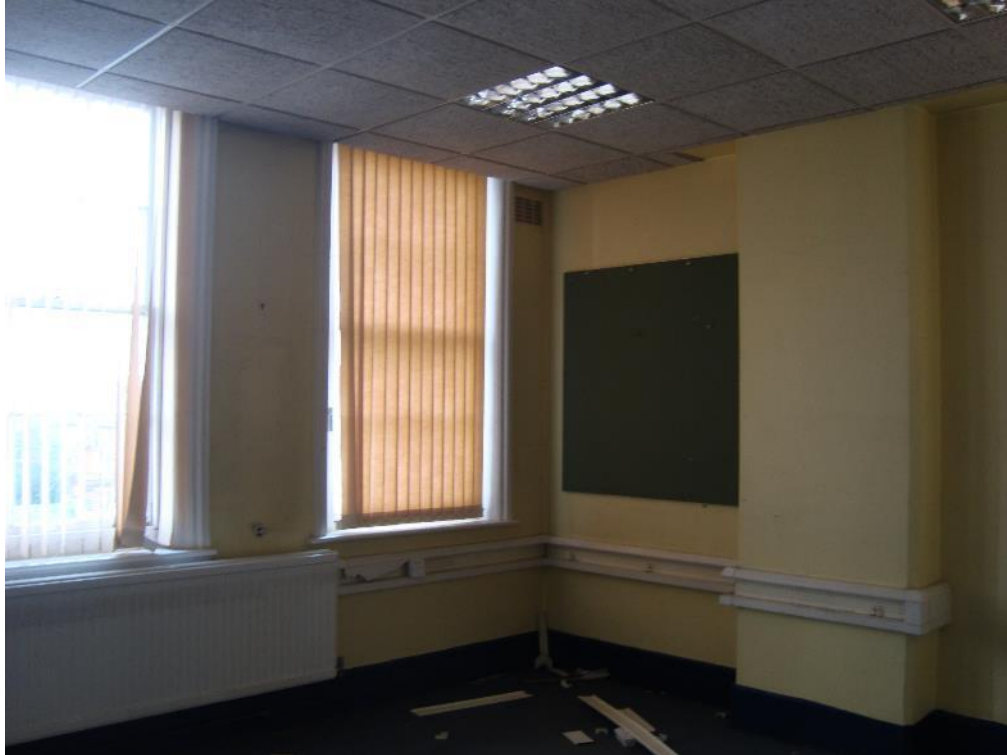
Plate 37: Station, Range 1, Room 14, note south-east chimneystack truncation, facing south-east (CgMs_0154)

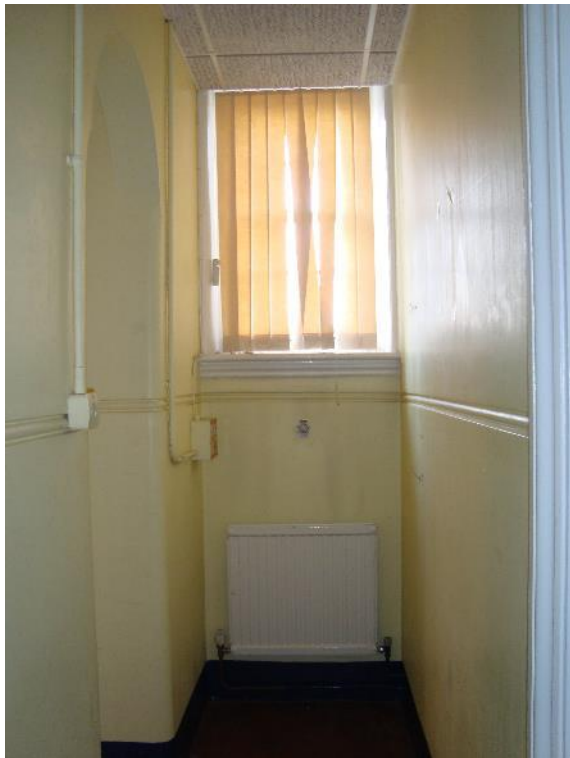
- 6.2.21 The remainder of the second floor was accessible from a south-west – north-east aligned corridor (Plate 38) which was entered via the arched opening at the north-west end of the landing. The corridor comprised all the typical characteristics and appears to have formed an original arrangement due to the bull-nosed jambs of the opening and the integral dado rail detailing visible on all walls. The corridor contained two openings within its north-west and north-east walls, both of which were set with moulded architraves and modern door replacements. The area was lit a single window within the north-west elevation, the top of which is obscured by the inserted ceiling panels.

Plate 38: Station, Range 1, Room 15, facing south-west (CgMs_0156)

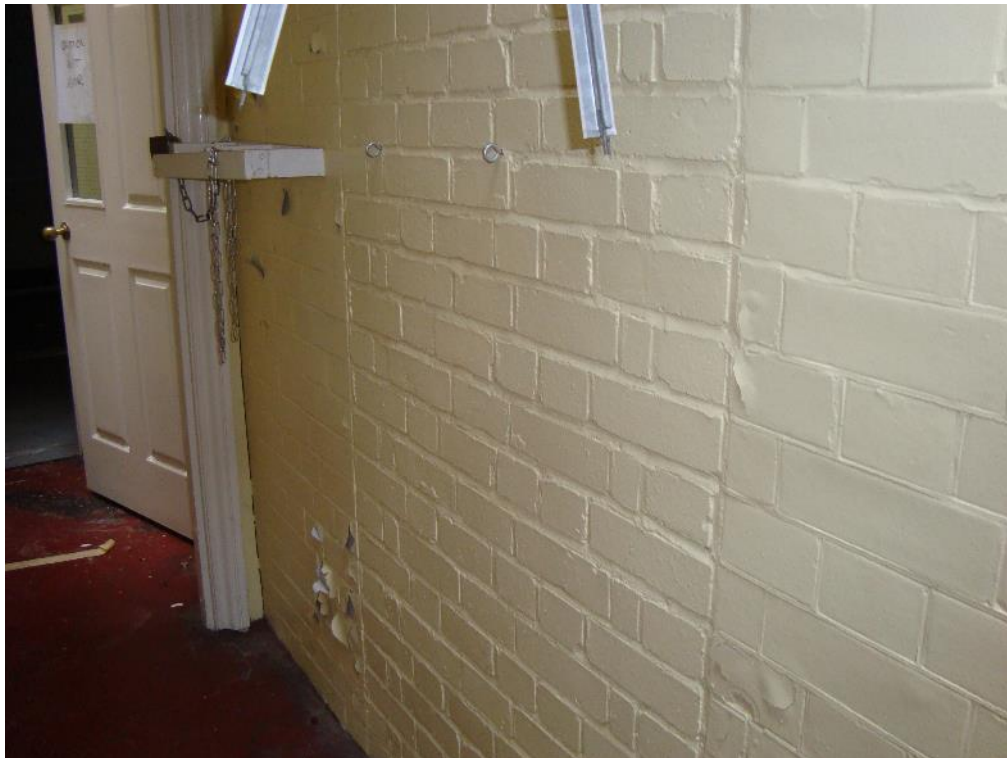
Plate 46: Station, Range 2, Room 19, blocked doorway to the south-east side of the corridor formerly providing access to Room 20, facing east (CgMs_0254)

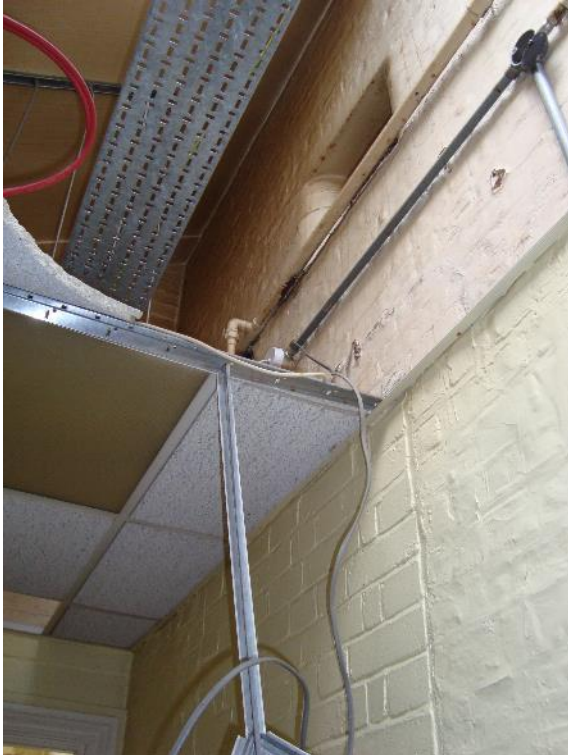
Plate 47: Station, Range 2, Room 19, air vent above Room 20 visible above the modern ceiling within the south-east wall, facing north-east (CgMs_0255)

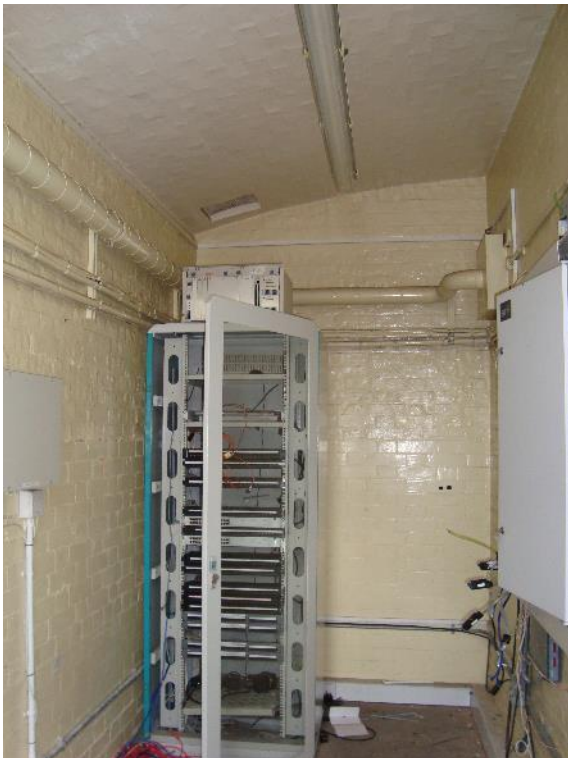
6.2.31 Room 23 (Plate 52) retained its original doorway entrance to the south-east, although by 2013 the door itself comprised a modern replacement. The room contained a south-east – north- west aligned space, with cement floor and coved brickwork ceiling inset with ventilation grille. The walls are as elsewhere, glazed at their lower half and painted bare brick above.

Plate 52: Station, Range 2, Room 23, facing north-west (CgMs_0201)

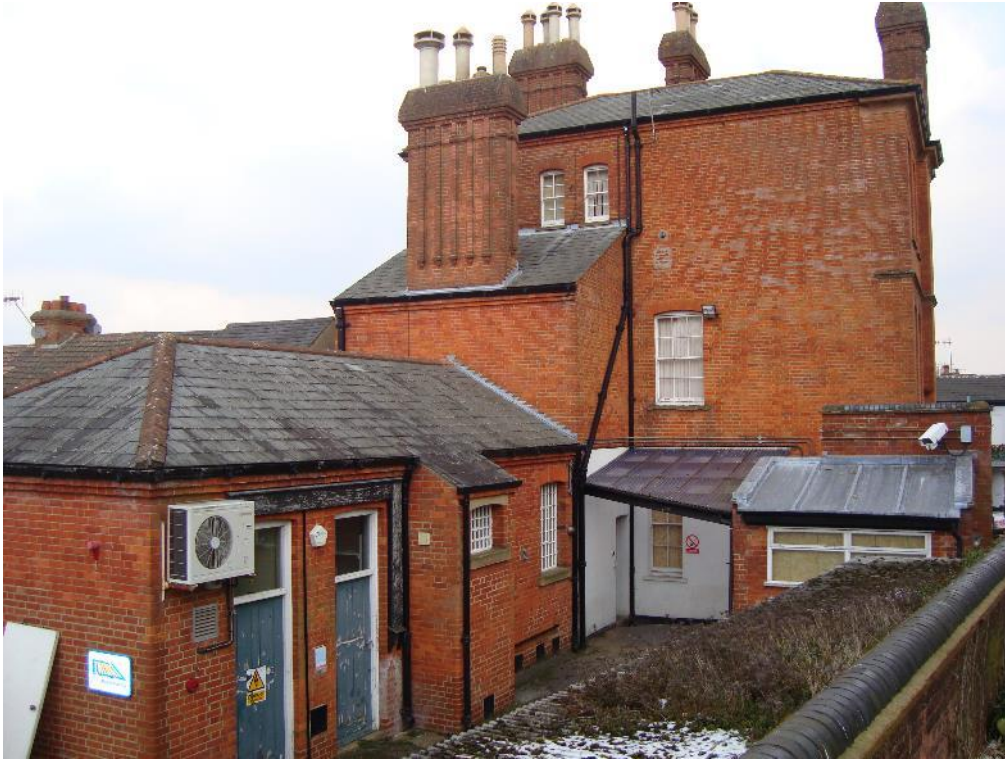
6.2.32 Range 3 (Plate 53) comprised two adjoining outbuildings; one square in plan (north-east) and the other L-shaped (south-west). The north-east outbuilding contained a WC and washroom by 2013 and was accessed from an internal doorway set within the south-east end of the south-west elevation of Range 1. The L-shaped outbuilding, contained a separate WC, accessed from an external doorway set within the north-west elevation. Due to the extensive redevelopment of this range, its original function and layout are uncertain. It is noted that a former mortuary was located to the rear of the station and demolished in 1950. It is possible that the structure shown on historic mapping linking Range 3 to the two-storey lean-to, situated to the north-west, served this purpose. Historic photos dating to 1893 indicate that the L-shaped outbuilding was *in situ* by this date and originally had two external openings with arched brick lintels within the south-west elevation. No evidence of these openings remain due to the insertion of a modern window in this location and the areas of selected rebuilding to extend the range north-westwards. The most likely function of the linked outbuildings was externally-accessed WCs and stores.

Plate 53: Station, Range 3, south-west elevation, facing north-east (CgMs_0190)

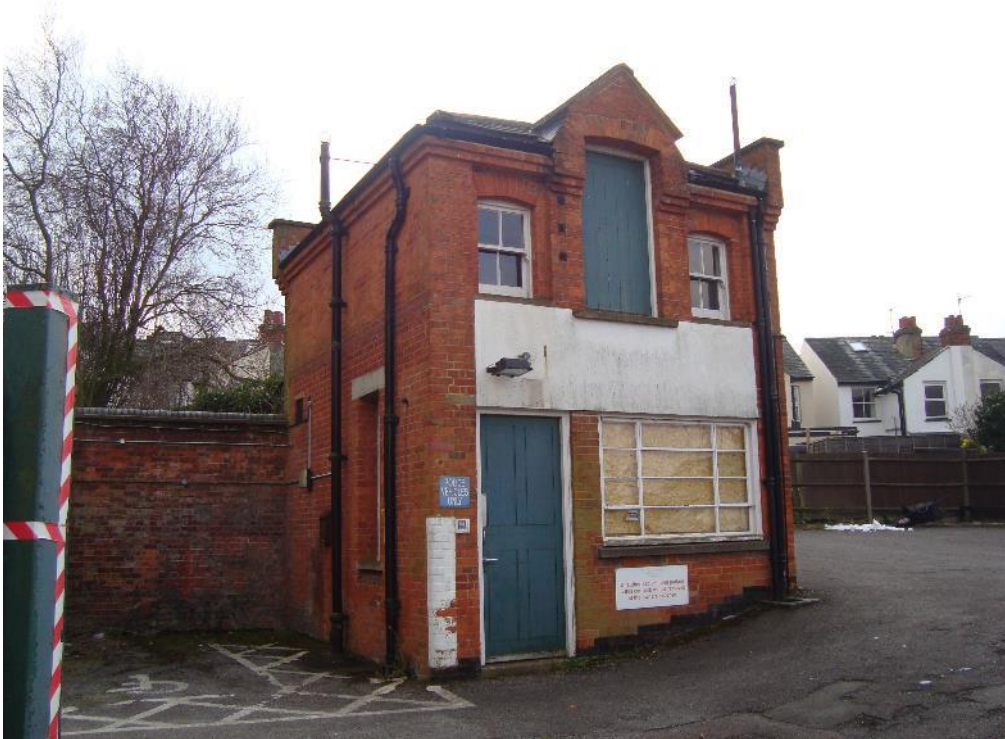
- 6.4.2 The structure's external appearance appears relatively unaltered compared with the photography dating to 2013. Main alterations to the principal elevation (Plate 63) comprise the replacement of the large ground floor window from an early 20th century 12-pane metal casement. Other alterations include the replacement of two cast iron downpipes set to the south-west side. The side north-east and south-west elevations each contained a single cast iron ventilation grille set with a sandstone cill and lintel. These appear consistent with those within Range 2 of the station building and were likely to have been original. These would have been included to provide additional ventilation to the horse stalls at ground floor level. The rear south-east elevation (Plate 64) was previously served by an external winder stair. The stair appears to have been constructed in cast iron with encircling balustrade with tubular handrail. It seems to have had plain/stick balusters and open treads. The staircase terminated at a short landing at first floor level, which was supported on its underside by arched wall-mounted brackets. The brackets and landing platform both contained circular pierced decoration. A centrally-located doorway with shallow arched brick lintel provided external access to the first floor level. Closers surrounding the doorway indicate that the opening formed part of the original design. A modern air conditioning unit had been mounted to the elevation at ground floor level.

Plate 63: Hay Loft (stable), north-west elevation, facing south-east (CgMs_0186)

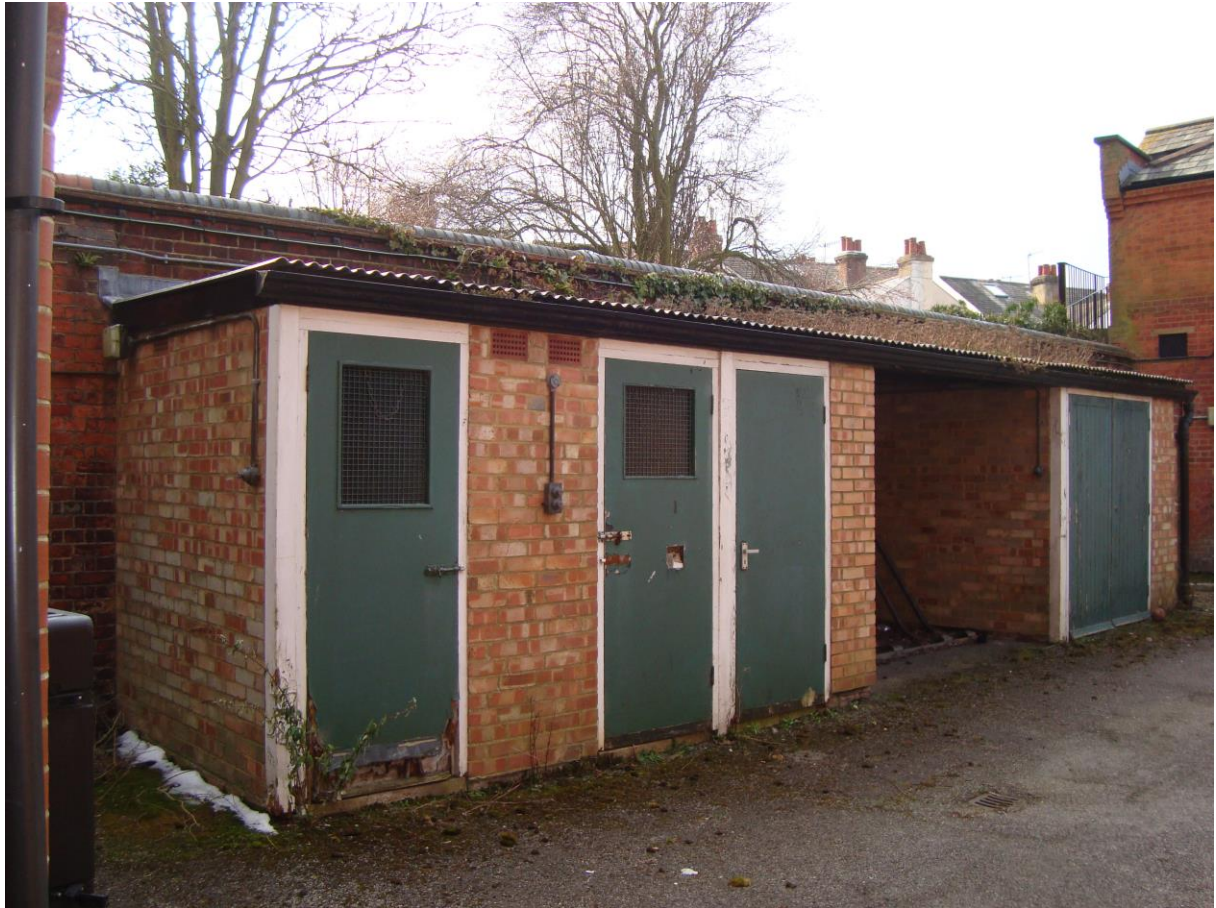
Plate 65: Photograph of the demolished structure formerly located within the rear yard along the site's south-eastern boundary, facing south-east (CgMs_0182)
