**Archaeological Watching Brief Report
Ellinge Hall, The Street
Glynde, East Sussex**

**South Downs National Park Authority
Planning Reference: SDNP/17/00568/FUL
ASE Project No: 170294
Site Code: ELL 17
ASE Report No: 2017495
OASIS ID: archaeol6-302098**

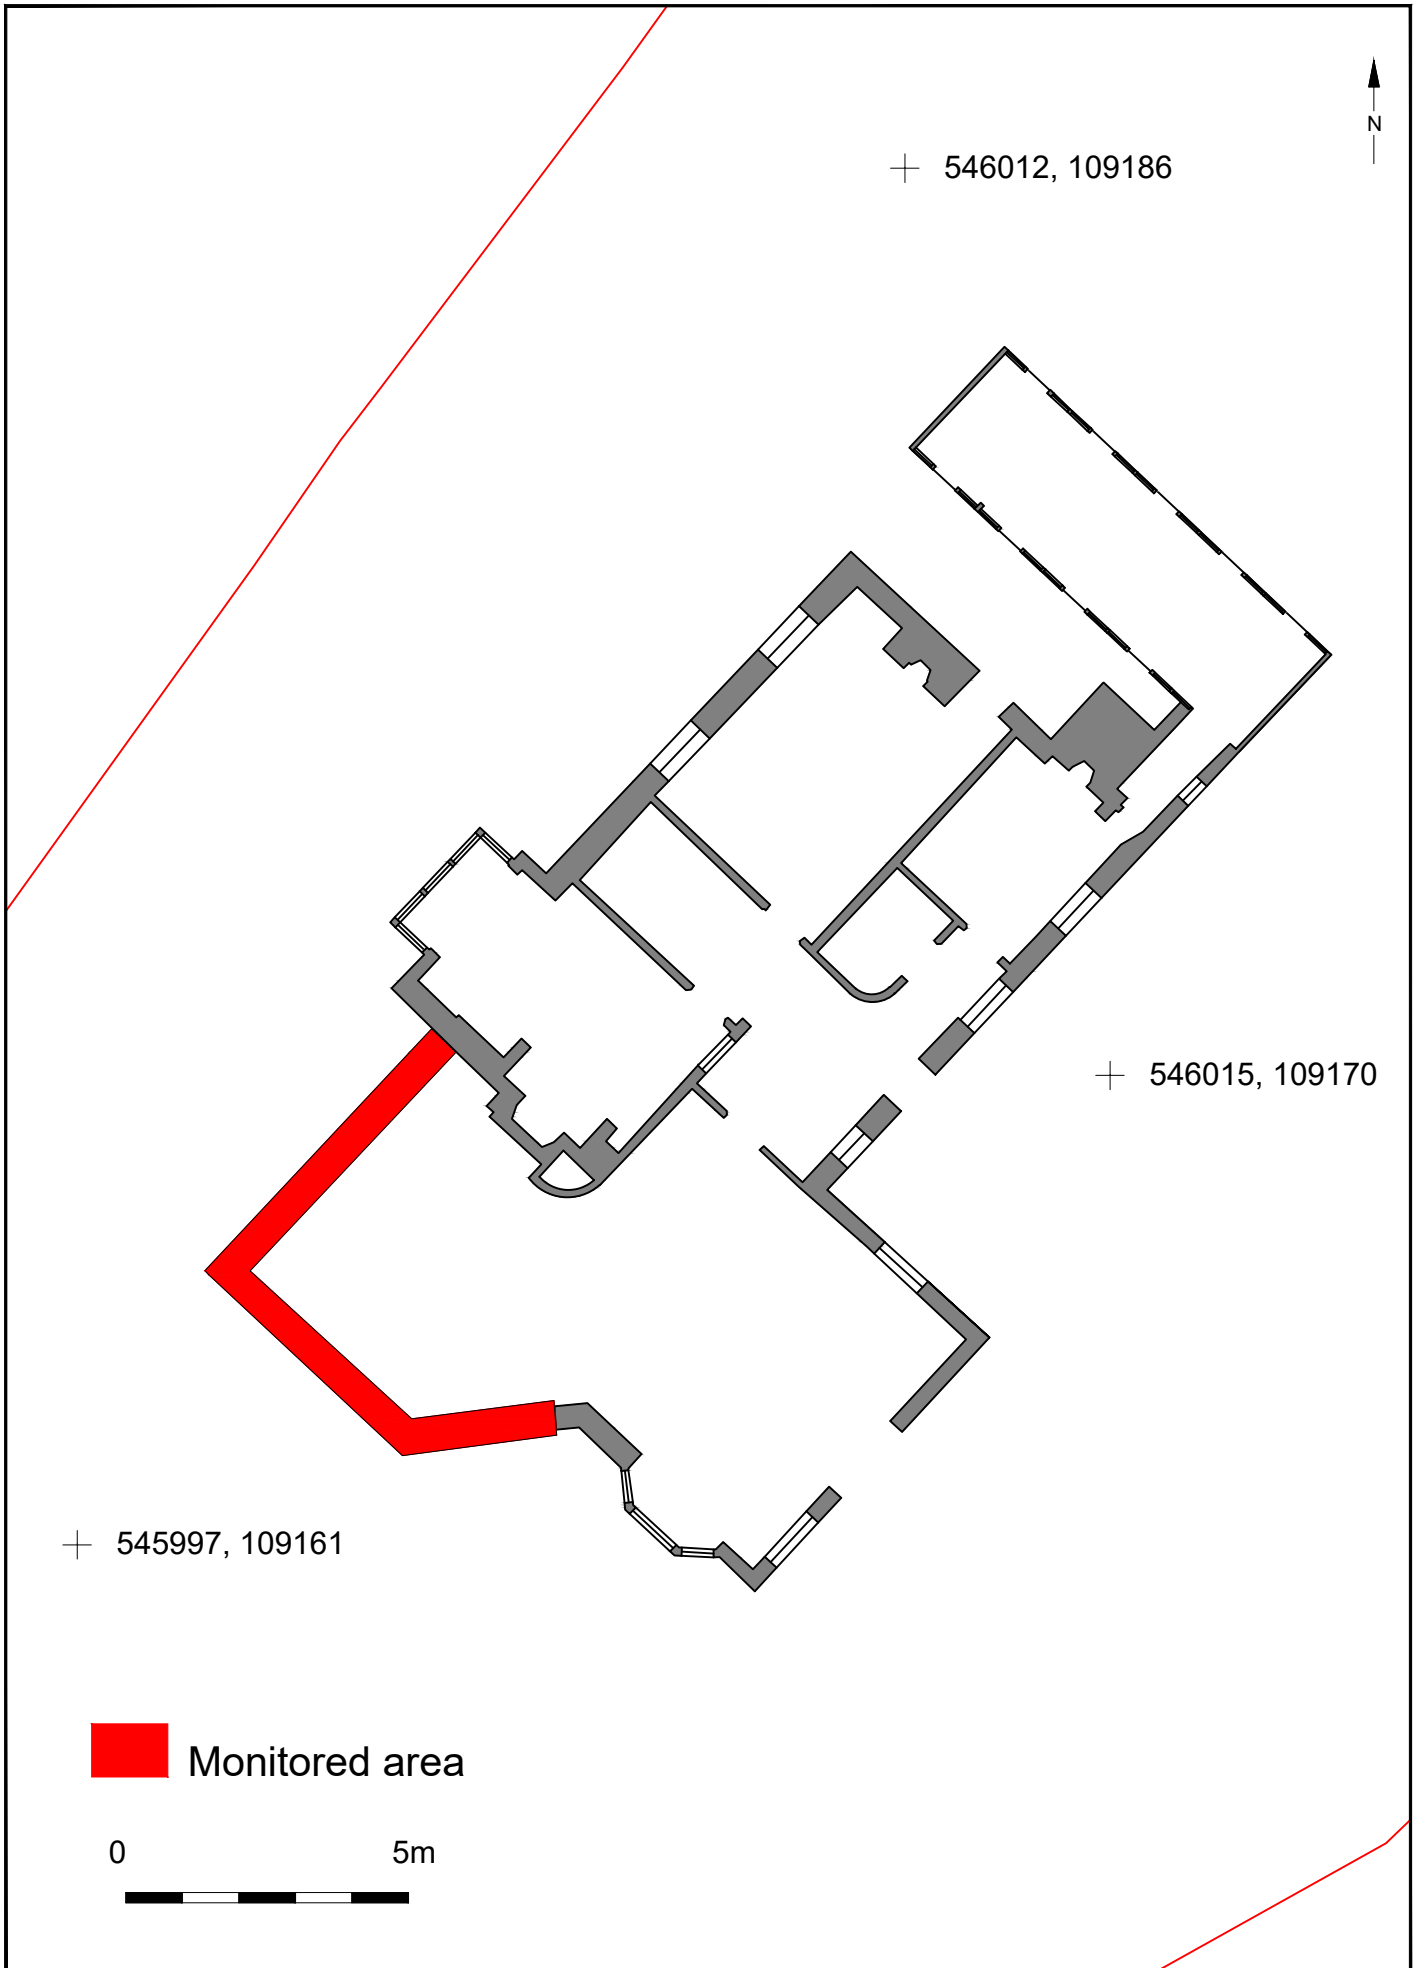
© Archaeology South-East		Ellinge Hall, The Street	Fig. 2
Project Ref: 170294	March 2017	Monitored footings	
Report Ref: 2017495	Drawn by: SC

4.1.1 The mechanical excavation of strip footings by a Kubota KX-14 tracked excavator were monitored on 22nd November 2017. The foundations were 600mm wide and a maximum of 1m in depth.

4.2.1 Monitoring of excavations immediately to the south-west of the existing structure revealed a straightforward stratigraphic sequence. It consisted of a thin surface layer of mid-greyish brown to mid-brown heavily rooted mortary made ground, context [001], left after the recent removal of a patio surface. This directly over the greyish white/whitish grey surface of the marly chalk, context [002]. There had been disturbance to both deposits close to existing structure from the laying of a service.

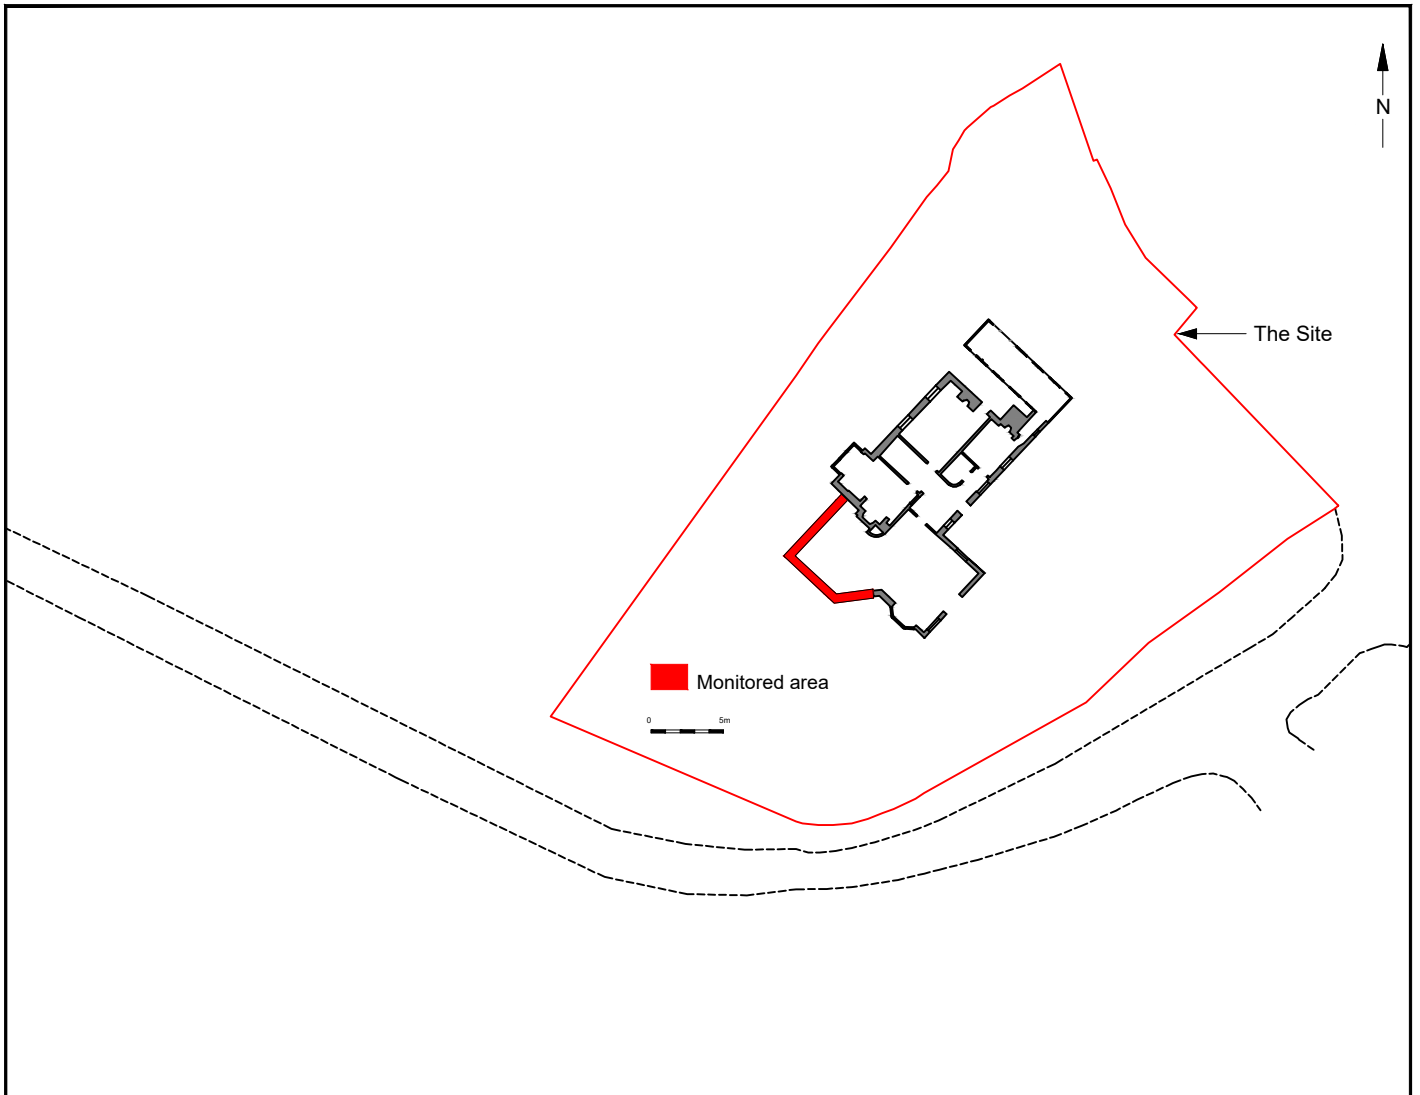
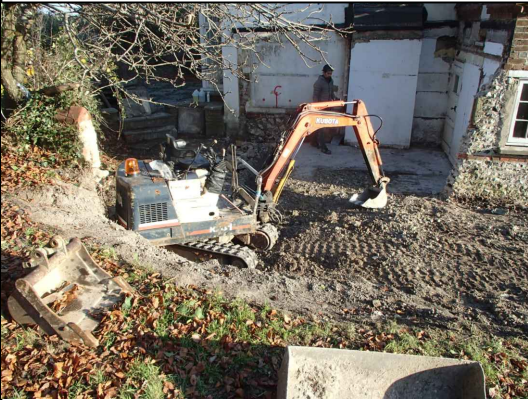
© Archaeology South-East		Ellinge Hall, The Street	Fig. 3
Project Ref: 170294	March 2017	Monitored footings plan and photos	
Report Ref: 2017495	Drawn by: SC

4.2.2 No archaeological deposits, features or finds were recorded, and as recently deposited made ground was laid directly on the surface of the 'natural' with no evidence of a topsoil or subsoil layer, it is apparent that there has been substantial earthmoving at the site, potentially removing any archaeological deposits.

The site looking N

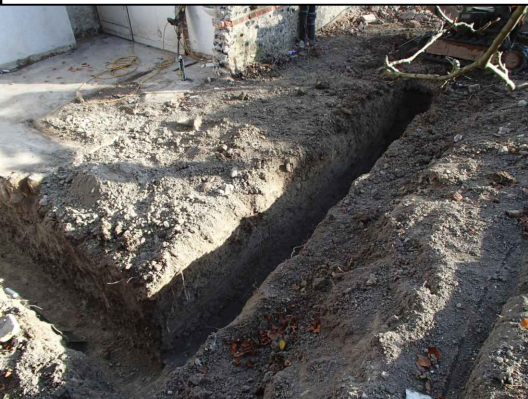
Looking NE

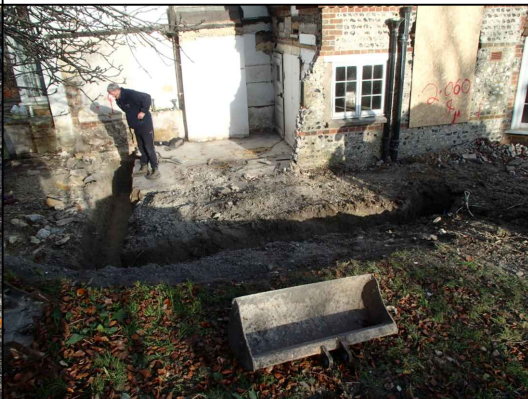
Looking NE
