**An Archaeological Watching Brief
Petworth Boat House, Petworth House, Petworth, West Sussex**

**ASE Project No: 171035
Site Code: PBO17**

**ASE Report No: 2017515
OASIS id: archaeol6-302955**

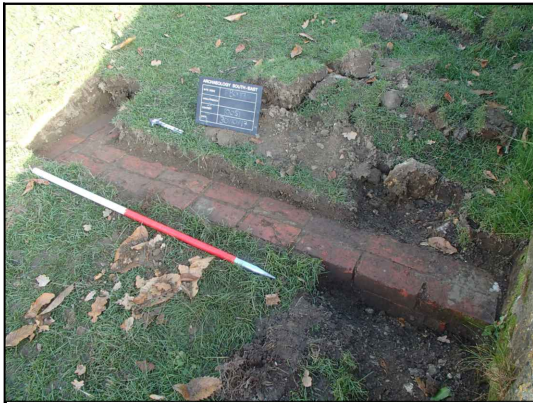
Wall [005], looking northeast

- 4.1.5 A brick wall [005] was identified on the other side of the Boat house, just below the topsoil. The bricks measured 215mm x 105mm x 70mm. They were very flatly cut, and bonded with a yellowish, hard sandy mortar. It was on a

north-south alignment, with a right angle corner to the east. The southernmost part of the wall butted against the wall of the Boat House. It is probably contemporary with the Boat House, but could also be a later addition.

- 6.3.5 Part of the kiln has seen limited re-use, probably in the 18th century, as it was exposed by the creation of the Upper Pond, and subsequently utilised as a surface.
- 6.3.6 The brick wall identified abutting the Boat House is likely to be contemporary with its construction during the early 19th century (AD 1807). It remains in situ.
- 6.3.7 The date of two stones [004] are unknown. They are probably either from the construction of the Boat House, or Petworth House itself, and are no longer in their original context. They remain in-situ as they were found.
- 6.3.8 An unstratified glass linen smoother of 18th century date was recovered during the fieldwork.

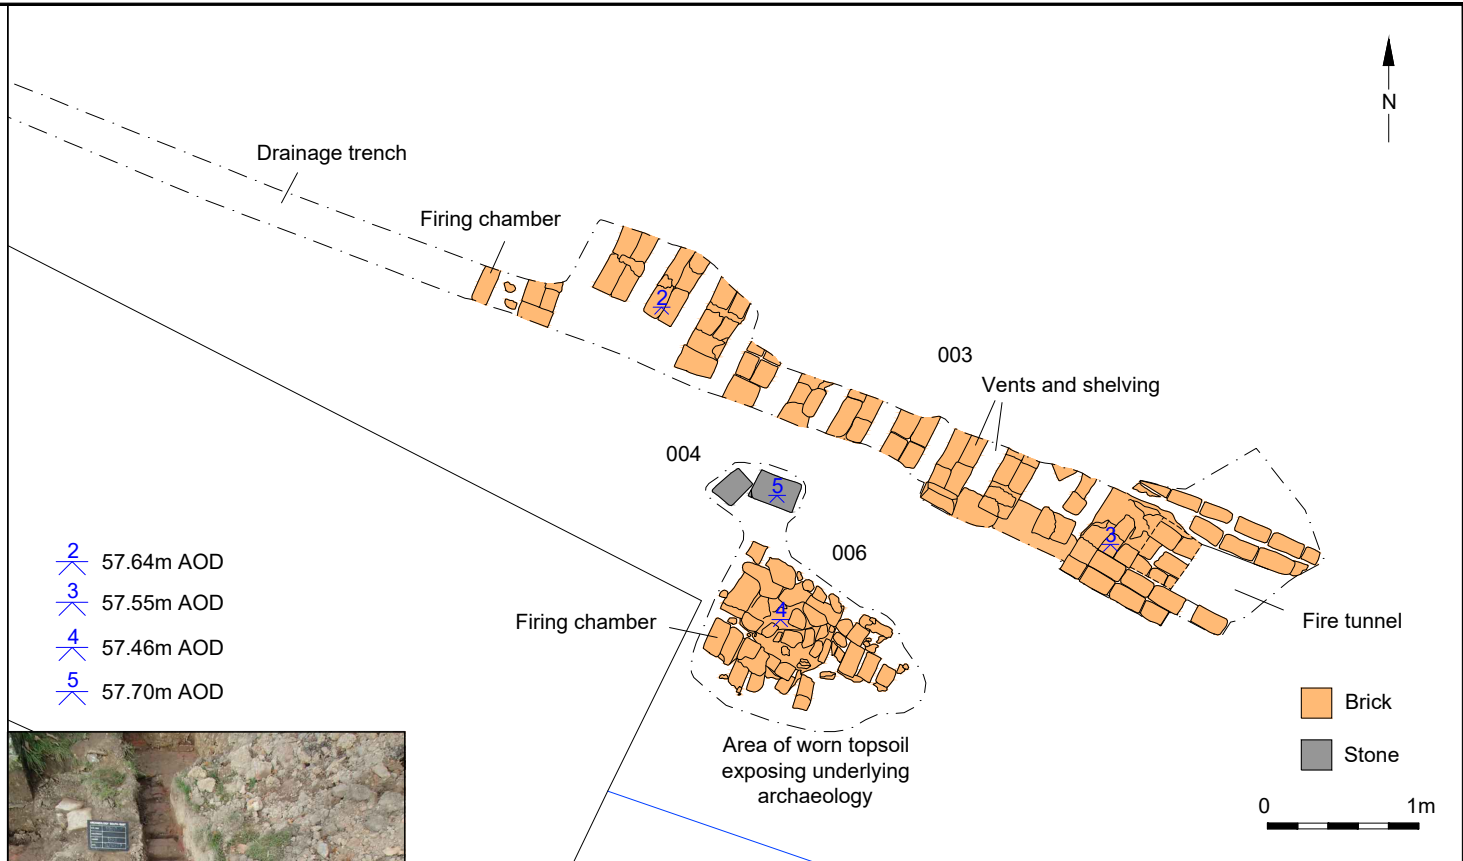
- 2 57.64m AOD
- 3 57.55m AOD
- 4 57.46m AOD
- 5 57.70m AOD

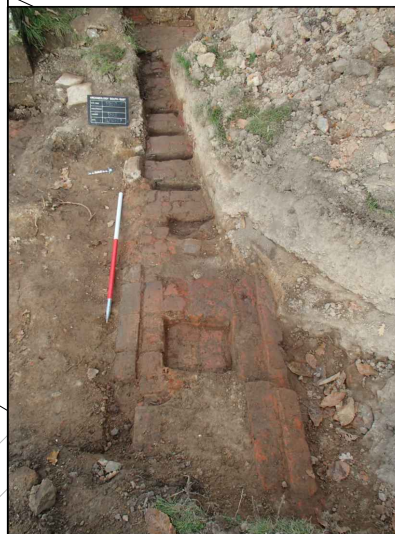
Kiln [003] looking west

- 4.1.2 A brick structure [003] most likely a kiln was identified. It was formed of red bricks, the majority of which were laid out as stretchers. They were roughly bonded with a soft, gritty brownish grey mortar. It is likely that it extends significantly further than that exposed during the groundworks. As indicated by the brick samples the kilns origins probably date to the 16th century at the latest, however, some later material may indicate continued use/reuse of the structure. It is also possible that the kiln represents a structure created predominantly from re-used 16th century bricks, however, there was little within the small sample of Ceramic Building Material to suggest this. It is interesting to note, however, that the fabrics are consistent with the nearby Lodge site which was demolished at the end of the 16th century, and that some of the brickwork present in the kiln exhibits possible decorative 'diaper work', which might not be associated with such a functional feature.

- 6.3.1 The probable kiln identified is likely to be for the creation of ceramic building material. The bricks identified put the construction of the kiln in the 16th century at the latest, however, some of the brick may be of later date (see section 5.3.3). The later brick possibly indicates continued use/reuse of the kiln prior to the 19th century and it is interesting to note that the structure survived as late as the mid-18th century as it appears to be shown on contemporary maps (Figure 5; WSRO PHA 6623, 1). It is also possible that the kiln represents a structure created predominantly from re-used 16th century bricks, however, there was little within the small sample of Ceramic Building Material to suggest this. It is interesting to note, however, that the fabrics are consistent with the nearby Lodge site which was demolished at the end of the 16th century, and that some of the brickwork present in the kiln exhibits possible decorative 'diaper work', which might not be associated with such a functional feature. From what has been identified, the remains of the kiln are fairly large, and thus would have a significant output. It does not appear that the base has been reached, and there could be a substantial amount to expose below ground in the area already uncovered. The eastern part of the kiln, where the brick stretchers were on a roughly east-west alignment probably relates to part of the fire or flue tunnel, with the fuel being added and raked out further to the east. The north-south aligned bricks are the shelving with intervening vents for the bricks being fired. The bricks at the far west of [003] could be another part of the shelving, or the wall of the firing chamber, along with the bricks identified to the south [006].

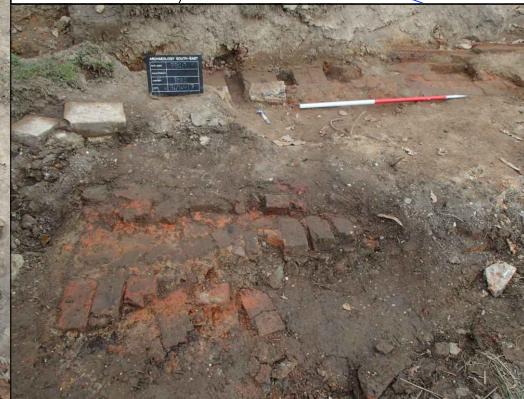
Part of kiln [006], looking north

- 4.1.3 Just to the south of [003] was [006]. It was also formed of red bricks, but they were significantly more worn than those seen in [003]. They are likely part of the same kiln as [003]. They had significantly less overburden covering them, and as such this part of the structure seems to have been reused as a solid step into the Boat House, or down to the waterfront of Upper Pond.

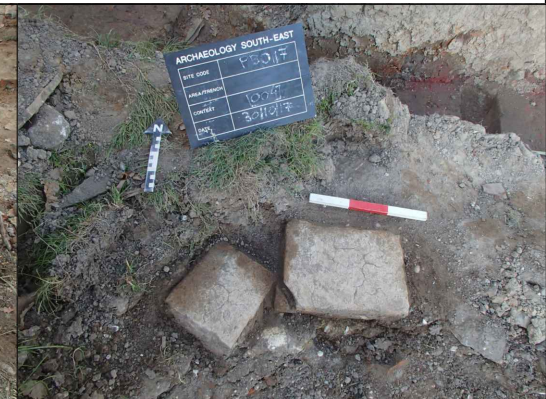
Worked stone blocks [004], looking north

- 4.1.4 Two worked stone blocks [004] were identified directly below the topsoil. They were of separate sizes, one was 295mm x 210mm and 80mm deep and one was 210mm x 190mm with an unknown depth. There was no sign of bonding material. It is likely that this stone is not in the original situation. It could be associated with the construction of the Boat House, or perhaps represent further makeshift steps.

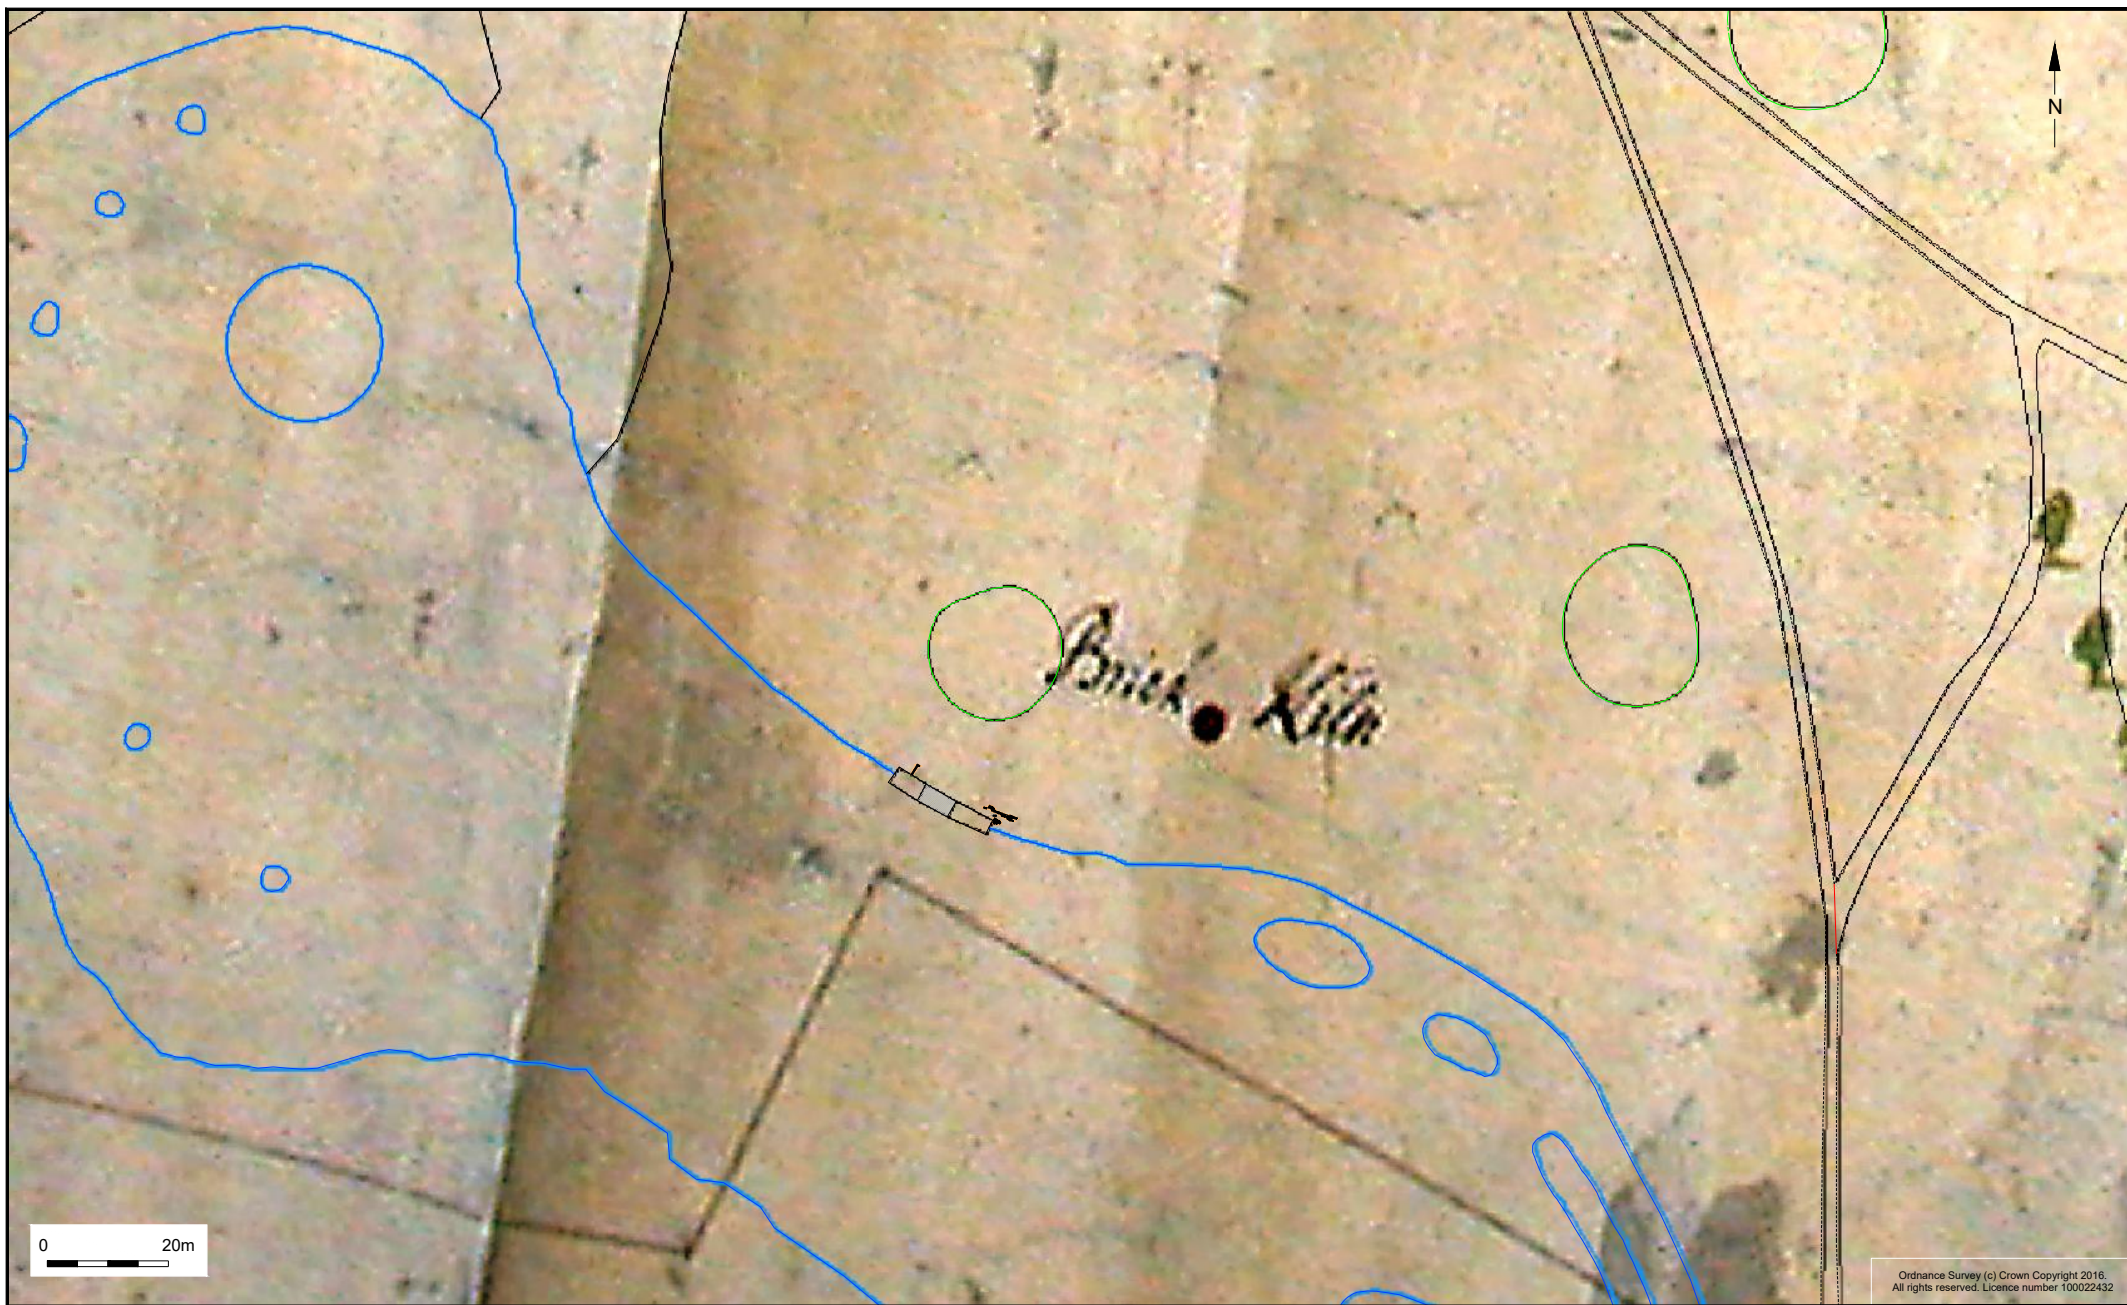
© Archaeology South-East		Petworth Boathouse, Petworth Park, Petworth, West Sussex	Fig. 5
Project Ref: 171035	December 2017	Boathouse location overlain on an extract of 1706 map by John Hutchinson, Lands of the Duke of Somerset between Petworth and Tillington (PHA 3580)	
Report Ref: 2017515	Drawn by: NH
