**LAND AT COURTLANDS FARM,
PARK ROAD, BANSTEAD, SM7 3EF**

**HISTORIC BUILDINGS RECORD
(HISTORIC ENGLAND LEVEL 4)**

**Historic Buildings Record
(Historic England Level 4)**

**ASE Project No: 171102
Site Code: CFB17**

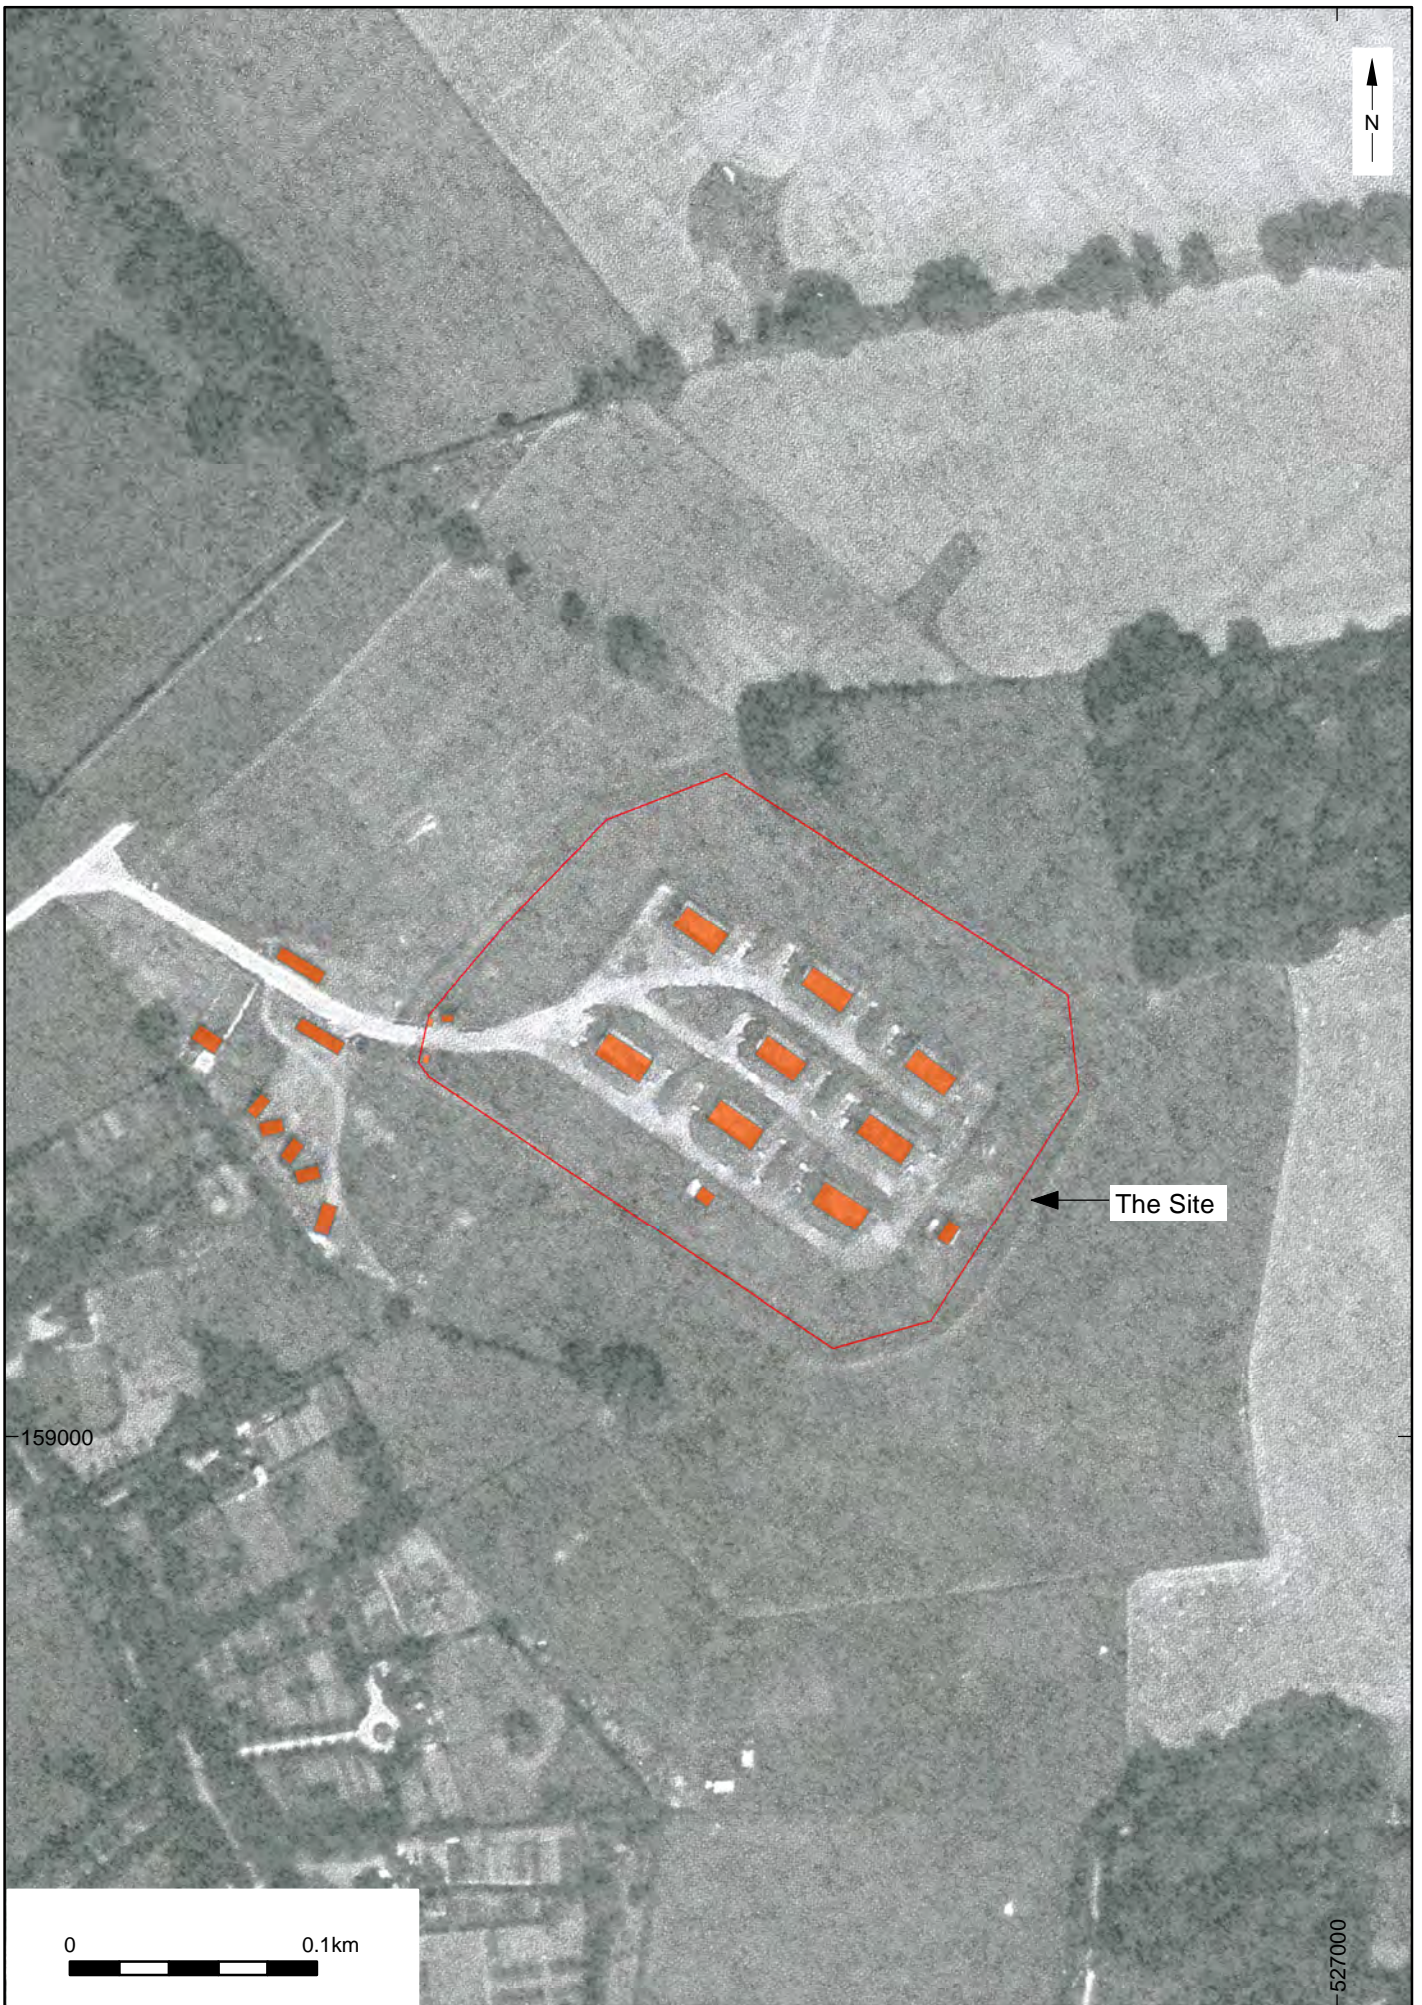
© Archaeology South-East		Land at Courtlands Farm, Park Road, Banstead, Surrey	Fig. 7
Project Ref: 171102	January 2018	1947 aerial photograph overlaid with block site plan	
Report Ref: 2017537	Drawn by: JLR	(RAF 106G 1G 30 RP 3054)

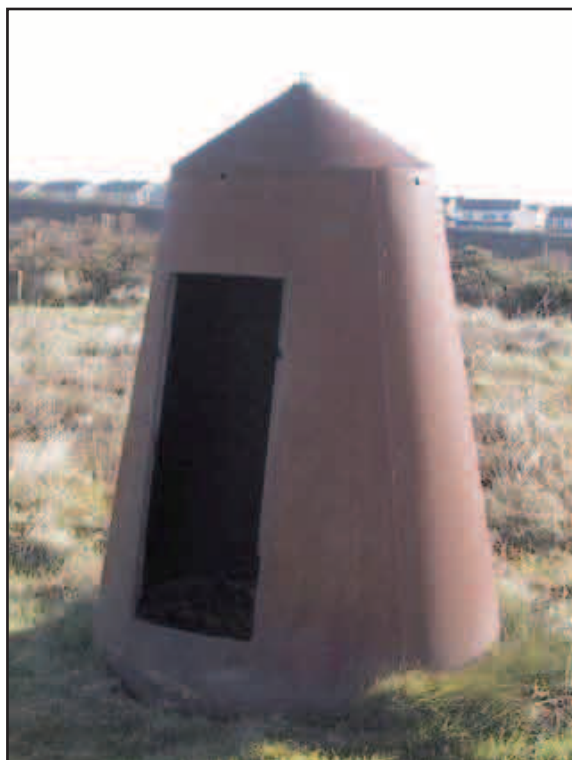
Example of a Consul shelter constructed by a firm called 'Vickers-Armstrong', situated on Walney Island, Burrow-in-Furness (http://www.users.globalnet.co.uk/~rwbarnes/defence/barrow_walney_consol-.htm)

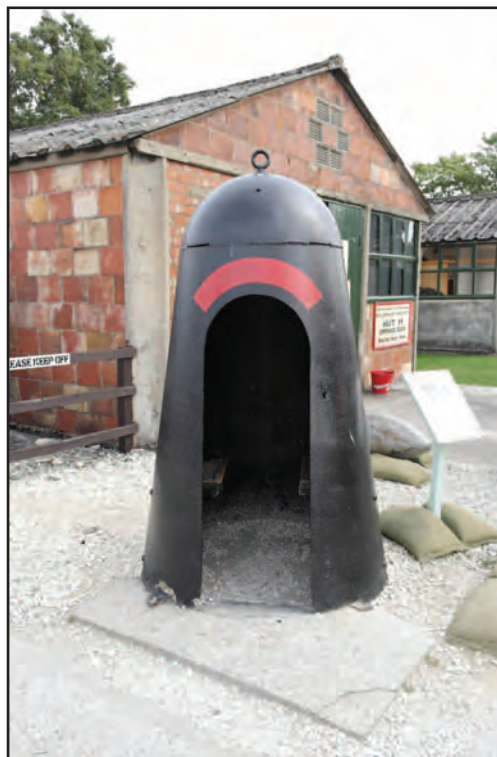
Example of a Consul shelter used as a fire watch shelter, displayed at the Eden Camp, Malton, North Yorkshire (<https://www.militaryimages.net/media/fire-watch-shelter.83535/>)

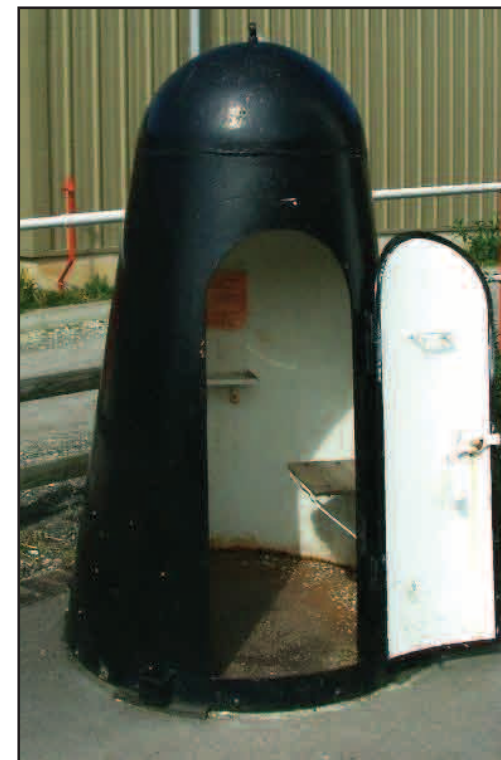
Example of a Consul shelter displayed at the Amberley Working Museum, Amberley, West Sussex (<https://www.tracesofwar.com/sights/15273/One-Person-Air-Raid-Shelter-Amberley-Museum.htm>)

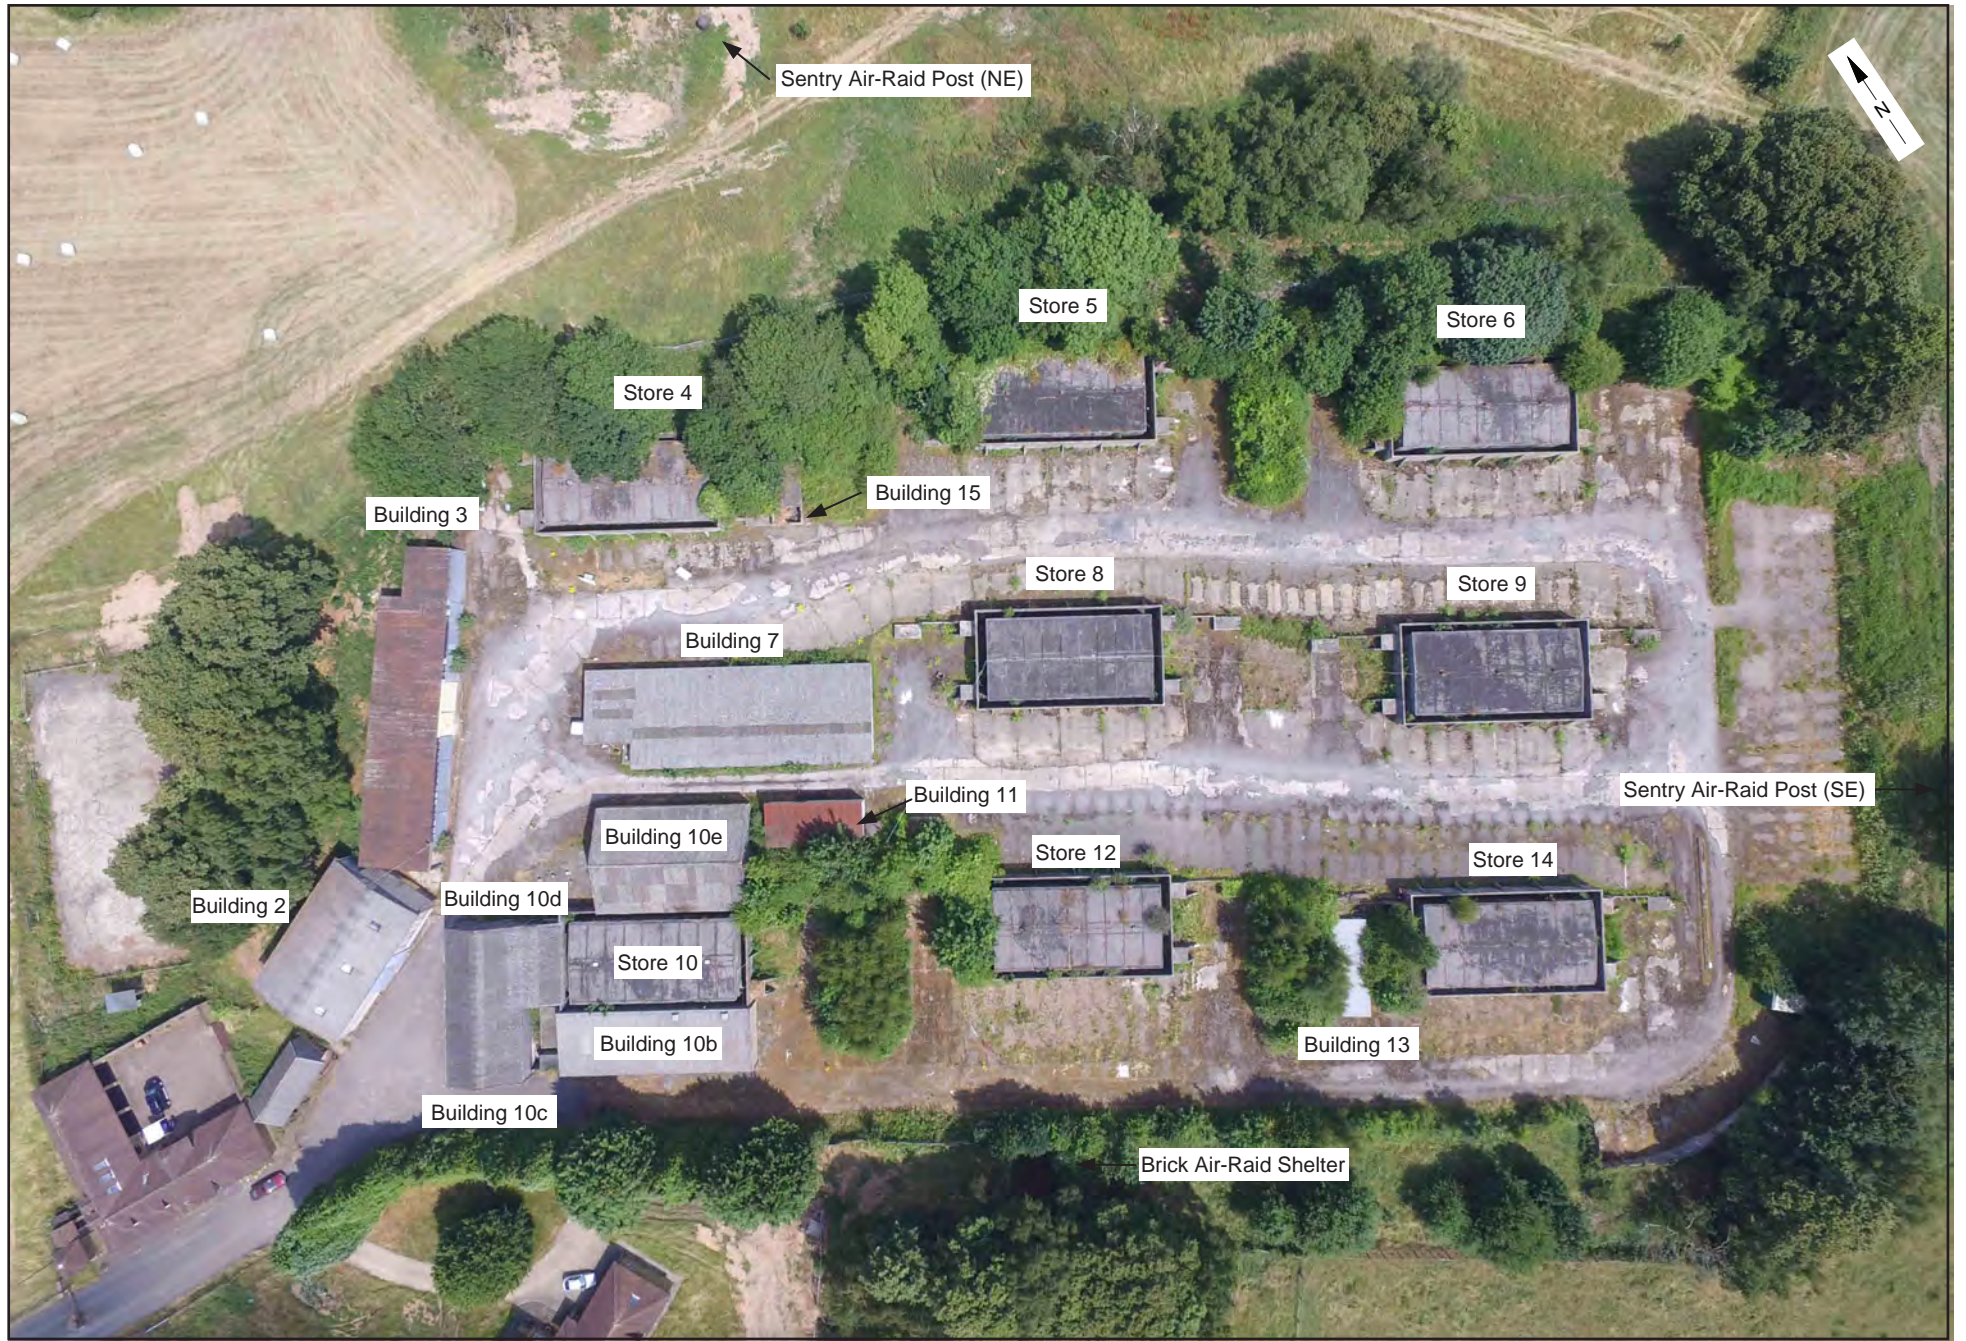
© Archaeology South-East		Land at Courtlands Farm, Park Road, Banstead, Surrey	Fig. 32
Project Ref: 171102	July 2018	Aerial photograph of the site as existing (2018)	
Report Ref: 2017537	Drawn by: HS

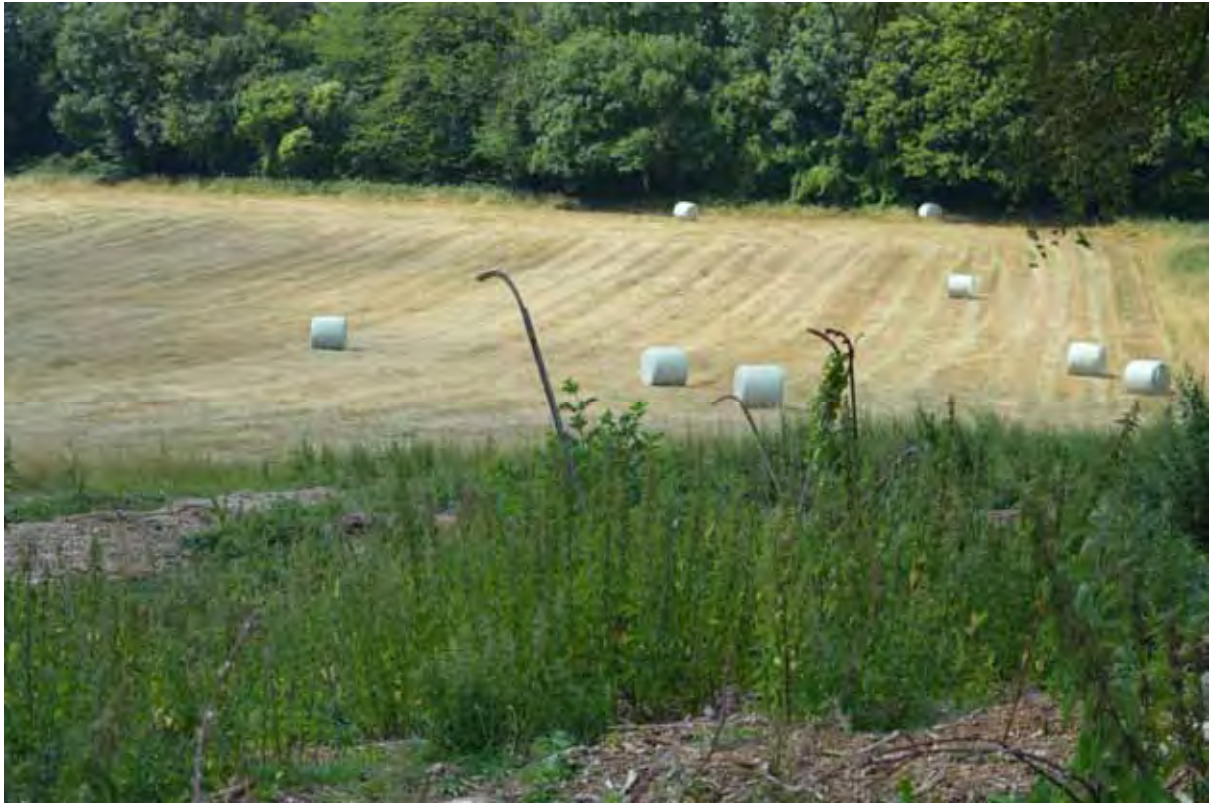
Plate 1: View of original perimeter fence line along the north-east site boundary, facing north (613)

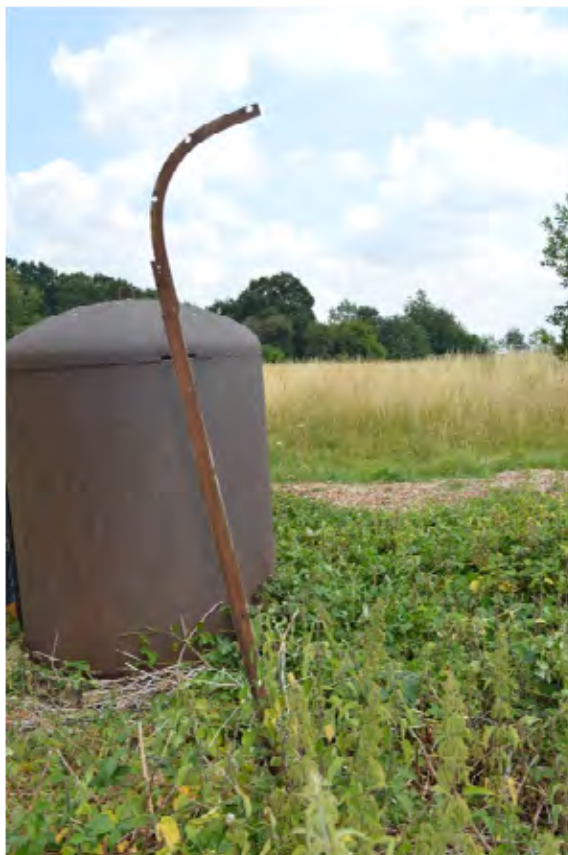
Plate 2: Detail of an original perimeter fence bracket along the site's north-eastern boundary, facing east (612)

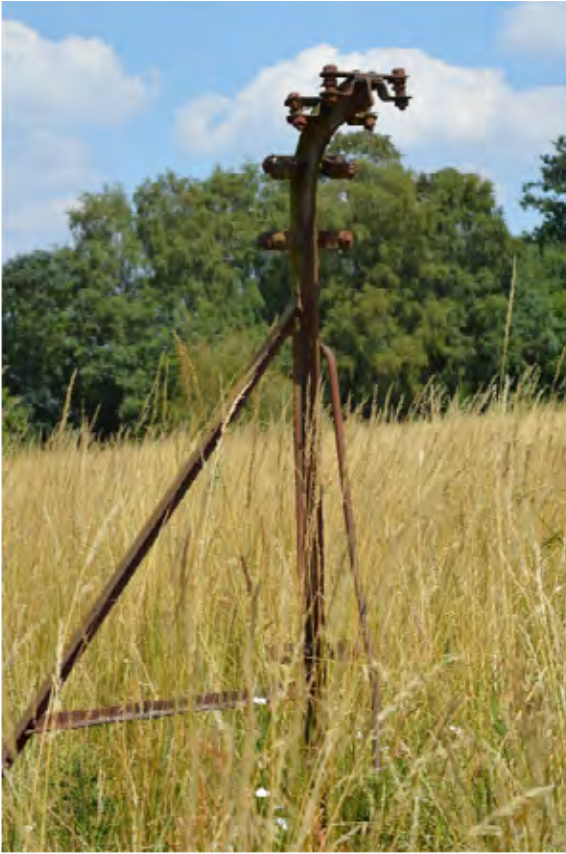
Plate 3: Detail of an original perimeter fence bracket along the site's north-eastern boundary, facing north-east (622)

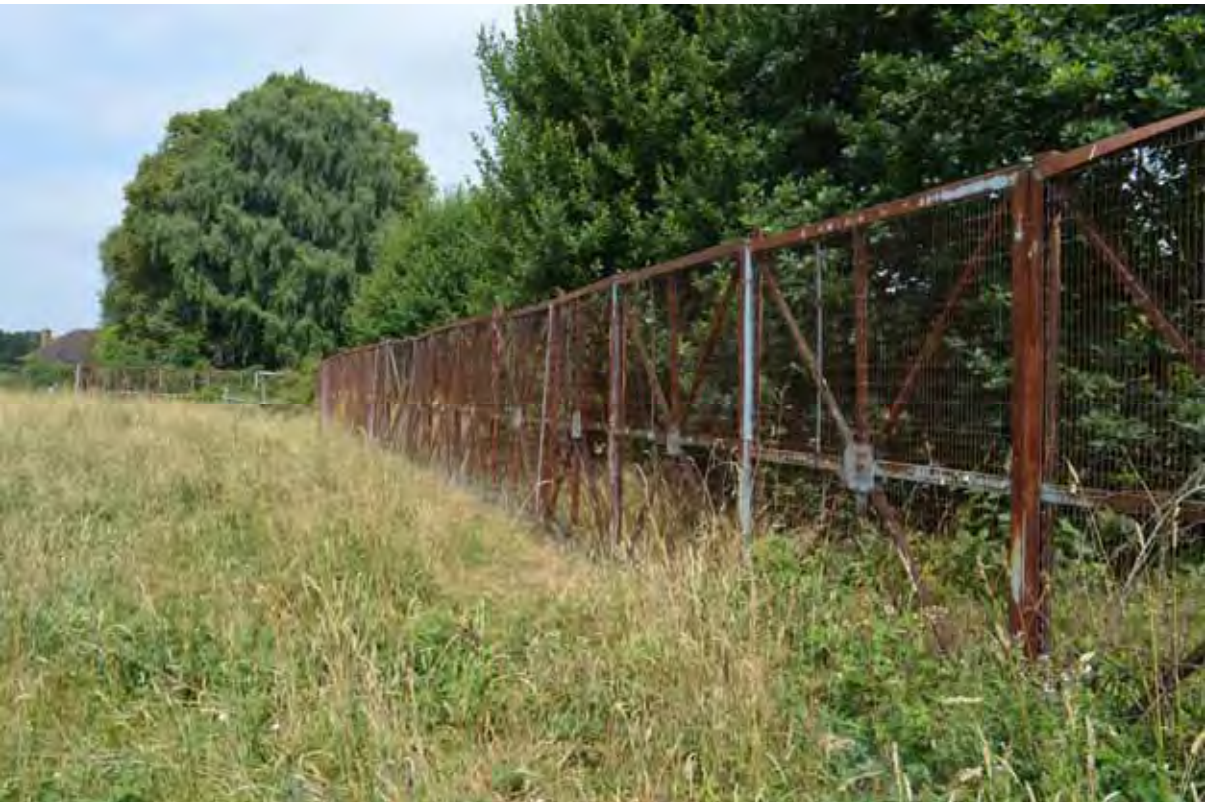
Plate 4: Detail of the later 20th century perimeter fence defining the modern site compound, facing west along the south-west boundary (599)

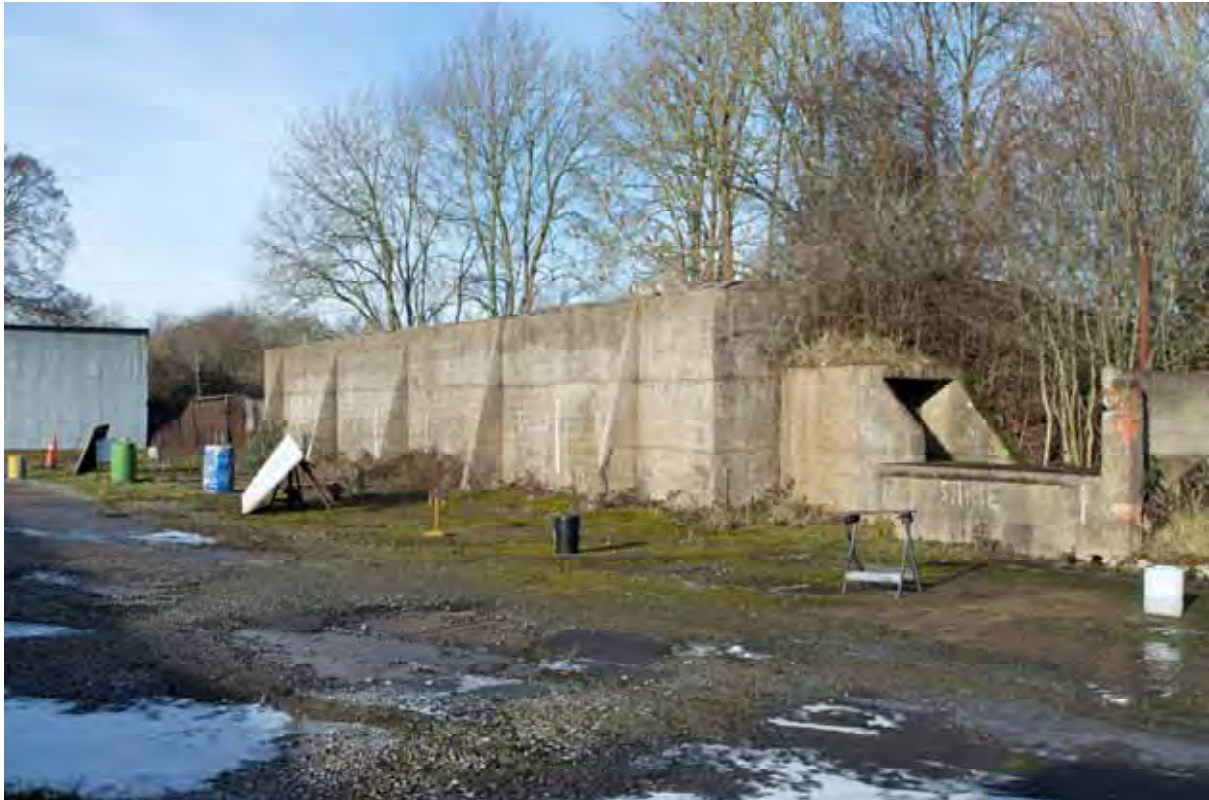
Plate 5: Store 4 – View of the south-west and south-east elevations, facing north-east (229)

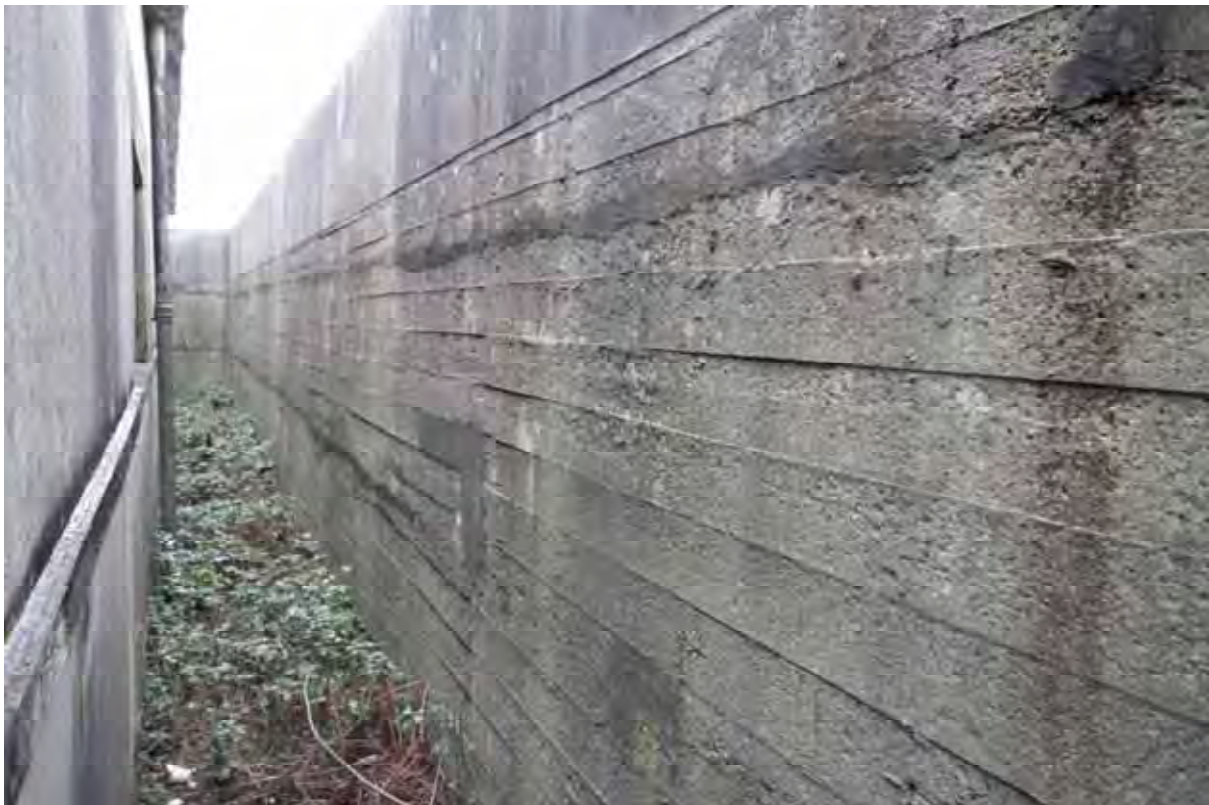
Plate 6: Store 4 – View of the open walkway separating the internal store structure from the outer blast walls, facing south-east (50)

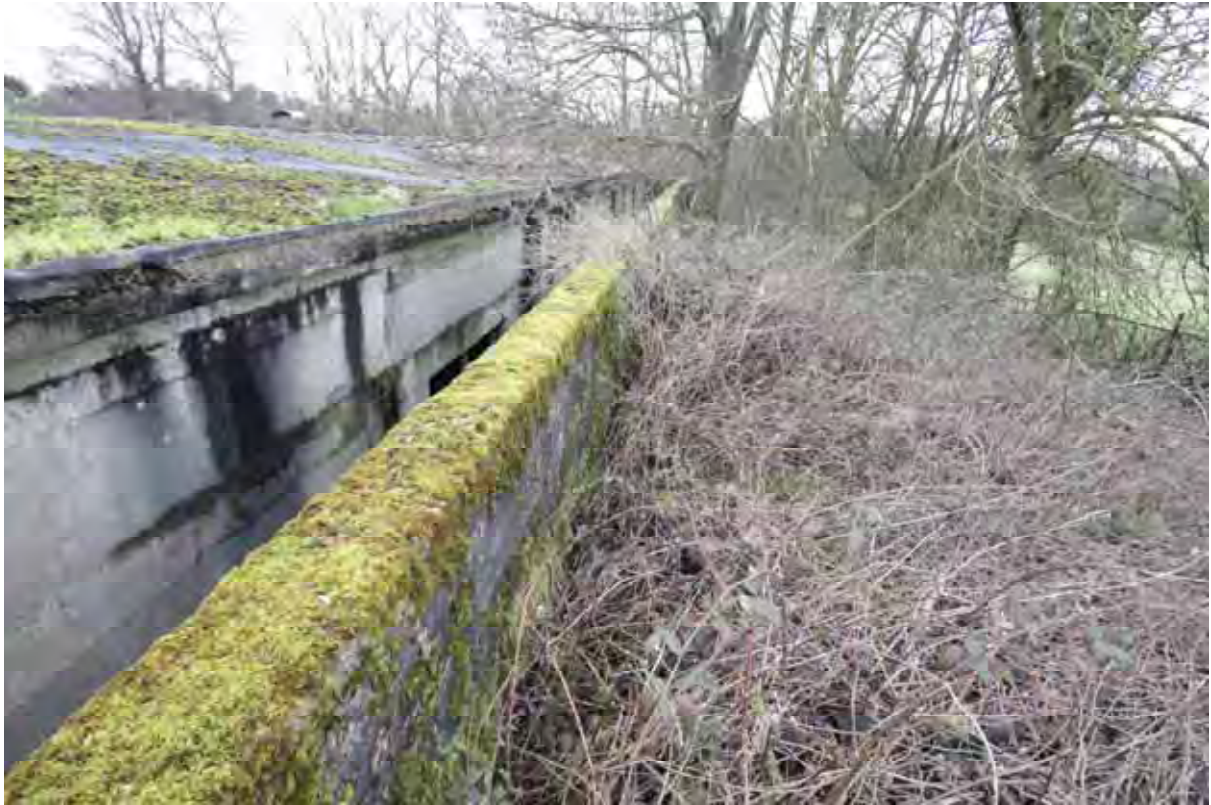
Plate 7: Store 4 – View of the open walkway separating the north-east elevation of the store from the outer blast wall, facing north (81)

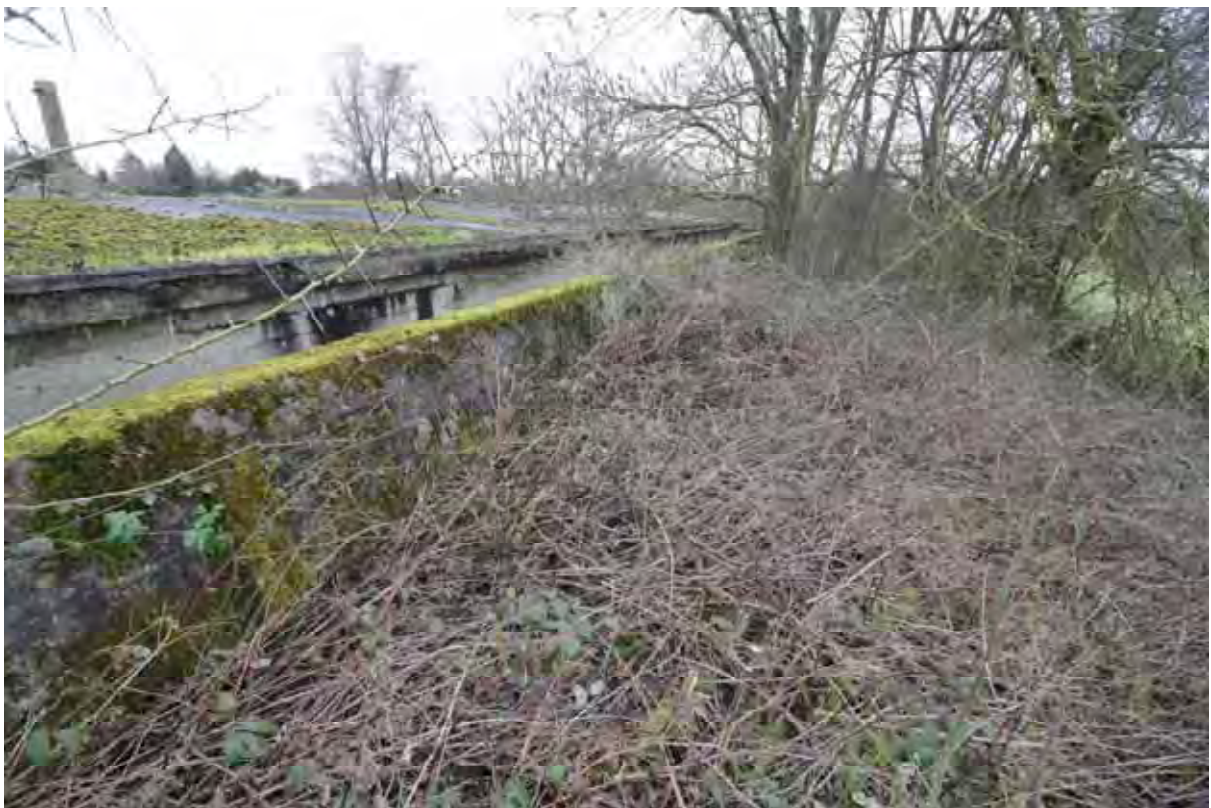
Plate 8: Store 4 - View of the earth blast barrier banking the north-east elevation of the outer blast wall, facing north (73)

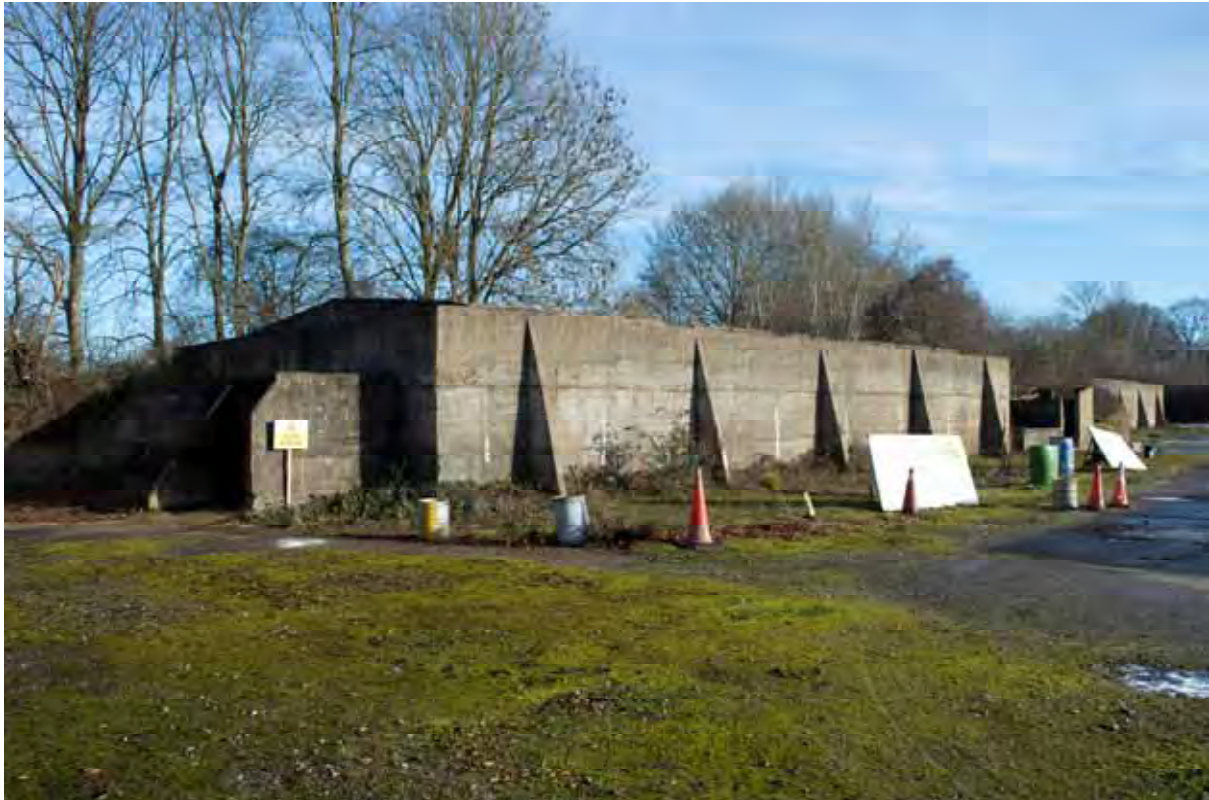
Plate 9: Store 4 – View of the north-west and south-west elevation of the outer blast wall, facing south-east (233)

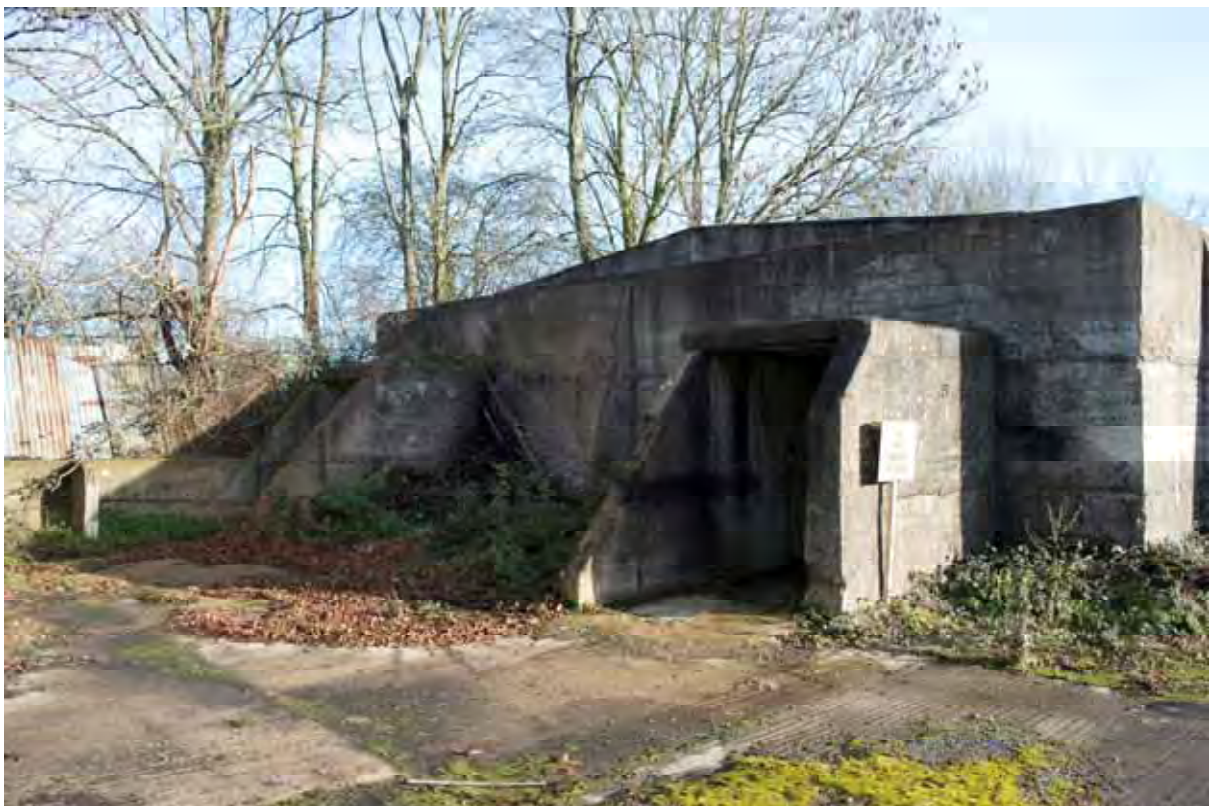
Plate 10: Store 4 – View of the northern loading bay, note the removed western platform, facing south-east (235)

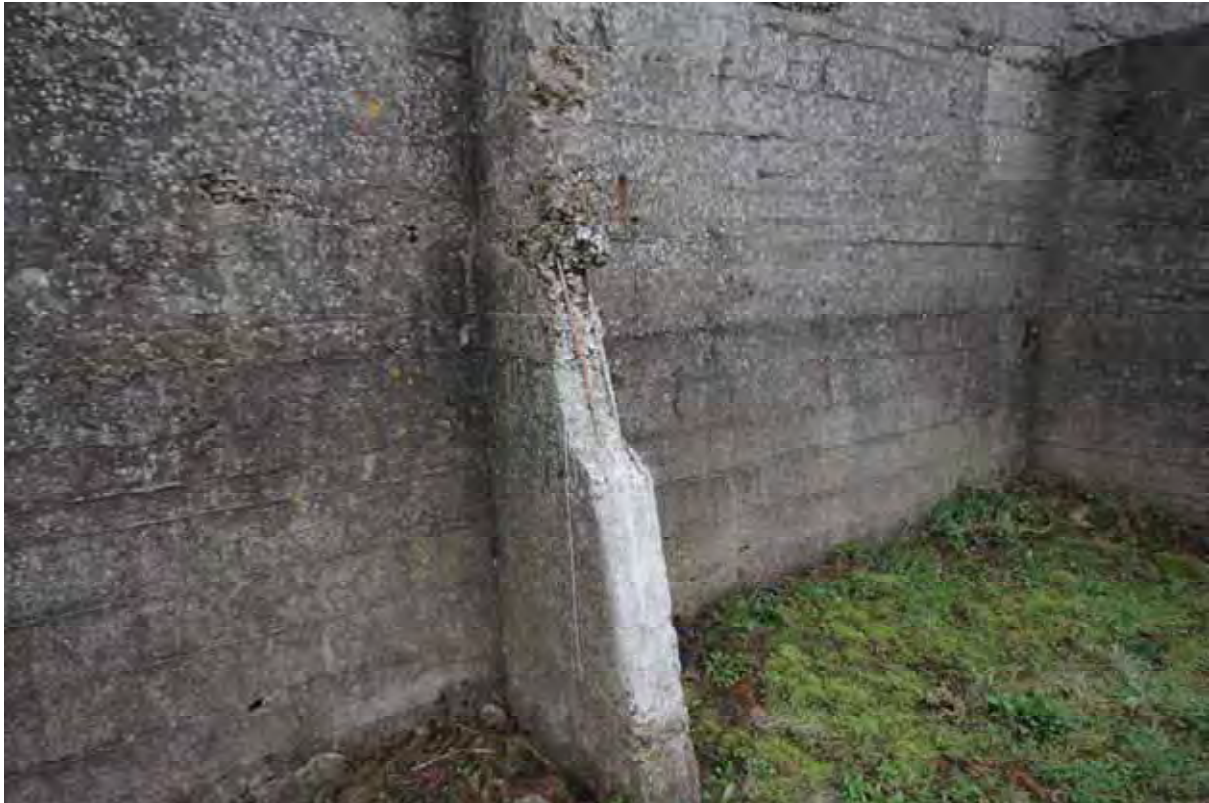
Plate 11: Store 4 – Detail of the concrete buttresses supporting each outer blast barrier wall, facing south-east (135)

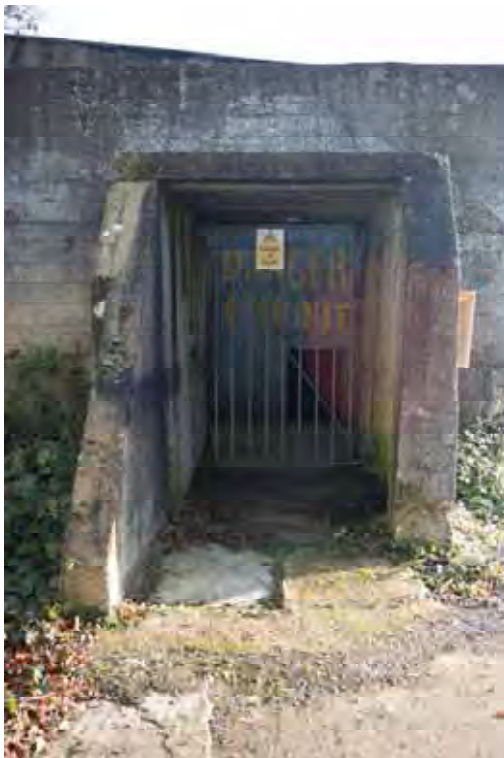
Plate 12: Store 4 – Detail of the covered entrance providing access into the walkway perimeter surrounding the inner structure, facing south-east (237)

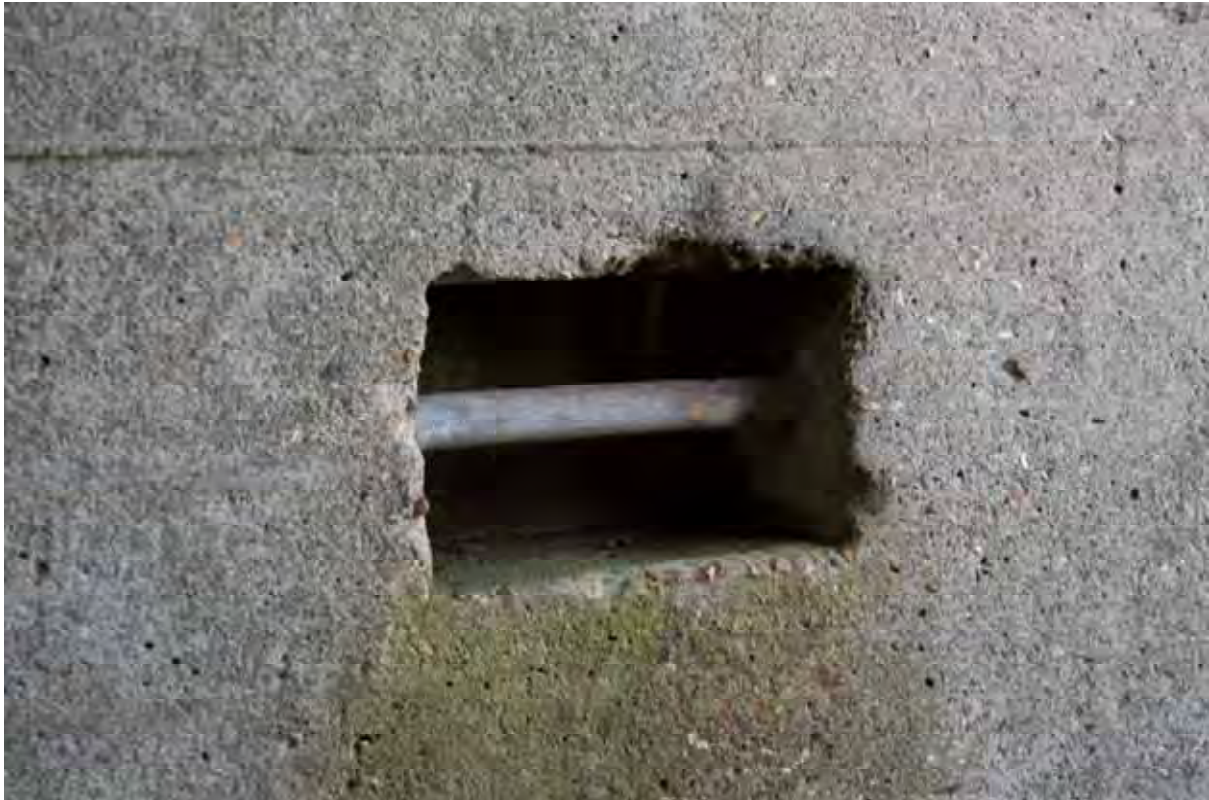
Plate 13: Store 4 – Detail of the integral locking bar for the gates within each covered entrance, facing east (334)

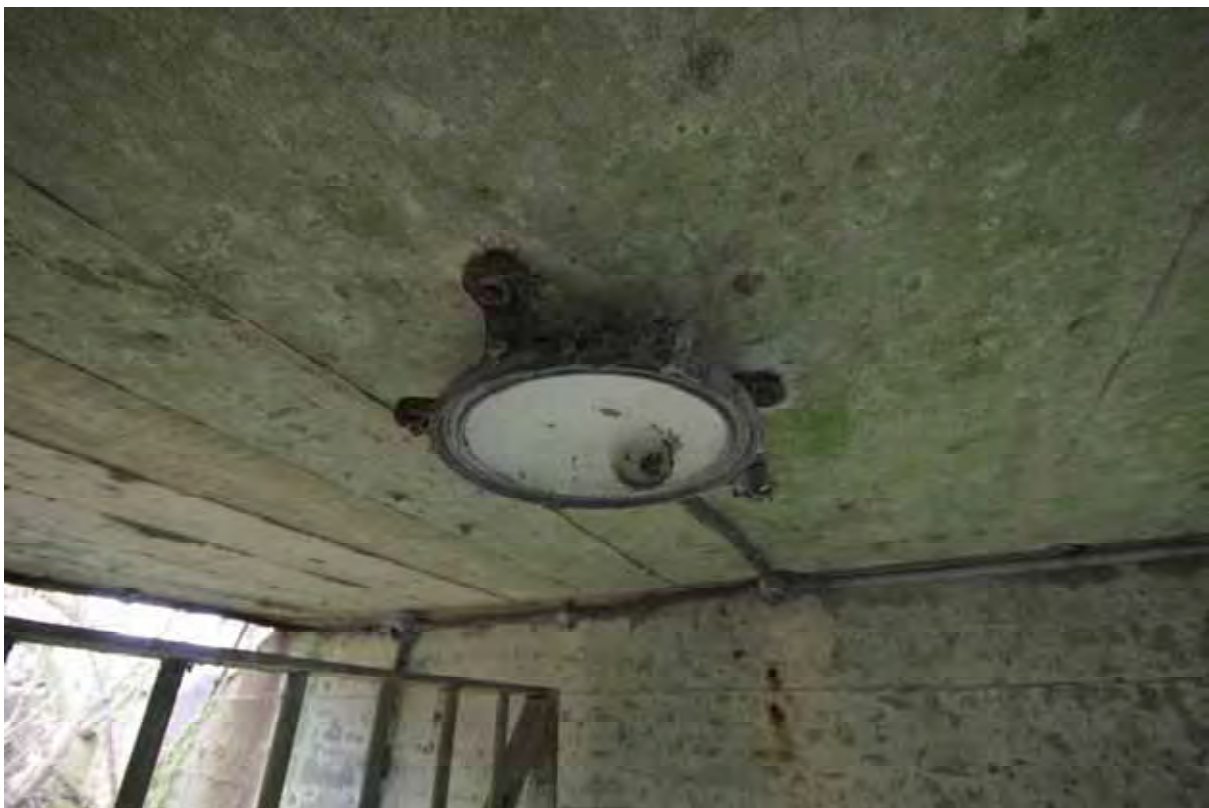
Plate 14: Store 4 – Detail of the Revo light fitting serving each covered entrance, facing west (64)

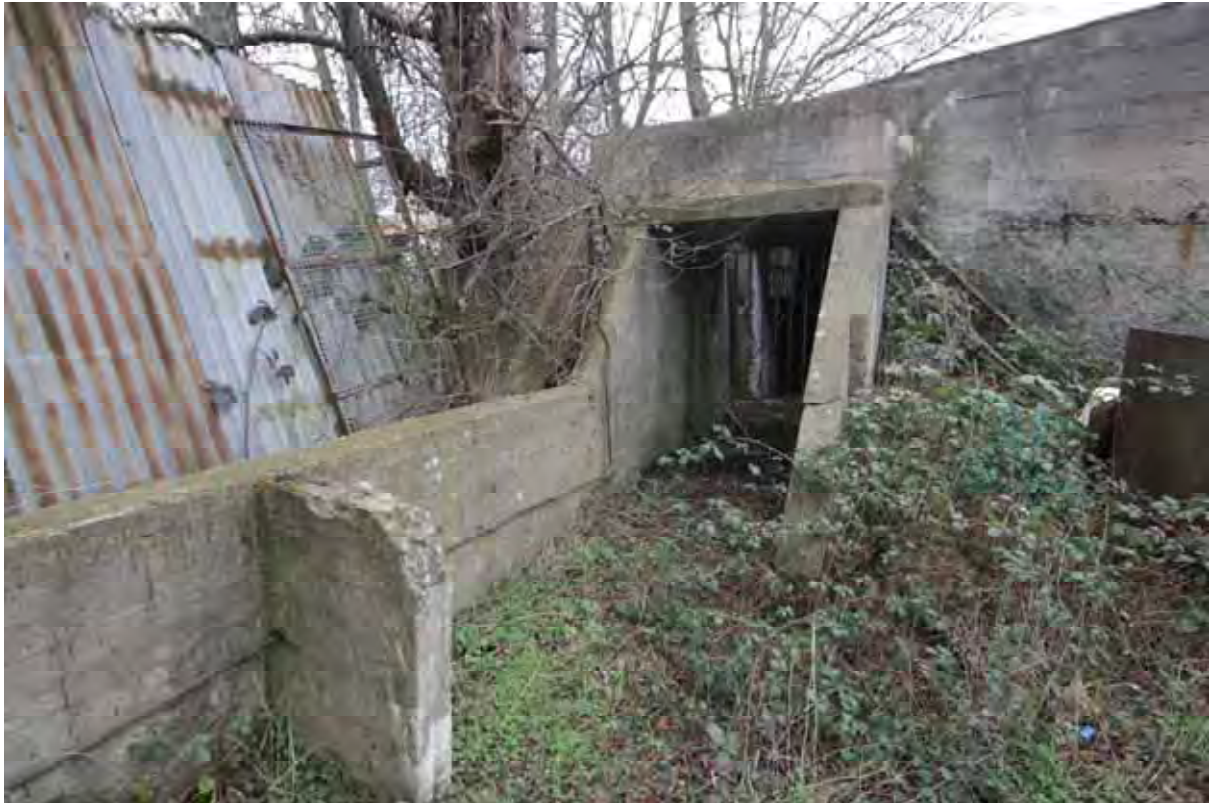
Plate 15: Store 4 – View of the northern loading bay entrance and conveyor base, serving the eastern half of the store, facing south-east (55)

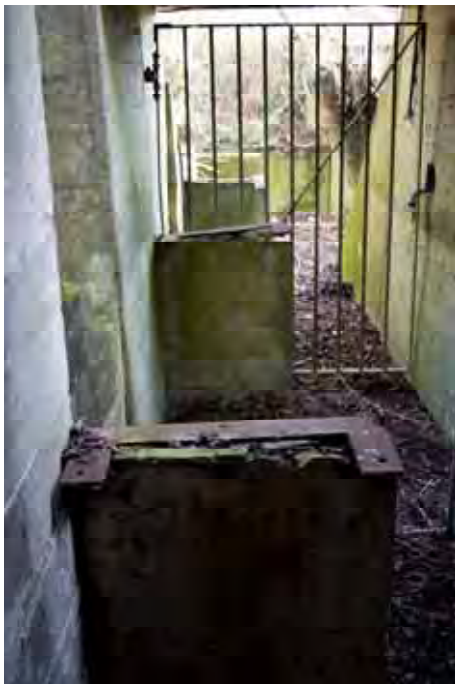
Plate 16: Store 4 – View of the southern loading bay serving the eastern half of the structure, note the complete nature of the bases and end platform (with brackets), facing south-east (277)

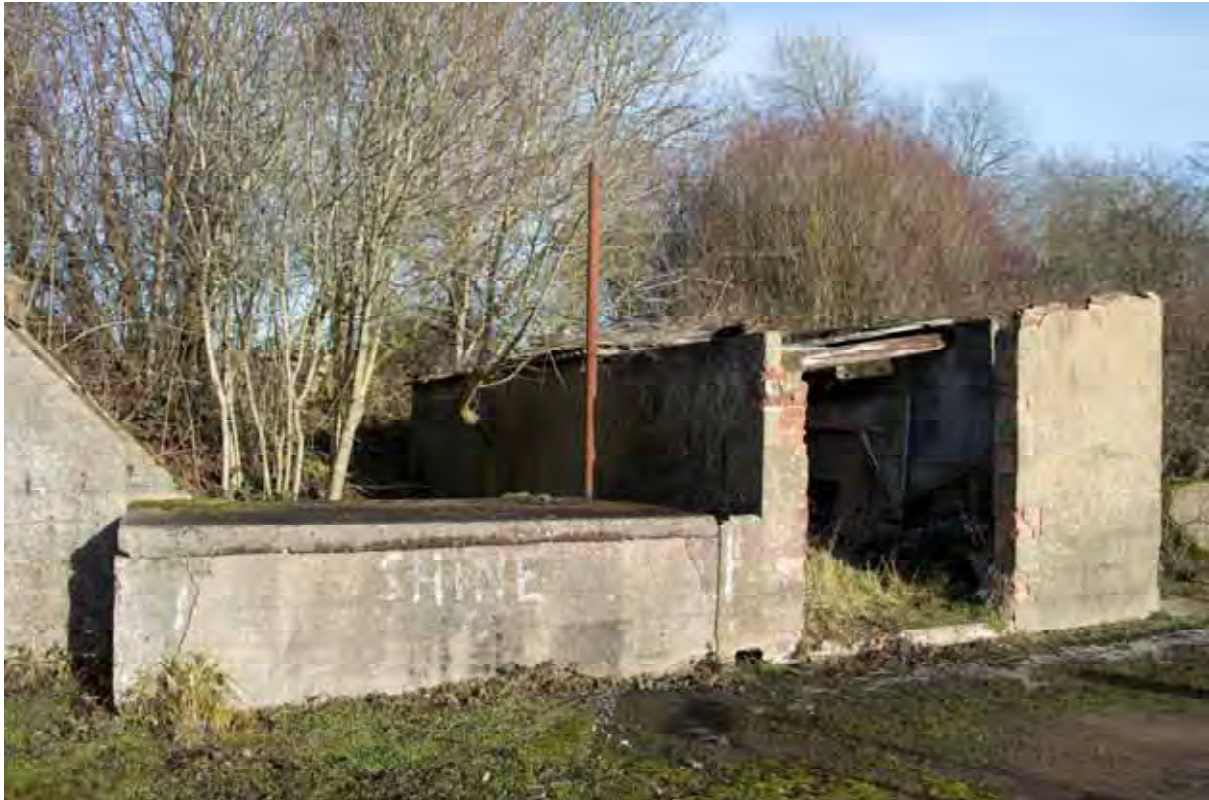
Plate 17: Store 4 / Building 15 – View of the southern loading platform serving the western half of the store, note the lamp post detailing, facing east (282)

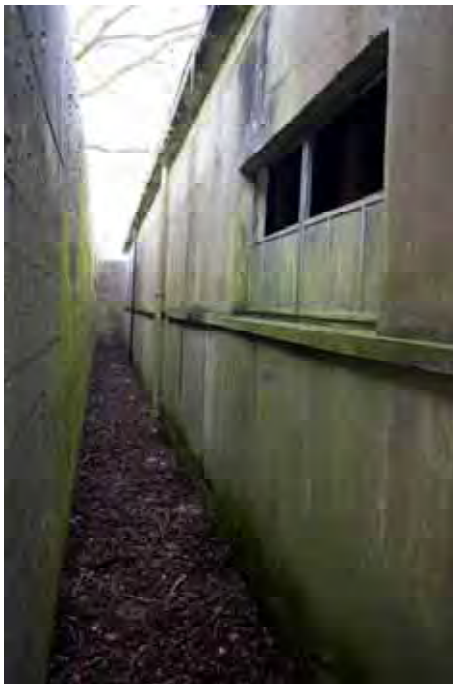
Plate 18: Store 4 – View of the inner walkway separating the north-east elevation of the inner structure and outer blast wall, facing south-east (270)

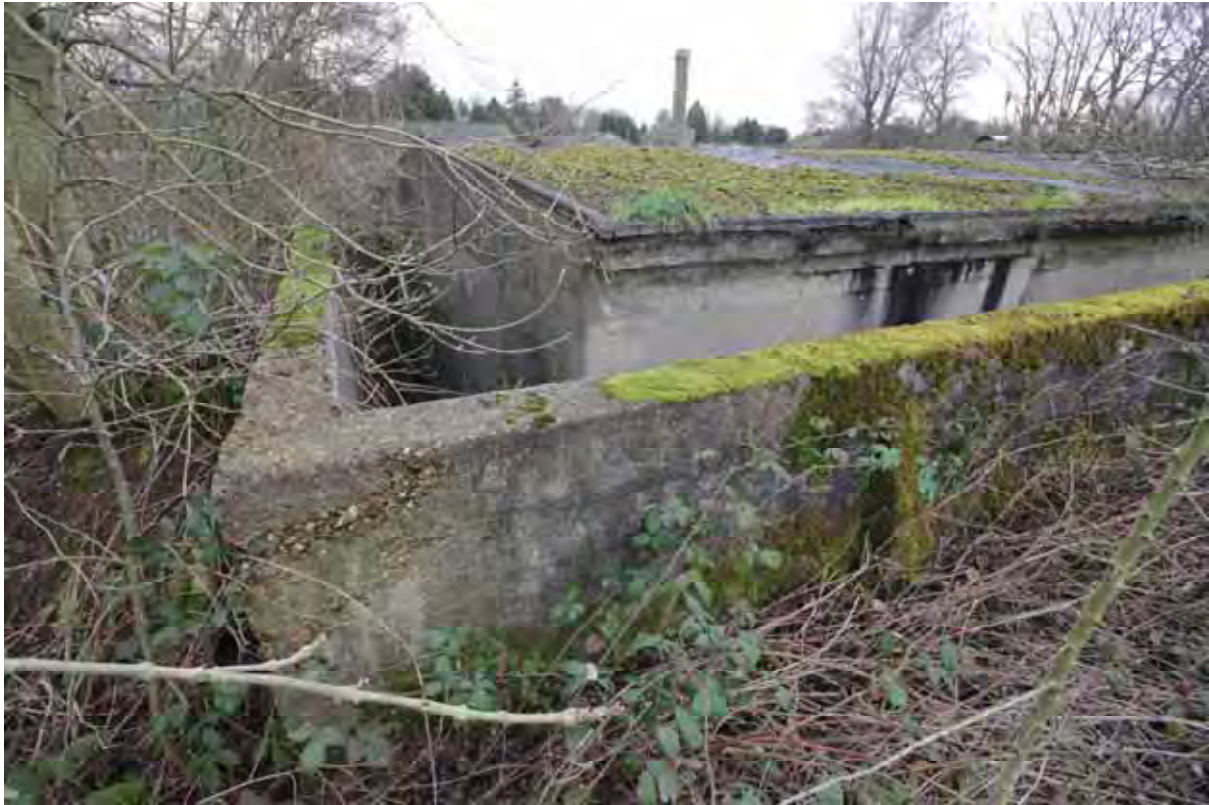
Plate 19: Store 4 – Detail of the roof and walkway separating the inner structure and outer blast walls, facing west (74)
