**LAND AT COURTLANDS FARM,
PARK ROAD, BANSTEAD, SM7 3EF**

**HISTORIC BUILDINGS RECORD
(HISTORIC ENGLAND LEVEL 4)**

**Historic Buildings Record
(Historic England Level 4)**

**ASE Project No: 171102
Site Code: CFB17**

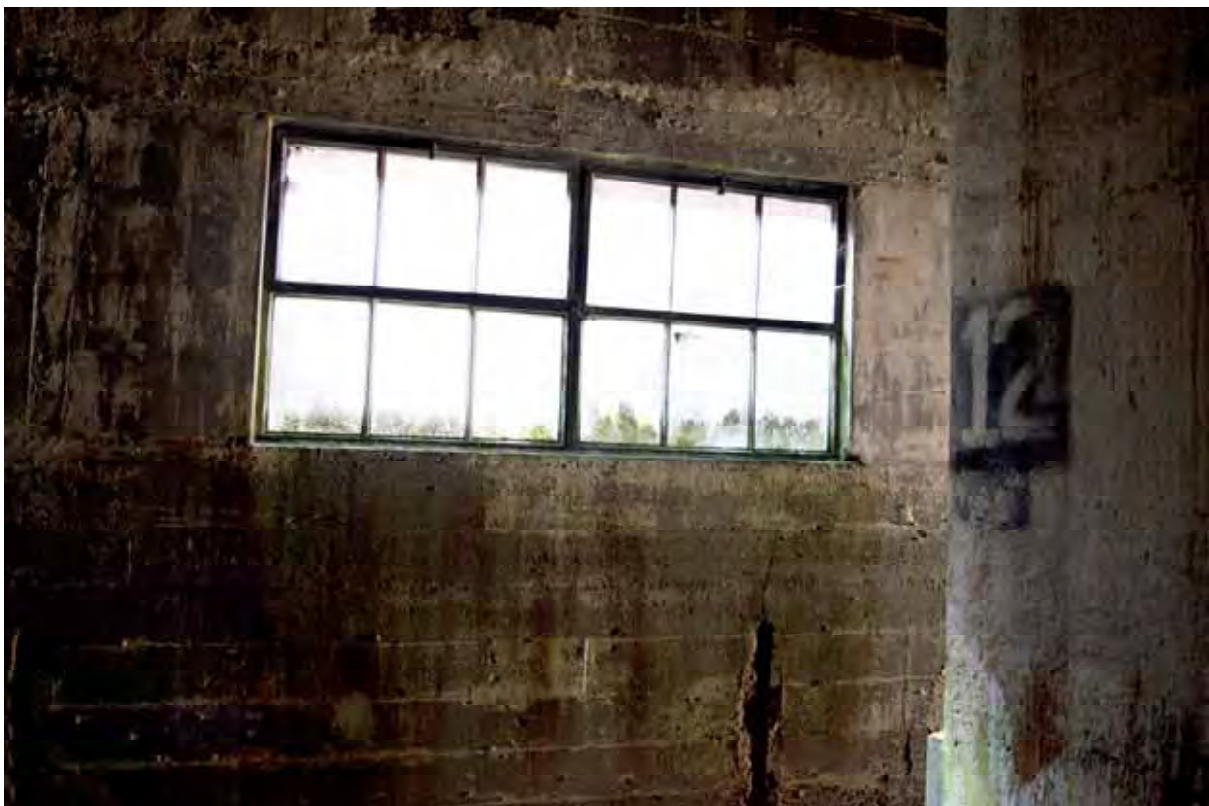
Plate 20: Store 4 – Detail of the current window detailing within the southern end of the store's south-west elevation, facing south-west (248)

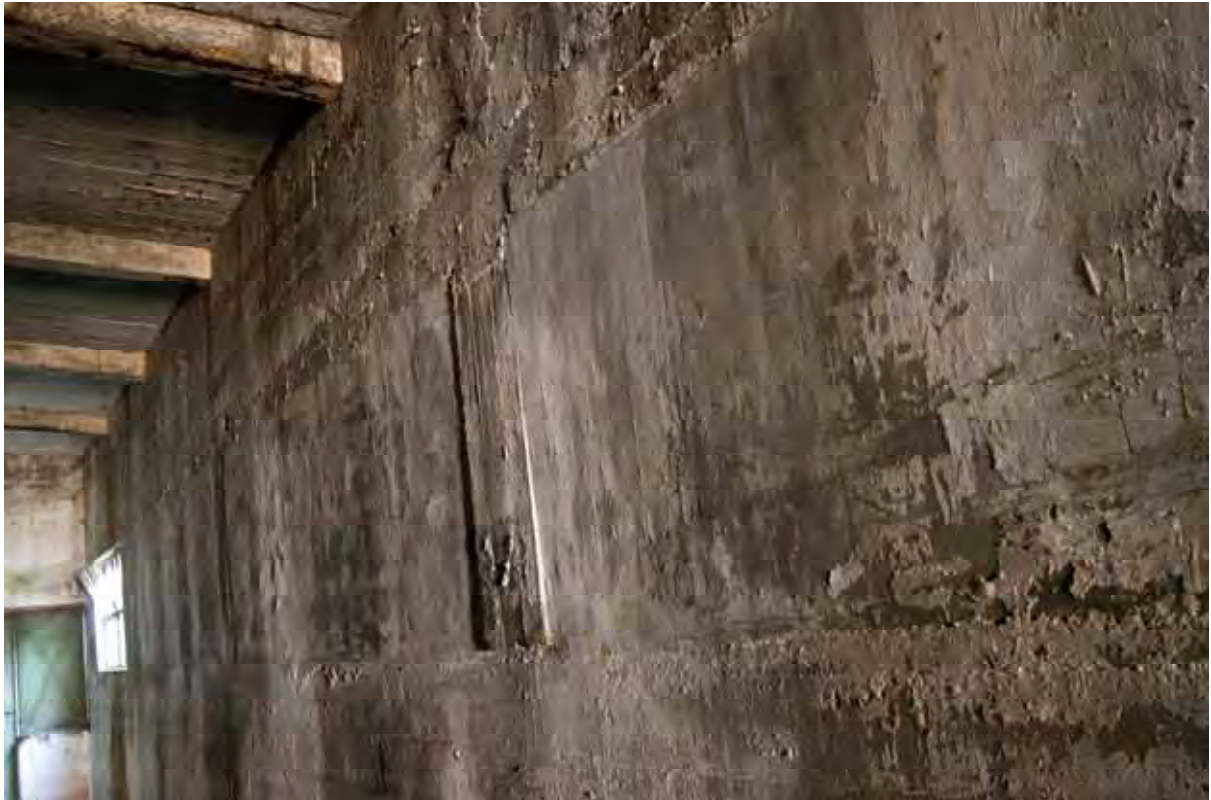
Plate 21: Store 4 – Detail of the blocked opening within the store's south-west elevations, facing south-east (254)

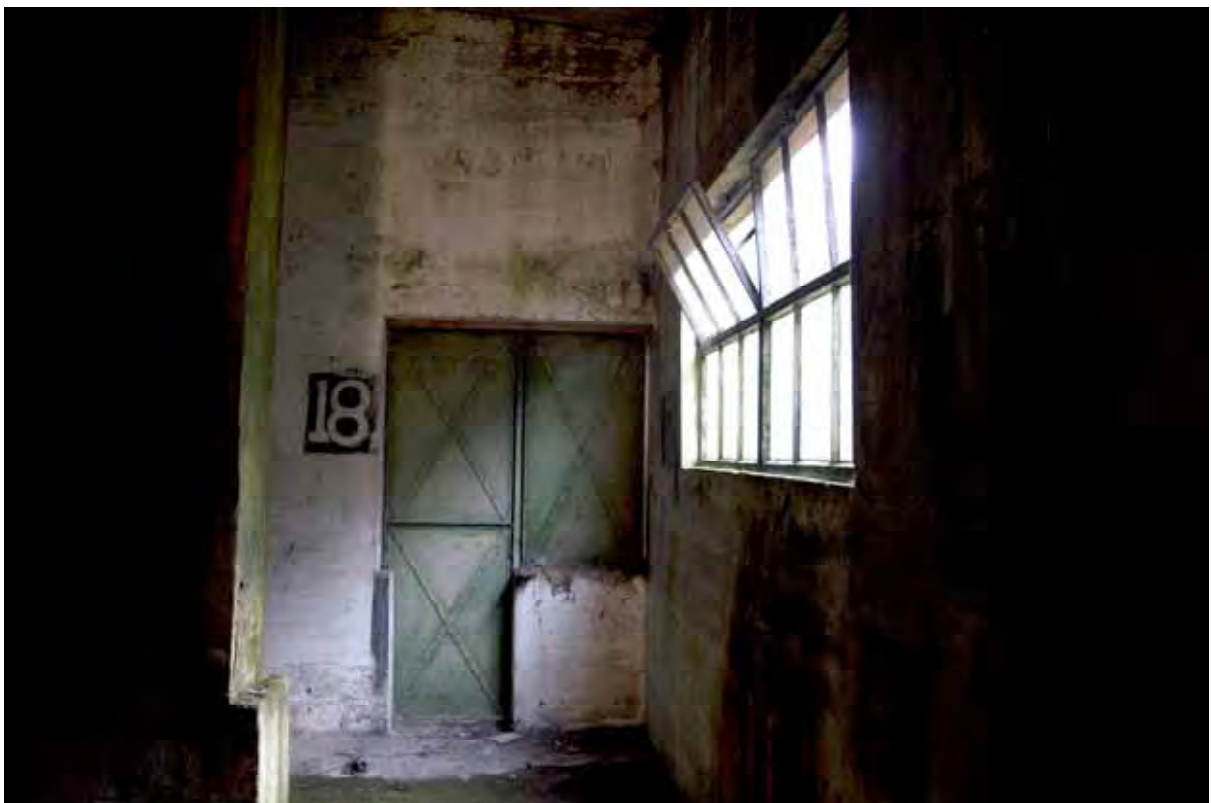
Plate 22: Store 4 – Detail of the internal door and window arrangement within each store (western door to southern loading bay), facing south-east (258)

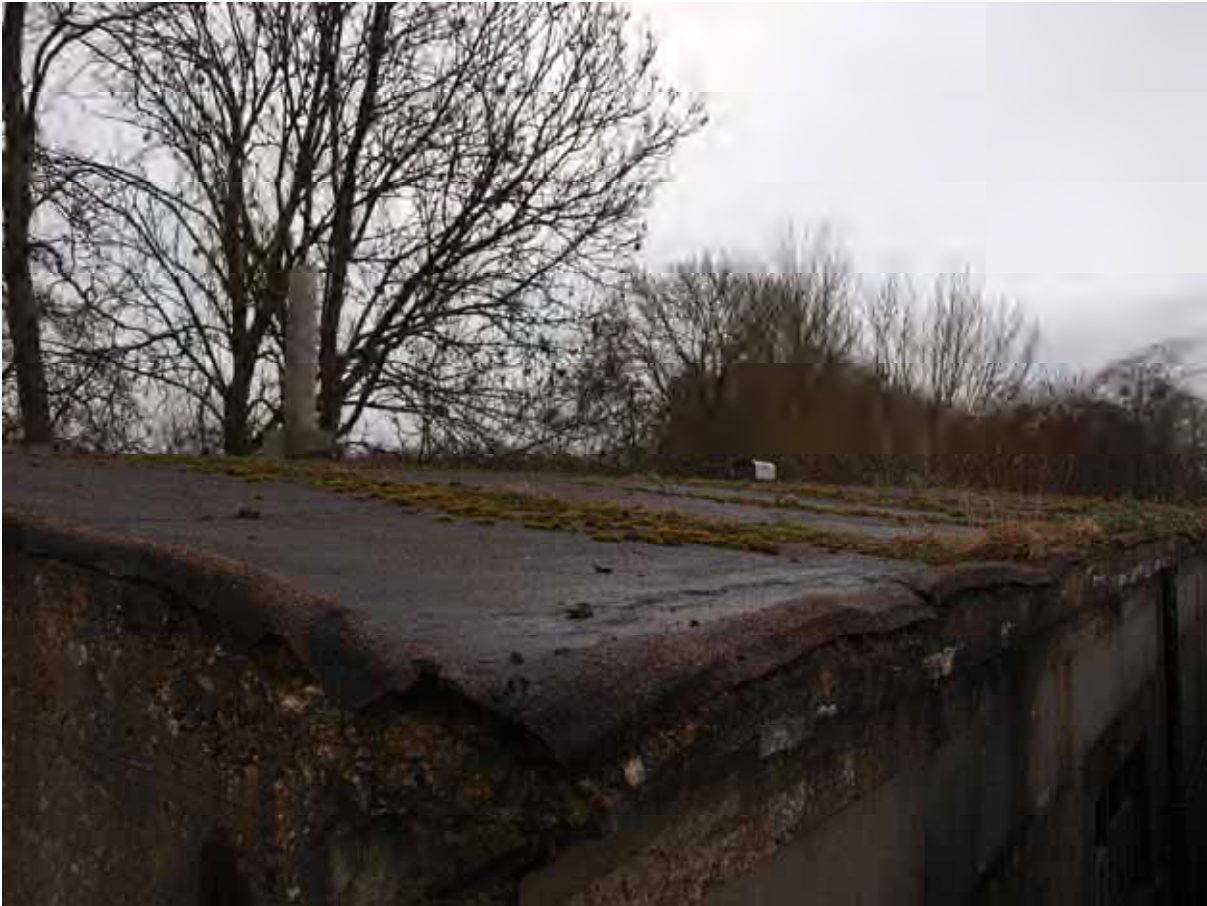
Plate 23: Store 4- Detail of the roof arrangement and central vents, facing east (187)

- 6.10 The store walls, measuring 0.24m thick, are constructed in solid shuttered concrete, and are pierced by ventilation shafts and grilles in order to discourage internal high moisture conditions. The north-east and south-west elevations presently contain two window openings at either end (Plate 20). Each contains a paired, six-light, steel-framed window; the top three panes of which comprise a single bottom-hung opening section. The windows themselves are set within a run of six blocked openings (Plates 21 and 22), which continue the length of both elevations. Each aperture measures 3m in length and c.1m in height, and is blocked with aerated red-brick dust coloured concrete blocks. The exact nature of these blocked sections is unknown, however they appear to form original window openings set 2m above the internal floor height. Presently the store interiors are predominantly served by electric lighting, with the current windows providing only limited natural light. At the start of the war, it was presumed that the majority of German air assaults would be carried out by day. However, as the war developed, advancements in aviation and navigation technology allowed for night-time bombing raids, so that by the autumn of 1940, it was recognised that the majority of German air strikes were being undertaken at night (Historic England 2017). This circumstantial information would support the suggestion of a war-time transition from the use of light wells, to electric lighting, within the ammunition stores on the site. This explanation is also consistent with data collected about the site's ammunition replenishment, which although was initially assumed would be a day-time operation, in practice seems to have generally been undertaken at night (WO 166/5331 & WO 166/5338). This transition from day-time to night-time bombing would have rendered such substantial light wells redundant, perhaps explaining their blocking. Drainage on these elevations comprise a combination of cast iron downpipes which run through the overhanging eaves of the felted shallow pitched roof (Plate 23), and modern uPVC replacements.

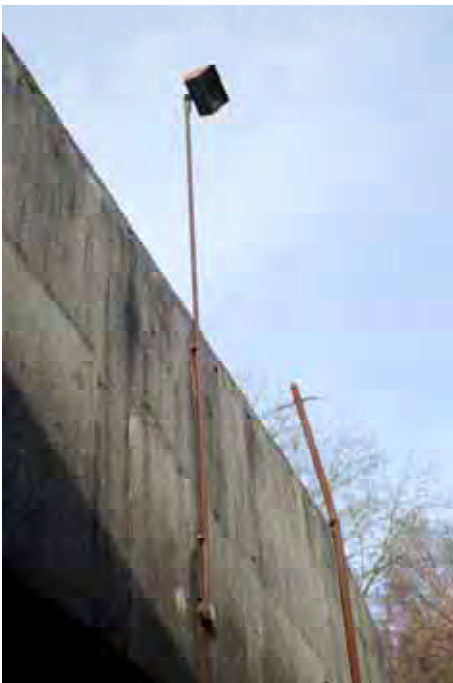
Plate 24: Store 4 – View of the light fittings serving each loading bay (south-east elevation), facing north-east (299)

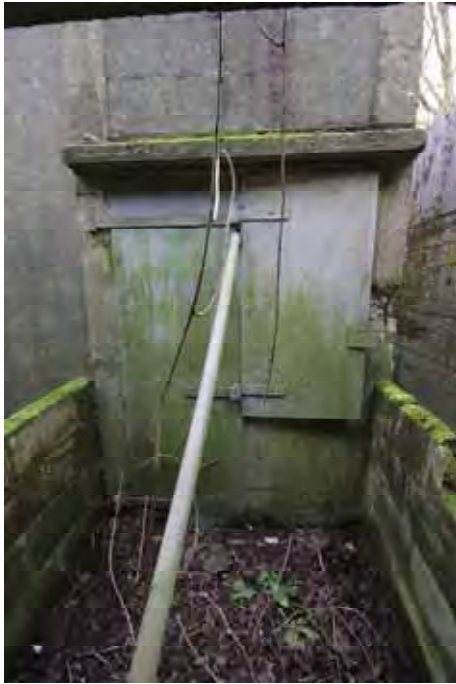
Plate 25: Store 4 – Detail of the doorways serving each store (eastern doorway serving the southern loading bay), facing north-west (60)

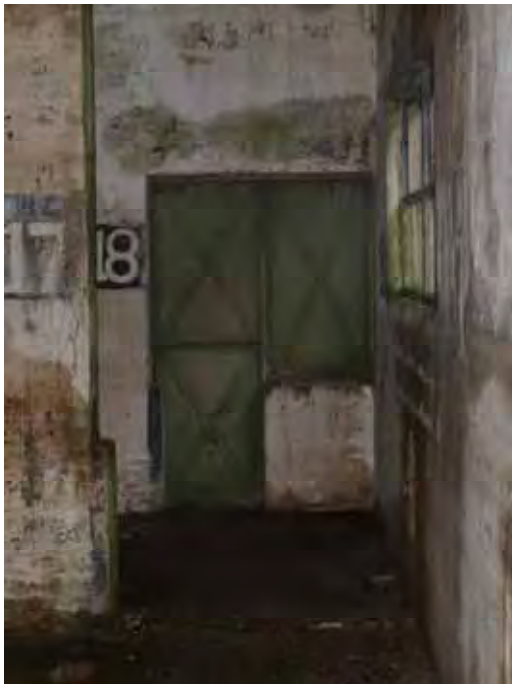
Plate 26: Store 4 – Detail of the internal door face serving the inner structure of each store (western doorway serving the southern loading bay), facing south-east (217)

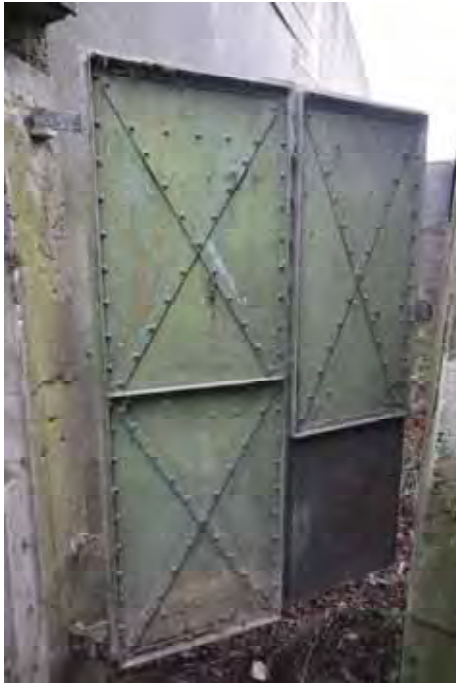
Plate 27: Store 4 – Detail of the internal door face serving the inner structure of each store (eastern doorway serving the northern loading bay), facing south-west (43)

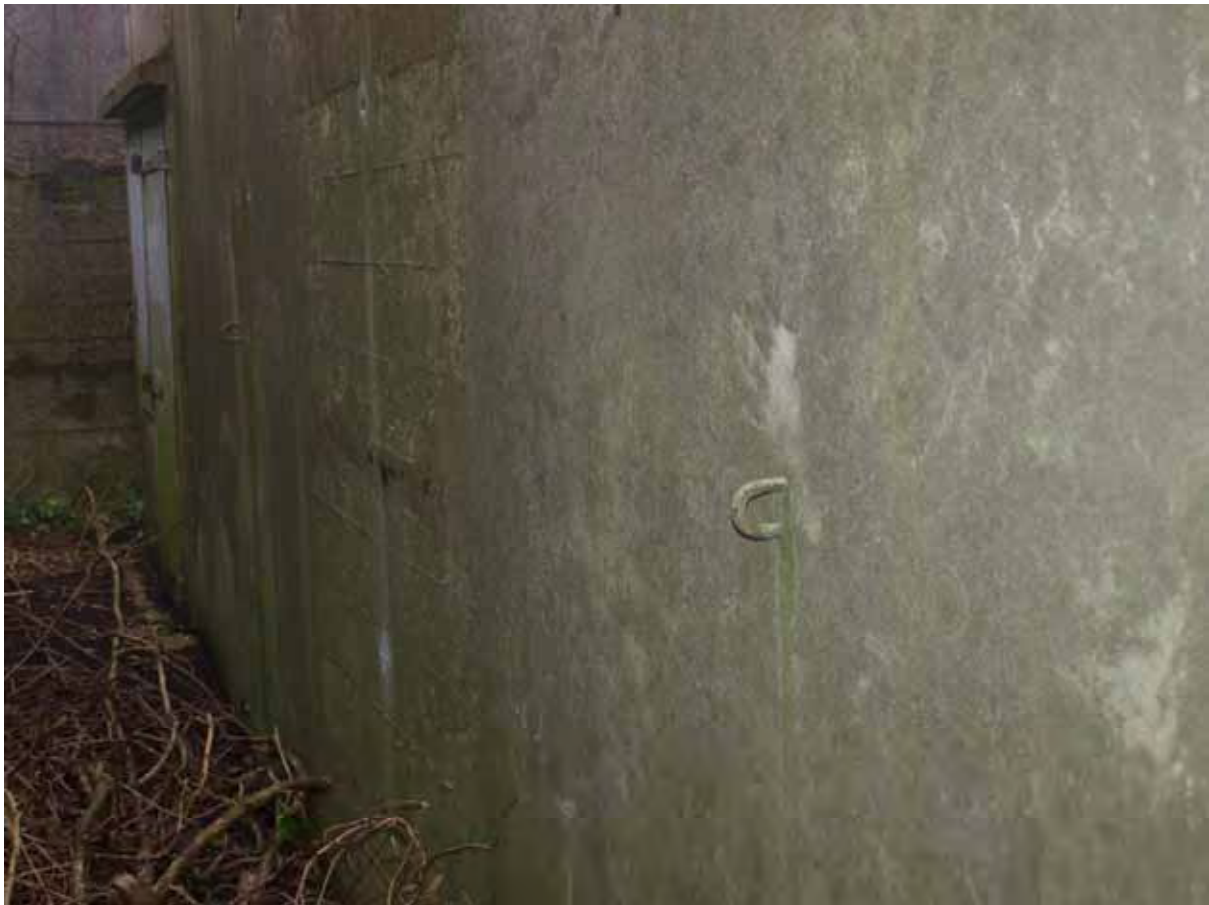
Plate 28: Store 4 – Padlock hook located adjacent to each doorway (south-east elevation), facing west (220)

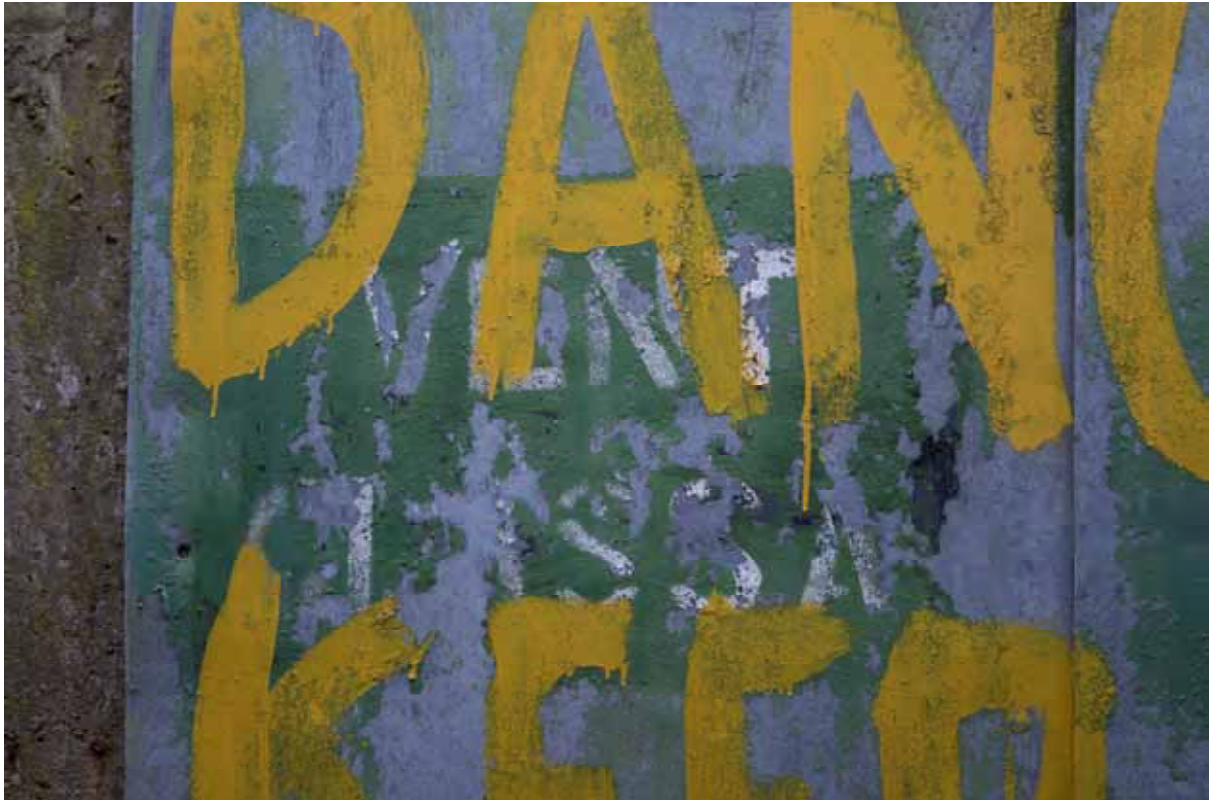
Plate 29: Store 4 – Detail of the 'Vent Class A' stencilling found on the external face of each store door (western door serving the northern loading bay), facing south-east (266)

and storage. It is recorded that the Banstead site could hold a maximum capacity of 960 tons of ammunition, comprising shells for 3.7" and 4.5" aircraft guns and rockets (BHRG 2006), suggesting that 'Class A' may relate to the type of ammunition being stored in that particular store and/or the storage conditions required for each type. The external door faces are each painted green. Each entrance is set within a protruding concrete door-case, with overhanging concrete lintel.

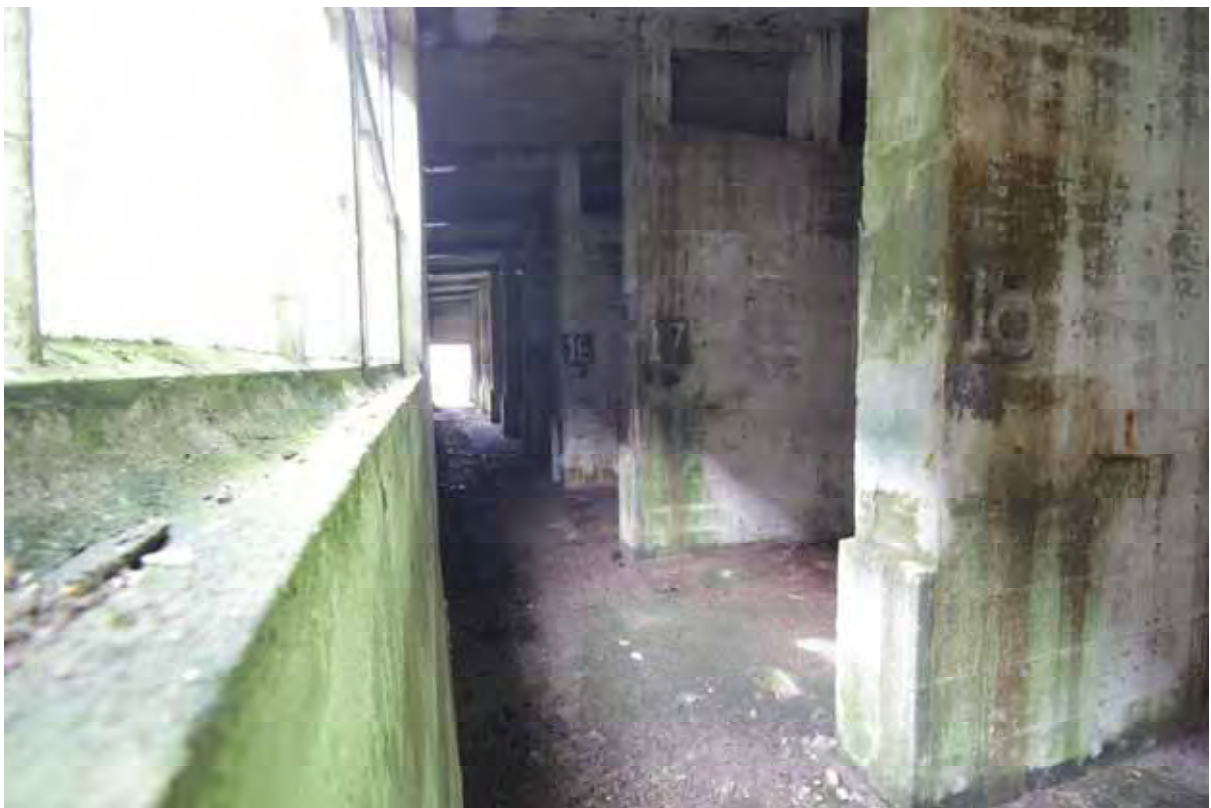
Plate 30: Store 4 – Internal view of the western passage and storage bays, facing north-west (1)

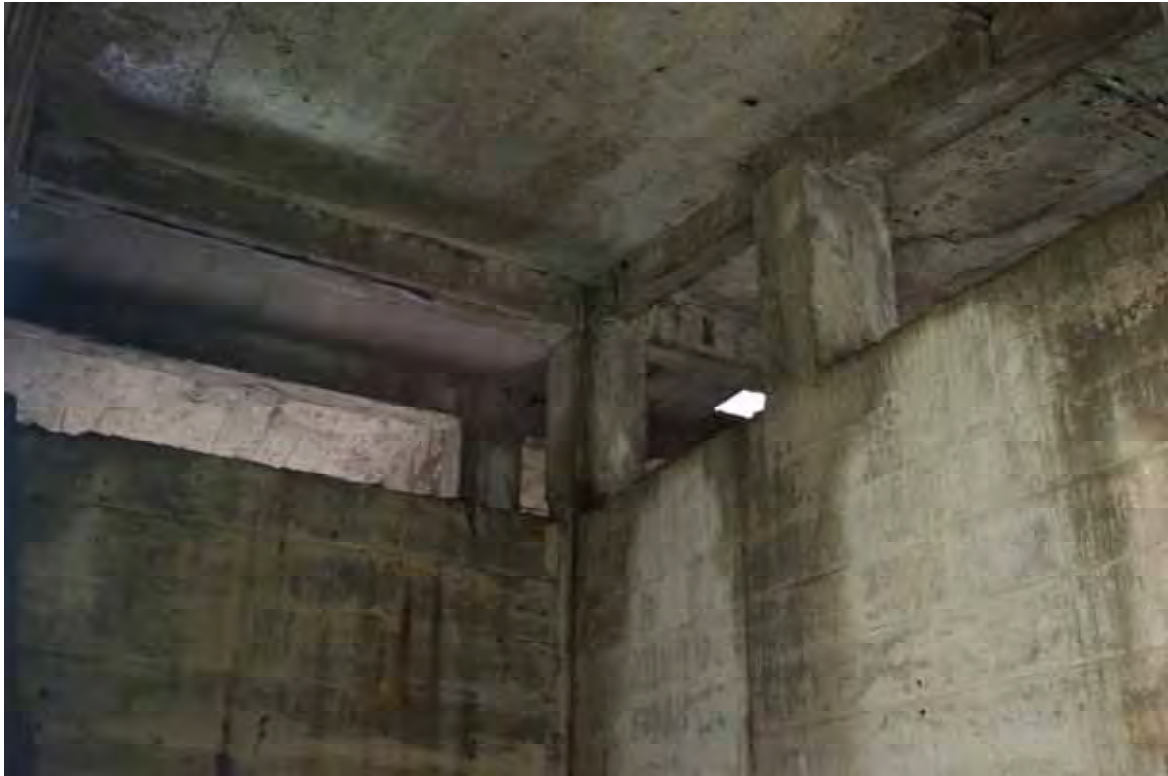
Plate 31: Store 4 – View of a typical bay arrangement (western half), facing north-east (264)

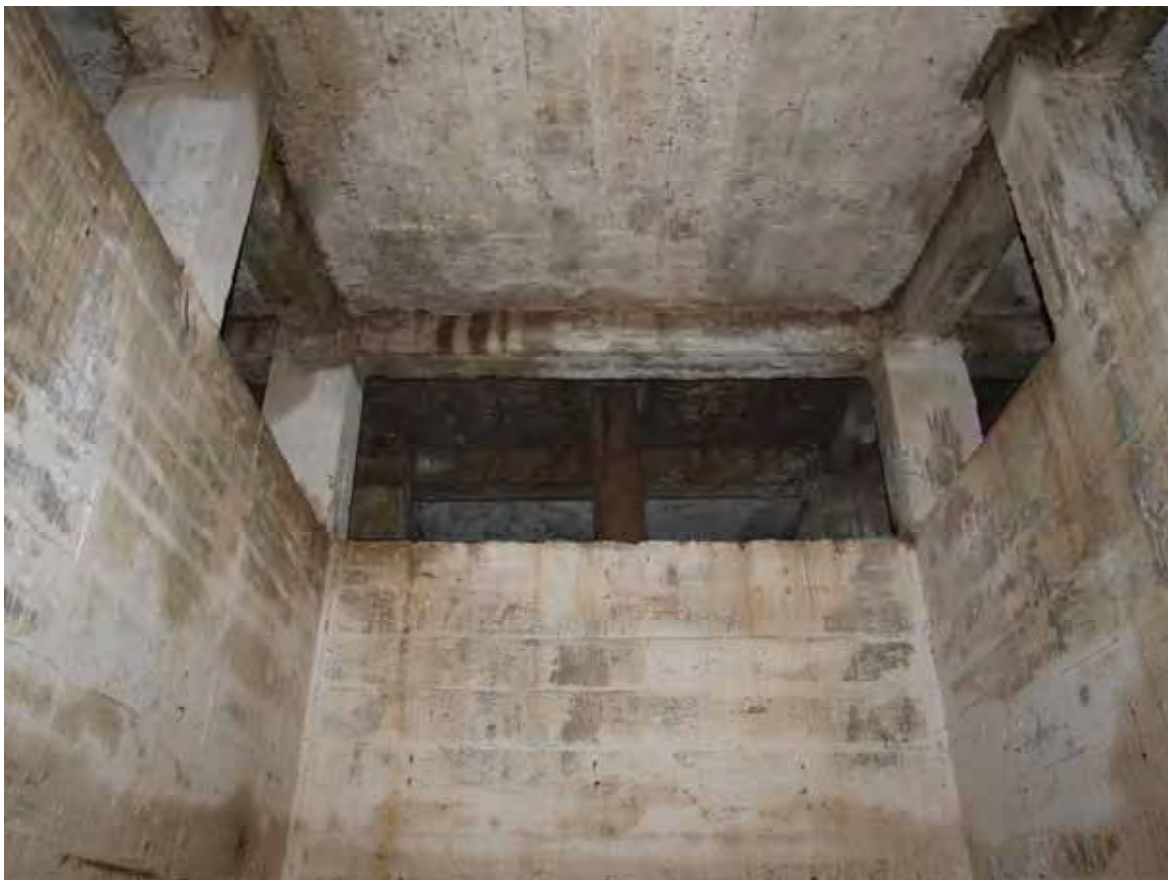
Plate 32: Store 4 – View of the roof arrangement above each bay (western half), facing north-east (196)

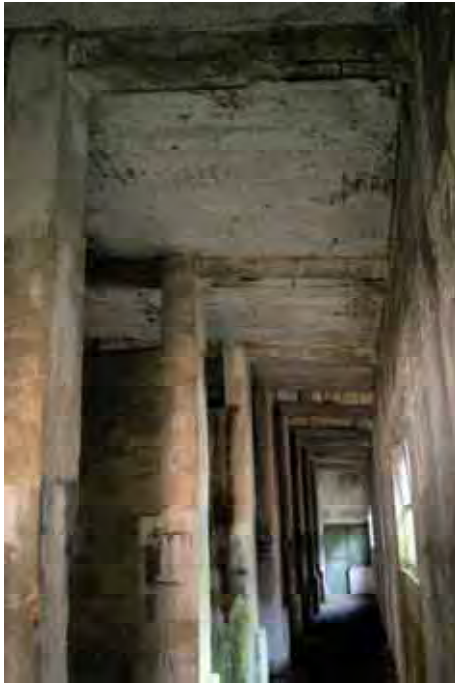
Plate 33: Store 4 – View of the store's roof construction above the western passage, facing south-east (263)

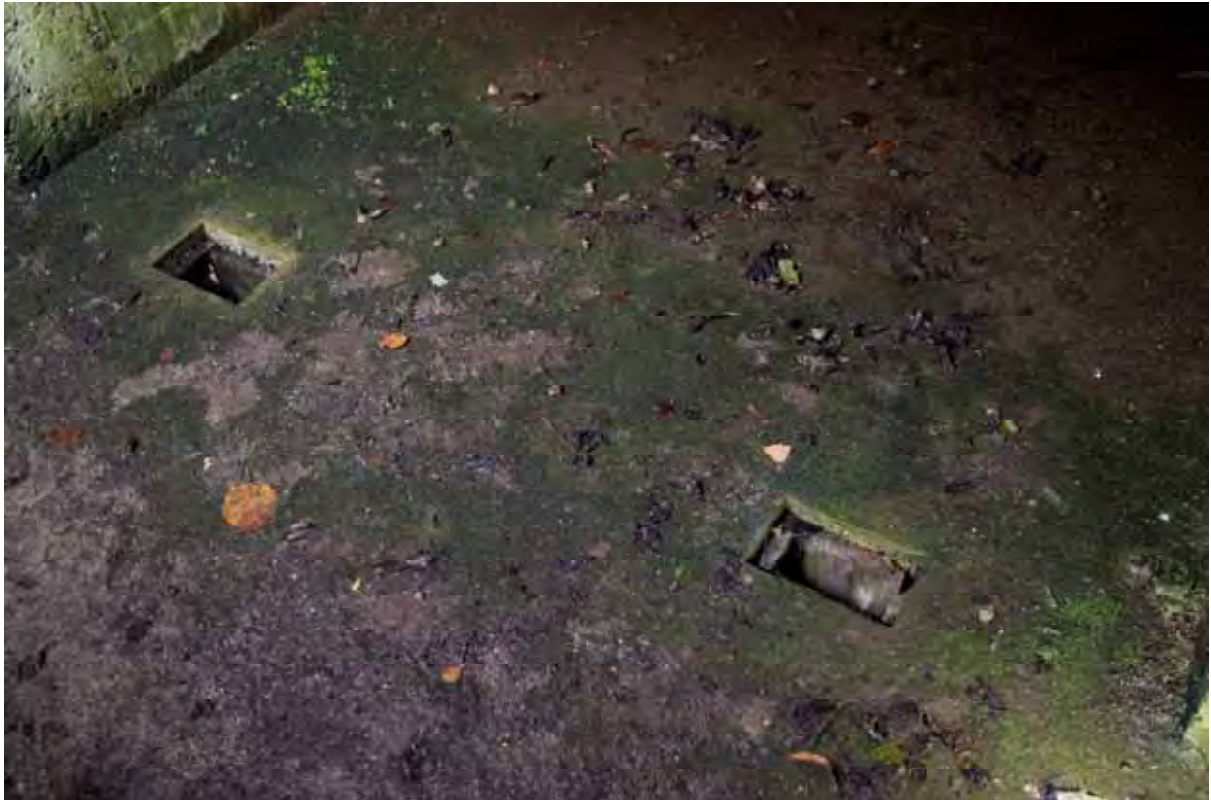
Plate 35: Store 4 – Detail of the floor sockets within each bay (eastern half), facing south (261)

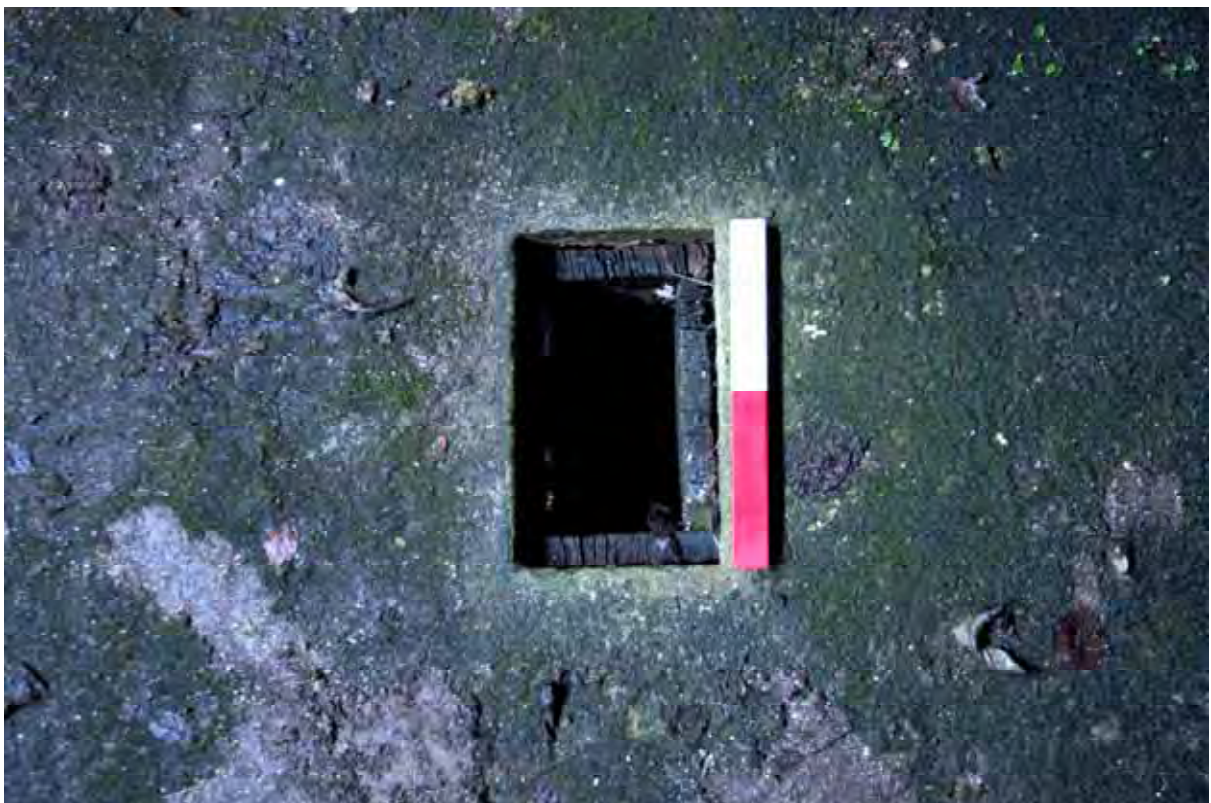
Plate 36: Store 4 – Detail of the floor sockets within each bay (eastern half), facing south-west (251)

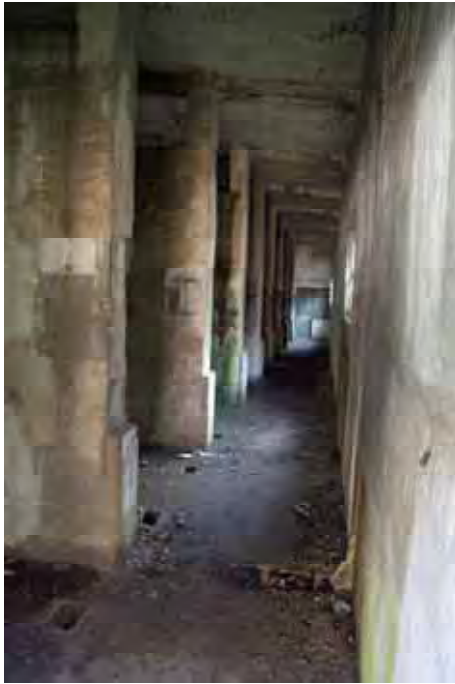
Plate 37: Store 4 – View of the store's western passage and bay divisions, facing south-east (245)

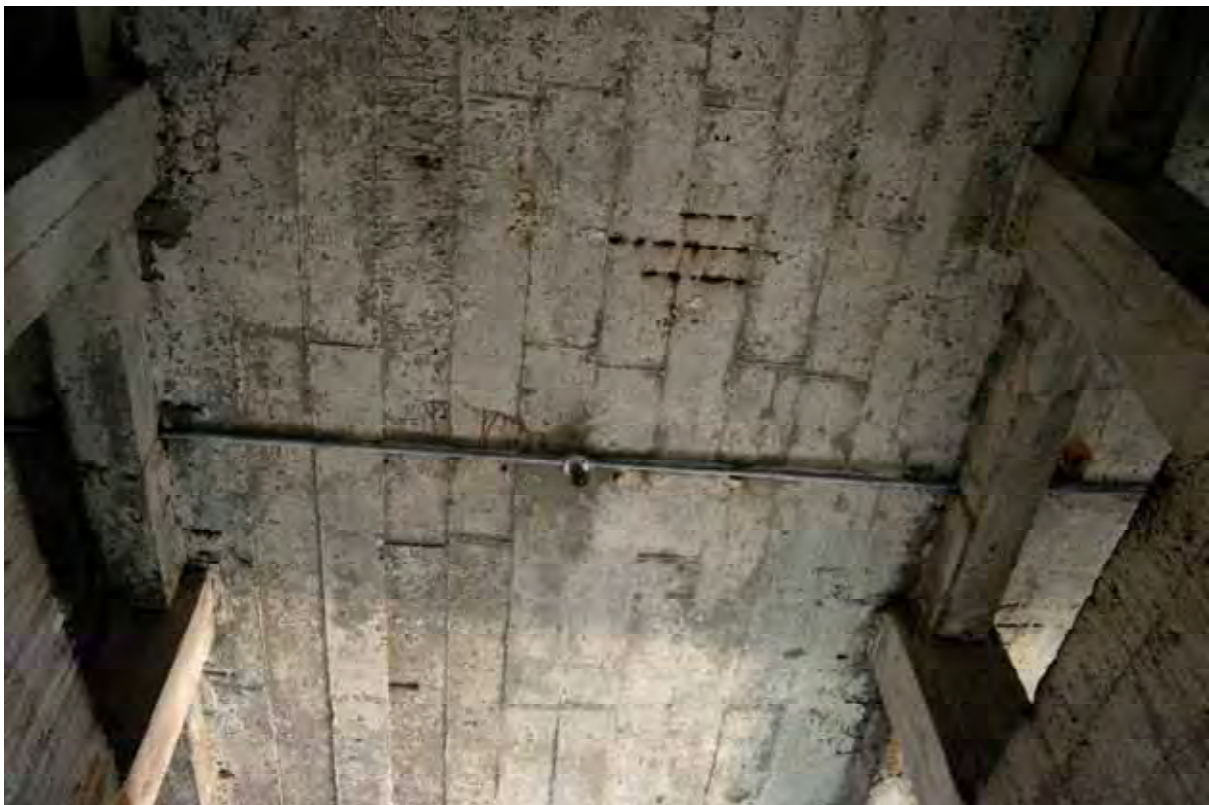
Plate 38: Store 4 – Detail of the roof and light detailing above each bay (eastern half), facing south-west (249)

- 6.16 Each bin is lit by a single bulb (Plate 38) with simple steel back plate and is connected to a mains fuse box, mounted within Bins 1 and 10. The fuse boxes comprise a combination of automatic and 50p coin operated types (Plate 39), both issued by the 'Electric Meter Servicing Co. Ltd. Leatherhead, Surrey'.

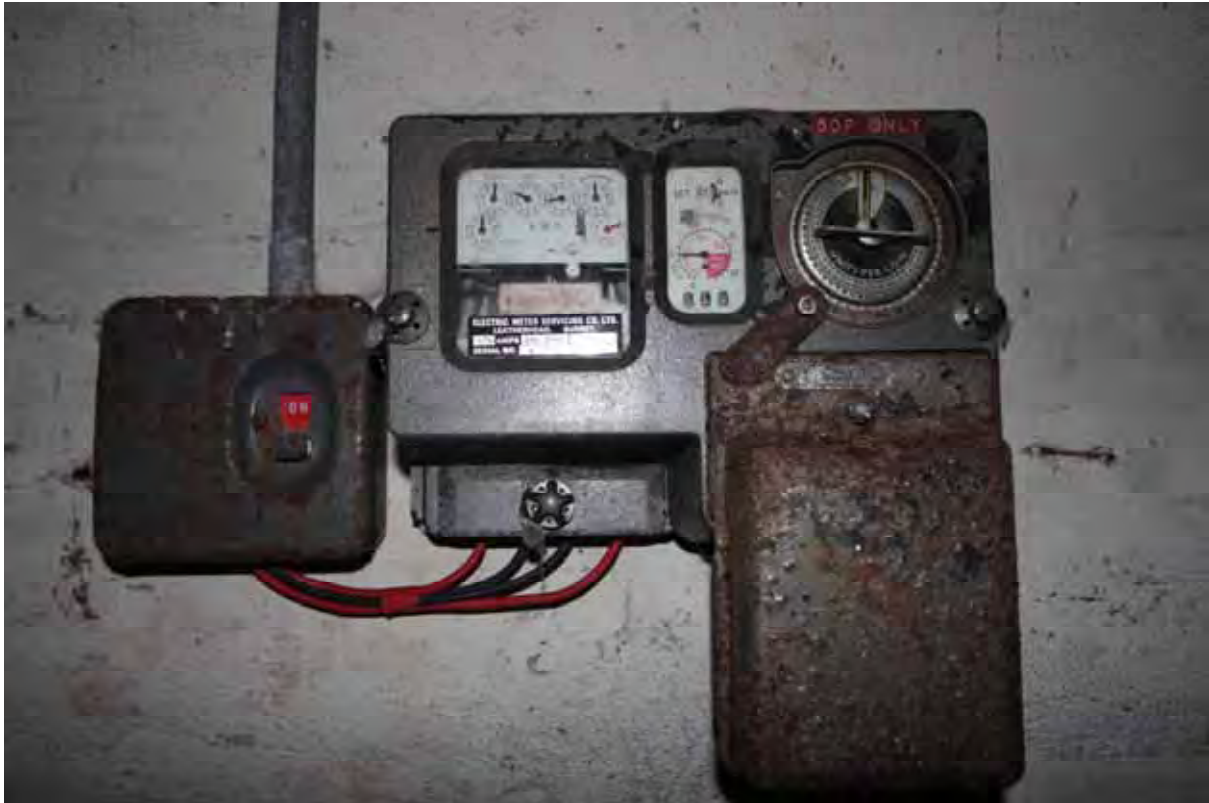
Plate 39: Store 4 – Detail of the electric fuse box found within Bins 1 and 10 within each store (eastern half), facing north-west (30)

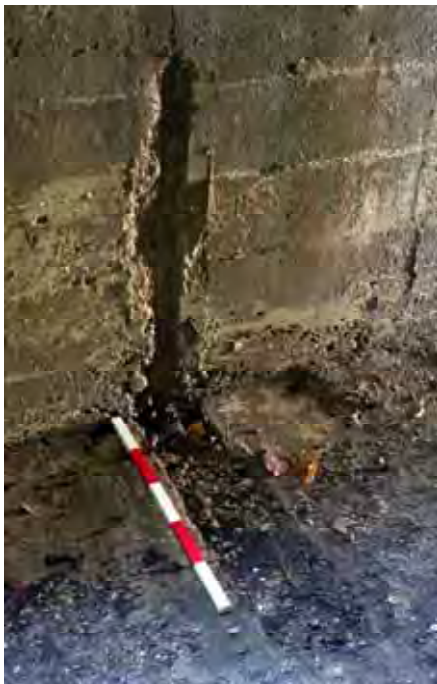
Plate 40: Store 4 – Detail of one of the removed conveyor bases within the western passage, facing west (250)

- 6.17 The bins are accessed via a passage, which runs the length of each row. Fragmentary evidence survives of eight former concrete supports (Plate 40) that formerly served the internal conveyor system – the supports are as those described externally. A number of passages contained a wall-mounted, timber information board at their north-west ends (south-west halves only). Although of a degraded nature, a number are clearly marked with 'FIRE ORDERS' and 'REGULATIONS' and contain printed information about types of ammunition and fire precaution and alarm procedures; all set against a painted red backdrop. Wall hooks consistent with this location, are found within each store, indicating notice boards were formerly situated in all stores.

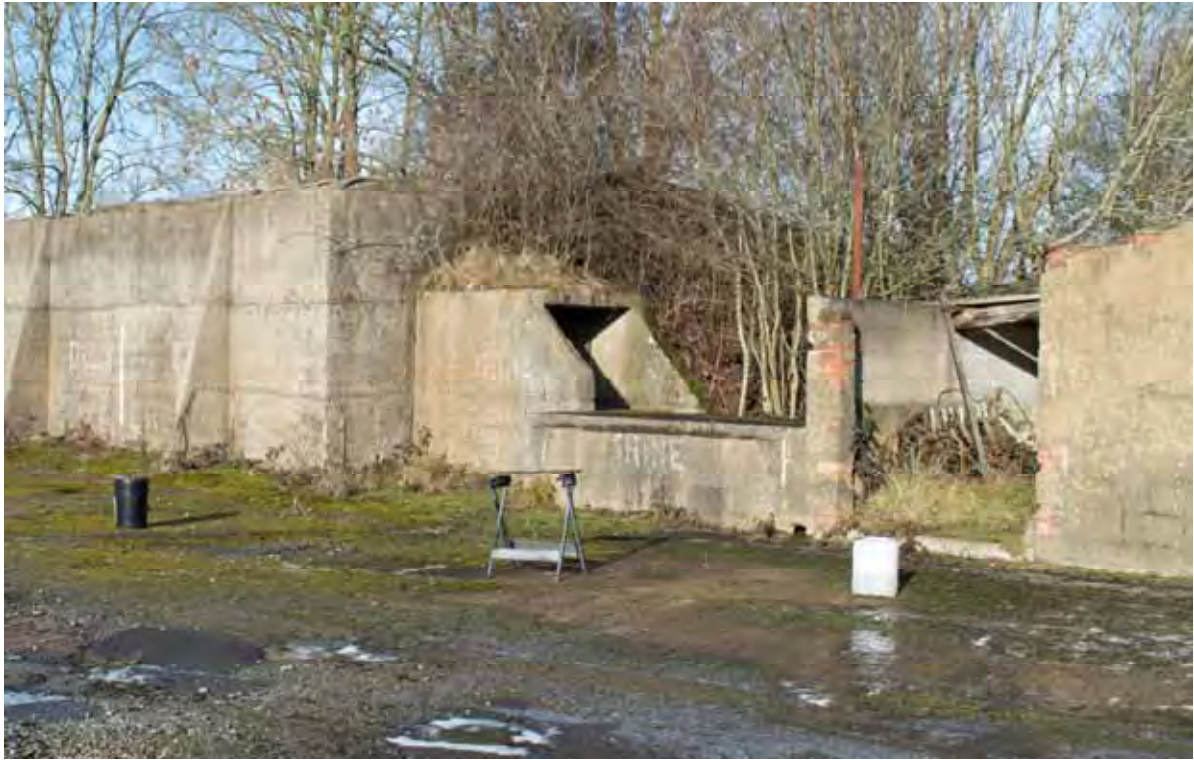
Plate 41: Store 4 – View of the western loading platform serving the southern loading bay, facing north (230)

- 6.18 Store 4 (Plate 41) is proposed for retention within the new development. The structure is as described above, with no notable internal alterations. The outer blast wall retains its earth blast barriers to the north-east and south-east but those formerly situated to the north-west and south-west, as seen on aerial photography, have been removed. The western loading platform serving the store's north-west elevation has been removed, with only fragmentary footings providing evidence of its former location. The loading platforms at the southern end retain elements of their original lamps, comprising a single post (south-west; Plate 42) and displaced light (south-east; Plate 43). The north-east (Plate 44) and south-west platforms retain flat-bar steel fixings (Plate 45) for the conveyor system. The structure has lost the majority of its conveyor system bases, although four out of the six which remain, situated externally along the eastern side, survive as the most complete example of the former conveyor system on the entire site; with all four bases and end platform surviving, the majority of which preserve original metal brackets (Plate 46).

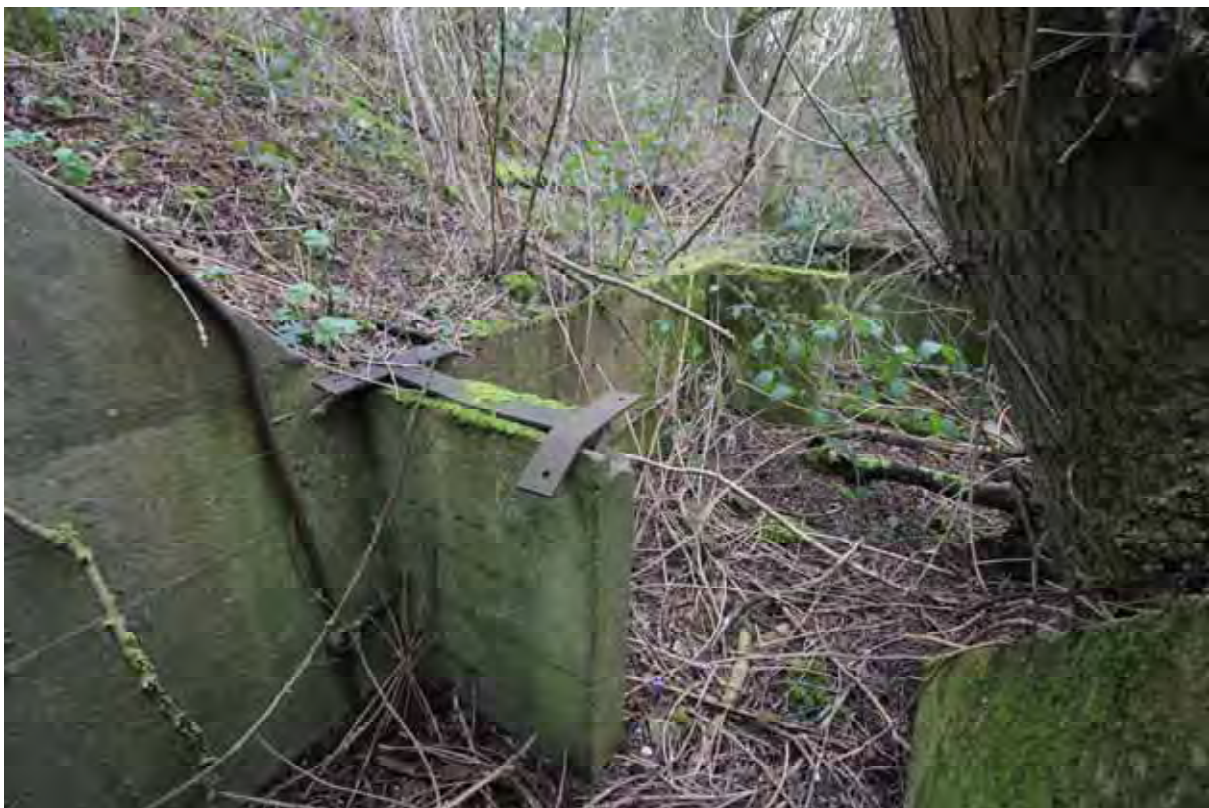
Plate 46: Store 4 – Detail of the retained conveyor bases within the southern loading bay (eastern side), note the metal brackets, facing north-east (66)

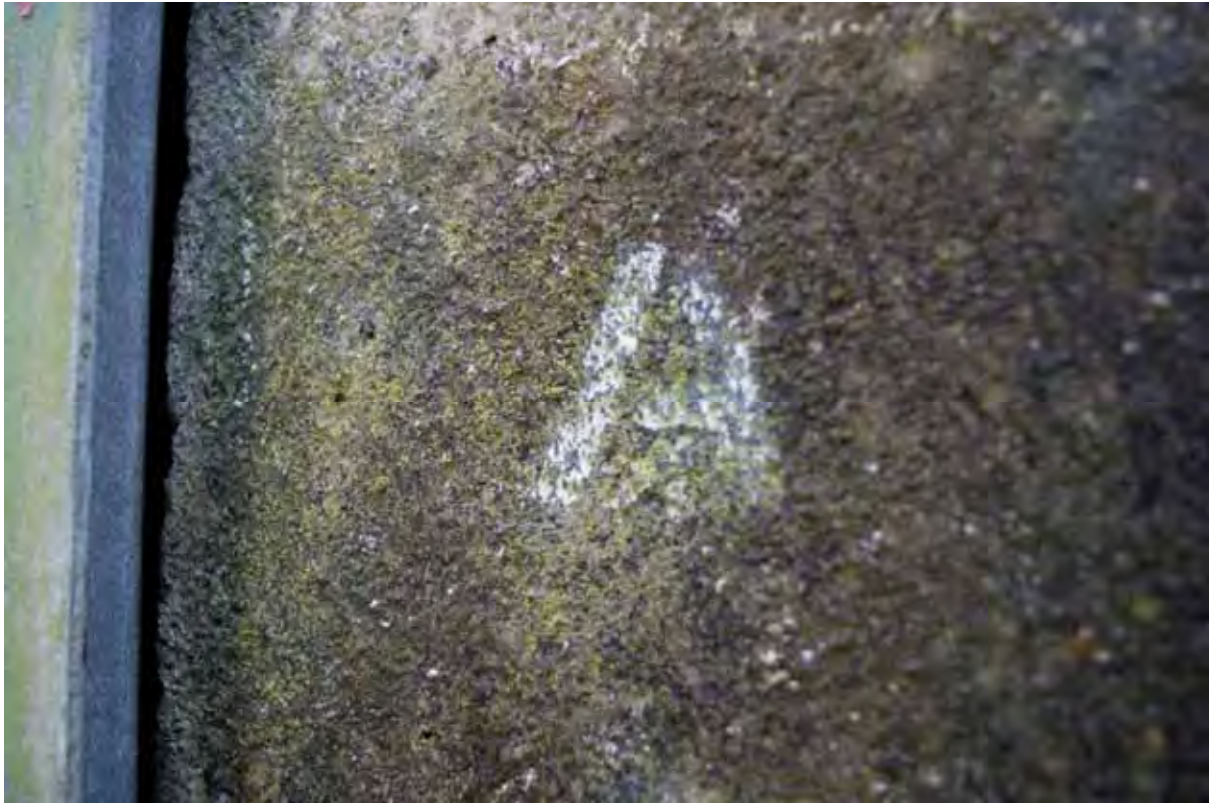
Plate 47: Store 4 – Detail of the painted marking on the western door serving the northern loading bay, facing south-east (265)

- 6.19 The north-west entrance retains its 'Vent Class A' stencilling, in addition to a small painted 'A' on the western door jamb (Plate 47). The nature of this additional signage is uncertain, although it may reflect an alphabetical signage system to indicate the direction of travel through the western half of the structure from north-west to south-east. The south-eastern entrance has been latterly framed to the east and west by low-level concrete block walls (Plate 48), which block the inner walkway in this location – the reason for these is not clear but they were presumably added as a much later alteration due to the nature of the blocks. None of the entrances retain any fire hydrant signage as described previously. The structure's north-east and south-west inner walls contain a continuous sill along their entire lengths (Plate 49), presumably serving the blocked openings in these locations, which are consistent with this height. Curiously the openings within this store, are set significantly lower than those elsewhere, at a height of c.1m above the inner ground level. The existing window (Plate 50) lighting the northern end of the eastern half of the structure, has lost its upper opening casements, these have however been stored internally within Bin 1 (Plate 51).

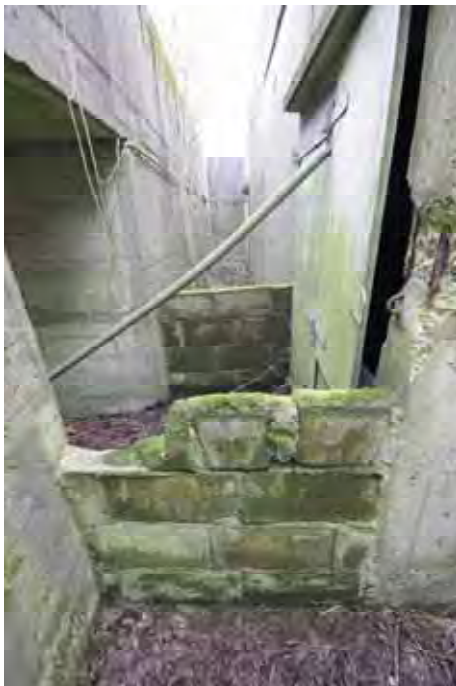
Plate 48: Store 4 – Later 20th century alterations to the south-east walkway, comprising low level concrete block walls, facing south-west (11)

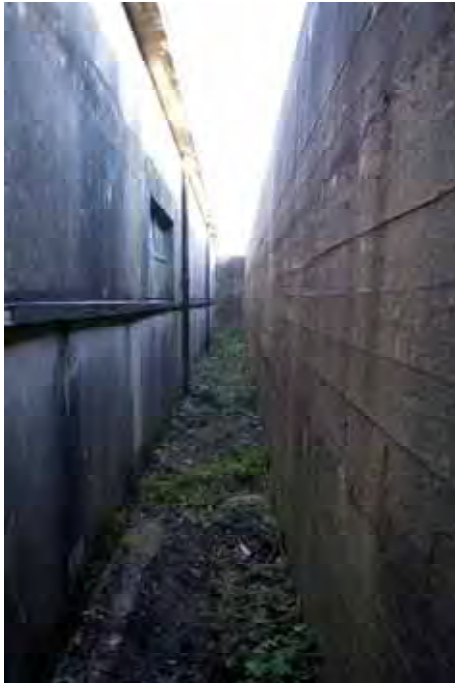
Plate 49: Store 4 – Detail of the continuous cill running the length of the store's south-west elevation, facing south-east (241)

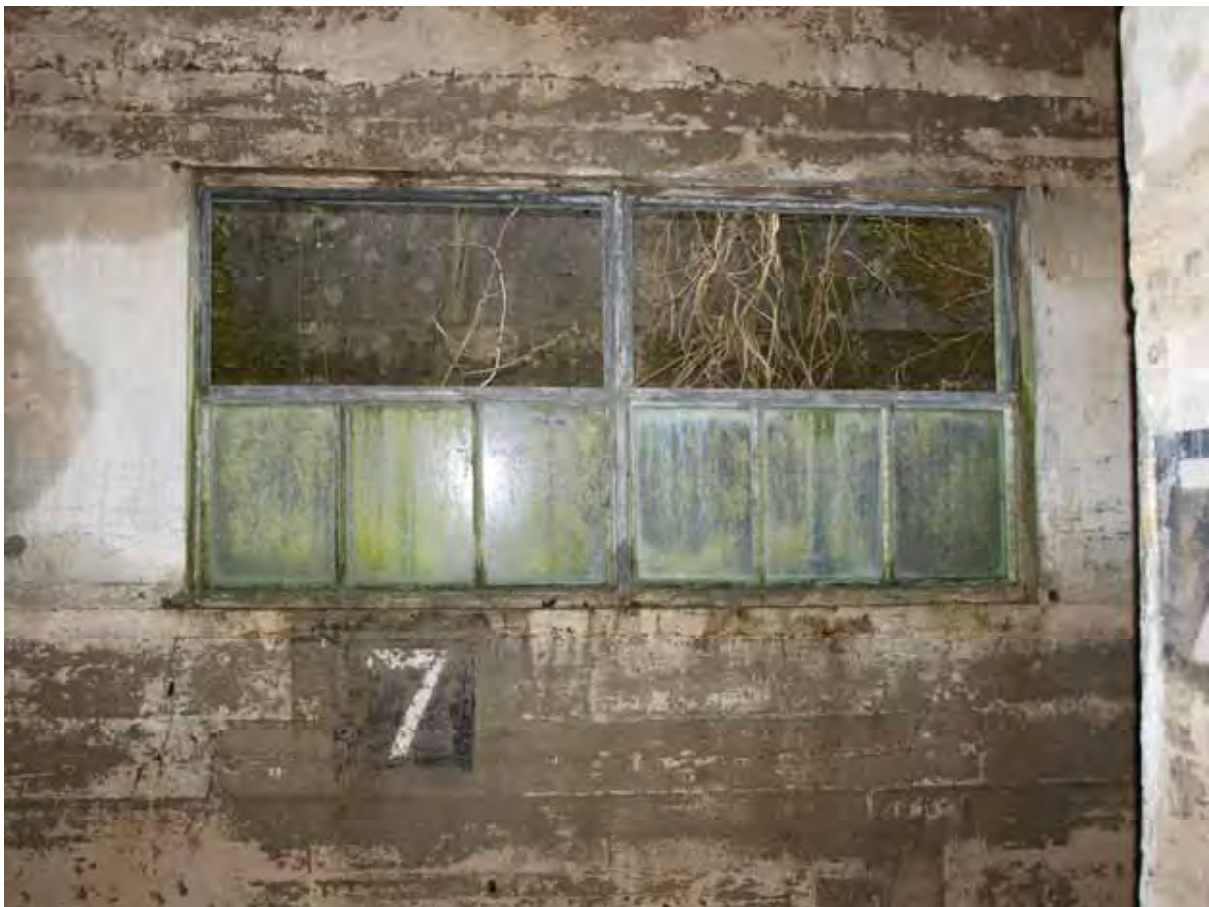
Plate 50: Store 4 – Missing window casements within the northern window in the eastern passage, facing north-east (201)
