**LAND AT COURTLANDS FARM,
PARK ROAD, BANSTEAD, SM7 3EF**

**HISTORIC BUILDINGS RECORD
(HISTORIC ENGLAND LEVEL 4)**

**Historic Buildings Record
(Historic England Level 4)**

**ASE Project No: 171102
Site Code: CFB17**

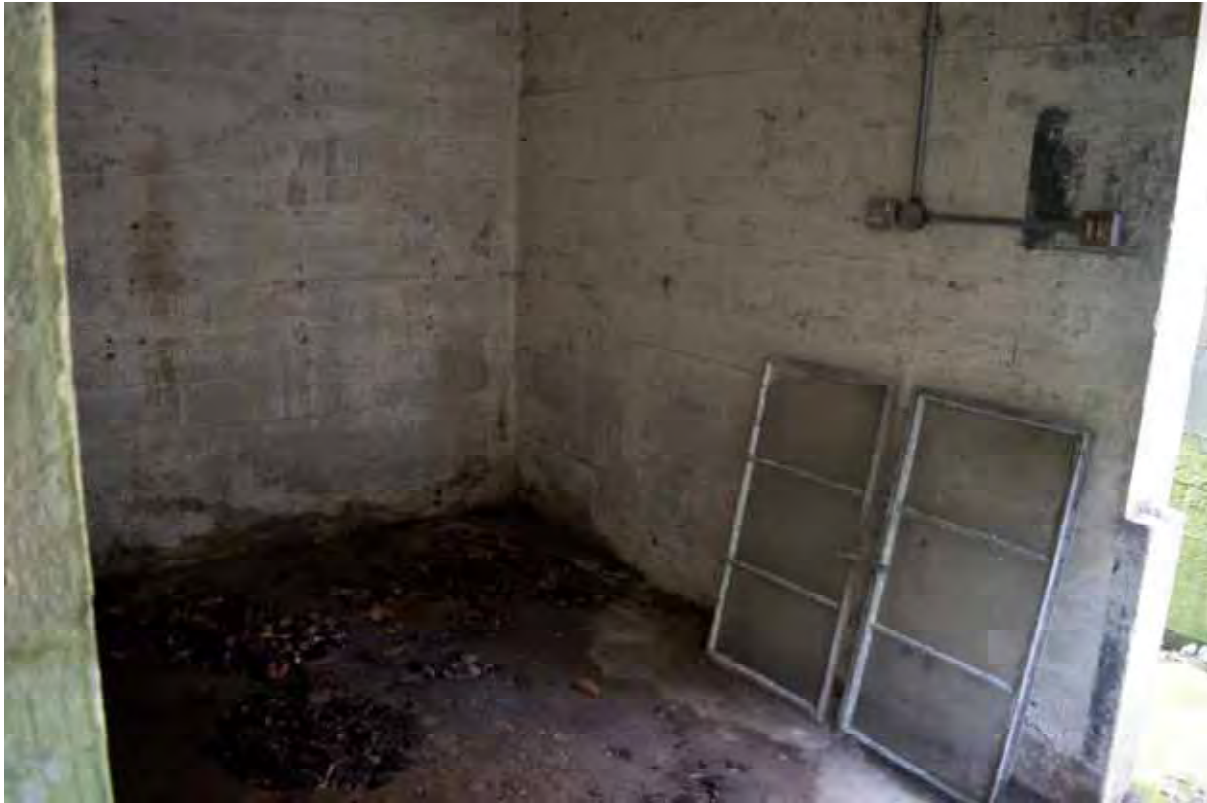
Plate 51: Store 4 – Displaced window casements within Bin 1 (eastern half), facing north-west (274)

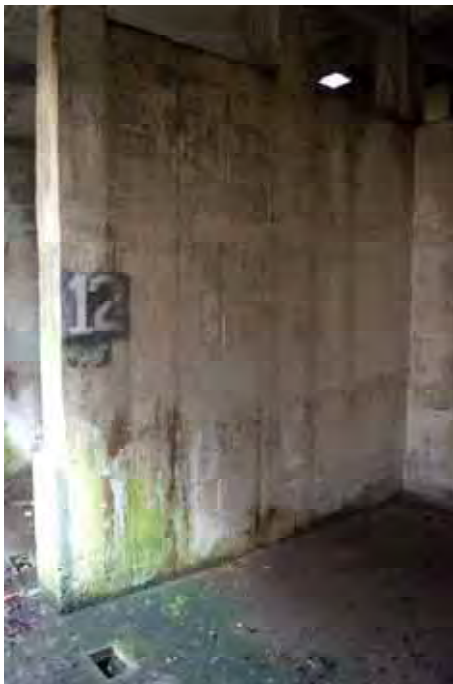
Plate 52: Store 4 – View of the internal bay signage and floor sockets (western half), facing north (247)

- 6.20 Internally, each bin contains four redundant floor sockets and each retains its numerical signage (Plate 52). Many of the bin numbers show signs of successive phases of repainting and the signage for Bin 9 (Plate 53) has been latterly covered by white paintwork, suggesting the structure was repainted in-part internally during its subsequent use. The coin-operated fuse box located within Bin 1 partially covers the signage of this storage bay, indicating that it was mounted to the wall at a later date – supporting the theory that the transition from day to night working conditions, necessitated additional electric lighting (see Section 6.9). Other notable features include the absence of the timber signage board within the northern end of the western half of the structure (as seen elsewhere). Although no fabric remains of the board itself, its former location can be marked by a series of metal brackets in this location.

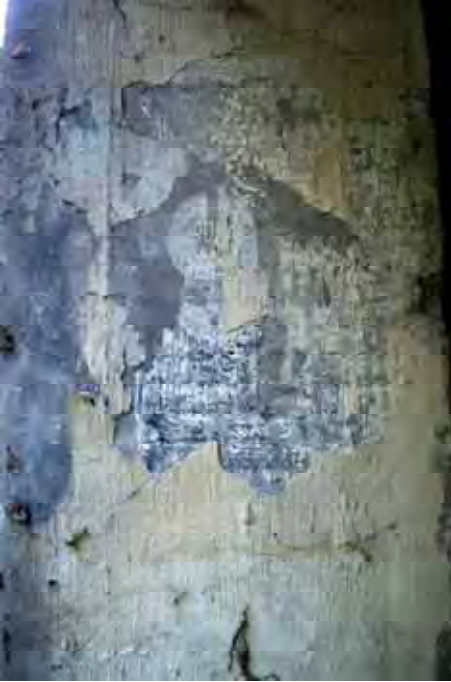
Plate 53: Store 4 – Bay signage detail, note the phasing (eastern half), facing north-west (280)

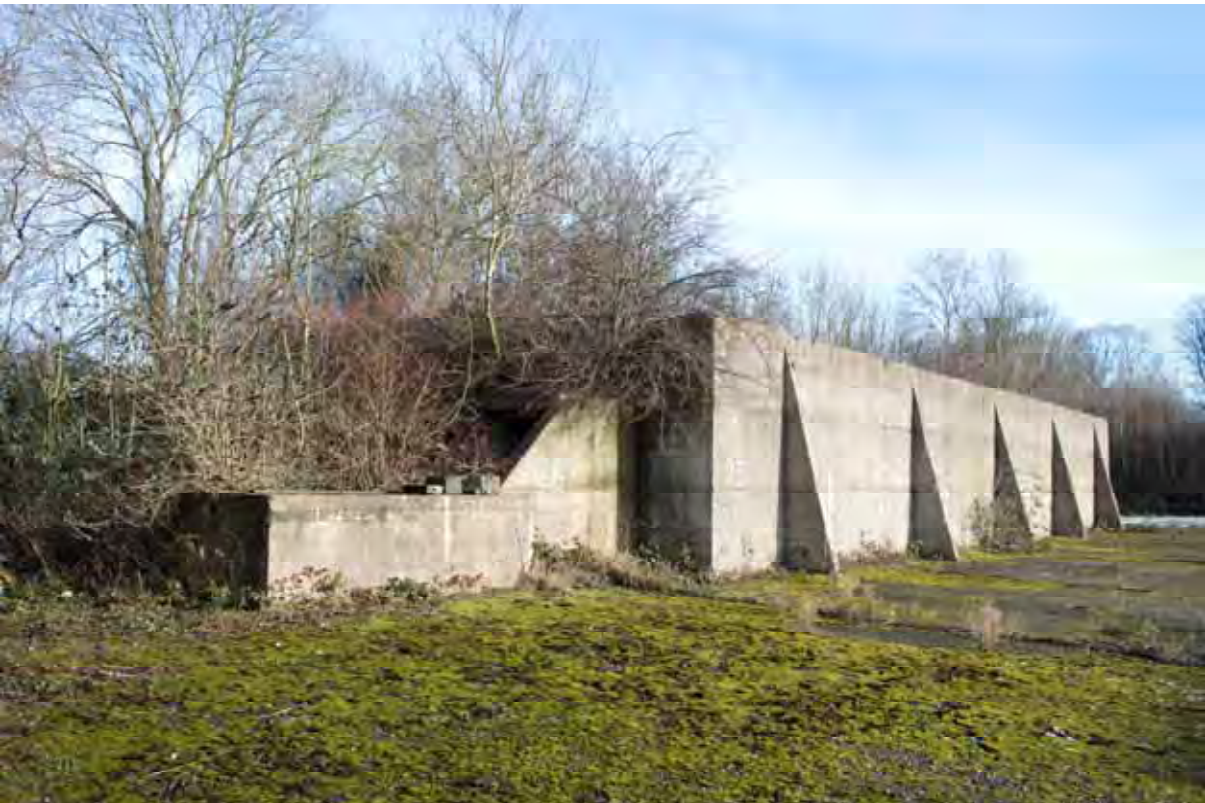
Plate 54: Store 5 – View of the north-west and south-west elevations of the outer blast wall, note the retained earth barrier along the north-west elevation, facing south-east (290)

- 6.21 The north-east and north-west sides of Store 5 remain encased within their earth blast barriers, while those to the south-west and south-east have been removed (Plates 54 and 55); the bund separating Stores 4 and 5 remains in place (Plate 56).

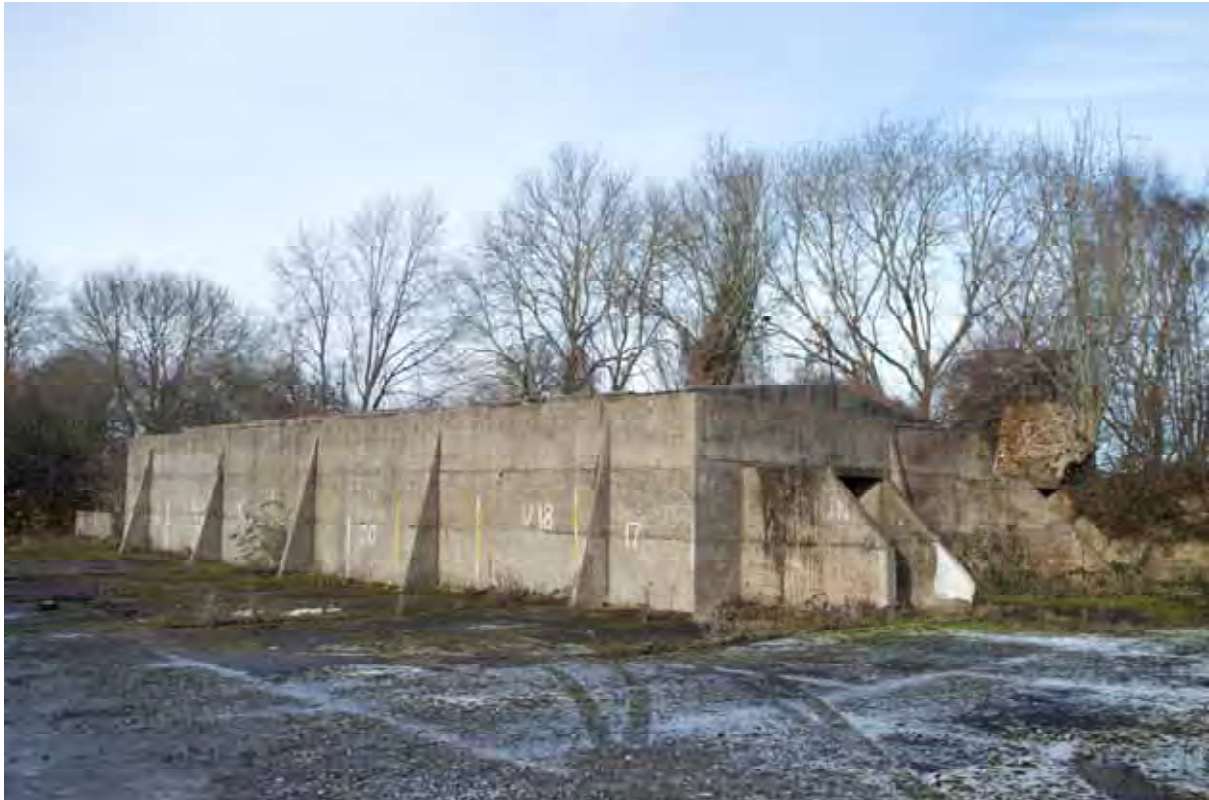
Plate 55: Store 5 – View of the south-west and south-east elevations of the outer blast wall, facing north (294)

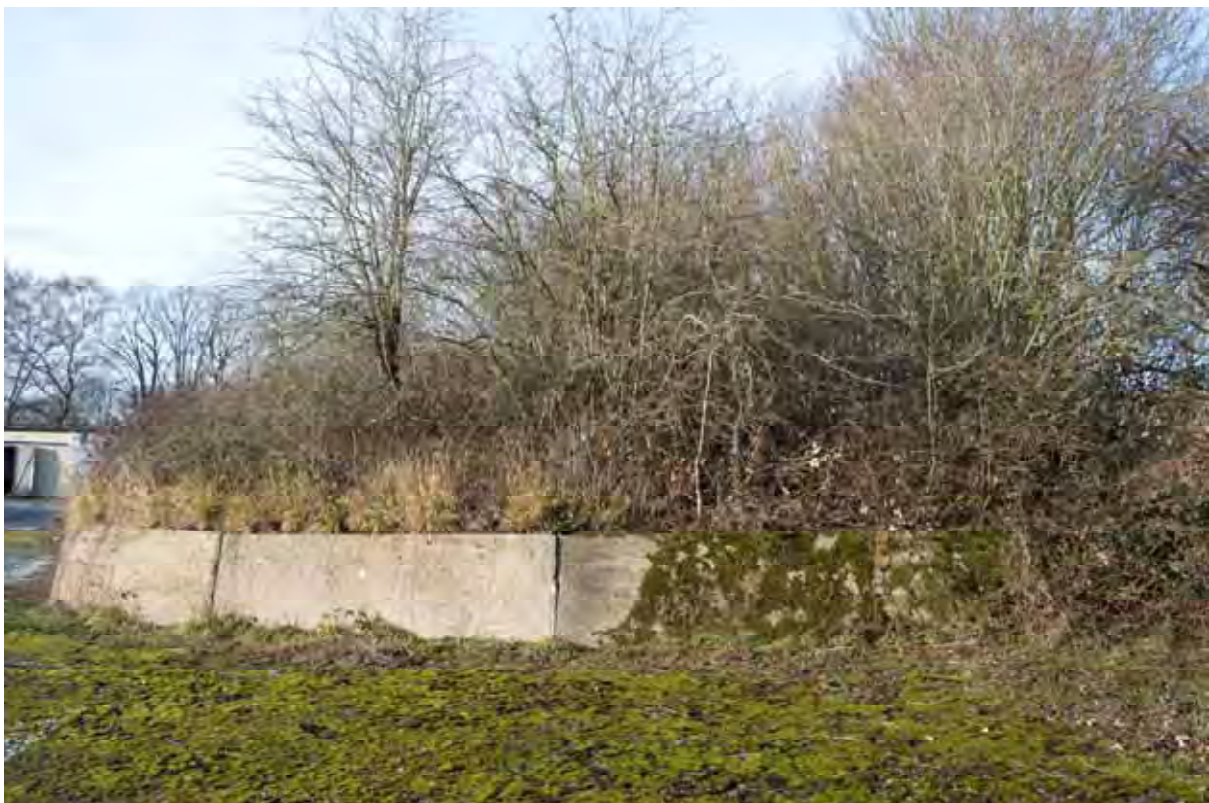
Plate 56: Bund separating Stores 4 and 5, facing north-west (289)

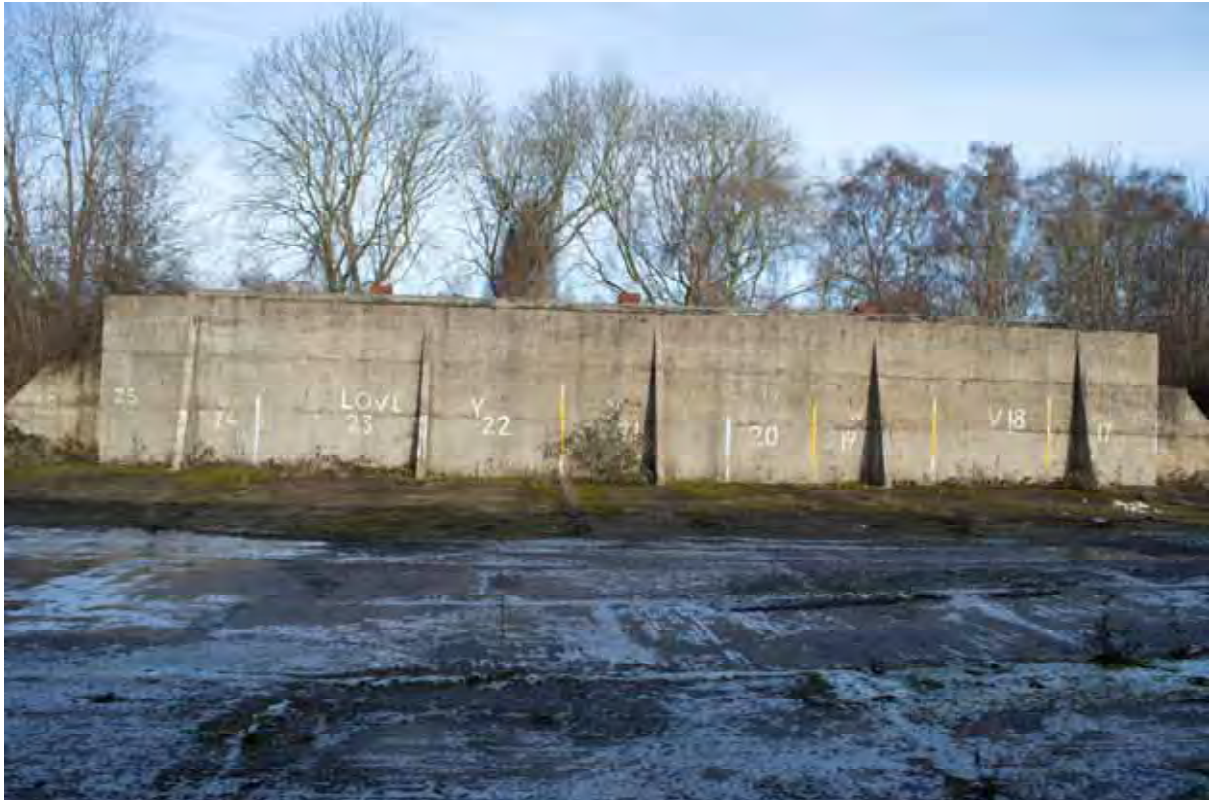
Plate 57: Store 5 – View of the south-west elevation, facing north-east (293)

The three roof vents are covered with sloped steel hoods (Plate 57), presumably to limit internal moisture levels. The structure retains all of its loading platforms except that to the south-west, and the lamp fitting serving the north-east loading platform also endures (Plate 58). The conveyor system bases have all been lost, with the exception of a single example, situated in the north-west doorway (Plate 59), which is complete with metal brackets. None of the entrances retain any signage, although the north-west door is labelled with a painted 'R' (Plate 60) and the south-east door with an 'H' (Plate 61). Both letters appear to have been painted free-hand rather than stencilled like all other original lettering found elsewhere and presumably therefore relate to one of the post-war uses of the structure. In line with the generic description, this store's blocked openings to the north-east and south-west, are set c.2m above the internal floor level (Plate 62) and are not accompanied by a cill (Plate 63).

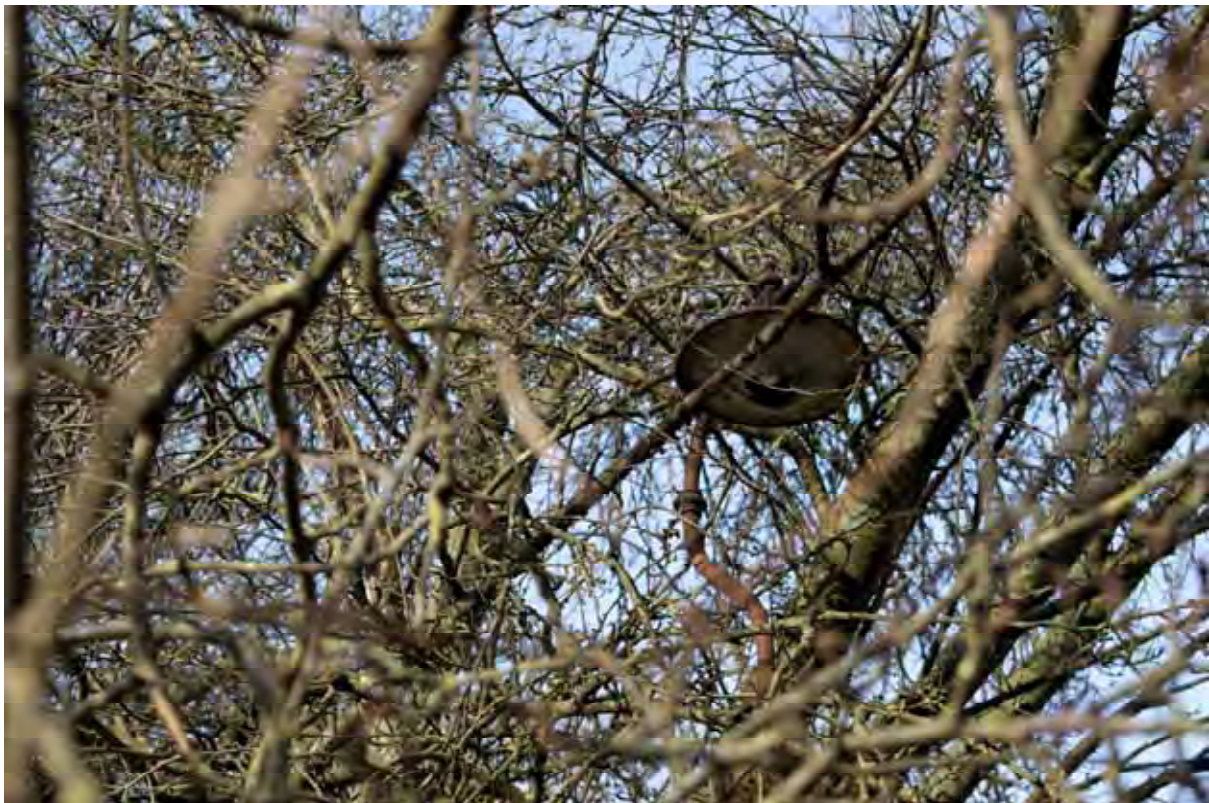
Plate 58: Store 5 – Light fixture retained on the eastern loading platform serving the northern bay, facing north-east (291)

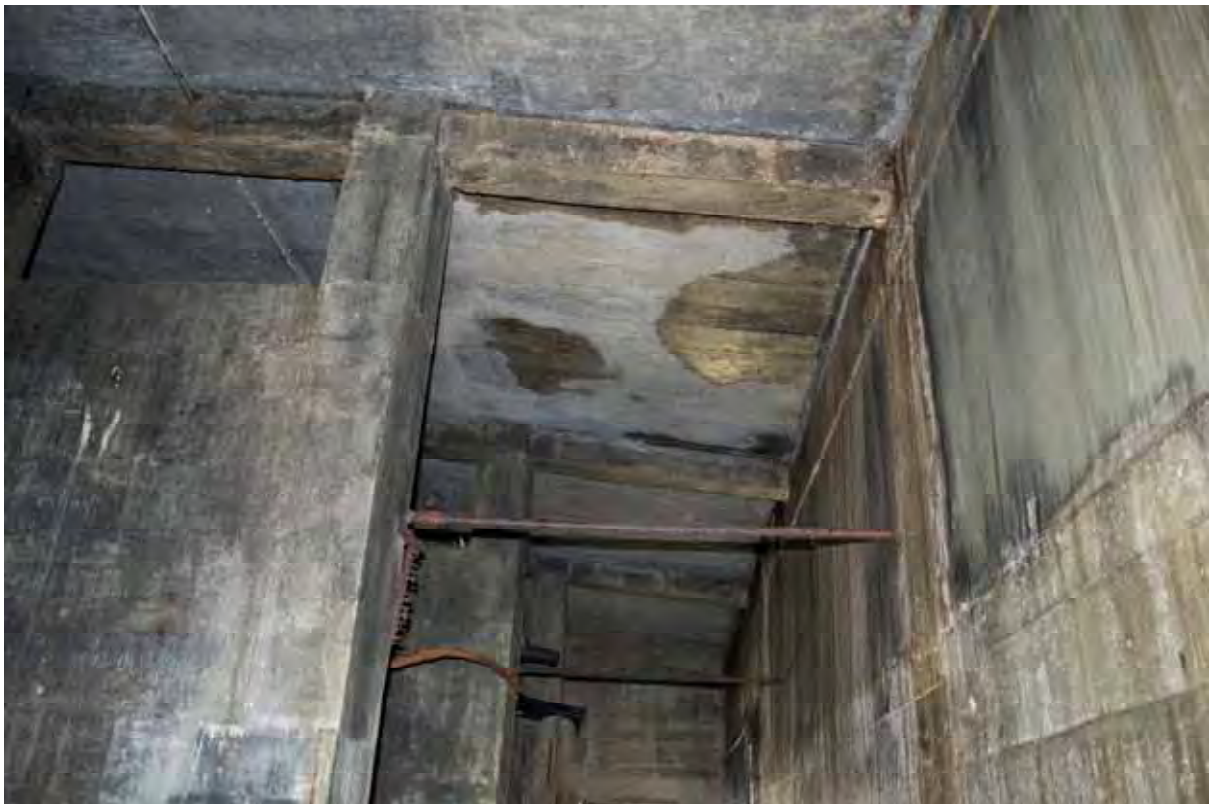
Plate 62: Store 5 – View of the internal western passage, note the high-set openings within the south-west elevation, facing south-east (317)

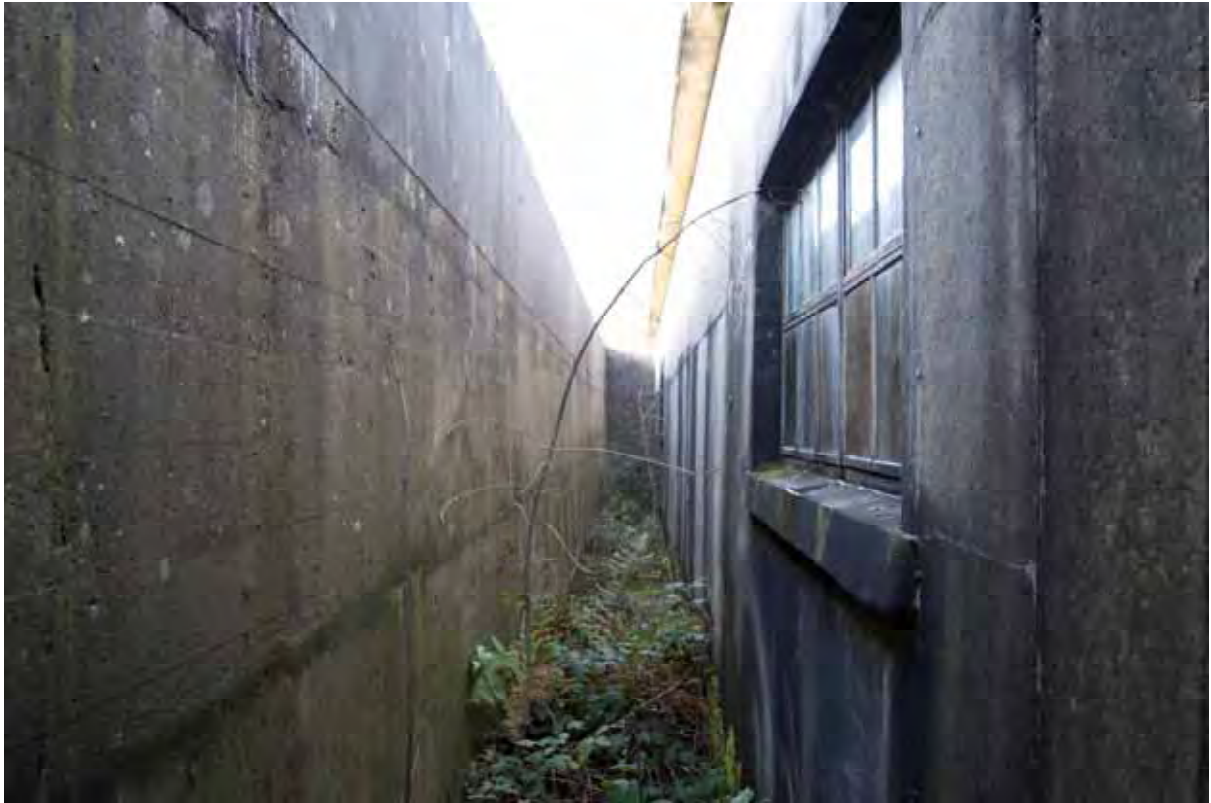
Plate 63: Store 5 – View of the western walkway, note the absence of a cill and high-set openings, facing north-west (297)

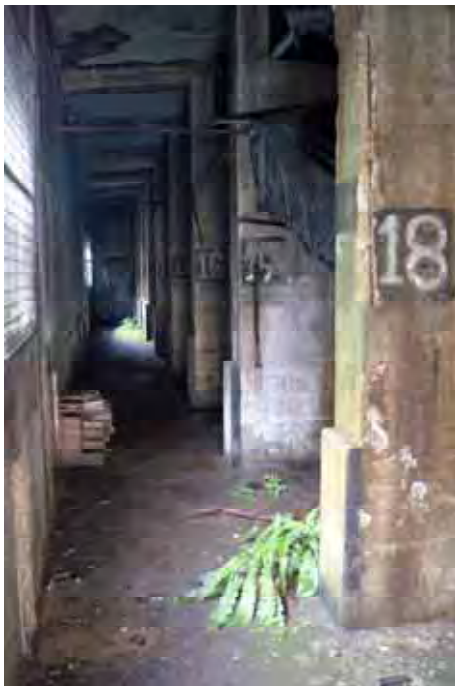
Plate 64: Store 5 – View of the western passage, facing north-west (301)

- 6.22 Internally (Plates 64 and 65), both halves have been subject to limited later alterations, principally comprising the addition of later timber stud framework to the roofs of a number of the bays. Examples of this modern framing are best observed in Bins 16 and 10 (western half; Plate 66). Two curved track brackets (Plate 67) frame Bin 16, their nature is unknown, however their singularity, suggests they form part of the later modifications. The bay is additionally flanked by steel rods, which pass between the containment walls and passage wall, again these appear to be later features. A number of bays within the western half of the structure have had their electric lighting replaced with later hanging bulbs and modern strip lighting. The containment walls of Bin 4 are soot-stained from a former wall-mounted timber frame (Plate 68) which has been destroyed by fire. Each bin contains four redundant floor sockets as described above. The end face of each bay containment wall is marked with a numerical stencil (Plate 69), which is smaller than those marking the inside of each, and are presumably of earlier origin, due to the fact that many are on paint layers beneath the larger signage. At odds to the white paintwork found elsewhere, the southern end of the eastern half of the structure has a turquoise painted finish (Plate 70). Situated within the northern end of the western passage are the fragmentary remains of a timber notice board (Plate 71), the brackets of which remain *in situ* within the wall (Plate 72).

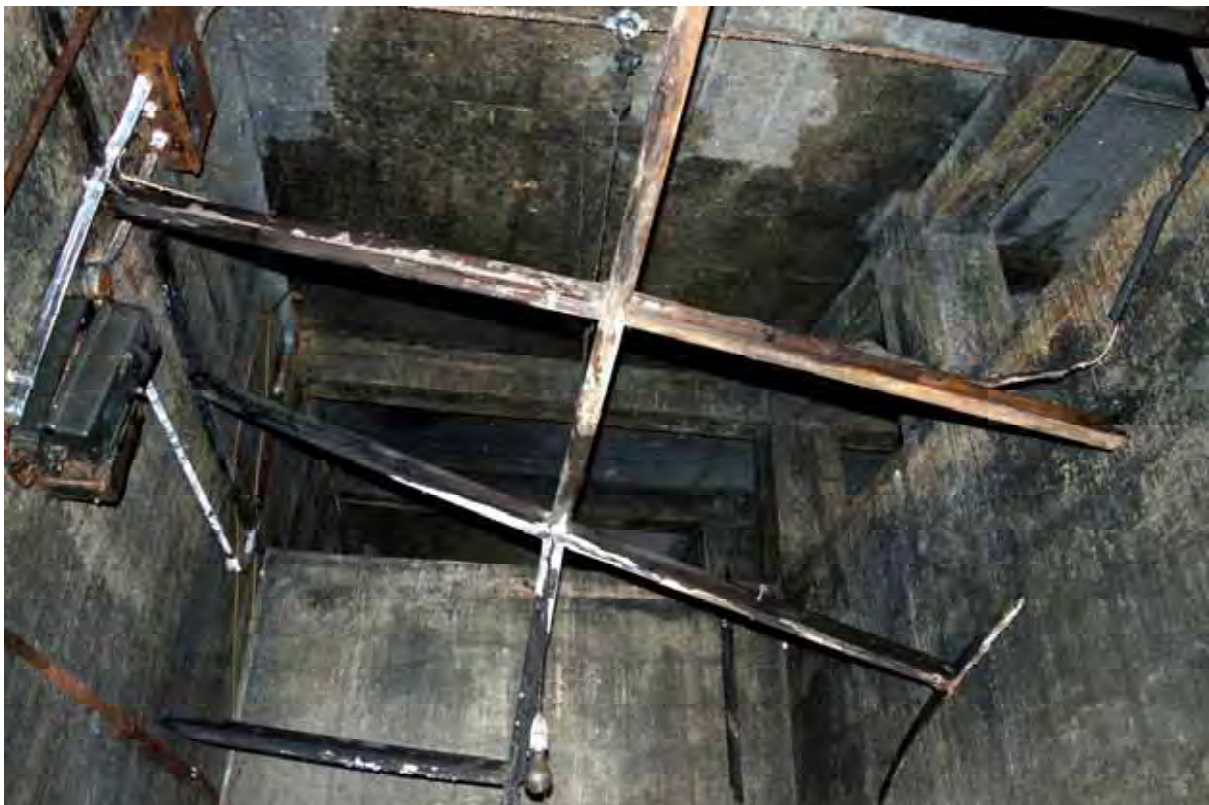
Plate 66: Store 5 – Detail of the inserted stud framework used to create lower ceilings in a number of the bays (Bin 10), facing north-east (308)

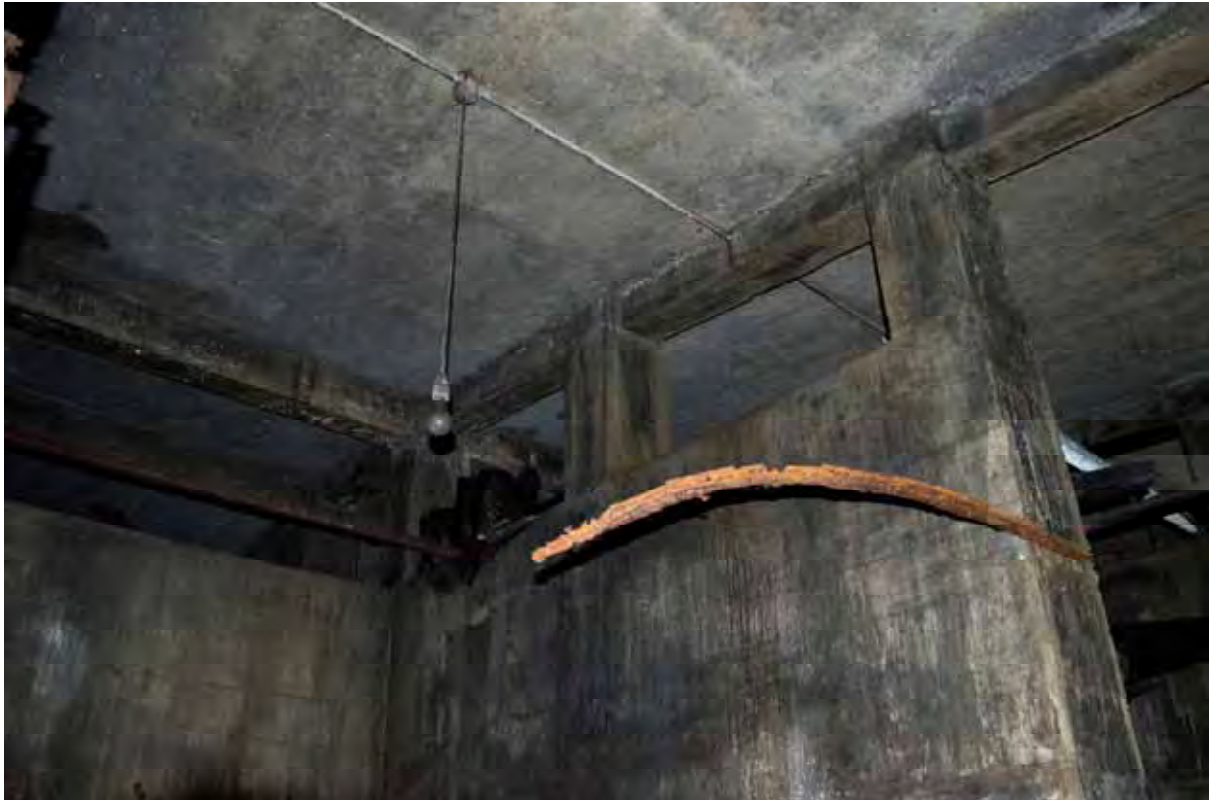
Plate 67: Store 5 – Detail of the metal brackets framing the containment wall of Bin 6, facing east (305)

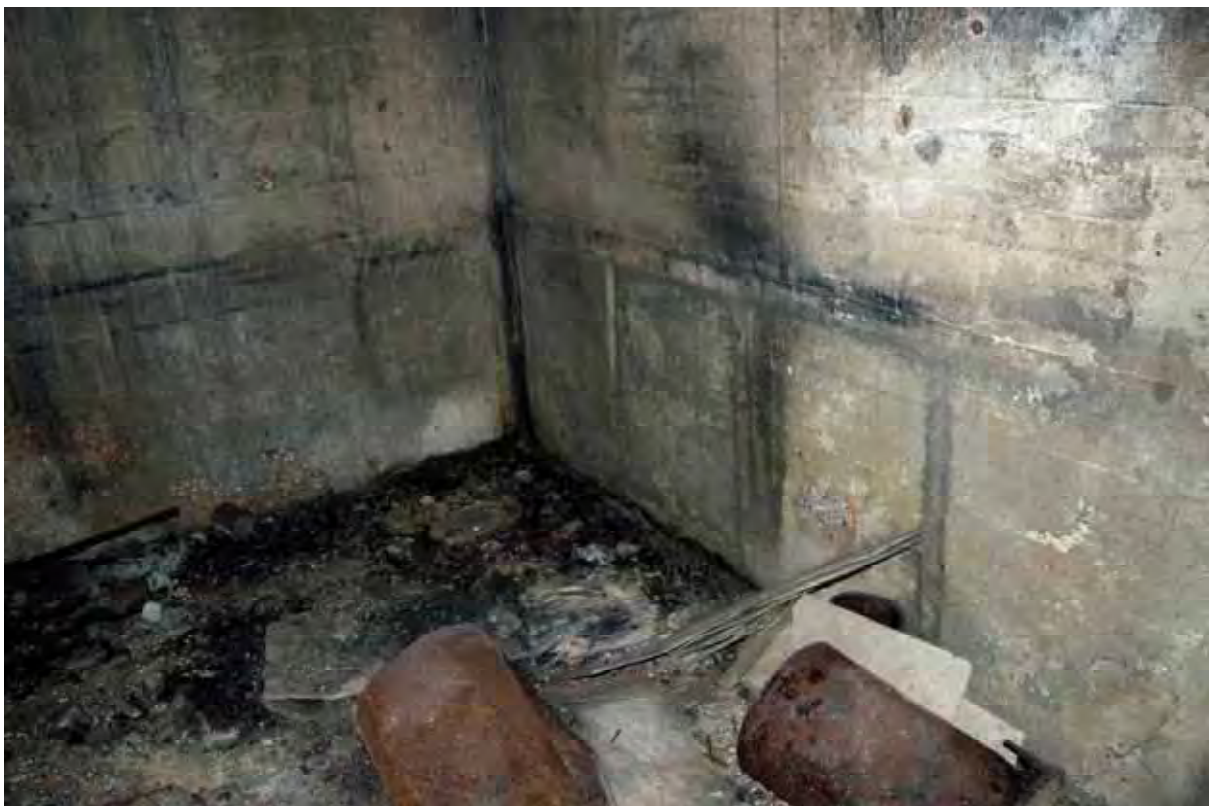
Plate 68: Store 5 – Soot staining left on the walls of Bin 4, facing west (322)

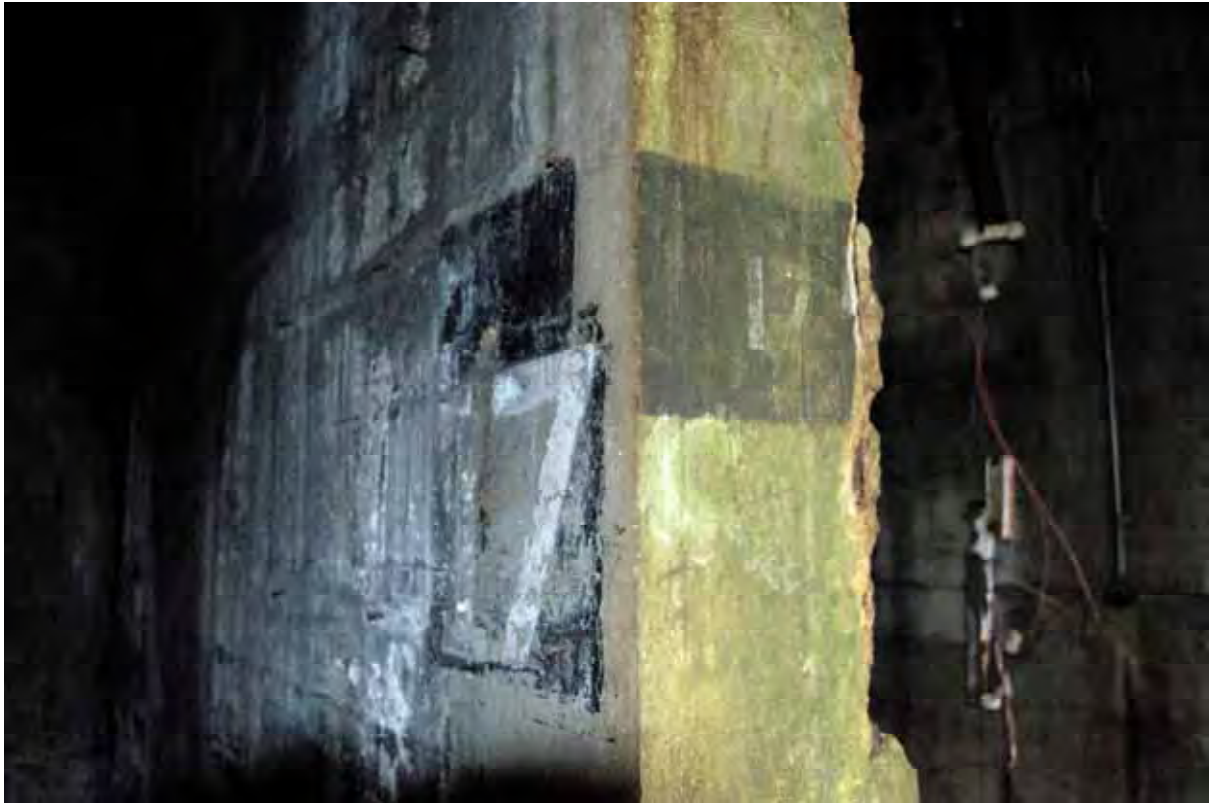
Plate 69: Store 5 –Detail of the phased bay signage visible throughout the structure (Bin 17), facing east (303)

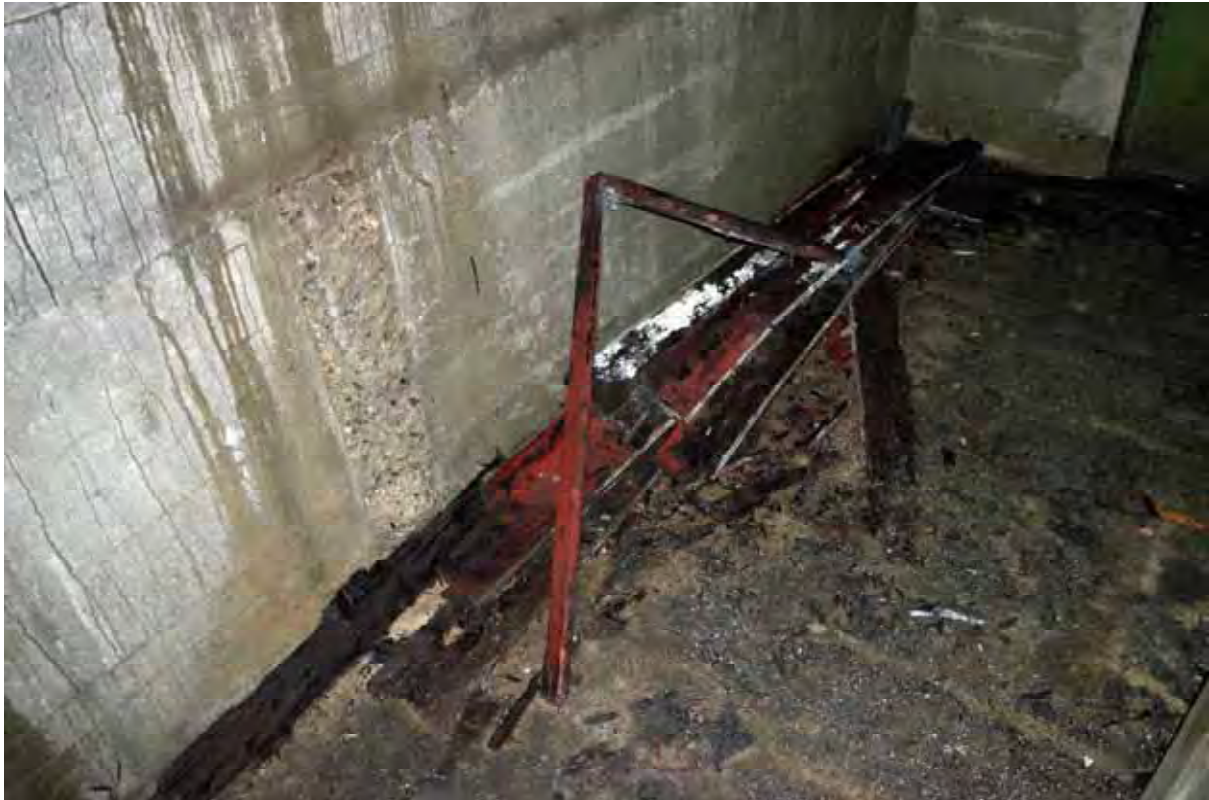
Plate 71: Store 5 – Detail of the degraded timber notice board within the northern end of the western passage, facing west (306)

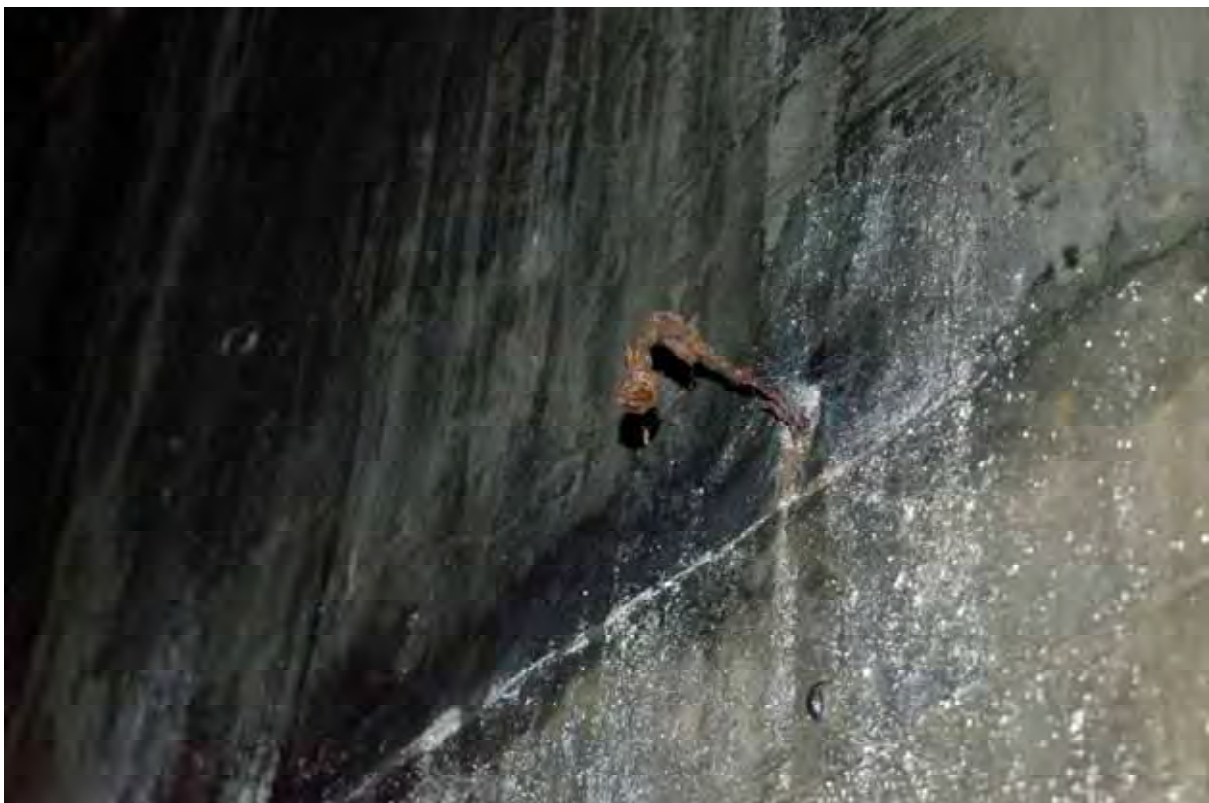
Plate 72: Store 5 – Detail of the brackets formerly securing the timber notice board within the northern end of the western passage, facing south-west (313)

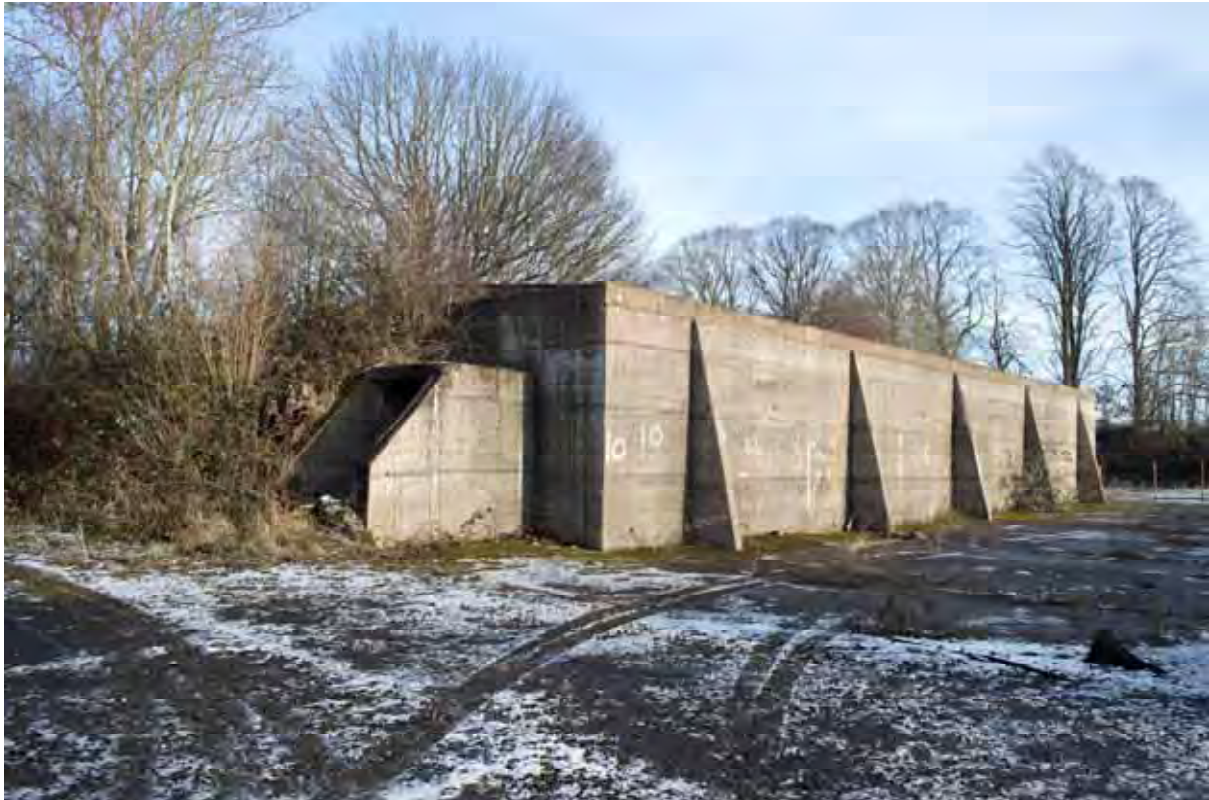
Plate 73: Store 6 – General view of the north-west and south-west elevations, facing east (328)

- 6.23 Store 6 (Plate 73) retains its earth blast barriers along its north-east and north-west elevations only (Plate 74). The loading platforms formerly serving the north-western end of the store have been removed (Plates 75 and 76), as with the majority of the conveyor system bases (Plate 77). The remaining south-eastern loading platform (Plate 78) retains its post for the former lighting. The bases that do remain number five in total and are situated within the north-western loading bays. Both bases, complete with metal fixings, remain within the north-western doors (Plate 79) and covered entrances, providing a good example of how each entrance was originally constructed.

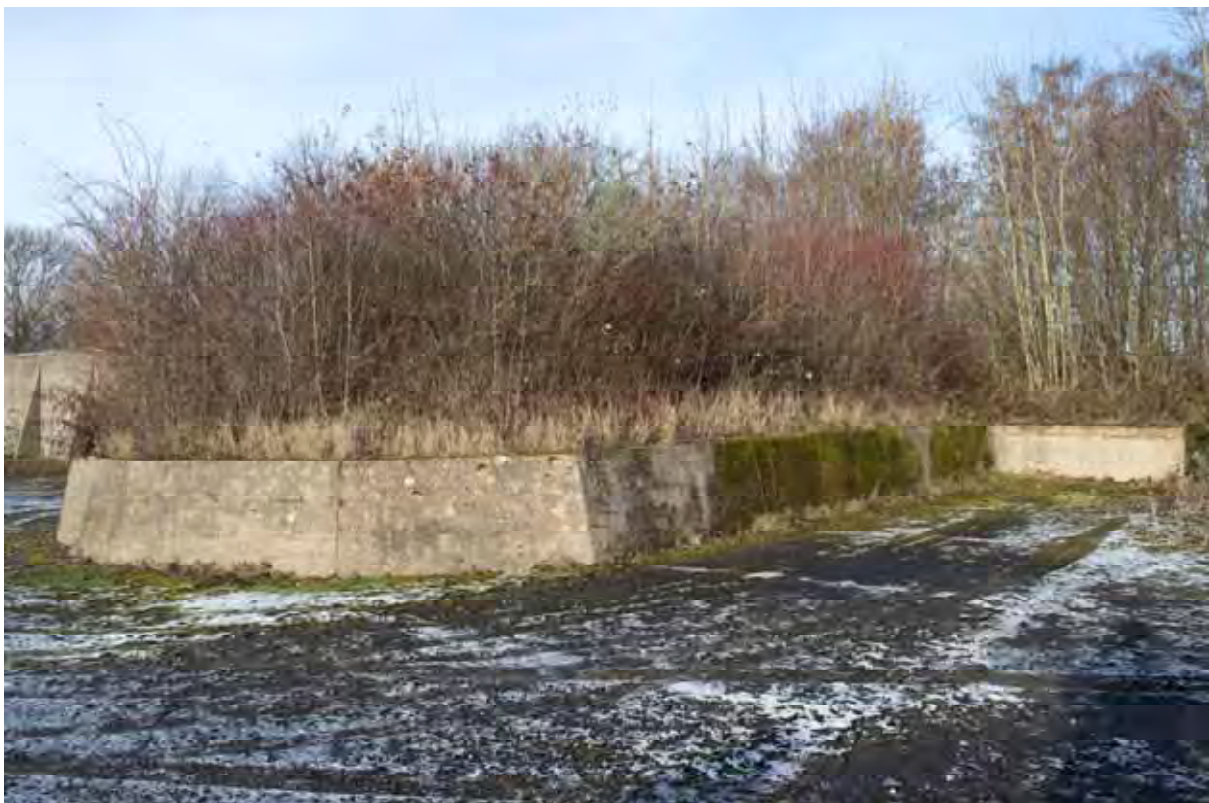
Plate 74: Store 6 – View of the bund separating Stores 5 and 6, facing north-east (325)

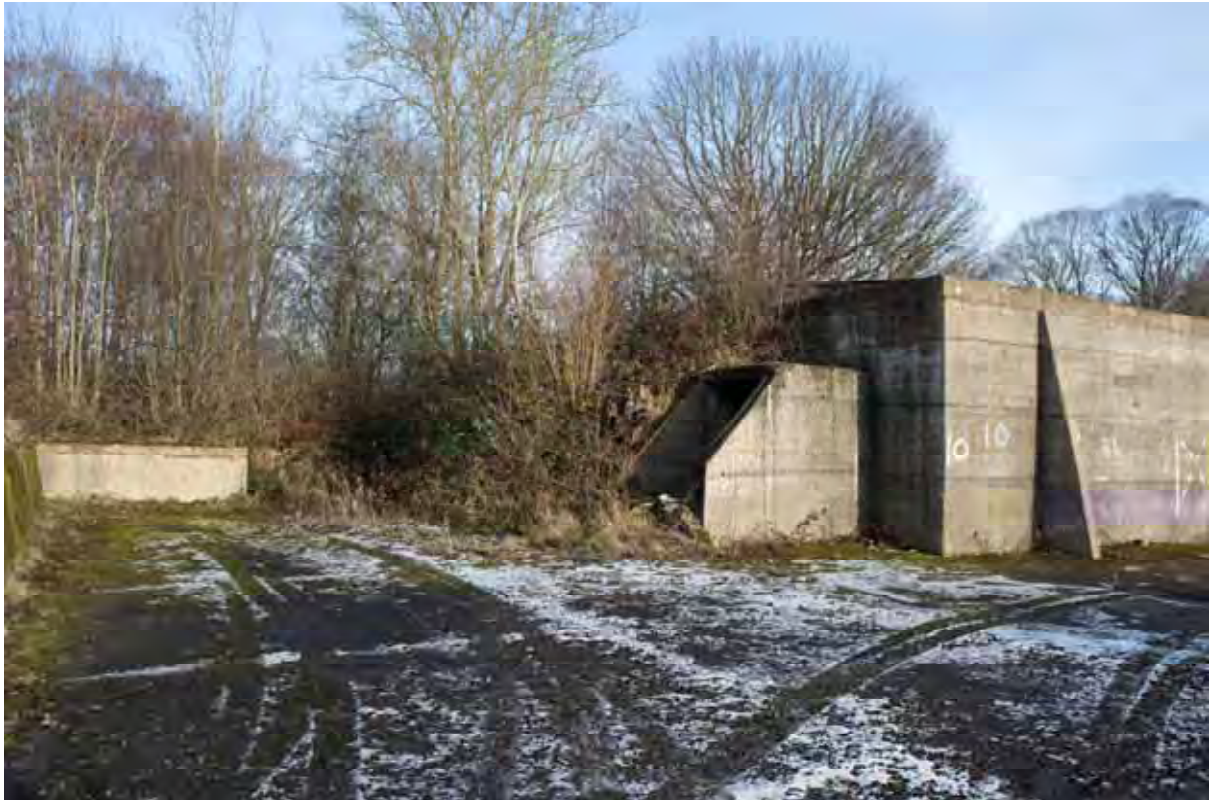
Plate 75: Store 6 – View of the northern loading bay, facing north-east (327)

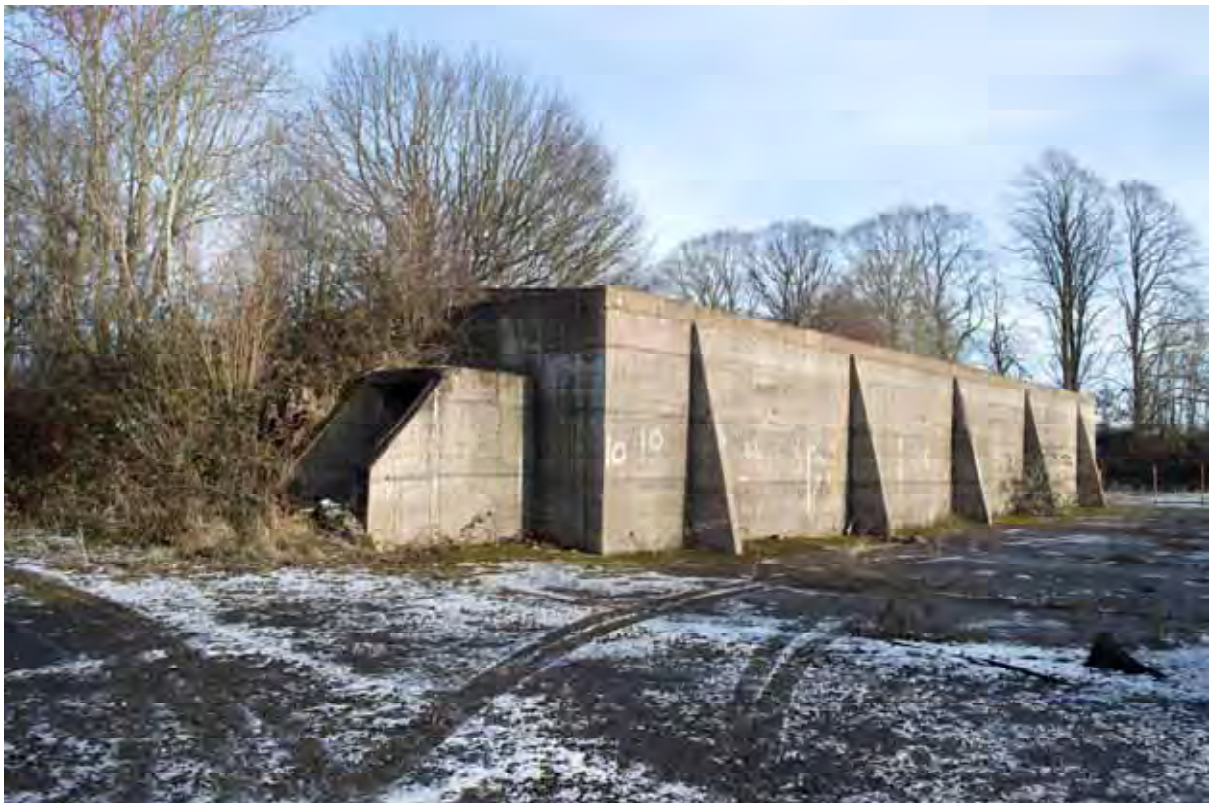
Plate 76: Store 6 – Detail of the removed loading platform to the western side of the northern bay, facing east (328)

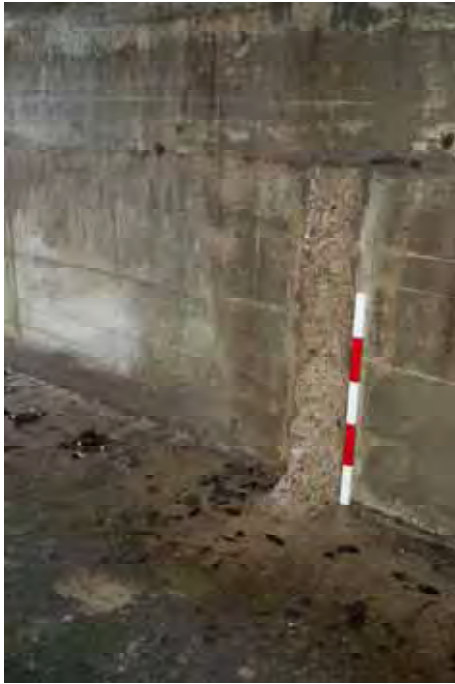
Plate 77: Store 6 – Detail of the retained footings of a former conveyor base situated in the western passage, facing south (346)

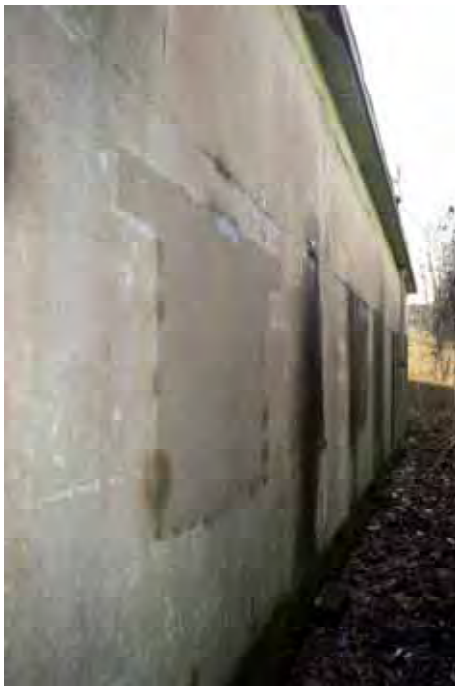
Plate 80: Store 6 – Detail of the blocked windows visible within the north-east elevation, facing north-west (359)

- 6.24 None of the covered entrances retain any stencilled signage, although the doors providing access to the western half of the structure are marked with 'A' (north-west) and 'K' (south-east), in the same manner as Store 4. Two blocked windows are clearly visible within the north-east elevation of the inner wall (Plates 80 and 81). Both measure 0.97m (length) by 0.86m (height) and previously had lintels measuring 0.24m in height. These represent later 20th century additions. The downpipes along the same elevation are additionally served by channelled concrete blocks at ground level, presumably used to direct rainwater away from the

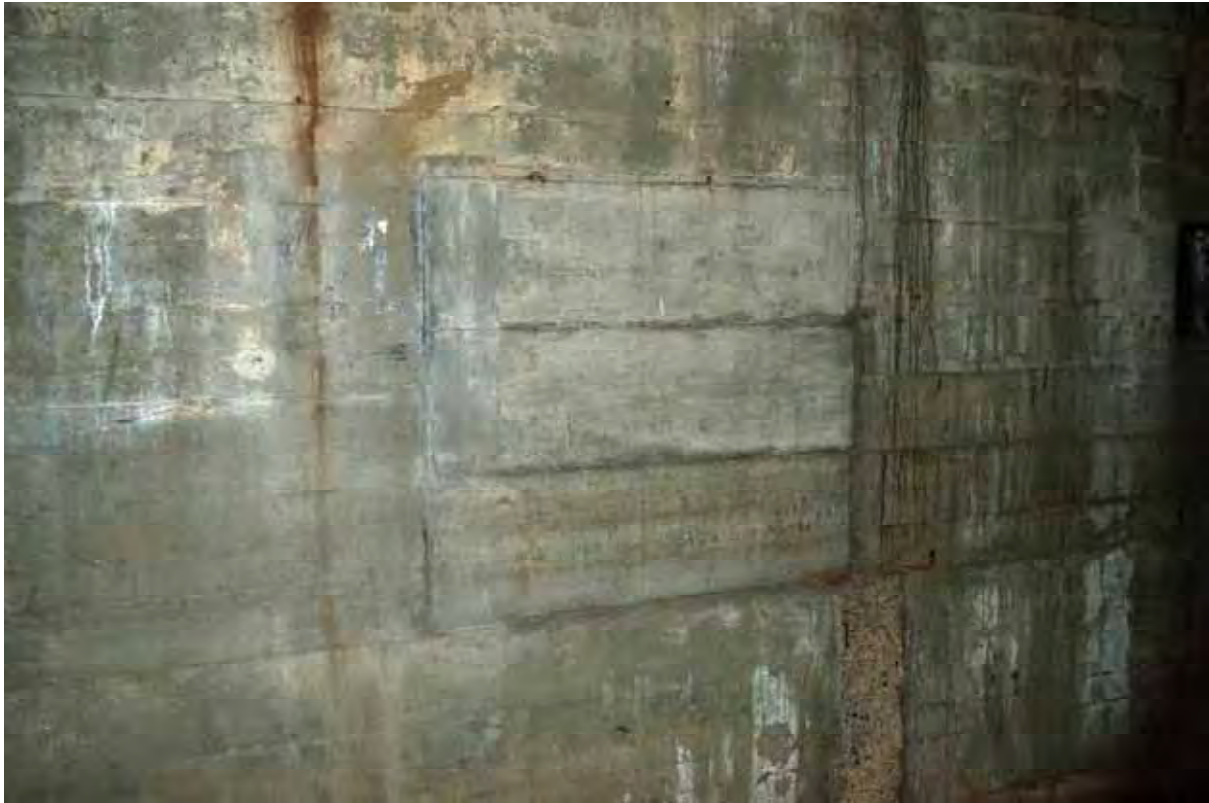
Plate 81: Store 6 – Evidence of the blocked window opening within the store's north-east wall, facing east (357)
