**LAND AT COURTLANDS FARM,
PARK ROAD, BANSTEAD, SM7 3EF**

**HISTORIC BUILDINGS RECORD
(HISTORIC ENGLAND LEVEL 4)**

**Historic Buildings Record
(Historic England Level 4)**

**ASE Project No: 171102
Site Code: CFB17**

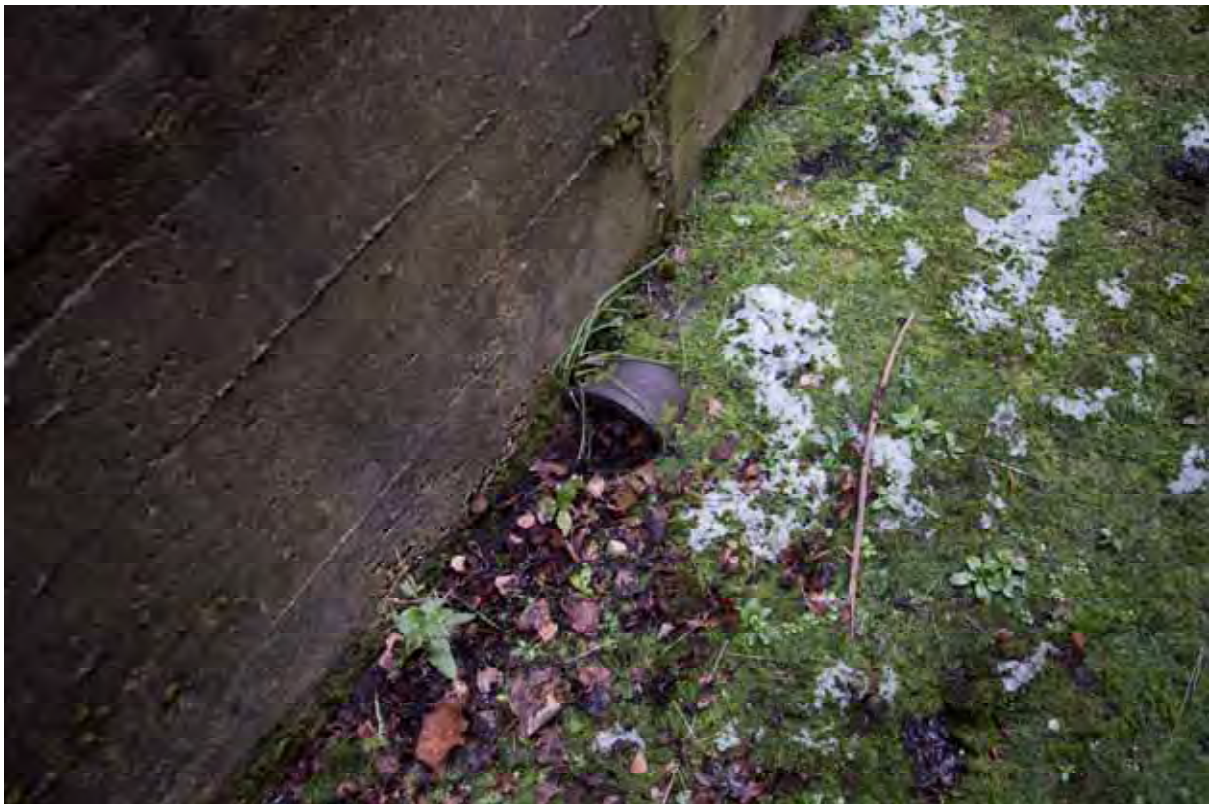
foundations on this side. The drainage gullies situated around the inner walkway perimeter (as above) are served by cast iron drainage pipes (Plate 82), which are visible to the south-eastern end due to degraded hardstanding.

Plate 82: Store 6 – Detail of the drainage channels built into the inner walkway (south-east elevation), facing south (347)

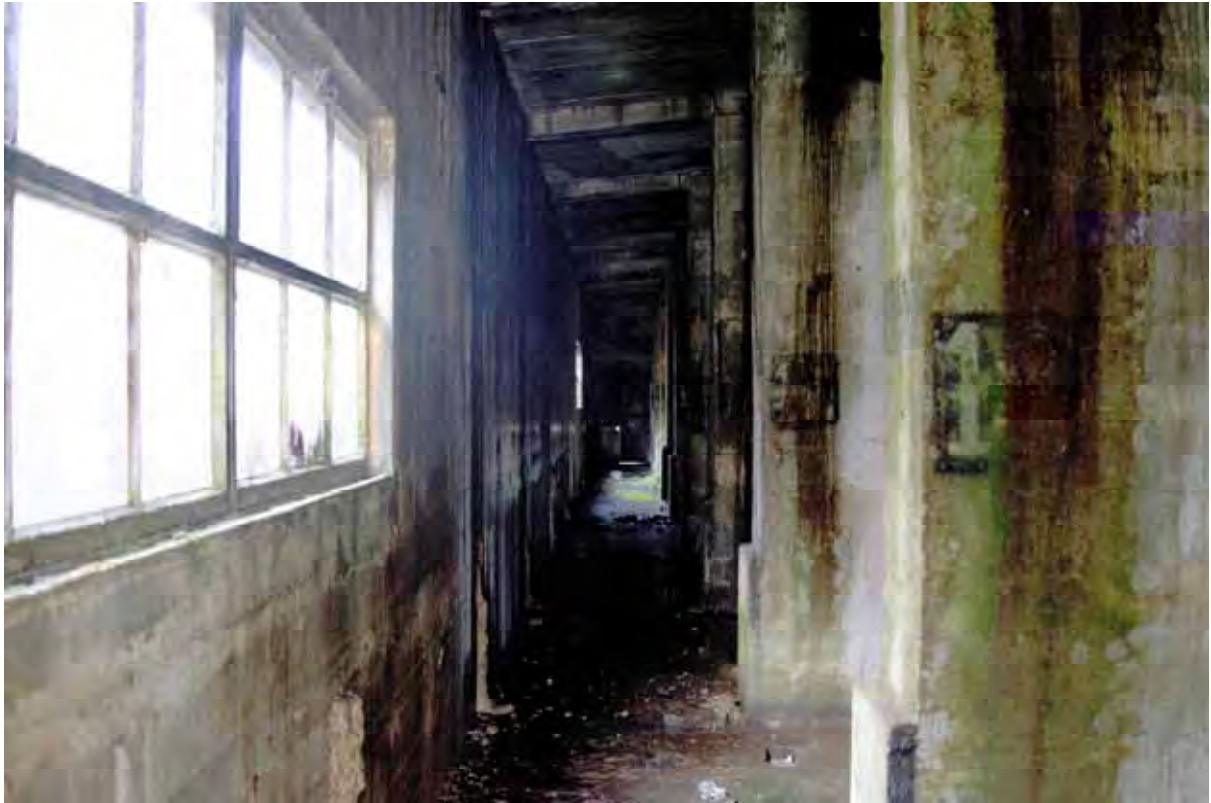
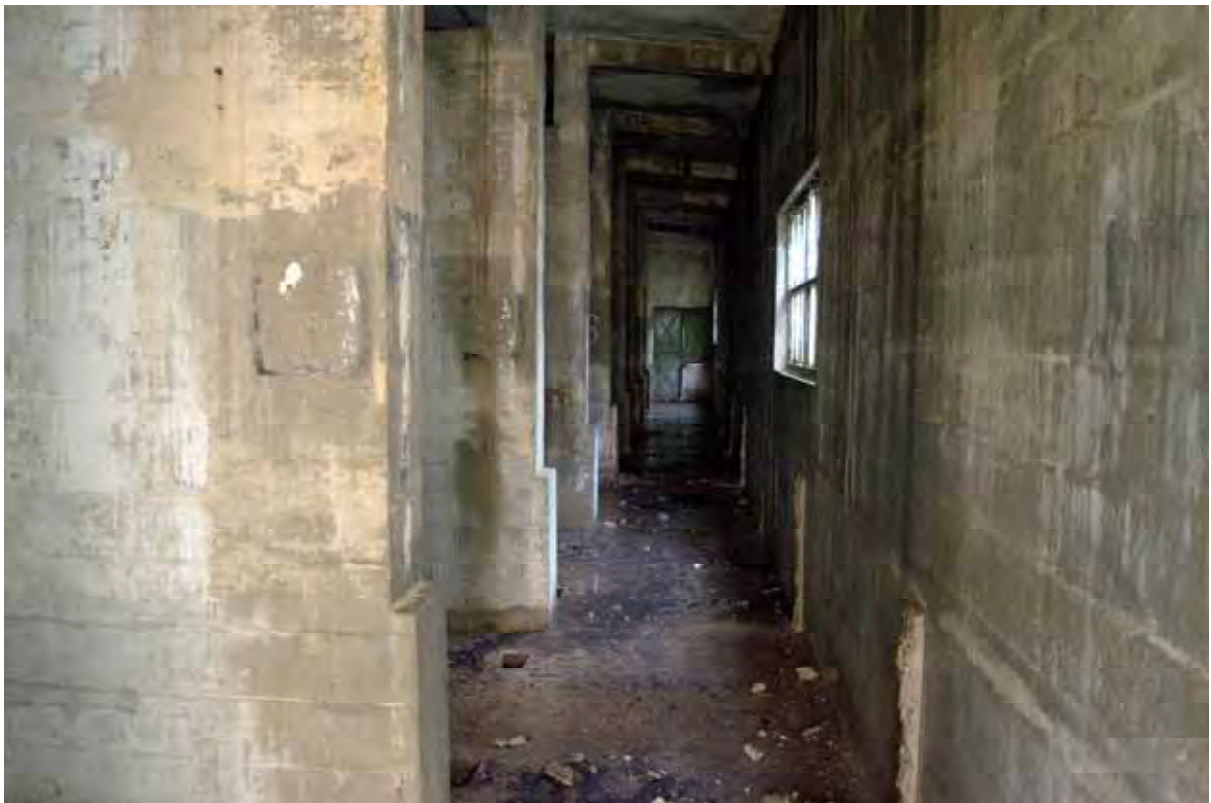
- 6.25 Internally (Plates 83 and 84), the structure differs little from the generic description, with only minor later alterations, including the loss of the conveyor bases and the original lighting in each bay. Each bay (Plate 85) contains four redundant floor sockets and retains a mixture of both large (Plate 86) and small (Plate 87) numerical stencil signage. The most notable feature within this store is the retention of its red timber notice board within the north-western end of its western half (adjacent to Bin 10). The board has remained mounted to the wall and is marked 'FIRE ORDERS' (Plates 88 and 89), although fragmentary paper signage appears to have been mounted to the board historically; no words were discernible.

Plate 83: Store 6 – View of the western passage, facing north-west (338)

Plate 84: Store 6 – View of the eastern passage, facing north-west (349)

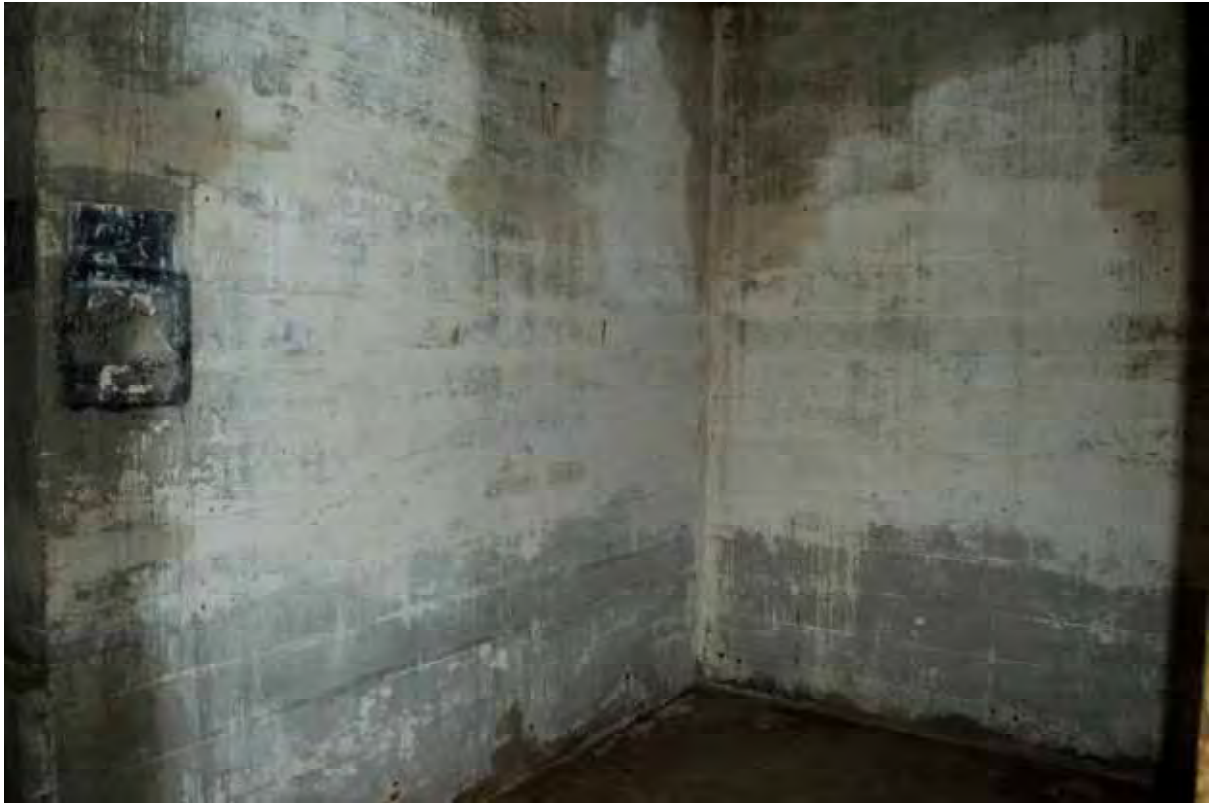
Plate 85: Store 6 – View of Bin 3, facing south (353)

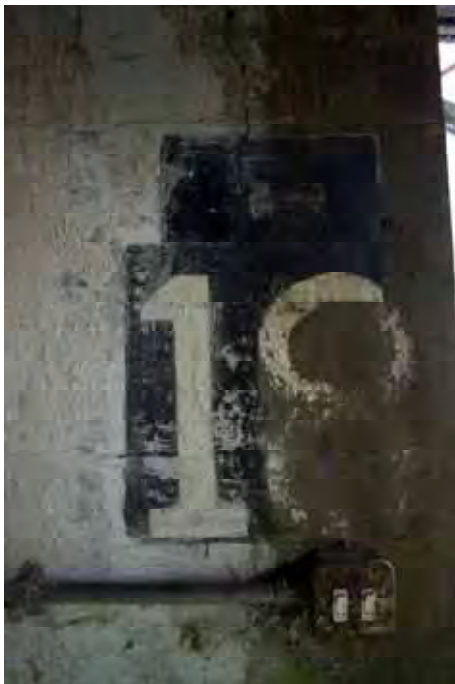
Plate 86: Store 6 – Detail of the phased bay signage visible throughout the store (Bin 18), facing south-east (339)

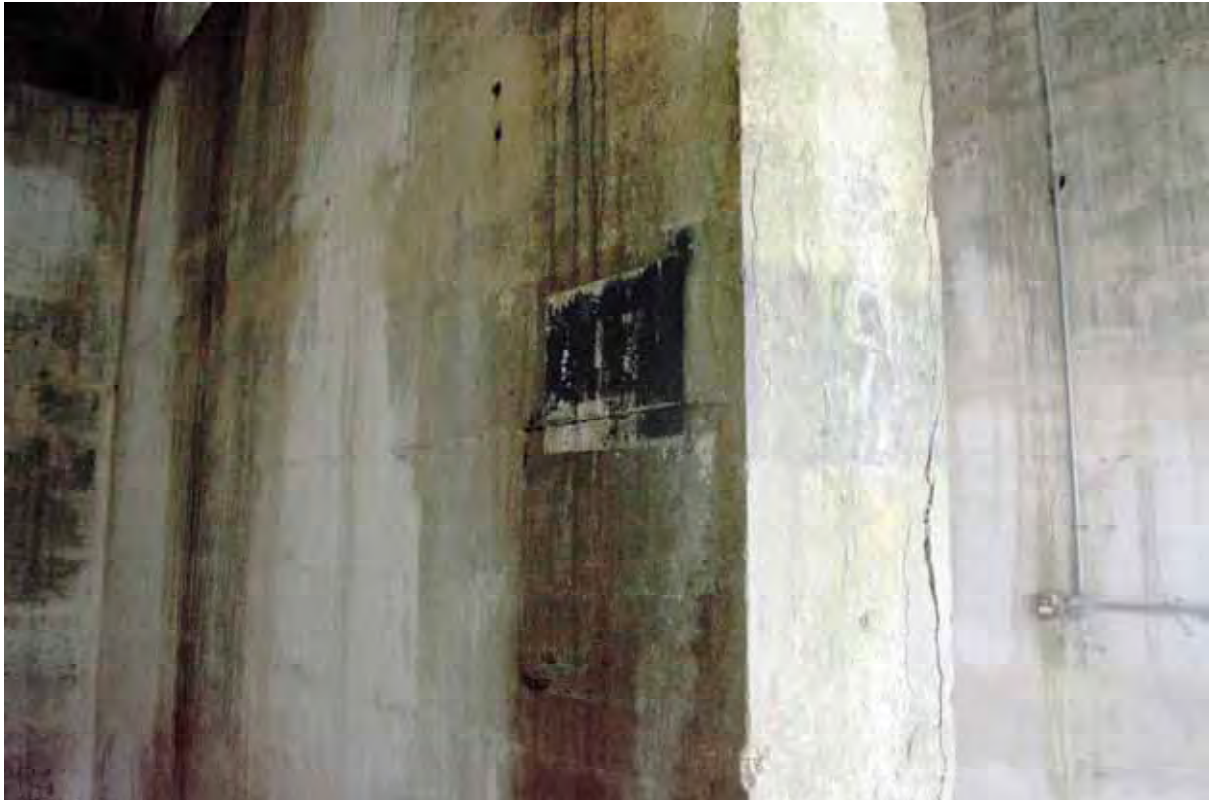
Plate 87: Store 6 – Detail of the signage visible on a number of the containment bay walls (Bin 9), facing north-west (340)

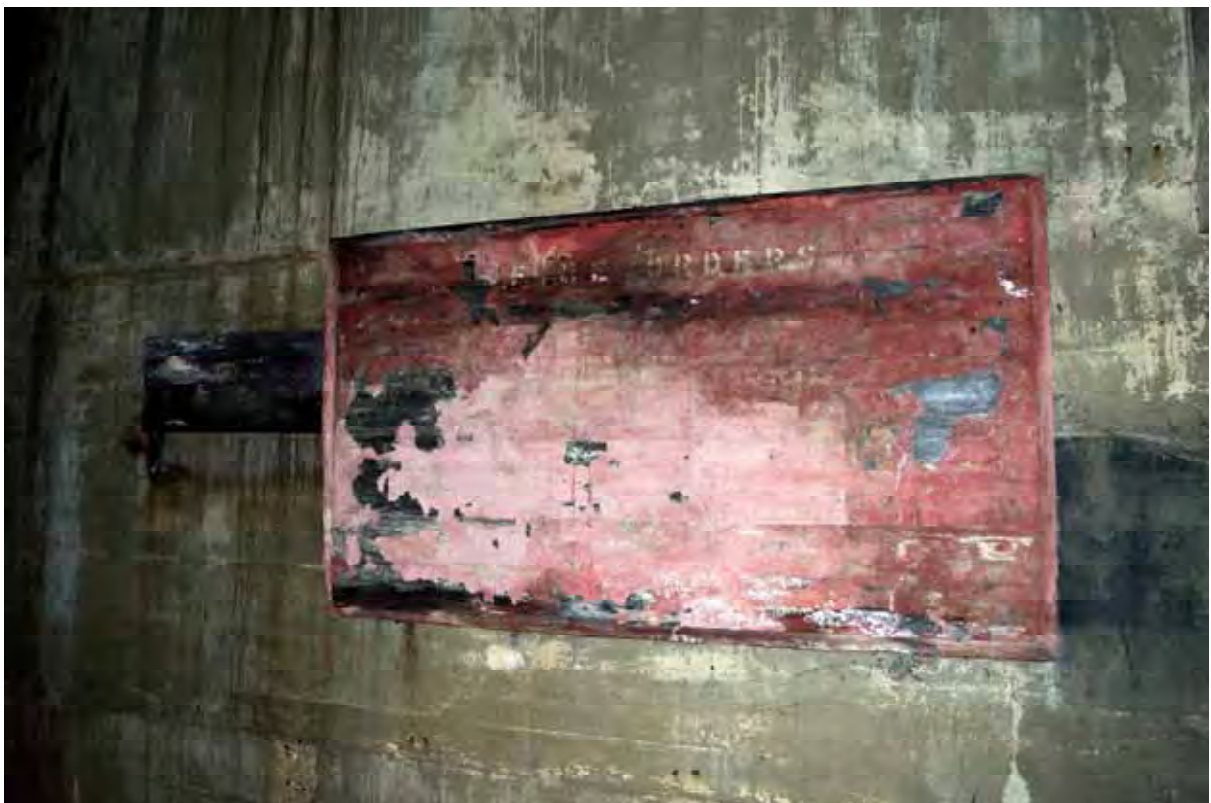
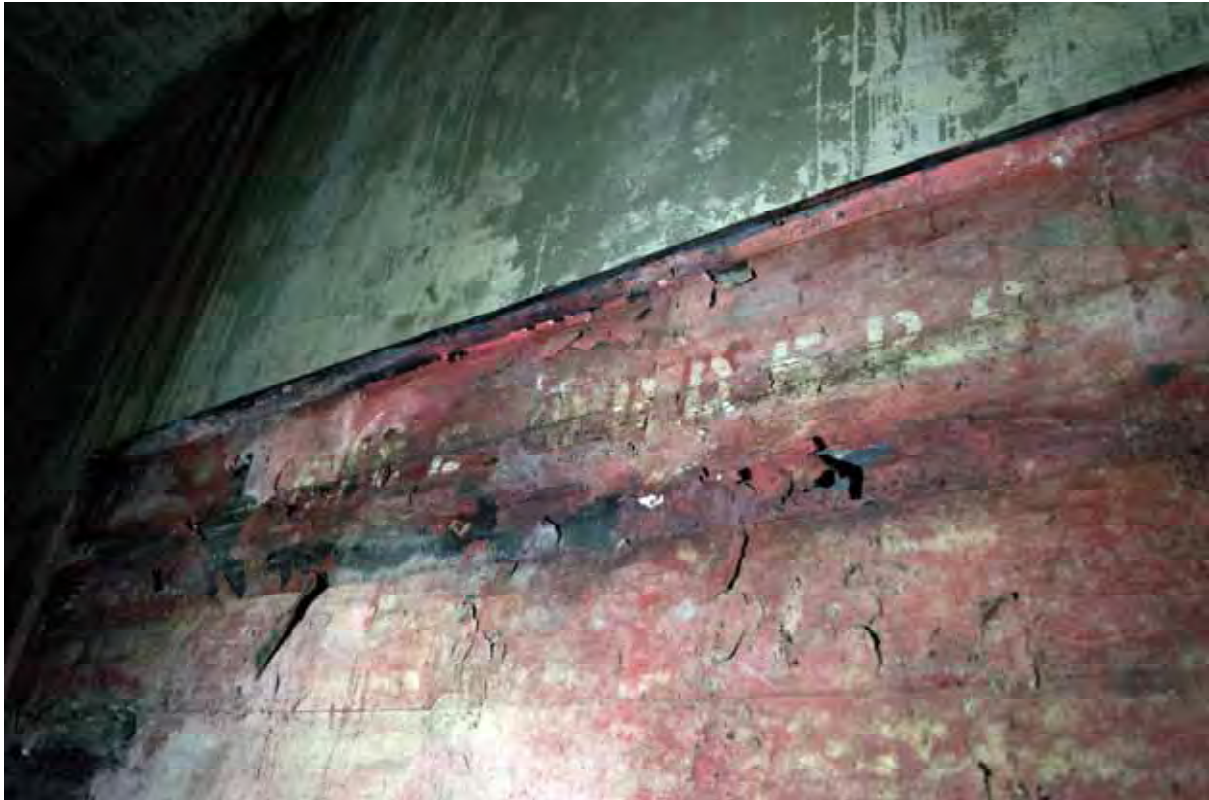
Plate 88: Store 6 – Detail of the retained timber notice board within the northern end of the western passage, entitled 'Fire Orders', facing south-west (341)

Plate 89: Store 6 – Detail of the retained timber notice board within the northern end of the western passage, entitled 'Fire Orders', facing south-west (342)

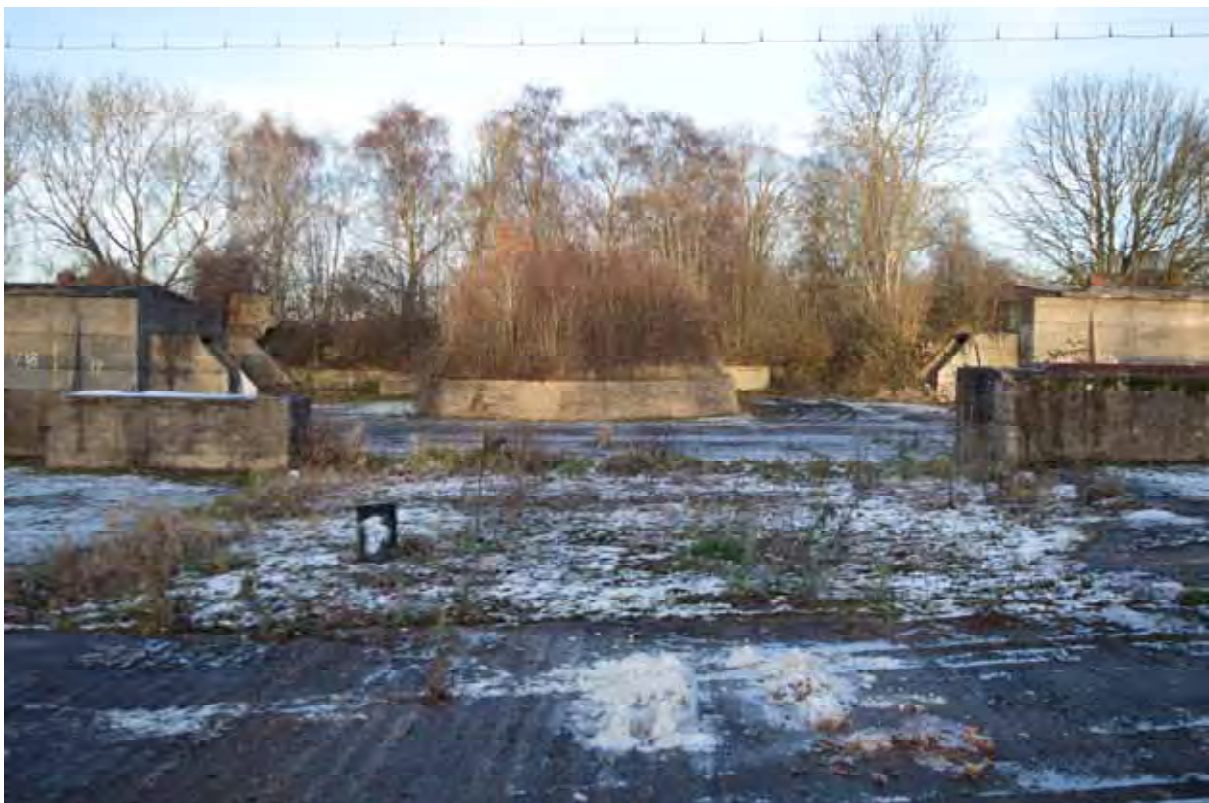
- 6.26 Each of the former earth blast barriers (Plate 90) surrounding Store 8 (Plate 91) has been removed, as have the loading platforms serving the western half of the structure (Plates 92 and 93). Five of the conveyor system bases remain within the southern loading bay but all others have been removed. All of the surviving bases (Plates 94 and 95) and loading platforms (Plate 96) retain metal brackets used to secure the conveyor belt. Only partial fabric of a lamp post remains on the southern loading platform. The south-eastern doorway serving the eastern half of the structure is marked with 'Vent Class A' stencilling, as per the generic description. The covered entrance on the same side but serving the western half, contains stencilled signage comprising white stencilled letters, set against a black background (Plate 97). Although slightly degraded, the sign located on the west wall to the south of the gate, reads, 'IN CASE OF A FIRE BUCKETS TO BE FILLED FROM HYDRANT'. To the west of the structure is a displaced steel girder (Plate 98); its nature is not known for certain, but it is plausible that it formed part of the now-removed conveyor system.

Plate 90: View of the area formerly occupied by the bund separating Stores 8 and 9 (removed after 1990), facing north-east (412)

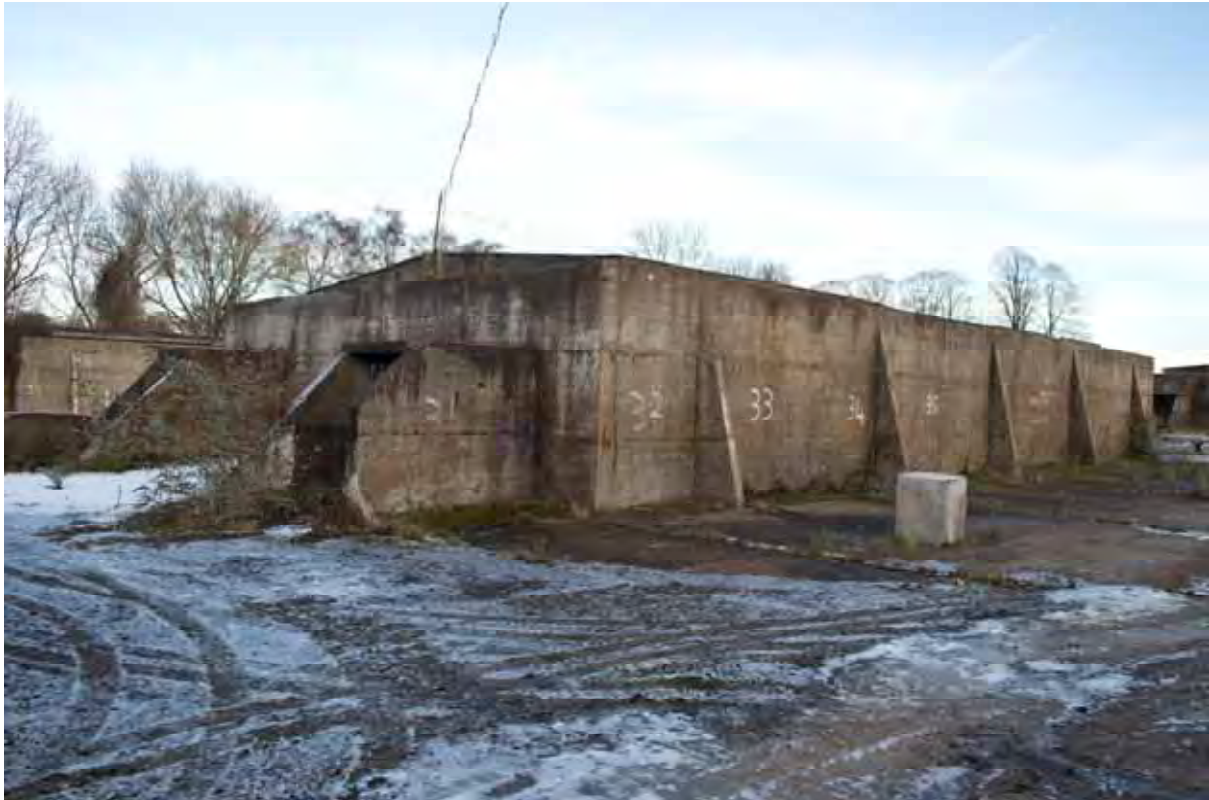
Plate 91: Store 8 – View of the north-west and south-west elevations, facing east (419)

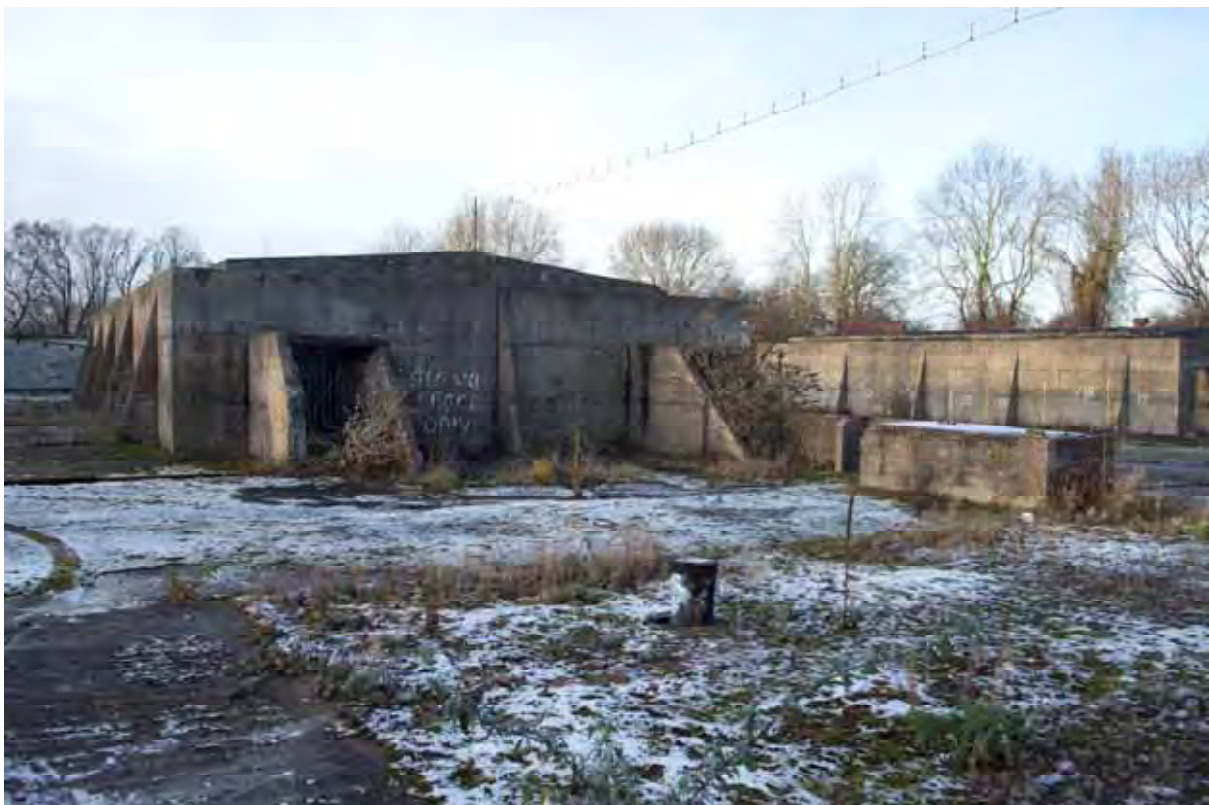
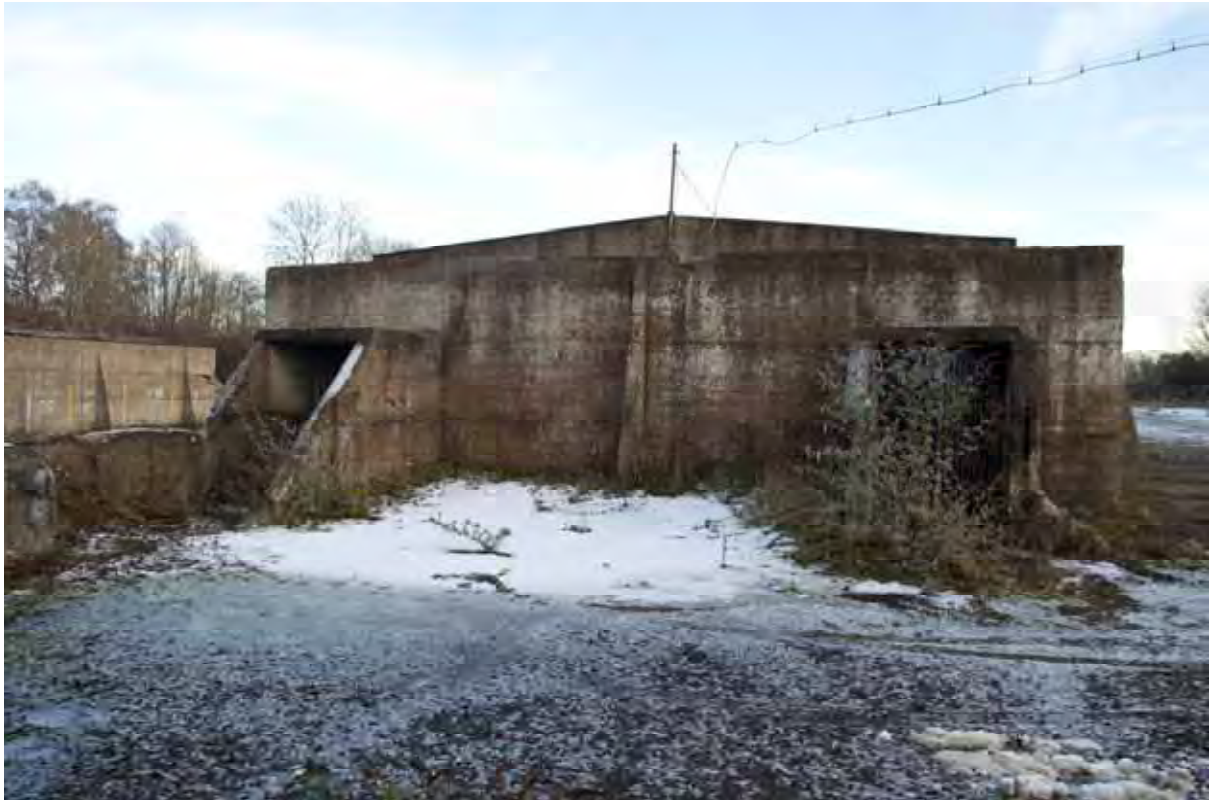
Plate 92: Store 8 – View of the southern loading bay, facing north (411)

Plate 93: Store 8 – View of the northern loading bay, facing south-east (420)

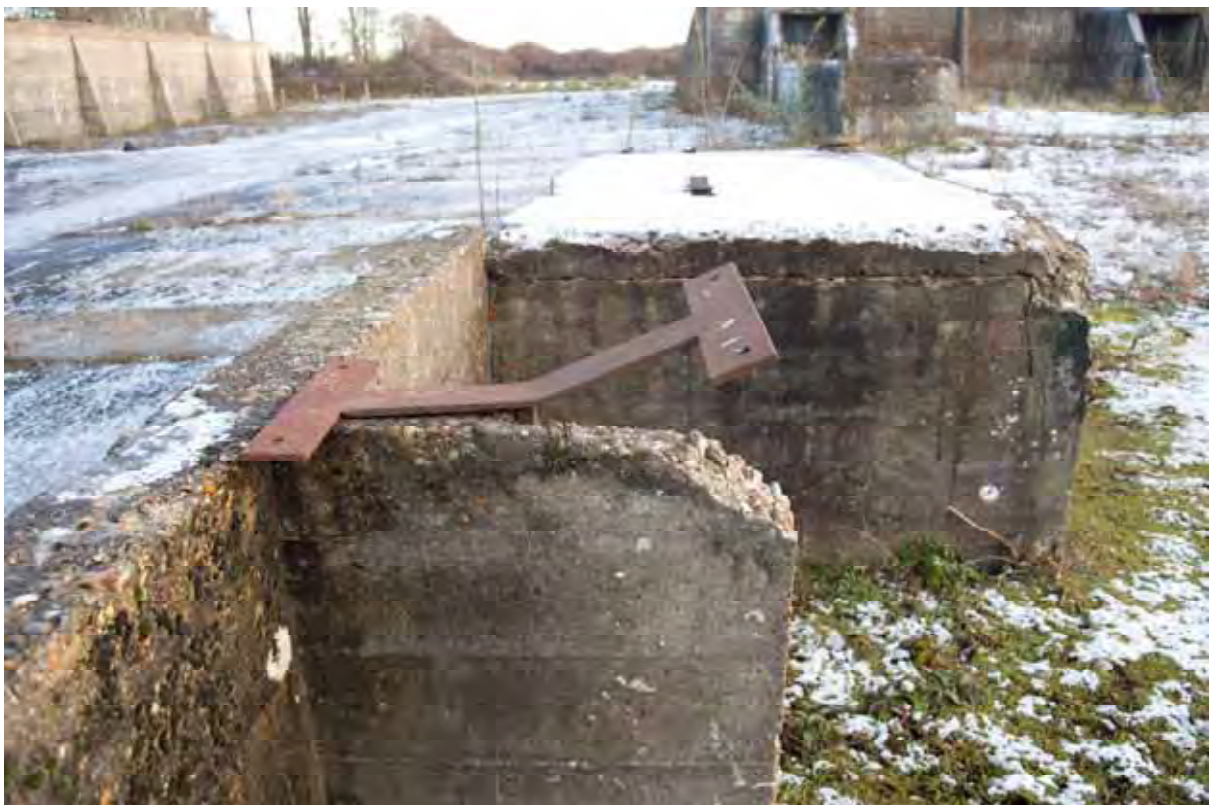
Plate 94: Store 8 – Detail of a retained conveyor base serving the eastern side of the southern loading platform, note the bracket fixing, facing south-east (414)

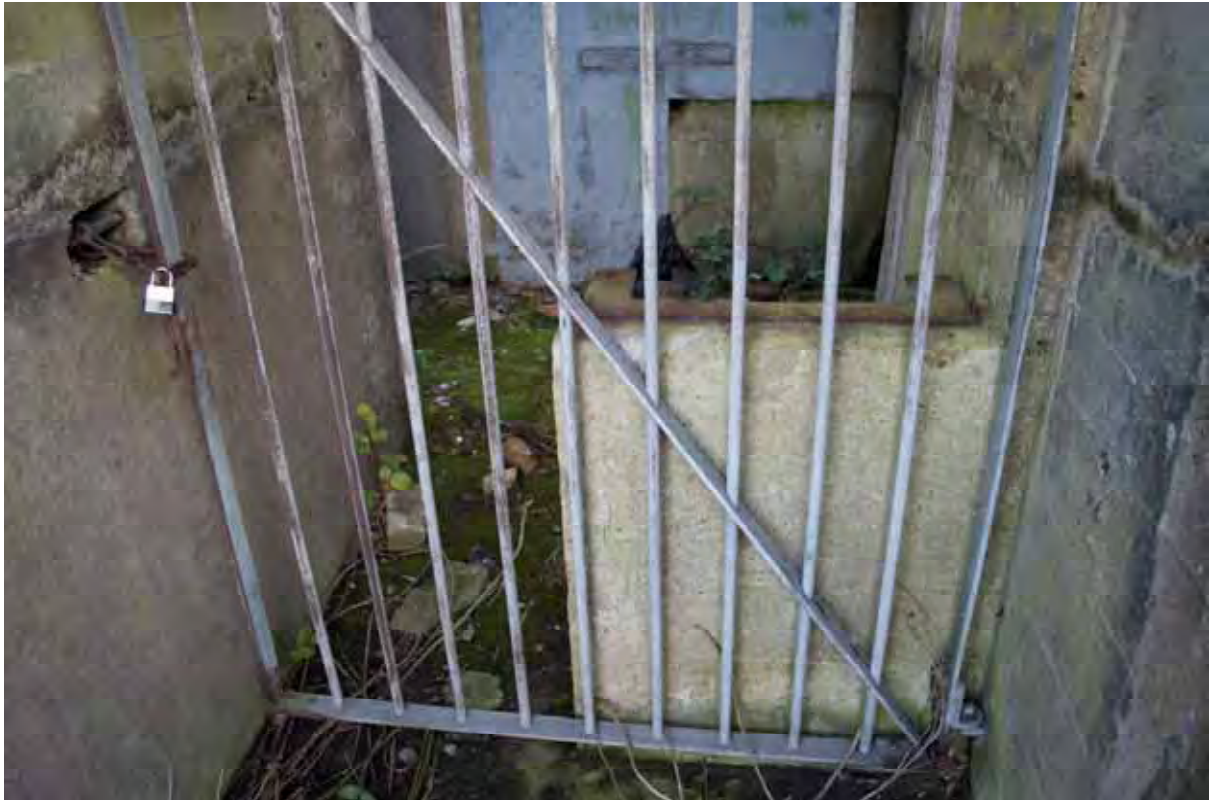
Plate 95: Store 8 – Detail of the conveyor bases retained within the western entrance serving the southern loading bay, facing north-west (409)

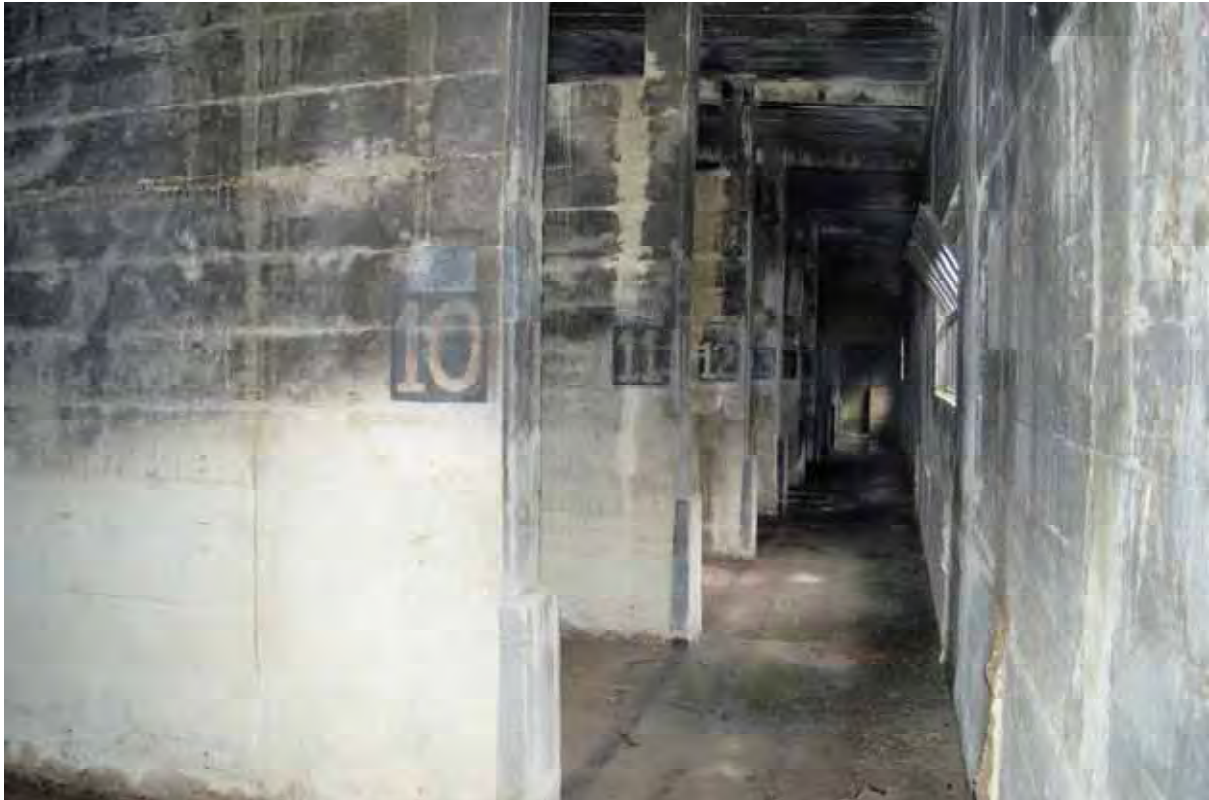
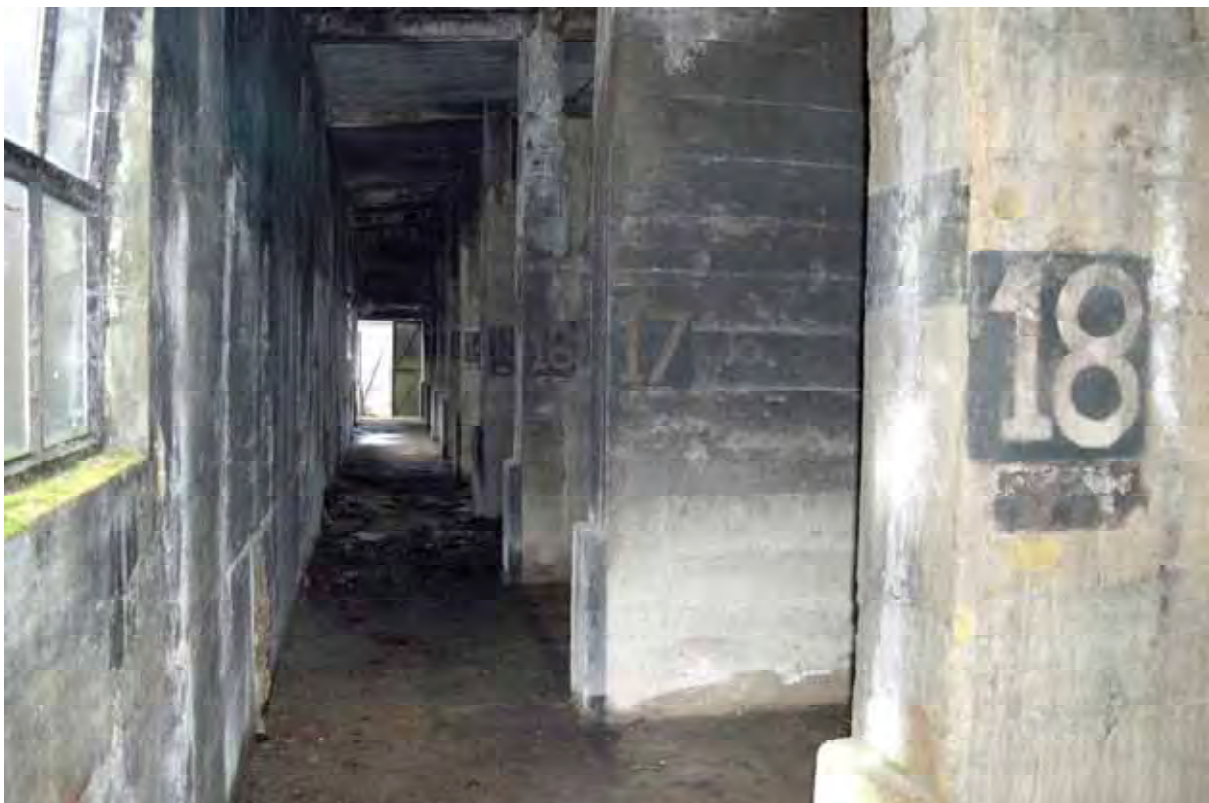
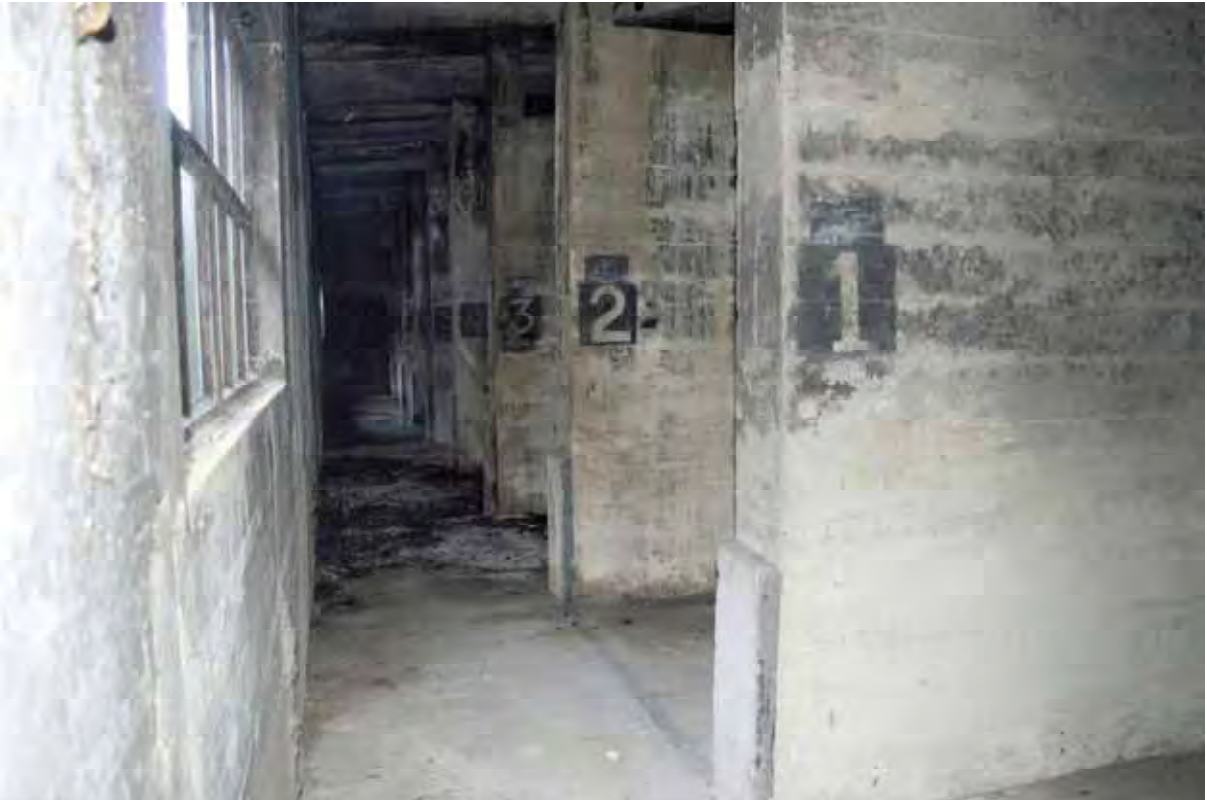
- 6.27 Both halves of the interior have been negatively affected by fire damage (Plates 99-102). Damage caused to the inner wall has clearly revealed the brick-dust coloured concrete blocks (Plate 103) used to fill the high openings within each passage. The bays within this structure contain no floor sockets. Instead, each bay is visually separated from the adjacent passage by a painted black line (Plate 104). This may perhaps signify that this store was used to store a different type of ammunition, as suggested previously. The timber notice board within this structure has suffered significantly from fire damage (Plate 105), with only half remaining and displaced from its original position (adjacent Bin 10). The board titled 'FIRE O[R]DERS' was located within Bin 10 and retains no discernible writing. The northern end of the eastern passage wall contained additional signage (Plate 106), to what would have been the northern side of the original notice board location. The signage, set against a black backdrop, contained white and green stencilled lettering, however its degraded nature made it illegible. The remainder of the interior was unchanged from the generic description (Plate 107).

Plate 99: Store 8 – View of the western passage and bay arrangement, facing south-east (426)

Plate 100: Store 8 – View of the western passage, facing north-west (434)

Plate 101: Store 8 – View of the eastern passage, facing south-east (437)

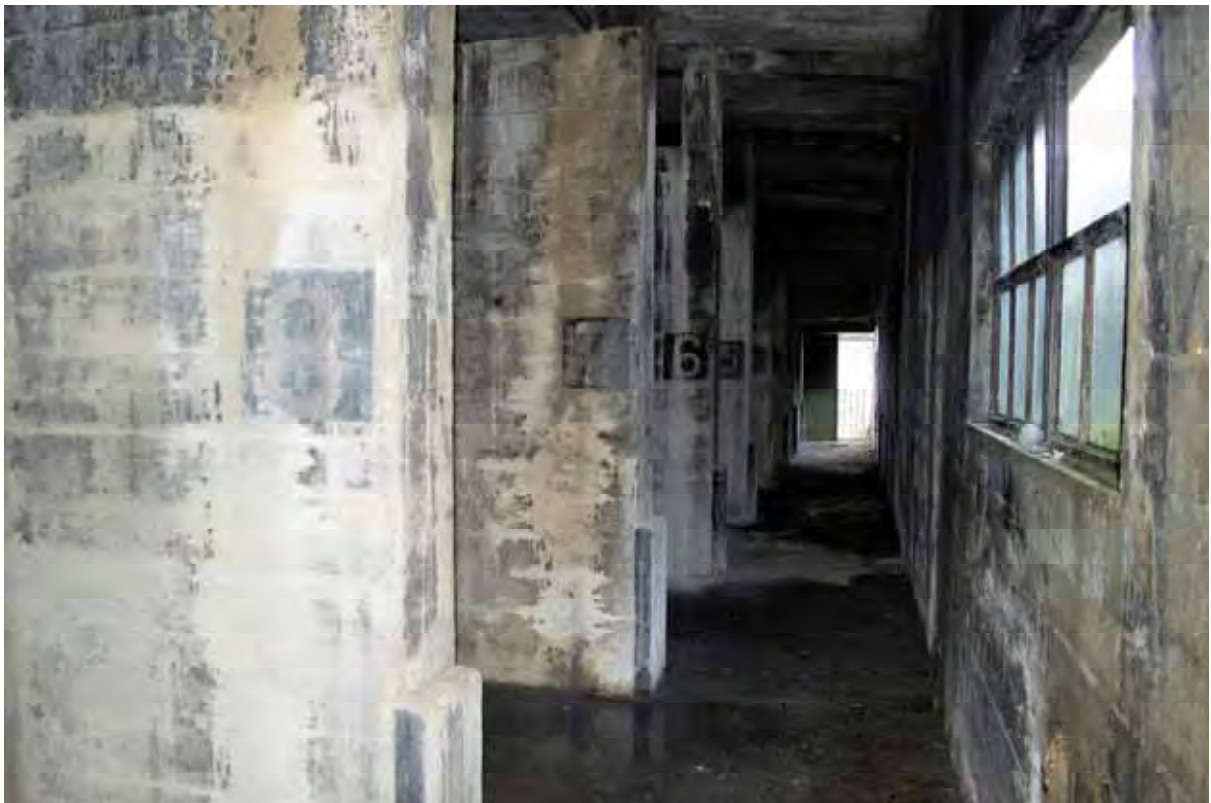
Plate 102: View of the eastern passage and bay arrangement, facing north-west (440)

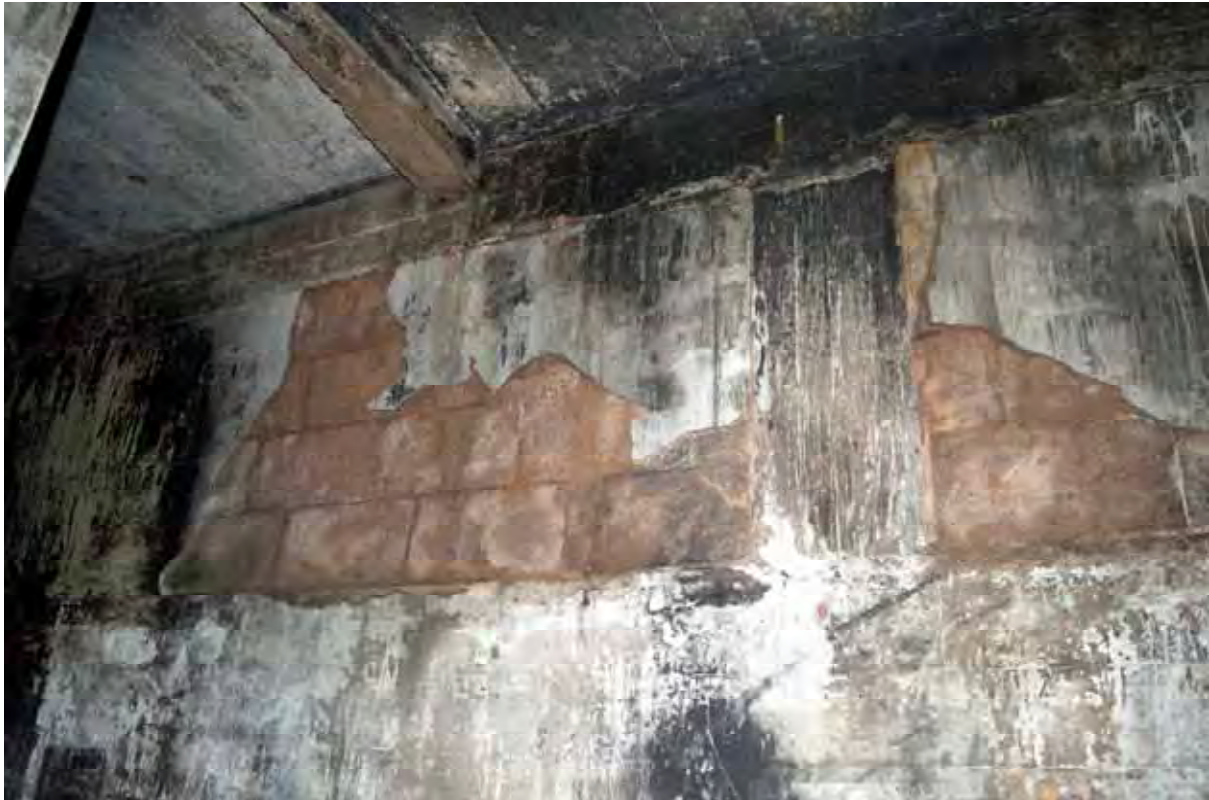
Plate 103: Store 8 – Detail of the fire damaged south-west wall within the western passage, note the concrete blocks used to fill the former openings, facing south (431)

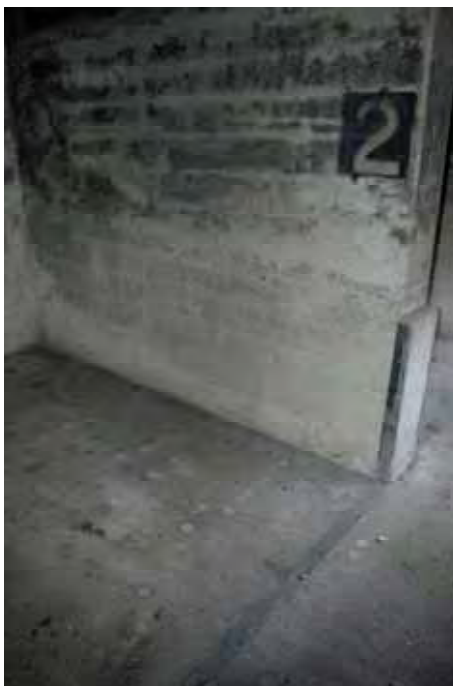
Plate 104: Store 8 – Detail of the bay divisions, note the absence of floor sockets, facing west (442)

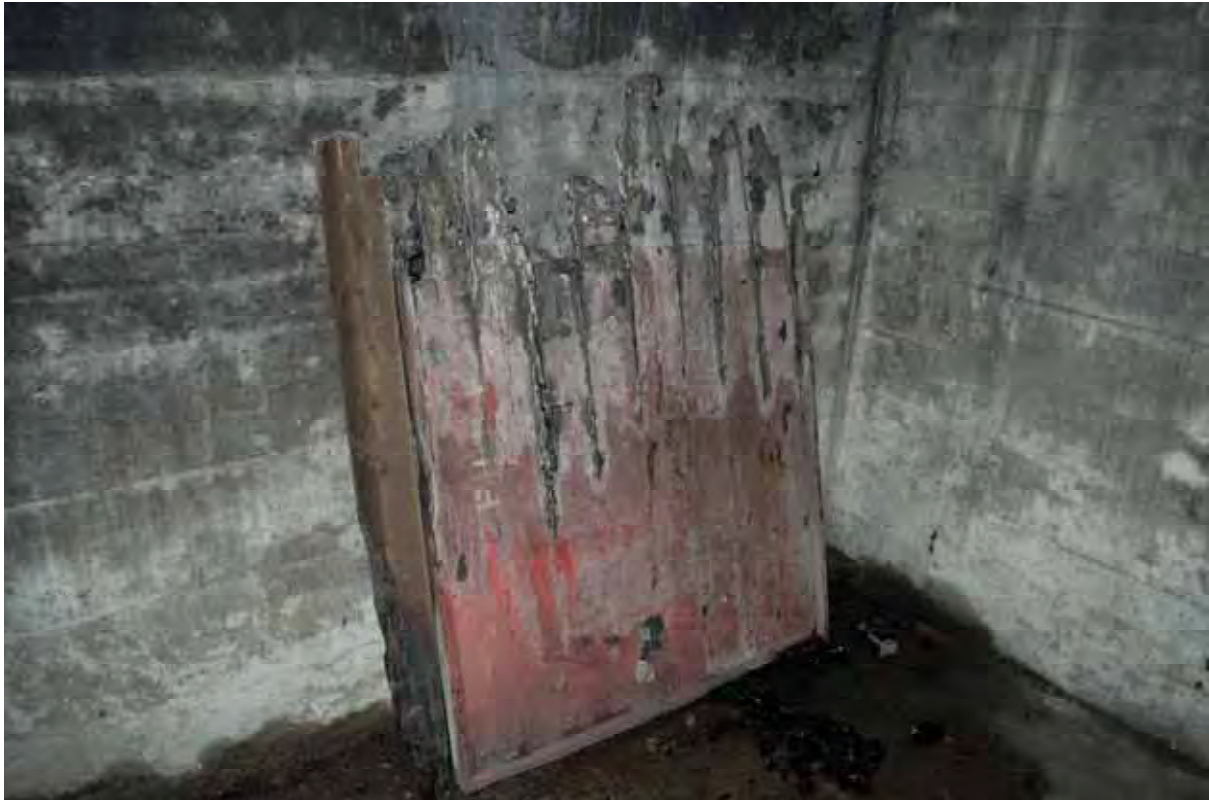
Plate 105: Store 8 – Detail of the fire damaged timber notice board within Bin 15 (western half), note the 'Fire Orders' title still visible, facing north (432)

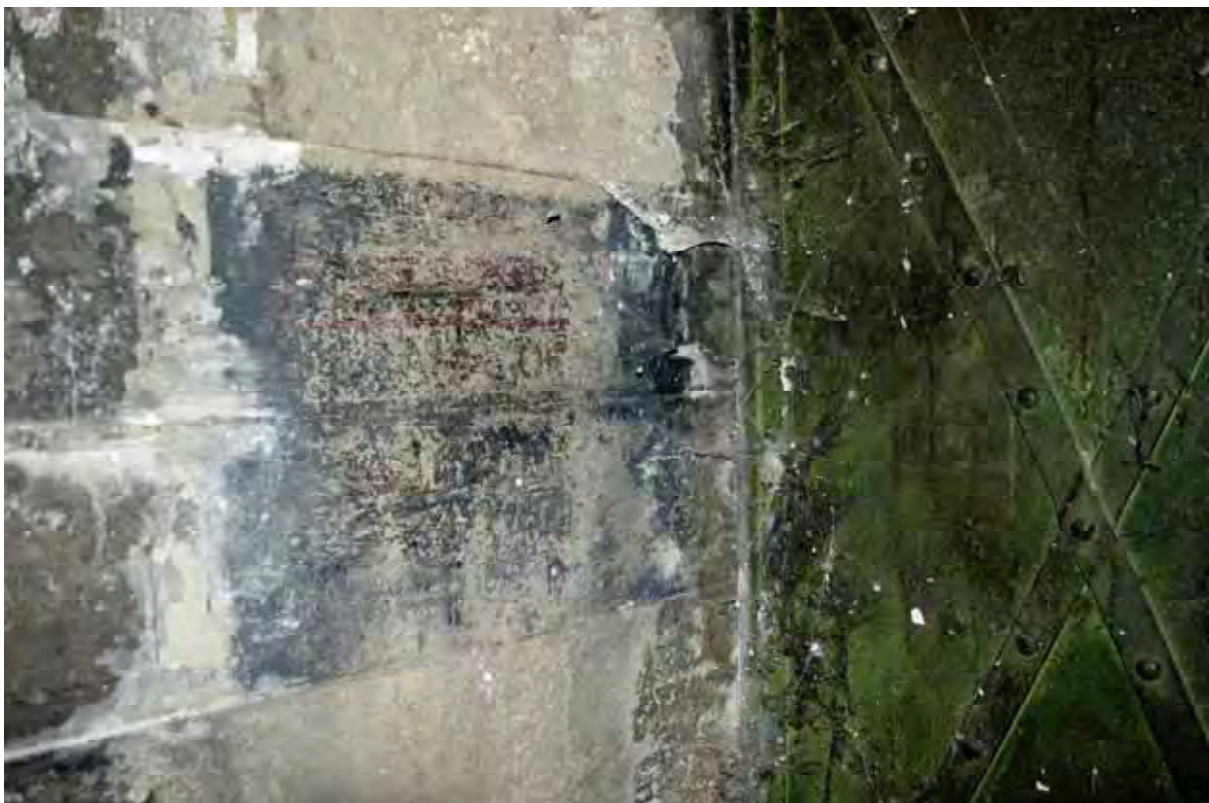
Plate 106: Store 8 – Detail of the degraded signage to the north of the former location of the notice board, upon the store's south-western elevation, facing west (441)

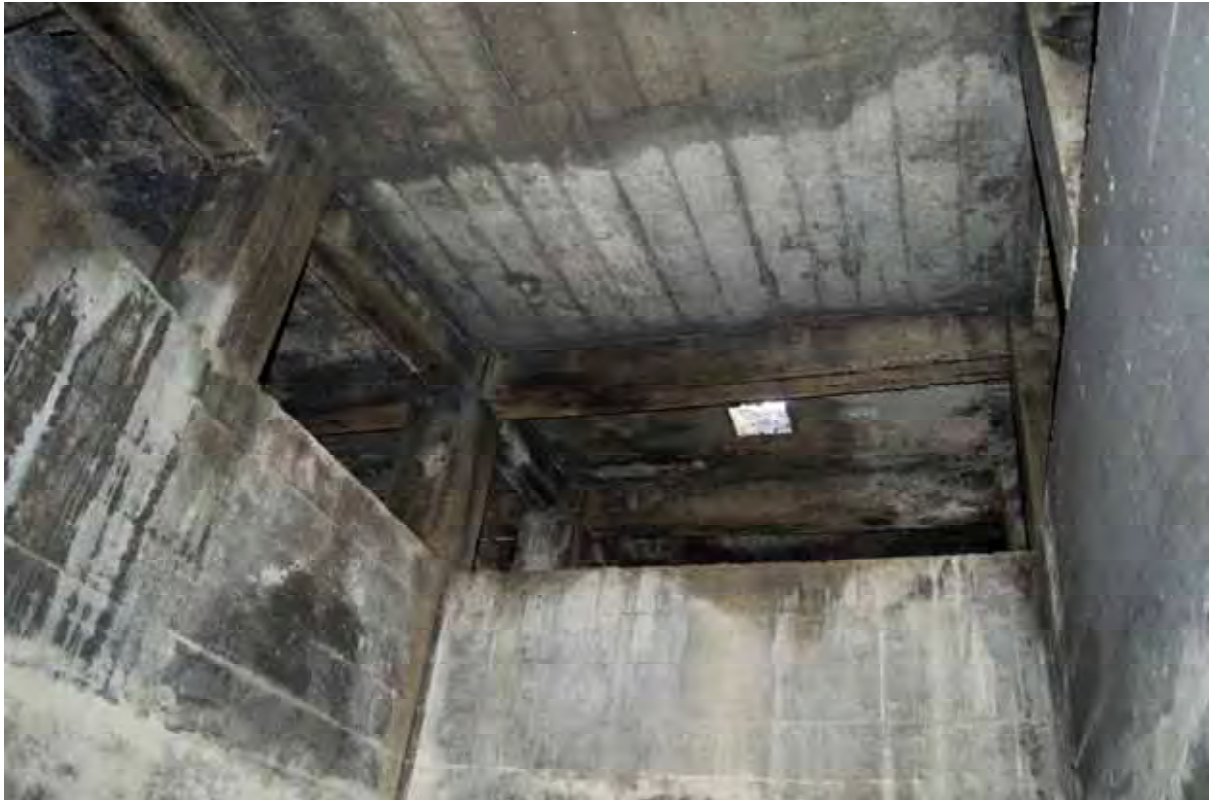
Plate 107: Store 8 – View of the bay roof arrangement and external vents situated above the central void, facing south-west (439)
