**LAND AT COURTLANDS FARM,
PARK ROAD, BANSTEAD, SM7 3EF**

**HISTORIC BUILDINGS RECORD
(HISTORIC ENGLAND LEVEL 4)**

**Historic Buildings Record
(Historic England Level 4)**

**ASE Project No: 171102
Site Code: CFB17**

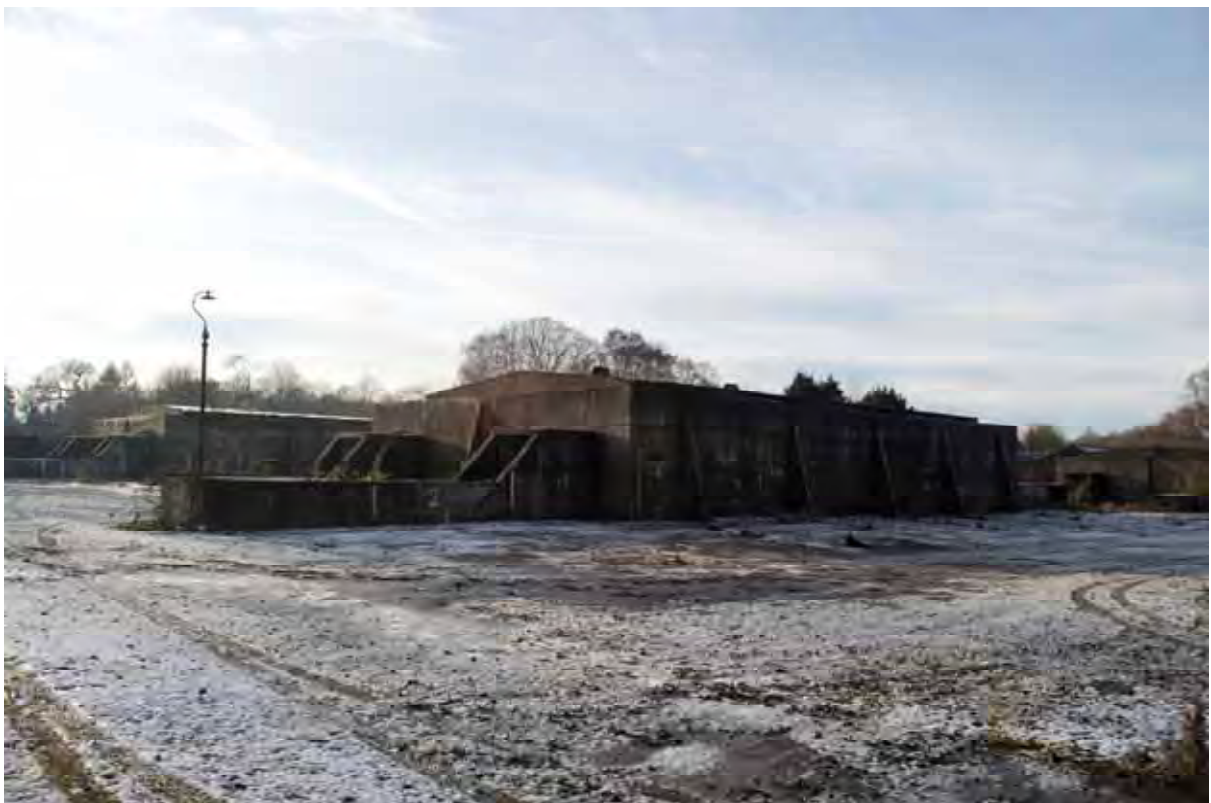
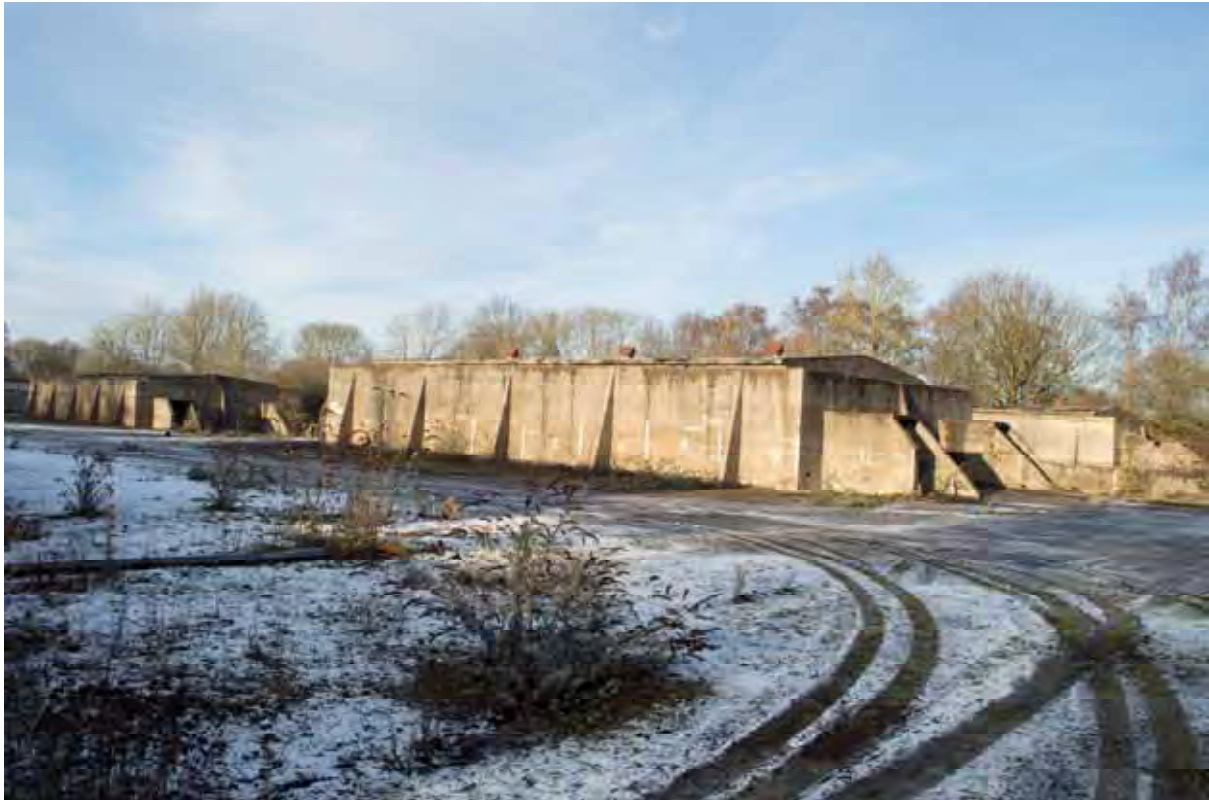
- 6.28 All earth blast barriers have been removed around Store 9 (Plates 108 and 109). As with Store 5, the roof vents over this structure are served by steel-hoods (Plate 110). The loading platforms (Plates 111 and 112) formerly serving the western half of the store have been removed. The south-eastern loading platform retains a very good

Plate 108: Store 9 – View of the south-east and north-east elevations, facing west (360)

Plate 109: Store 9 – View of the south-east and south-west elevations, facing north (364)

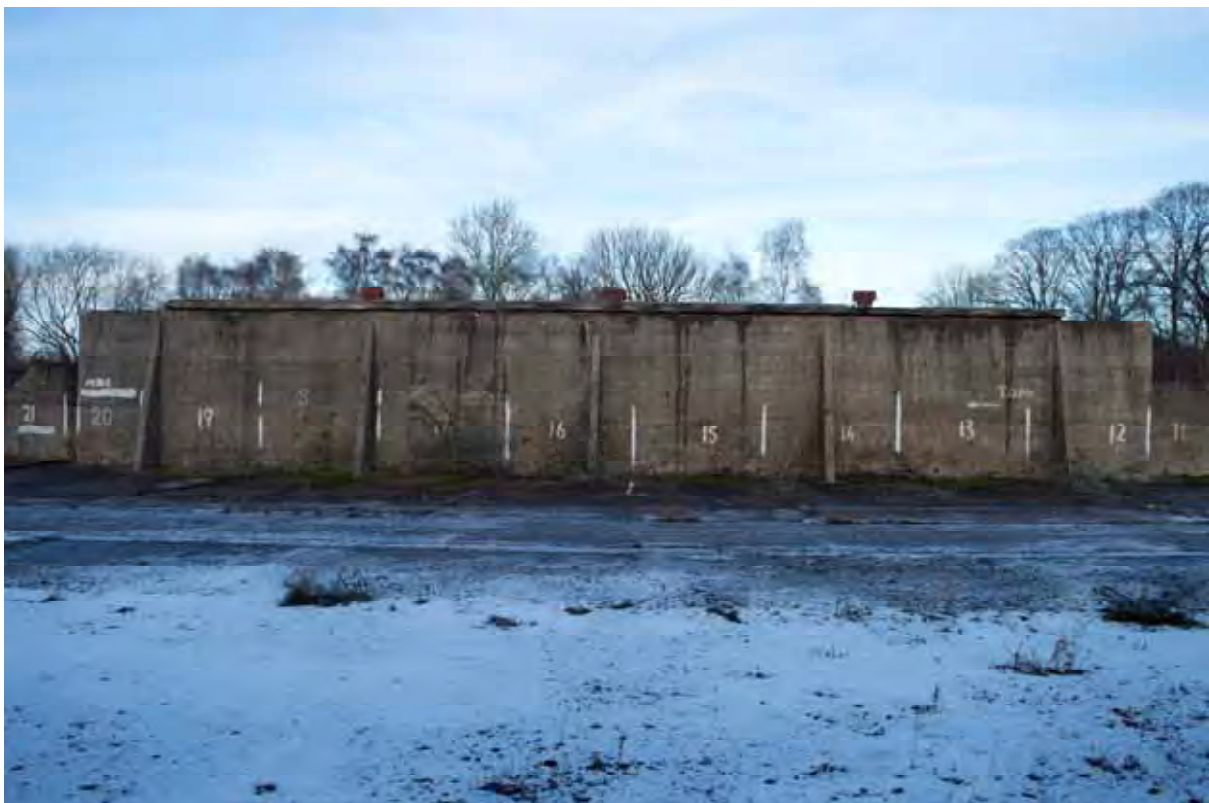
Plate 110: Store 9 – View of the south-west elevation, facing north-east (399)

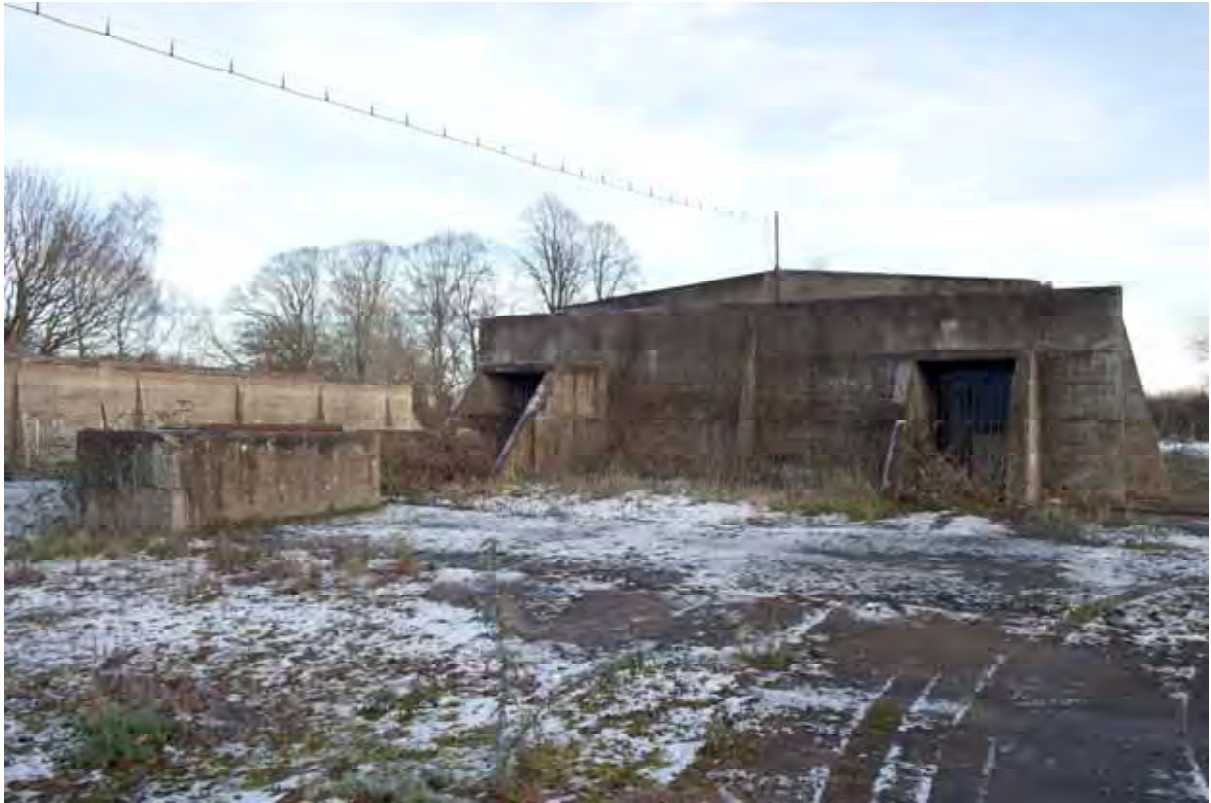
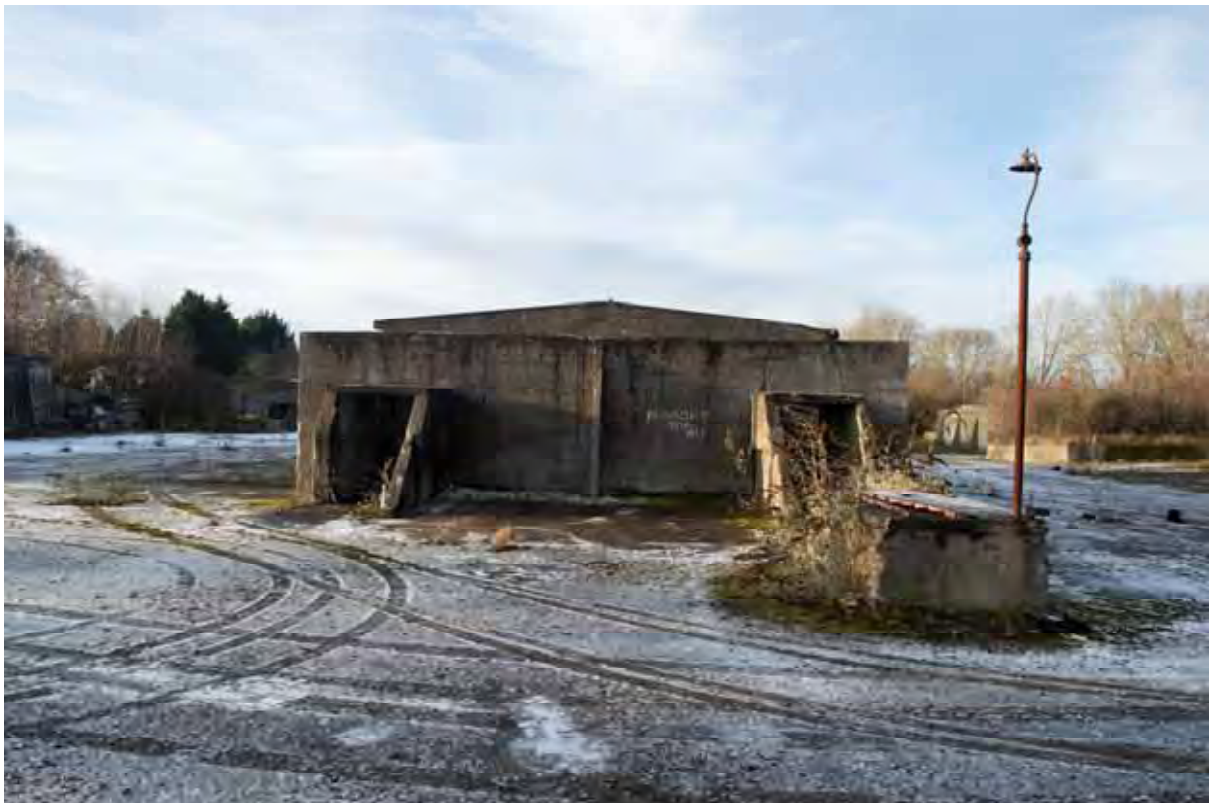
Plate 111: Store 9 – View of the northern loading bay, facing south-east (400)

Plate 112: Store 9 – View of the southern loading bay, facing north-west (370)

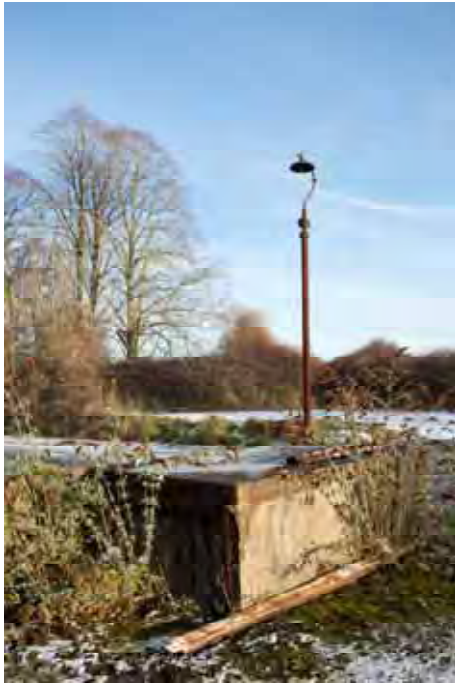
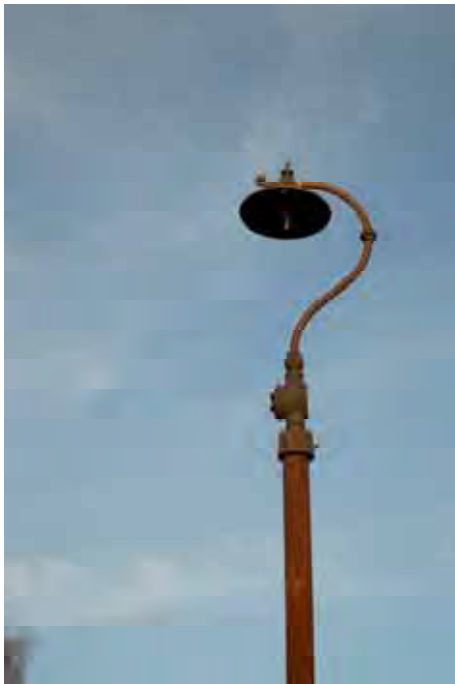
example of one of the lamp posts which formerly lit the loading bay operations (Plates 113 and 114), in addition to the metal fastening mentioned previously. On the same platform is a slender timber ladder, covered with a red paint covering. It is not known for certain if this ladder is an original fixture, although the shade of red matches that of the surviving internal notice boards, suggesting it forms part of the site's general war-time equipment. Adjacent to the platform is a steel 'U'-shaped girder (Plate 115) with two redundant circular sockets at each end. It is likely that this girder formed part of the now dismantled conveyor system, however its exact nature is uncertain. The northern loading platform contains what appears to form part of the former conveyor system (Plate 116). It comprises a shallow 'U'-section steel girder, lined with gritted felt, measuring c.3m (length) by c.0.7m (width) and containing two small fixing holes at its southern end and along each lip, presumably used to fasten the belt sections together. Each of the conveyor system bases remain at the northern end, including those within the north-eastern entrances and doorways (Plate 117). All others elsewhere have been removed. The western covered entrance (Plate 118) in the south-eastern elevation contains a good example of the fire hydrant signage (Plate 119) described within the principal description. No other signage was noted on any other entrance or inner wall (Plate 120).

Plate 113: Store 9 – Detail of the retained lamp post upon the eastern platform in the southern loading bay, facing east (371)

Plate 114: Store 9 – Detail of the retained lamp post on the eastern platform of the southern loading bay, facing east (373)

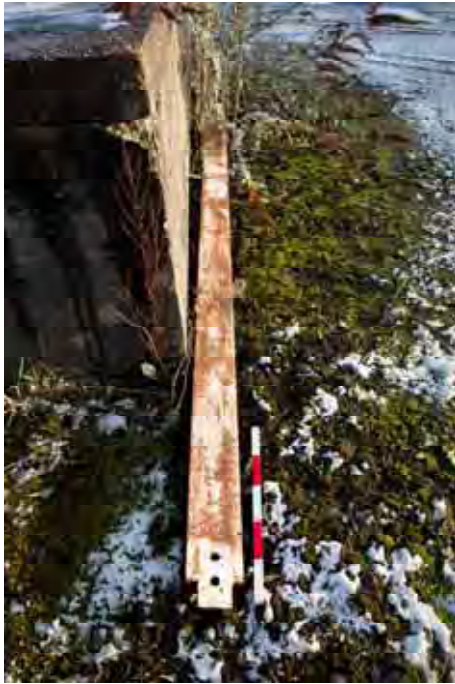
Plate 115: Store 9 – Detail of the displaced girder within the southern loading bay, facing south-east (372)

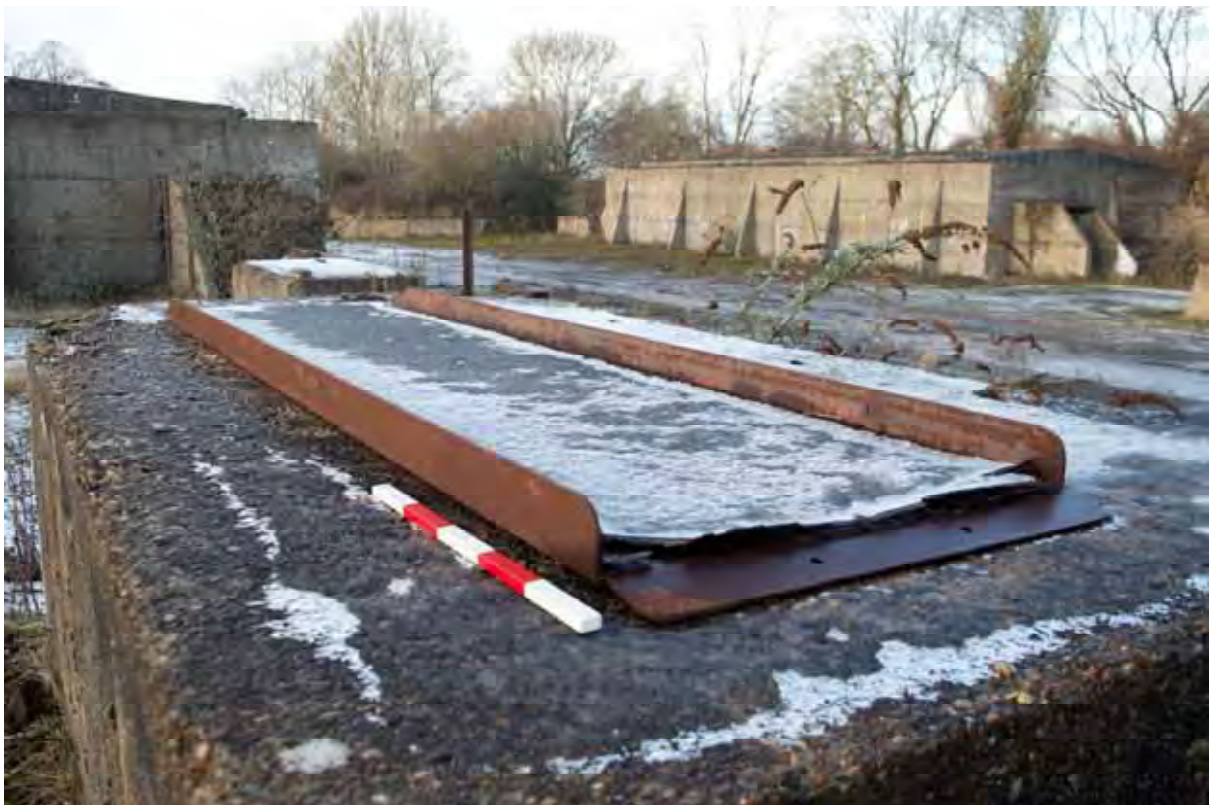
Plate 116: Store 9 – Retained conveyor track on the eastern platform within the northern loading bay, facing north (406)

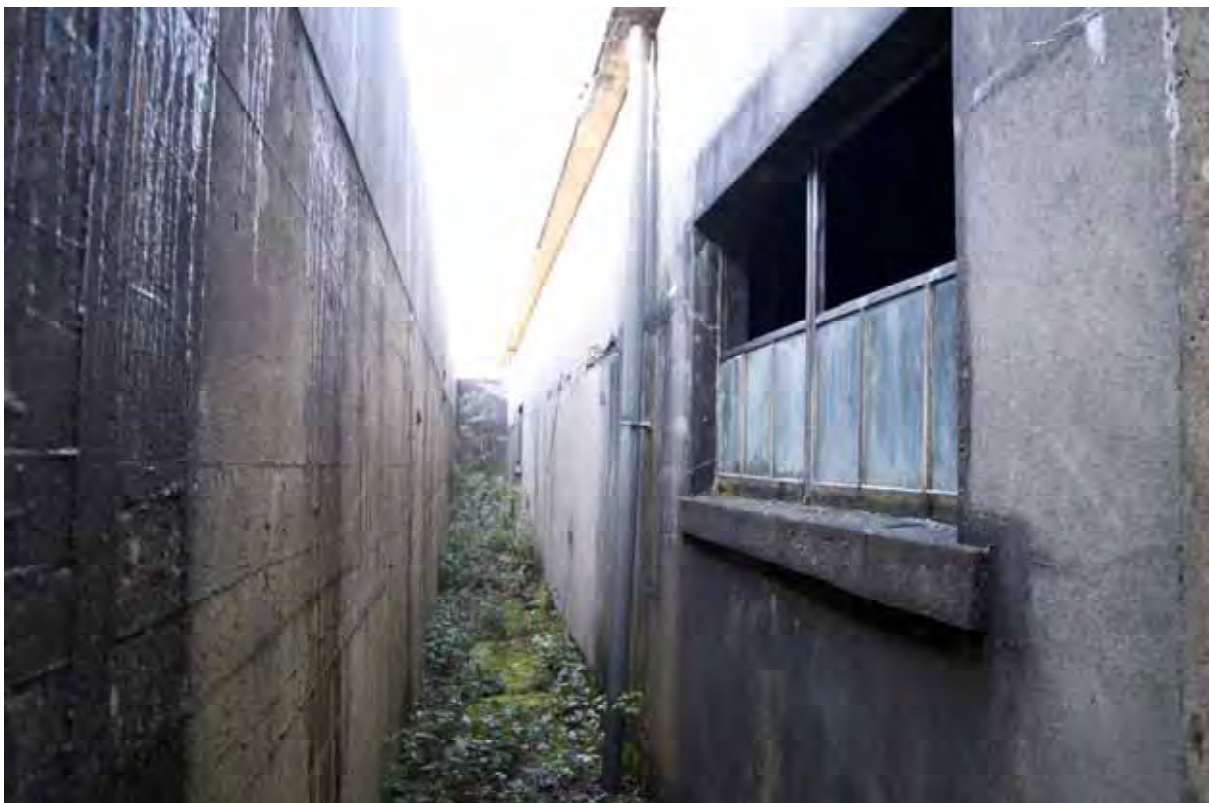
Plate 120: Store 9 – View of the western walkway, facing north-west (379)

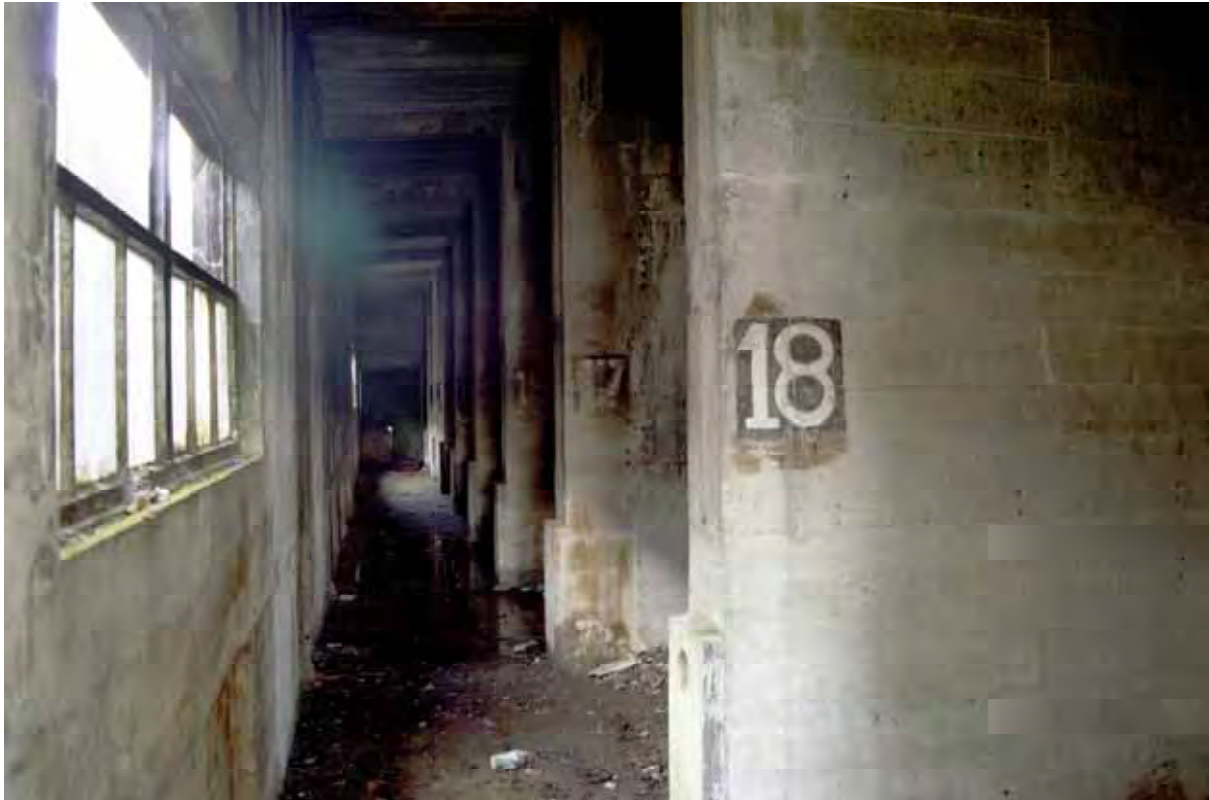
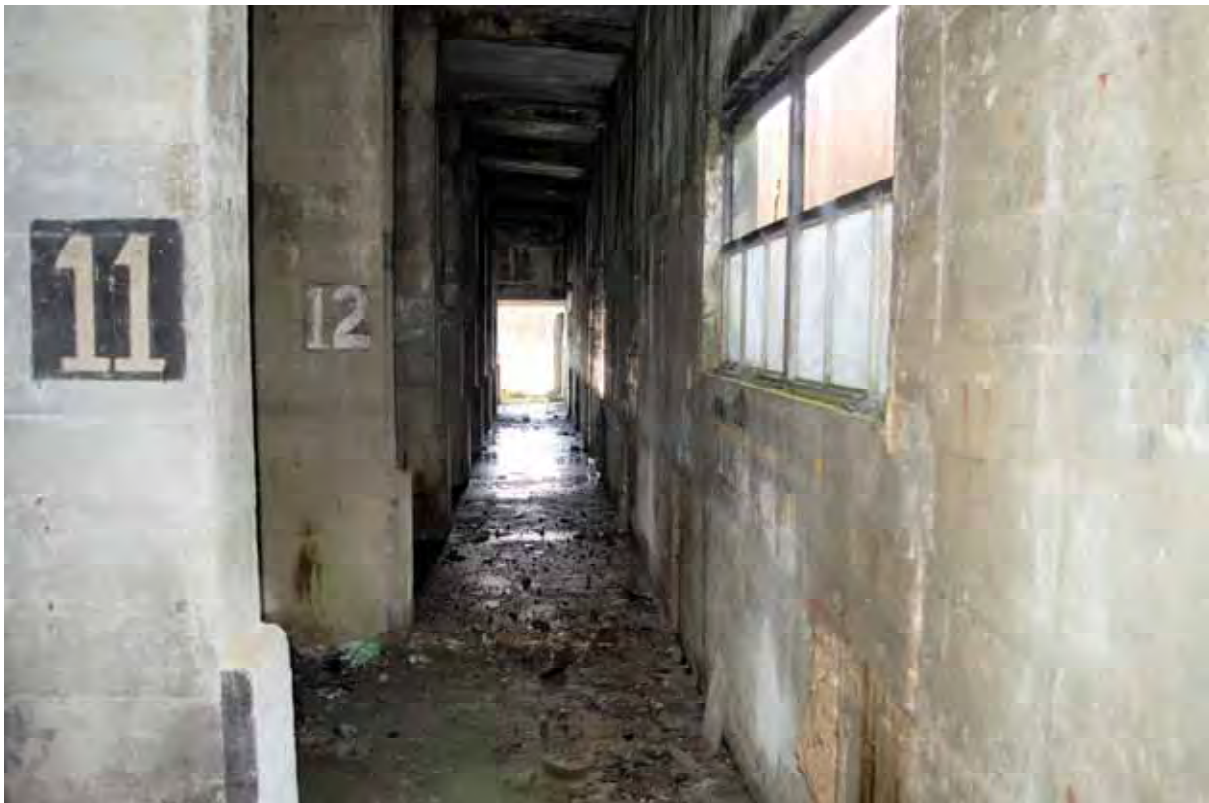
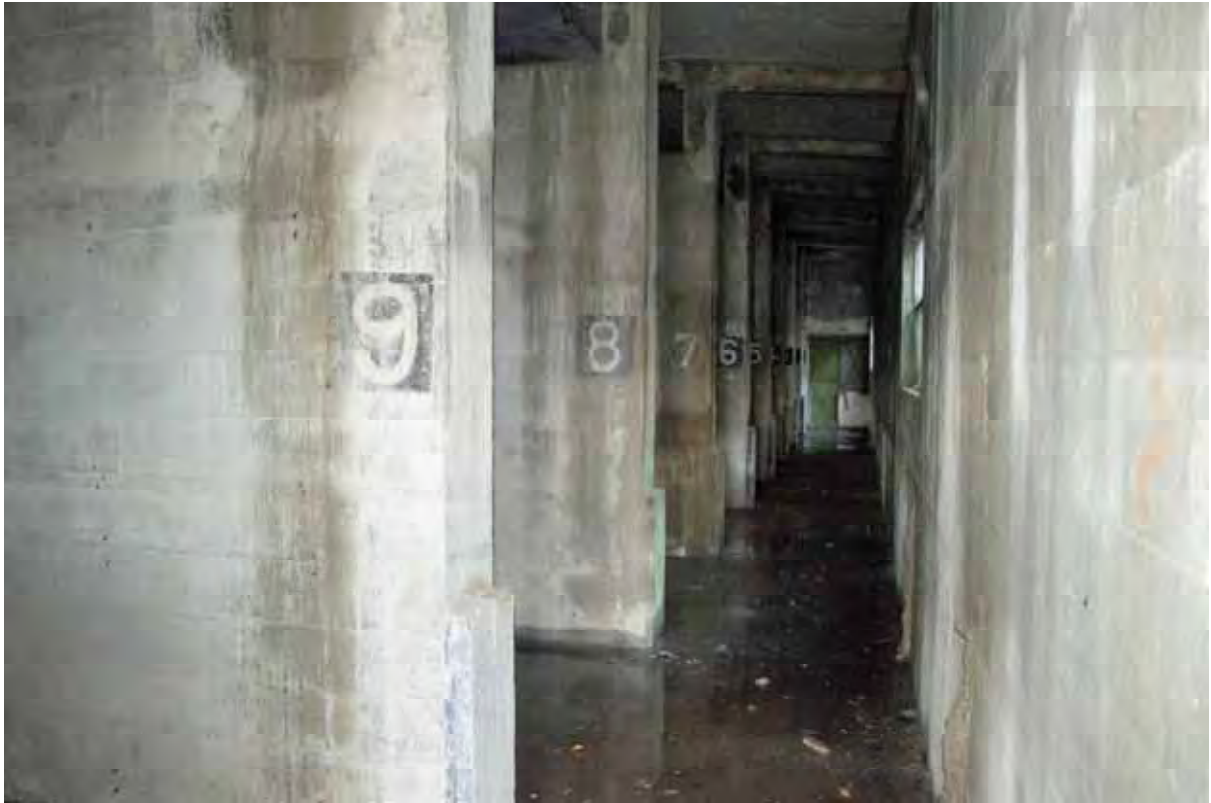
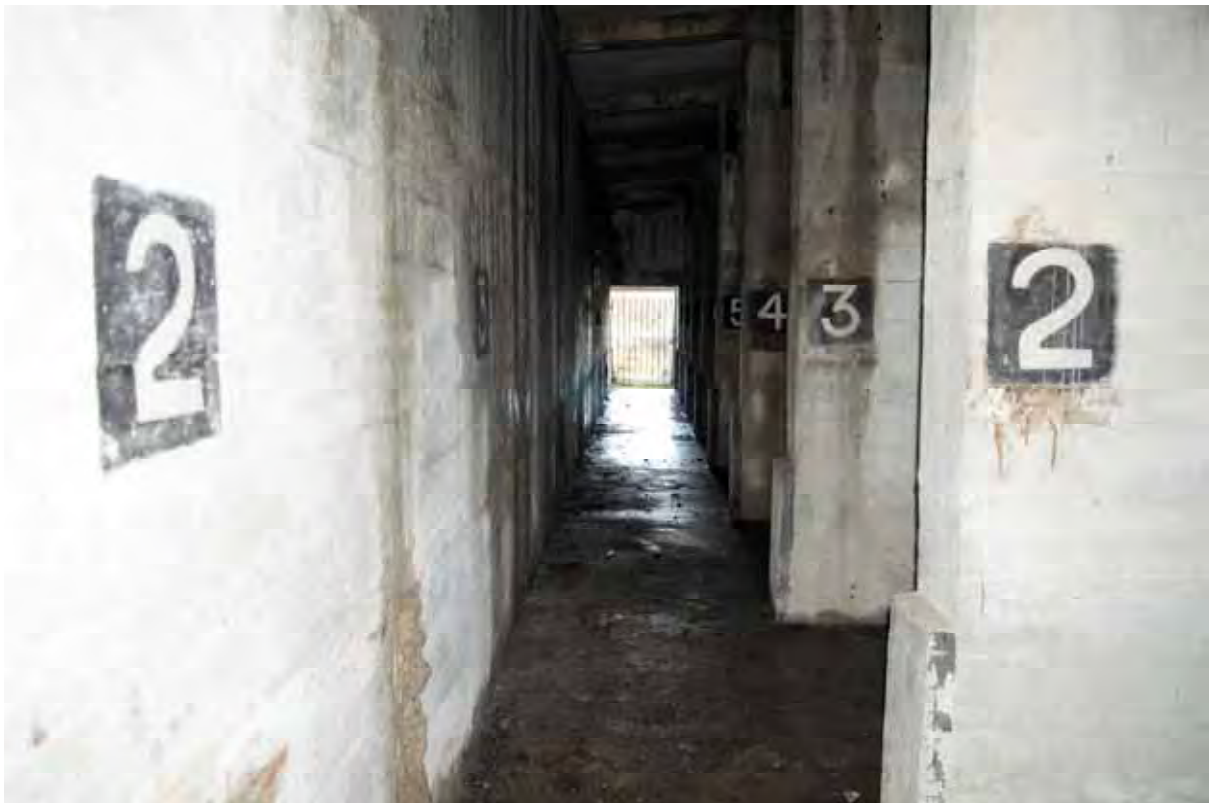
- 6.29 The store interior (Plates 121-124) is largely unchanged and provides particularly clear examples of the larger numerical bay signage (Plate 125), the markings being especially vivid against white-washed walls within the eastern half of the structure. The bays within this structure contain no floor sockets (Plate 126), but instead have painted black lines (Plate 127), visually separating the bins and internal passage. The most notable feature within this store is the retained timber notice board (Plate 128) adjacent to Bin 10. The board now rests on the floor, having separated from its wall mounting which remains *in situ*. Despite fire damage caused to its southern end, the board forms an valuable insight into the information given on these boards, with fragmentary evidence in the form of historic paper notices visible behind the red paint covering. The board, headed 'REGULATIONS' (Plate 129) contains information on the general storage and use of oil (lamps?) and stoves (Plate 130), in addition to fire precaution matters and actions to be taken in the event of a fire – including hailing 'FIRE! FIRE! FIRE' and sounding the fire alarm (Plate 131). Tantalising fragments of instructions are provided for the storage procedures for the different types of ammunition (Plate 132), including the use of an ordered tiered storage system and the use of wooden wedges and battens to protect ammunition on the bottom tier and to prevent 'projectiles ... from being slewed over the [?place / floor]'. Further information is given for the correct temperatures different types of ammunition should be stored at and for what time duration, stating that 'a) Cordite, Mk., I, R.D.B.' and 'b) Cordite, M.D., M.C. ... R.D.N. ... to remain for more than a month'. It also provided fire information regarding 'Ammunition containing Phosphorus', which states that 'if they ignite ... It (the phosphorus) is easily extinguished ...'.

Plate 121: Store 9 – View of the western passage, facing north-west (381)

Plate 122: Store 9 – View of the western passage, facing south-east (390)

Plate 123: Store 9 – View of the eastern passage, facing north-west (393)

Plate 124: Store 9 – View of the eastern passage, facing south-east (397)

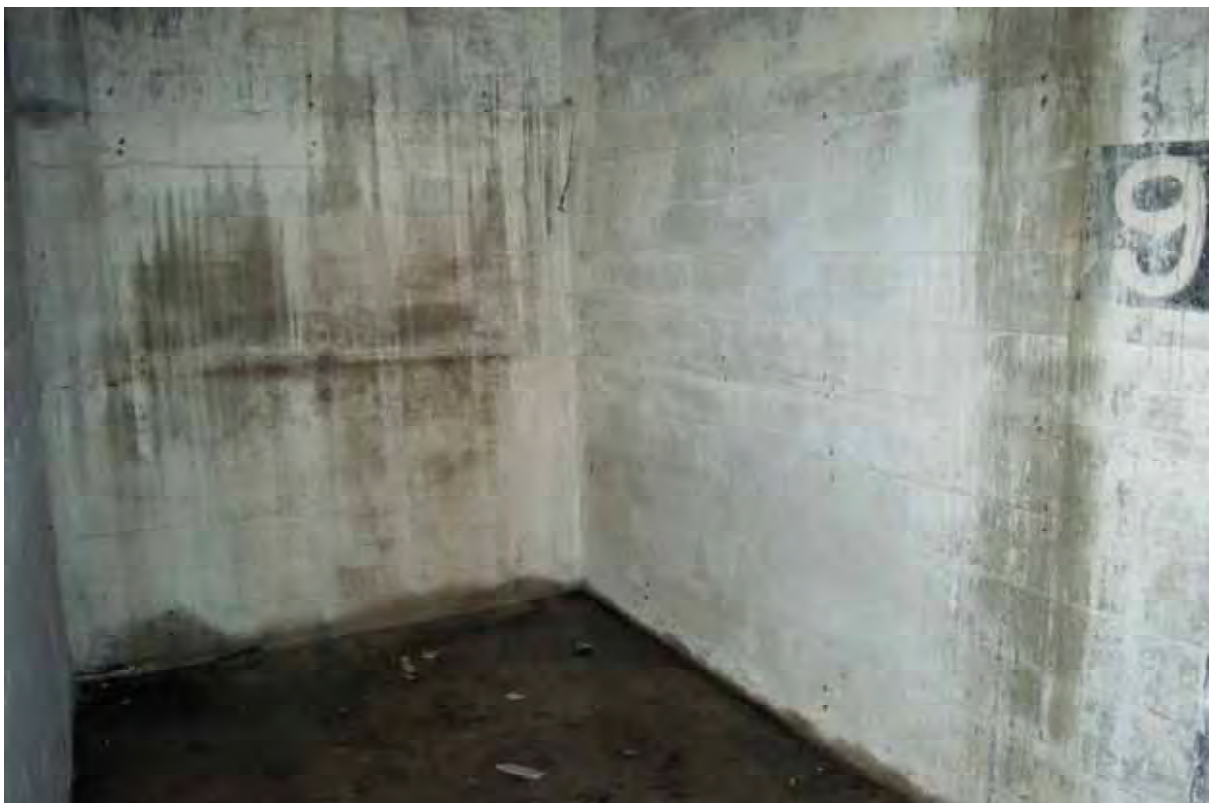
Plate 126: Store 9 – View of the bay arrangement (Bin 9), facing west (394)

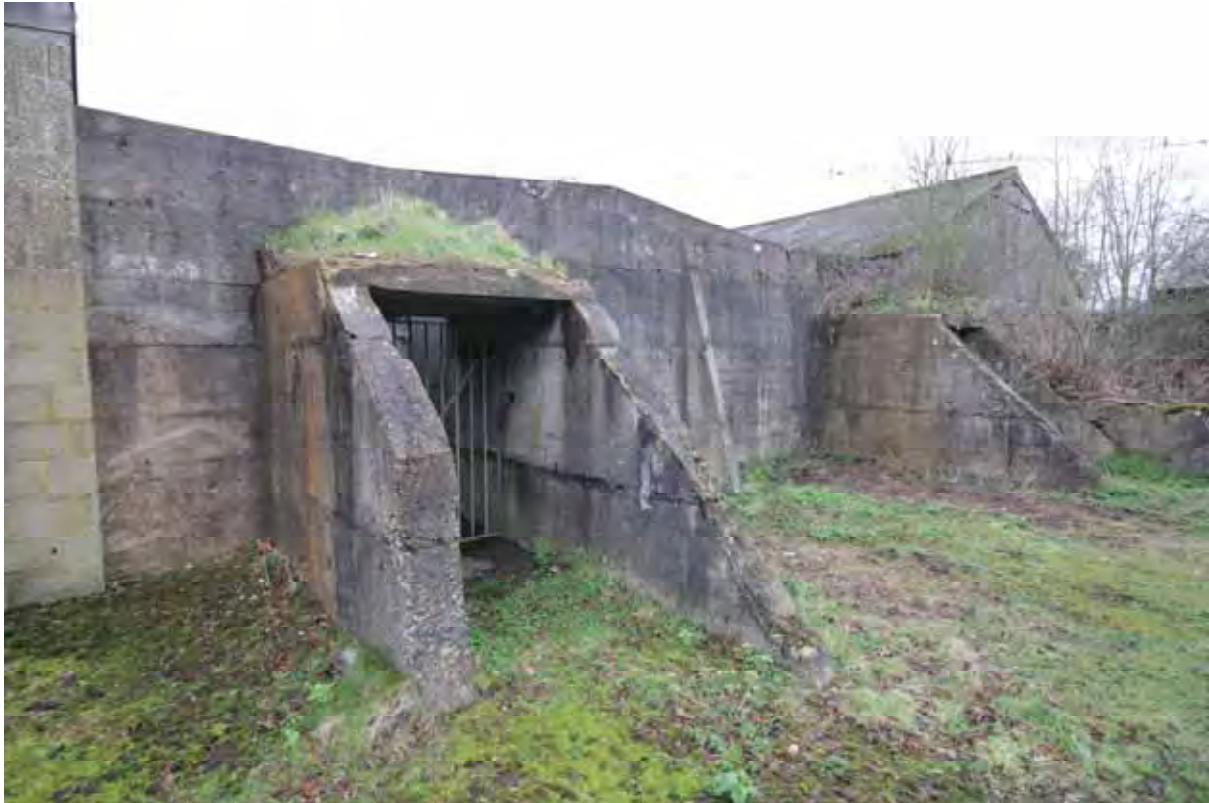
Plate 133: Store 10 – View of the south-east elevation, facing north (8)

- 6.30 Store 10 (Plate 133) has been encased on all but its south-eastern side by later structures (Buildings 10b – 10e; Plate 134); as a result, all earth blast barriers have been removed, except for the bund separating it from Store 12 (Plate 135). The construction of Building 10c / 10d has resulted in significant modification to the store's northern loading bay, including the removal of the western loading platform, the partial demolition of its western covered entrance and the removal of all of the external conveyor system bases. The southern loading bay has similarly been

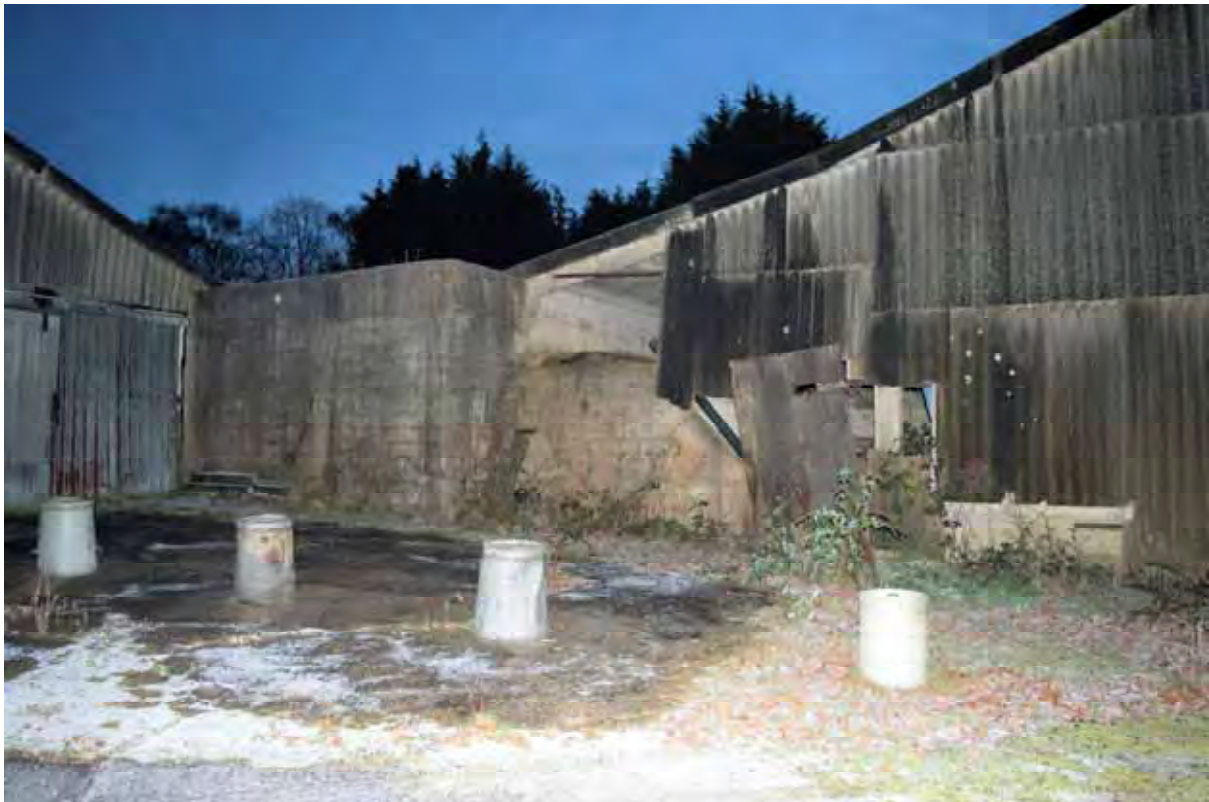
Plate 134: Store 10 – View of the northern end of the north-east elevation, note the encroachment of later 20th century structures on all sides, facing south (562)

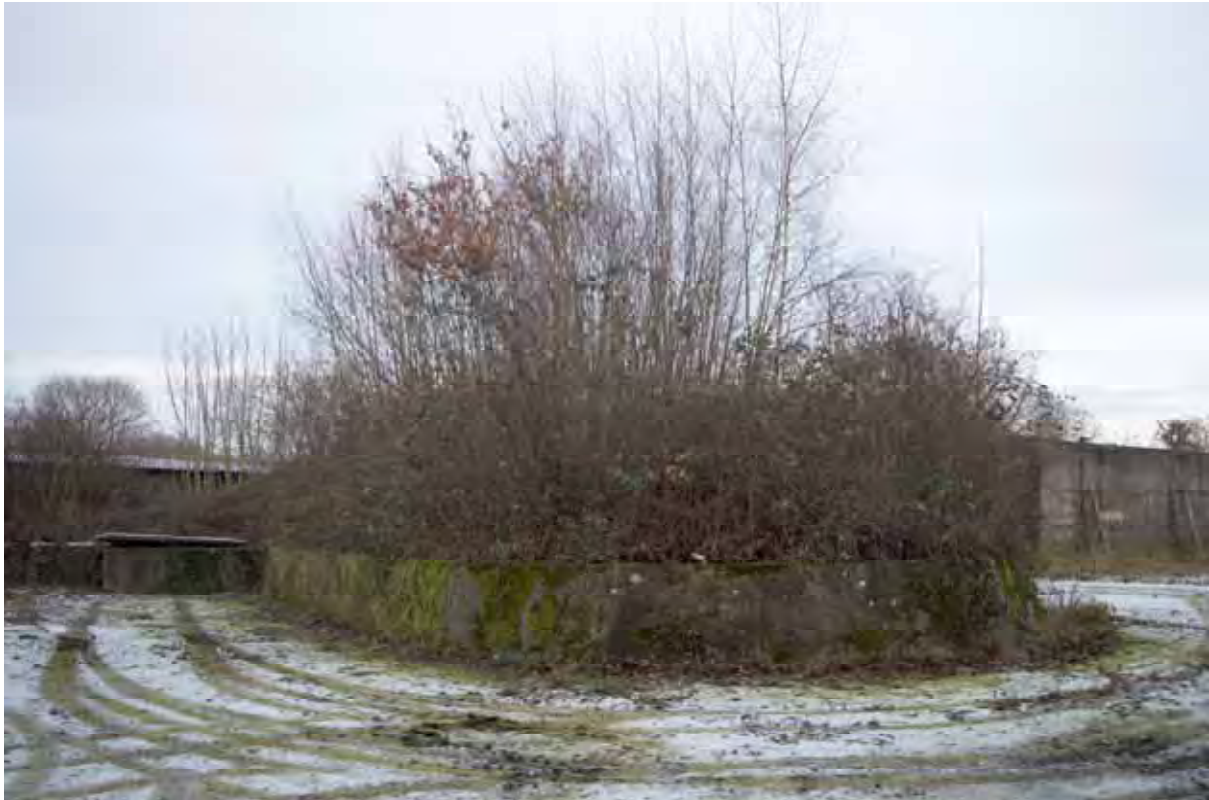
Plate 135: View of the bund separating Stores 10 and 12, facing east (514)

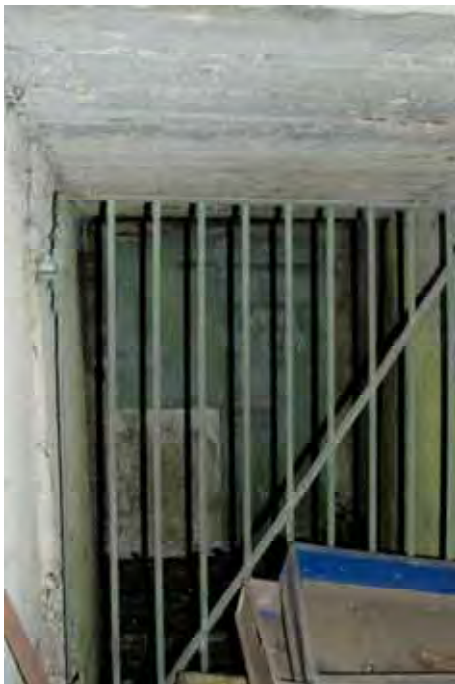
Plate 136: Store 10 – Detail of the eastern doorway serving the northern loading bay, facing south-east (565)

subject to alteration, with the removal of the western platform, along with all but one conveyor system base. All bases have been demolished internally, except for one within the northern doorway serving the eastern half of the structure. No evidence of former light fixtures or metal brackets were noted on the surviving platforms or bases. Nor was any evidence found of former signage on any of the covered entrances. The northern door serving the eastern half of the structure did retain its 'Vent Class A' signage (Plate 136), as described above.

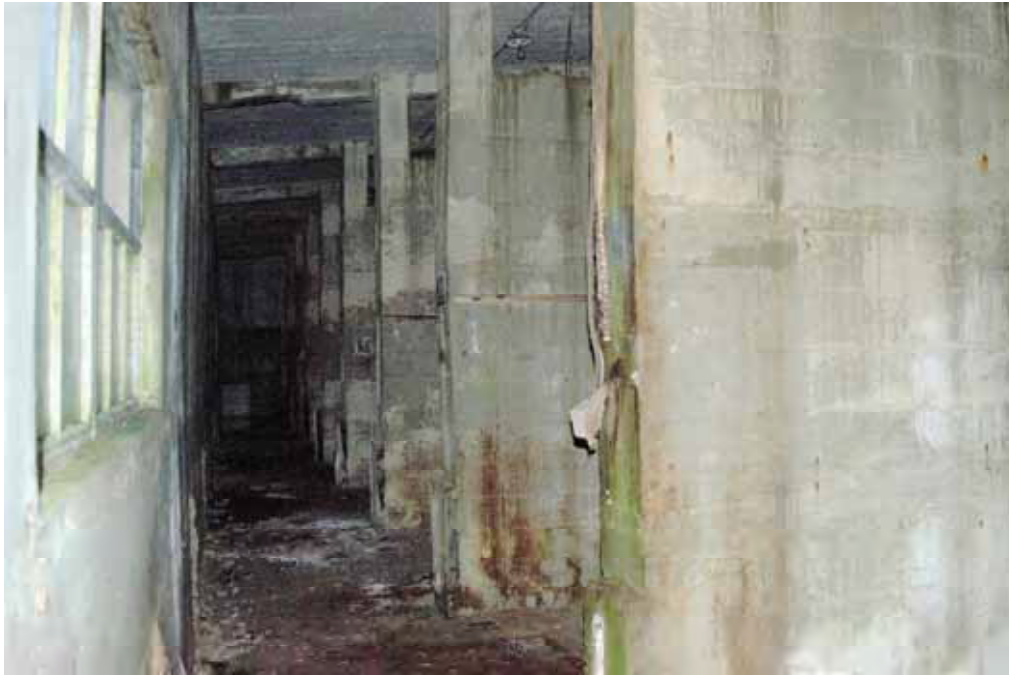
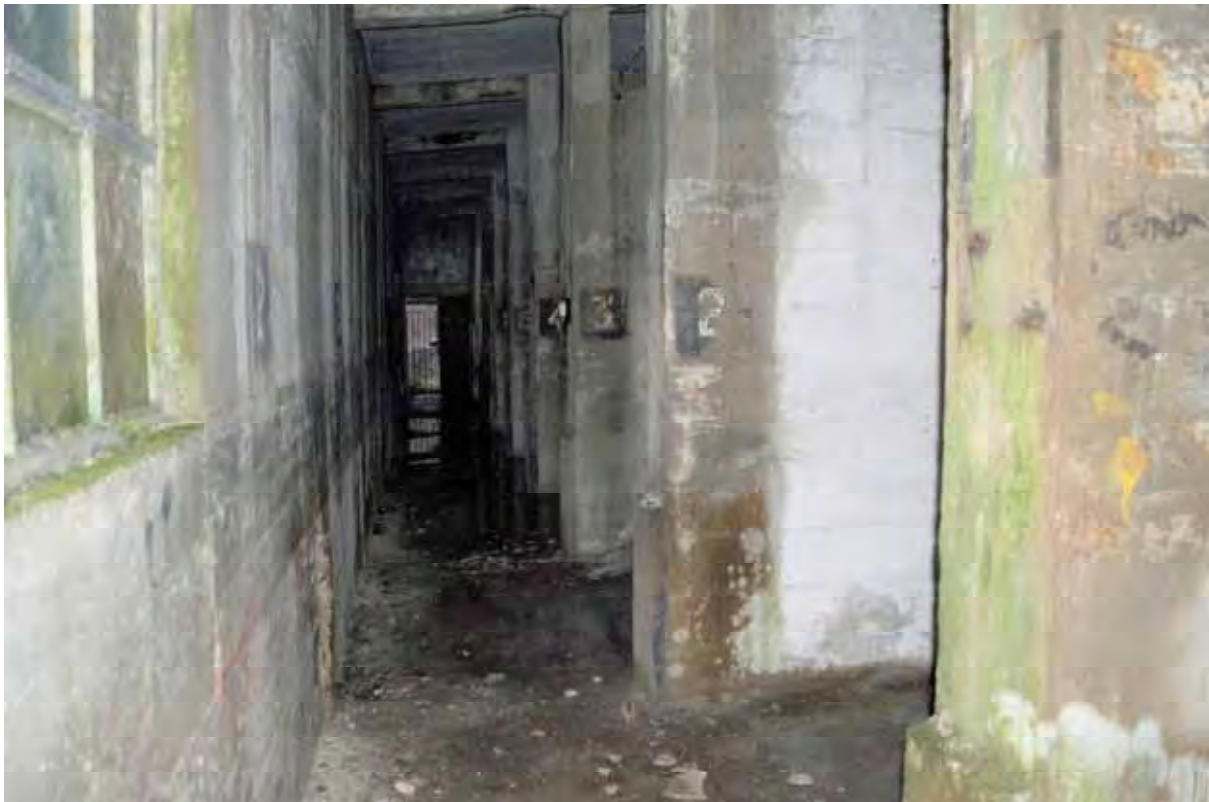
Plate 137: Store 10 – View of the western passage, facing north-west (522)

Plate 138: Store 10 –View of the eastern passage, facing south-east (528)

- 6.31 Internally, the structure differs little from the generic description (Plates 137 and 138). Alterations include the removal of the conveyor system bases, as elsewhere, and the removal of its timber notice board. Bay division signage within the western half has suffered from damp conditions and is such only partially legible; signage within the eastern half is comparatively clear as it is set against a bright white-washed wall (Plate 139). None of the bays contain floor sockets (Plate 140), although the black lines dividing the bins from the passages are no longer visible. A number of the bays have retained their original light fixtures (Plate 141). No other notable features were observed internally.

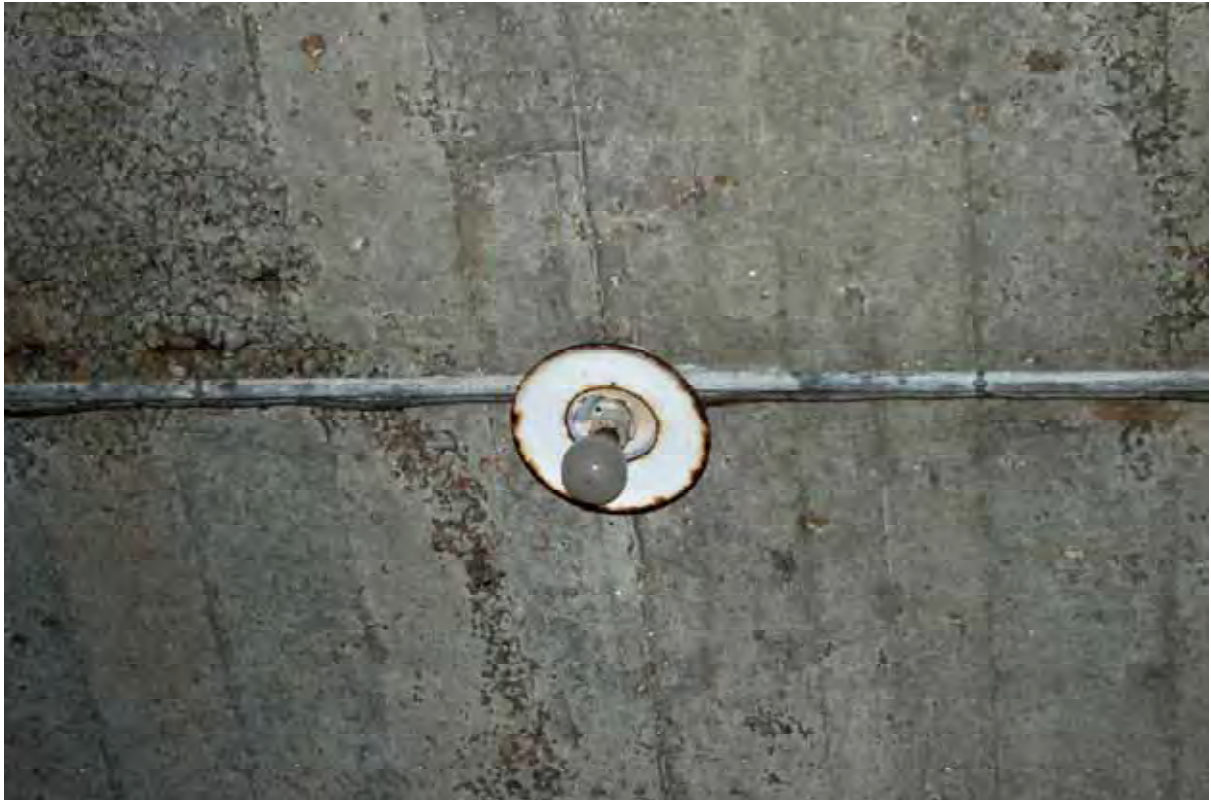
Plate 141: Store 10 – Detail of the retained light fitting within Bin 9, facing south-west (529)

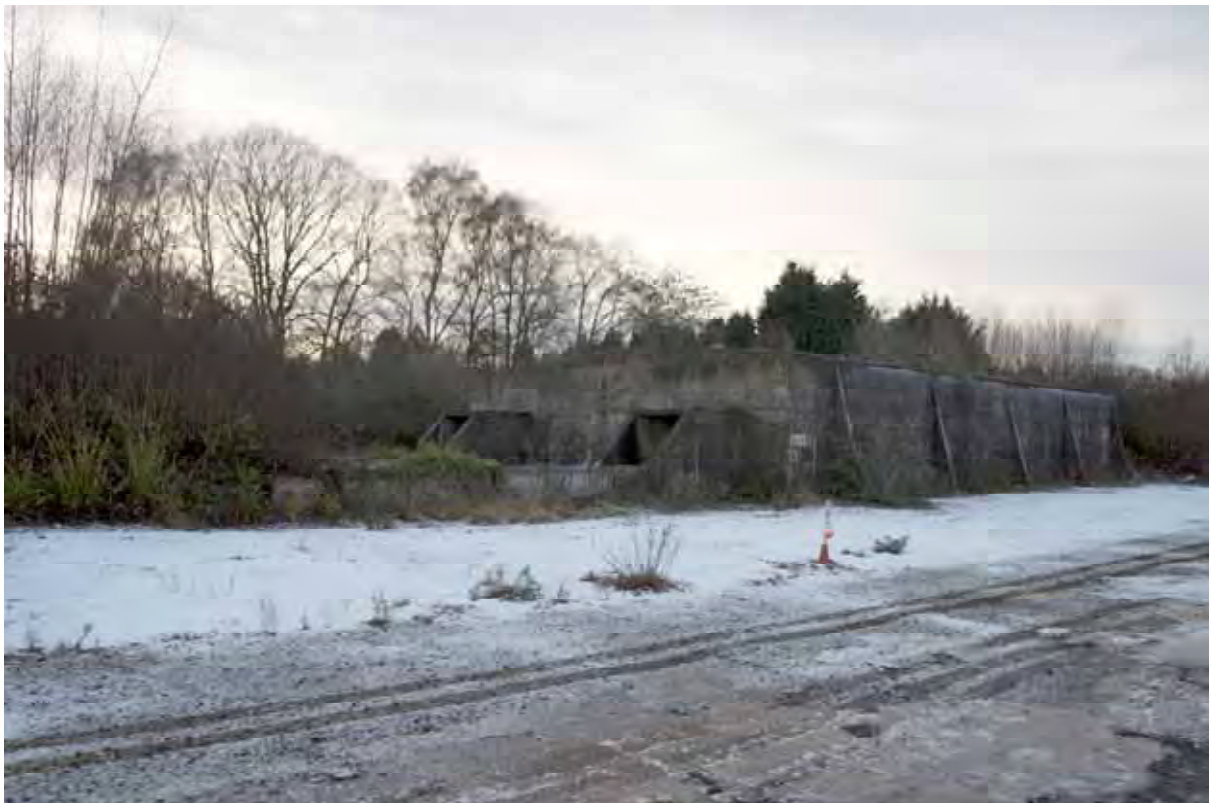
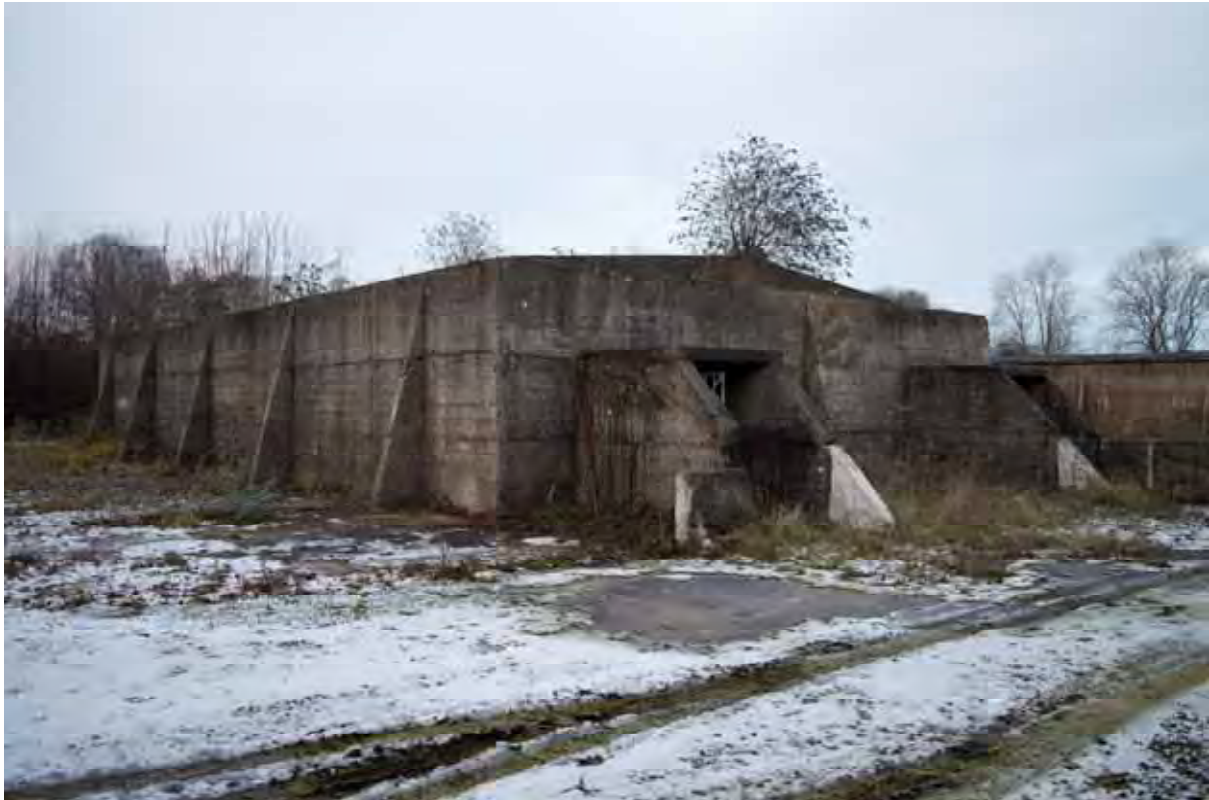
Plate 142: Store 12 – View of the north-east and south-east elevations, facing west (445)

Plate 143: Store 12 – View of the south-east and south-west elevations, facing north (487)

- 6.32 Store 12 (Plates 142 and 143) retains just one of its original earth blast barriers, situated along its north-west elevation (Plate 144). The loading platforms serving the western half of the structure have also been removed. Those serving the eastern half remain and the northern platform retains its original lamp post minus its lamp (Plate 145). To the north-east of the platform is an additional post which forms part of a wider system of timber electricity posts which carry cables between each store. All but one conveyor system base, situated to the eastern side of the northern loading bay, have been demolished.
