**LAND AT COURTLANDS FARM,
PARK ROAD, BANSTEAD, SM7 3EF**

**HISTORIC BUILDINGS RECORD
(HISTORIC ENGLAND LEVEL 4)**

**Historic Buildings Record
(Historic England Level 4)**

**ASE Project No: 171102
Site Code: CFB17**

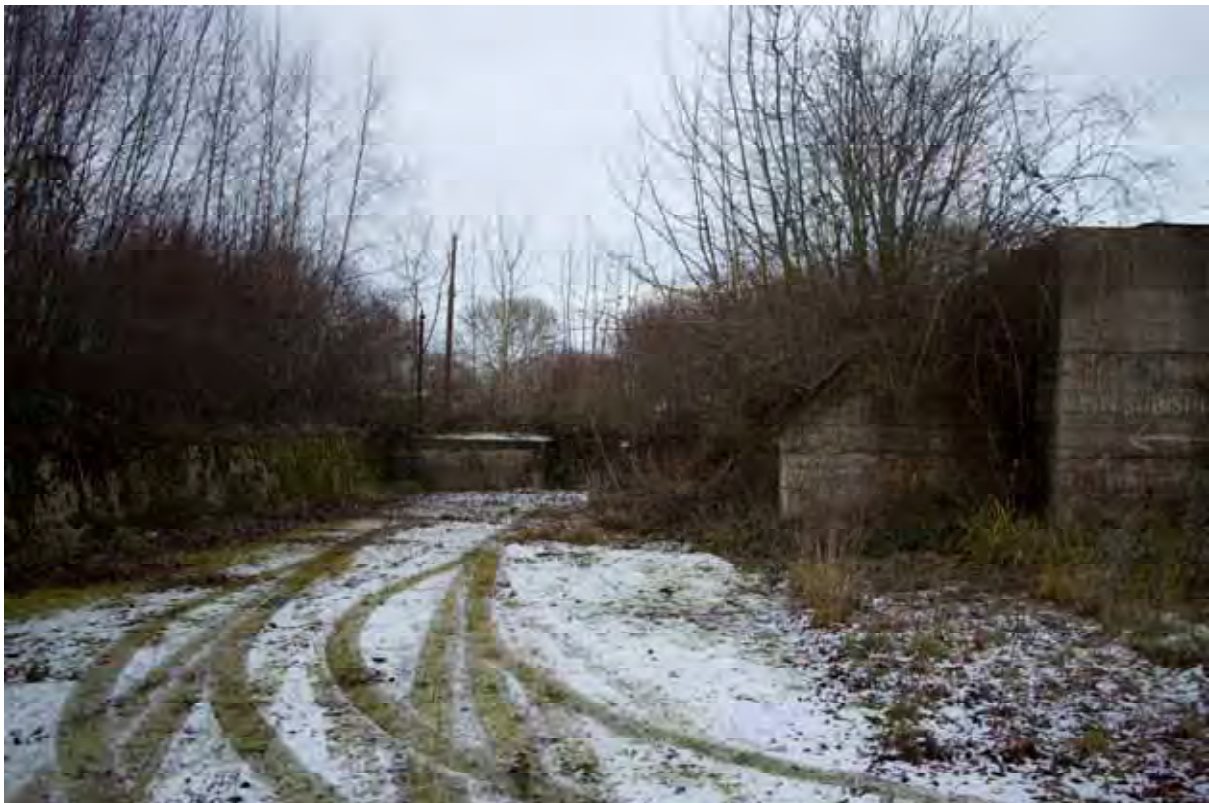
Plate 144: Store 12 – View of the northern loading bay, facing north-east (505)

- 6.32 Store 12 (Plates 142 and 143) retains just one of its original earth blast barriers, situated along its north-west elevation (Plate 144). The loading platforms serving the western half of the structure have also been removed. Those serving the eastern half remain and the northern platform retains its original lamp post minus its lamp (Plate 145). To the north-east of the platform is an additional post which forms part of a wider system of timber electricity posts which carry cables between each store. All but one conveyor system base, situated to the eastern side of the northern loading bay, have been demolished.

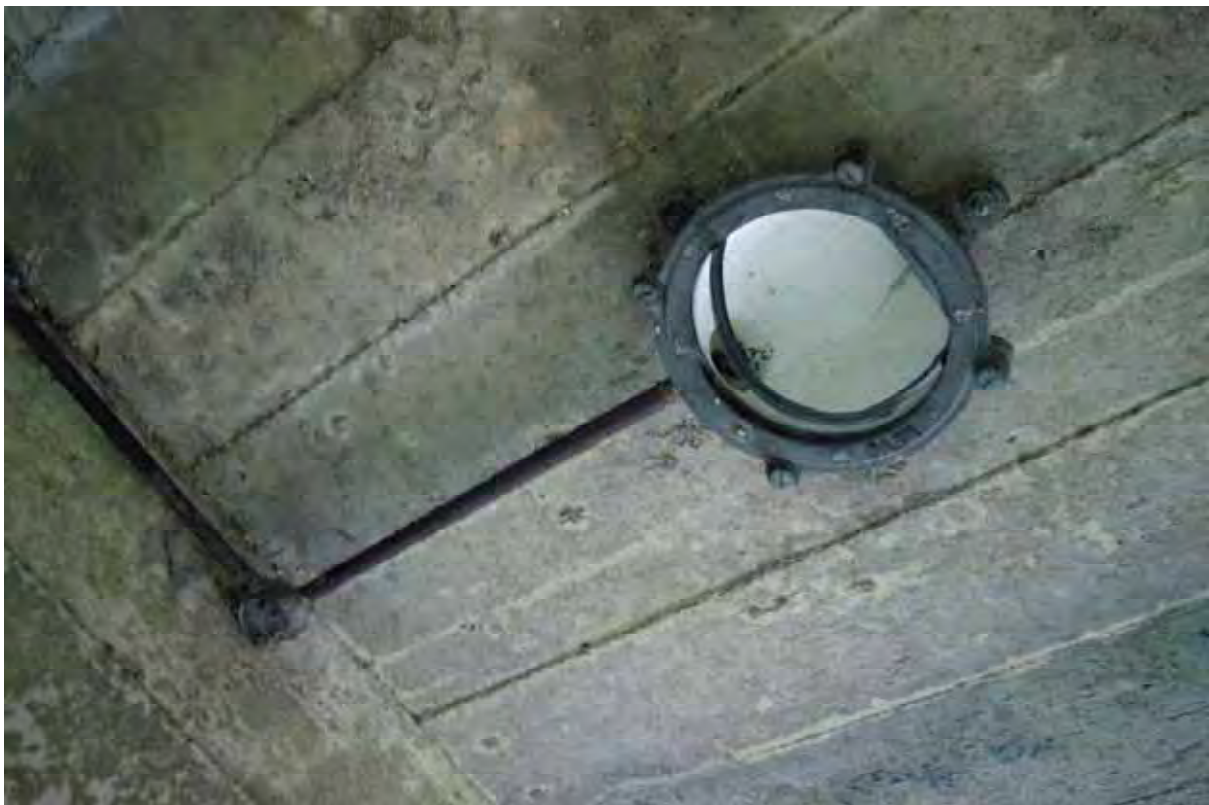
Plate 146: Store 12 – Detail of the lamp fitting serving the western entrance of the southern loading bay, facing south-west (500)

- 6.33 The southern covered entrance serving the western half of the store contains a good example of a 'Revo' light fitting (Plate 146) and fire hydrant signage (Plate 147), as described within the principal description. Situated at this entrance is a displaced steel girder, as elsewhere, which likely comprises part of the dismantled conveyor system. The western doorway accessed from the southern loading bay, contains 'Vent Class A' stencilling on its external face, as does the western doorway accessible from the northern loading bay (Plate 148). The northern doorway signage is particularly clear and shows signs of different phases of markings as elsewhere (Plate 149). All doors are fitted with rotating steel hook fastenings (Plate 150), which appear to have been added at a later date, given the absence of similar fixings on any of the other stores.

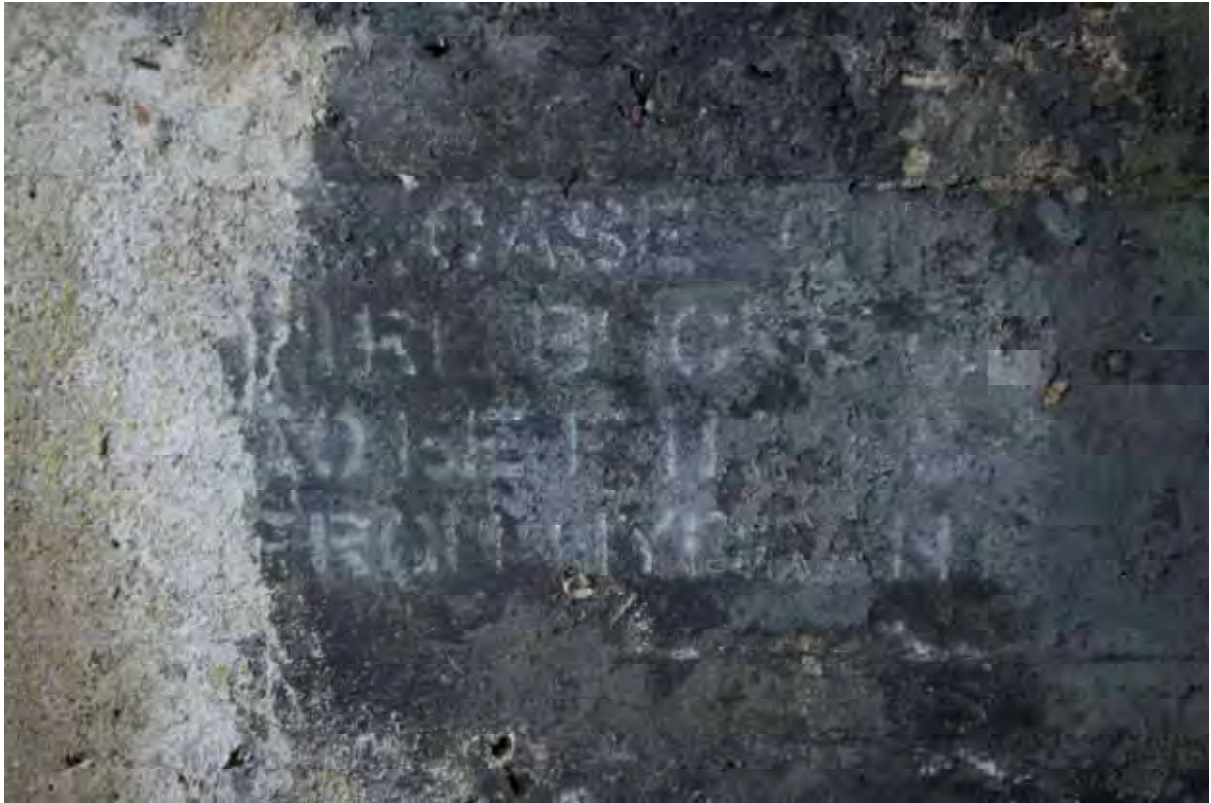
Plate 147: Store 12 – Detail of the fire hydrant signage situated on the south-west wall of the western entrance serving the southern loading bay, facing west (492)

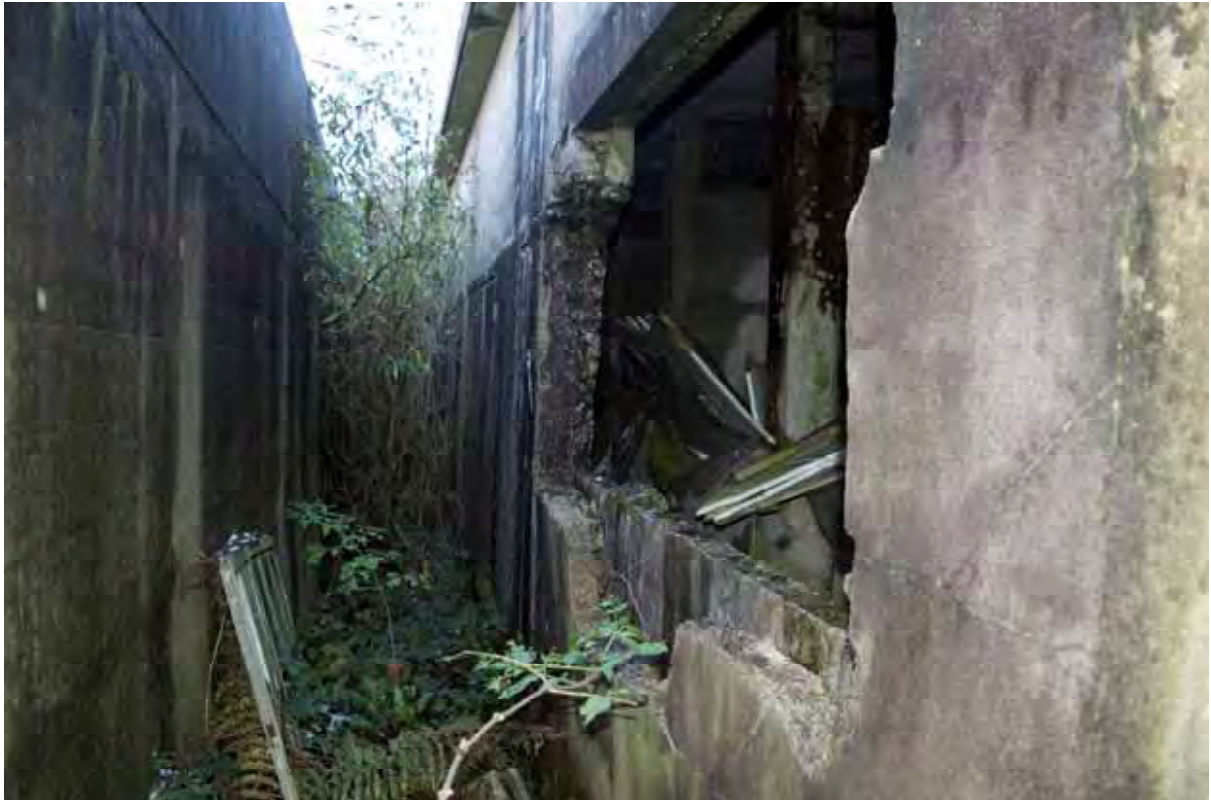
Plate 151: Store 12 – View of the western walkway, note the removal of the window from the south-west elevation of the inner structure, facing north-west (494)

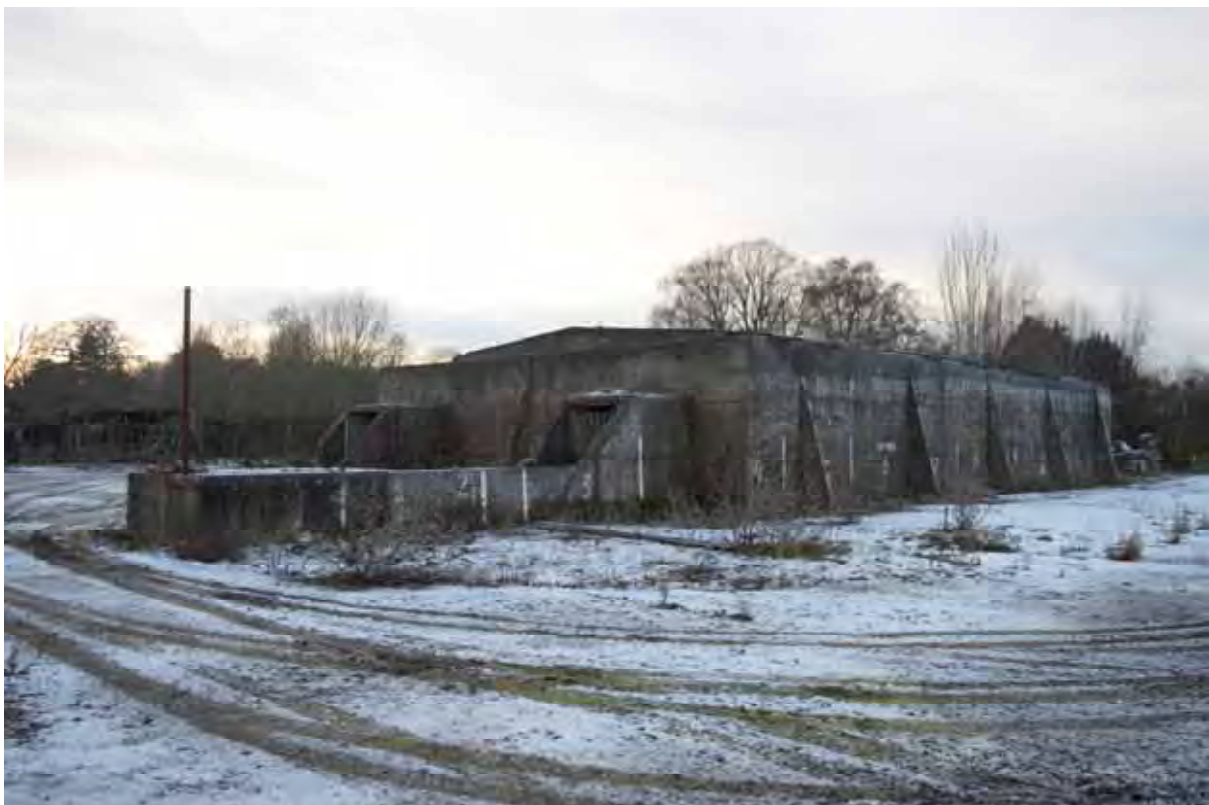
Plate 154: Store 14 – View of the north-east and south-east elevations, facing west (453)

- 6.35 Store 14 (Plate 154) is contained on its north-western side by one remaining earth blast barrier (Plate 155). The loading platforms serving the eastern half of the structure remain *in situ*, whereas those to the west have been demolished, with only fragmentary footings remaining. The southern loading platform (Plate 156) retains elements of its lighting, although the lamp itself no longer survives. The western loading platform to the north of the structure appears to have been demolished to accommodate the construction of Building 13, which post-dates the 1990 mapping. The northern loading bay has undergone various alteration since construction, principally due to the structure's use as a piggery during the latter half of the 20th century by Albert Sparrowhawk (BHRG, 2006). Alterations include the partial closing of the eastern entrance with a low level concrete block wall, and the construction of a concrete wall adjacent to the western entrance. It is likely this wall formed part of an enclosure between the store and adjacent earth blast barrier (Plate 157) (now Building 13). The blocking of the eastern entrance is likely to have been part of a managed circulation system, ensuring livestock could not access this area to the east of the earth blast barrier. To the immediate north-east of the northern loading bay (Plate 158), are the former containment walls for the removed earth blast barrier which originally separated Stores 8 and 9. All but three of the conveyor system bases have been removed.

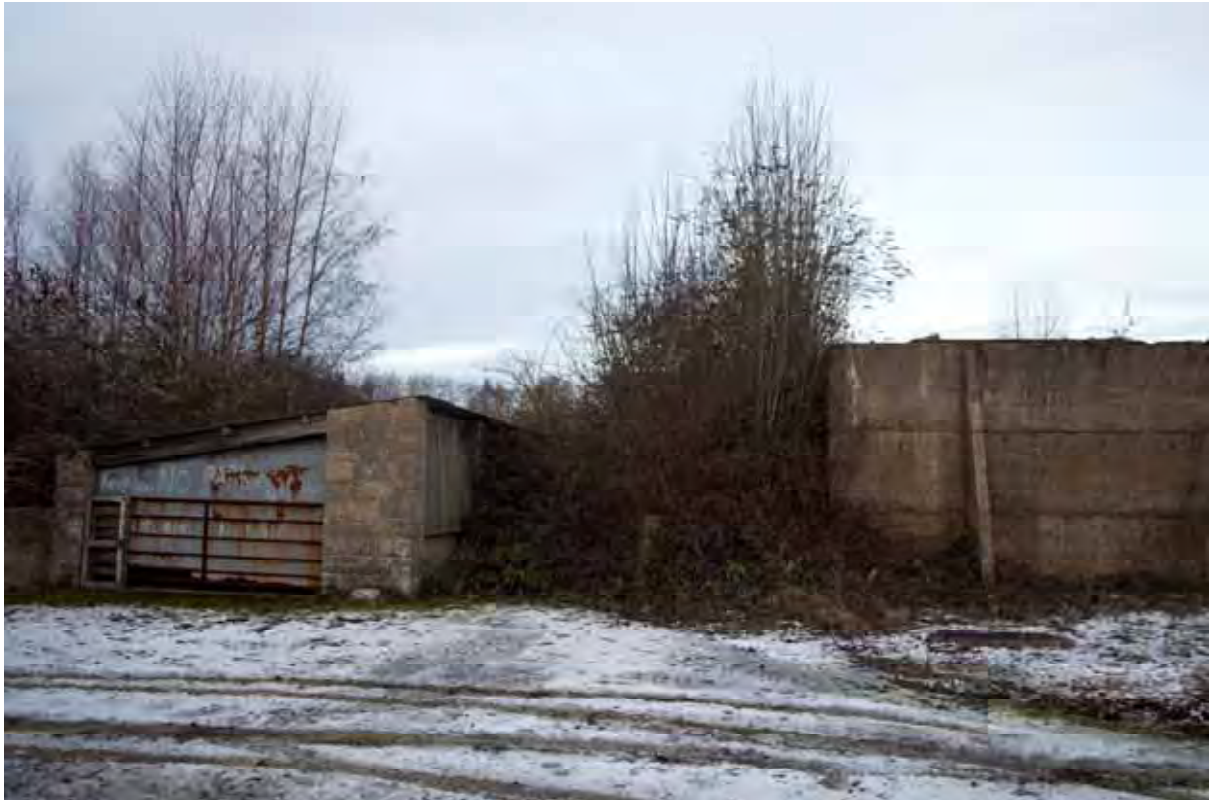
Plate 155: Store 14 / Building 13 – View of the northern loading bay, note the retained earth blast barrier, facing north-east (483)

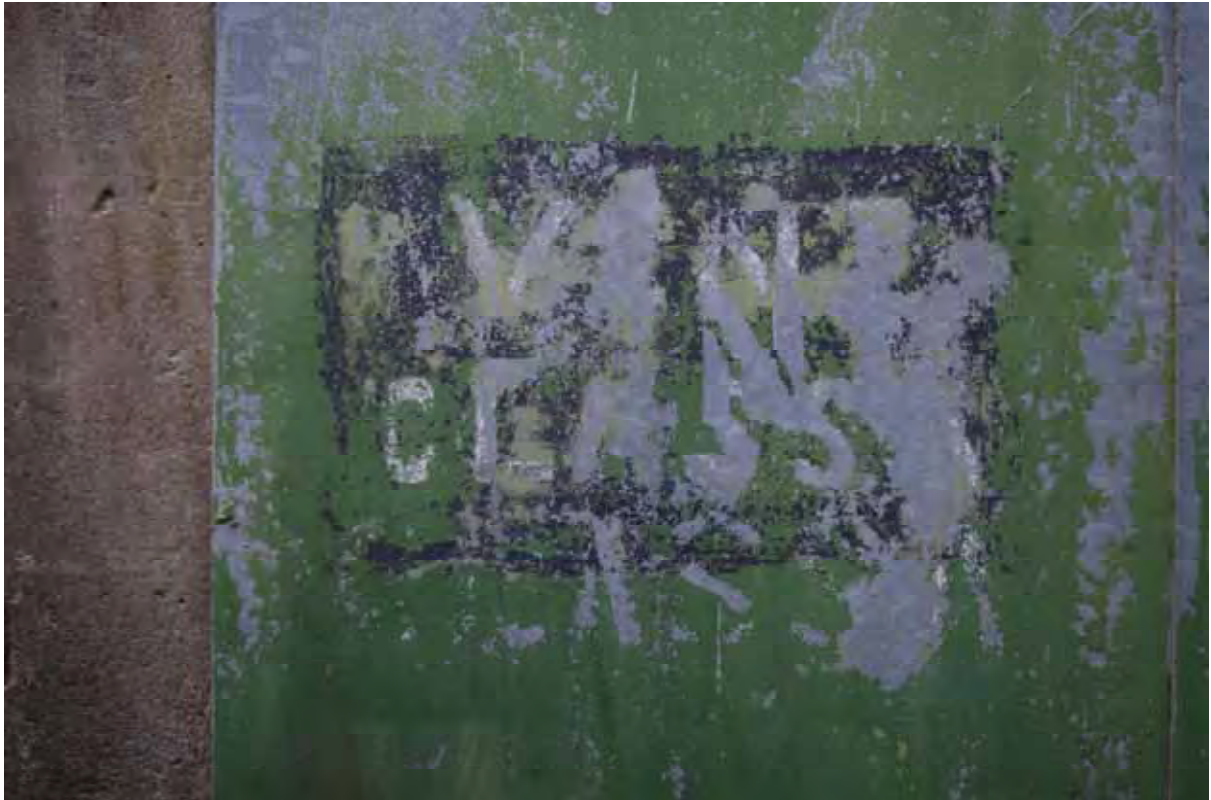
Plate 159: Store 14 – Detail of the eastern door signage serving the southern loading bay, facing north-west (458)

- 6.36 The southern entrance serving the eastern half of the structure is marked with the 'Vent Class A' signage (Plate 159), as previously described. The southern doorway serving the western side of the store, is marked with a hand-painted 'B'. Fire hydrant signage has been retained on their western entrance serving the southern loading bay (Plate 160).

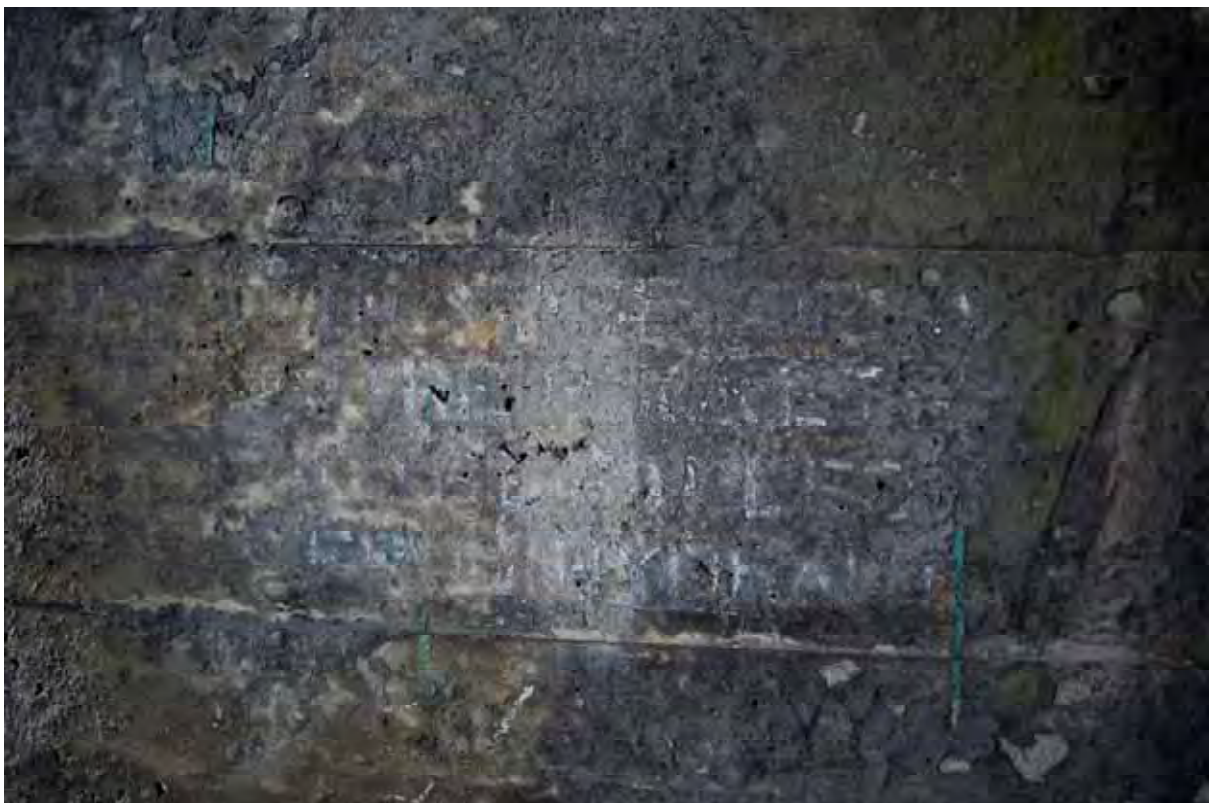
Plate 160: Store 14 – Detail of the fire hydrant signage on the south-west wall of the western entrance serving the southern loading bay, facing west (476)

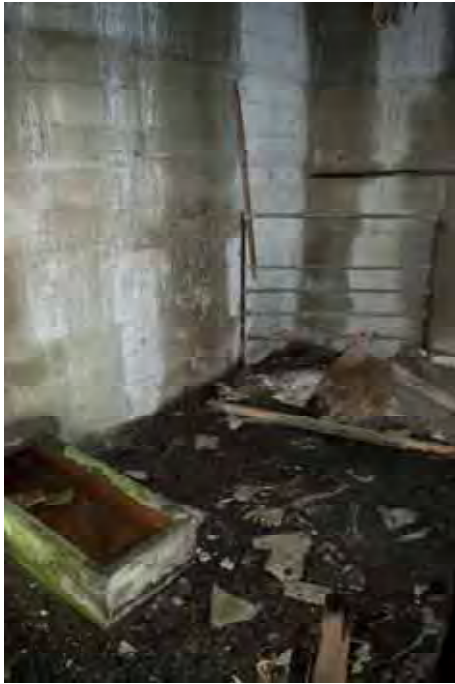
Plate 163: Store 14 – View of the alterations made within each of the eastern bays to accommodate the store's later use as a piggery, facing south-west (469)

- 6.37 The interior of the store (Plates 161 and 162) has been modified to accommodate its use as a piggery from the 1960s onwards. Each bay (Plate 163) has been fitted with a tubular steel grate feeding rack in its far northern corners and a trough to the southern side, adjacent to the passage. Each trough (Plate 164) comprises a cast concrete surround, filled with a glazed terracotta half-section pipe. Securing each bay / pen were steel bar gates, one of which remains within the southern end of the western passage. The gates were secured to a series of L-brackets (Plate 165), which have been secured to the end of each bay containment wall. A number of bays / pens retain ephemeral timber framework and plastic sheeting below the roof openings, which appears to have formed a rudimentary ceiling, presumably added for insulation purposes. Bay signage within each half is significantly degraded and little of the original features survive. An exception to this is the retention of a number of original back-plate light fittings (Plate 166) within the eastern bays. Mid-20th century electric lighting has been strung along the eastern passage wall, lighting each bay following the insertion of the modern ceilings.

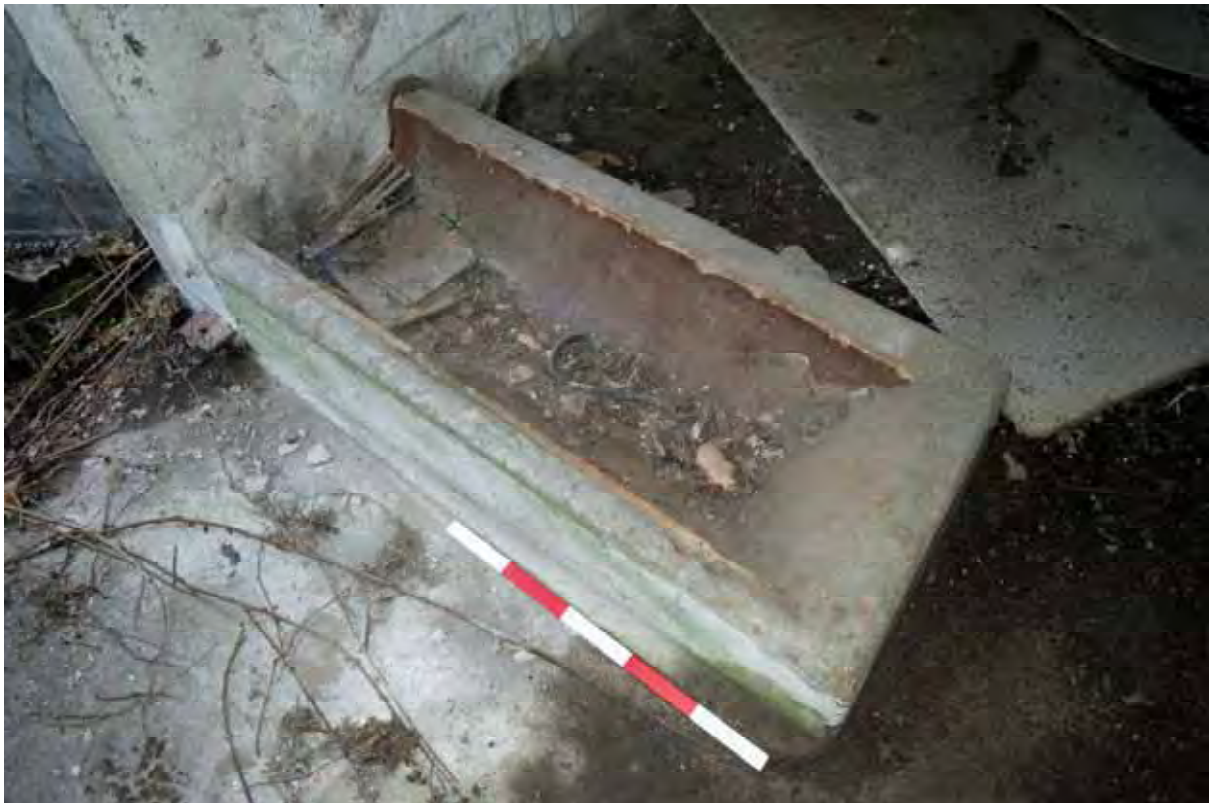
Plate 164: Store 14 – Detail of the troughs situated within each of the eastern bays, facing south (465)

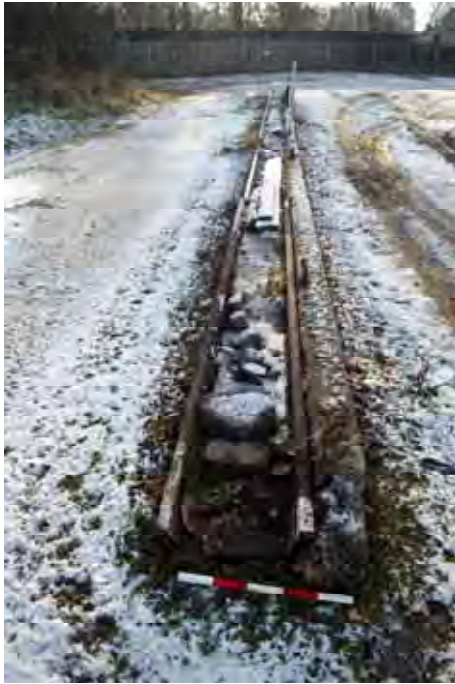
Plate 167: Detail of the feature situated along the site's south-eastern end, aligned south-west – north-east, facing south-west (366)

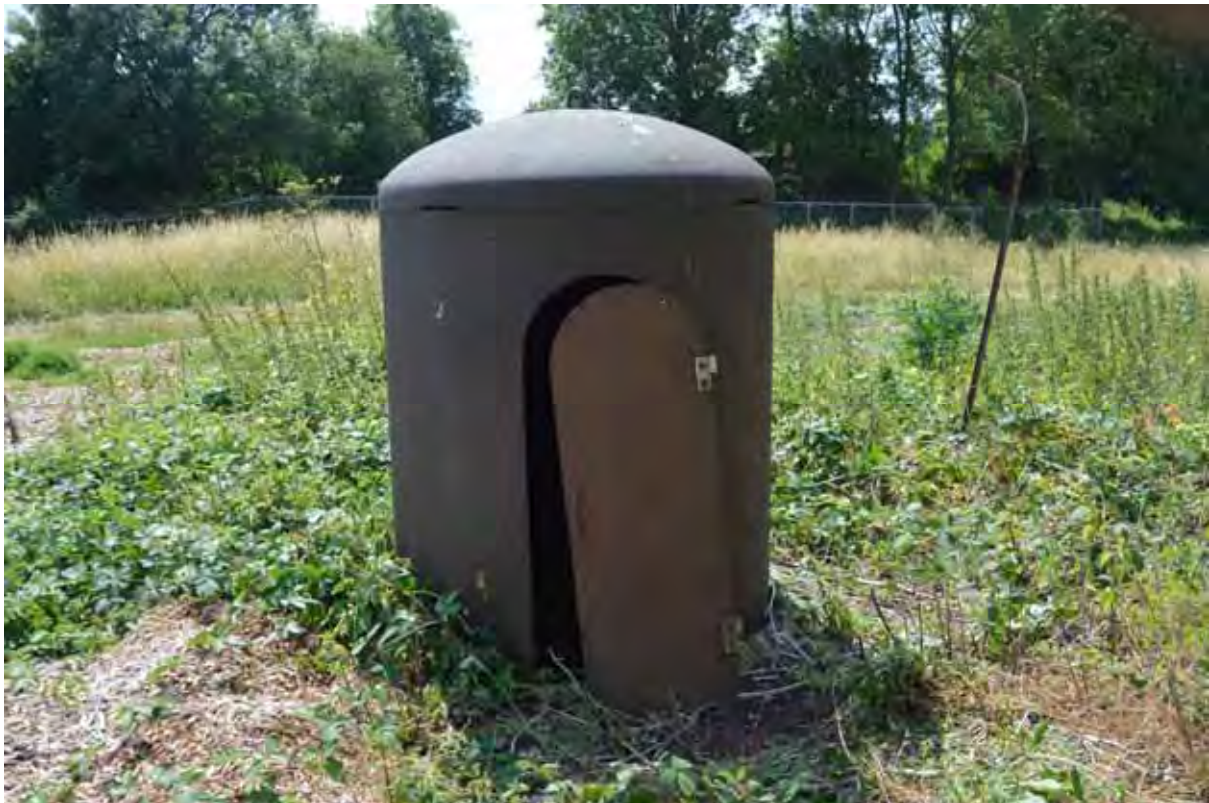
Plate 168: View of the north-eastern sentry post, facing south-west (620)

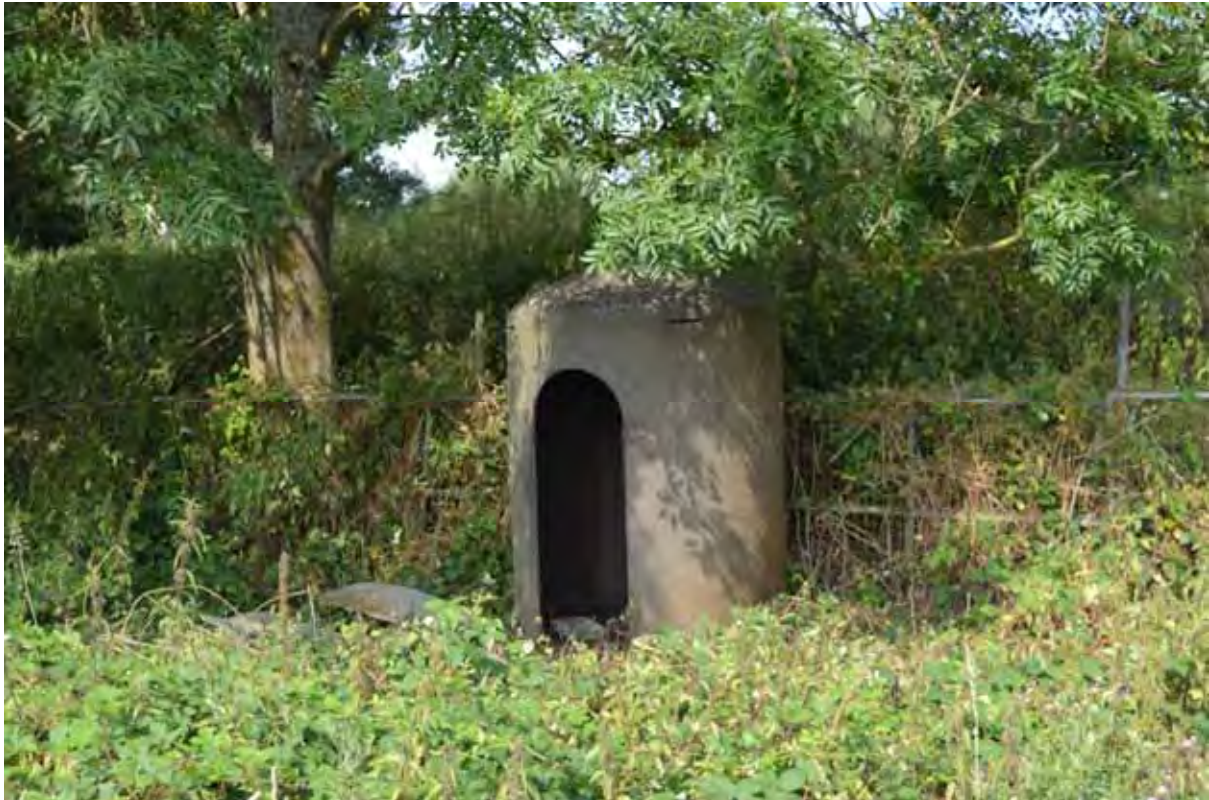
Plate 169: View of the south-eastern sentry post, facing north-west (590)

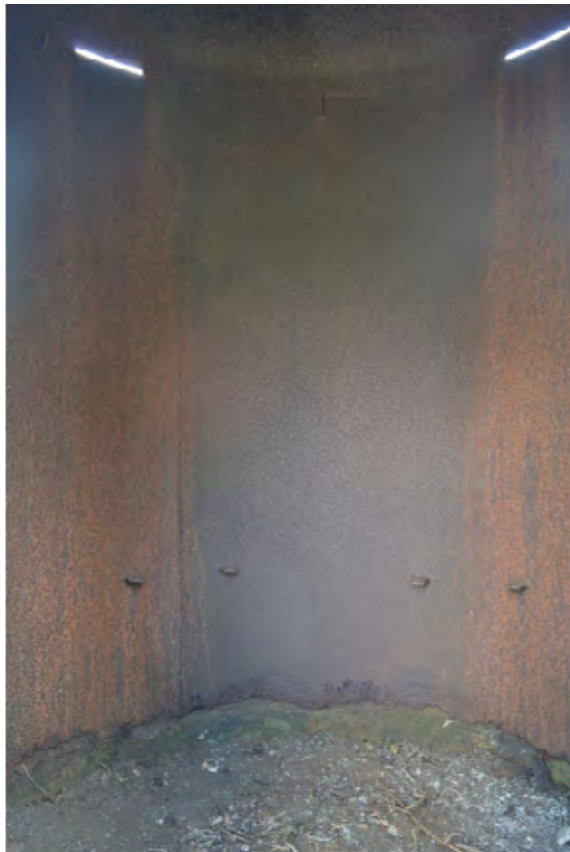
Plate 170: Internal view of the north-eastern sentry post, note the welded construction, facing south-west (619)

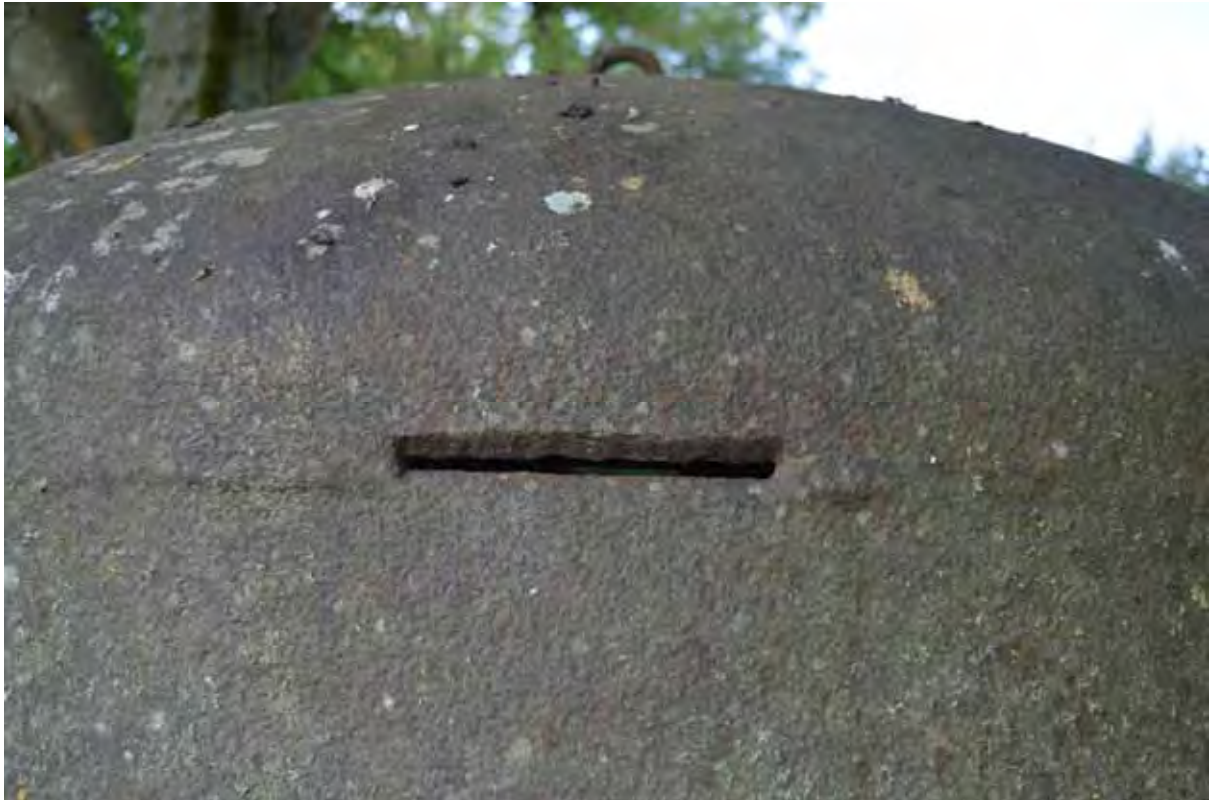
Plate 171: Detail of the air vent around the top of the south-eastern sentry post, facing north-east (593)

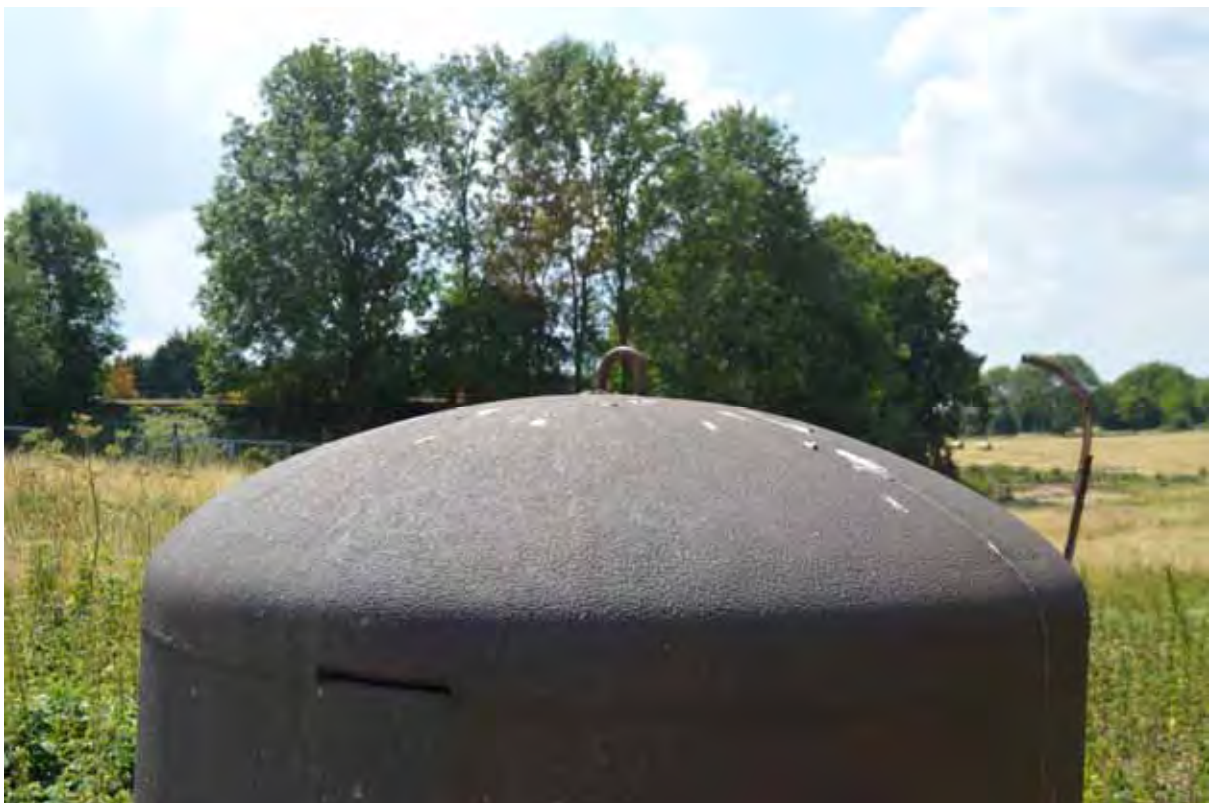
Plate 172: View of the north-eastern sentry post roof, note the central hoop, facing west (618)

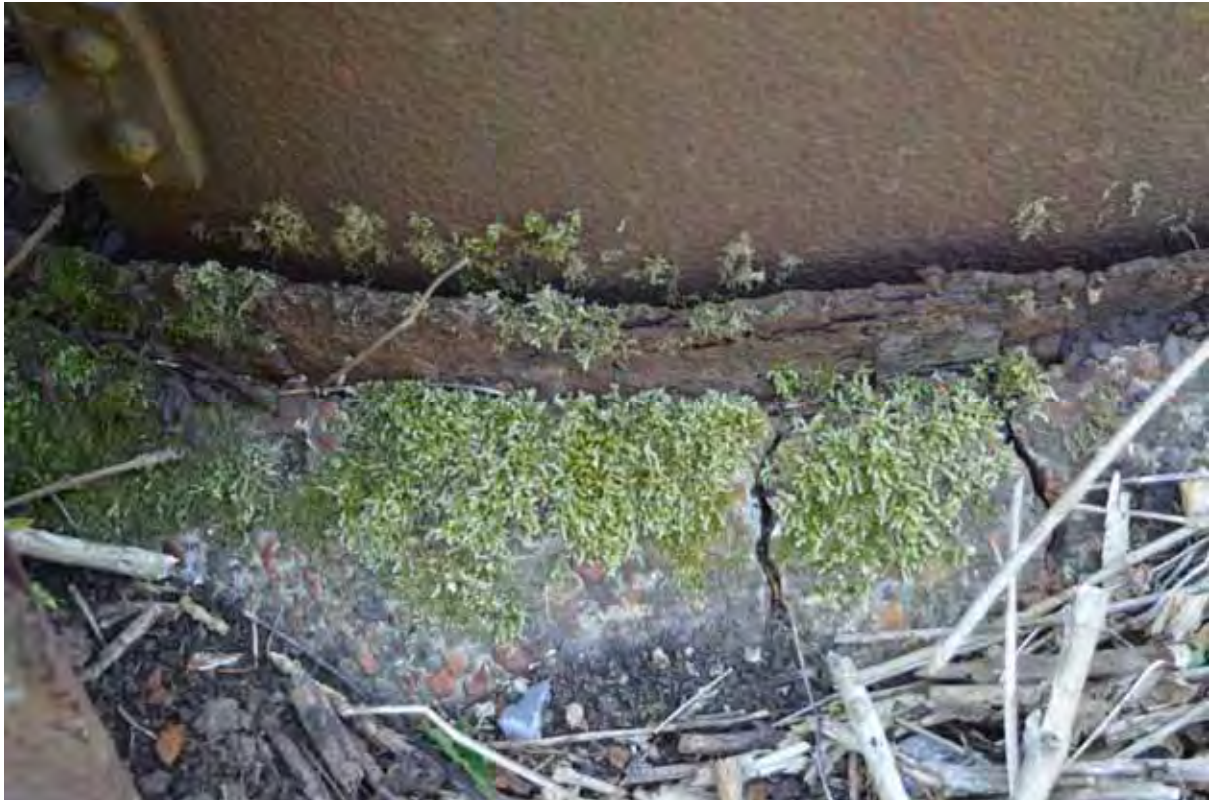
Plate 173: Detail of the hoop frame at the base of the north-eastern sentry post, facing south-west (621)

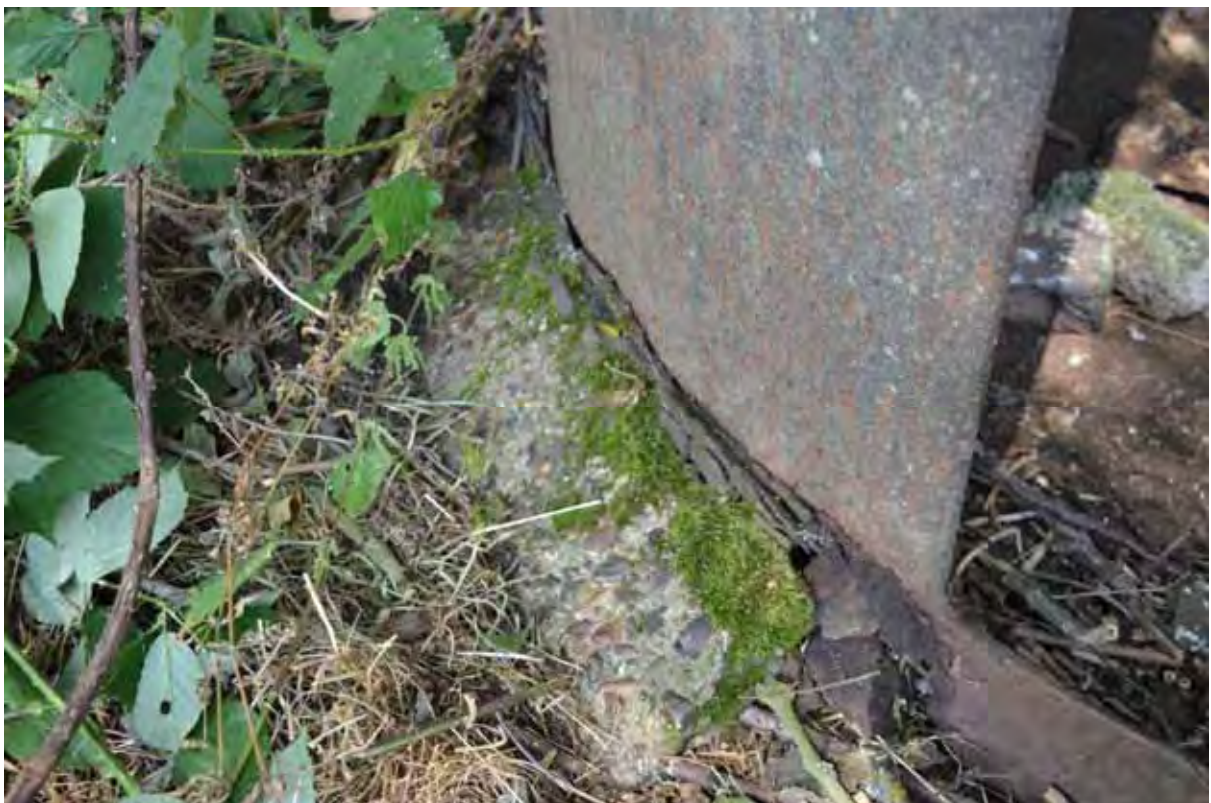
Plate 174: Detail of the ramped mortar base edge beneath the south-eastern sentry post, facing north-west (597)

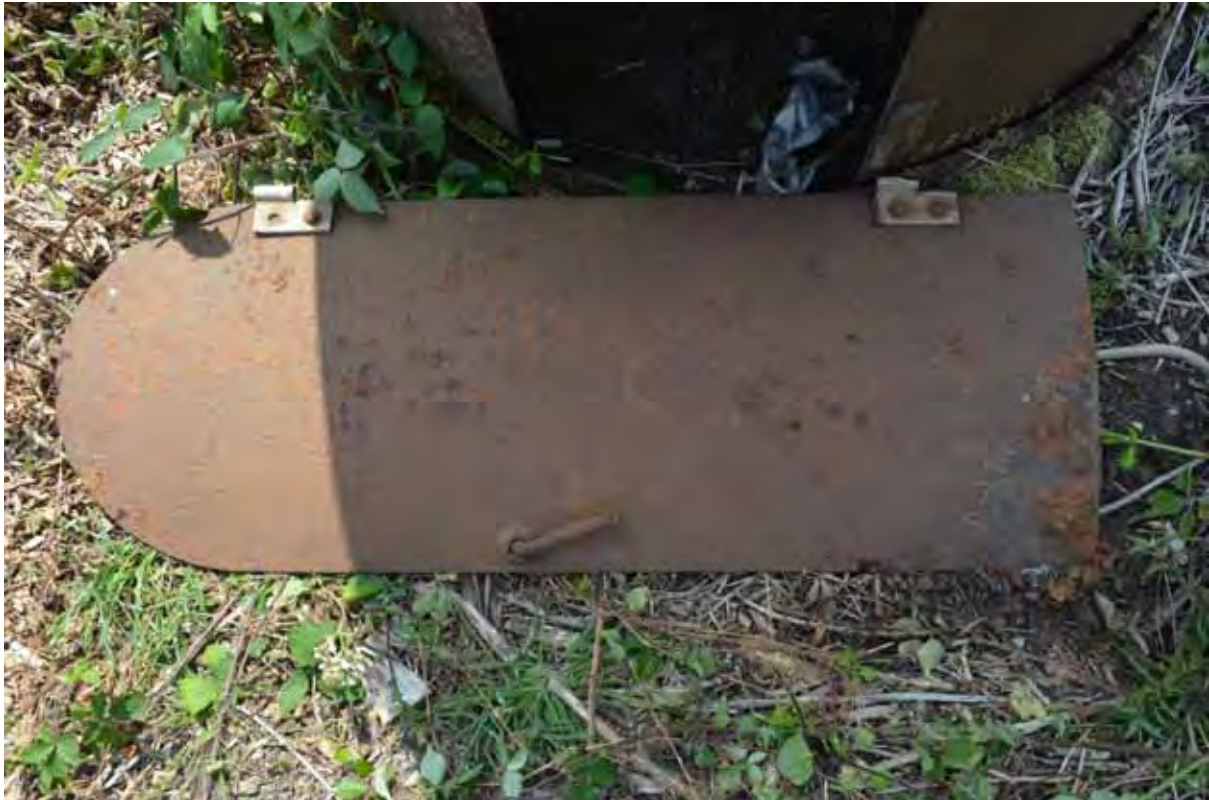
Plate 175: Detail of the detached door adjacent to the north-eastern sentry post, facing south-west (614)

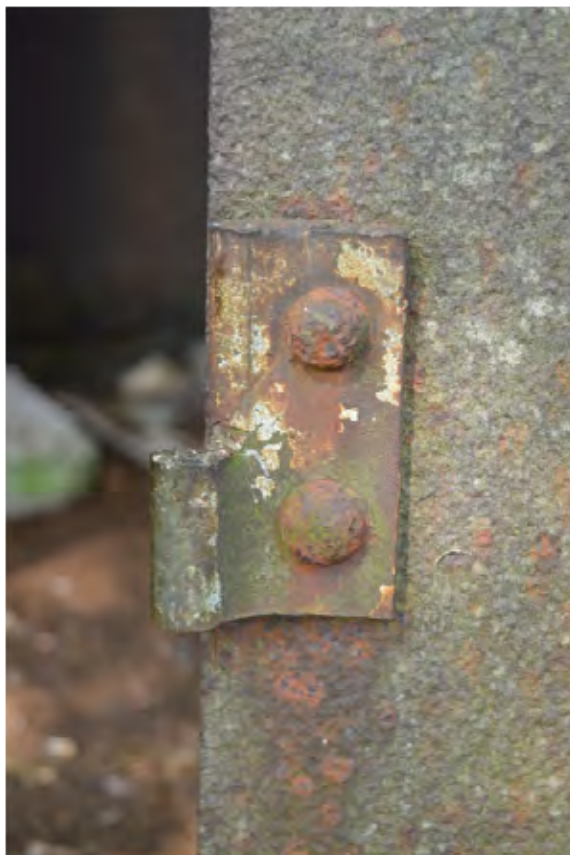
Plate 176: Detail of a door hinge serving the doorway on the south-eastern sentry post (592)

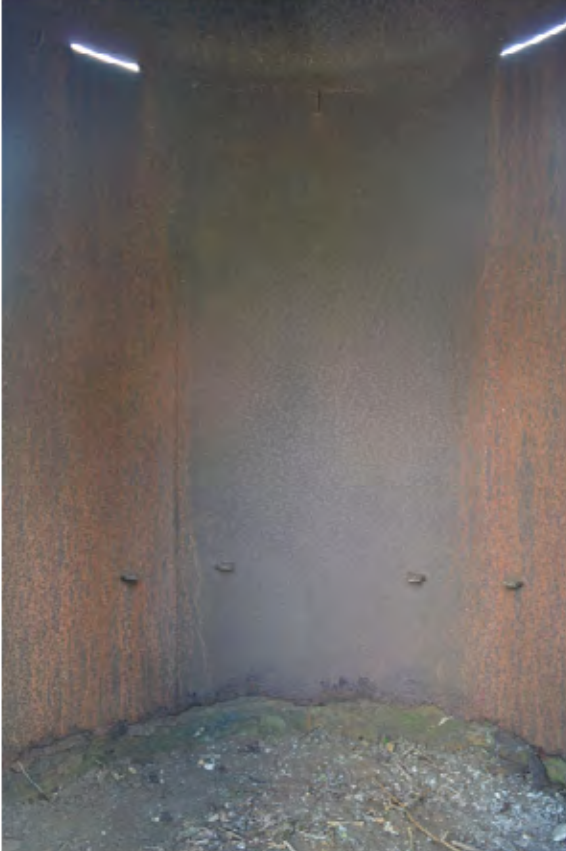
Plate 178: Internal view of the north-eastern sentry post, facing south-west (619)

- 6.42 The interior (Plates 177 and 178) of each sentry post measures a diameter of 1.35m, with a maximum height of 1.95m. Originally, the structure would have accommodated two opposing benches, suitable for two people in total. These have since been removed, however, the steel fittings that would have supported bench brackets remain *in situ* (Plate 179). These comprise four flat-plate steel fittings to each former bench, each containing a single hole, presumably for bolt fixings and each is welded to the interior wall face. Examples of these benches are typically found in sentry air-raid posts of a conical shape, for example those on display at Amberley Working Museum and Eden Camp, North Yorkshire (Figure 29). In addition to the benches are five steel hooks (Plate 180); two above each bench and one set centrally opposite the doorway. Each is located to the top of each wall plate and is welded in place. These are likely to be for equipment/coat storage. The only other notable internal feature is a welded steel flat-plate fillet (Plate 181), which lines the internal face of the semi-circular door arch. This would have prevented the door from swinging into the shelter during the resultant force of an air-raid, either due to direct blast impact or air turbulence.

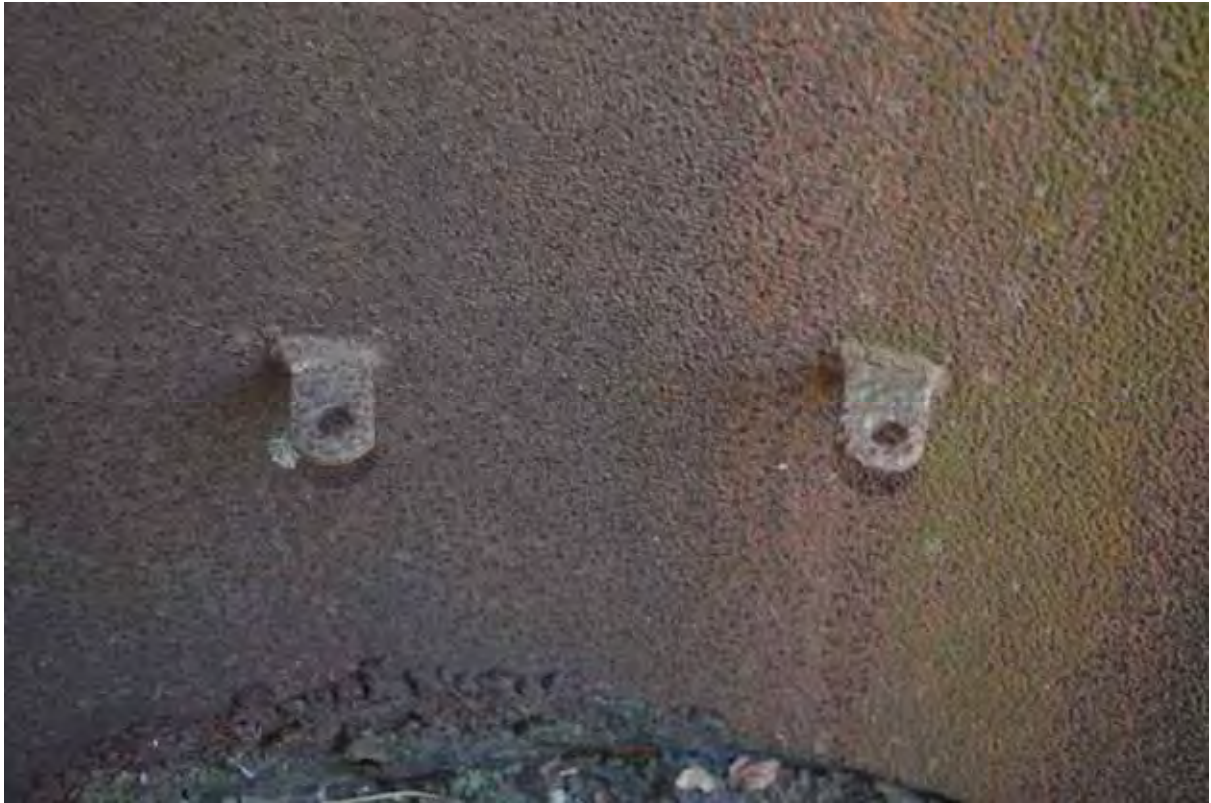
Plate 179: Detail of the bench brackets to either side of the north-eastern sentry post, facing south (617)

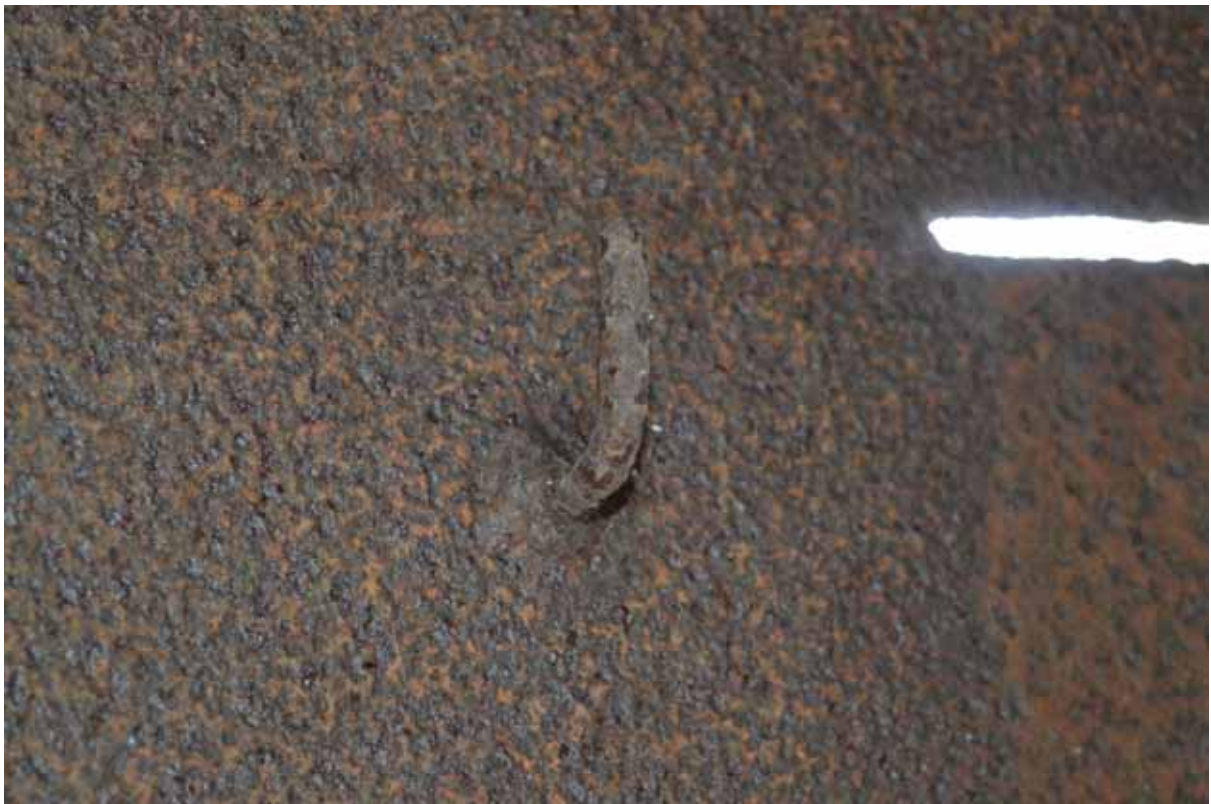
Plate 180: Detail of a hook within the south-eastern sentry post, facing south-west (598)

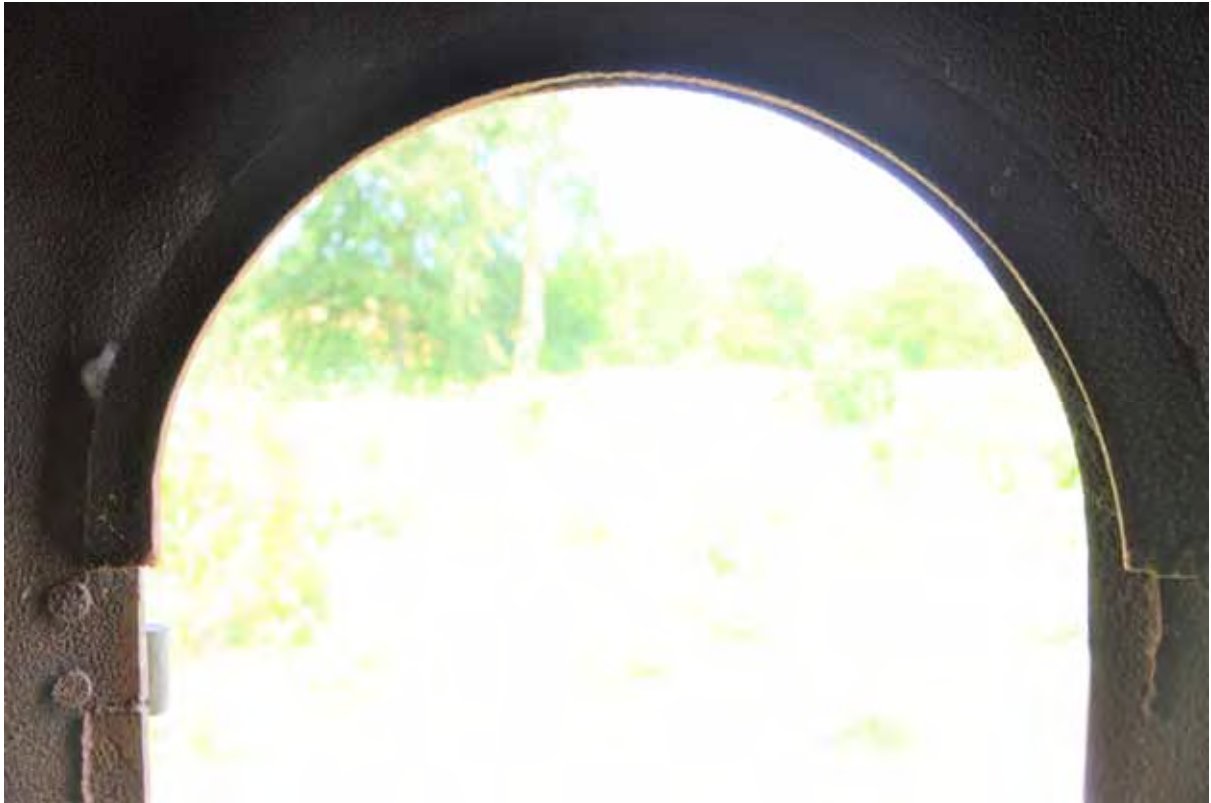
Plate 181: Detail of the doorway arch within the north-eastern sentry post, facing north-east (615)
