**LAND AT COURTLANDS FARM,
PARK ROAD, BANSTEAD, SM7 3EF**

**HISTORIC BUILDINGS RECORD
(HISTORIC ENGLAND LEVEL 4)**

**Historic Buildings Record
(Historic England Level 4)**

**ASE Project No: 171102
Site Code: CFB17**

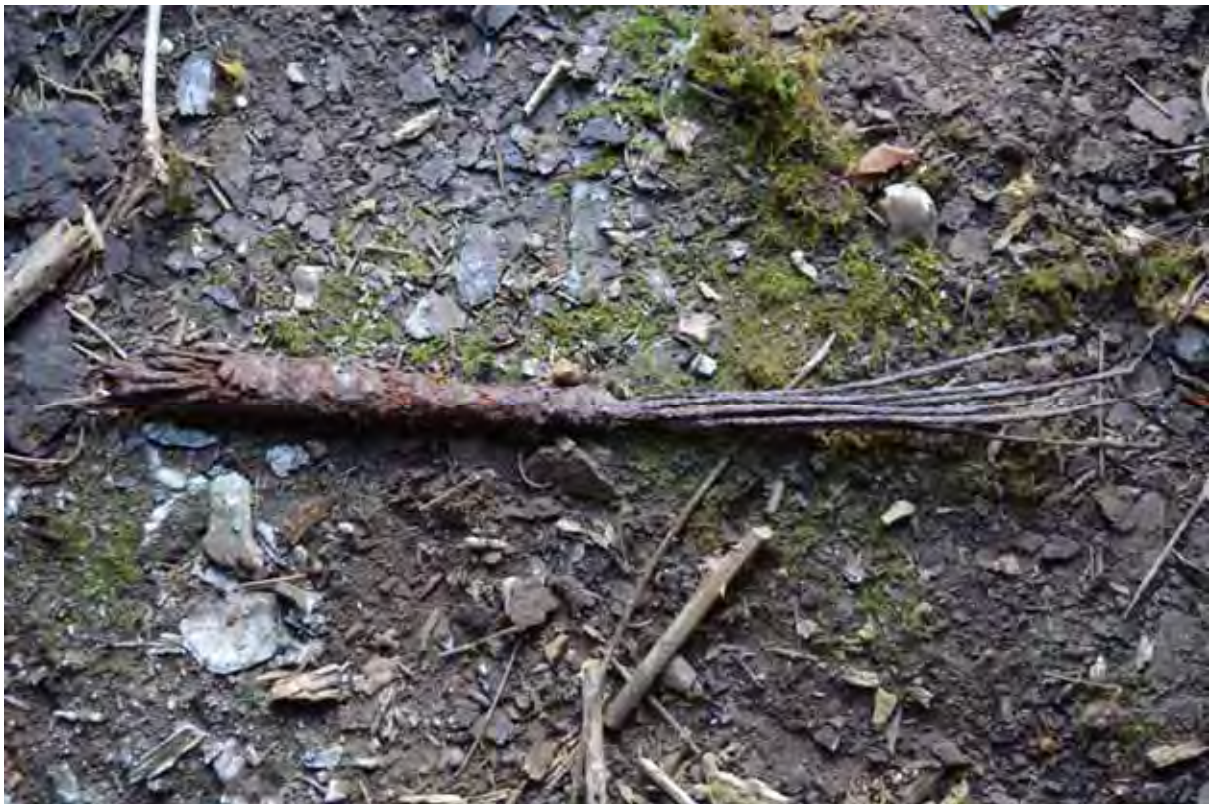
Plate 182: Detail of the wire found within the north-eastern sentry post, facing north-east (616)

- 6.43 Miscellaneous objects found within the north-eastern structure included a small amount of heavily corroded steel wire (Plate 182), the nature of which would not be ascertained. The south-eastern structure contained four fragmentary pieces of modern cinder block, one fragment of glazed ceramic (unmarked) pot, the remains of a 20th century brick, five partial painted timber shards and three aluminium sheets (Plate 183). The aluminium sheets (Plate 184) are common to those associated with water tanks and as with all other items, are thought to be unrelated to the sentry box. Two curved steel brackets (Plate 185) were also found within the south-eastern structure, and are identical to those forming the original fencing along the north-eastern site boundary. These are therefore thought to be displaced fence brackets from the south-eastern site boundary, which no longer remains *in situ*.

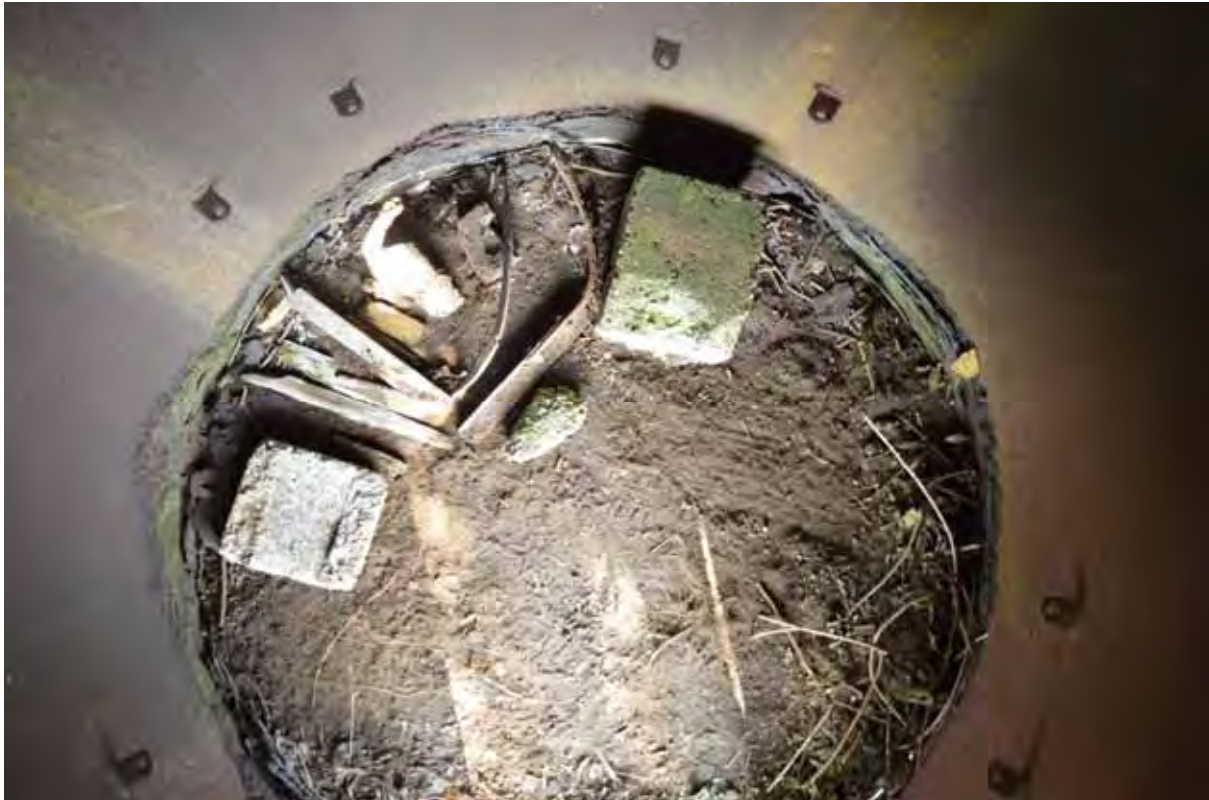
Plate 183: View of the miscellaneous material found within the south-eastern sentry post, facing north-west (591)

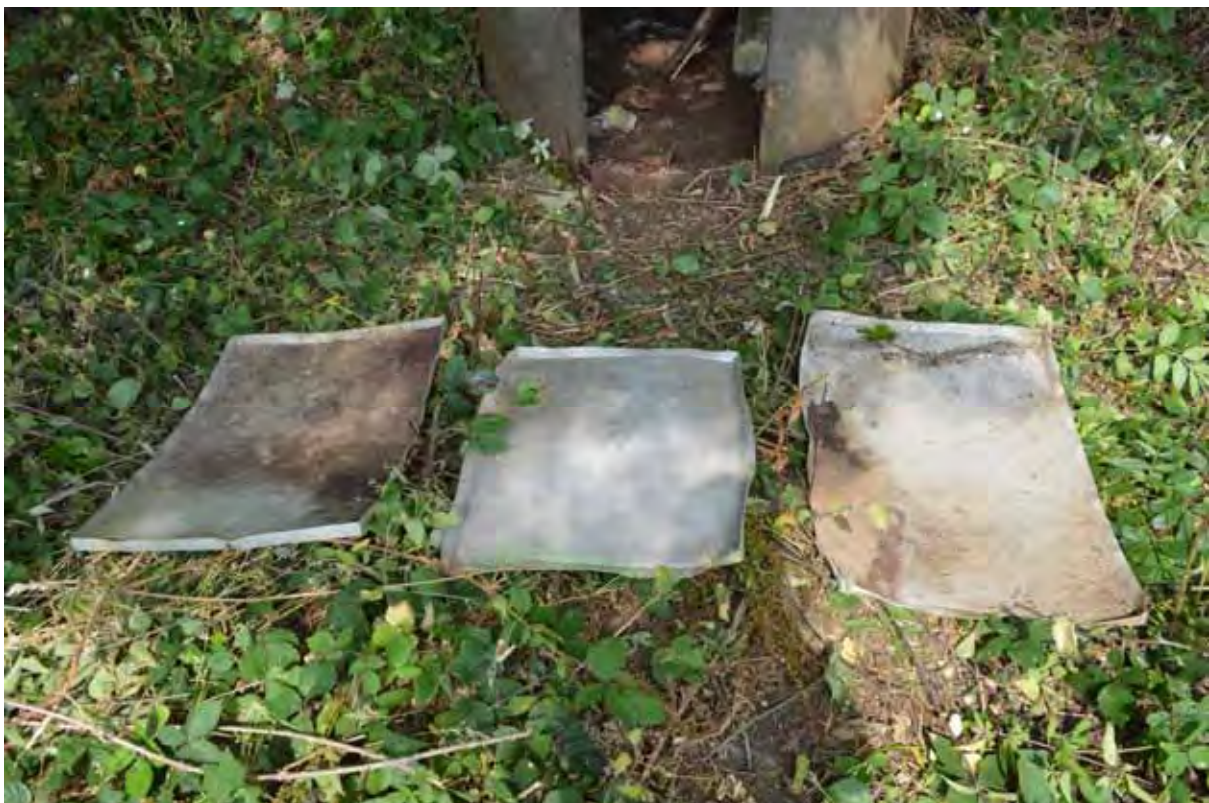
Plate 184: Detail of the aluminium sheets found within the south-eastern sentry post, facing north-west (596)

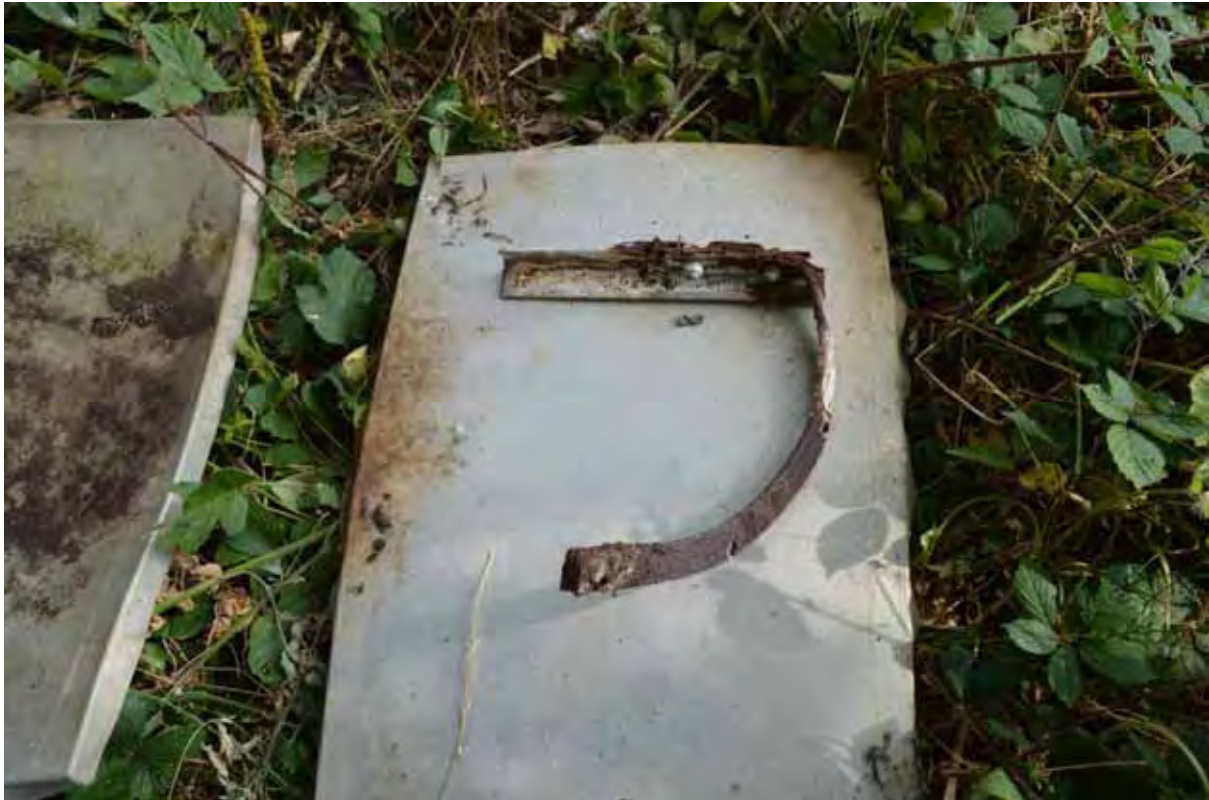
Plate 185: Detail of the fragmentary perimeter fence brackets found within the south-eastern sentry post (placed on aluminium sheet for photographic purposes) (595)

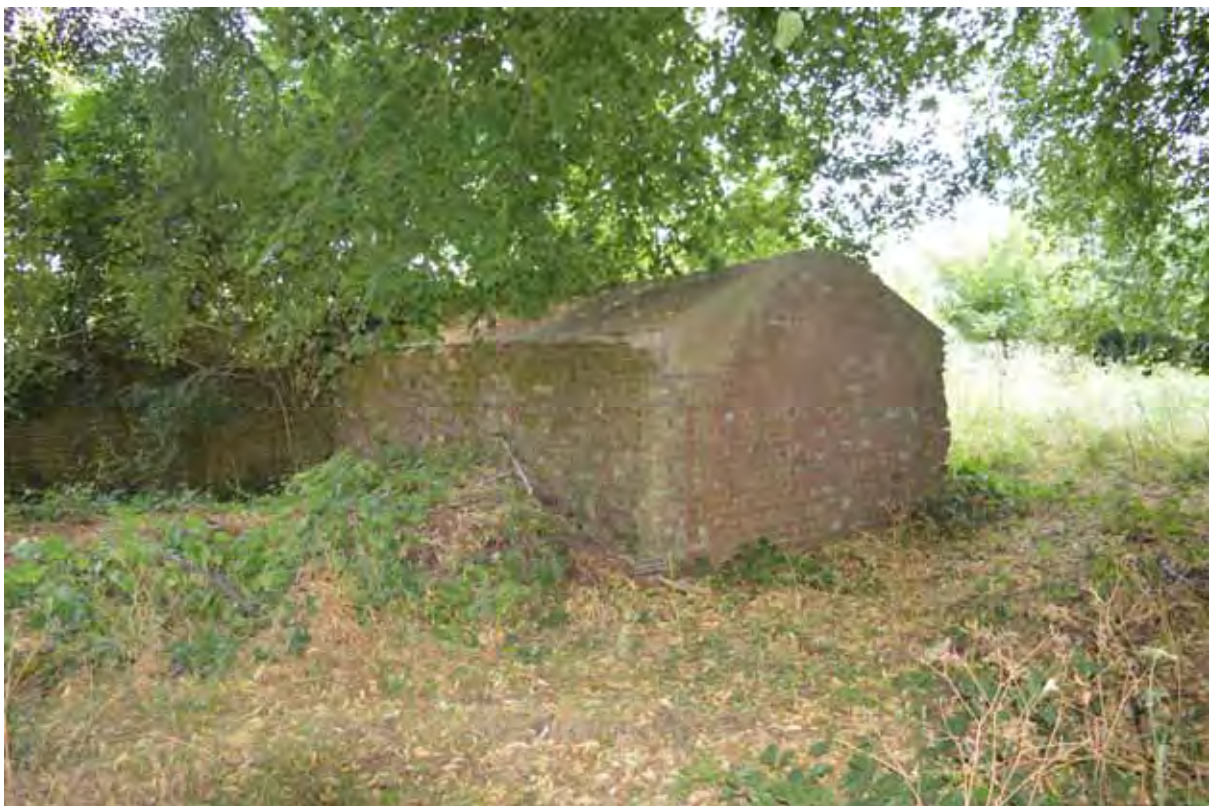
Plate 186: View of the air-raid shelter along the south-western site boundary, facing east (607)

- 6.44 The air-raid shelter (Plate 186) is located centrally along the south-western site boundary (Figure 2), within the confines of the modern perimeter fence. The structure is clearly visible on aerial photography dating to 1944 (Figures 6 and 7) and forms part of the original site design. Its location and size would indicate it was intended as a shelter for those situated within lodgings along the south-western side of the site, including those within the wooden huts and the foreman's bungalow.

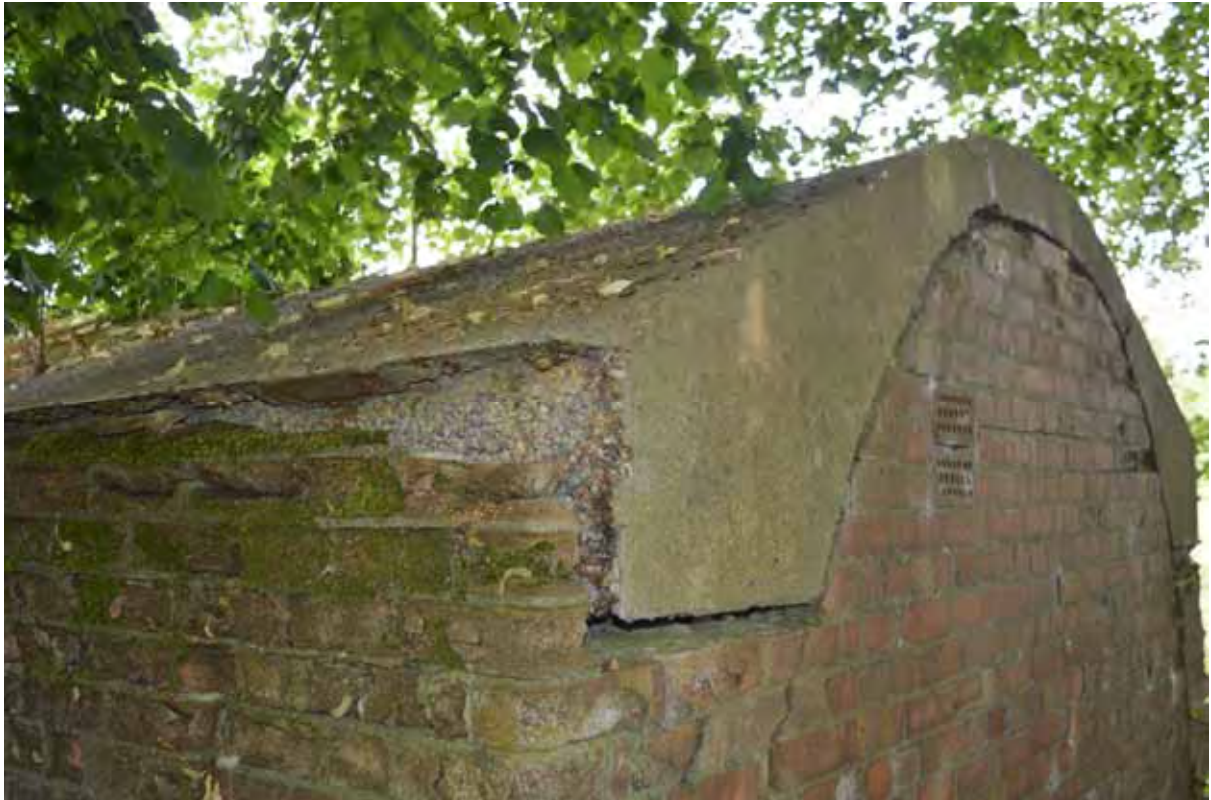
Plate 187: Detail of the air-raid shelter concrete roof cap, facing east (611)

(Plate 187) has a domed pitch and is constructed of a substantial concrete slab. This contains coarse pebbles and rocks of various sizes set within the cement matrix. Each elevation is plain, except for a number of air bricks (Plates 188 and 189) and a ventilation grille set within the north-east and south-west sides. Those within the north-east elevation are a mix of ceramic and cast iron types.

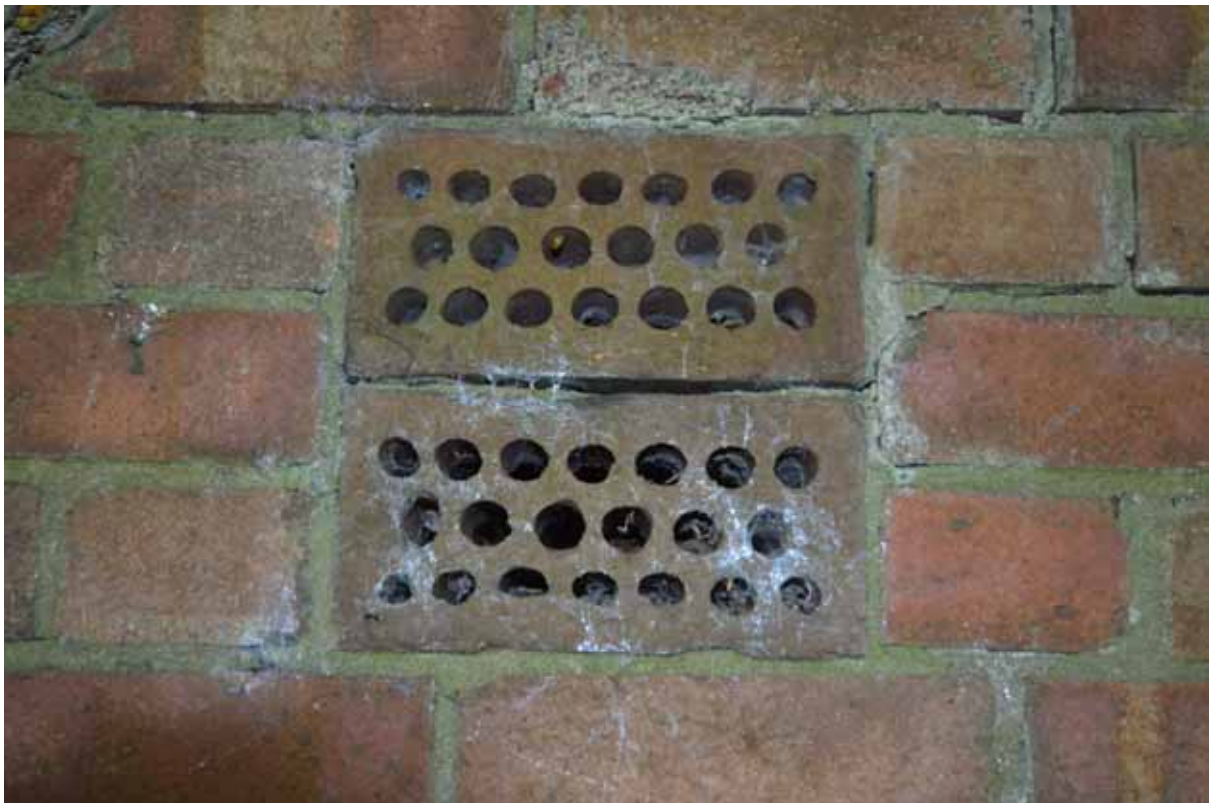
Plate 188: Detail of the air-bricks within the south-west elevation of the air-raid shelter, facing north-east (608)

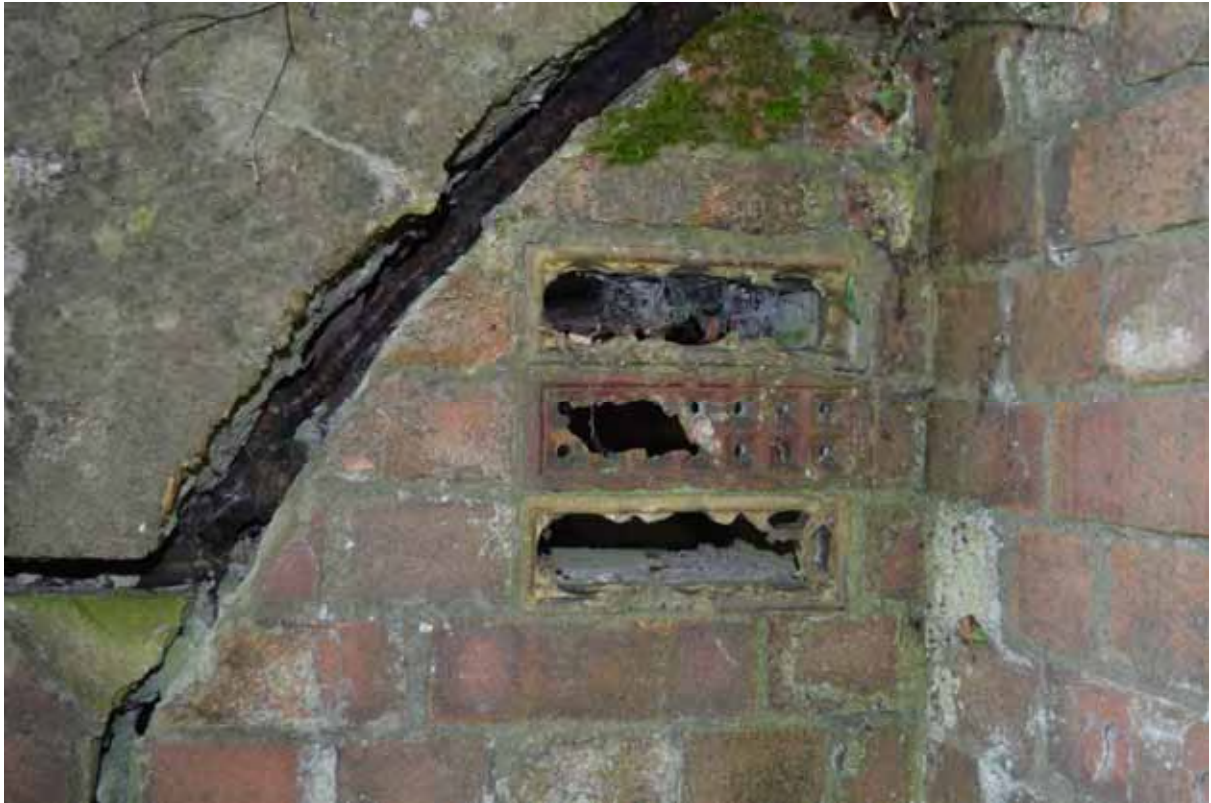
Plate 189: Detail of the air-bricks within the north-west elevation of the air-raid shelter, facing south-west (609)

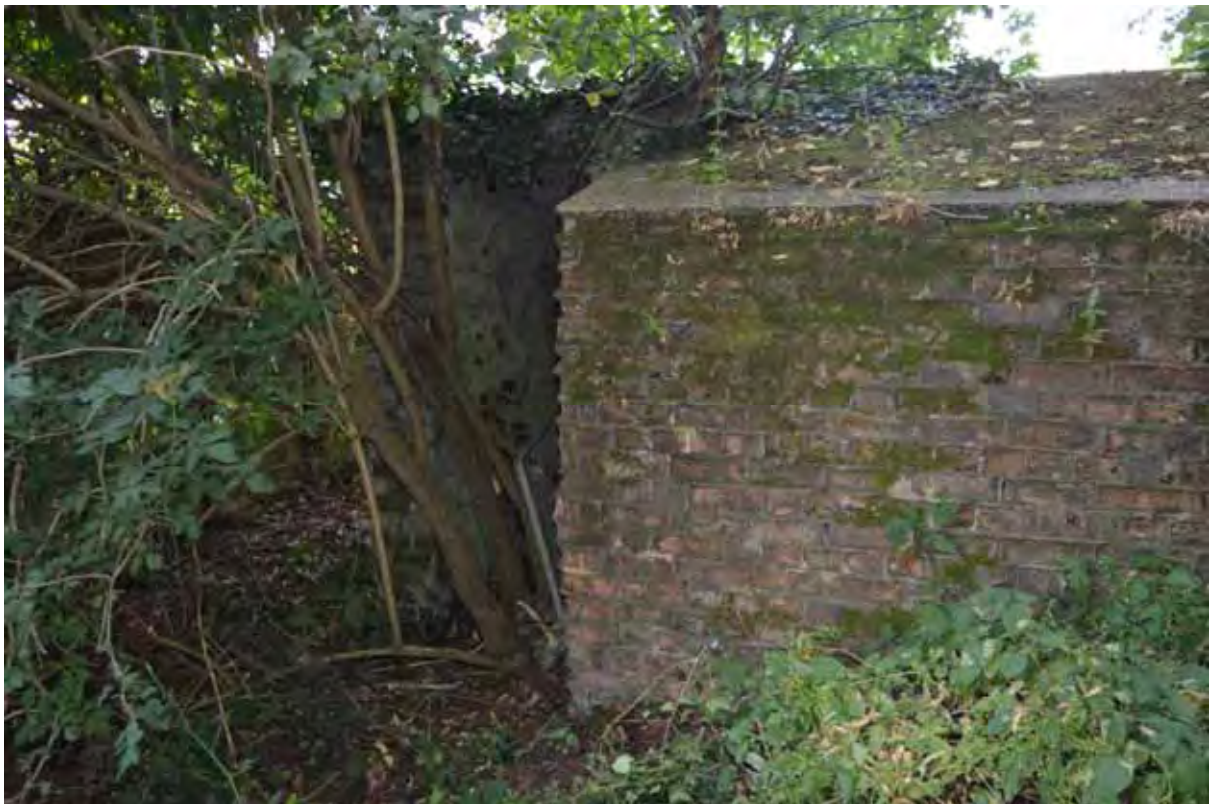
Plate 190: View of the air-raid shelter entrance at the north-eastern end, facing east (605)

- 6.46 The entrance (Plate 190) is situated at the north-east end of the structure and is arranged as a typical 'L'-plan baffle to protect against bomb blasts. It projects centrally from the elevation (Plate 191) and is of the same brick construction, the walls measuring 340mm thick. The roof of the entrance is a flat shuttered concrete slab, measuring a thickness of 150mm and set at a height of 2.10m. It is usual for air-raid shelters to have a secondary means of escape, to be used in the event of a blockage of the primary entrance. This can present itself as an area of intentional loosely mortared brickwork, which can be struck internally, for use in an emergency. This structure did not display any evidence of this safety feature.

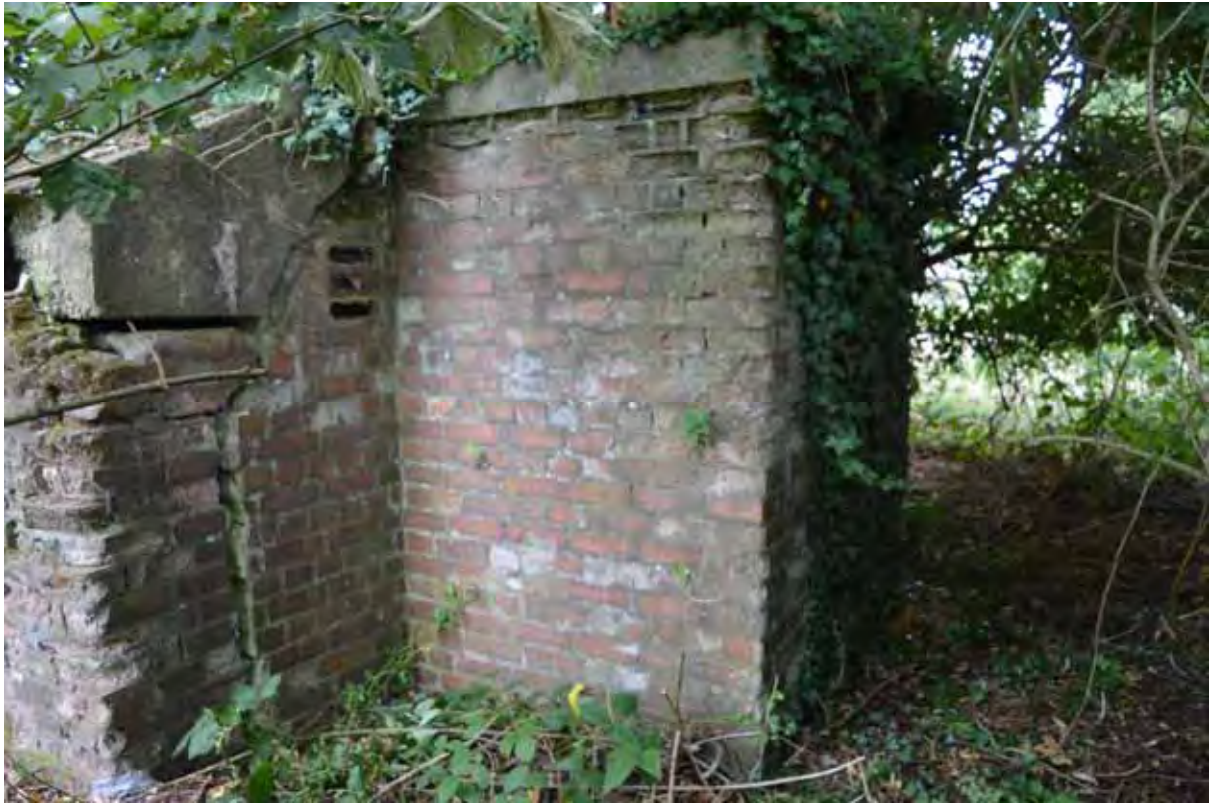
Plate 191: View of the north-east elevation of the air-raid shelter, facing west (610)

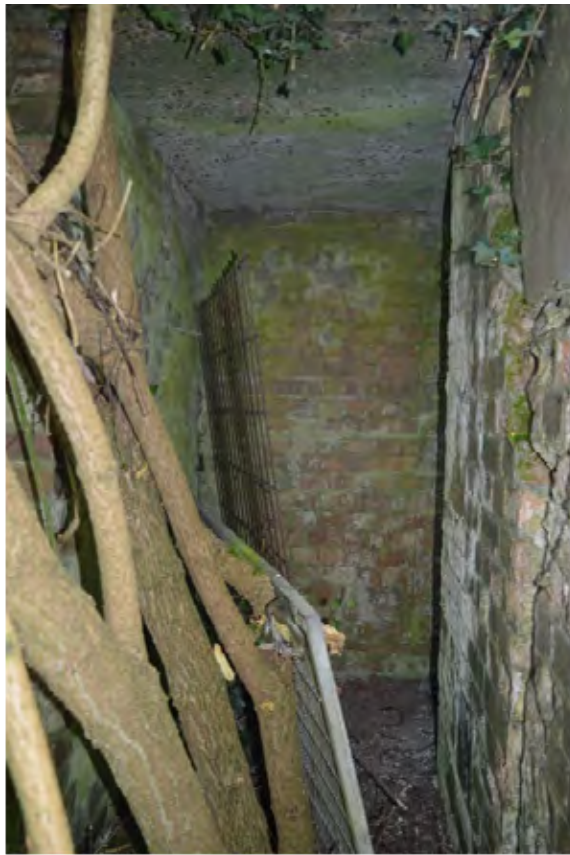
Plate 192: View of the air-raid shelter entrance interior, facing south-east (606)

- 6.47 The interior of the entranceway (Plate 192) comprises bare brick walls and a shuttered concrete ceiling, rising to a height of 1.95m. The internal doorway (Plate 193), set slightly off-centre within the north-east elevation, contains no door (or evidence of), measures a width of 0.83m and has a concrete lintel. The shelter interior (Plate 194) is domed, with a maximum height of 2.12m. The south-west and north-east walls are constructed of bare brick, with occasional air bricks (see above) (Plate 195) and are coloured with a yellow hue, either displaying a historic paint cover or occurring through discolouration from water ingress. The north-west and south-east walls (Plate 196) are constructed using an outer brick shell (34mm thick), overlain with cement infill with coarse aggregate inclusions (110mm thick). An inner layer of curved corrugated metal sheets (10mm thick) line both walls in addition to the roof, producing the characteristic domed interior. Originally, the metal sheet layer would have covered the entirety of both side walls and roof area, however, due to heavy corrosion, the base of each sheet no longer remains intact. The floor (Plate 197) is of concrete and measures 4.37m in length and 2.87m in width. No evidence of fixtures or fittings were noted.

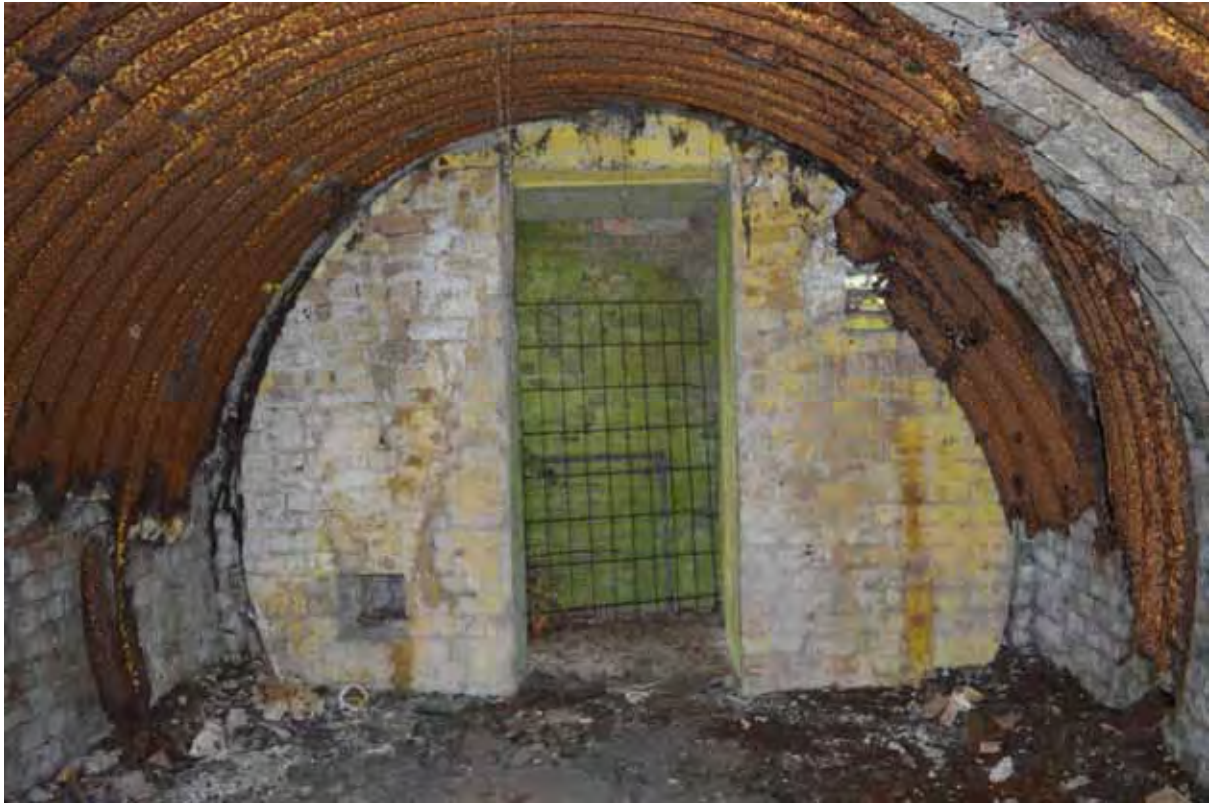
Plate 193: Interior of the air-raid shelter, facing north-east towards the entrance (604)

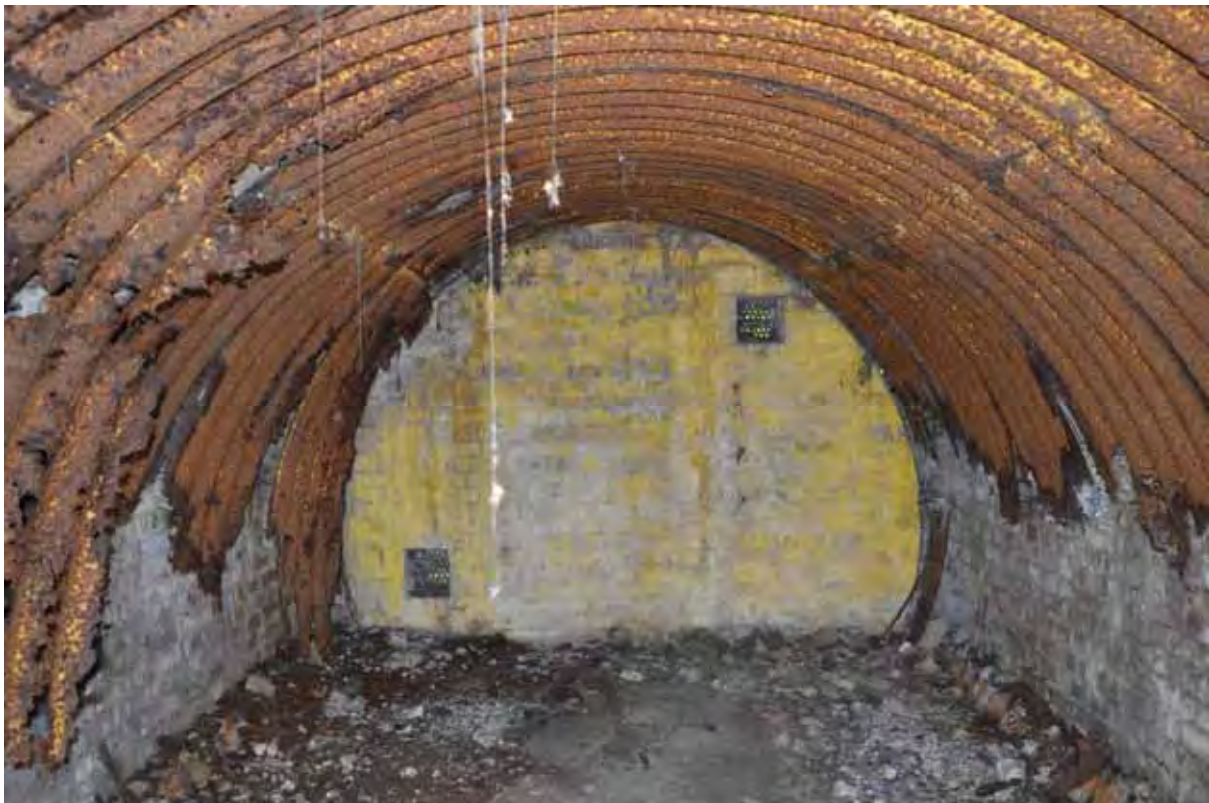
Plate 194: Interior of the air-raid shelter, facing south-west (600)

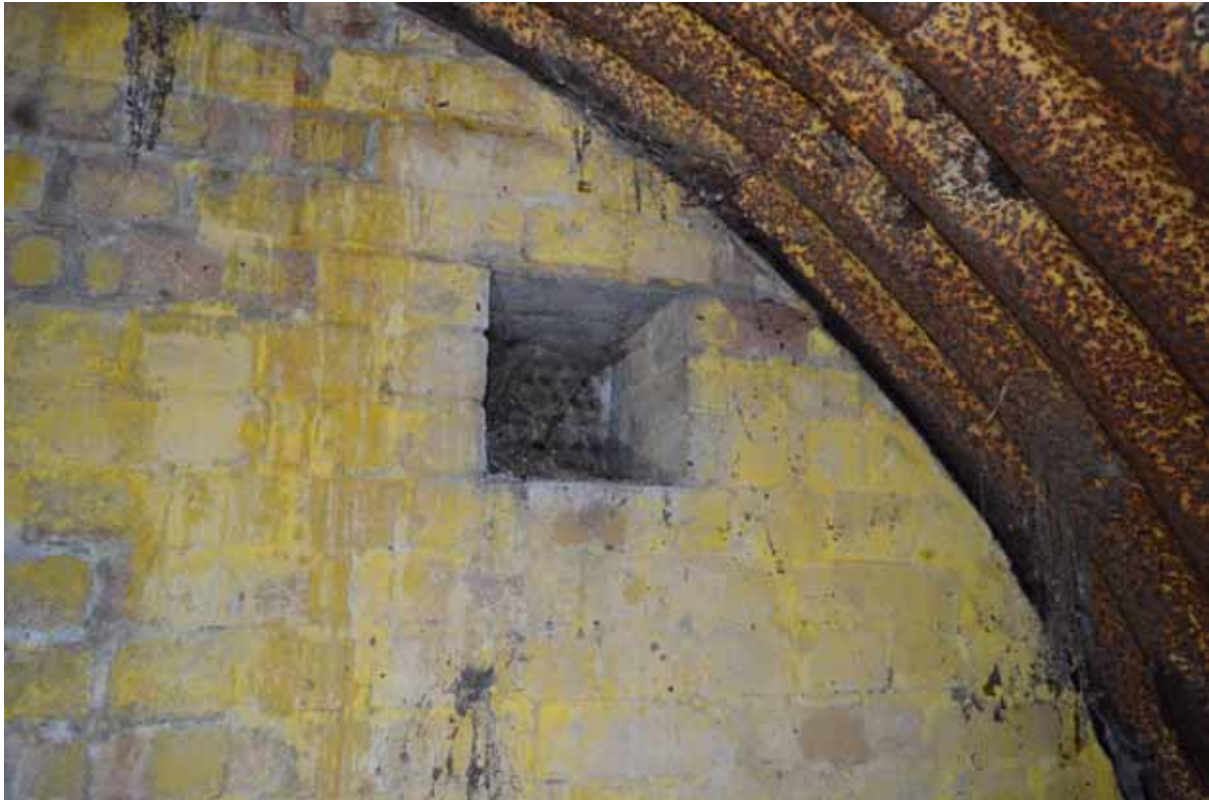
Plate 195: Detail of the air-brick within the south-west elevation of the air-raid shelter, facing west (603)

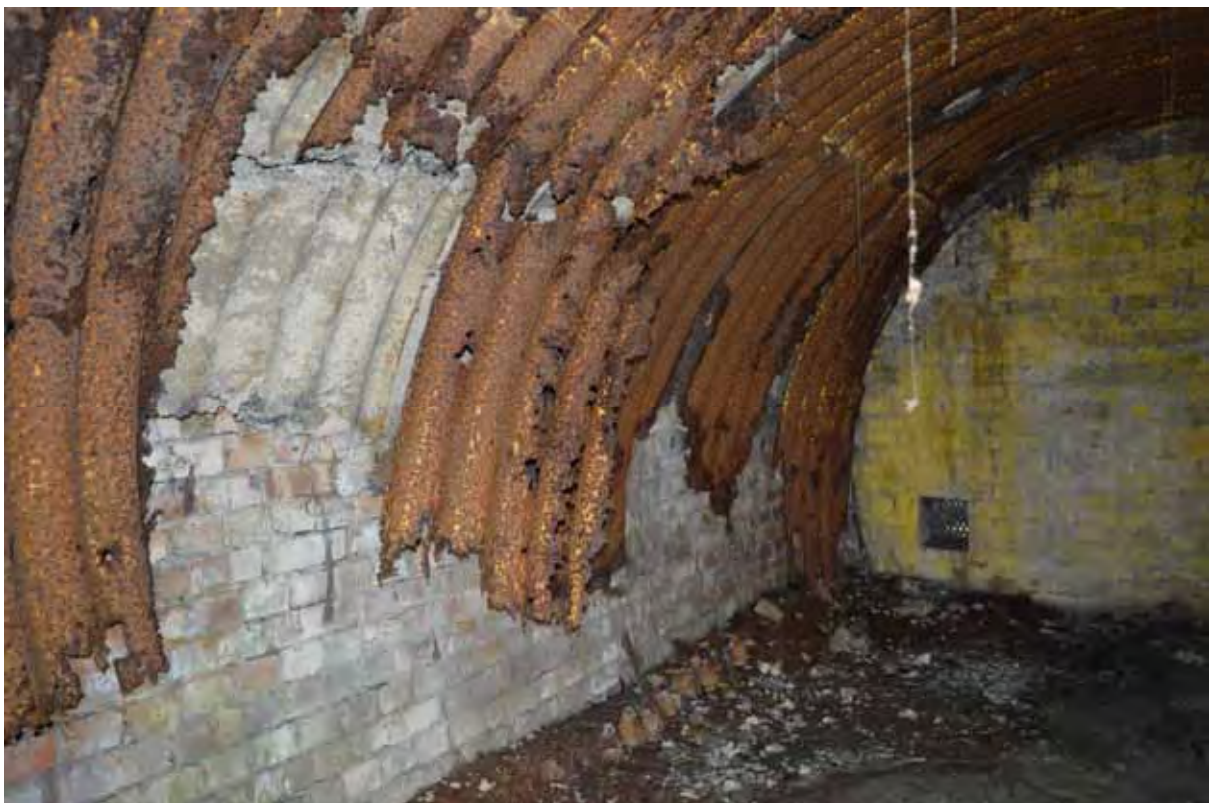
Plate 196: Detail of the side wall construction of the air-raid shelter interior, facing south (601)

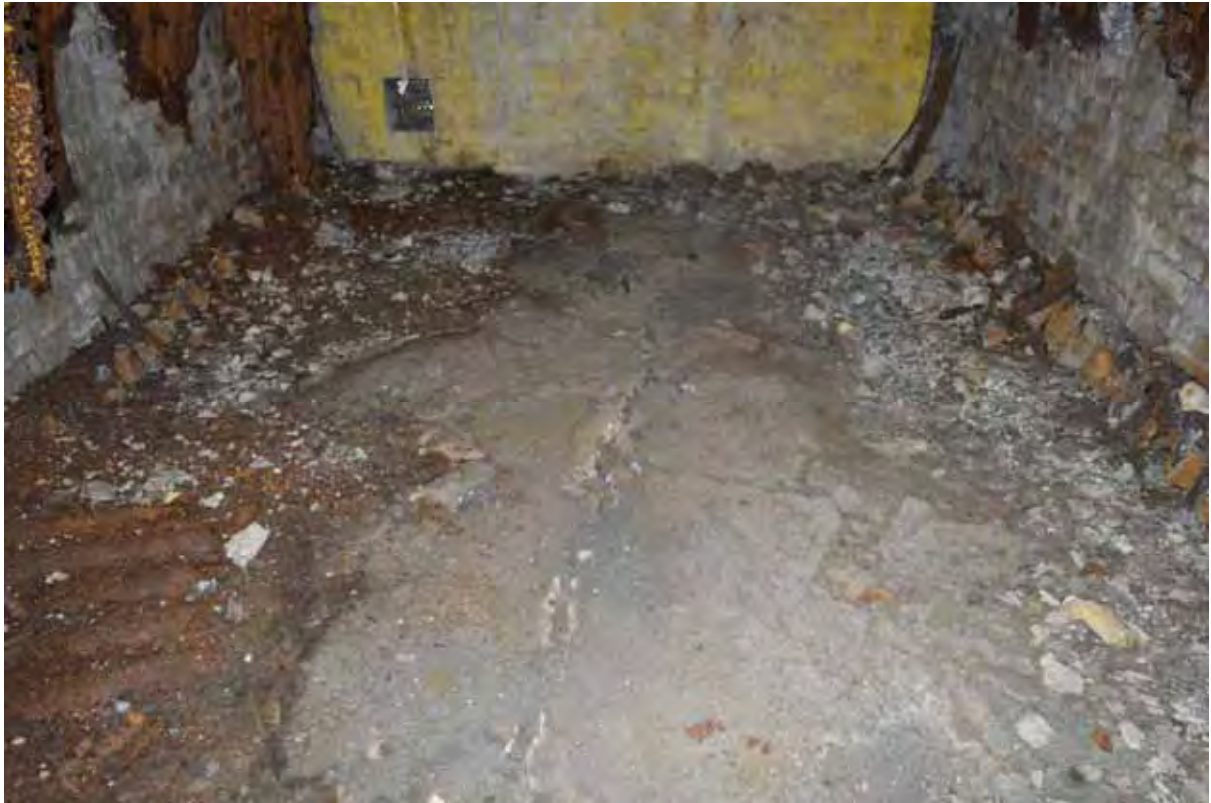
Plate 197: Detail of the air-raid shelter floor, facing south-west (602)

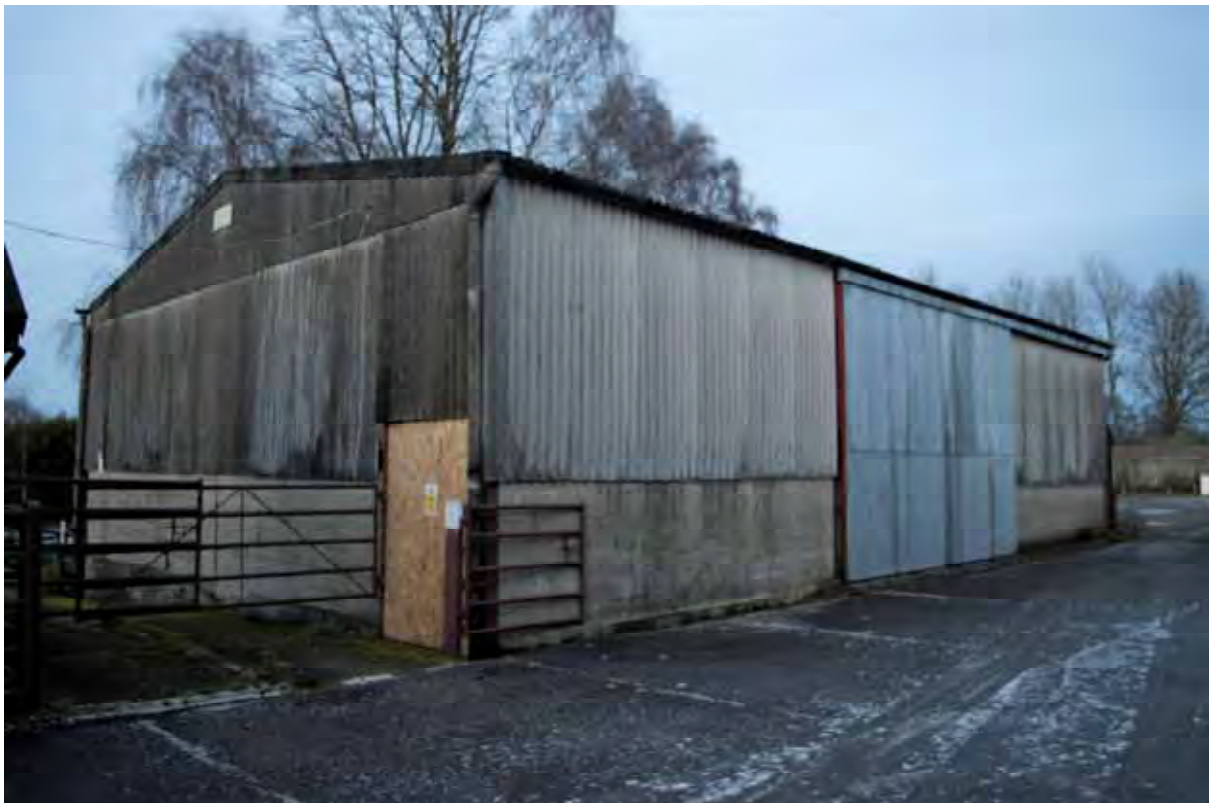
Plate 198: View of Building 2, facing north (545)

- 6.48 Building 2 (Plate 198) comprises a modern agricultural shed, constructed on concrete foundations inscribed with a date of 1979 (Plate 199), laid by Albert Sparrowhawk and shown on the 1990 mapping. The structure, situated at the western end of the compound's northern boundary, occupies a rectangular footprint. The building is aligned essentially east – west, with its principal elevation facing south towards the principal driveway entering the site. It is constructed of a breezeblock plinth, clad with panels of corrugated asbestos at its upper level. The roof has a shallow pitch and is covered with the same asbestos-cement sheeting. A rudimentary narrow lean-to, constructed of timber boarding, adjoins the southern end of the west elevation. This structure appears to have originally had a central doorway, which has since been blocked. A single doorway is set at the southern end of the west elevation (now boarded), and is served by a steel bar gate, indicating its use for cattle. The principal entrance is set centrally within the south elevation and comprises a substantial, full-height opening, fixed with a corrugated steel sheet door, set within sliding runners made of steel girders. The interior (Plate 200)

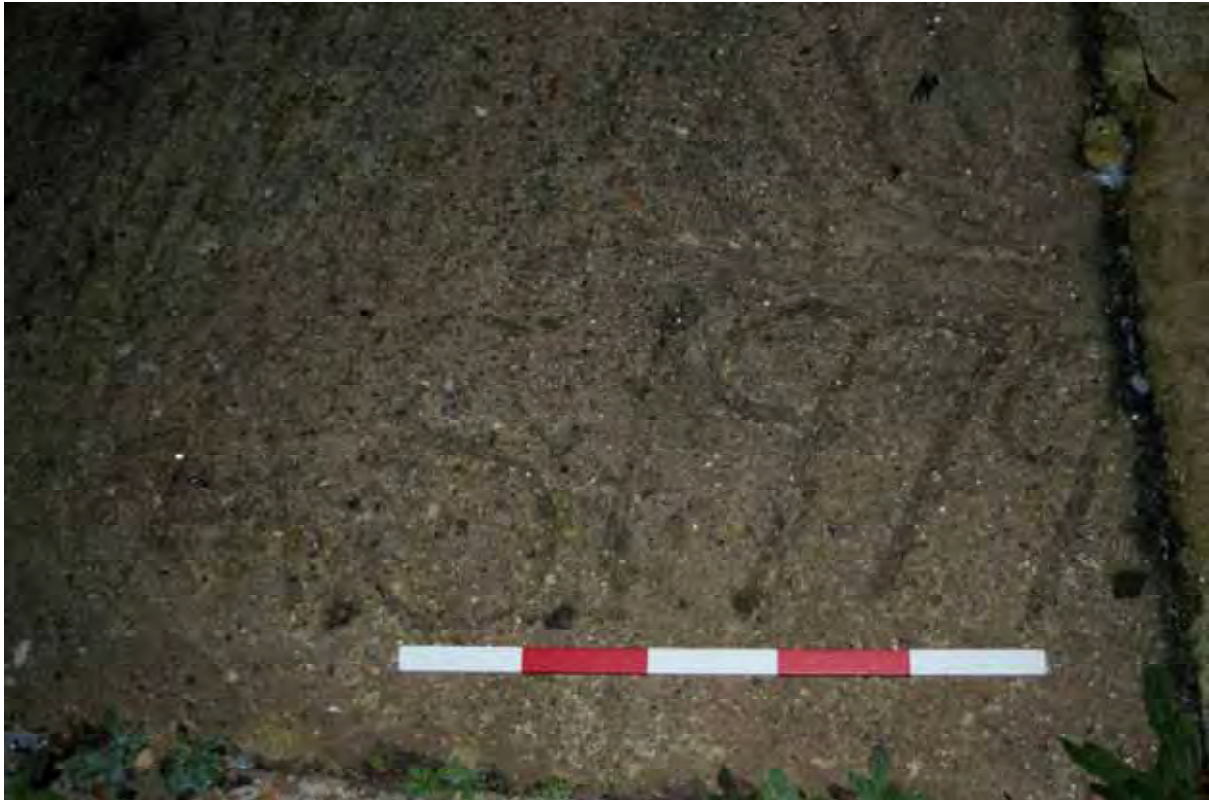
Plate 199: Detail of the inscribed concrete hardstanding which Buildings 2 and 3 rest on, reading 'AS 1979', facing north-west (553)

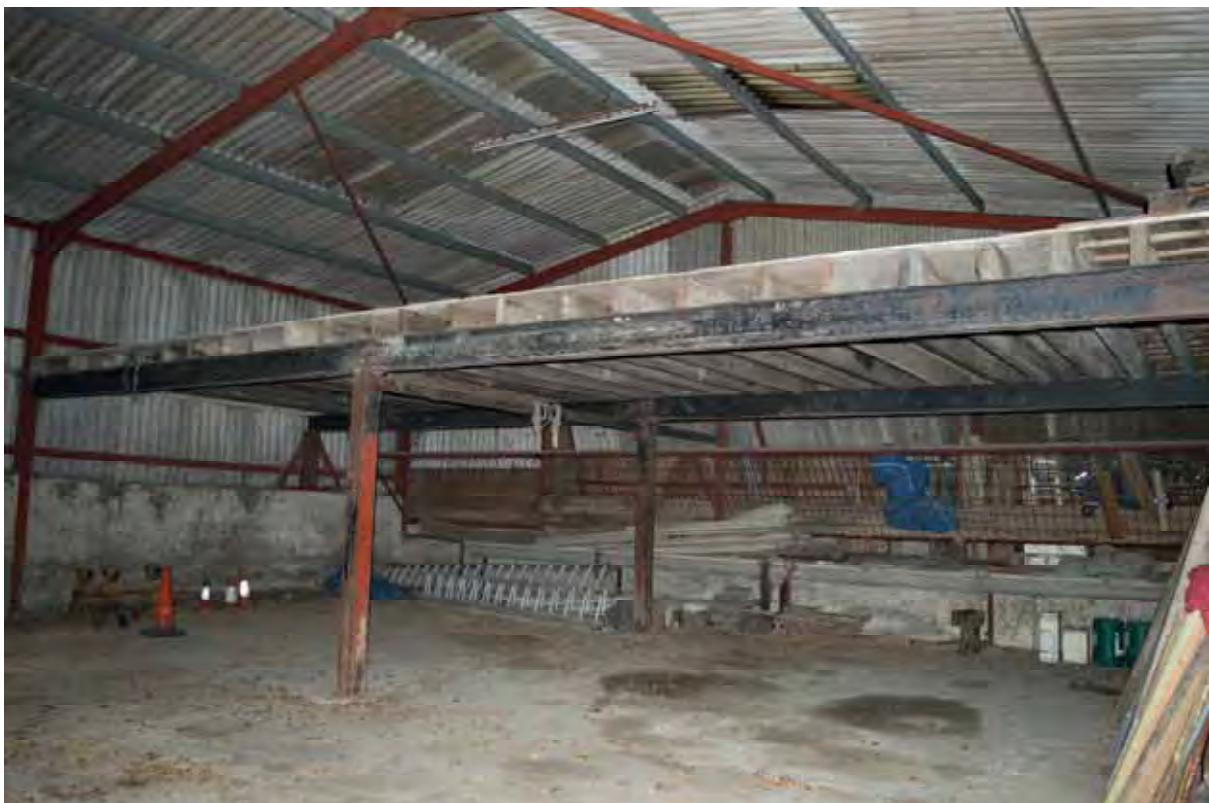
Plate 200: View of the interior of Building 2, facing north (546)

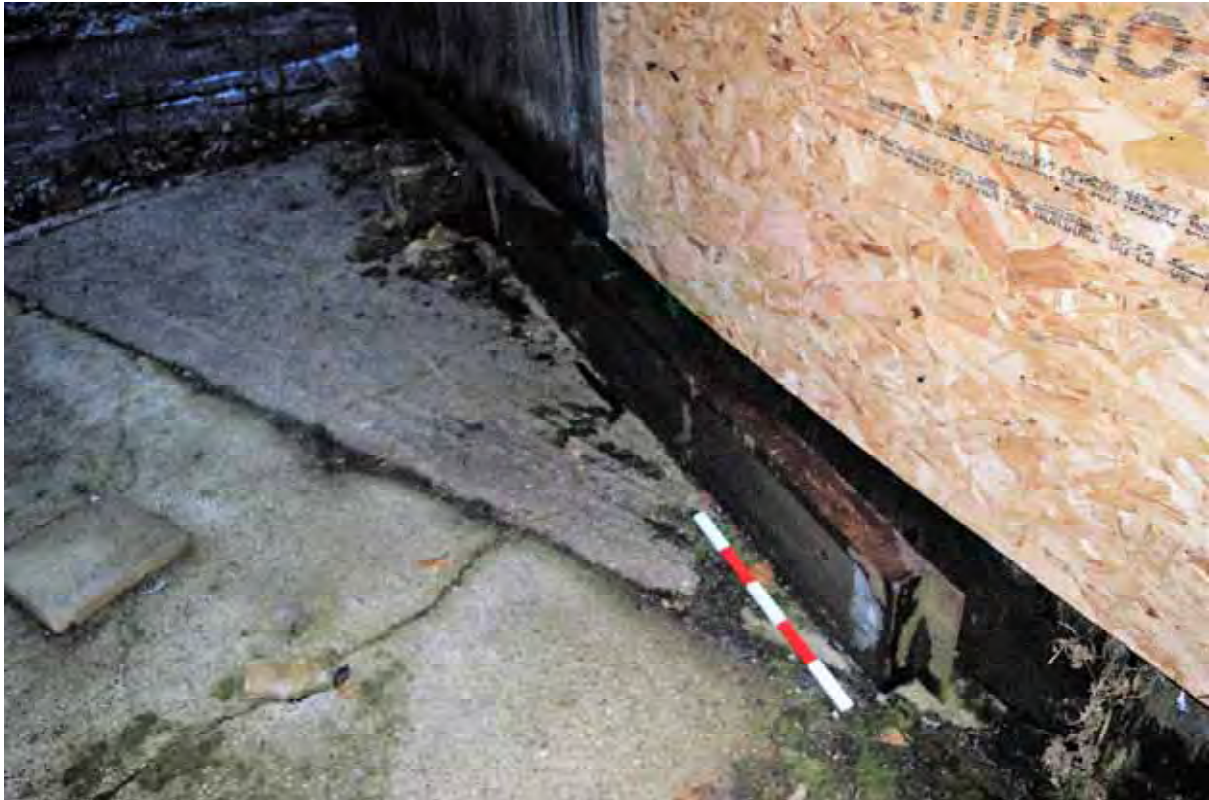
Plate 201: Detail of the displaced conveyor track element, situated adjacent to the south-east elevation of Building 2, facing south (551)

- 6.49 Two notable features are situated adjacent the structure's east elevation. The first appears to comprise part of the conveyor system (Plate 201 and Plate 202) which was situated throughout the site. The feature forms a shallow U-section plate, comprising felted timber board as a base, framed by steel plate sides and end L-brackets; the brackets themselves are punctured with fitting holes, presumably to fix the feature to an associated base. The nature of the second feature is not known, although the manner of its construction materials would suggest it is contemporary with the other war-time features on the site. Its location does not appear to be original and instead has been relocated here from elsewhere on the site. It comprises a square, concrete block (Plate 203), not dissimilar to the conveyor system bases found in each loading bay. It measures a depth of c.150m and has steel plate fixings attached to its upper face. The width between the metal fixings are consistent with those of the conveyor belt section found on the loading platform of Store 9, and potentially has an associated use. The centre of its upper face contains a central steel fitting which is handle-shaped, suggesting a potential hatch use, although this is unlikely due to its thickness.

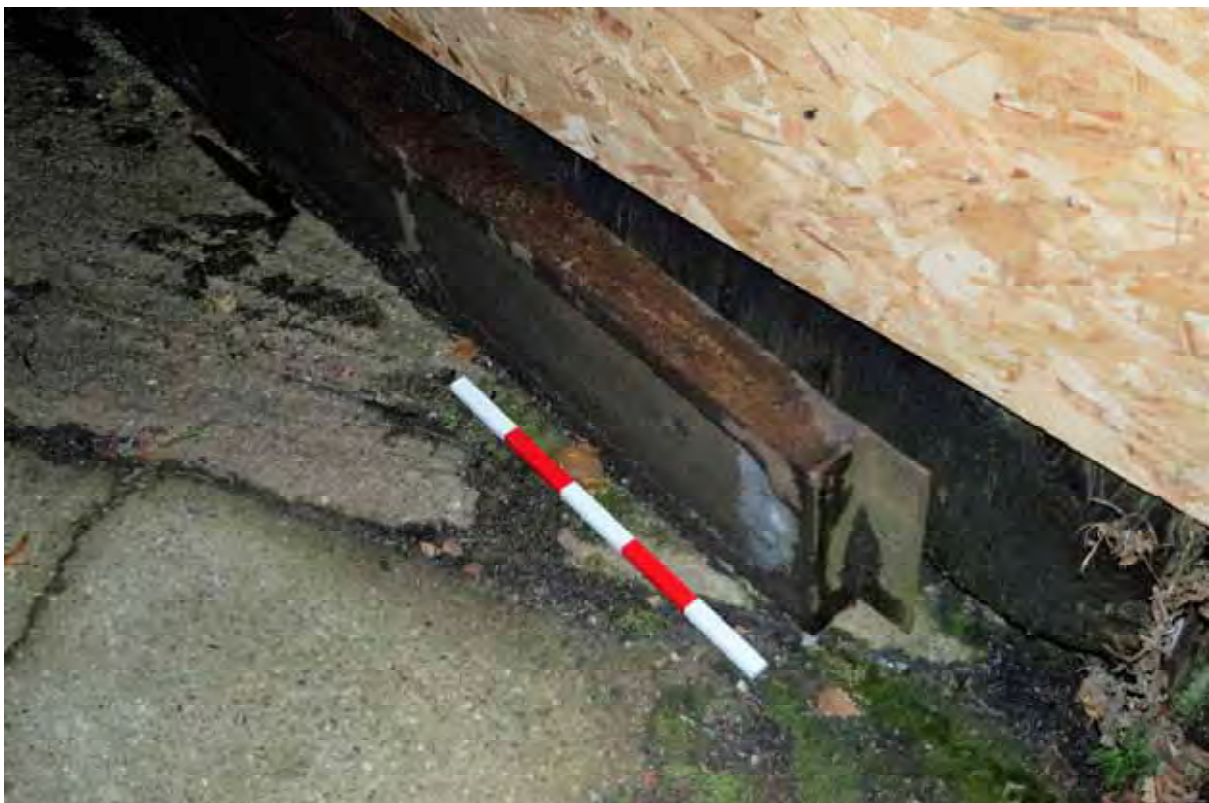
Plate 202: Detail of the displaced conveyor track element, situated adjacent to the south-east elevation of Building 2, facing south (552)
