**LAND AT COURTLANDS FARM,
PARK ROAD, BANSTEAD, SM7 3EF**

**HISTORIC BUILDINGS RECORD
(HISTORIC ENGLAND LEVEL 4)**

**Historic Buildings Record
(Historic England Level 4)**

**ASE Project No: 171102
Site Code: CFB17**

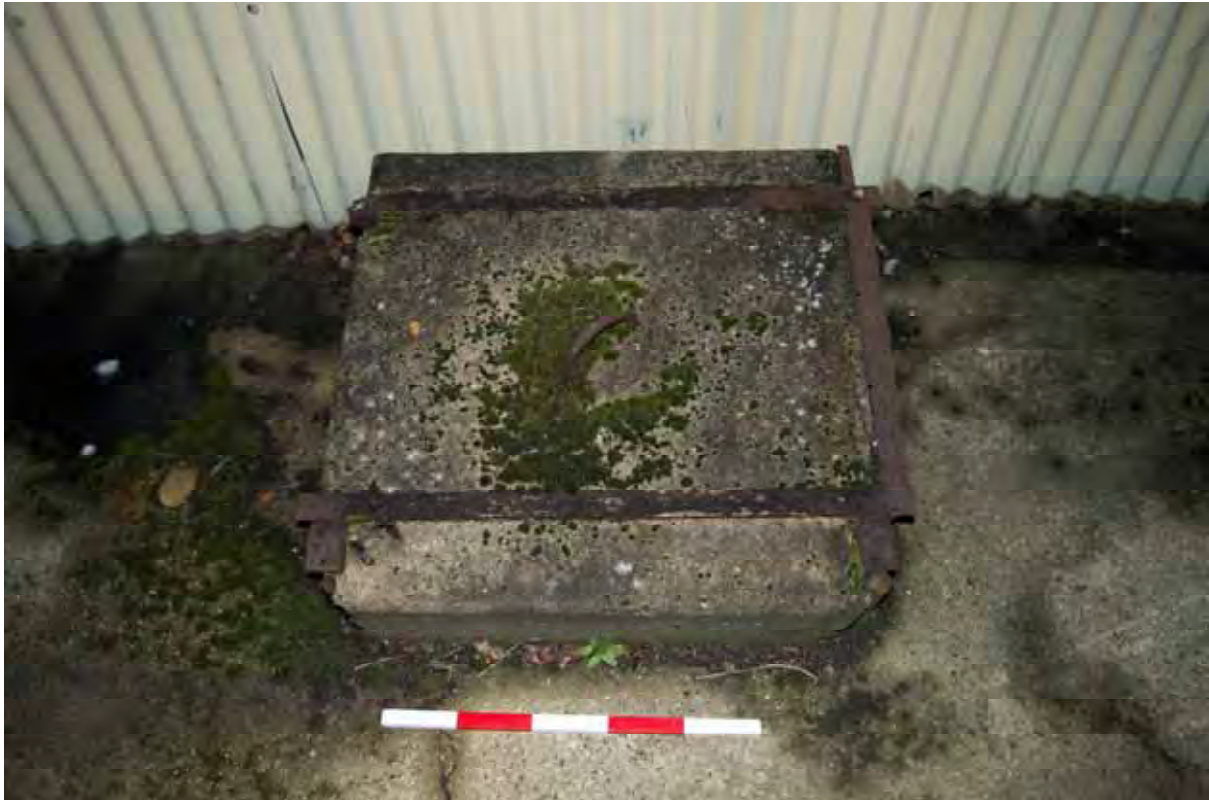
Plate 203: Detail of the displaced feature situated between Building 2 and 3, facing north-east (550)

- 6.49 Two notable features are situated adjacent the structure's east elevation. The first appears to comprise part of the conveyor system (Plate 201 and Plate 202) which was situated throughout the site. The feature forms a shallow U-section plate, comprising felted timber board as a base, framed by steel plate sides and end L-brackets; the brackets themselves are punctured with fitting holes, presumably to fix the feature to an associated base. The nature of the second feature is not known, although the manner of its construction materials would suggest it is contemporary with the other war-time features on the site. Its location does not appear to be original and instead has been relocated here from elsewhere on the site. It comprises a square, concrete block (Plate 203), not dissimilar to the conveyor system bases found in each loading bay. It measures a depth of c.150m and has steel plate fixings attached to its upper face. The width between the metal fixings are consistent with those of the conveyor belt section found on the loading platform of Store 9, and potentially has an associated use. The centre of its upper face contains a central steel fitting which is handle-shaped, suggesting a potential hatch use, although this is unlikely due to its thickness.

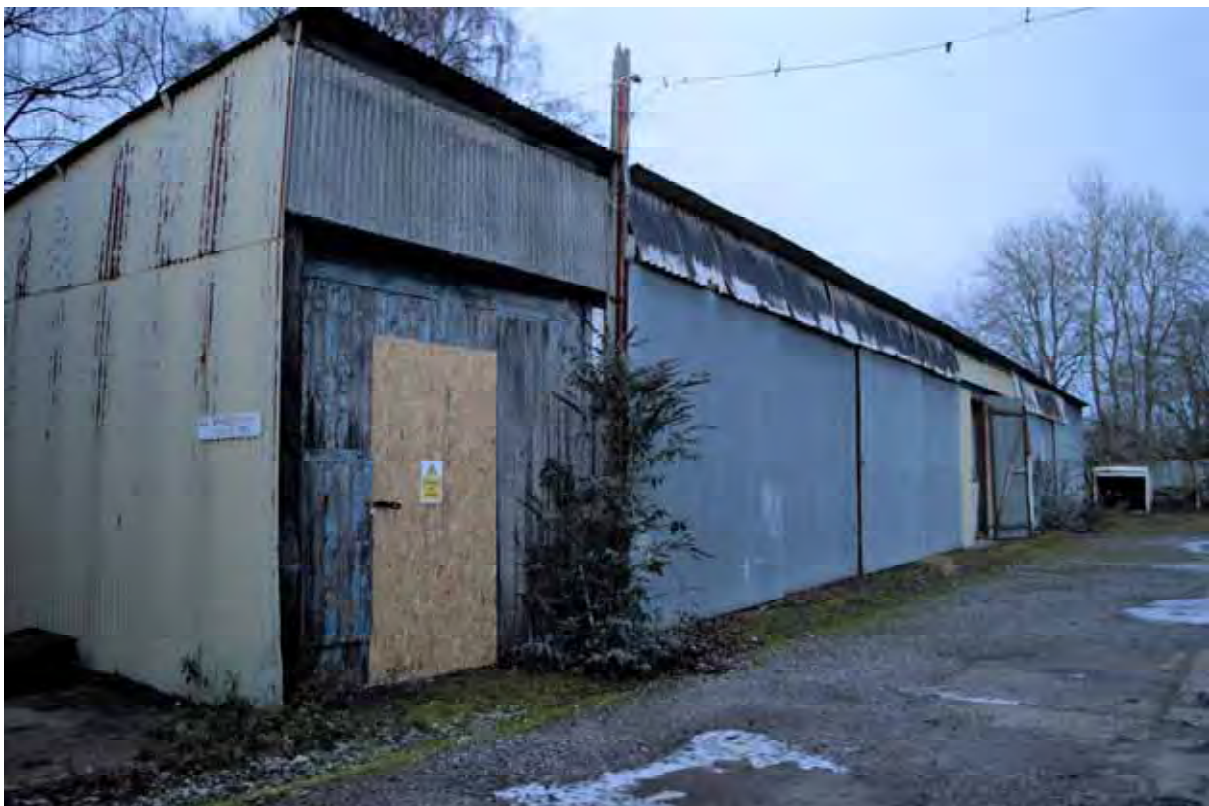
Plate 204: View of Building 3, facing north-east (549)

- 6.50 Building 3 (Plate 204) comprises a late 20th century agricultural shed (pre-1990 mapping), laid on concrete hardstanding dated to 1979 and was constructed by Albert Sparrowhawk. The building bounds the northern site boundary and occupies a south-west – north-east alignment, with its principal elevation facing south-east. The building was constructed as a mixture of workshops and stores. It is constructed using a slender steel frame, set on a concrete plinth, the exterior of which is clad with a combination of steel and corrugated asbestos-cement sheeting. The roof slopes down in a north-westerly direction towards the rear of the structure and is similarly clad in both types of sheet panelling, the underside being supported by I-section steel girders and U-section uprights. The building is divided internally into five bays, all of which are accessed via an entrance set within the south-east elevation. Doors comprise substantial full-height steel sheets, set within individual sliding steel girder frameworks; two of which also include single-width personnel doors (now boarded). The internal five bays are divided with ephemeral timber stud partitions, the walls dividing the western four bays include centrally-placed single-width doorways. A series of timber telegraph poles are situated across the central alignment of the structure (Plate 205), in addition to framing each wall of Bay 4 where they provide additional support to the roof truss arrangement. The walls are clad internally with timber boarding, primarily for insulation purposes and to provide a suitable base for shelving. Workshop equipment and machinery remains within Bay 1 (Plate 206).

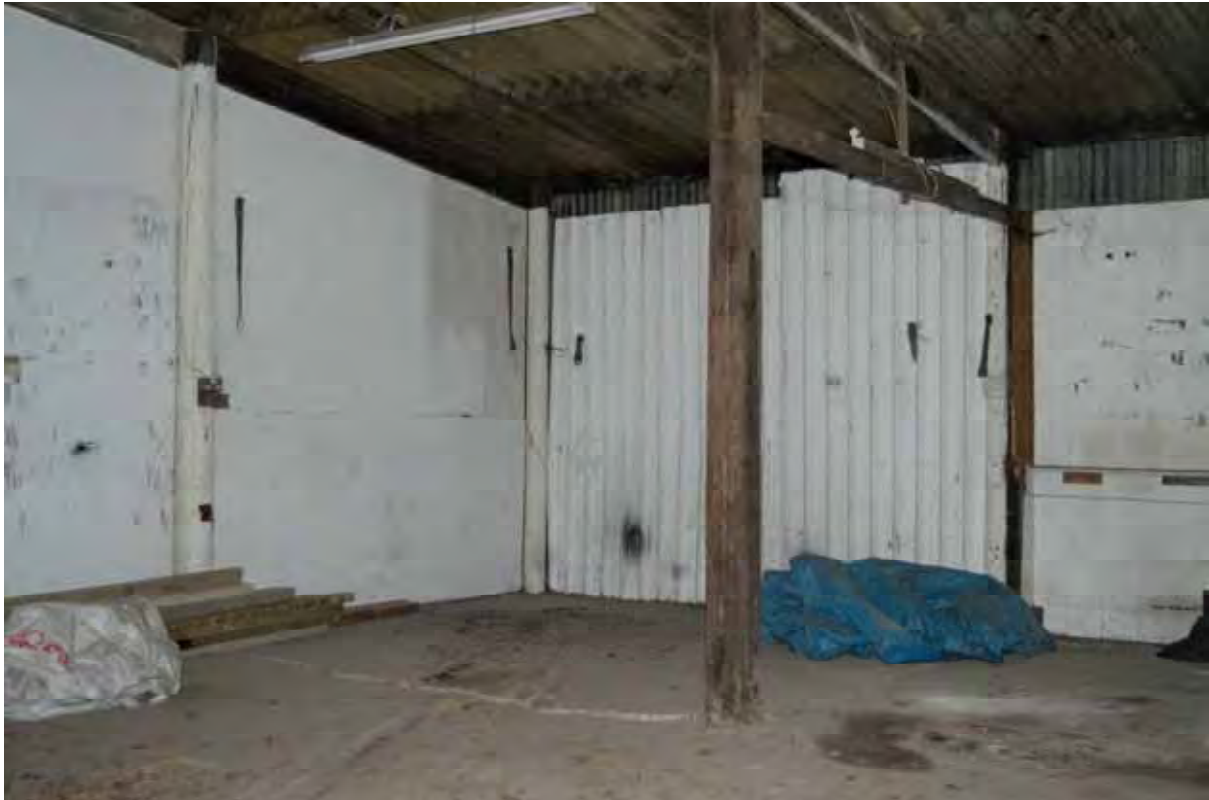
Plate 205: View of Bay 4 within Building 3, facing north-west (556)

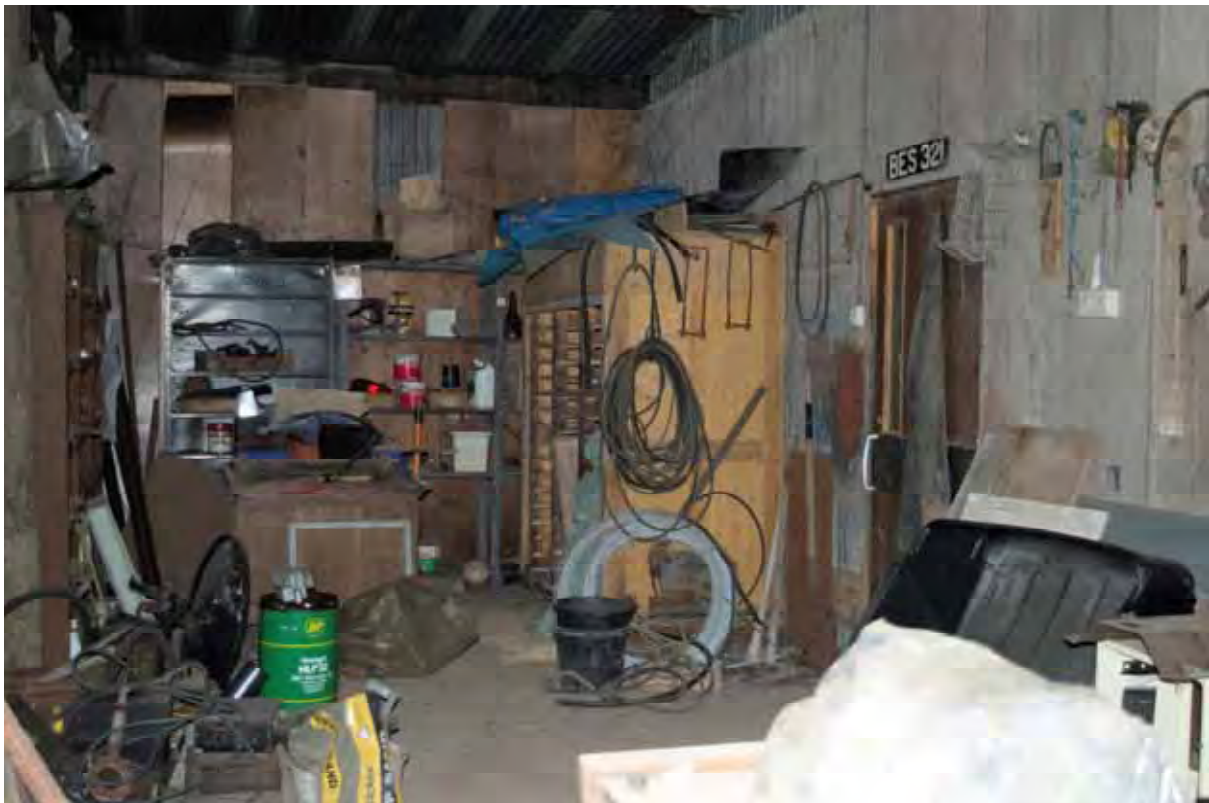
Plate 206: View of Bay 1 within Building 3, facing north (554)

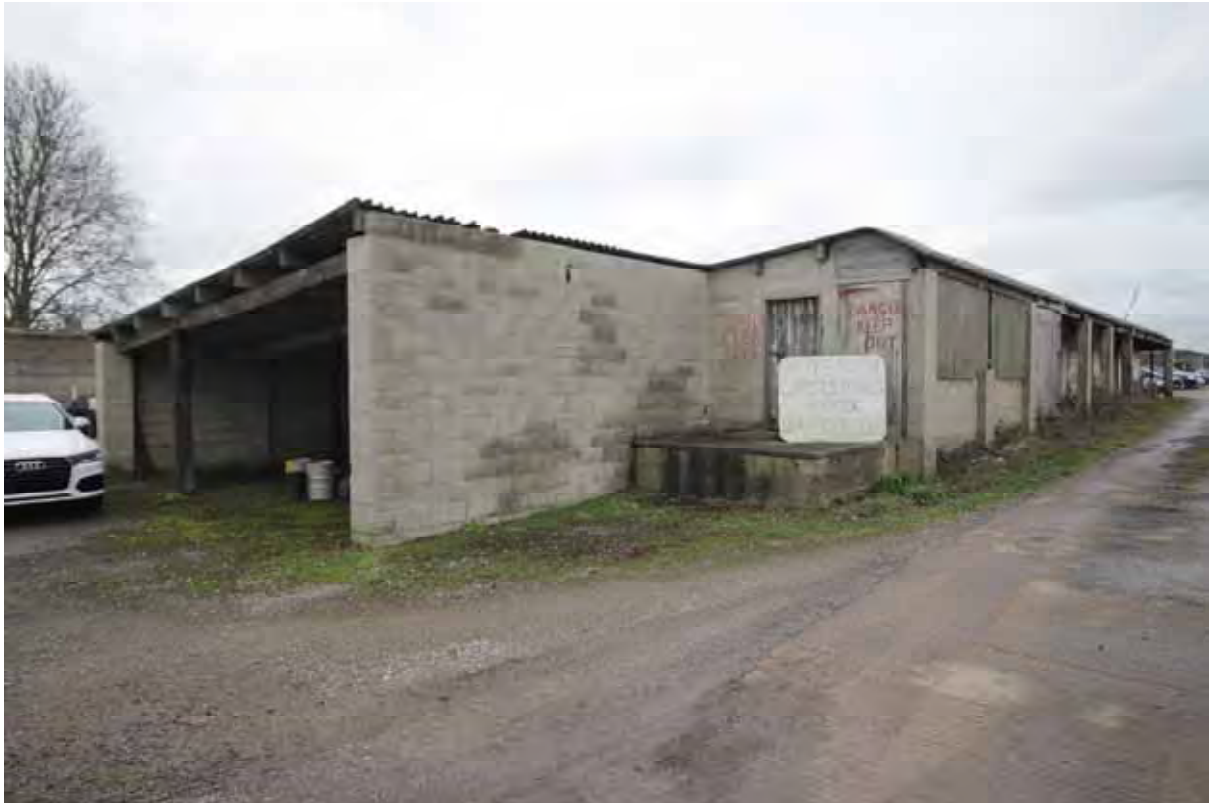
Plate 207: View of the north-west and south-west elevations of Building 7, facing east (158)

- 6.51 Building 7 (Plate 207) was constructed at some point between 1990 and 2003 (Google Earth) as a store associated with the agricultural use of the site. The structure is situated to the north-west of Store 8, on land previously occupied by earth embankments. The building is rectangular and occupies a north-west – south-east alignment, with the principal elevation facing south-west. The structure is set on a concrete base, elements of the north-western end of which match the construction detailing of the bund containment walls and loading bay platforms, suggesting the building utilised these elements as foundation materials. The walls are constructed in breezeblocks, with the external north-east elevation clad with corrugated asbestos-cement sheeting. The structure is open-fronted to the north-west and its interior accessed via nine doorways set along the south-west elevation. The roof is steeply sloped to the north-east and clad with corrugated asbestos-cement sheets. The roof over the open-fronted north-western end is supported by a pair of telegraph poles, used as central posts. The doorways set along the south-west elevation are served by a covered corridor, roofed with a continuation of the sheeting, supported on breezeblock plinths. The interior (Plate 208) is divided into eight bays, divided by breezeblock partition walls and lit from the north-east by narrow, high-set timber-framed window casements. All bays are accessed externally, except for the two north-western end bays, which are additionally connected by an internal doorway. All internal areas serve as stores, with restricted headroom to their north-eastern ends, exacerbated by the addition of polystyrene cladding to the roof underside for insulation purposes.

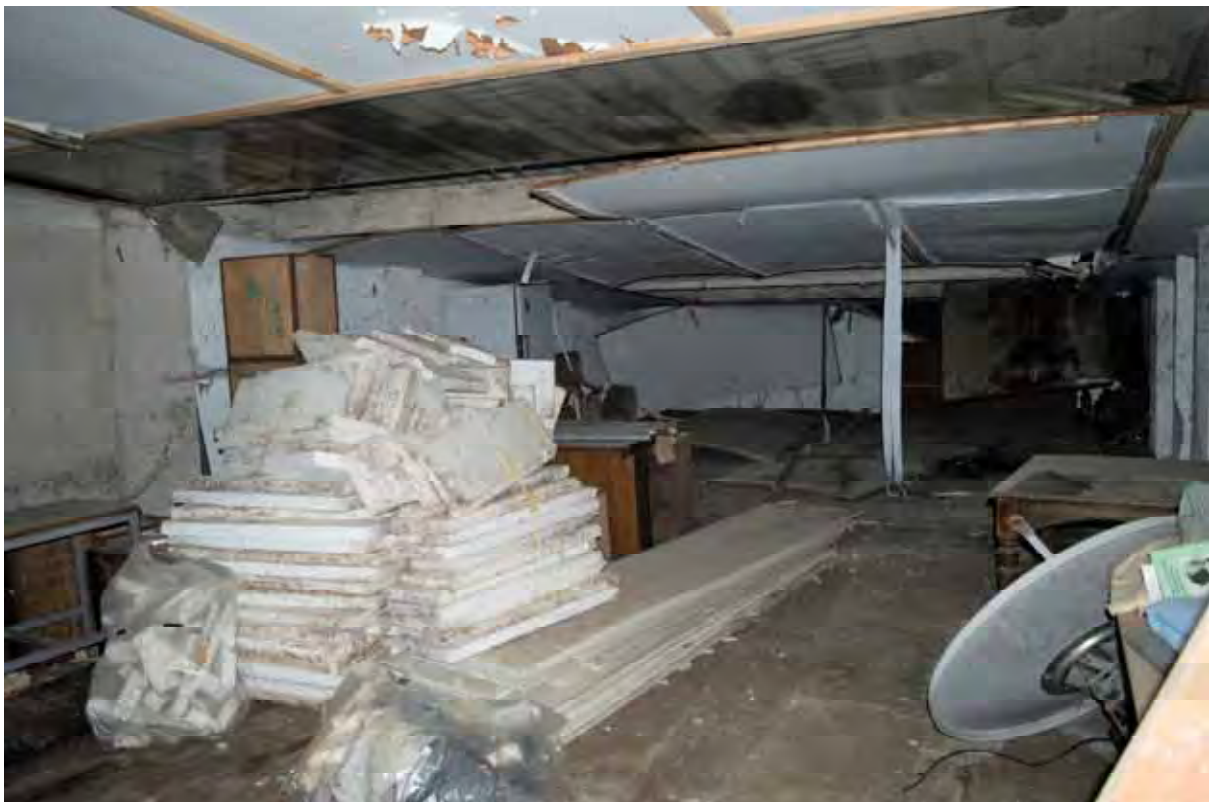
Plate 208: View of an internal bay within Building 7 (northern end), facing north-east (582)

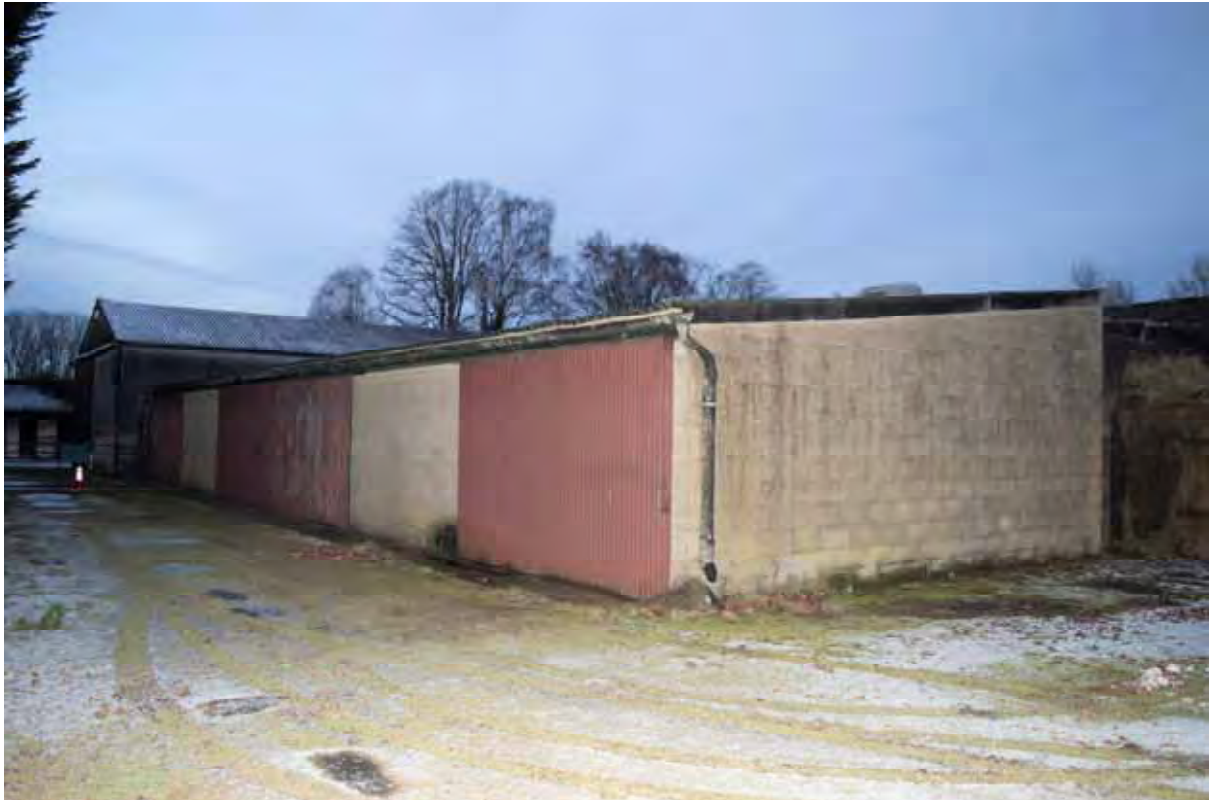
- 6.52 Building 10b (Plate 209) comprises a rectangular, four-bay lean-to, constructed against the south-west elevation of Store 10. The building is constructed in breezeblocks, with a corrugated asbestos-cement sheet roof. The building is accessed from four substantial openings set along the south-west elevation. Each door is set within a sliding frame constructed of I-section steel girders. The internal bays are divided by breezeblock walls (Plate 210), each additionally supported by a pair of plinths. The rear wall of each bay comprises the outer blast wall of Store 10, which retains each of its buttresses. Each of the bays retain machinery and storage equipment, indicating that these areas were used as stores and workshops. The north-west and south-east elevations are plain.

Plate 209: View of the south-west and south-east elevations of Building 10b, facing north (531)

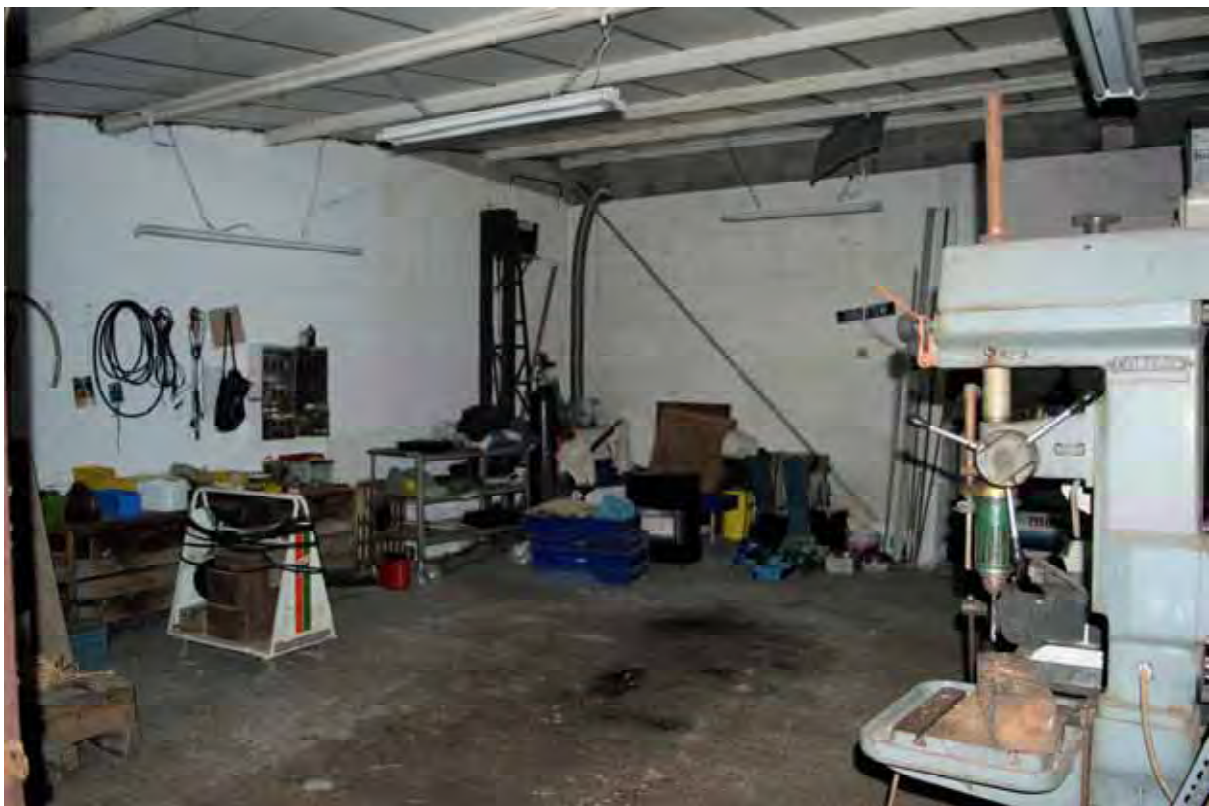
Plate 210: View of the end southern bay within Building 10b, facing north (535)

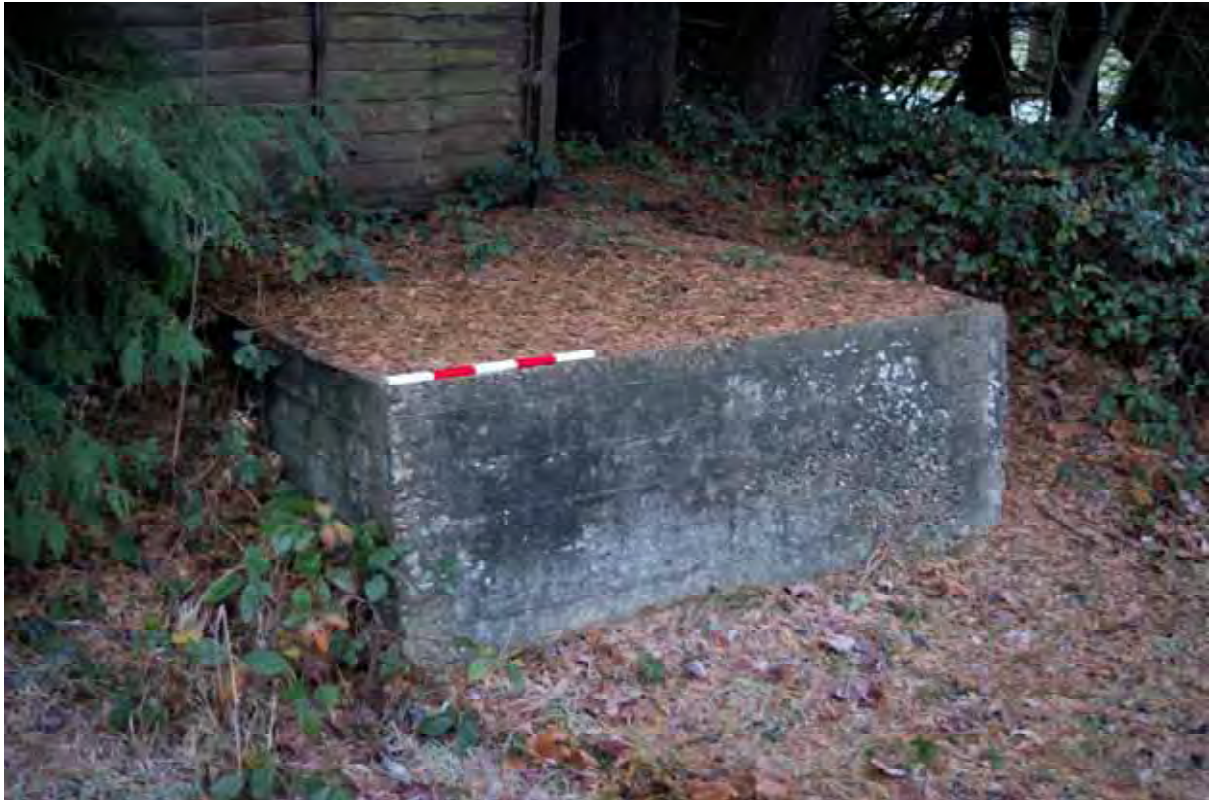
- 6.53 A notable feature to the south-west of the structure is a single loading platform (Plate 211) which is visible on the aerial photography taken in 1944 and presumably served the principal site entrance to the north-west. The photography also identifies a second platform situated to the south-west of Store 12, along the same boundary, although no evidence of this now remains.

Plate 211: View of the singular loading platform situated to the south-west of Store 10 and to the south-east of the principal site entrance, facing west (539)

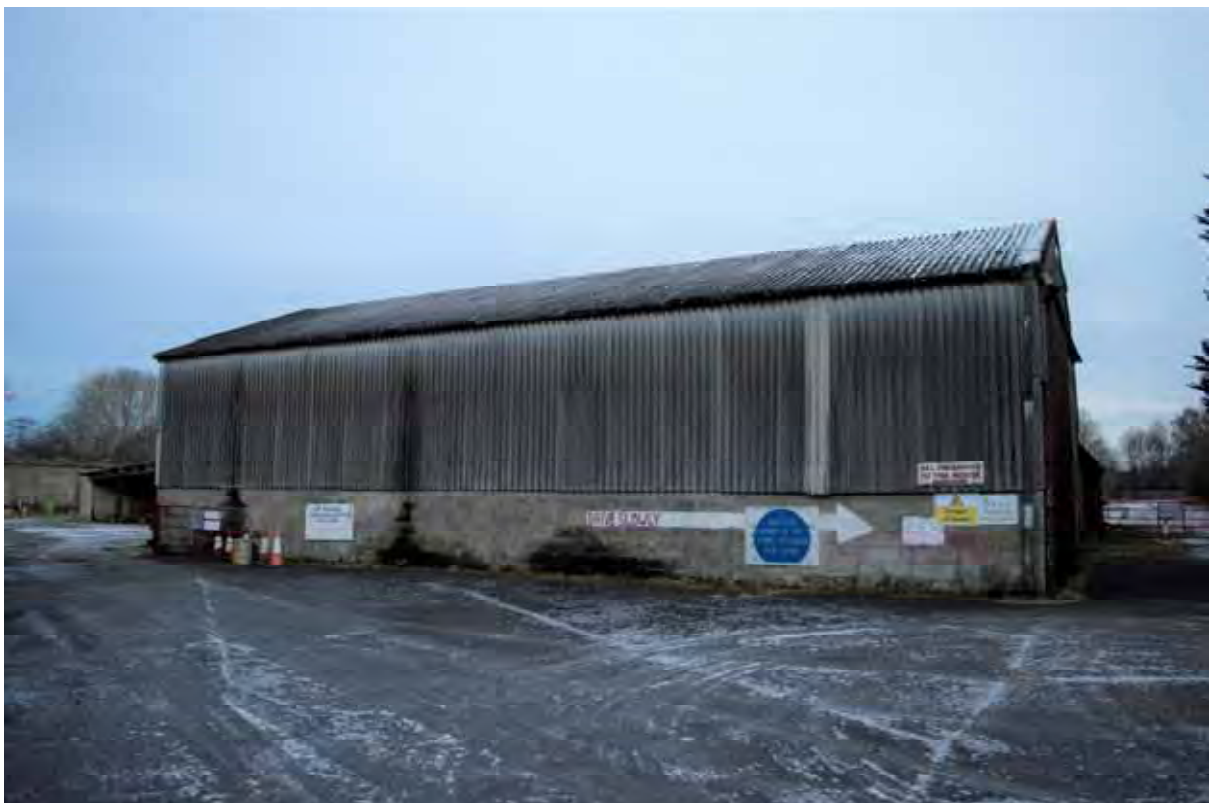
- 6.54 The buildings identified as 10c and 10d (Plate 212) comprise a single structure with an internal division. The structure has been constructed to the immediate north-west of Store 10, incorporating the remaining elements of the store's northern loading bay into the interior of 10d. The structure is rather rudimentary in nature, constructed of corrugated asbestos-cement sheeting, hung over a simple I-section steel girder frame, all set above a breezeblock plinth. The rectangular structure is aligned south-west – north-east and has substantial doorways set within both ends. Each doorway comprises corrugated iron panels, set within a steel girder sliding frame. The roof is

pitched along the same alignment and covered with the same sheeting as the walls. Building 10c is accessed from the south-west and comprises a single rectangular store. The south-east elevation of 10c is additionally supported by four external breezeblock buttresses. The rear north-west wall, separating the interior and 10c and 10d, is made of ply-board covered timber studs. The interior of 10d was accessed from the north-east, although this entrance is now blocked. The interior appears to have served as a barn and storage facility. The interior (Plate 213) occupies an L-shape and retains the eastern loading platform of Store 10's northern loading bay. The western platform has been demolished, presumably to accommodate the construction of this building.

Plate 212: View of the north-west elevation of Building 10c / 10d, facing south-east (544)

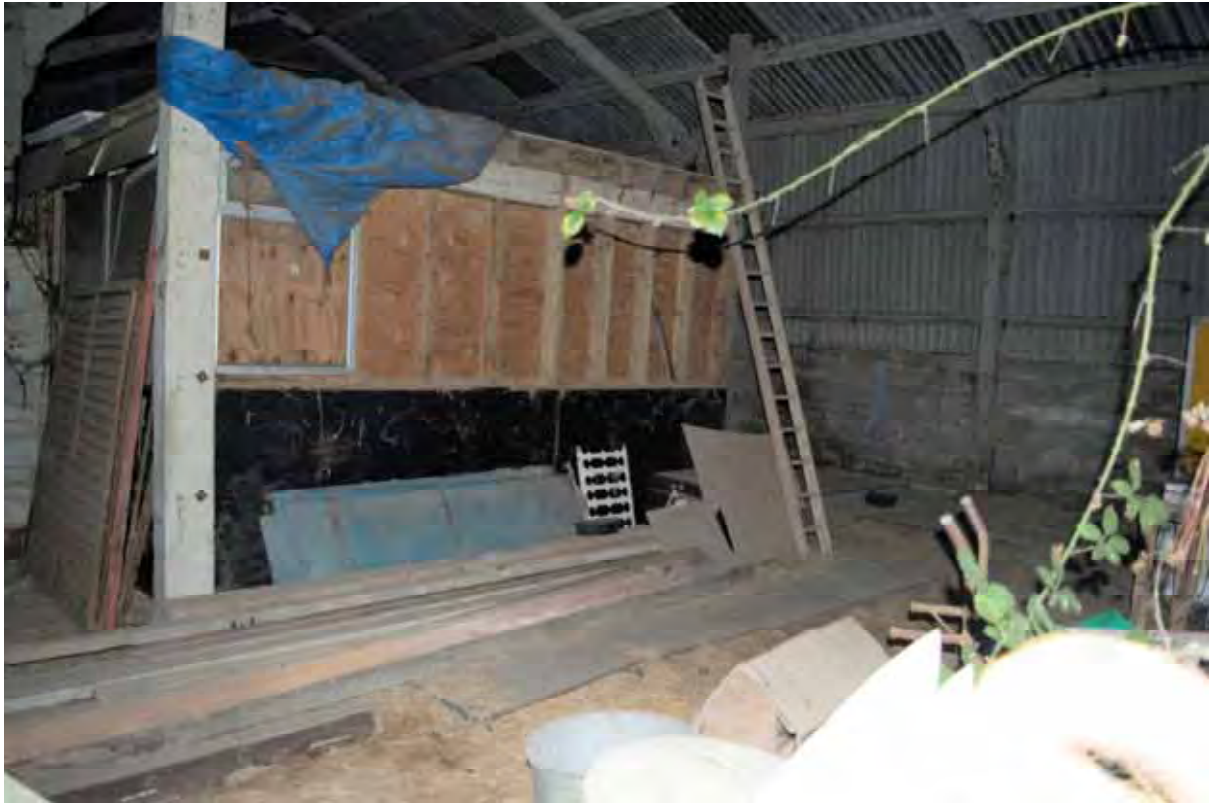
Plate 213: View of the interior of Building 10d, facing north (563)

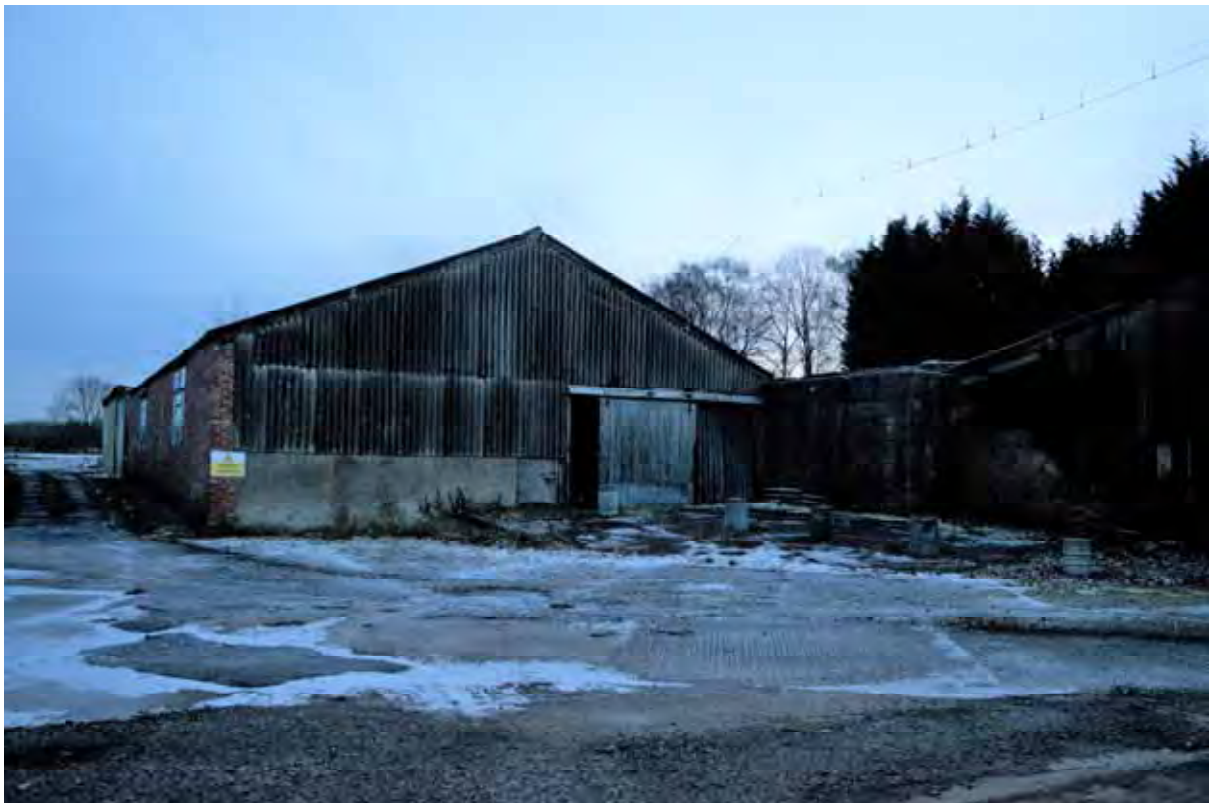
- 6.55 Building 10e (Plate 214) comprises a large, rectangular, lean-to, constructed against the north-east elevation of Store 10. The building follows the same alignment as the store, with its principal elevation facing north-west. Its north-west and south-east elevations comprise low breezeblock plinths, with regularly-spaced piers supporting corrugated asbestos-cement sheet cladding. The north-east elevation is built in stretcher-bonded orange brickwork (Plate 215), suggesting that the structure may have originally been open-fronted. Two timber-framed windows with timber lintels are set to either end of the north-east elevation. The roof is pitched and covered in corrugated asbestos-cement sheeting. The building interior (Plate 216) is accessed from two openings set within the north-west elevation, comprising a substantial sliding doorway (as elsewhere) with adjacent ramp and a single timber-boarded personal doorway set to the east. A single external doorway is additionally set centrally within the south-east elevation, providing quick access to Building 11. The interior comprises a single open-plan barn, with continuous cement screed floor. The south-west wall comprises the outer blast wall of Store 10 (Plate 217), complete with retained buttresses. The roof has been ceiled with aluminium composite panels, secured to a timber frame.

Plate 214: View of the north-west elevation of Building 10e, facing south (561)

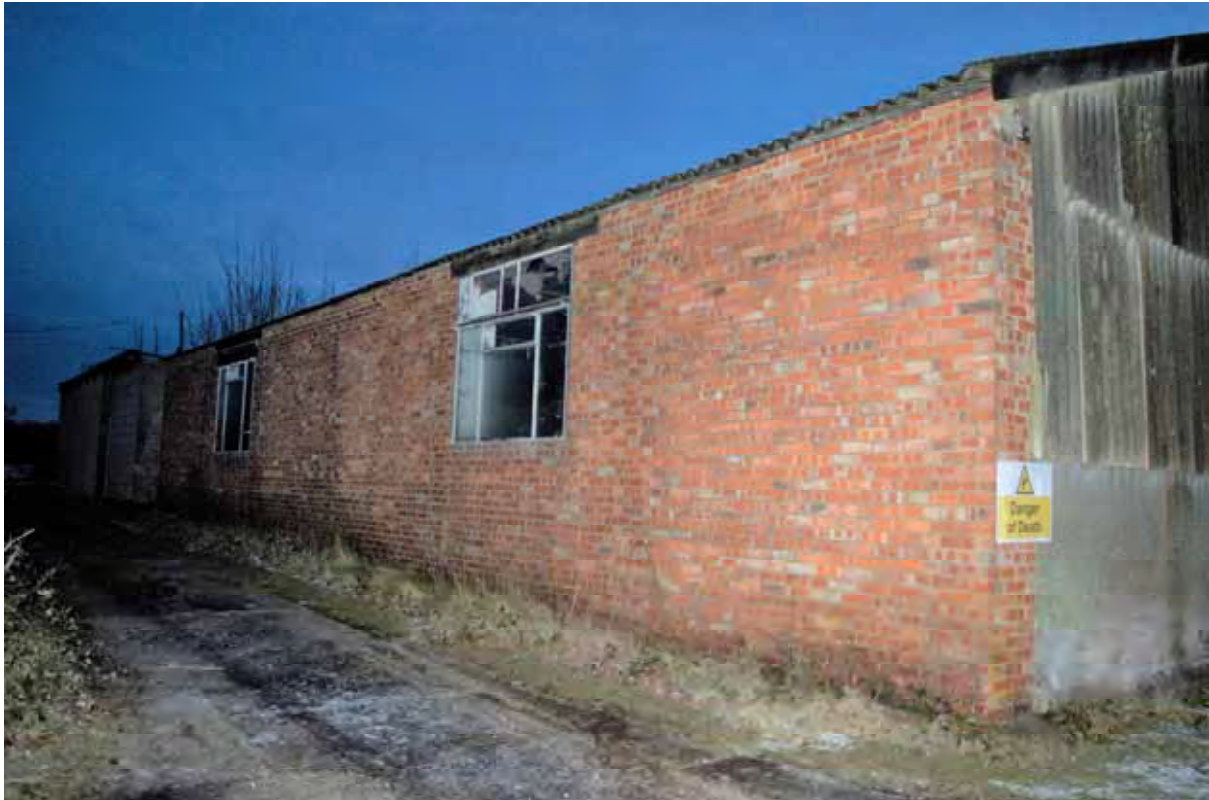
Plate 215: View of the north-east brick-built elevation of Building 10e, facing south (569)

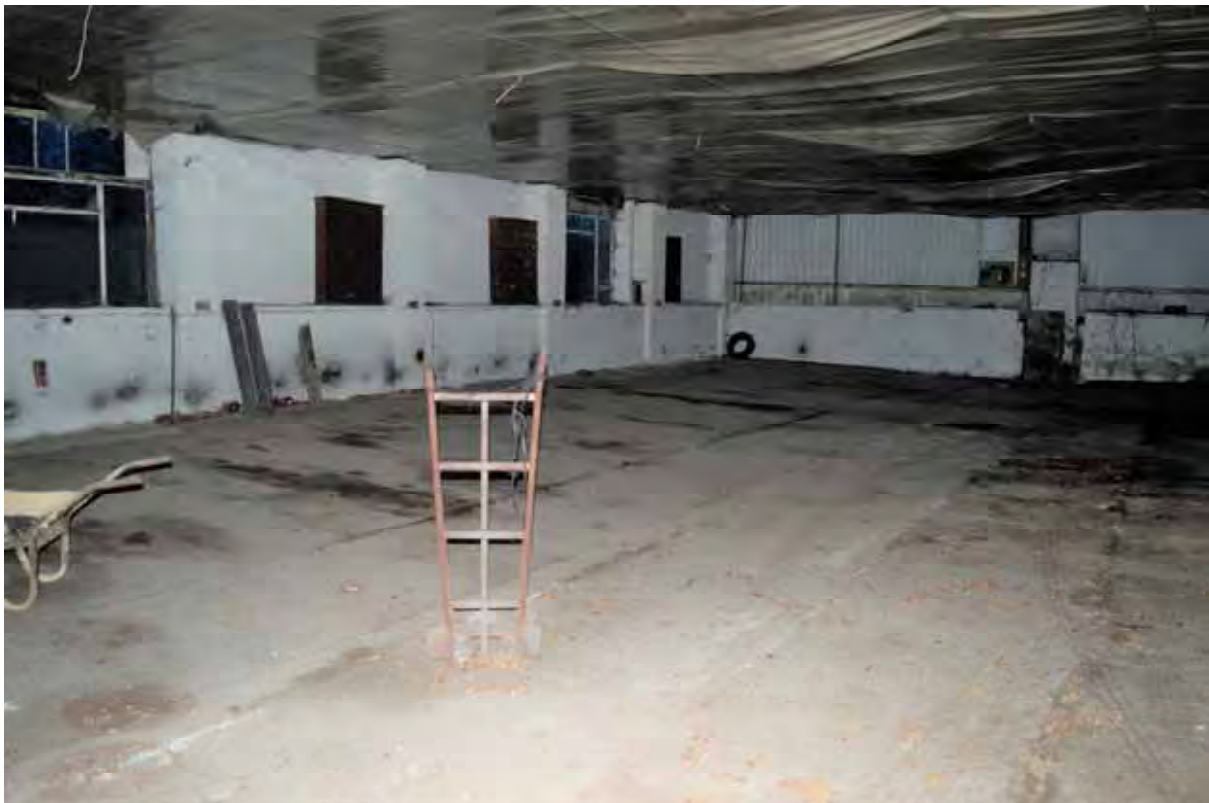
Plate 216: View of the interior of Building 10e, facing east (566)

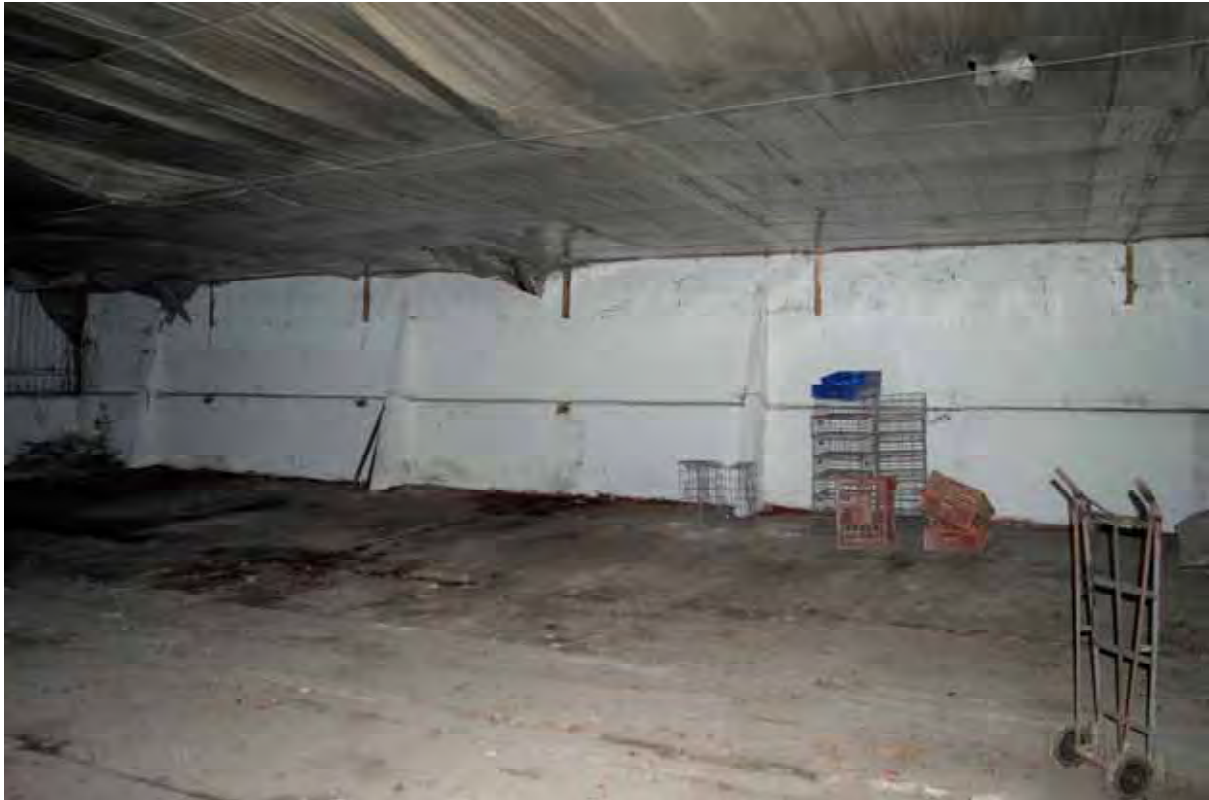
Plate 217: View of the north-east elevation of Store 10, situated within Building 10e, facing south-west (567)

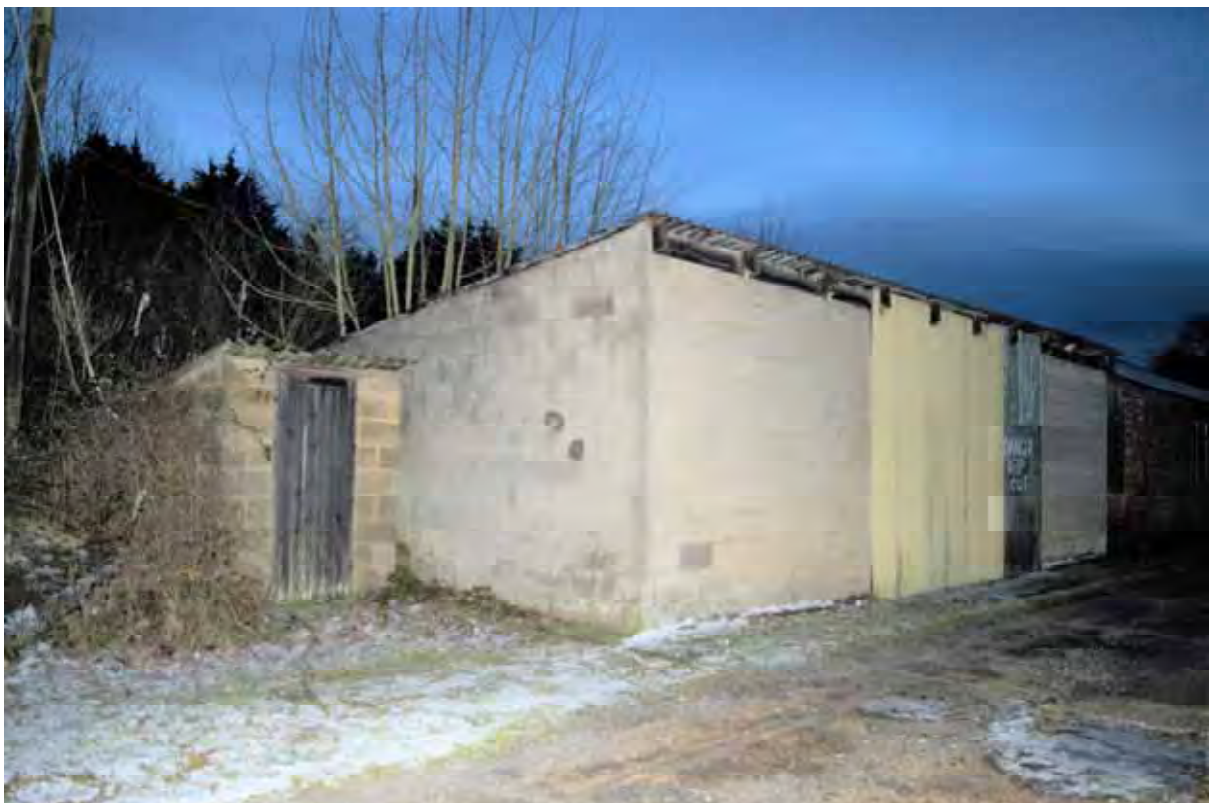
- 6.56 Building 11 (Plate 218) was constructed at some point between 1973 and 2003 (Google Earth), and therefore forms part of the site's later agricultural use; it was most recently in use as a fuel store. The structure occupies a rectangular footprint and is orientated north-west – south-east, with its principal elevation facing north-east. The structure backs onto the southern loading bay of Store 10, on its north-east side. It is constructed in concrete breezeblocks, and has a steeply sloping roof comprising softwood timbers, clad with corrugated iron sheeting. The principal elevation is filled at its centre by a wide full-height, ramped vehicle entrance, latterly blocked with corrugated iron sheeting and timber board. A single timber door fills the western end of the north-west elevation. The remaining elevations are plain. The interior comprises an open store. To the immediate south-east of the building is a small shed, constructed in the same manner, with a blocked single doorway set in its north-east elevation.

Plate 218: View of the north-east and south-east elevations of Building 11, facing north (572)

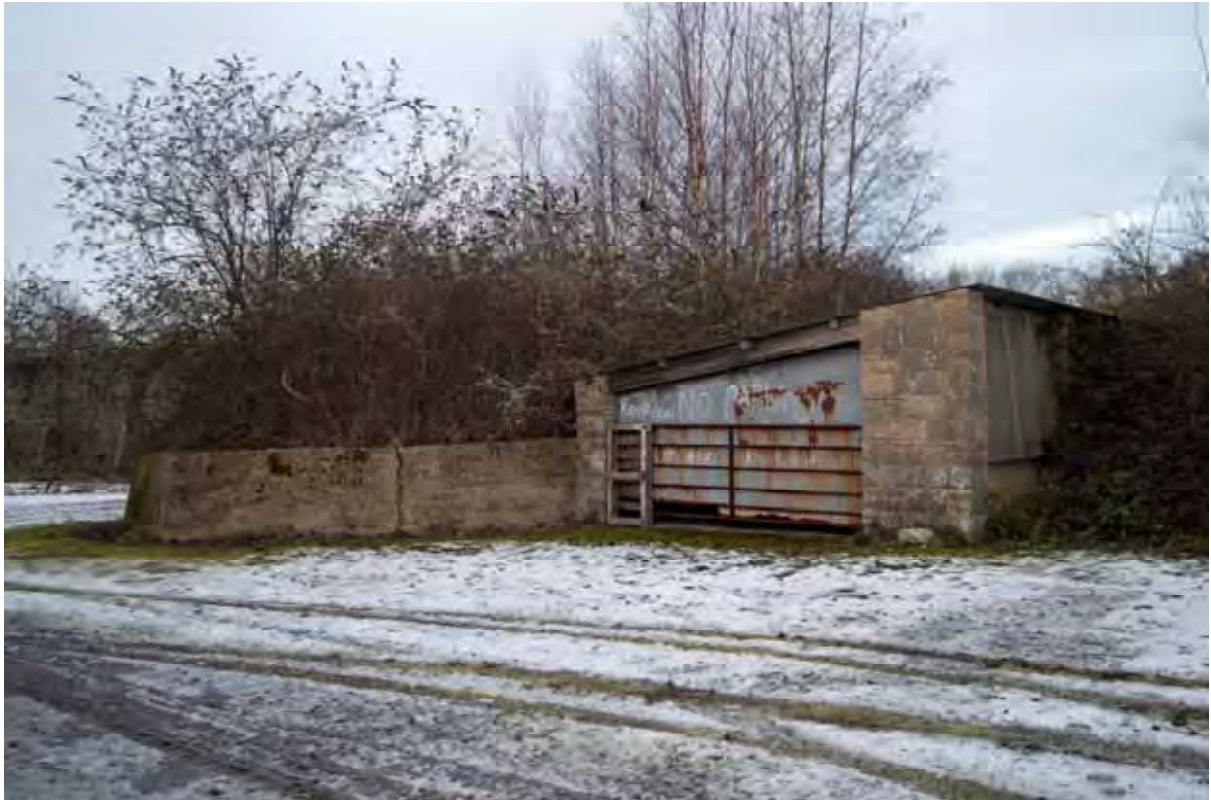
- 6.57 Building 13 (Plate 219) post-dates the historic mapping dating to 1973 and comprises a rectangular structure, aligned south-west – north-east. The building has been constructed within the northern loading bay of Store 14 to the immediate south-west of the earth blast barrier separating Stores 14 and 12. The principal elevation faces south-west, with the north-east elevation adjoining the remaining loading

Plate 219: View of the south-west elevation of Building 13, facing north (484)

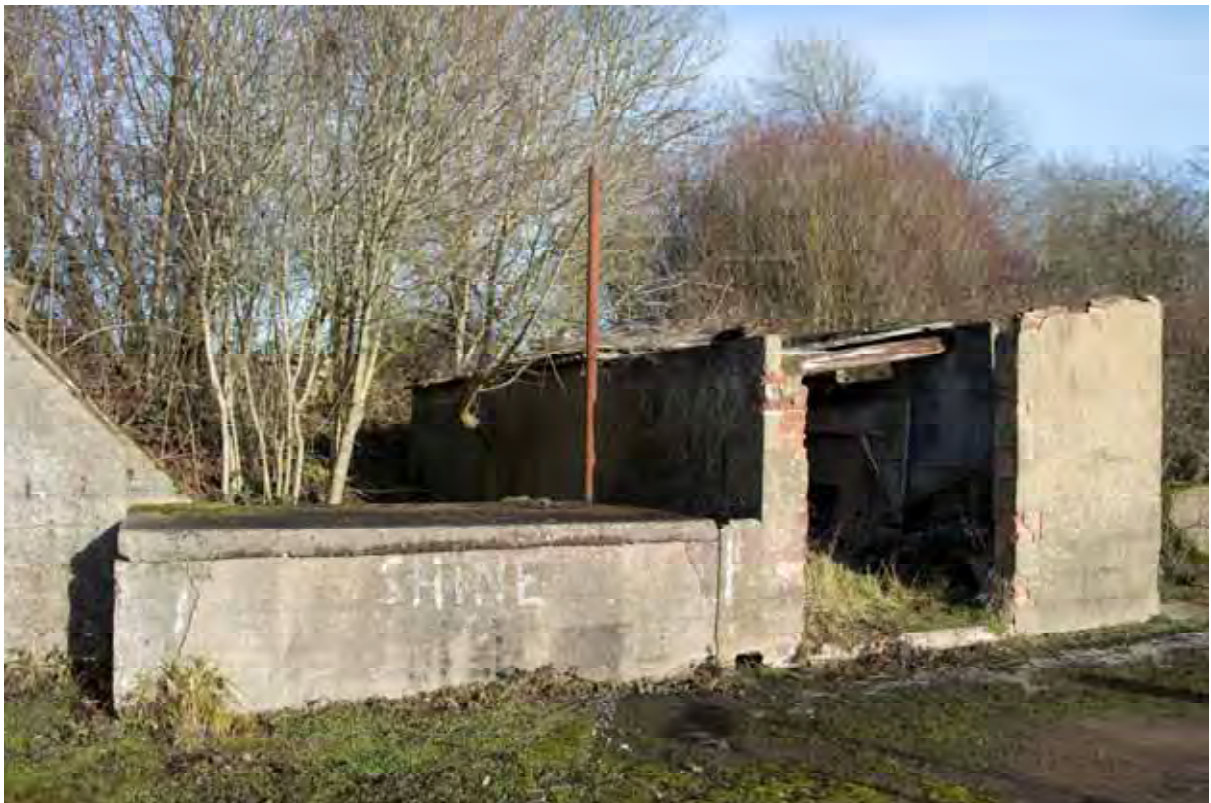
- 6.58 Building 15 (Plate 220) appears after 1973 and comprises a rudimentary rectangular shed, aligned south-west – north-east. The structure is situated to the immediate south-east of Store 4 and abuts the loading platforms in this location. The principal elevation faces south-west and is built in orange brickwork laid in stretcher bond, covered with a cement render. All other elevations are constructed in breezeblocks. The roof is sloped to the north-west and formed by sawn timber rafters, covered with asbestos cladding. The building is accessed via a double-width entrance to the south-west and is lit by two high-level, narrow windows (no glazing) set within the south-east elevation. The interior most recently served as a store but is now in a dilapidated condition.

Plate 220: View of the north-west and south-west elevations of Building 15, facing east (282)

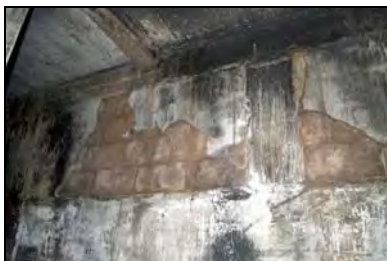
CFB17-0431
Store 8 (2017)

Plate 103: Store 8 – Detail of the fire damaged south-west wall within the western passage, note the concrete blocks used to fill the former openings, facing south (431)

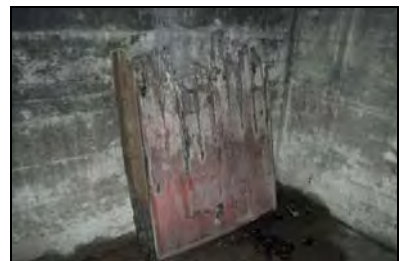
CFB17-0432
Store 8 (2017)

Plate 105: Store 8 – Detail of the fire damaged timber notice board within Bin 15 (western half), note the 'Fire Orders' title still visible, facing north (432)

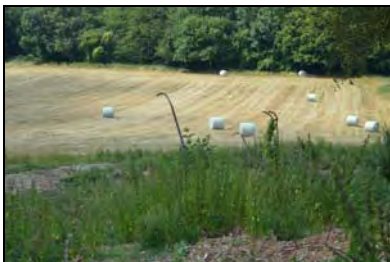
CFB17-0612
Detail of original perimeter fence (2018)

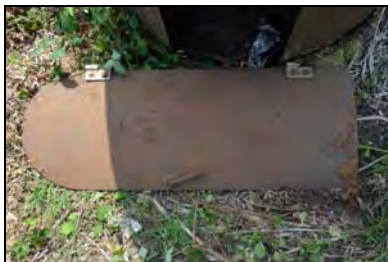
CFB17-0613
*Remnant of original perimeter fence
(2018)*

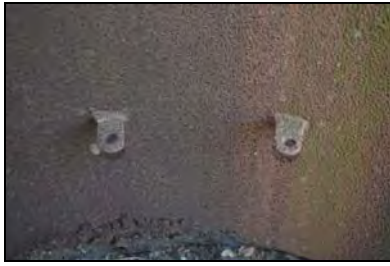
CFB17-0616
North-eastern sentry post

Plate 182: Detail of the wire found within the north-eastern sentry post, facing north-east (616)
