**Archaeological Evaluation Report
Sandhurst Wastewater
Treatment Works
Kent**

**NGR: 581003 128937
(TQ 81003 28937)**

**ASE Project No: 170989
Site Code: SDT17
ASE Report No: 2018105
OASIS id: archaeol6-312178**

Prepared by:	Lucy May with Alice Dowsett	Archaeologists	
Reviewed and approved by:	Dan Swift	Project Manager	
Date of Issue:	April 2018		
Version:	1

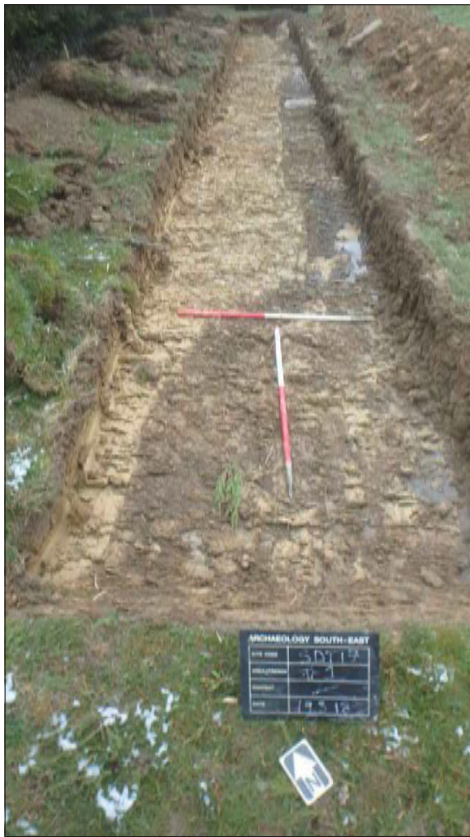
Trench 1 looking north-east

5.1.1 This trench measured c. 20m x 1.8m. A yellow-orange (Wadhurst) clay was overlain by a geotechnical membrane covered with ballast. A thin topsoil deposit, consisting of a dark, grey-brown, silty clay, sealed all this.

5.1.2 No archaeological finds, features or deposits were encountered.

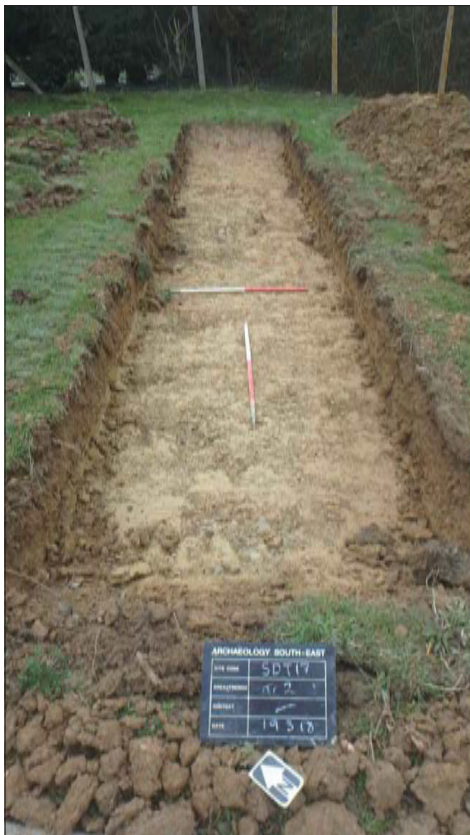
Trench 2 looking north-east

5.2.1 This trench measured c. 8.5m x 1.8m. A yellow-orange (Wadhurst) clay was overlain by a subsoil comprising of a mid, orange-brown, silty clay. A dark, grey-brown, silty clay topsoil sealed this.

5.2.2 No archaeological finds, features or deposits were encountered.

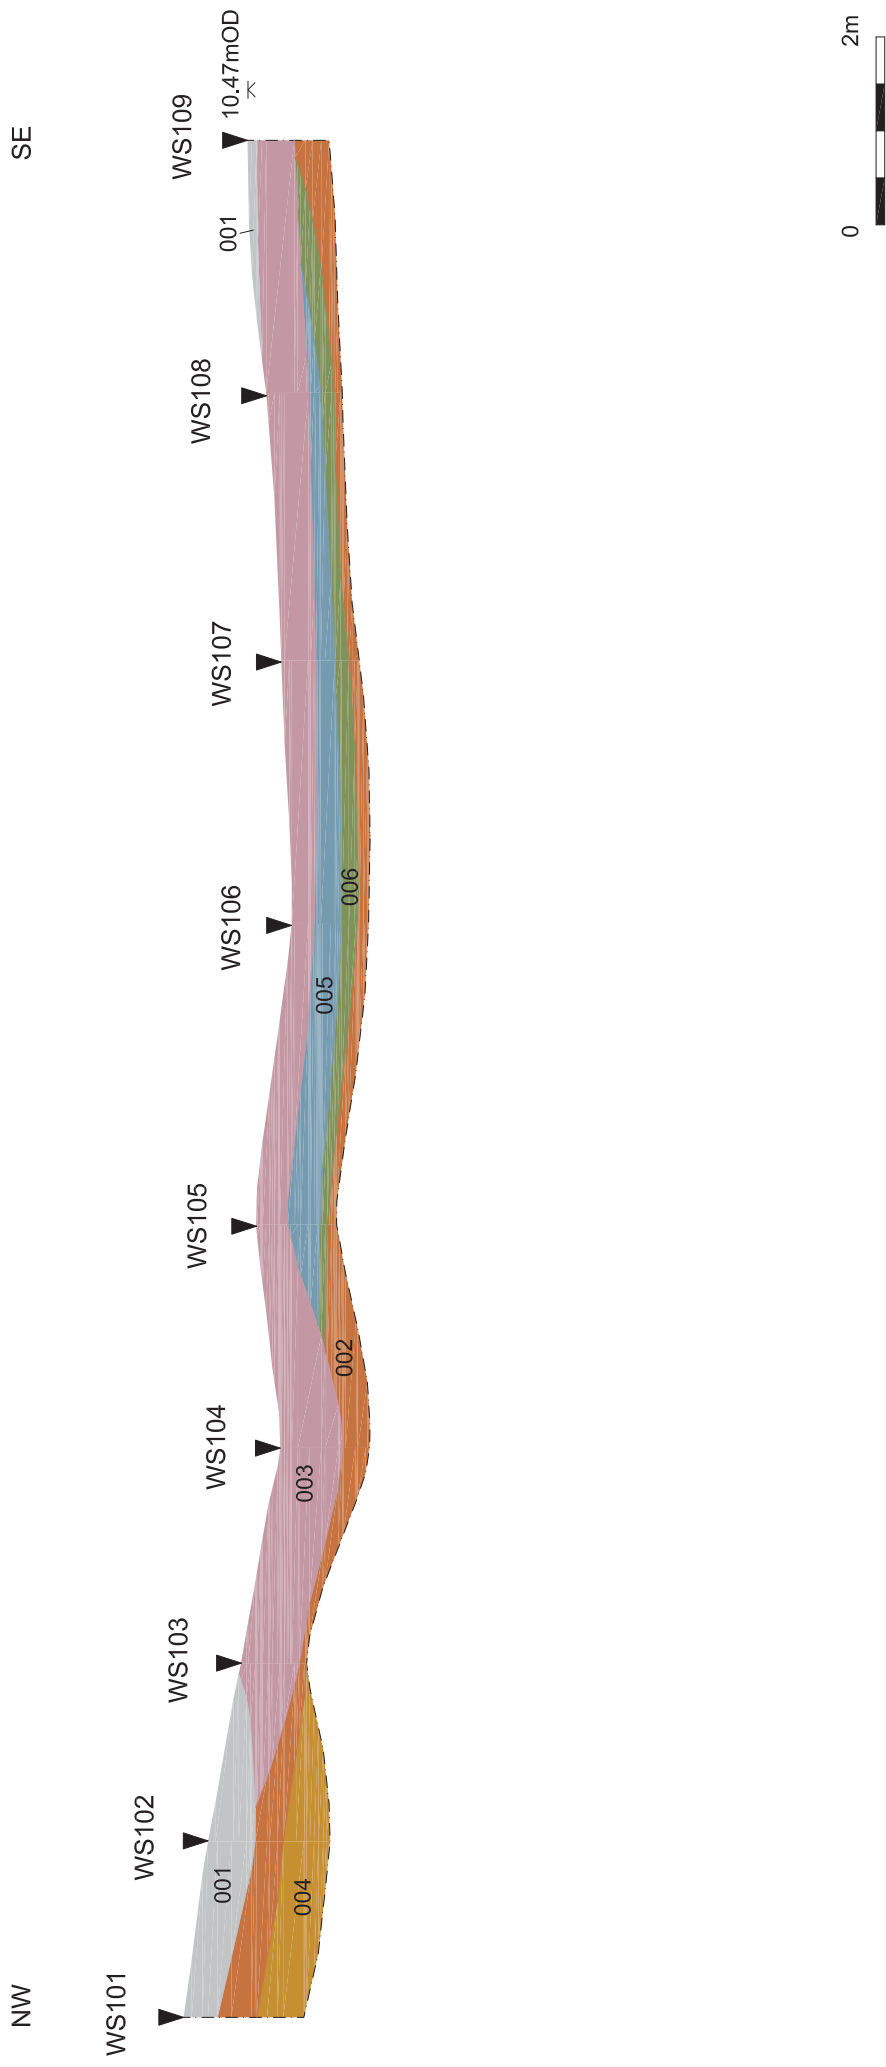
Fig.4

© Archaeology South-East		Sandhurst Wastewater Treatment Works, Kent	
Project Ref: 170989	April 2018	Indicative section along window sample transect	
Report Ref: 2018:105	Drawn by: LG

- 8.3.2 The results indicate that at the lowest point of the site at the base of the bank, along the north-east site boundary, lay deposits which may be related to the medieval moat (WS105-WS108). Directly overlying the weathered Wadhurst Formation is a band of soft dark grey-brown silty clay with occasional organics [006], c.0.08-0.17m. The colour of the deposits indicates that they have not undergone weathering, whilst the fine nature of the silty clay indicates a possible low-energy environmental for deposition in a river. This is then overlain by a band of compact grey-brown silty clayey gravel, with rounded flint pebbles and occasional organics [005], c.0.13-0.34m. This colour also indicates that the sediment has not undergone weathering, and the rolled nature of the gravel indicates possible high-energy riverine deposition. Made ground seals WS105-WS108.

8.3.3 WS101, WS102 and WS109 all exhibited Wadhurst Clay Formation sediment, directly overlain by topsoil and were of no further interest. WS103 and WS104 exhibited Wadhurst Clay Formation sediment, directly overlain by made ground and were also of no further interest.

8.5.1 The bank to the south of the window sample transect is likely completely built up of made ground, which then slopes down fairly steeply by ~1m towards the site boundary to the north. It appears that most of the remnants of the possible moat have likely been removed and replaced with made ground, and that the only surviving moat deposits lay against the north fence of the site, at the base of the slope of built up ground.

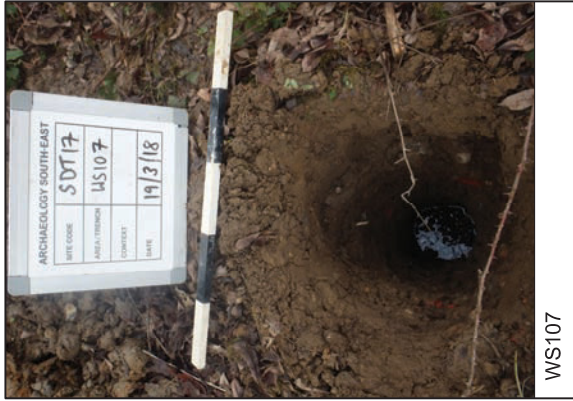
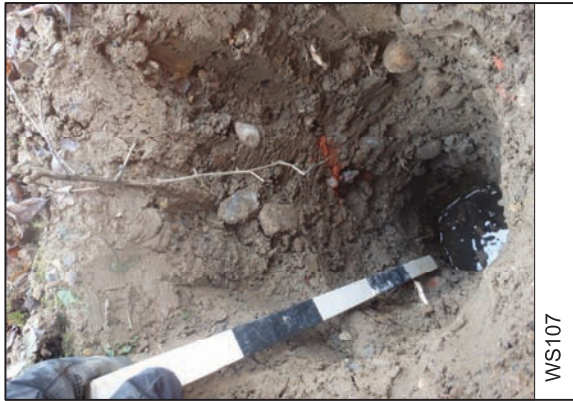
6.8.1 WS107 (figure 5) comprised a firm mottled grey-blue and orange-brown clay with mudstone inclusions [002], which was interpreted as weathered Wadhurst Clay Formation. This was overlain by a dark-grey silty clay with occasional organics [006], which was interpreted as a possible low-energy natural riverine deposit. Overlaying this was a grey-brown silty clayey gravel [005] with occasional organics, which was interpreted as a possible natural high-energy riverine deposit. Finally, this was sealed by an orange-brown mixed with blue-grey sandy clay with CBM and concrete [003], this was interpreted as made ground.

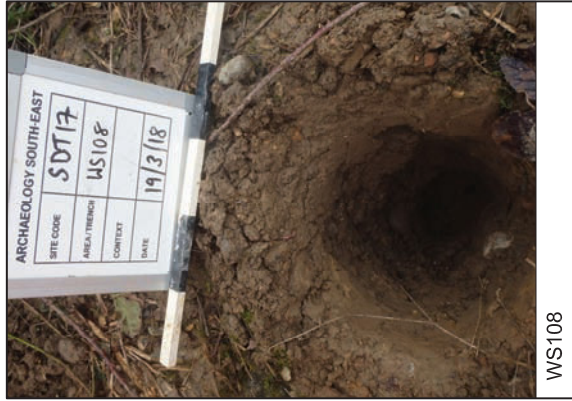
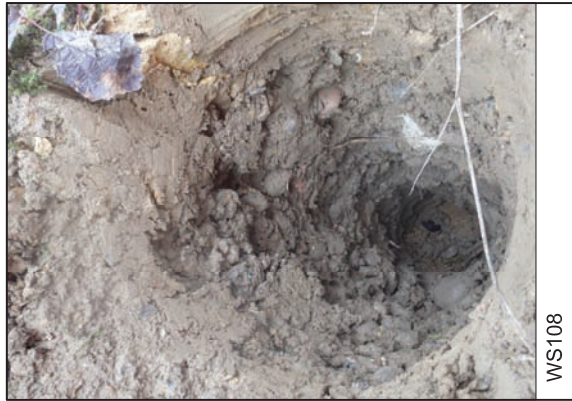
6.9.1 WS108 (figure 5) comprised a firm mottled grey-blue and orange-brown clay with mudstone inclusions [002], which was interpreted as weathered Wadhurst Clay Formation. This was overlain by a dark-grey silty clay with occasional organics [006], which was interpreted as a possible low-energy natural riverine deposit. Overlaying this was a grey-brown silty clayey gravel [005] with occasional organics, which was interpreted as a possible natural high-energy riverine deposit. Finally, this was sealed by an orange-brown mixed with blue-grey sandy clay with CBM and concrete [003], this was interpreted as made ground.

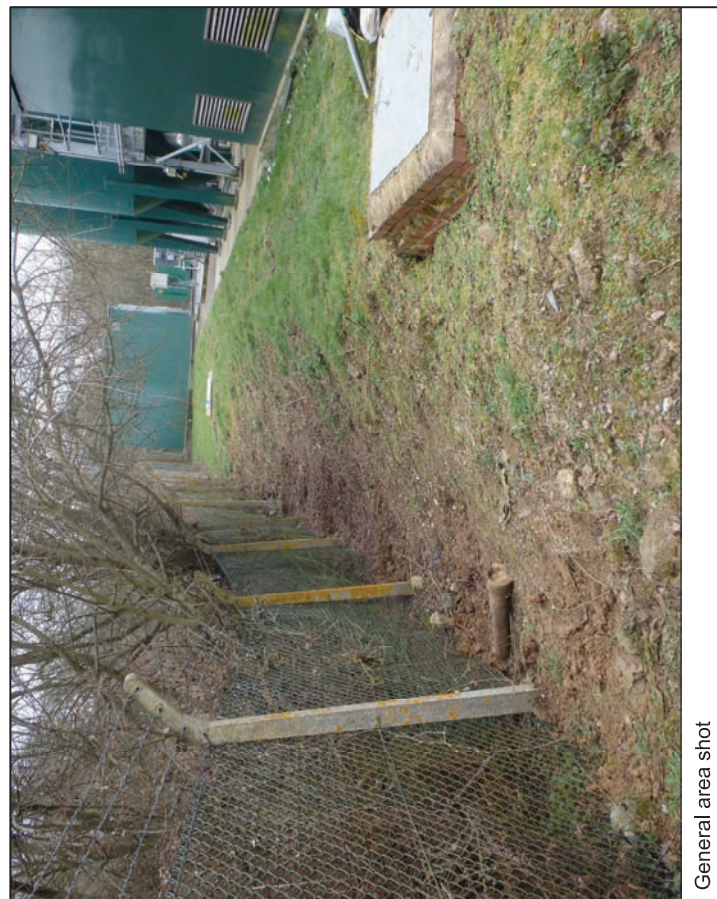
General area shot

© Archaeology South-East		Sandhurst Wastewater Treatment Works, Kent	
Project Ref: 170989	April 2018	Selected window sample photographs and transect area shot	
Report Ref: 2018:105	Drawn by: LG
