HACKNEY POLICE STATION, 2-4 LOWER CLAPTON RD LONDON BOROUGH OF HACKNEY, E5 0PA

Historic Buildings Record

**ASE Project No: 180171
Site Code: SJH18**

**ASE Report No: 2018103
OASIS id: archaeol6-312249**

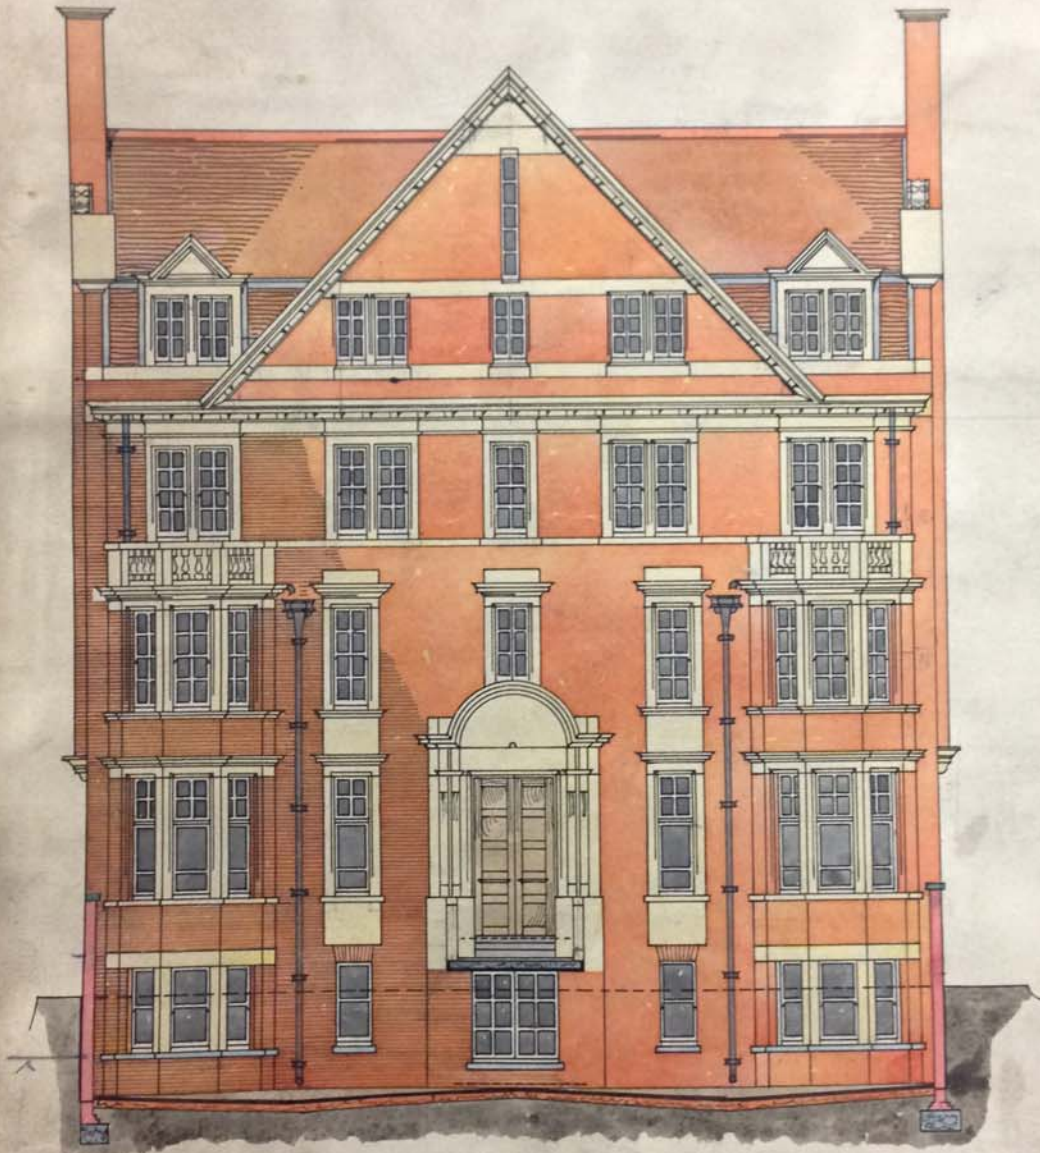
FRONT ELEVATION

- 6.2 The north elevation or street frontage of the building (Plate 1; Figure 6) comprises a lightwell to the basement, which has an original doorway to allow access directly to the lowest level from the exterior. To either side of the elevation canted bay windows extend down into the lightwell and rise over two floors; at their top they are surmounted by a pierced stone balustrade. Each bay is serviced by cast iron drainpipes with rainwater hoppers dated 1904.

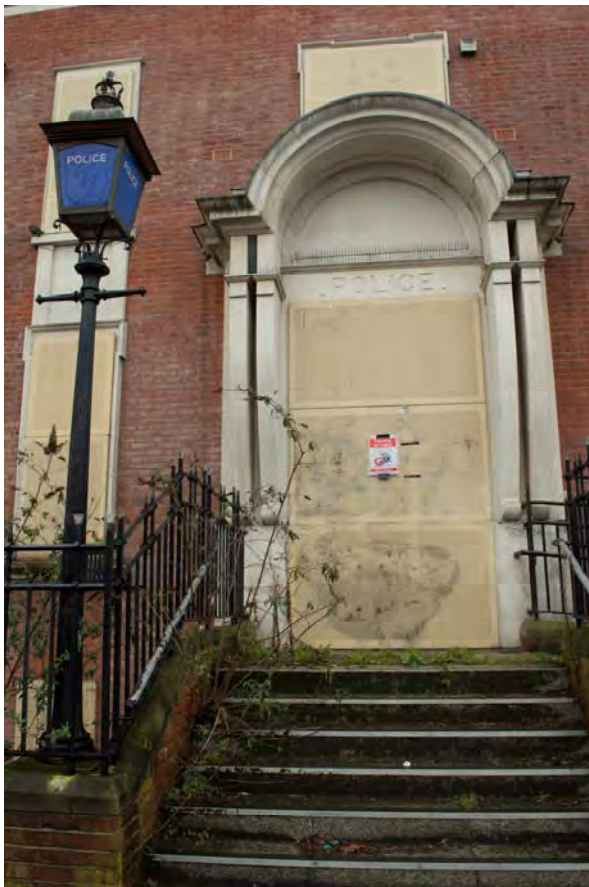
Plate 2: The main entrance and POLICE lantern (SJH18-0032)

- 6.3 The central main doorway is reached via a short flight of modern cast concrete stairs and a modern access ramp. It is surmounted by an oversized corbelled hood consisting of a broken segmental pediment. *POLICE* is inscribed in the frieze and the date *AD1904* to the lower right hand side. The front of the building precinct is defined by a low wall topped with stone and with cast iron railings and an original cast iron *POLICE* branded, blue-glazed street light (Plate 2).

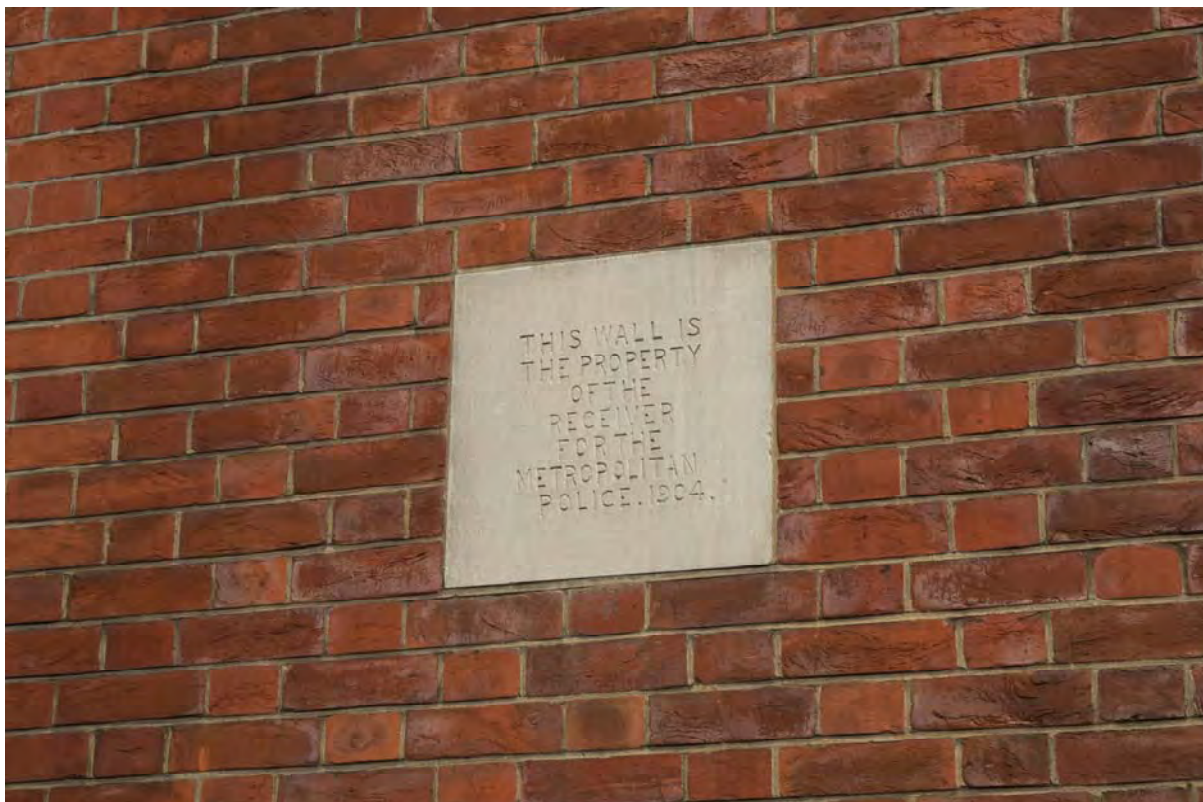
Plate 3: Blind wall of the east elevation with inscribed stone (SJH18-0029)

- 6.6 The east elevation is blind and of plain red brick. It is dominated by a large chimney stack and has a single inscribed Portland stone block set at ground floor level. This reads: *THIS WALL IS THE PROPERTY OF THE RECEIVER FOR THE METROPOLITAN POLICE. 1904* (Plate 3).

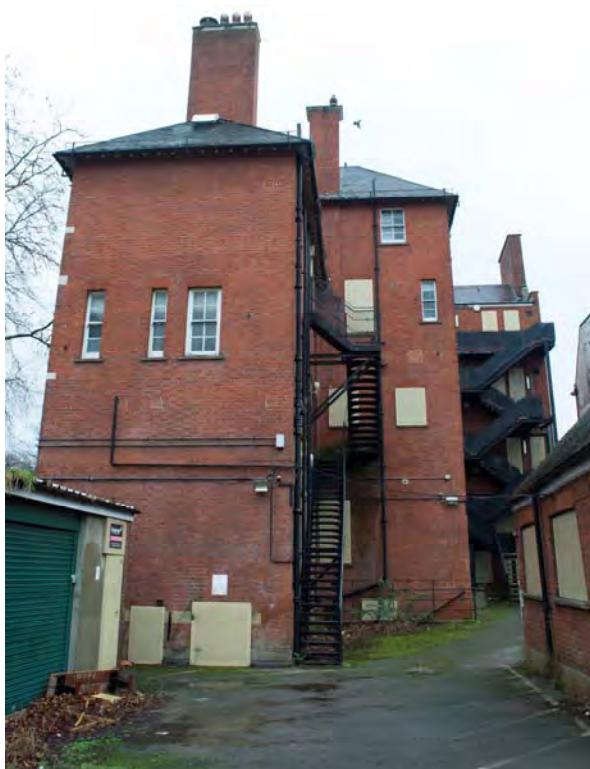
Plate 4: Rear elevation (SJH18-0003)

- 6.7 The rear elevation of the building has suffered the most modification, with the addition of a large fire escape marring a large part of the elevation. An original cast iron external staircase is also still present; the design of the handrails match those of the internal staircases. The fenestration is less formally arranged and is mainly of single or paired sash windows. Each window has stone sills and those which provide light to the cells have stone heads and cast iron grille framing. Two windows at basement level, originally coal and coke chutes, also have stone heads (Plate 04). A staircase to the basement level appears to have been built instead of a lift shown on the original basement level plans.

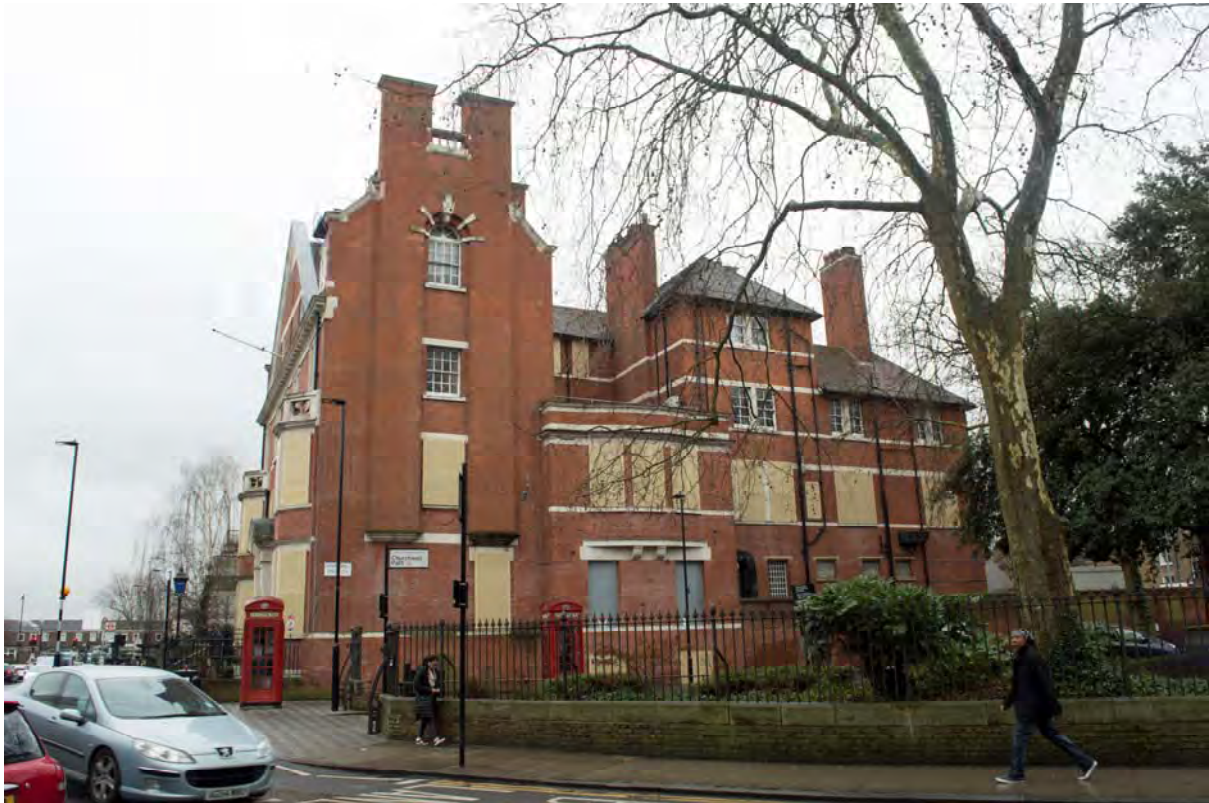
Plate 5: The western elevation (SJH18-0021)

- 6.8 The west elevation, as with the north, is visible from public space and thus has been treated in a more grandiose way than the less visible south and east elevations. It comprises the largely symmetrical end wall of the street range, with the adjoining rear range which is set variously over two, three and four storeys. The end wall of the main range is dominated by two large chimneys which spring from Portland stone corbels at first floor level and meet above the third floor with a rounded arch with stone keystone and voussoirs into which is set a segmented sash window. At the apex of the roof the chimneys separate again, and are joined by pierced stone balustrading matching that above the bay windows to the north (Plate 5). Two further windows are located between the stack at first and second floor level, while an inserted window is located towards the rear at ground floor level.

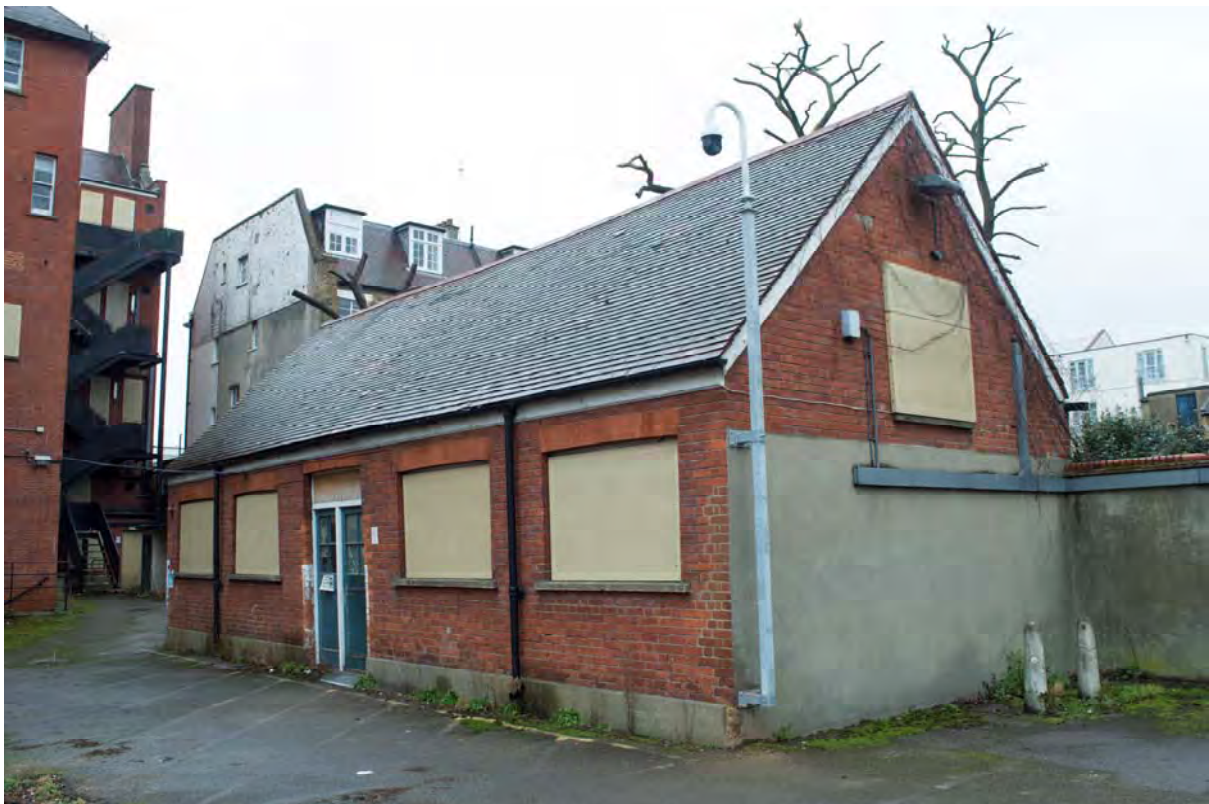
Plate 6: The parade hall (SJH18-005)

6.11 The Parade Hall located to the rear of the main station building is a simple structure. It comprises a five-window range constructed of red brick laid in Flemish bond with a clay-tiled roof (Plate 6). Each gable end has a single, high-set window. The west elevation has four windows with a central double doorway, while the east elevation is plain. The original plans show lavatory facilities at the northern end of the building however these have been removed and a doorway inserted. The plans also show a lamp store and ambulance shelter at the south end, which have also been removed.

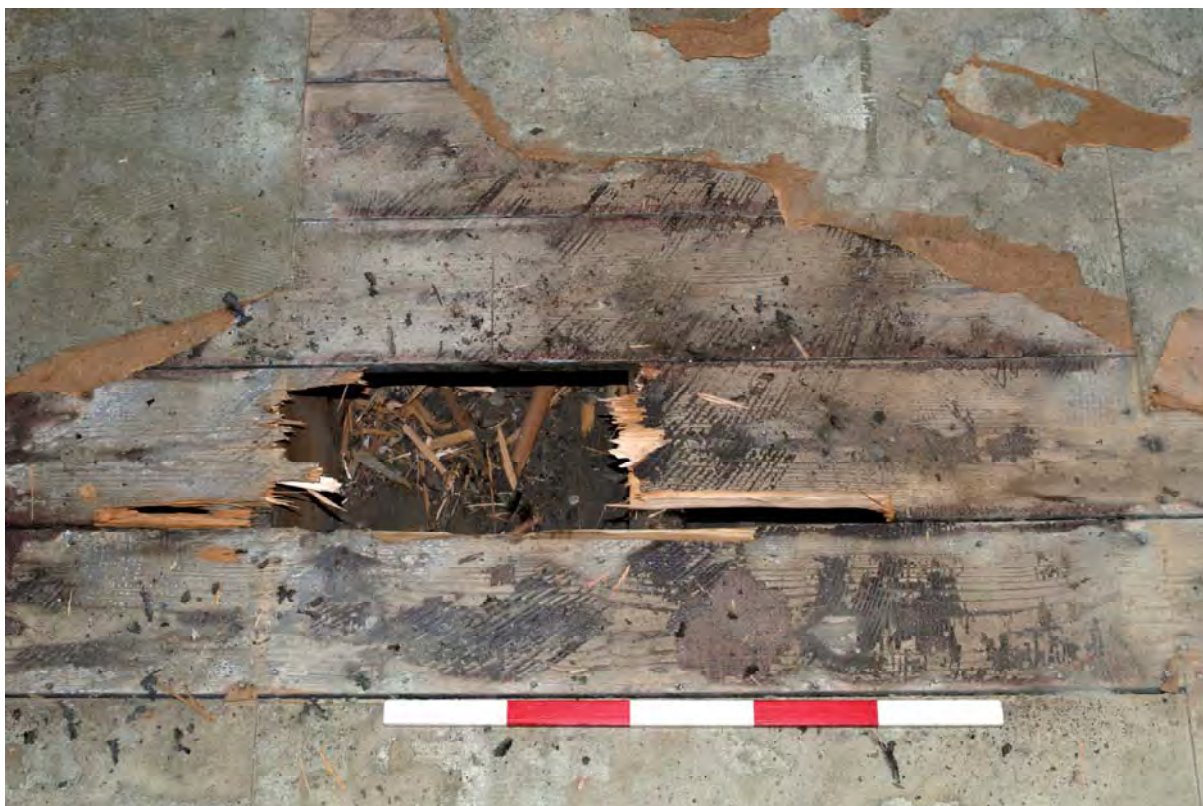
Plate 24: Original floorboards (SJH18-0115)

- 6.42 Minor original features such as skirting boards have survived in some areas. Areas of original narrow pine floorboards were exposed under the modern flooring in some rooms (Plate 24). Other more recent features still relating to the buildings use as a police station such as an intercom system speaker were also noted.
