Archaeological Evaluation

**Land adjacent to Chain Bridge Farm,
Roman Road, Shenfield,
Essex**

**ASE Project No: 180424
Site Code: MSCBF18**

ASE Report No: 2018286

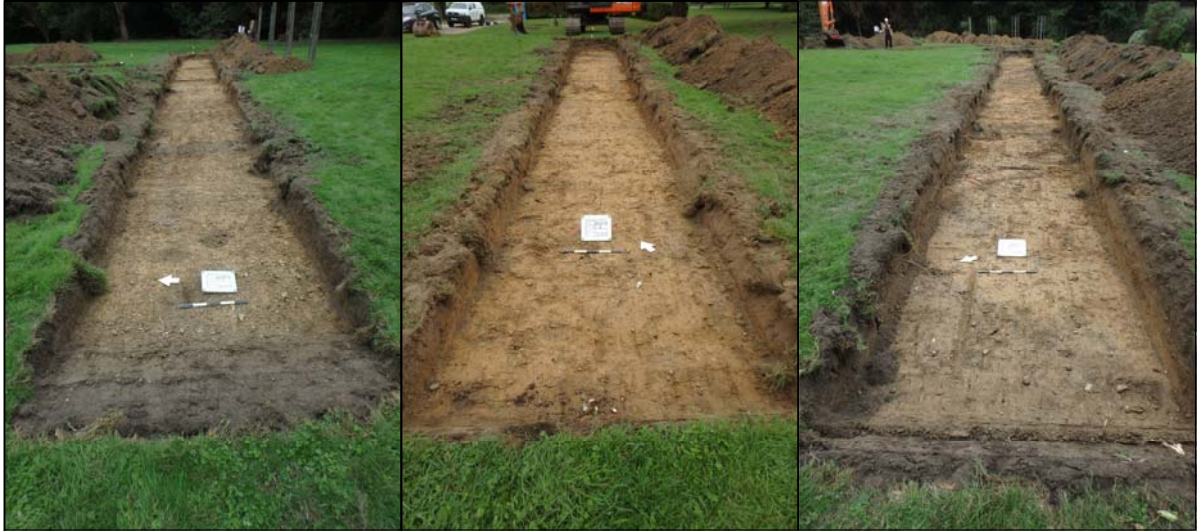
© Archaeology South-East		Chain Bridge Farm, Roman Road, Shenfield	Fig.3
Project Ref: 180424	Sept 2018	Trench photographs	
Report Ref: 2018286	Drawn by: APL

- 4.1.2 The general site sequence consisted of a mid-brownish grey silty clay topsoil and turf over a light yellowish brown clay silt subsoil that in turn overlay the light brownish yellow silty sand natural deposit that contained scattered patches of gravel. This sequence was c.0.32-0.40m deep across the site. Twentieth-century iron fragments were observed in the topsoil, but not recovered/retained.

5.1.2 Post-medieval brick, 19th-20th century ceramics and iron fragments from both overburden layers suggest a modern topsoil and a disturbed subsoil interface, likely through service installation and landscaping associated with the existing farm buildings. This was corroborated by the presence of modern land drains, service gullies and test pits, cut from below the turf into the natural deposit, in all three trenches.

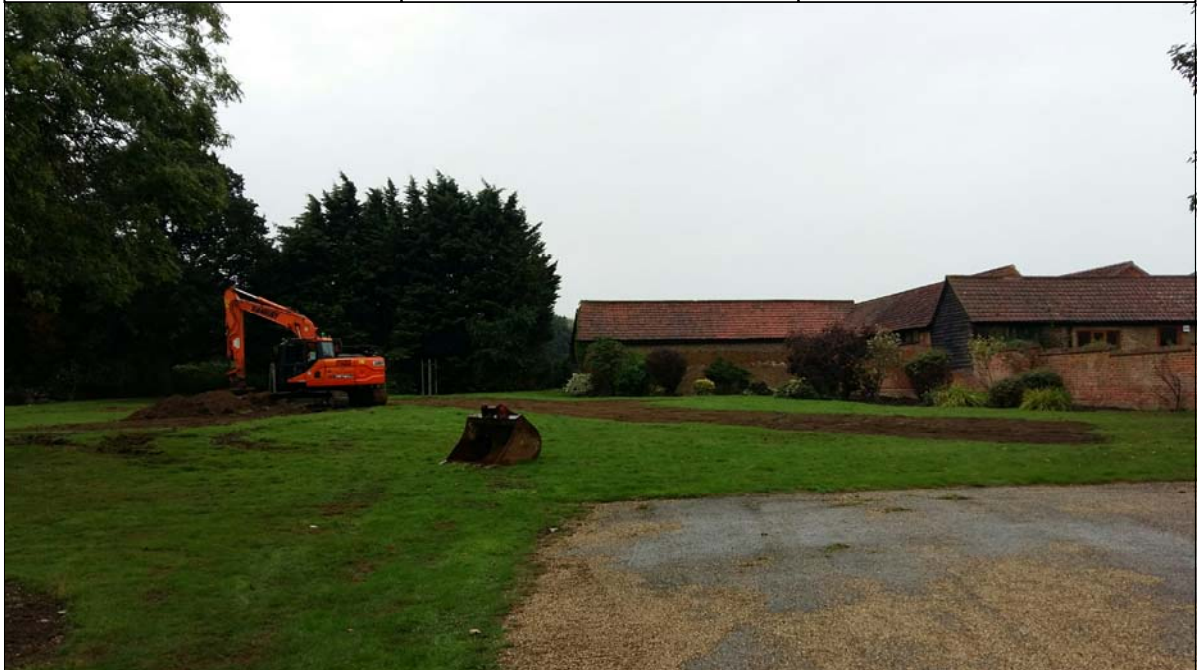
Trench 2

Trench 3

General site view
