**An Archaeological Desk-Based Assessment, Walkover Survey
and Watching Brief of land at Dover Castle New
Admissions Building, Dover, Kent**

**Project No 3127
Report Number 2007251**

**Prepared on behalf of
English Heritage**

November 2007

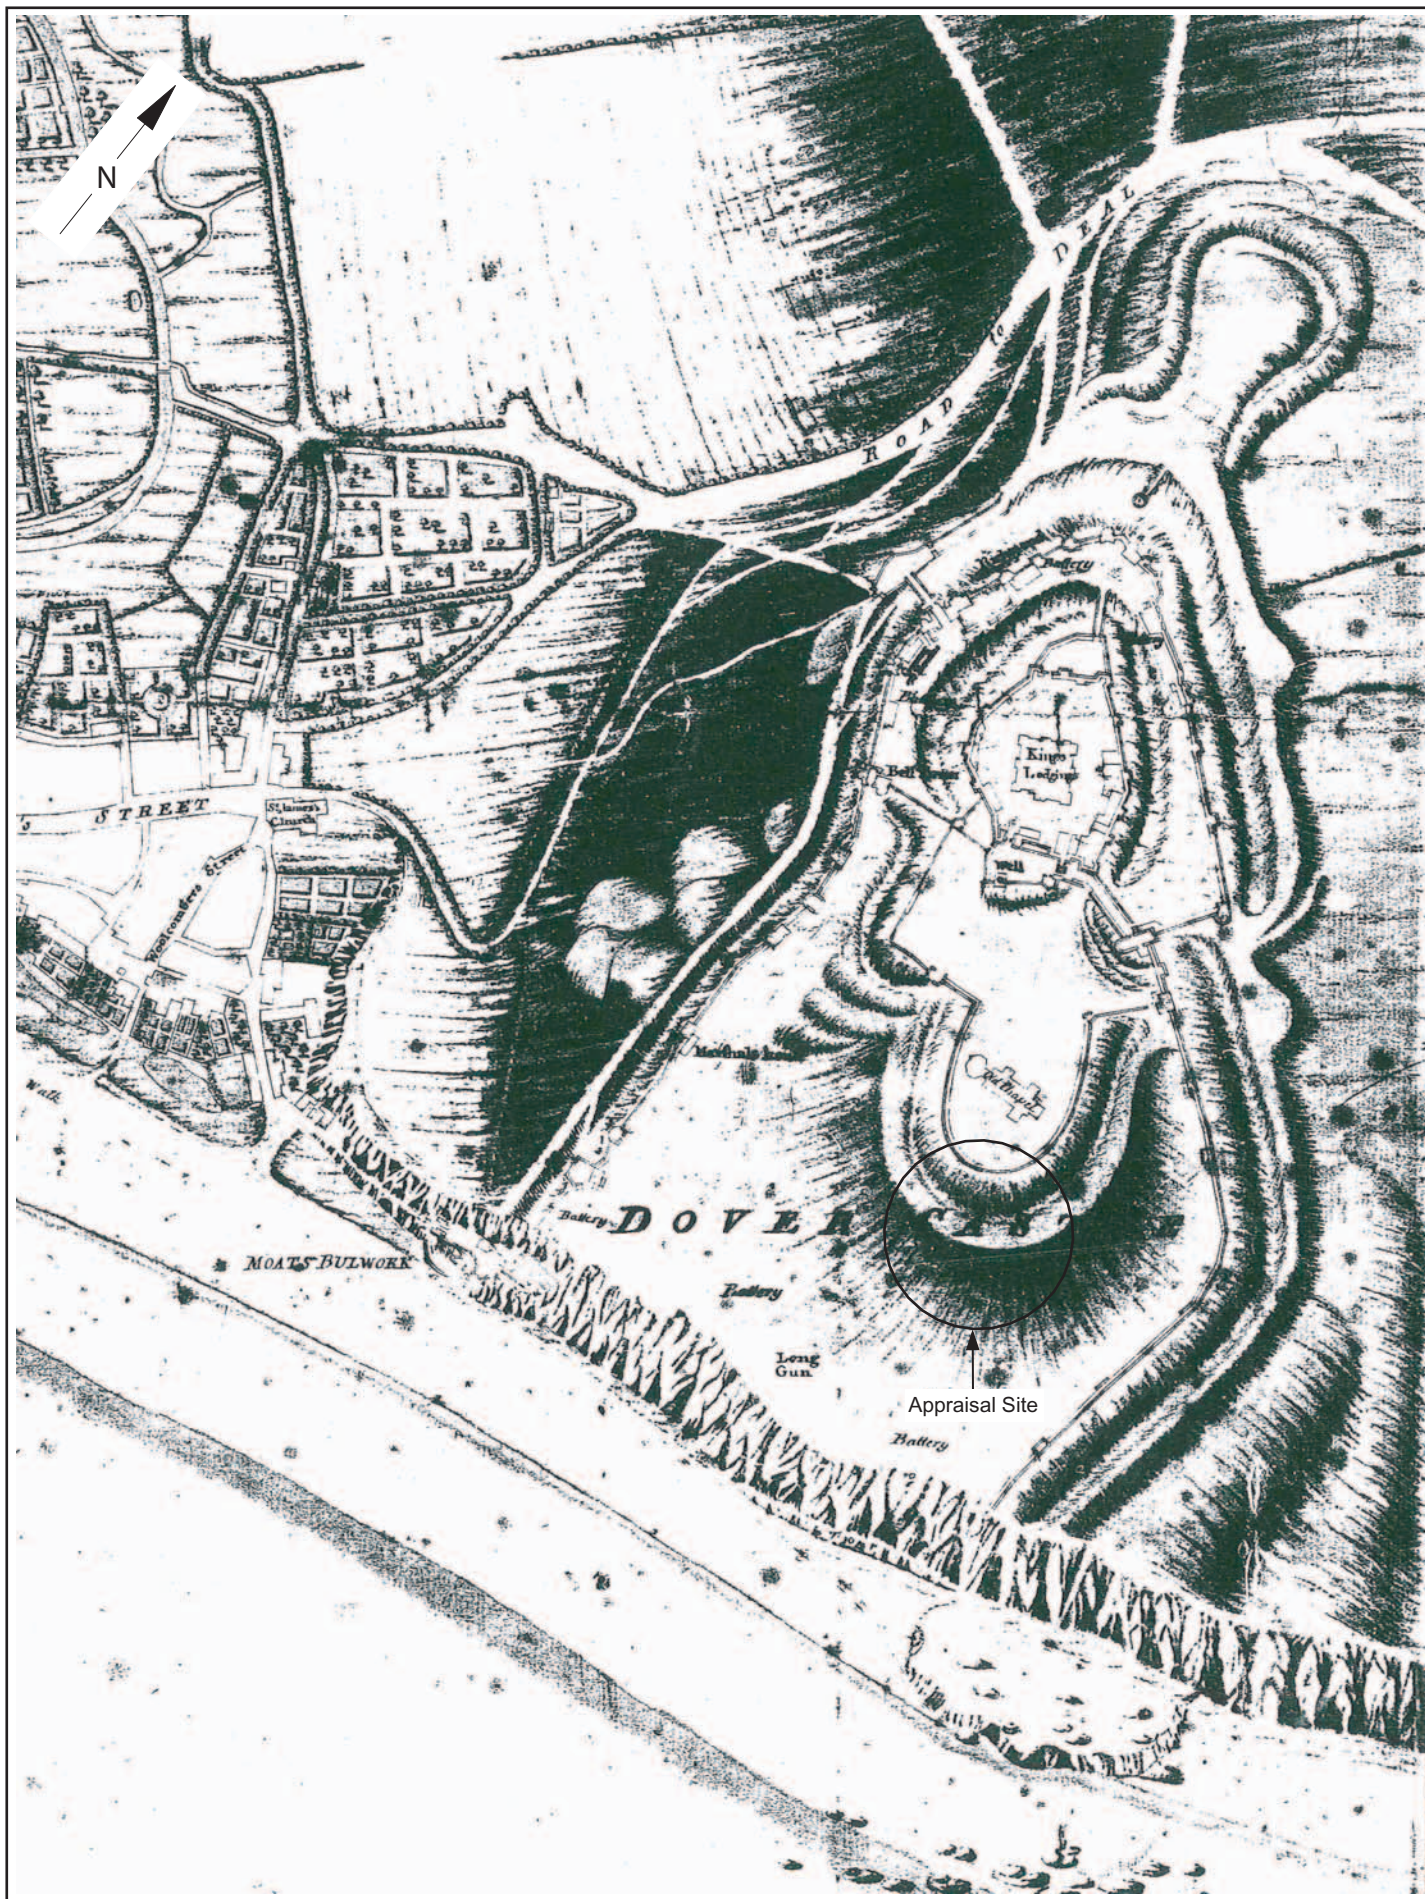
© Archaeology South-East			Dover Castle New Admissions Building	Fig. 7
Ref: 3127	Nov 2007	Drawn by: JLR	Plan of the Town, Harbour and Fortifications, 1737

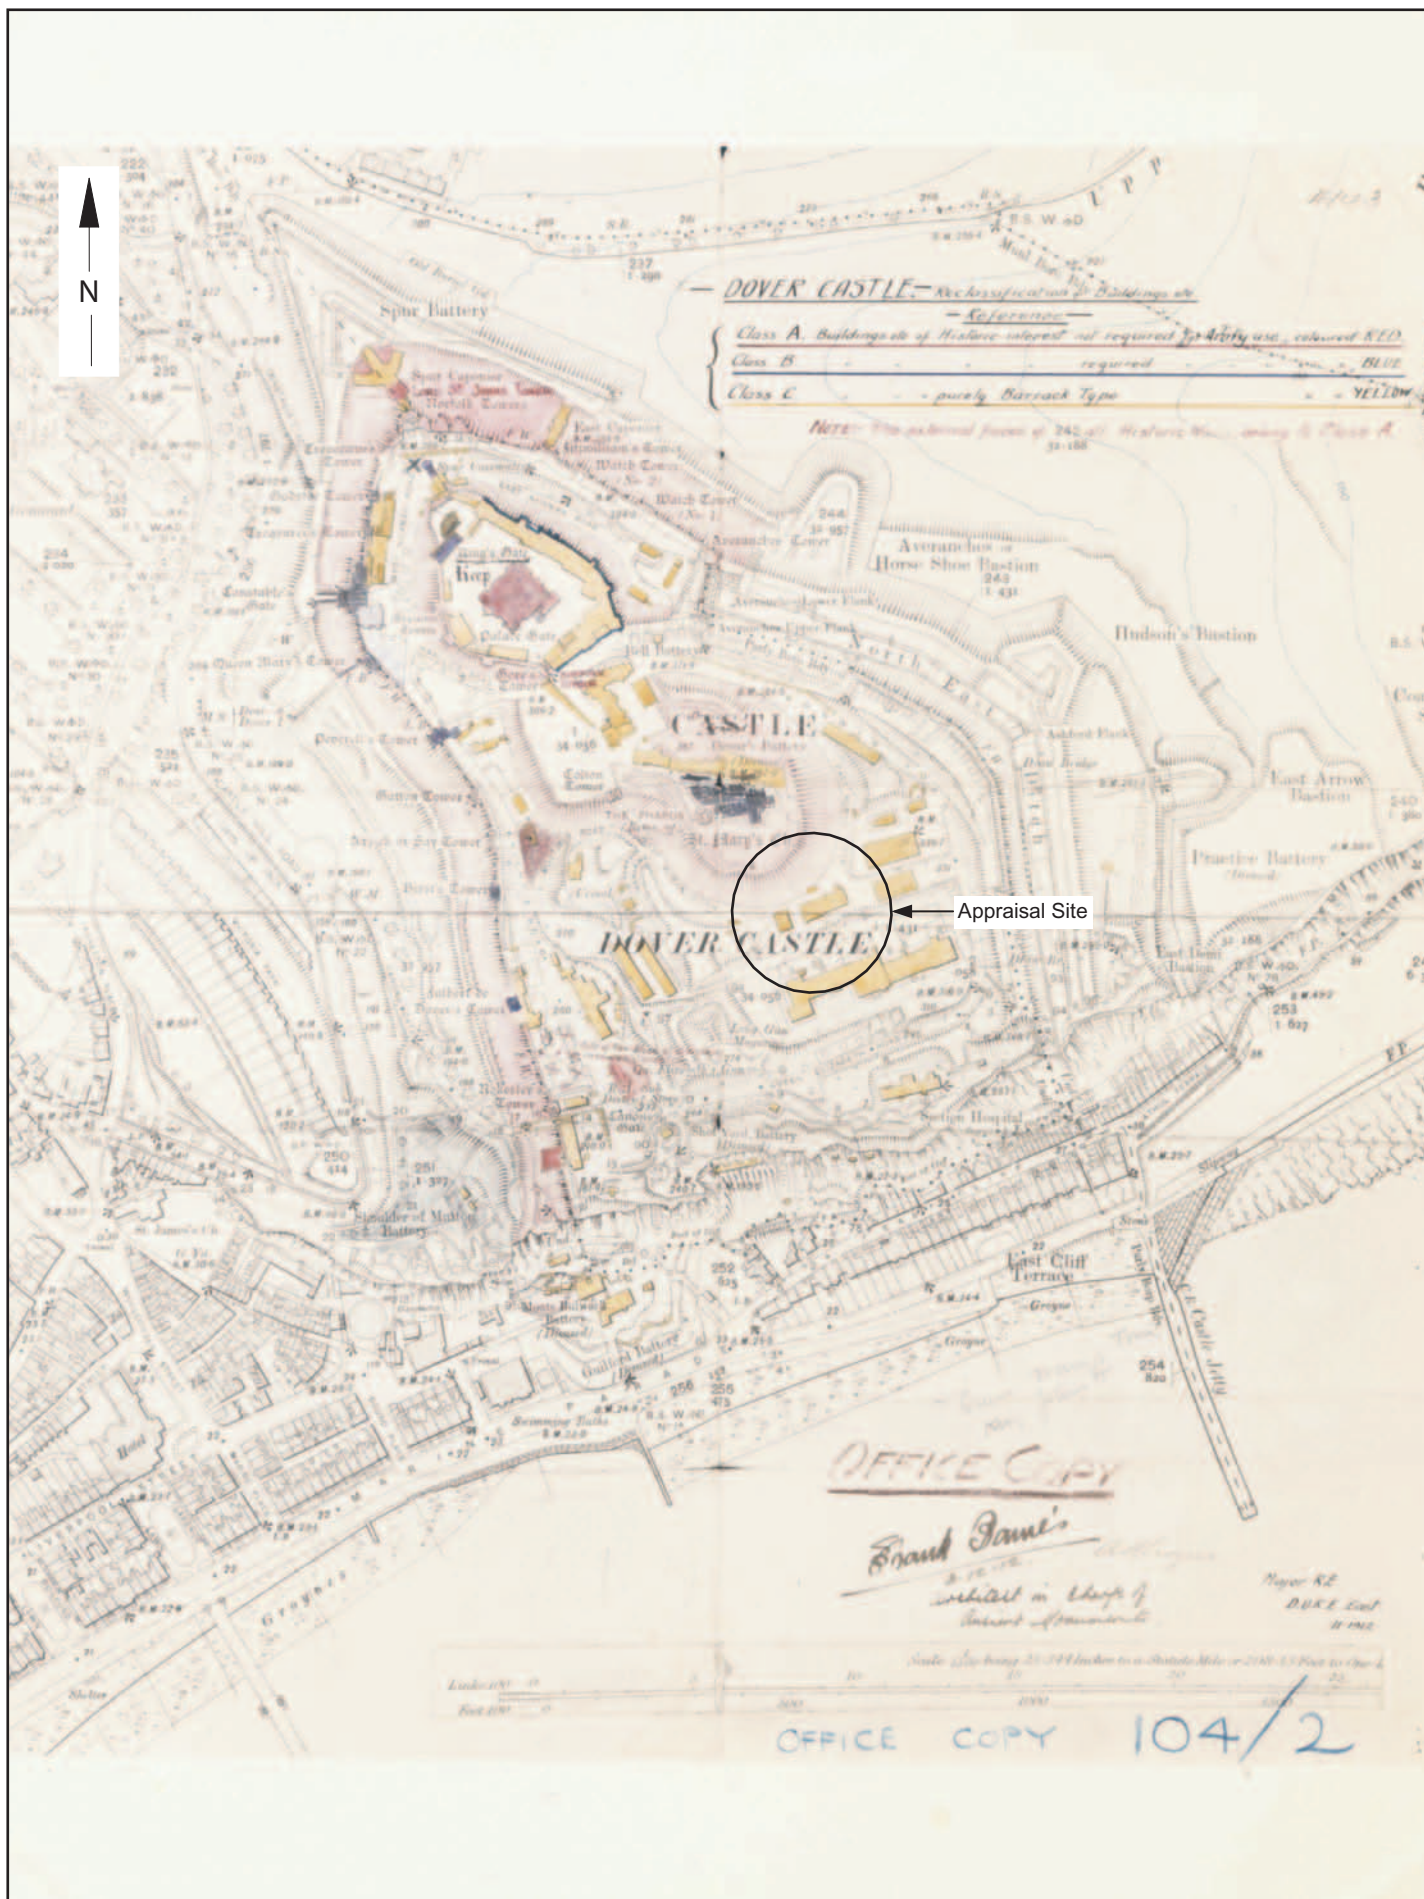
© Archaeology South-East			Dover Castle New Admissions Building	Fig. 11
Ref: 3127	Nov 2007	Drawn by: JLR	Map of the Castle showing reclassification of buildings, 1912

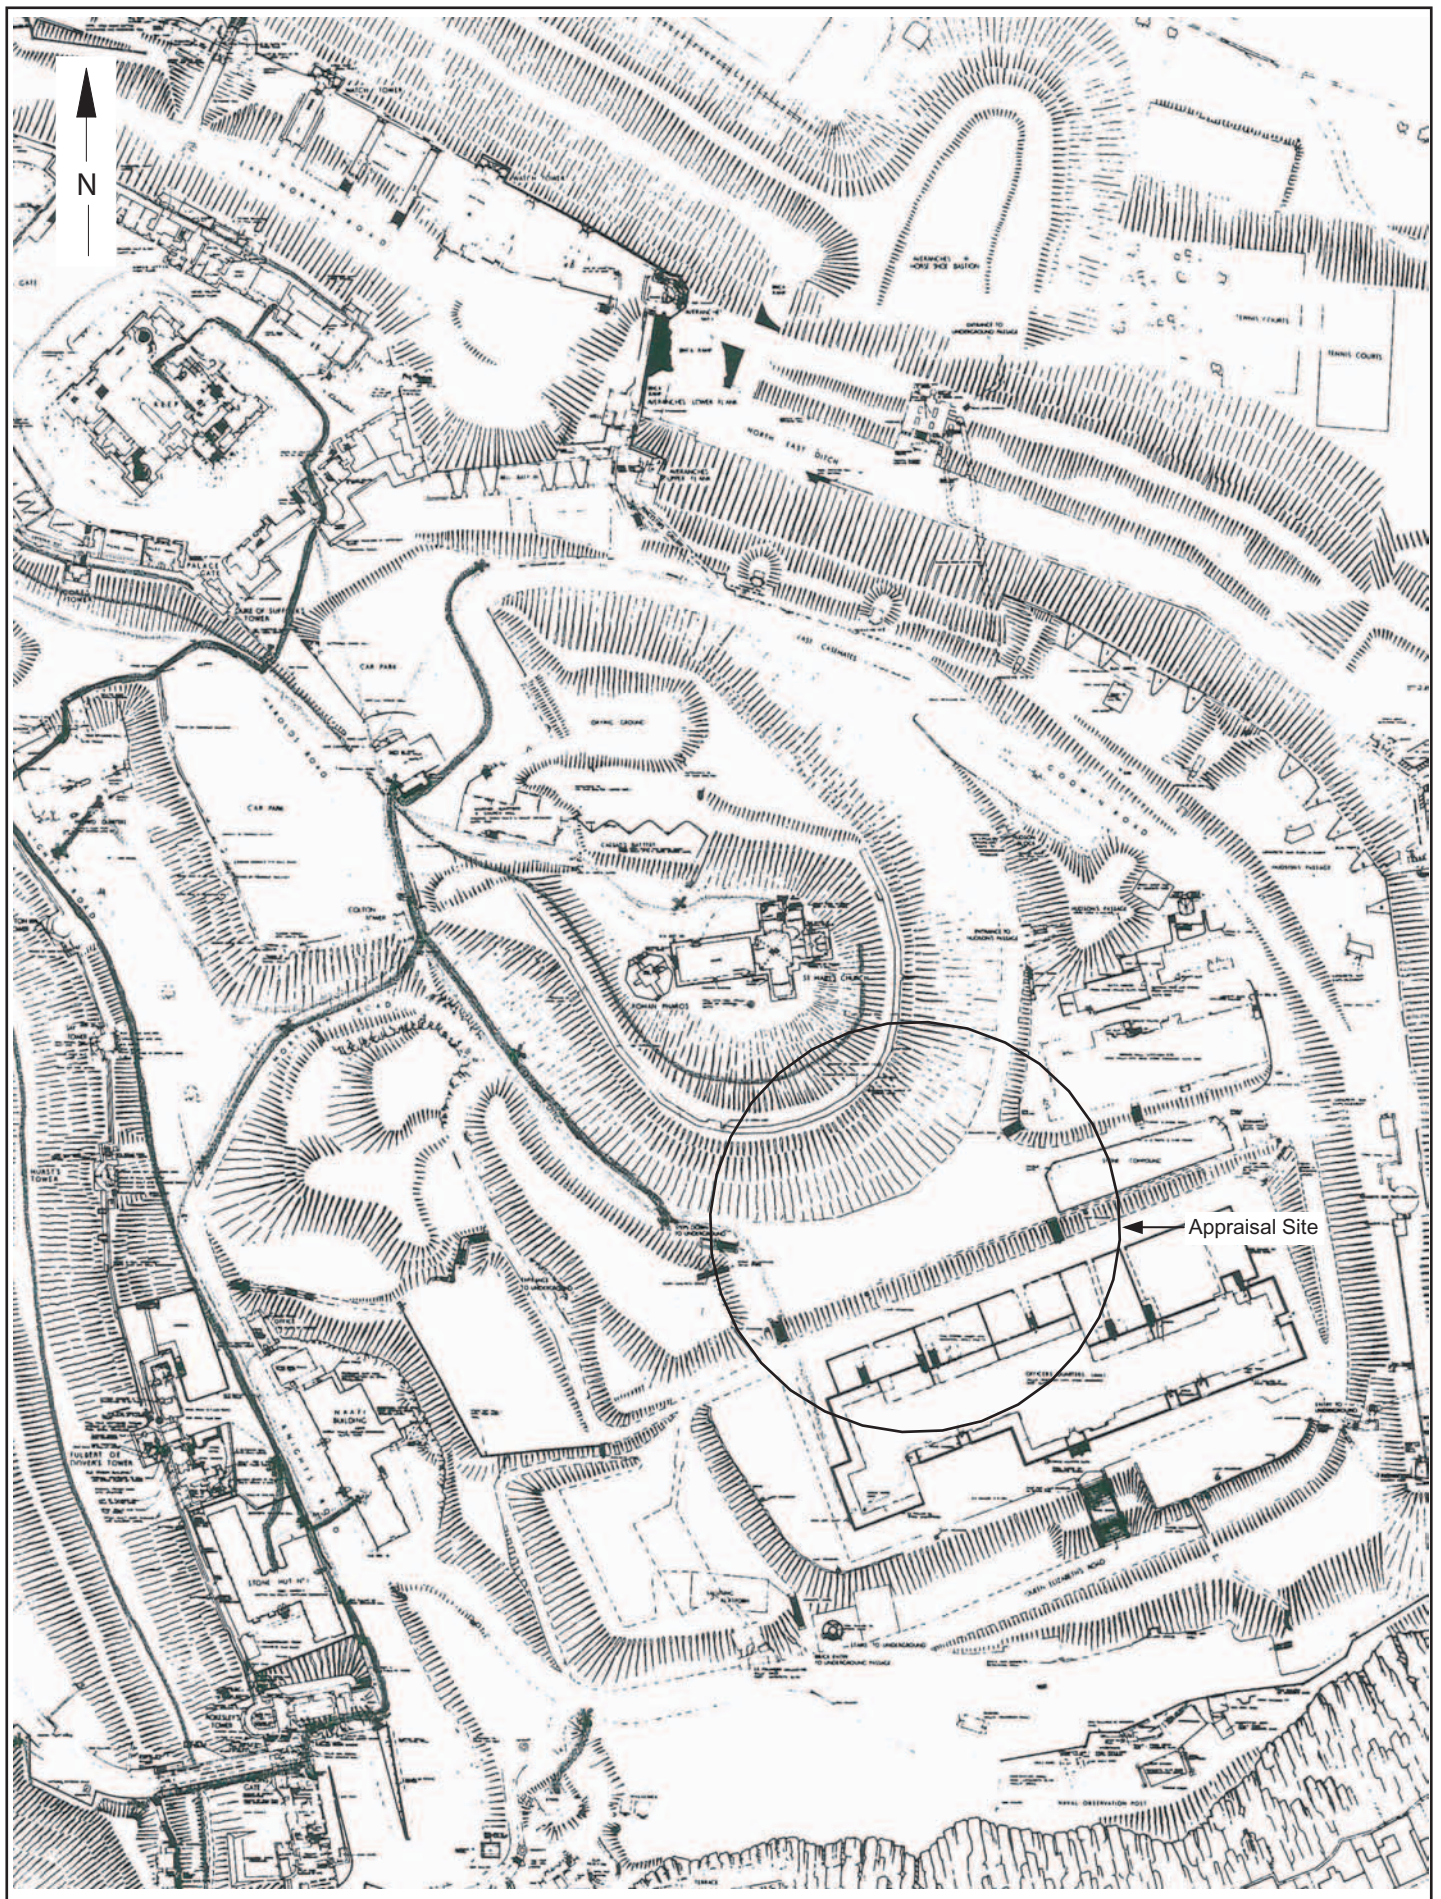
© Archaeology South-East			Dover Castle New Admissions Building	Fig. 13
Ref: 3127	Nov 2007	Drawn by: JLR	Ministry of Public Buildings and Works general site plan, 1966

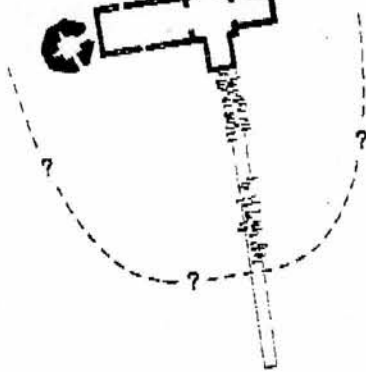
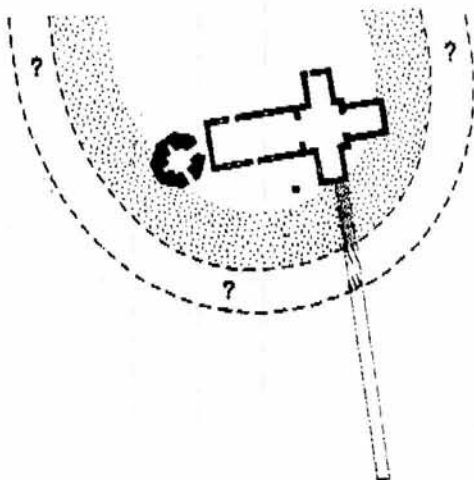
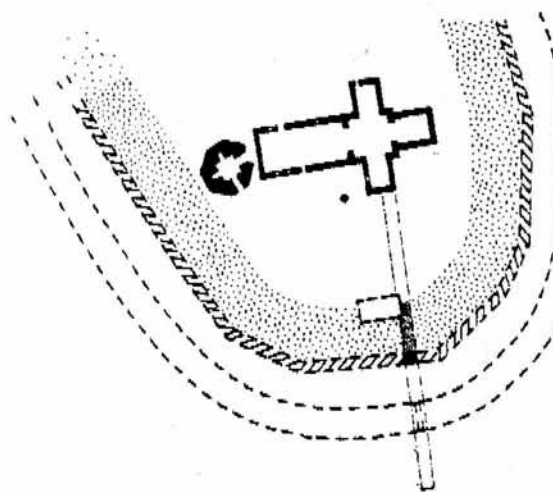
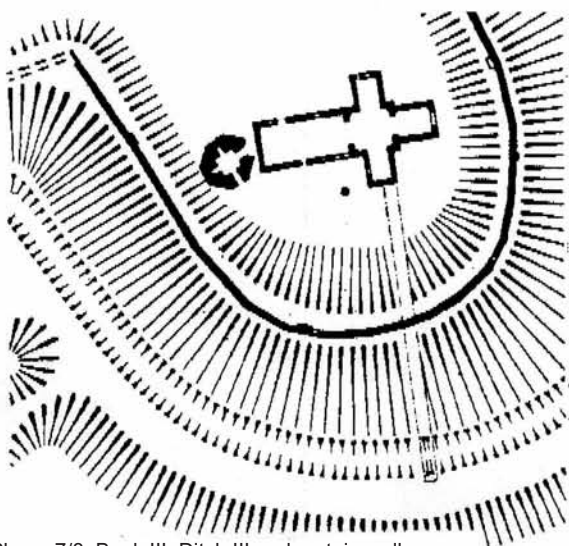
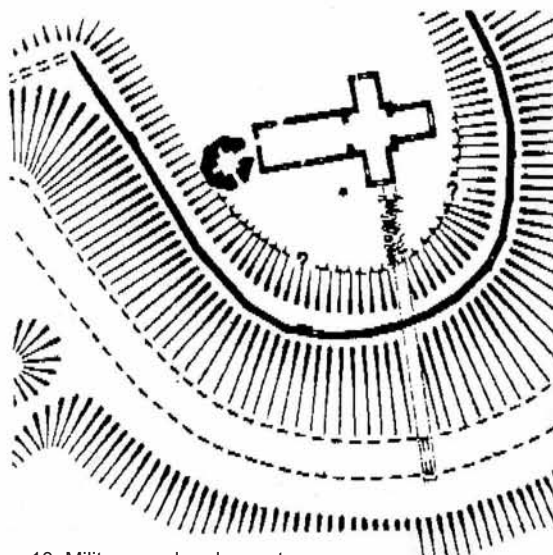
Fig 17: Site phasing (Biddle forthcoming, Fig. 12)

- 4.3.3** Two Iron Age entries refer directly to the appraisal site. The first is a generalised entry for the probable hillfort itself (Site 1). The second entry refers to evidence for a late 1st c BC/1st c AD settlement which was revealed as a result of a landslide of part of the 'Saxon earthworks' south of St Mary in Castro. Excavations carried out in 1962 by the Ministry of Works, under the direction of Professor Martin Biddle, comprised the excavation of a single trench through the earthwork. Pits, gulleys, floor levels and Iron Age potsherds were exposed (Site 2) (Fig 17, phase 1).

produced evidence of a bank and ditch thought to date to the middle 11th century situated beneath the great 13th century bank. This ditch cut through the earlier Saxon cemetery, and the internal bank was located close to the south wall of the church (Fig 17 phases 3/4). It is possible that this earthwork represents part of William the Conqueror's defences (Coad 1995, 20). Alterations and developments to the castle continued throughout the Norman and Plantagenet periods. Some of the most significant construction occurred during the reign of Henry II (1154-1189), who constructed the great keep, and much of the castle as it exists today. It is during this period that the first ditch is thought to have been backfilled and a second bank and a wall were constructed to the south of the church (Fig. 17, phases 5/6).

4.6.2 During the reign of Henry III the rampart encircling the south of the Pharos and church were constructed (Fig. 17 phases 7/8). This is believed to have taken place in the late 1220's or 1230's, and constituted a massive defensive project, which may have swept away much of the remains of the 11th century defences (Coad 1995, 43). Professor Biddle's excavations established that the ditch encircled the base of the bank within the area of the appraisal site, and had a maximum surviving width of 8m and approximate depth of 5.5m. This feature had been recut several times (Fig 18). The rampart was surmounted by a palisade and later a masonry wall.

- 4.7.2** Throughout the remainder of the 18th and 19th century the defences were updated. The 1960's excavations identified a Post Medieval cemetery located on the back of the Medieval rampart to the south of the church in the 18th/19th centuries (Biddle forthcoming, phase 10a). They also encountered a 18th/19th century road within the assessment site within the line of the Medieval ditch, at a depth of between 3 – 3.5m below the current ground surface. This feature had silted and turfed over before a sewer was laid and the ditch infilled to present ground levels (Biddle forthcoming, phase 10b – 11a) (Fig. 17 phase 10) (Fig. 18).

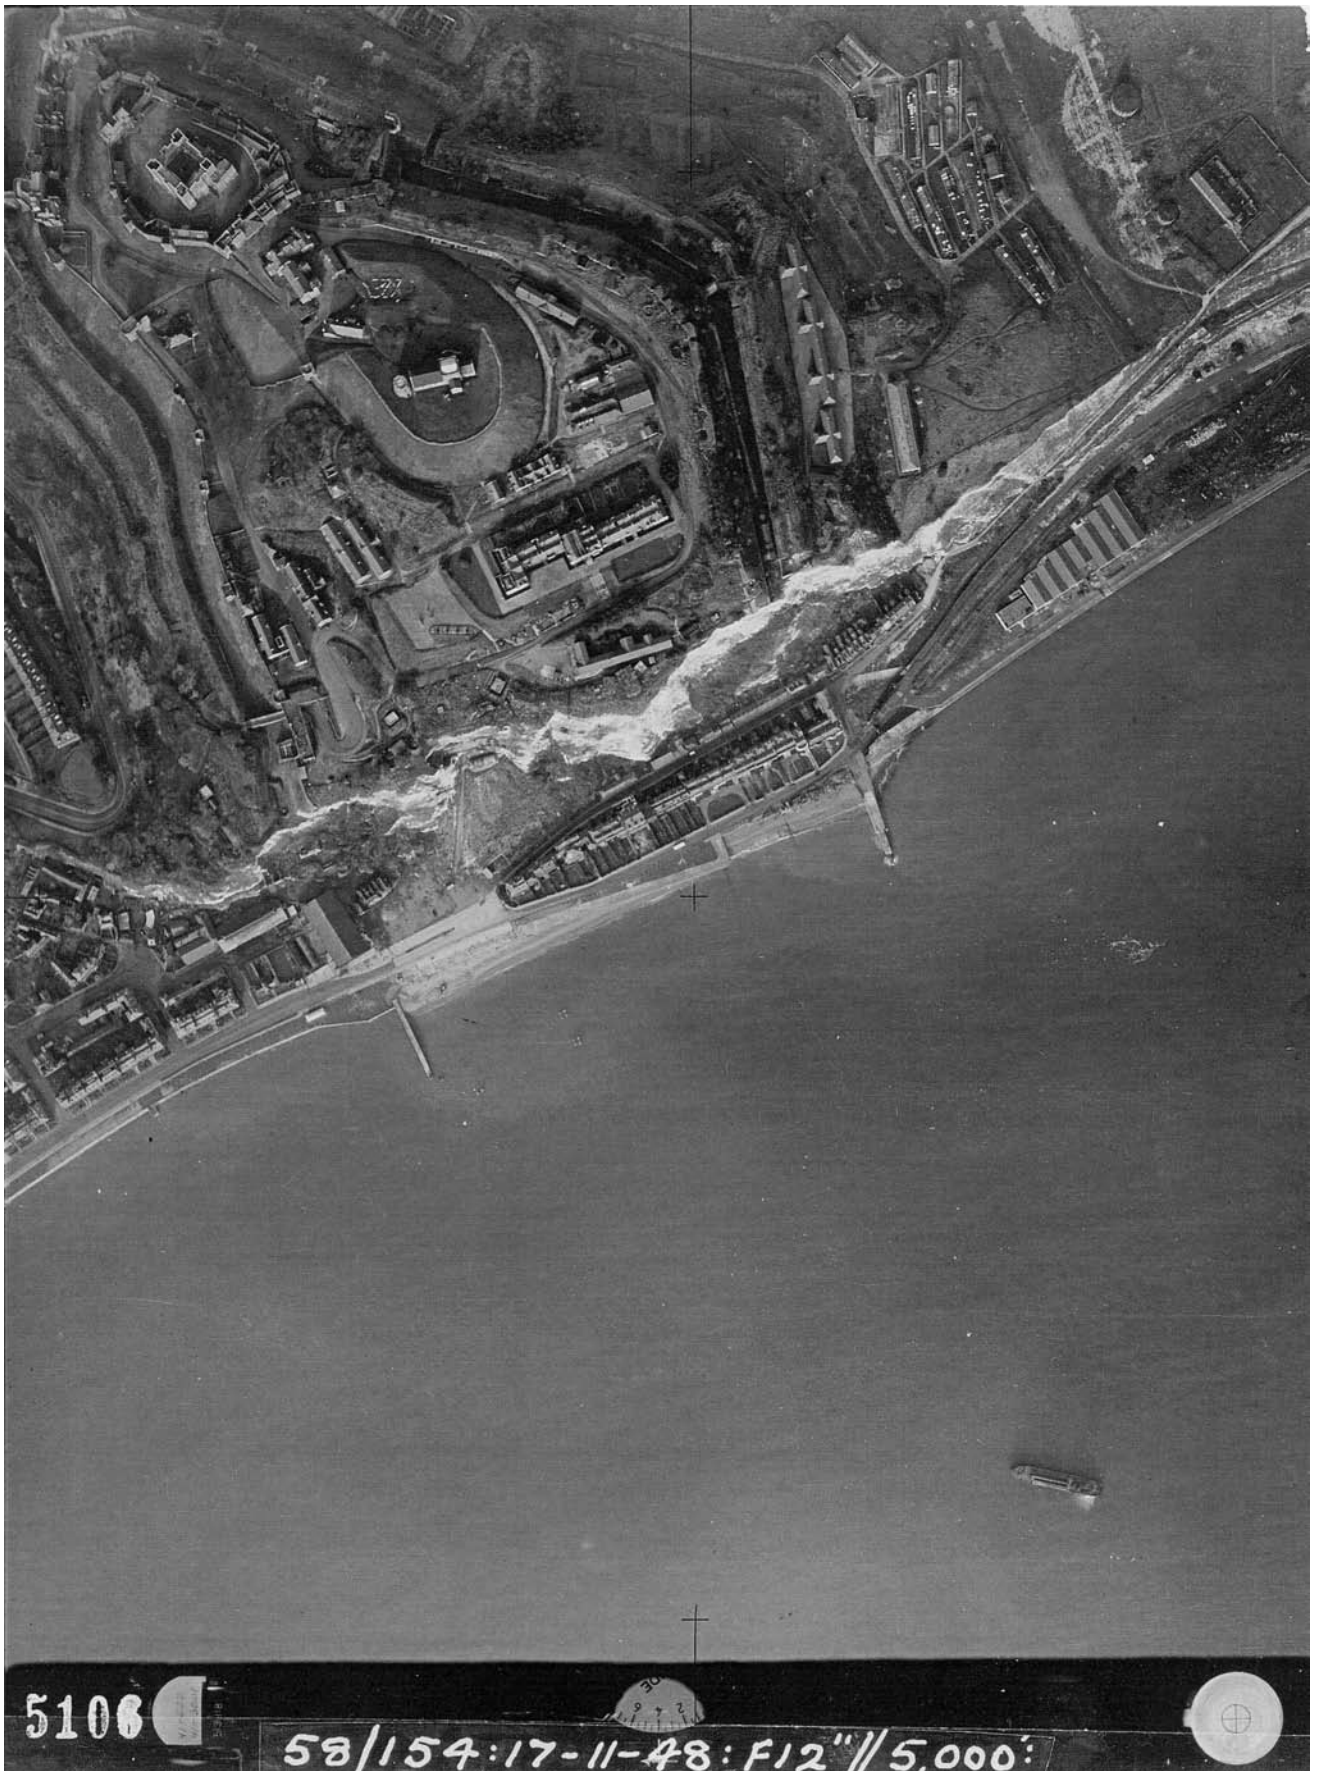
Plate 2: Aerial Photograph 1948 (REF/58/154 Frame 5106)

- 9.2** A fairly good spread of photographs was available for the site from the 1940s to the 2000s.
- 9.3** The earliest photographs consulted date from 1941 and 1945 and show the terraces to the rear of the Officers Mess densely occupied by the mid nineteenth century buildings (Coad 2004, 77) (Plate 1). The castle bank is depicted clearly, and shows no signs of the slumping and fissure which become apparent on later images. By 1948 a square structure which had occupied the western end of the terrace within the area of the proposed development site had been demolished, and this space now appears as open (possible garden?) and crossed by a footpath leading to the terrace steps. In the eastern end of the terrace a large rectangular structure or shed had been demolished, and the area appears to be covered with a patchwork of scars, probably resulting from this demolition process. A small structure remains standing at the far eastern end of the terrace (Plate 2).

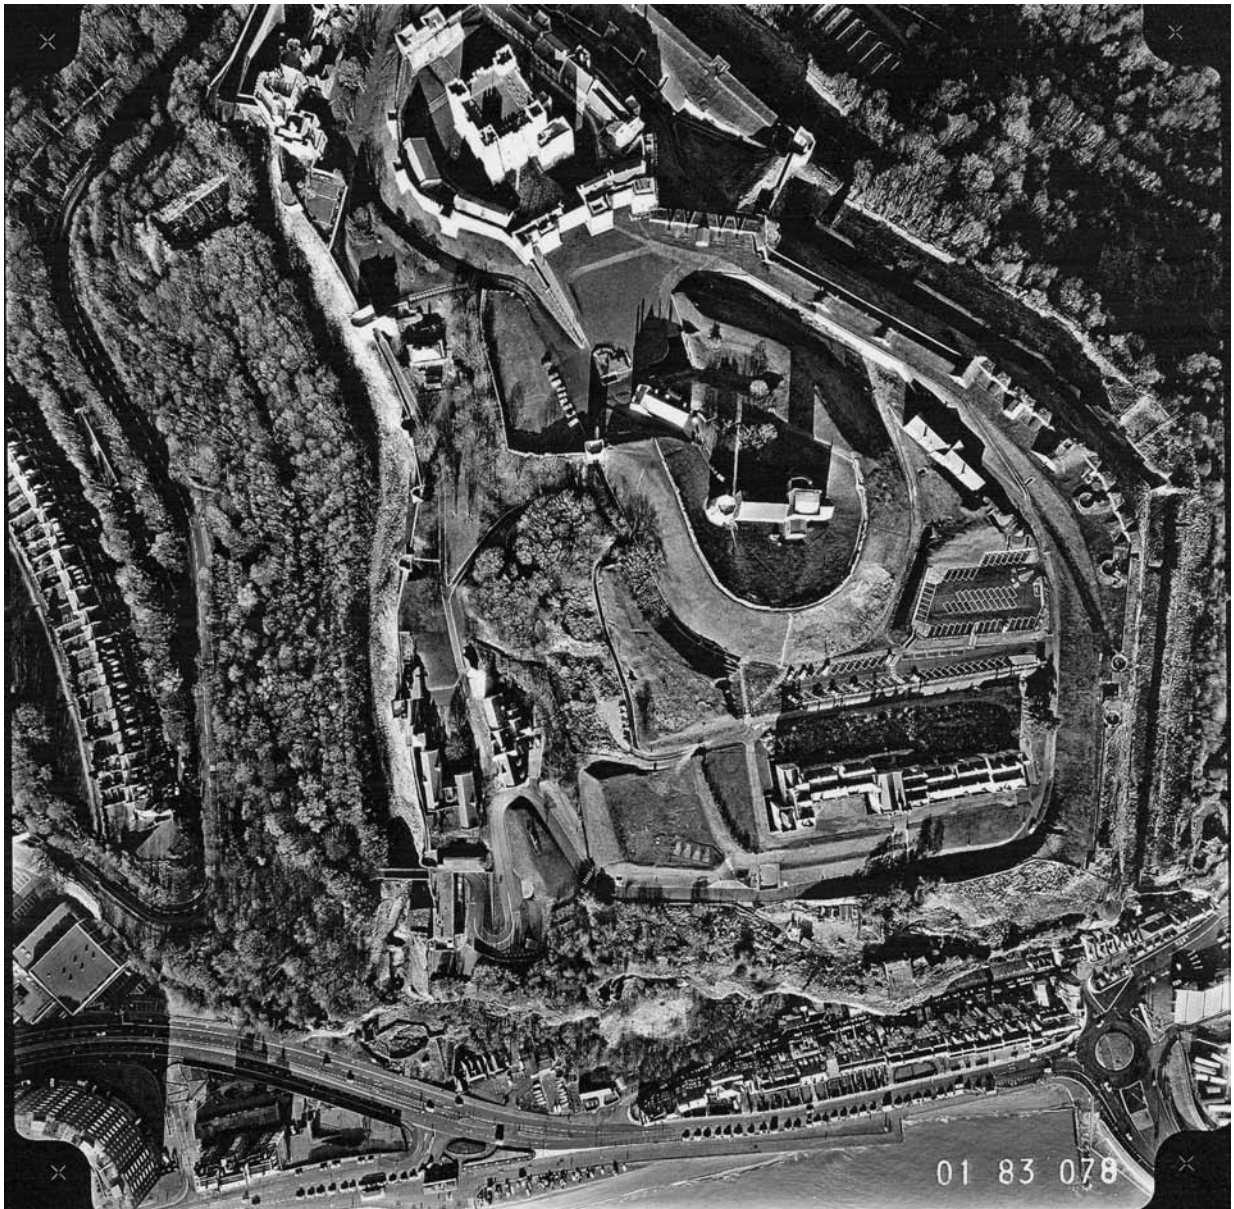
Plate 7: Aerial Photograph 1983 (MAL/83001)

- 9.8** By 1983 the 'Old Bagwash' site has been fully cleared, and a car park has been laid out across both terraces. The far western part of the terrace (the site of the current temporary admissions building) remains an area of open grass crossed by footpaths, much as it had since the demolition of the mid 19th century structure shown in Plate 1. On the southern bank a scar still appears to demark the line of the 1960's excavation trench, and the fissure to the east remains visible (Plate 7).

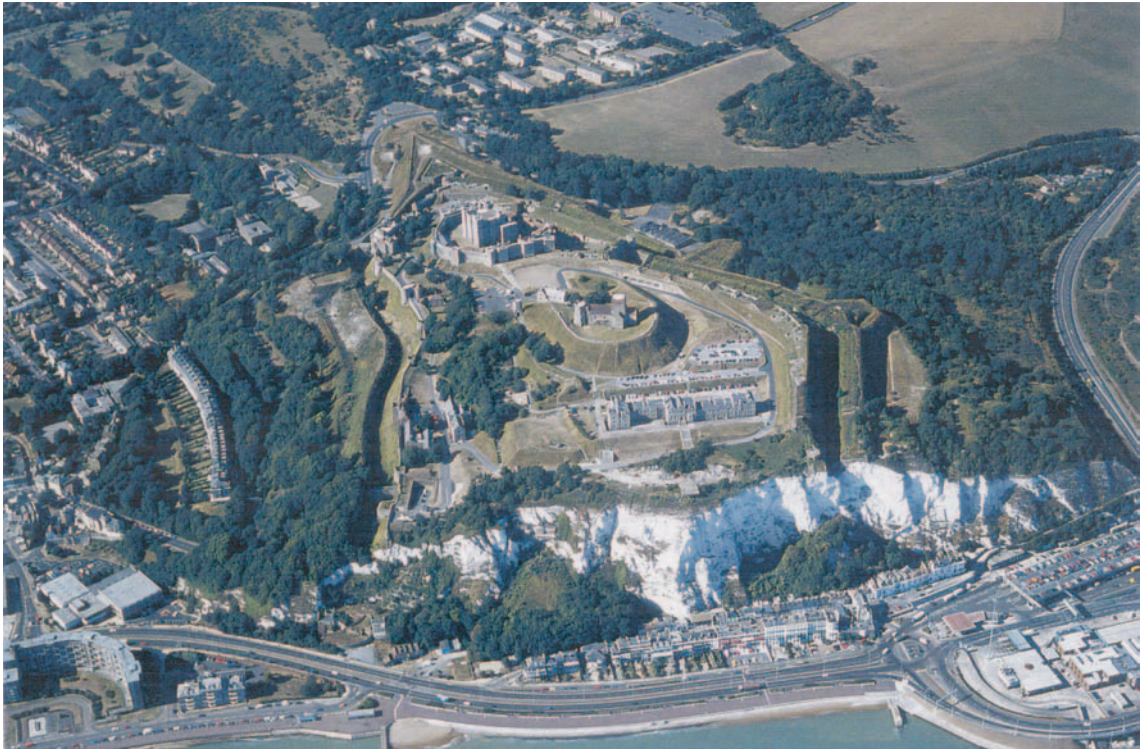
Plate 8: Aerial Photograph 1995 (TR3241/44)

- 9.9** In an oblique image dating to 1995 worn paths running straight up the southern bank from the terrace are visible (Plate 8). The far western part of the terrace remains grassed over. By 2005 the current temporary admissions building has been constructed. A 2006 image shows the site in clearest detail (Plate 9). The worn footpaths of the preceding decade have disappeared. However, the image does show a faint earthwork on the southern bank which is thought to correspond to the line of the 1960's excavation. Slumping is clearly visible around the base of the mound, as is the fissure discussed in the next chapter.

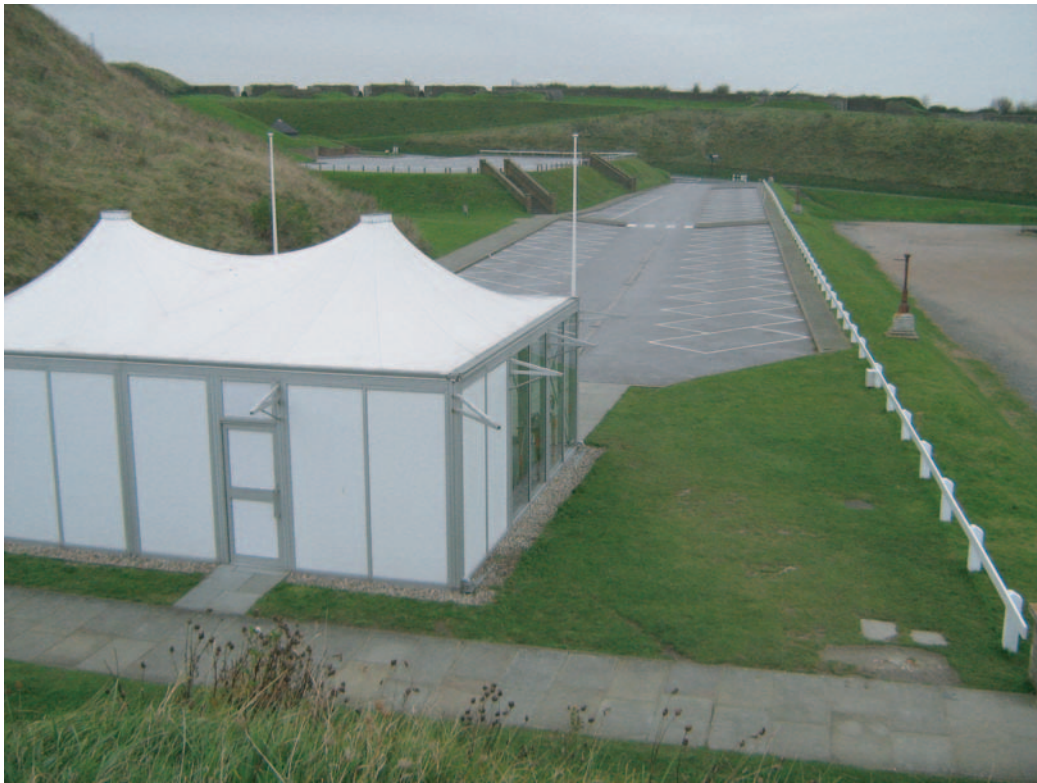
Plate 10: Site shot facing east

- 3.2** The site has been subject to considerable landscaping. The proposed development site is situated in the western third of the upper terrace at the base of the southern slope of the earthwork bank around St Mary in Castro. The site is currently occupied by a temporary admissions building and car park. The site is flat, and measures approximately 135m by 20m wide. It is orientated east- west and is located at a height of approximately 99.60mOD (Fig 2) (Plate 10).

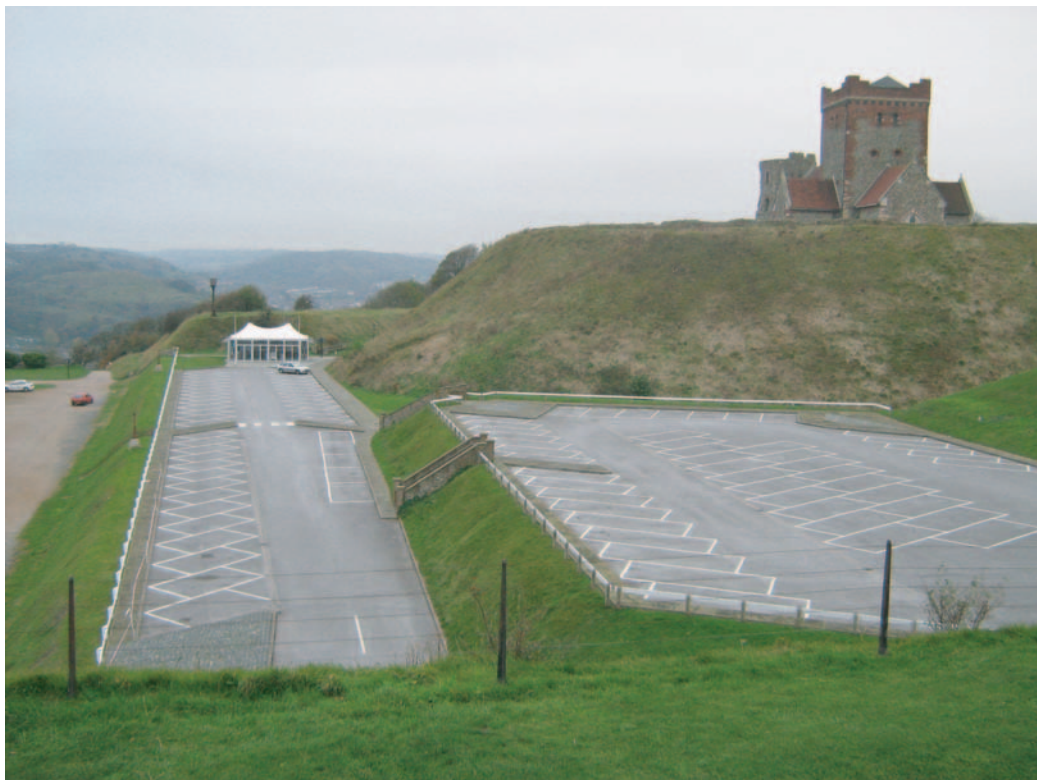
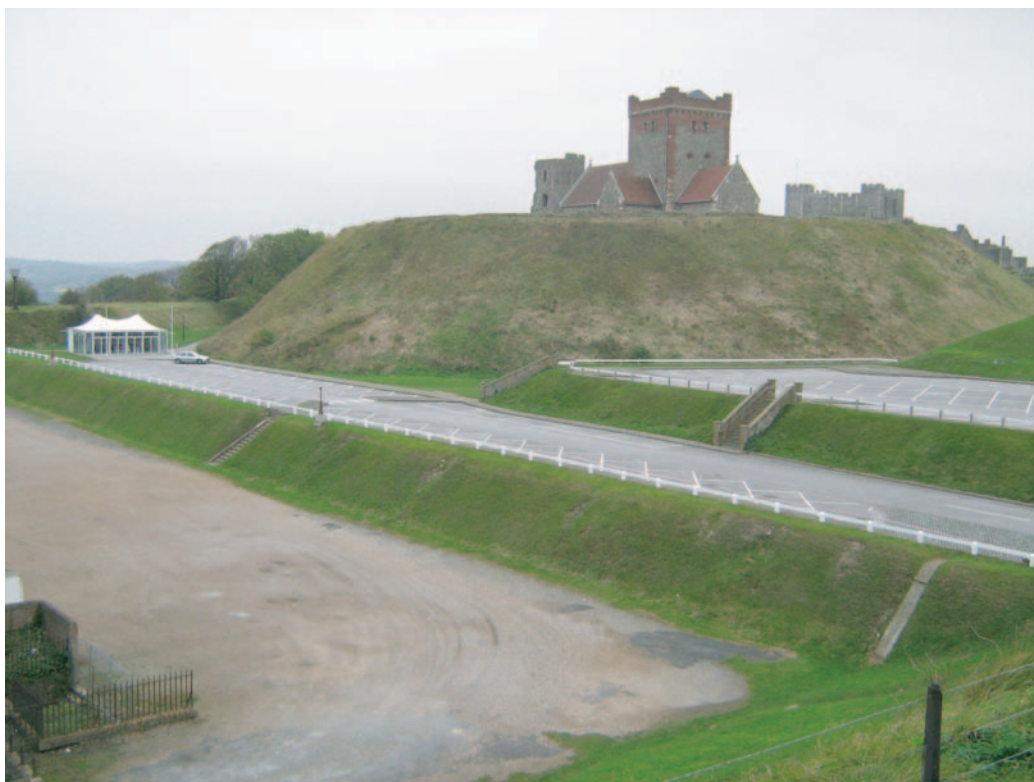
- 3.3** The appraisal site encompasses part of the southern bank encircling the church and the Roman Pharos, and a small part of a block of landscaping immediately to the west of the current temporary admissions building, at the base of which is the entrance to a mid 19th century magazine. The appraisal site also encompasses part of the Officers Mess and a lower terrace immediately behind the building situated at approximately 96.20mOD. It includes a small part of a second car park situated to the north east (an area formerly known as the 'Old Bag wash') located at an approximate height of 102.50m OD. Footpaths run north - south at the site's west end, and around the base of the earthwork (Plates 11 and 12).

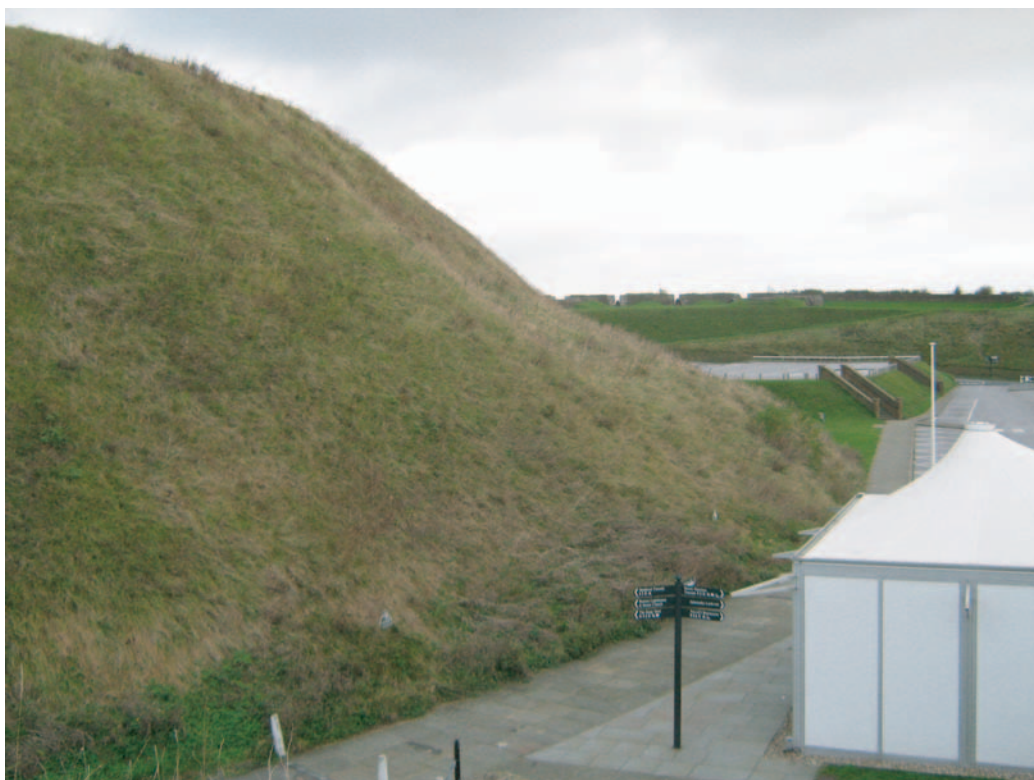
Plate 13: Site shot showing slumping at base of bank (facing east)

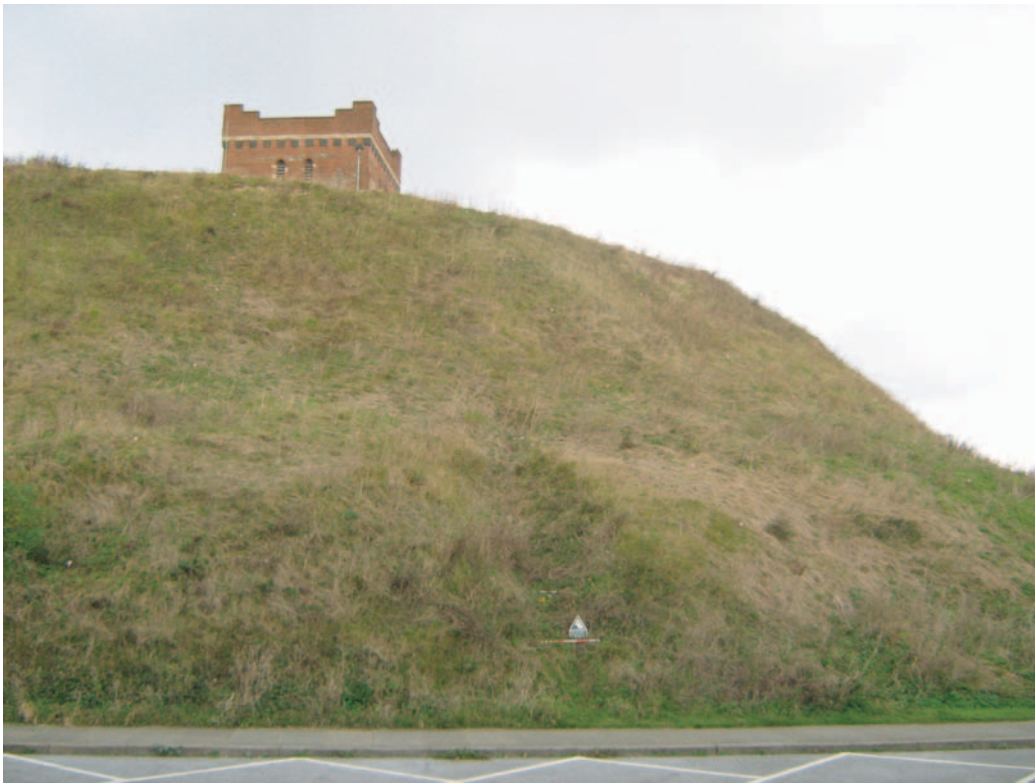
Plate 14: Site shot showing fissure at base of bank (facing east)

- 10.5** The base of the mound also contains a substantial fissure (Plate 14). This measures approximately 3m wide by 1.6m deep at its largest extent, narrowing and shallowing northwards into the castle bank. This may also be a result of soil movement on the castle bank, and is visible of photographs from the 1960's onwards. However it may also relate to the structure noted on the 1927 map of the areas (see Fig. 12).

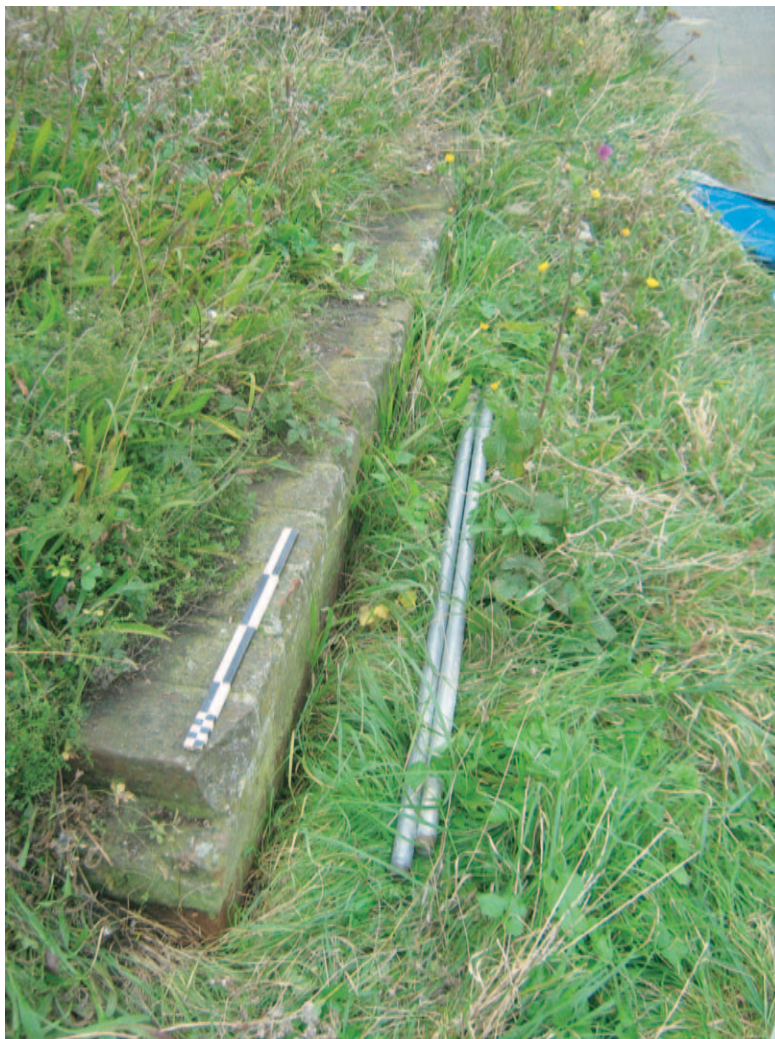
Plate 15: Shot of brick wall facing east

- 10.6** A stretch of a low brick wall was noted partially encircling the base of the castle bank (Plate 15). This consisted of a one stretcher width of possible 19th century red brick bonded with a hard concrete mortar. A maximum of four courses were visible above ground. Large sections of this wall were missing, and much of it is believed to have been removed as it was subject to movement resulting from the pressure of soil movement on the face of the castle bank (Graham Daws pers. comm.). The depth of this wall is not known.

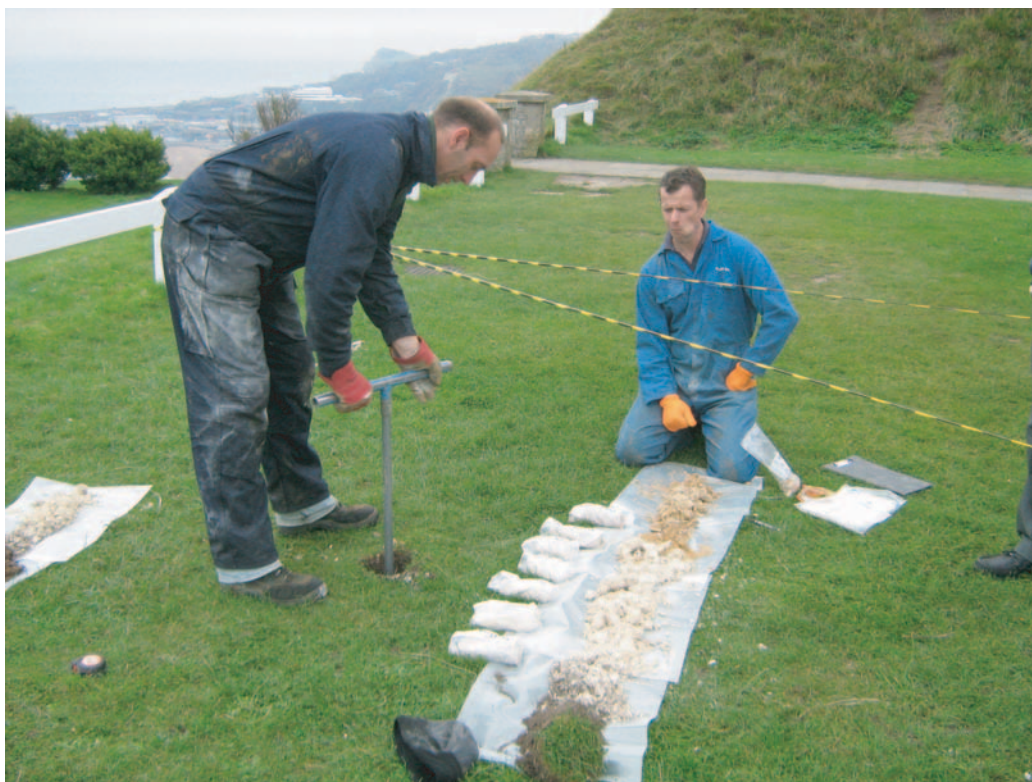
Plate 16: BH 1A under excavation

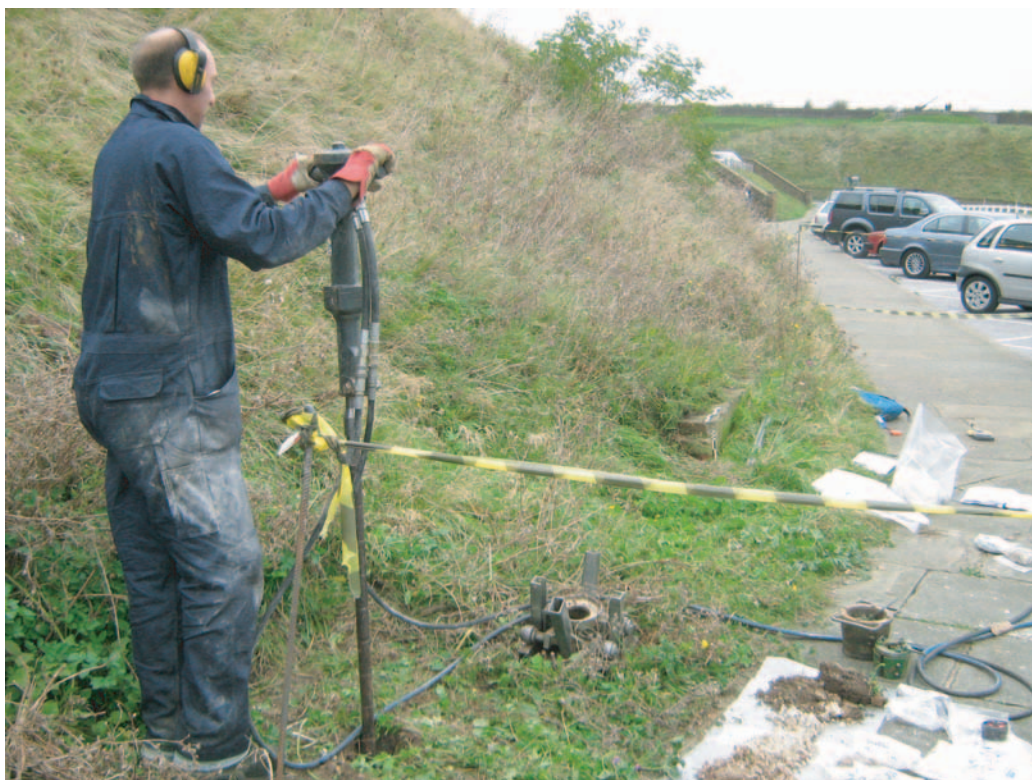
Plate 17: BH 2A under excavation and relative location of brick wall
