**Archaeological Watching Brief
89 Rayleigh Avenue,
Leigh-on Sea**

Archaeological Watching Brief

**89 Rayleigh Avenue,
Leigh-on Sea, Essex
SS9 5DL**

**ASE Project No: 180724
Site Code: RARA18**

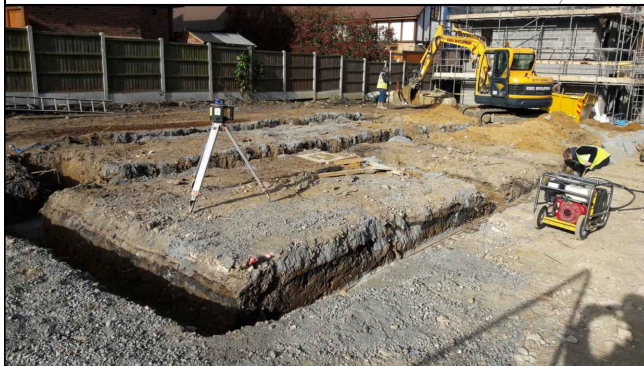
4.2.16 Plot 1 was located in the southeast of the development site (Fig. 2). No significant ground reduction was undertaken across the footprint, with wall foundation trenches instead cut directly from the existing surface of the previously cleared site. The following deposit sequence was observed:

- [1/001]: firm dark grey brownish sandy silt clay, with infrequent stones, up to 0.35–0.40m thick. Topsoil.
- [1/002]: orange to red/brown sandy silt clay with infrequent to moderate small, pale grey gravels, exposed to a maximum depth of c.1.4m. Undisturbed natural deposit.

4.2.17 Very little topsoil was left *in situ* by general site clearance here. Where remaining, it was observed to directly overlay the variable natural deposit [1/002]. Otherwise, the cleared surface was disturbed by construction works and obscured by debris, and was not able to be archaeologically inspected in plan.

4.2.18 All except the eastern end wall trenches were inspected in Plot 1. No archaeological deposits, features or finds were identified. No significant disturbances or intrusions into the natural deposit were observed.

Plot 1 foundation trenches

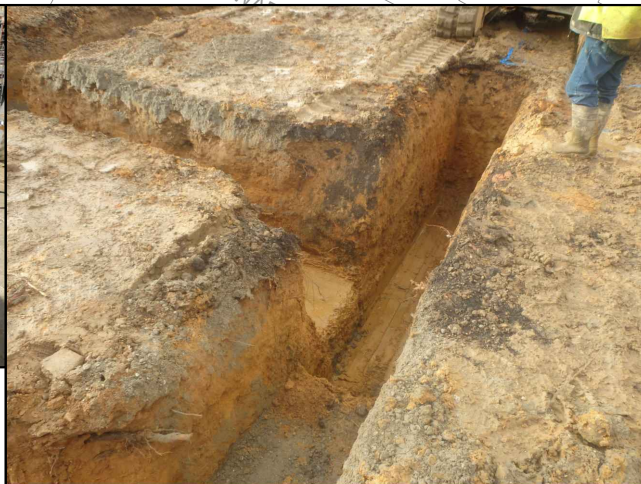
- 4.2.8 Minimal ground reduction was undertaken by machine across a rectangular area measuring c.13m NW/SE by 11m NE/SW, to create the required construction level. Trenches were therefore cut from roughly the ground surface level after general clearance of the site. The recorded deposit sequence as observed in the foundation trenches comprised (from top to bottom):

- [2/001]: light brownish grey gravelly silt-sand, compact, 0.10-0.13m thick. Made-ground.
 - [2/002]: dark greyish brown sandy clayey silt, 0.19-m thick. In SW of plot only. Topsoil.

- [2/003]: Mid brown silty sand with pebbles at base, 0.24-0.47m thick. Subsoil or less-reworked base of [2/002]?
 - [2/004]: Orangey brown sandy clay with pebbles, exposed to depth of c.09m. Undisturbed natural deposit.

- 4.2.10 The excavation of the majority of Plot 2 wall foundation trenches was observed. This established that made-ground and topsoil deposits directly overlay natural deposit [2/004].

- 4.2.11 No archaeological deposits, features or artefacts were identified in the natural deposit where exposed in plan or section in the observed foundation trenches in Plot 2. However, a NE/SW aligned wall foundation constructed of modern

frogged bricks, together with service runs, were observed in the trench sections across the northwest end of the plot. This corresponded with the external wall of the demolished former dwelling (No. 89).

Plot 2 foundation trenches

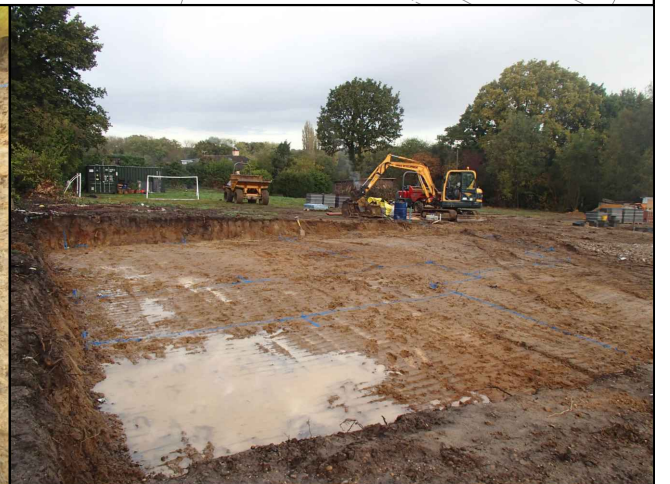
4.2.12 Plot 3 was located in the southwest of the development site (Fig. 2). Ground reduction was undertaken by machine across a rectangular roughly square area measuring c.16m NW/SE by 14m NE/SW, down to the required construction level. Due to the sloping site, a c.0.7-1.3m thickness of deposits were removed; however, at the northernmost corner, the reduction depth more-or-less coincided with the extant ground surface height. The recorded deposit sequence comprised (from top to bottom):

- [3/001]: Mid/light greyish brown silty sand with occasional CBM, plastic and glass inclusions, and root disturbance, 0.4-0.52m thick.
- [3/002]: Orange silty clayey sand, exposed to a maximum depth of c.0.8m (at southernmost corner). Undisturbed natural deposit.

4.2.13 The orange natural deposit [3/004] was exposed across much of the reduced plot extent, with overburden deposits remaining *in situ* only along the northeast edge. No archaeological deposits, features or artefacts were identified in the machine-reduced surface of the natural deposit.

Plot 3 ground reduction, looking north-west

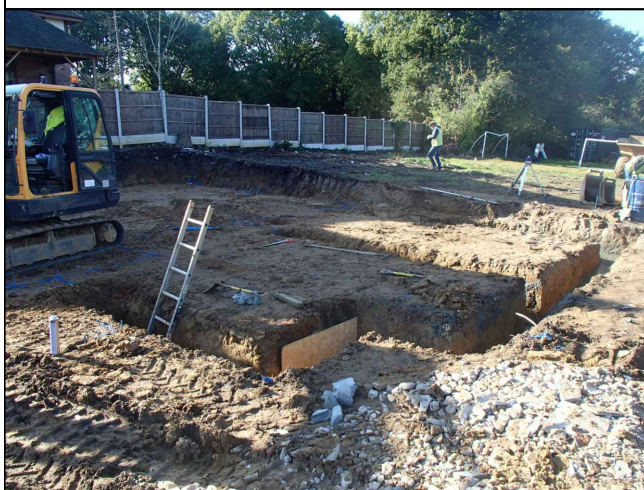
4.2.14 The excavation of wall foundation trenches across the obscured northern part of the plot was observed. These established that the remaining overburden deposit, presumably a lower portion of [3/001], was 0.26-0.52m thick and directly overlay natural deposit [3/002]. The trenches intruded into the natural deposit up to a depth of 0.9m.

4.2.15 No archaeological deposits, features or artefacts were identified in the natural deposit where exposed in plan or section in the observed foundation trenches in Plot 3.

Plot 3 foundation trenches

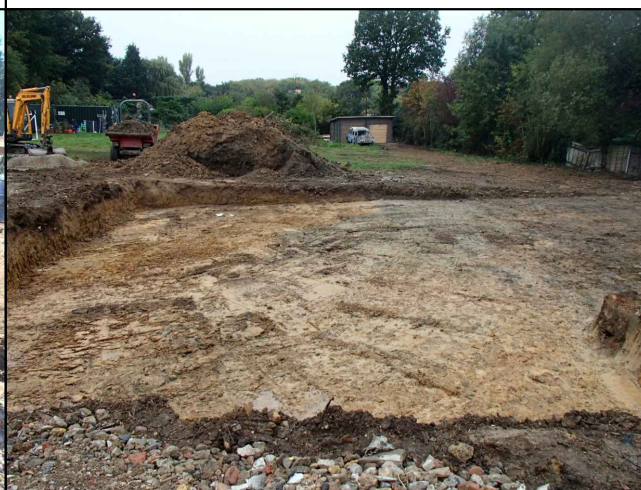
- 4.2.2 Ground reduction was undertaken by machine, across a roughly L-shaped footprint with maximum measurements of 20m NE/SW by 15m NW/SE, down to the required construction level. Although as little as 0.1m of deposits were removed at the northern corner, elsewhere this ranged from 0.95m to 1.54m, being greatest at the southern corner. As exposed in the deepest section face, along the southeast side of the plot, the observed deposit sequence comprised (from top to bottom):

- [4/001]: brick and concrete rubble in gravel and grey sand, up to 0.15m thick. Demolition debris?
 - [4/002]: Orange sand and concrete rubble with fragmentary tarmac surface on top, c.0.30m thick. Driveway or yard between No. 89 and outbuilding?

- [4/003]: Mid grey-brown sandy silt, with common roots, 0.22-0.63m thick. Former garden soil?
 - [4/0004]: Compact orange clay with blue-grey lenses and patches, exposed to a maximum depth of 1.0m. Undisturbed natural deposit.

- A former drain was observed in section directly below demolition rubble spread [4/001] that appeared to cut former hard surfacing [4/002]. A larger service trench containing a cable and a plastic pipe was identified below [4/0002].

- 4.2.3 Across the reduced footprint, the orange natural deposit [4/004] was exposed across much of its southern half. This was intruded into by a land drain and a circular soakaway pit of modern date. No archaeological deposits, features or

artefacts were identified in the machine-reduced surface of the natural deposit.

Plot 4 ground reduction, looking north-west

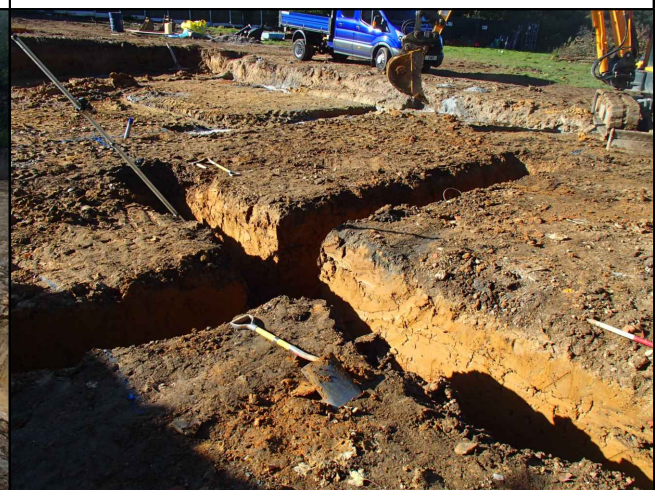
- 4.2.4 Due to the nature of the sloping ground, at the required construction level the northern half of the Plot 4 footprint was covered by a mottled mid and dark brown clayey sandy silt [4/006] that overlay the natural deposit, but also a localised patch of light blue-grey silty clay [4/007]. Both contained CBM, charcoal, wood fragments, ironwork and roots and were clearly modern reworked deposits. It is likely that they were both lower/interface portions of the garden soil [4/003] seen elsewhere in section. A service trench was observed to cross remnant garden soil [4/006] at the northeast corner of Plot 4. This was probably a further part of the service trench seen in the section.

- 4.2.5 As the surface of the natural deposit had not been reached in the northern part of the house plot, the excavation of the wall foundation trenches was observed. These were excavated to a further c.1.2m depth below the reduced ground level and demonstrated that the undisturbed natural deposit directly underlay deposits [4/006] and [4/007], these being generally c.0.3m thick, but seemingly increasing to as much as 0.75m along the northernmost edge of the plot.

- 4.2.6 No archaeological deposits, features or artefacts were identified in the natural deposit where exposed in plan or section in the observed foundation trenches.

Plot 4 foundation trenches
