**Archaeological Evaluation Report  
4-10 Church Street  
Reigate, Surrey**

**NGR: 525409 150242  
(TQ 25409 50242)**

**Planning Ref: 16/00428/F  
ASE Project No: 190019  
Site Code: RGT19  
ASE Report No: 2019219  
OASIS id: archaeol6-360296**

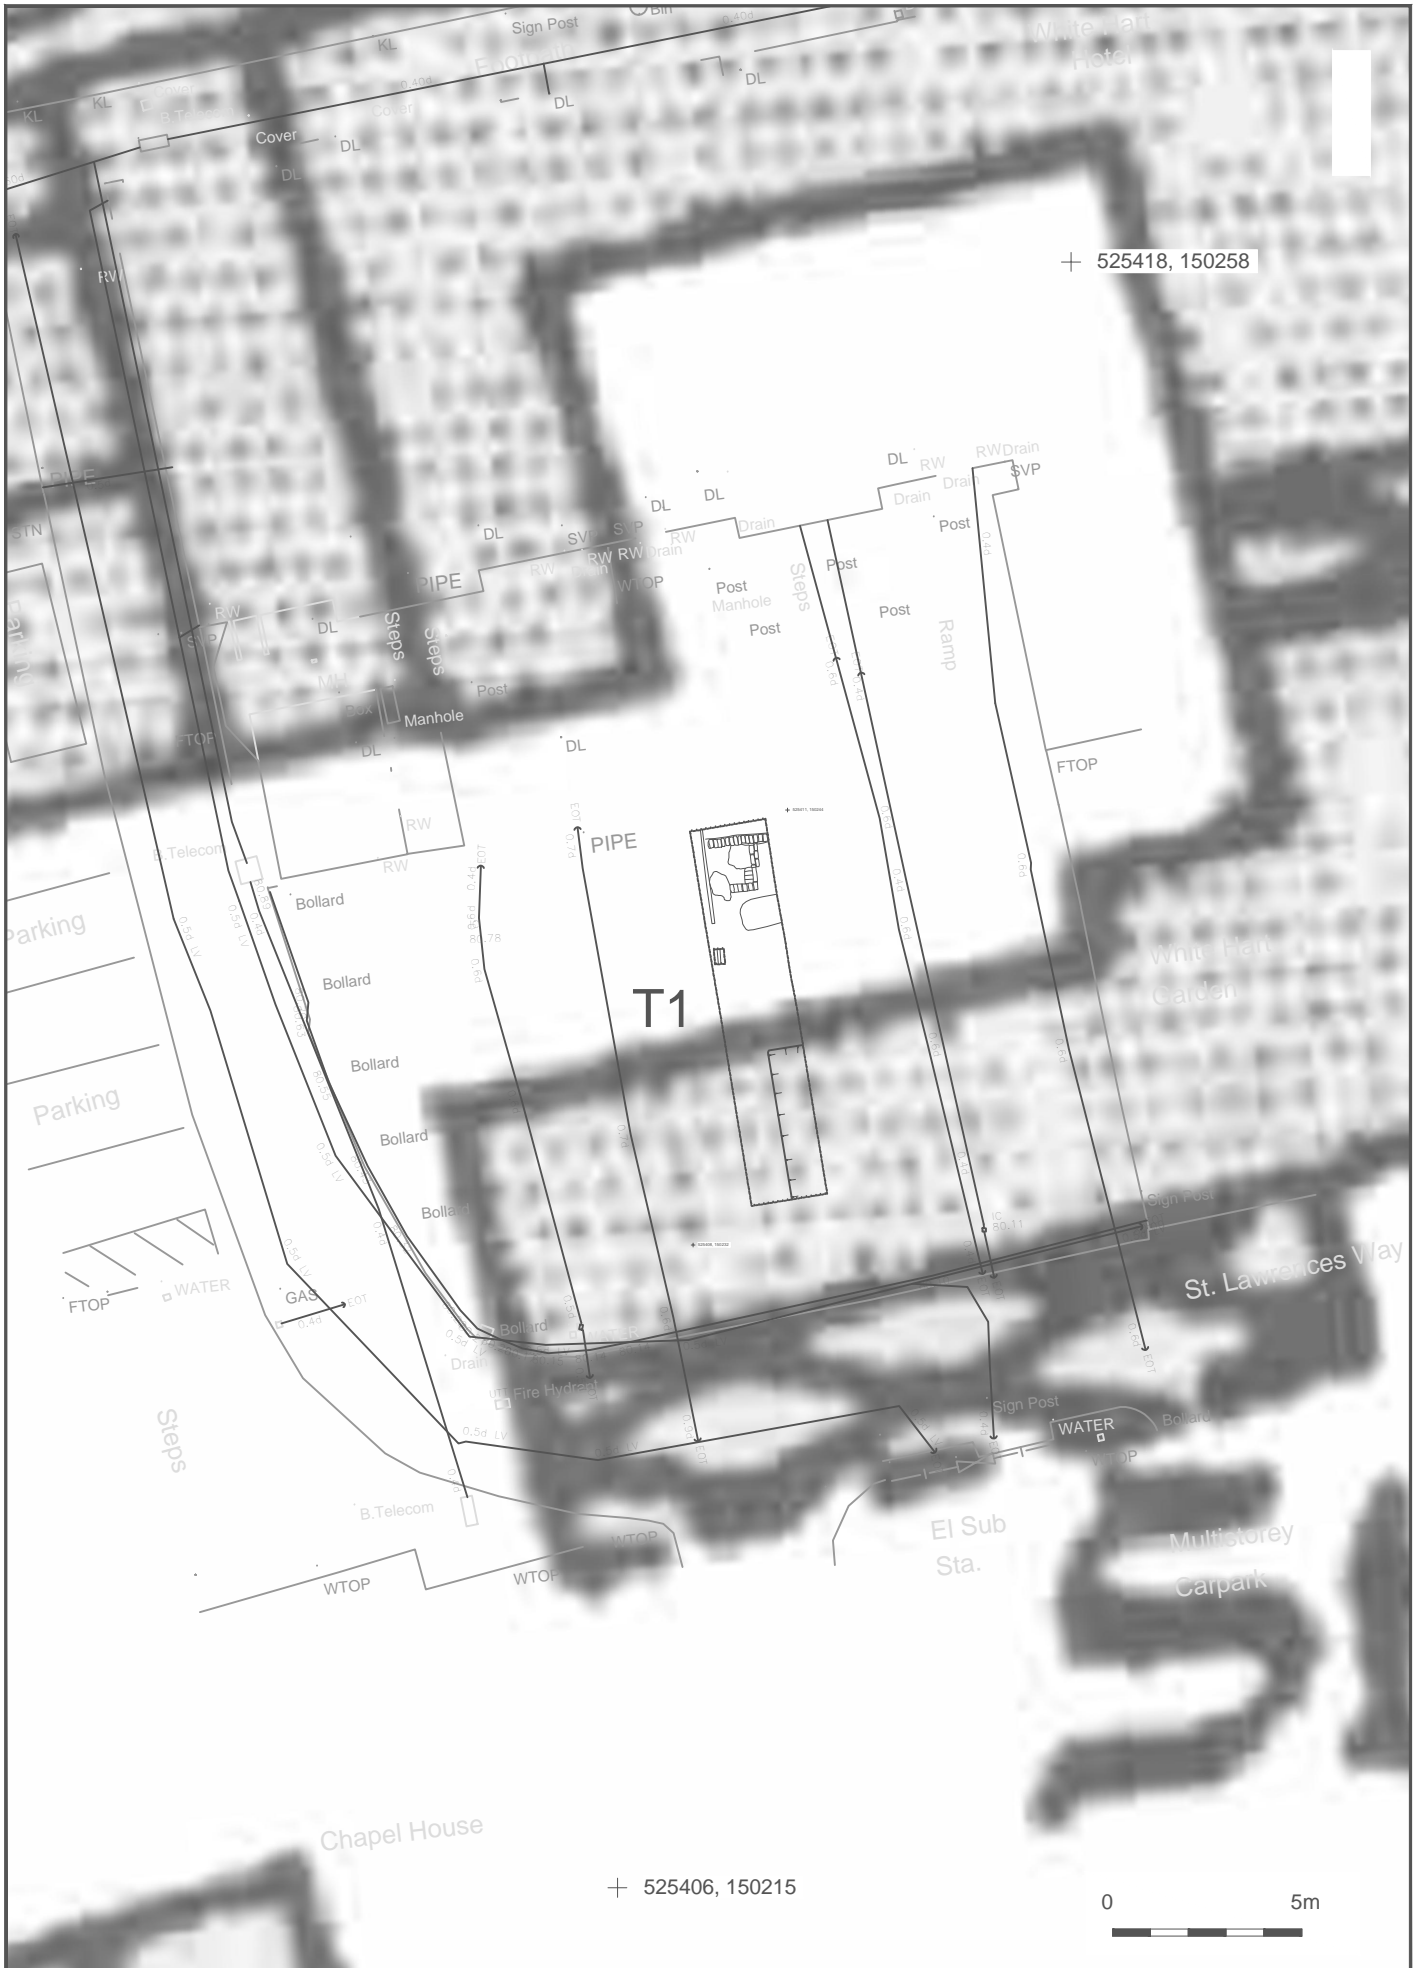
© Archaeology South-East		4-10 Church Street, Reigate, Surrey	Fig.4
Project Ref: 190019	July 2019	1933, OS Survey map, overlay site plan	
Report Ref: 2019219	Drawn by: AR

5.3.1 The subsoil and buried topsoil did not contain any finds and so could not be dated. The structural remains in the north of the trench comprised wall foundations and floors from the possible stables recorded on Ordnance Survey maps of the 19<sup>th</sup> and earlier 20<sup>th</sup> centuries (Figure 4); these buildings may actually have their origins in the 17<sup>th</sup> or 18<sup>th</sup> centuries and could have been associated with the White Hart Inn (Perry 2009). Given the materials used in the construction of these remains, including concrete and deeply frogged red brick, it seems highly likely they represent a later phase of the buildings. Some earlier bricks were noted within these foundations, but they appear to have been reused.
