**249-251 Merton Road,
London Borough of Wandsworth SW18
Archaeological Evaluation**

**Site code: MWA 08
NGR: TQ 252 738**

**ASE Project no. 3258
ASE report no. 2008014**

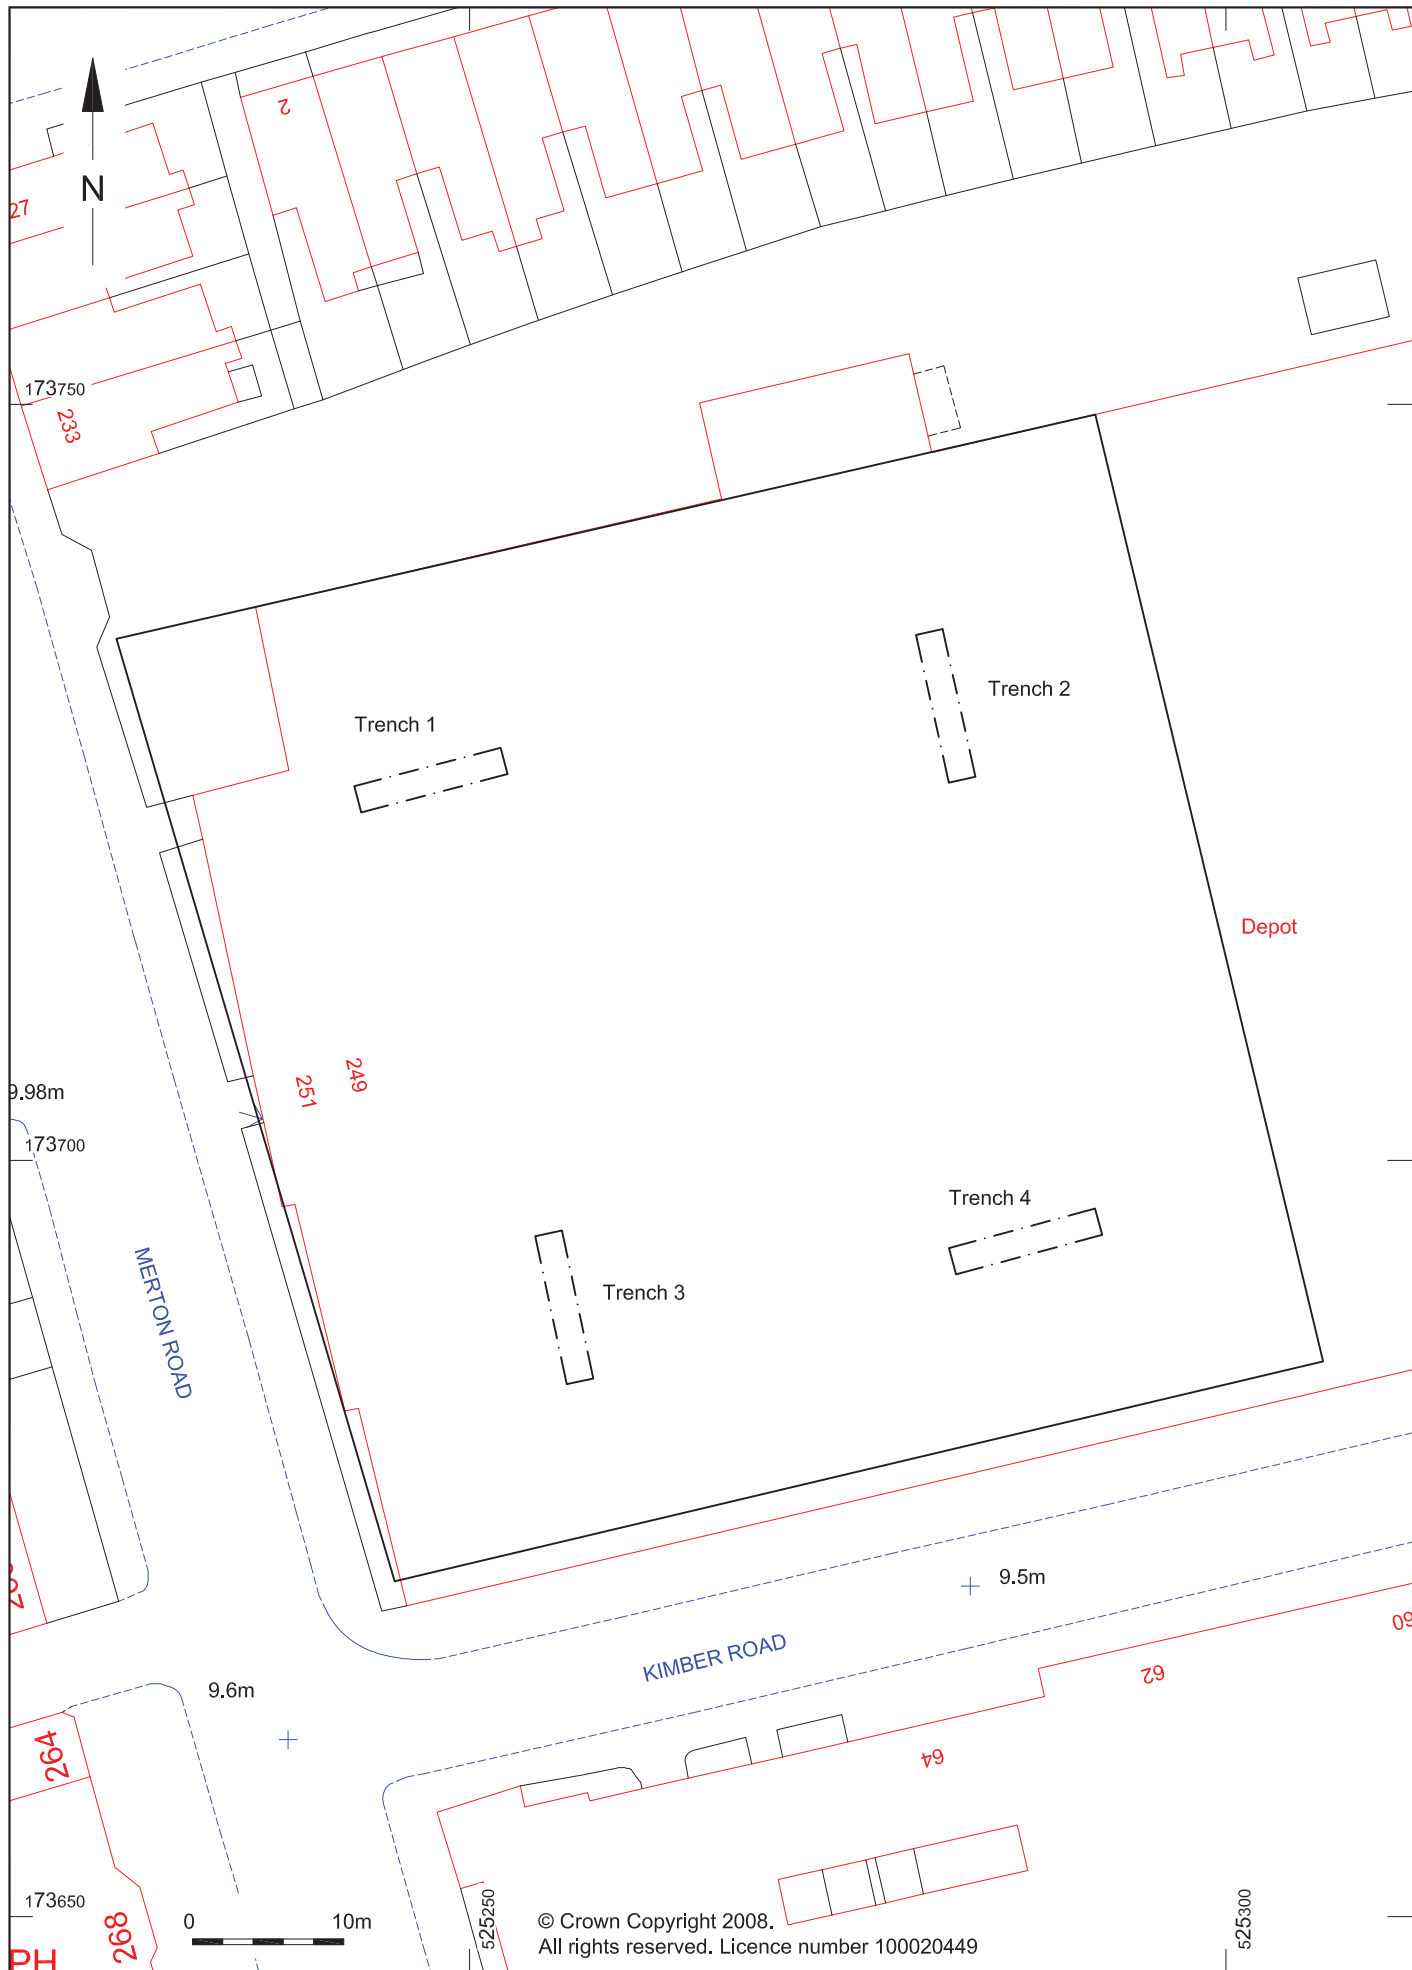
© Archaeology South-East		Merton Road, Wandsworth	Fig. 2
Project Ref: 3258	Feb 2008	Trench Location	
Report Ref: 2008014	Drawn by: JLR

- 3.4 The trench layout was agreed prior to the evaluation between CgMs Consulting Ltd and the London Borough of Wandsworth, and was designed to provide a representative sample of the redevelopment area not truncated by previous activity (see Figure 2). The evaluation consisted of four trenches, each 10m x 1.8m. The precise location of the trenches was agreed in advance with CgMs Consulting Ltd (Richard Meager).

- 3.9 The trenches were measured to known points and reproduced on a site plan in relation to the Ordnance Survey (see Fig 2).
- 3.10 A trench record sheet was filled out for each trench and measured sketch sections were produced. Standard UCLFAU context record sheets were filled in for each archaeological deposit encountered.
- 3.11 An online OASIS form was filled out for the site, a copy of which is reproduced as an appendix to this document.
- 3.12 The archive is presently held at the Archaeology South East office in Portslade and will be offered to the Wandsworth Museum in due course. All finds are the property of the landowner, but will be donated to a suitable museum.

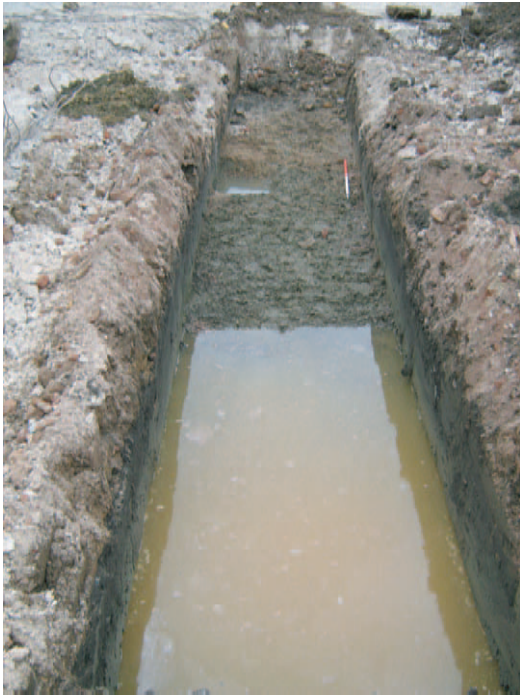
Plate 1: Trench 1

The top of trench 1 was recorded at 8.55m OD (see Plate 1)

The earliest deposit encountered comprised natural orange gravel at 7.53m OD. This was cut toward the north of the trench by a probable palaeochannel measuring 7.00m north-south. This channel was filled by a light to mid green sandy silt with frequent gravel inclusions 0.40m thick. In turn the entire trench was covered by a dark brown very sandy silt 0.15m- 0.30 thick. This in turn was overlain by 0.70m of modern made ground.

No archaeological deposits were present.

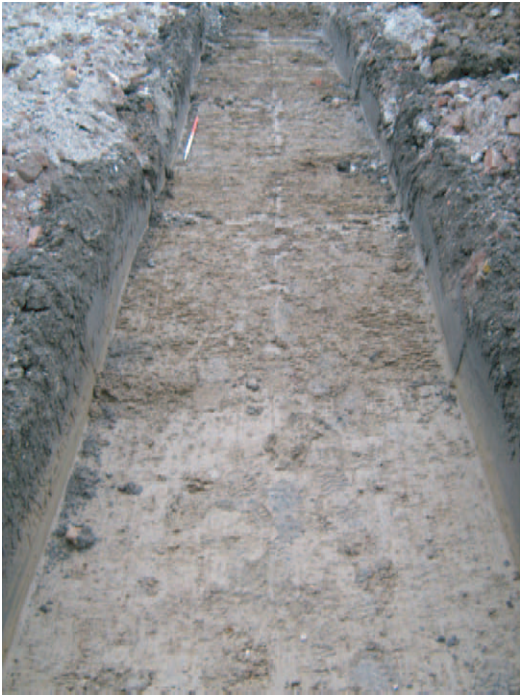
Plate 2: Trench 2

The top of trench 2 was recorded at 8.16-8.21m OD (see Plate 2)

Natural brick earth was encountered at 7.80m OD this was overlain by up to 0.40m of dark fine sandy silt. This in turn was overlain by modern made ground.

No archaeological deposits were present.

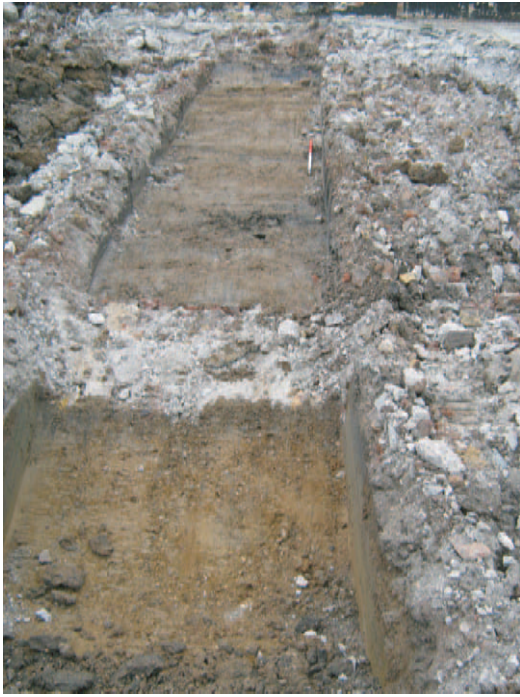
Plate 3: Trench 3

The top of trench 3 was recorded at 8.42m OD (see Plate 3)

Truncated natural gravel was encountered at 7.40m OD and was overlain and cut through by a series of modern foundations and made ground to a depth of up to 1.0m.

No archaeological deposits were present.
