**An Archaeological Watching Brief at Camber Wastewater Treatment Works,  
Camber, East Sussex**

**ROTHER: Camber  
NGR TQ 98853 18539**

**Project No. 2795  
Site Code: CTW 07**

**ASE Report No. 2008135  
OASIS id: archaeol6-47679**

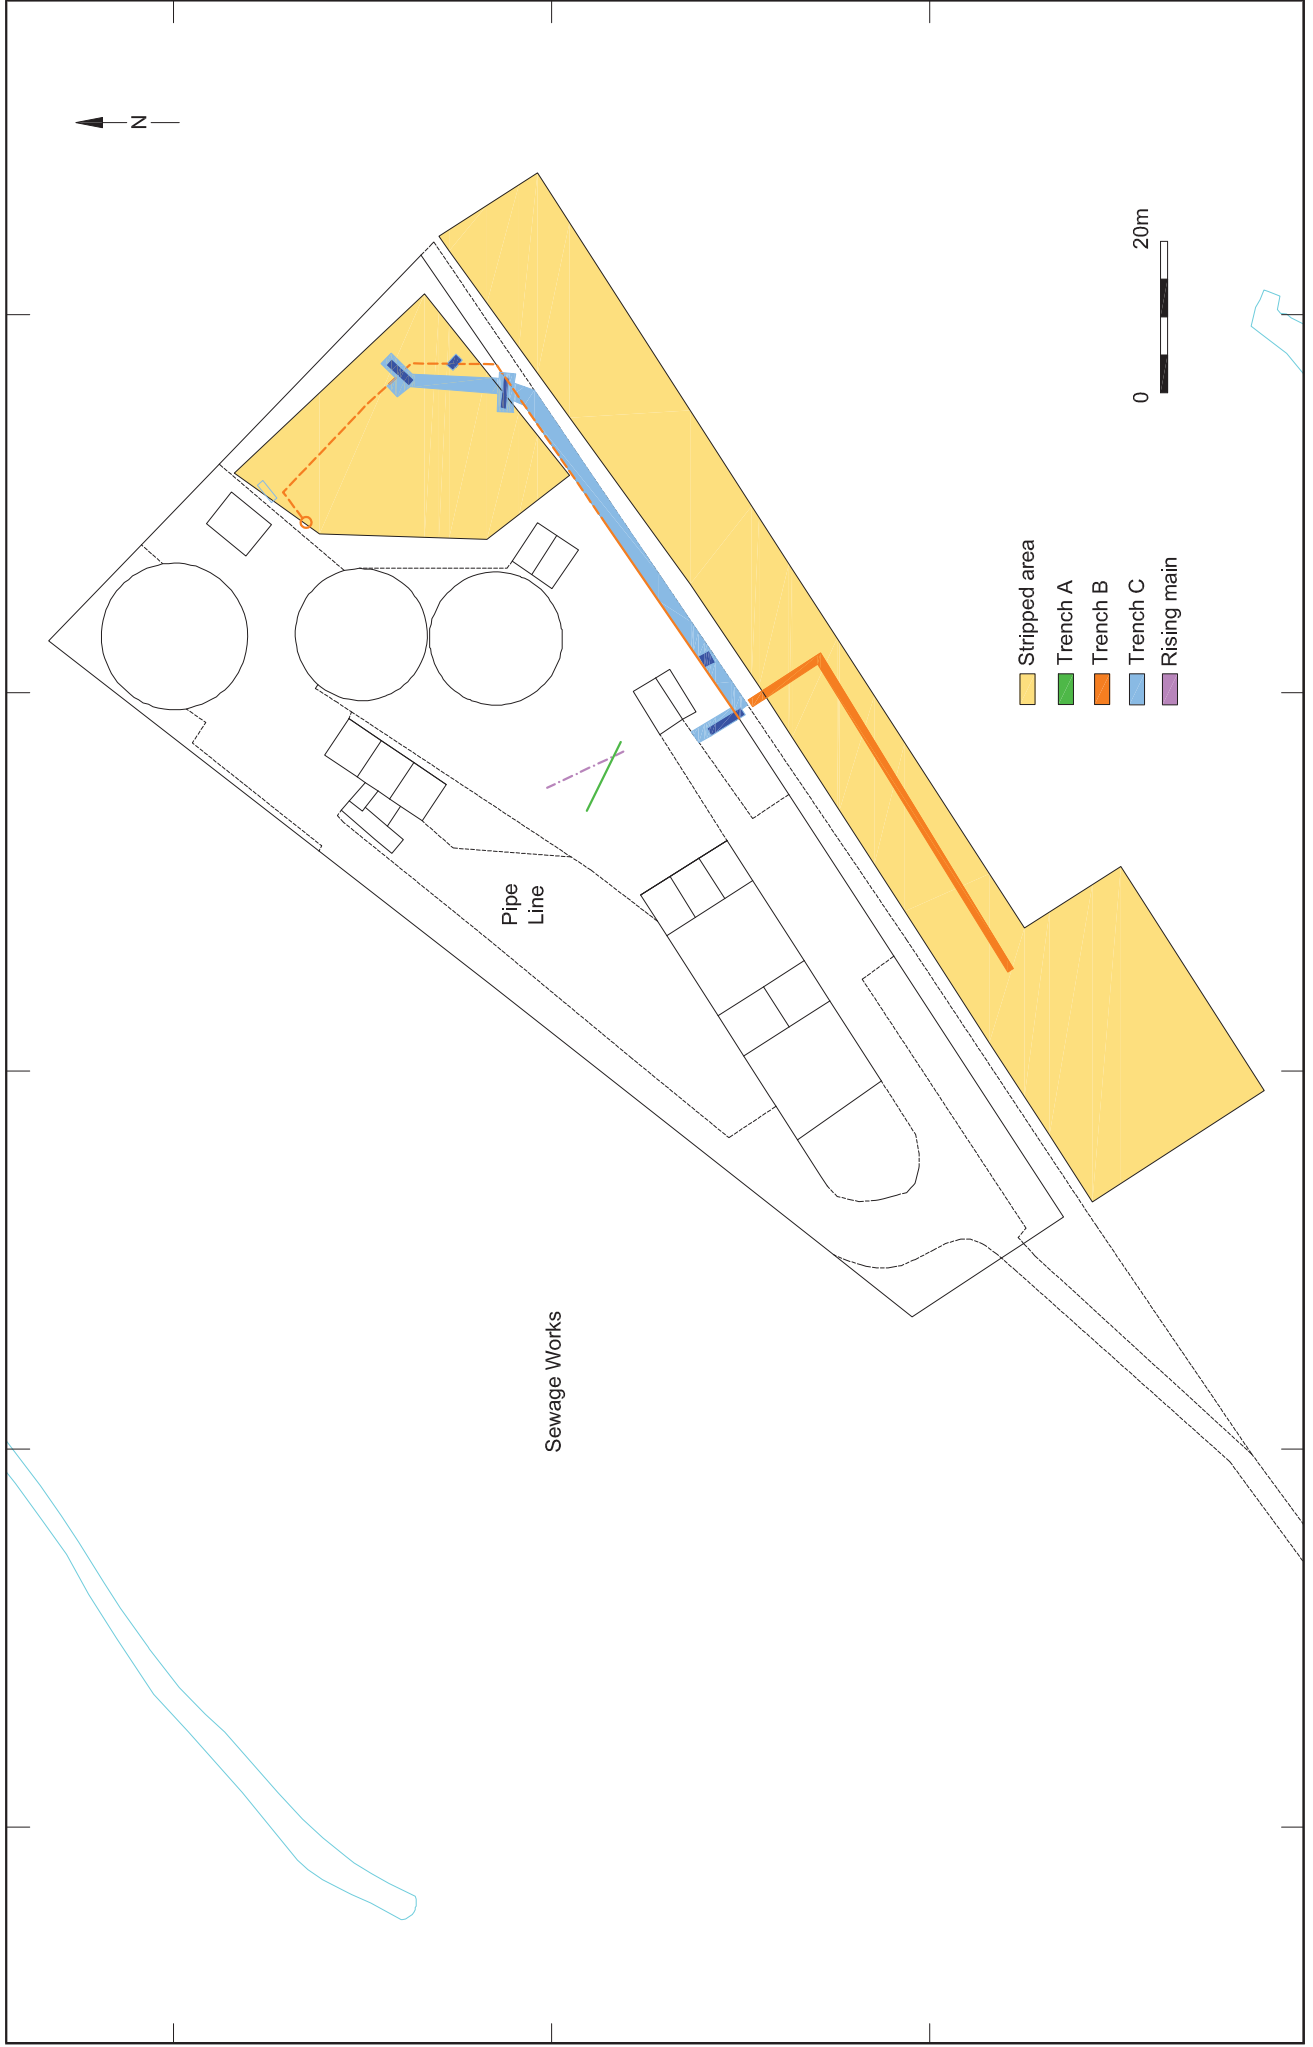
© <b>Archaeology South-East</b>		Camber Wastewater Treatment Works		Fig. 2
Project Ref: 2795	Jan 2009	Site Plan		
Report Ref: 2008135	Drawn by: HLF

- 4.1.1 In March 2007, initial monitoring was undertaken at the site during the stripping of an area for the installation of two new humus tank chambers at the eastern end of the site (Fig. 2). The excavation was undertaken by a 13 tonne 360° excavator fitted with a 5ft wide toothless ditching bucket. The area was stripped to depths between c.150mm and c.300mm, which was not deep enough to reveal any underlying geological deposits. The only encountered deposit was a mid-brown silty clay topsoil Context [100], which had been disturbed by the laying of services.

- 4.1.5 The other monitoring at the site was undertaken during realignment of services. The mechanical excavation of a trench measuring 7m long by 600mm wide by 600mm deep by a 5 tonne mini-excavator was undertaken during October 2007. (Fig. 2, Trench A). No geological deposits were exposed, and the only encountered deposit was a mixture of mid-brown silty clay ploughsoil, Terram Sheet and imported pea shingle (Context [104]).

- 4.1.6 A further service trench was dug by the same machine in early November 2007. It was c.50m long, 600mm wide and a maximum of 1m deep (Fig. 2, Trench B). The encountered deposits were the disturbed soil, Context [104], which was 300mm in thickness and directly overlay Context [105], a 650mm thick orangey brown clay which appeared to be an alluvial deposit. This overlay a grey gravel (Context [106]) of unknown extent, which could not be fully recorded owing to problems with access to the trench. No archaeological deposits, features or finds were encountered.

- 4.1.7 Further groundworks at the site were monitored during December 2007. The manual excavation of a number of test-pits to ascertain the position of buried services in advance of more service diversion was monitored (Fig 2, Trench C). Small-scale excavations to a maximum depth of 900mm confirmed the stratigraphic sequence seen during the excavation of Trench B, although the surface of the underlying gravel (Context [106]) was not reached.

4.1.8 Subsequently the mechanical excavation of the service trench (Fig. 2, Trench C) by a 5 tonne mini-excavator was monitored. The trench was c.140m long, 400mm wide and a maximum of 800mm deep. The stratigraphic sequence was identical to that recorded in the test-pits, and no archaeological deposits, features or finds were encountered.
