An Archaeological Watching Brief at St Peter's Church, Woodmancote, near Henfield, West Sussex.

Planning Ref: DC/06/1093

Project No:3406 Site Code: SPW08

ASE Report No. 2008159 OASIS id:archaeol6-49443

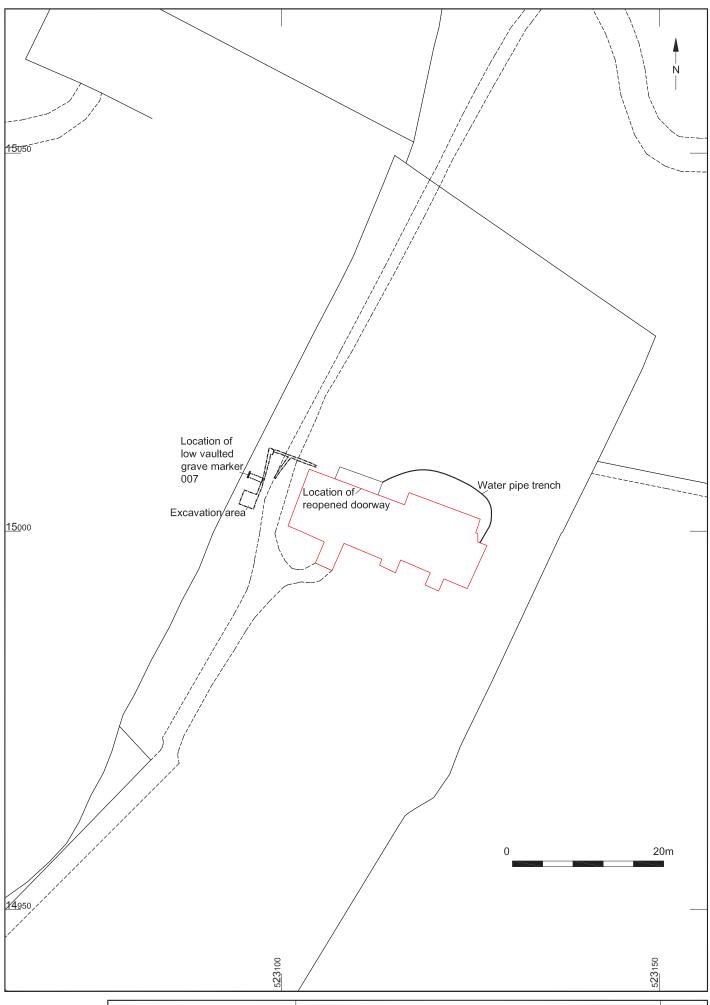
| © Archaeology South-East | | St Peter's Church, Woodmancote | Fig. 2 |

4.1.1 Several areas were monitored and these comprised of a rectangular area to the north of the church, 6.3m by 2.2m excavated to a depth of 0.75m below ground level; 30m long water-pipe trench, 0.30m wide and 0.40m deep; a sewerage tank pit, 2.5m² and 3.6m deep; 20m long sewer pipe trench, 0.30m wide and up to 0.60m deep.

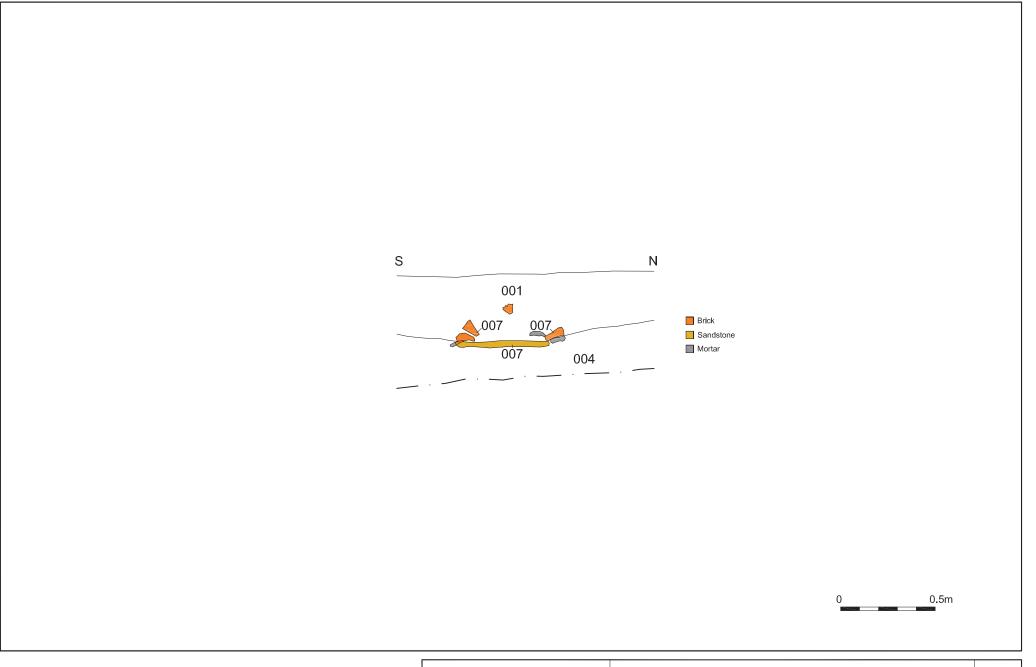
| © Archaeology South-East | | St Peter's Church, Woodmancote | Fig. 3 |

- 4.1.3 A low grave marker [7] was identified in the western section edge of the service pipe trench (Fig. 3) for the sewerage tank. The monument consisted of a flat slab of sandstone measuring 0.5m wide by 40mm thick, overlain by wedge shaped red bricks measuring 0.21m in length by 60mm wide by 0.1m thick. The grave marker was overlain by the topsoil deposit [5]. The grave marker was bonded by a whitish yellow sandy lime mortar in places. The bricks probably formed a vaulted above ground structure to the grave. A headstone immediately 2m to the west of the trench and apparently contemporary with the grave marker had a mostly illegible inscription but appeared to date from the 1770s. The marker was left *in situ* as it was not to be further disturbed by the works.

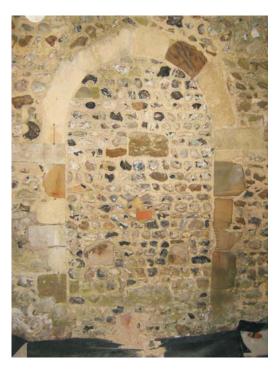
- 5.1.1 The blocked doorway (Fig. 4) in the northern elevation of the church, now housed within a modern extension, measures 2.05m in height and 1.02m in width with the wall at 240mm wide to the inner reveals which are an additional 540mm (making the wall a total of 780mm thick). The doorway is of shaped stone blocks and has a rounded arch on the exterior and a four-centred arch on the interior (Fig. 5), wider by 112mm to the sides and 170mm to the top than the outer rounded arch opening. The masonry is rebated to the leading edge (Fig. 6), recessed 20mm from the opening and set back 32mm. No trace of fixings was observed. The reveals and arch had been lime plastered with the exception of the rebates.

Figure 4: The blocked northern doorway

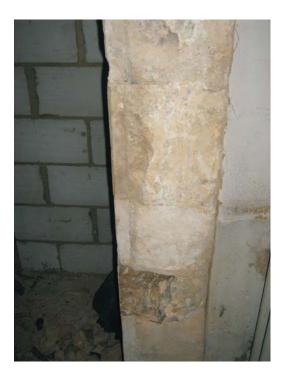
Figure 6: The rebated eastern edge of the doorway

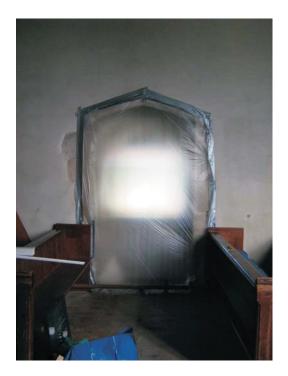
Figure 5: Interior view of the doorway, protected by plastic, but with the outline of the four centred arch visible

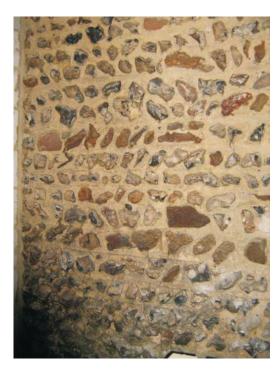
- 5.1.2 Visible fabric within which the doorway was sited is mortar-rich with flint and some ironstone (Fig. 7). Some of the masonry is laid herringbone-style indicating an early medieval origin. The shape of the doorway on the exterior is consistent with such a date but the four centred interior arch is of a later medieval style, perhaps consistent with the remains of the crown post roof *in situ* within the church.

Figure 7: Detail of the fabric of the north wall to the east of the doorway

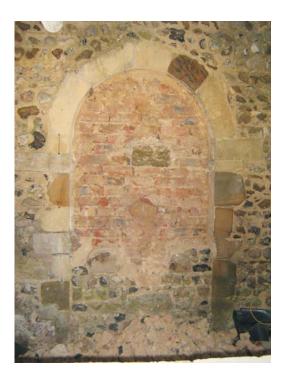
- 5.1.3 The opening up of the blocked northern door of the church revealed two skins to the infill (Fig. 8). The exterior side had been finished in flint and mortar with the random inclusion of masonry blocks, some of which showed traces of shaping and tool marks indicating re-used material. The interior skin was finished in reddish brown brick in stretcher bond. The bricks measured 215mm by 105mm by 63mm and the mortar bedding joints were 12mm thick. The bricks had sharp arrises and were frogged on one side only. The frog was rectangular in plan and shallow, but pressed rather than scraped. Horizontal skintles were visible on some bricks and the fabric was mottled with clinker-like inclusions. The style and size of the brickwork is consistent with a 19<sup>th</sup> century origin.

Figure 8: The un-blocking in progress showing the brick skin behind the outer face of flint.

- 5.2.2 The re-modelling of the church to the designs of Henry Woodyer in the late 19<sup>th</sup> century may have included the blocking up of the northern doorway. The materials utilised in the in-fill are consistent with such a date.
