**An Archaeological Watching Brief at New Barn,
Michelgrove, Patching, West Sussex**

**Planning Ref: PA/9/06
Arun: Patching**

**Project No: 2755
Site Code: NBP07**

**ASE Report No.:2008196
OASIS id:archaeol6-50246**

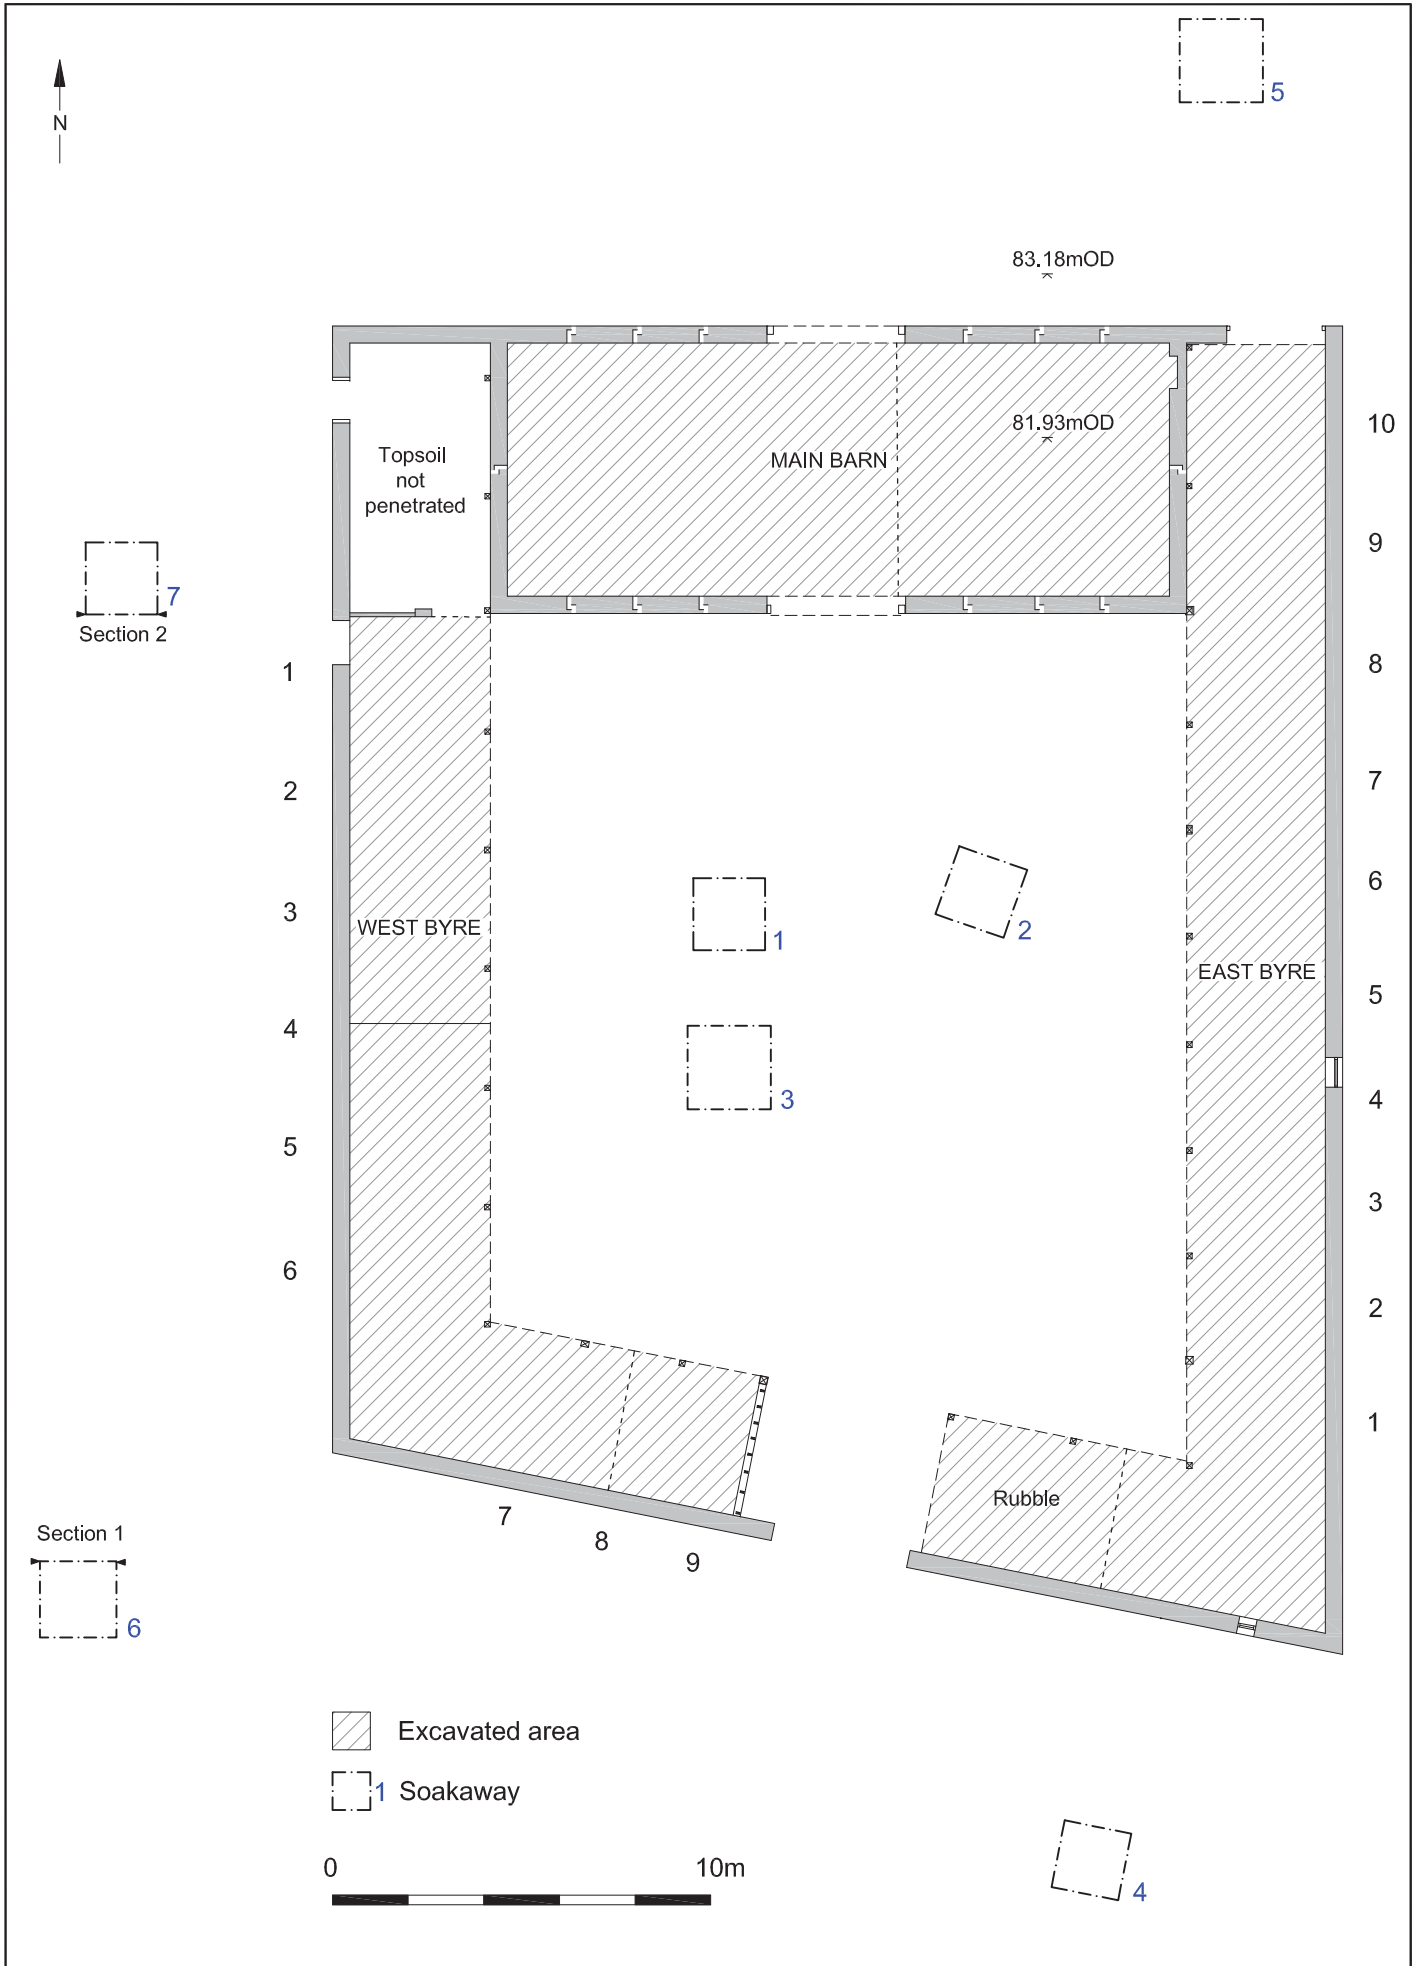
© Archaeology South-East		New Barn, Michelgrove, Patching	Fig. 2
Project Ref: 2755	Oct 2008	Location plan showing excavated areas	
Report Ref: 2008196	Drawn by: AW

- 4.1 Ground reduction occurred within all parts of the barn structure described above. Furthermore, seven soak away pits were to be excavated to an approximate depth of between 1-2 metres; three within the central courtyard area and four close to the external parameters of the development (fig. 2).
- 4.2 The archaeological results of ground reduction at the barn conversion are provided below in the order of sequence in which the excavations were undertaken. This was firstly the east and west sections of the main barn at the north end of the site followed by the compartments of the West Byre and its eastern extension. The final excavations were of the East Byre and its compartments and its western extension.
- 4.3 The results of the excavations of the 7 soak away pits will be dealt with separately.

- 4.4.3 The depth of ground reduction for the West Byre area (Piers 1-6), including the eastern extension (Piers 7-9) (fig. 2) varied between 0.60m and 0.40m. Following excavation to the required depth of Piers 1-8 in the West Byre context [004] was revealed beneath a 0.10-0.20m thick layer of beaten floor [001]. Context [004] (probably same as [003]) is described as 90% whitish grey angular chalk blocks contained within a mid-brown silt clay matrix. No

- 4.4.5 The greatest depth of excavation in the West Byre was in the final 4 metres of the eastern extension (Pier 9: fig. 2) where at a depth of 0.60/0.65m the natural chalk [002] was encountered below context [004]. No archaeological cut features or finds were seen.

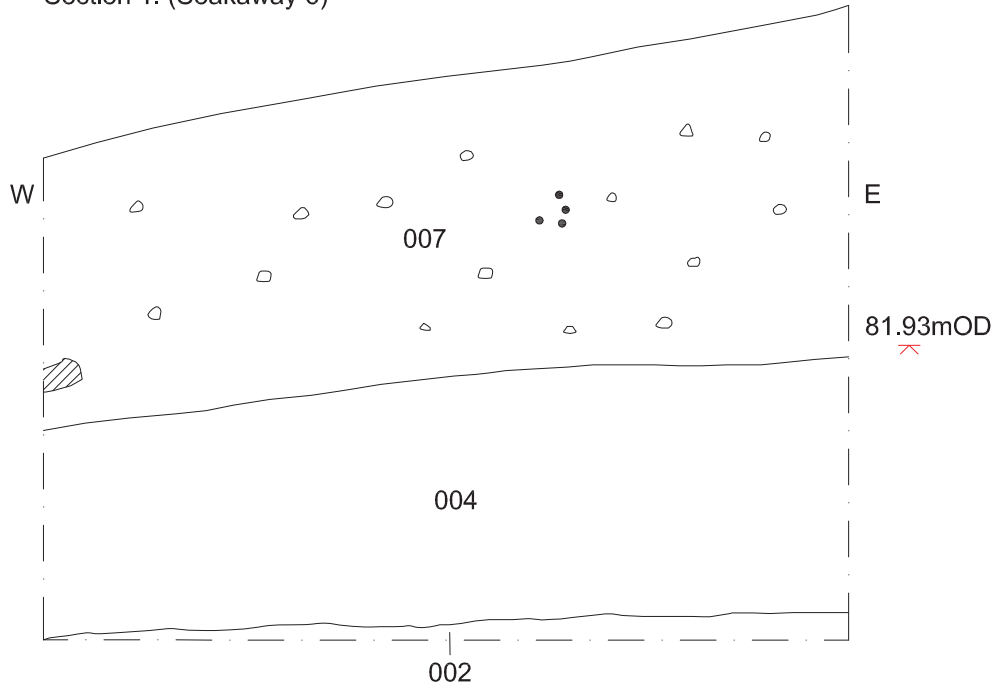
Section 1: (Soakaway 6)

4.11.1 Soakaway 6 measured 2.0m square and excavated to a depth of 1.60m. The profile comprised 0.70m of mixed topsoil deposit [007] (disturbed by BT cabling) overlying chalk rubble subsoil [004] of 0.60m thickness. 'Natural' chalk [002] was encountered at 1.40m. No archaeological features were observed. A piece of 1930's ceramic was found in the topsoil (not retained).

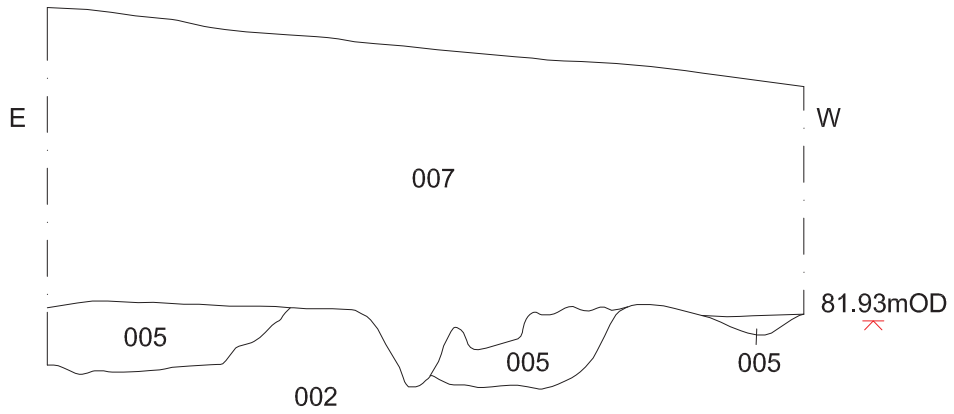
Section 2: (Soakaway 7)

4.12.1 Soakaway 7 measured 1.90m square and was excavated to a depth of 1.80m. The profile comprised 0.80m of mixed topsoil deposit [007], a mid-dark brown loamy soil containing 15% sub-angular natural flint pieces (50-70mm diameter), the disturbed nature of this deposit is emphasised by the inclusion within its matrix of 19th/20th century bricks and glass bottles (not retained). Deposit [007] immediately overlay the chalk bedrock [002].

4.12.2 The north facing section of Soak away 7 (fig. 3) shows some irregular hollows at the base of the subsoil deposit [005] close to the contact with the 'natural' chalk. On investigation there was some evidence of solifluction (Coombe rock) but also root activity suggesting a former north-south hedge line on the west side of the existing track way. No other archaeological features or finds were noted in Soak away 7.

- 6.3 Soak away 7 produced a possible archaeological anomaly. Irregularities at the interface between deposits [007] and [005] suggest root action and disturbance associated with a possible former hedge line running north-south on the west side of the barn some metres closer to the barn than the extant hedge line. It is therefore possible that the old hedge line was removed at the time the barn was originally constructed.

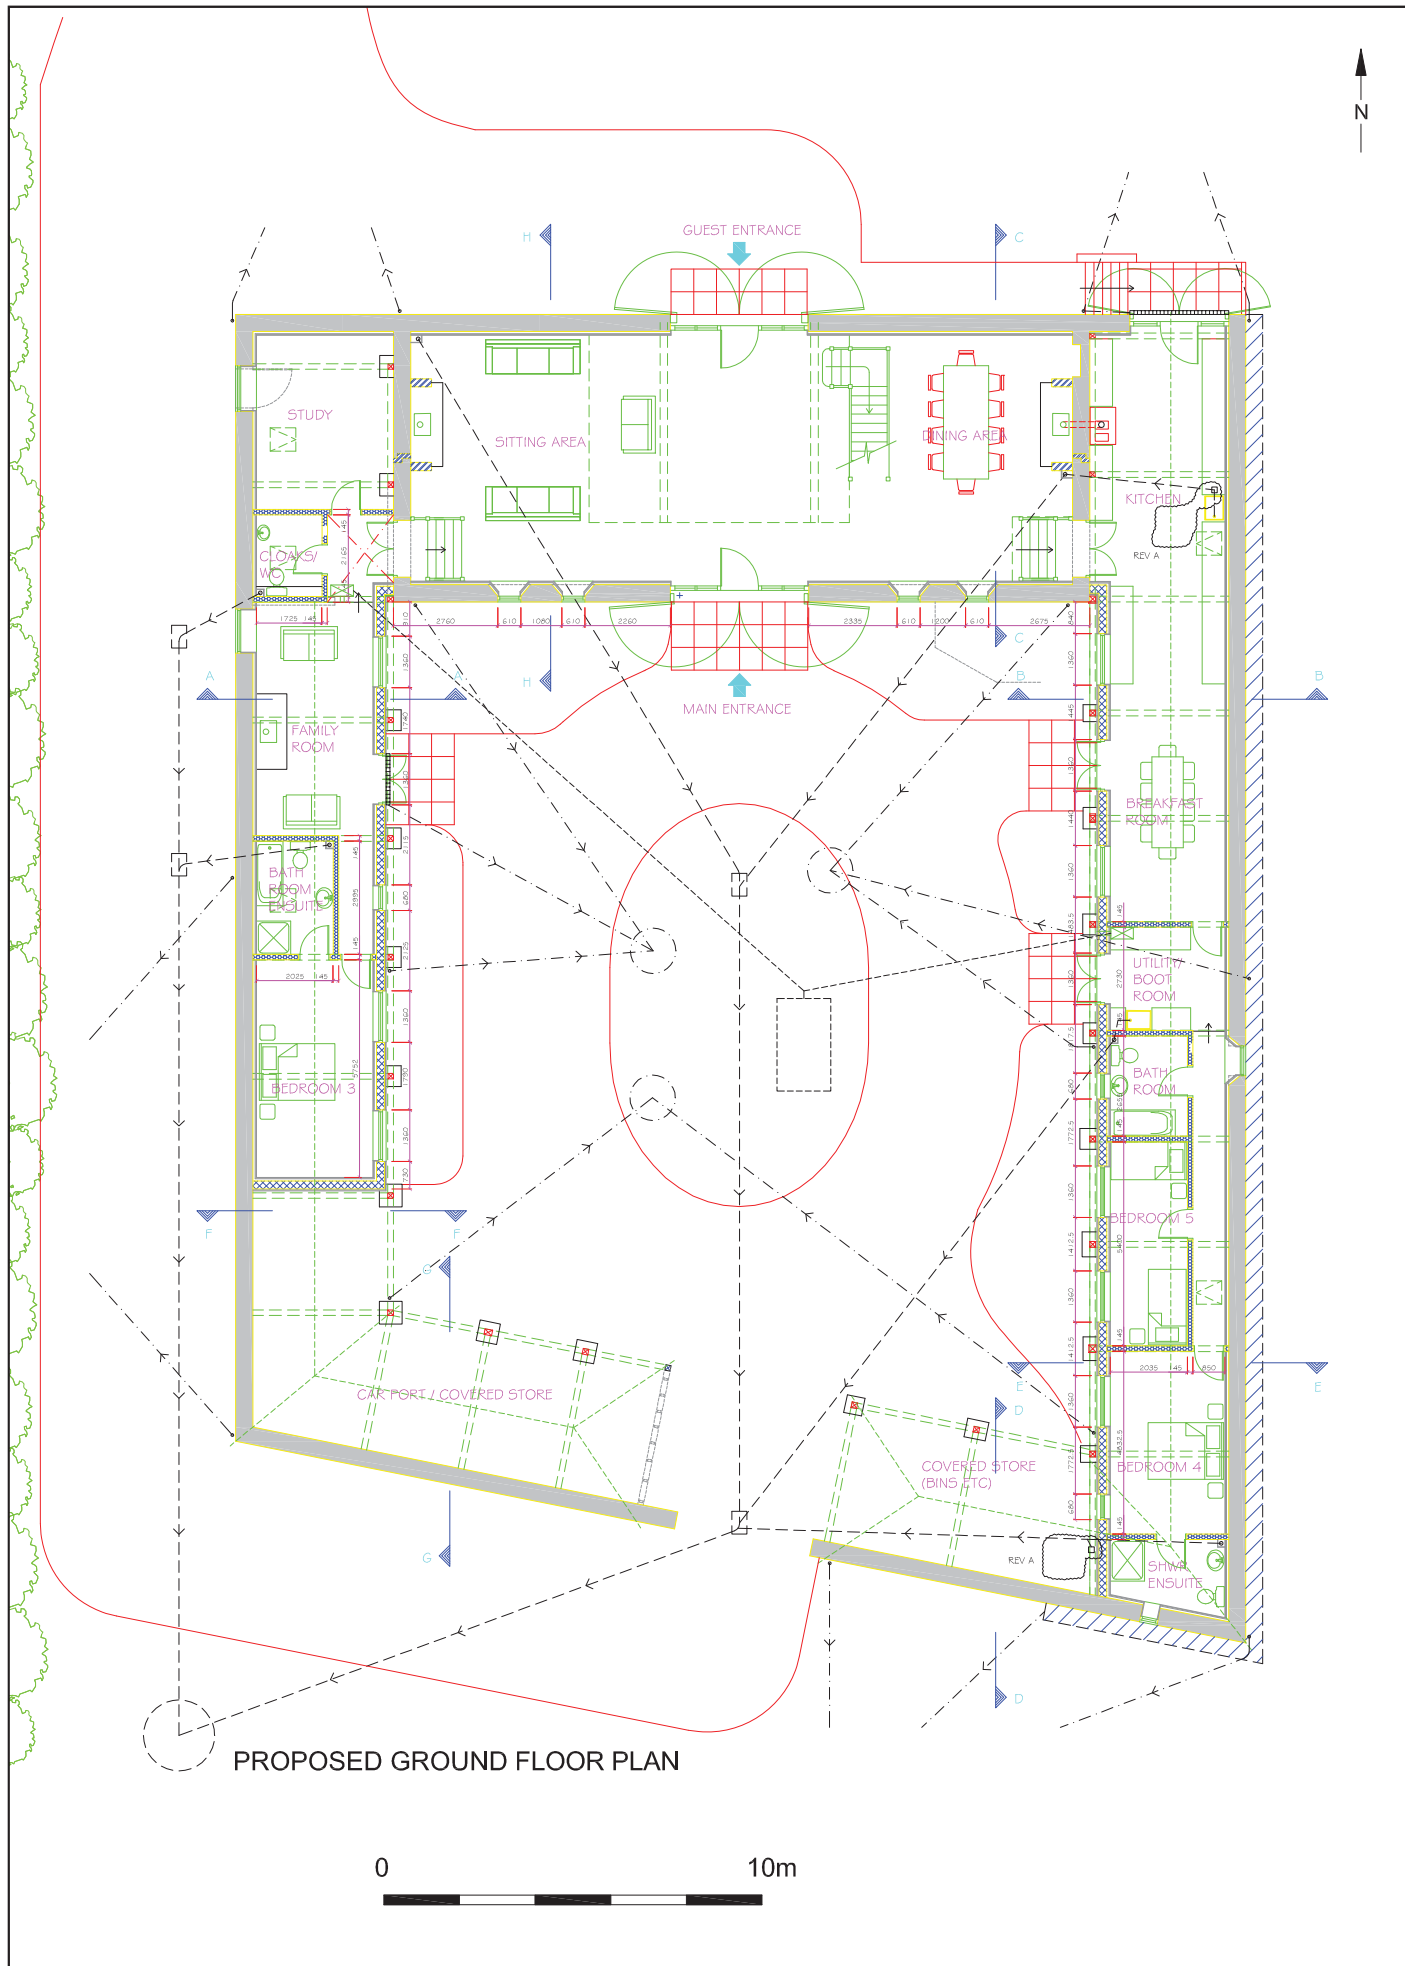
© Archaeology South-East		New Barn, Michelgrove, Patching		Fig. 4
Project Ref: 2755	Oct 2008	Proposed Development		
Report Ref: 2008196	Drawn by: JLR

- 1.1.2 Prior to the development the barn structure was comprised of a number of different elements (fig. 2). The main part of the barn (large storage area with high roof) was at the north end. This part of the structure is to be the principal sitting and dining area and will provide the main entrance(s) to the building (fig. 3). The east and west sides of the structure run north-south and are described as the East Byre and West Byre. The latter will in the main be bedroom and bathroom accommodation as well as having other domestic functions. The east and west extensions of the Byres at the south end of the building are to be covered storage and carport areas. All of the elements just described enclose a central courtyard area.
