**An Archaeological Watching Brief at Ingrams Farm,  
Hardham, Pulborough, West Sussex**

**Planning Ref: DC/06/2986**

**Project No: 2878  
Site Code: IFH 07**

**ASE Report No. 2008204  
OASIS id: archaeol6-51432**

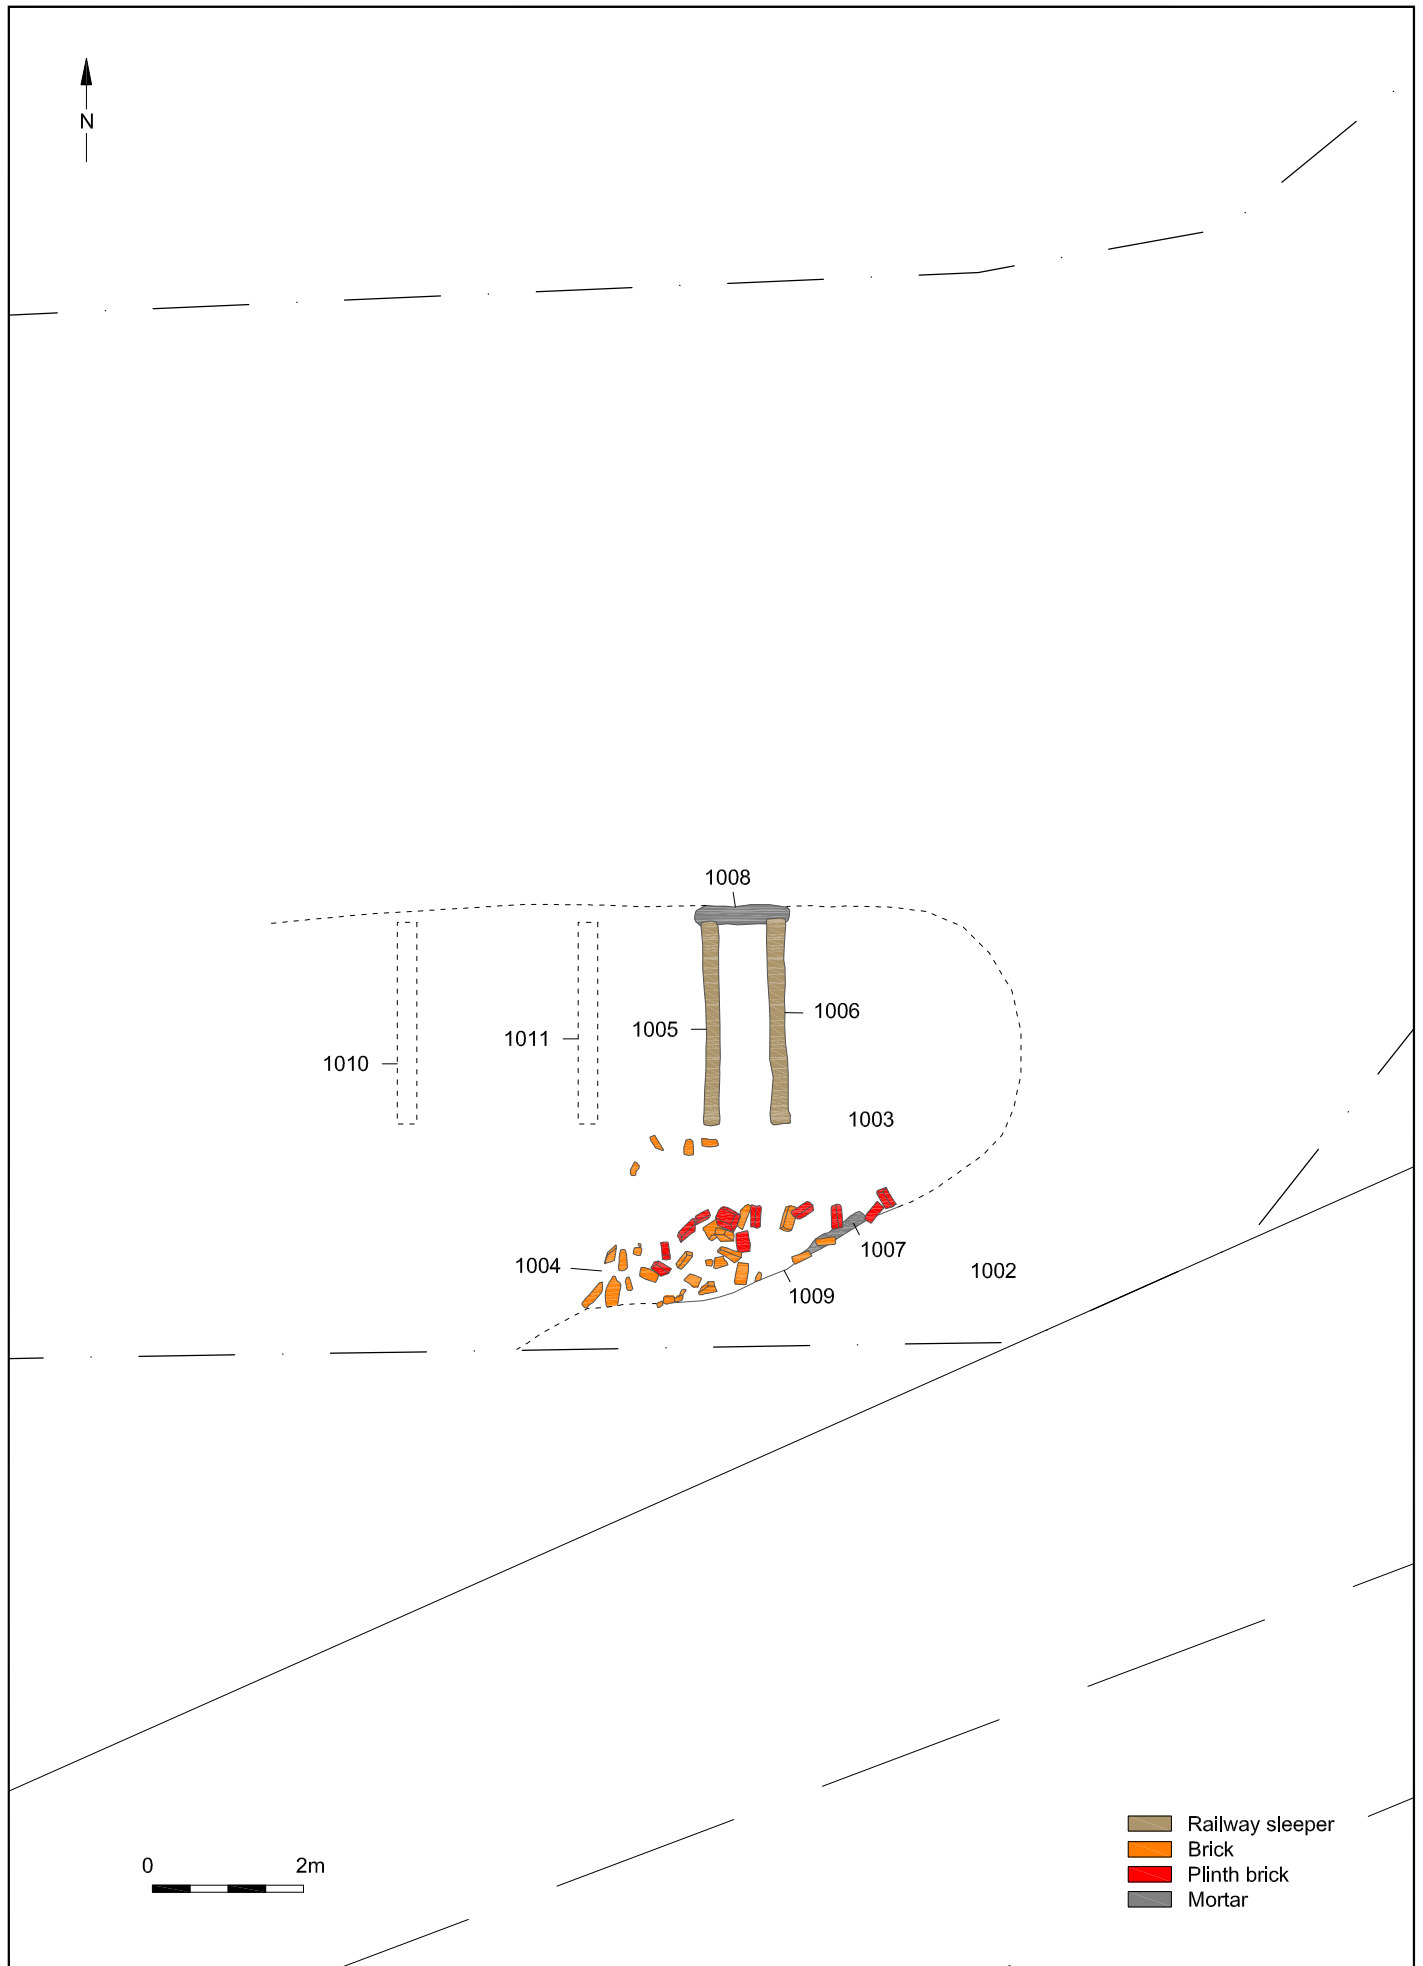
© Archaeology South-East		Ingrams Farm, Hardham	Fig. 3
Project Ref: 2878	March 2009	Site plan	
Report Ref: 2008204	Drawn by: HLF

4.2 Excavation of the area to a depth of 250 mm revealed a line of brickwork and two associated railway sleepers (as described below). As this material was discovered at the required depth for the construction of the foundations, it was recorded and left in-situ in order to preserve the archaeology (Fig 3).

- 4.3.6 Deposit [1008] was located at the northern end of the railway sleepers [1005] and [1006] (Fig. 3). This mortar-like deposit was a dark greyish black silt containing sub-angular chalk fragments. It appears to have been deposited later than [1005] and [1006] and it is unclear whether there is any direct association between the contexts.
- 4.3.7 Deposit [1003] was post-medieval material that had been backfilled within [1009], over the brickwork [1004] and the railway sleepers. It was a mid greyish brown clayey silt deposit containing occasional small stone inclusions and scattered pieces of brickwork.
- 4.3.8 The entire excavated area was covered by layer [1001], a mid reddish brown silty clay topsoil with an approximate depth of 0.25 metres.

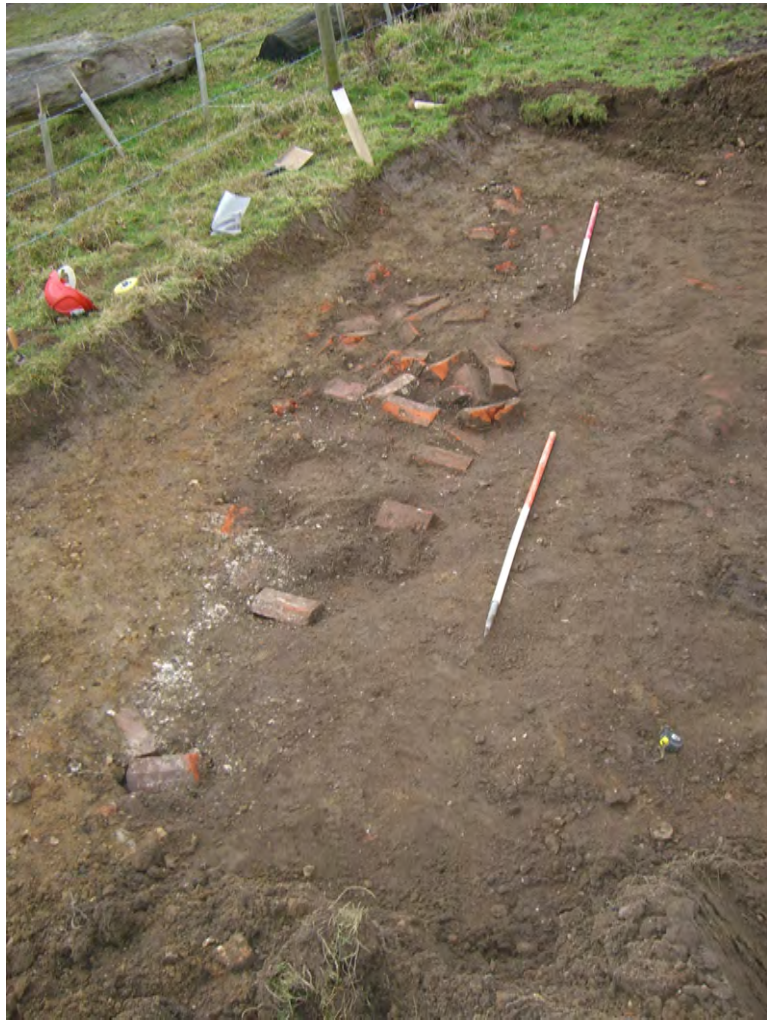
4.3.3 Masonry [1004] represented a line of disturbed brickwork at the edge of cut [1009], approximately 4.3 metres in length and 1.2 in width (Figs 3 and 4). The brickwork was heavily disturbed and consisted of approximately 36 bricks, the majority of which appeared to be plinth bricks.

4.3.4 Deposit [1007] was associated with the line of brickwork [1004]. It was a light brownish grey silty/sandy clay material with occasional small angular pebble inclusions. This deposit appears to be a mortar associated with the construction of the brickwork. It is isolated to a small area at the eastern end of the line of brickwork.

Fig. 4: Brickwork [1004], facing north-east

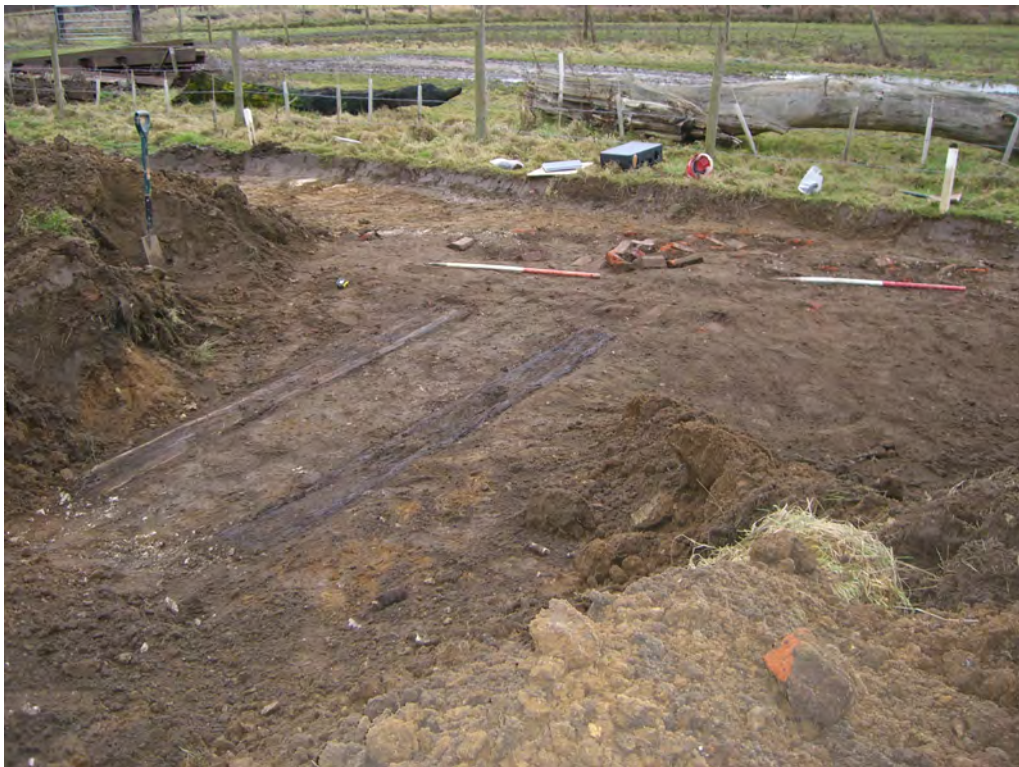
4.3.5 Timbers [1005] and [1006] were two railway sleepers located 1.1 metres to the north of brickwork [1005] (Fig 5). The timbers were aligned in a north to

south direction, parallel to one another at a distance of 0.62 metres. Both timbers measured approximately 2.71 metres in length and 0.24 metres in width. No tool marks, joints or fixings were evident on either timber, probably due to their poor state of preservation. Two further timbers [1010] and [1011] were only partially uncovered by the excavations. Their location within [1009], their appearance and their orientation suggest that they were also railway sleepers.

Fig. 5: Timbers [1005] & [1006], facing south-east
