**An Archaeological Watching Brief at
St Mary Magdalene's Church, Lyminster, West Sussex**

**Project No: 3432
ASE Report No. 2008138**

February 2009

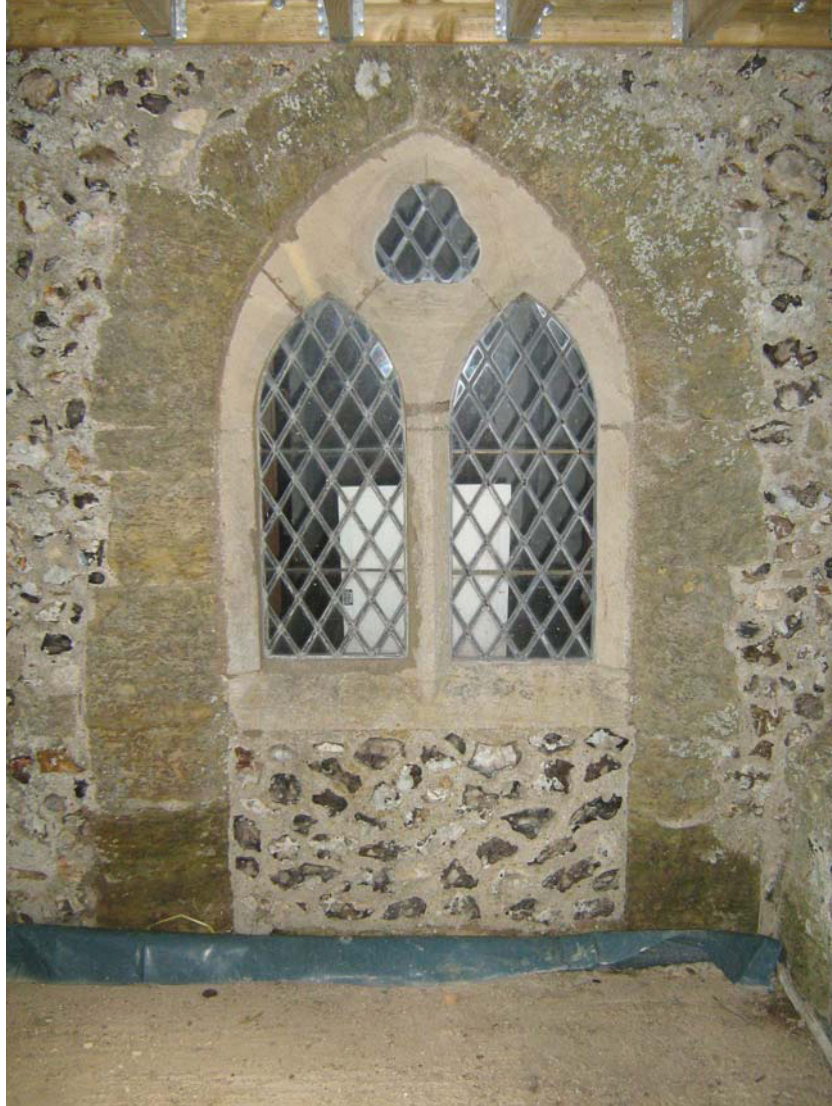
Fig. 7: The blocked northern doorway

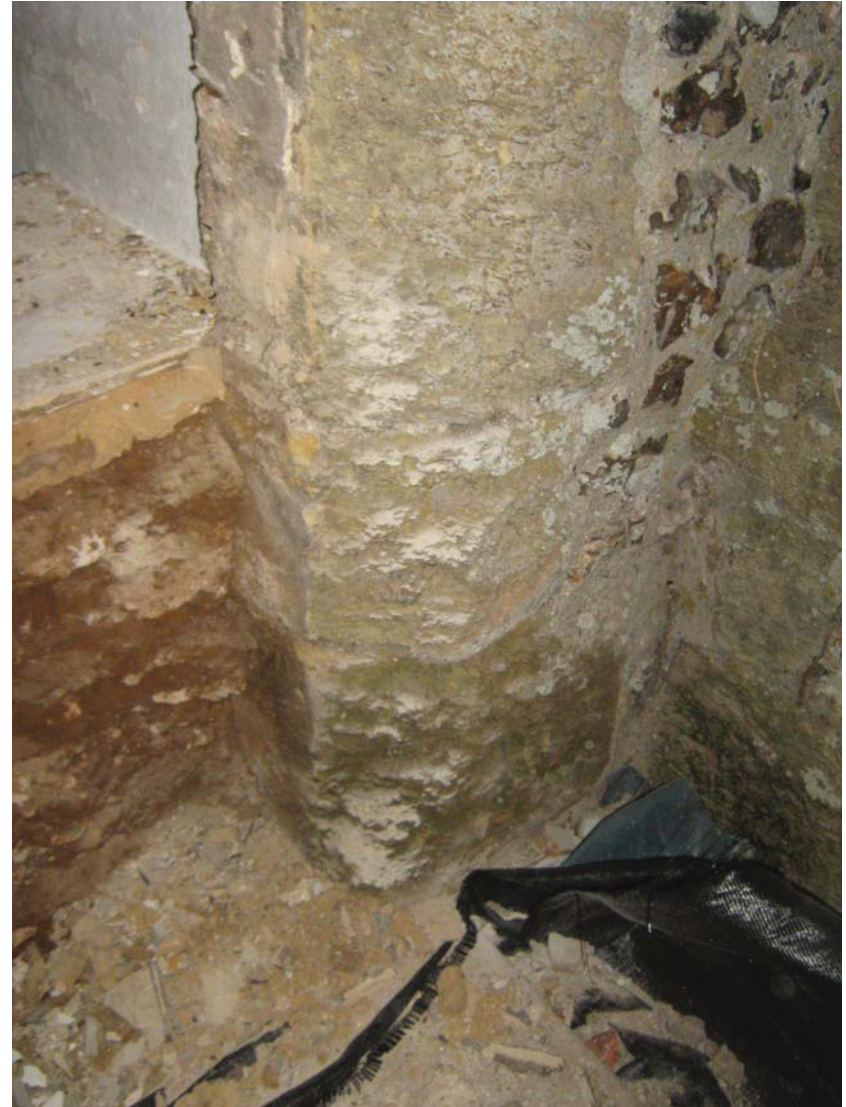
Fig. 8: The chamfer stop at the base of the eastern edge of the doorway

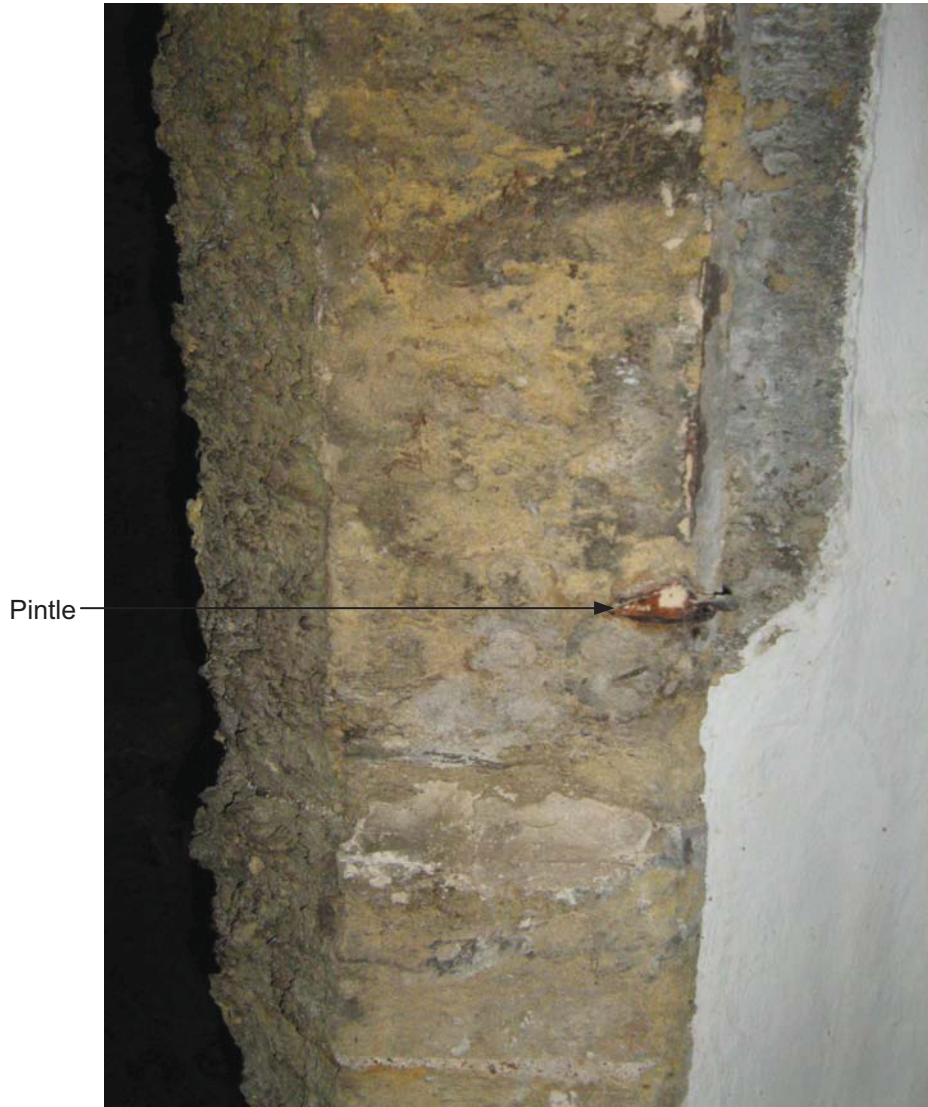
Fig. 9: The remains of the pintle on the west side of the doorway

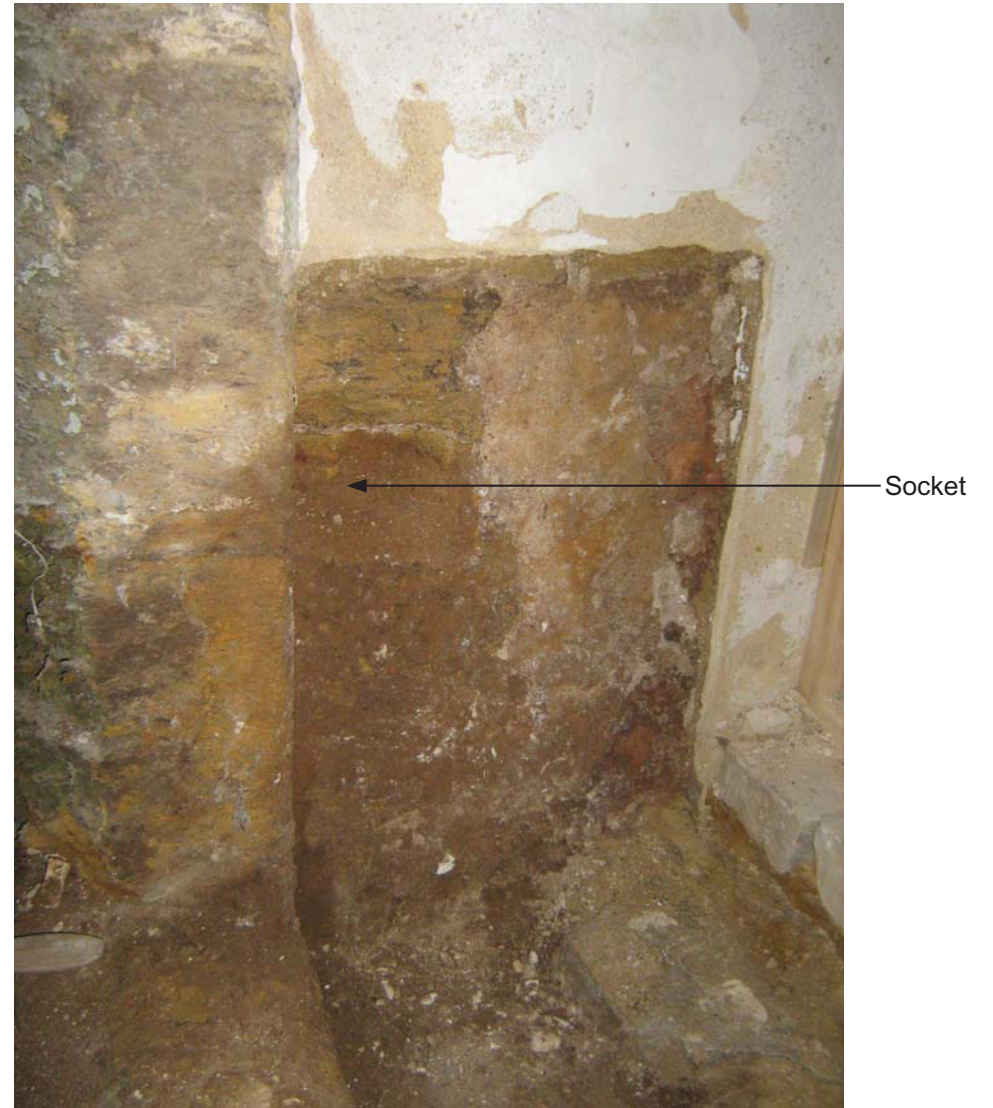
Fig. 10: The socket at the base of the west side of the doorway

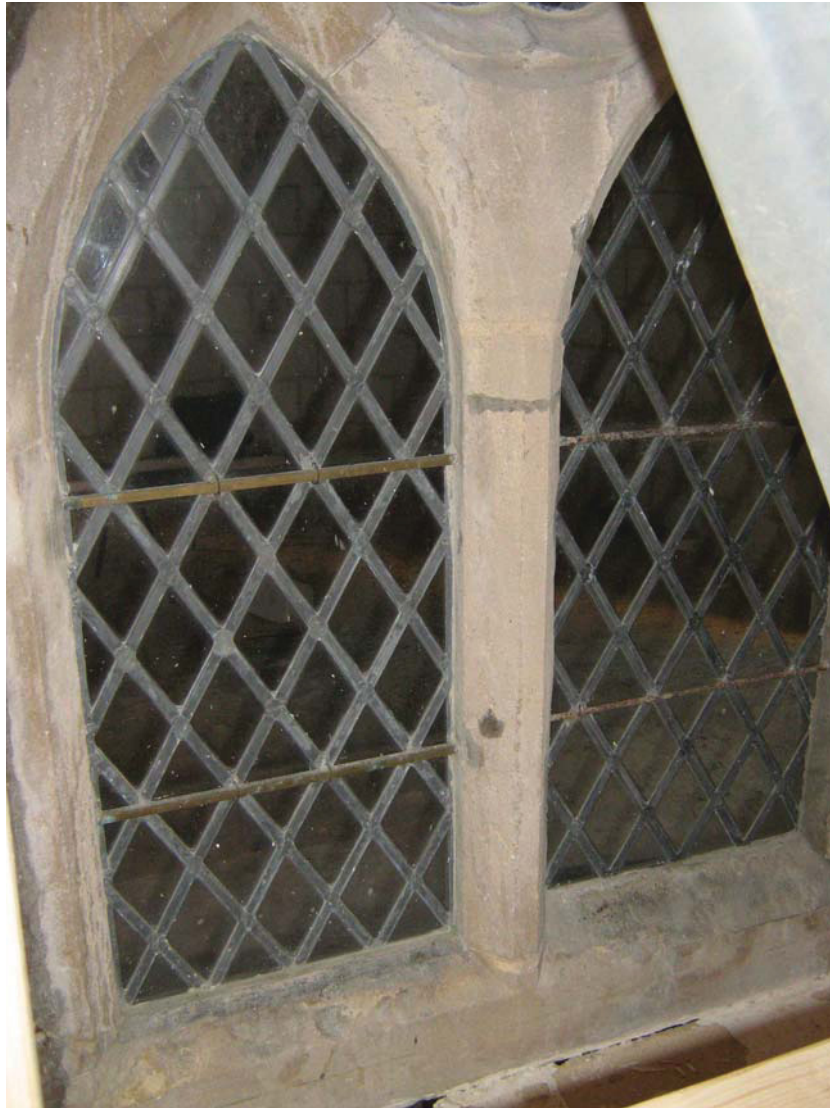
Fig. 11: Interior view of the inserted window still *in situ*

- 8.4.3 The stone, of the Cotswold Clipstone type that was commonly used after the 18th century in the repair of church masonry, the window style and the glazing suggest a mid to late 19th century origin for the construction which ties in nicely with the dates known for two programmes of restoration works (1864 and 1884) carried out to the church.

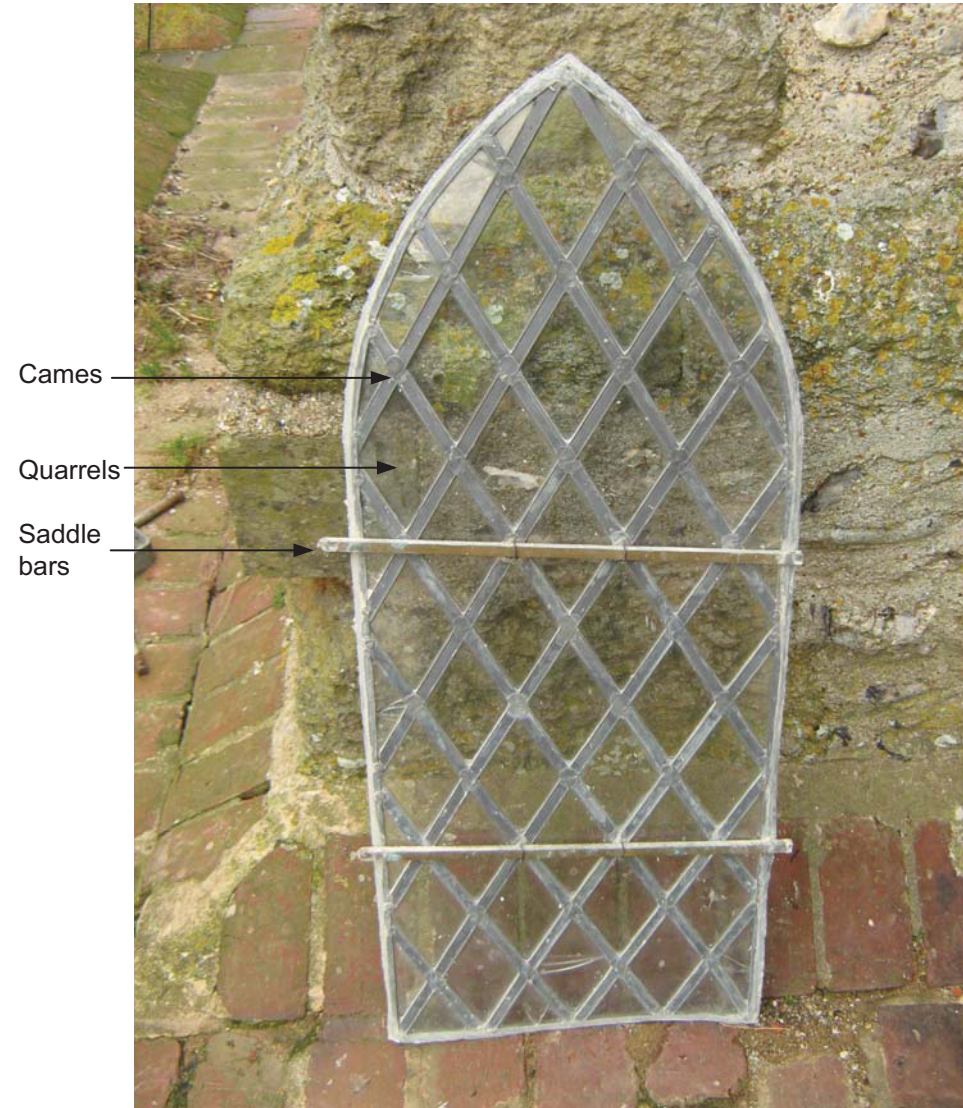
Fig. 12: Detail of the interior side of one of the windows showing comes, quarrels and saddle bars

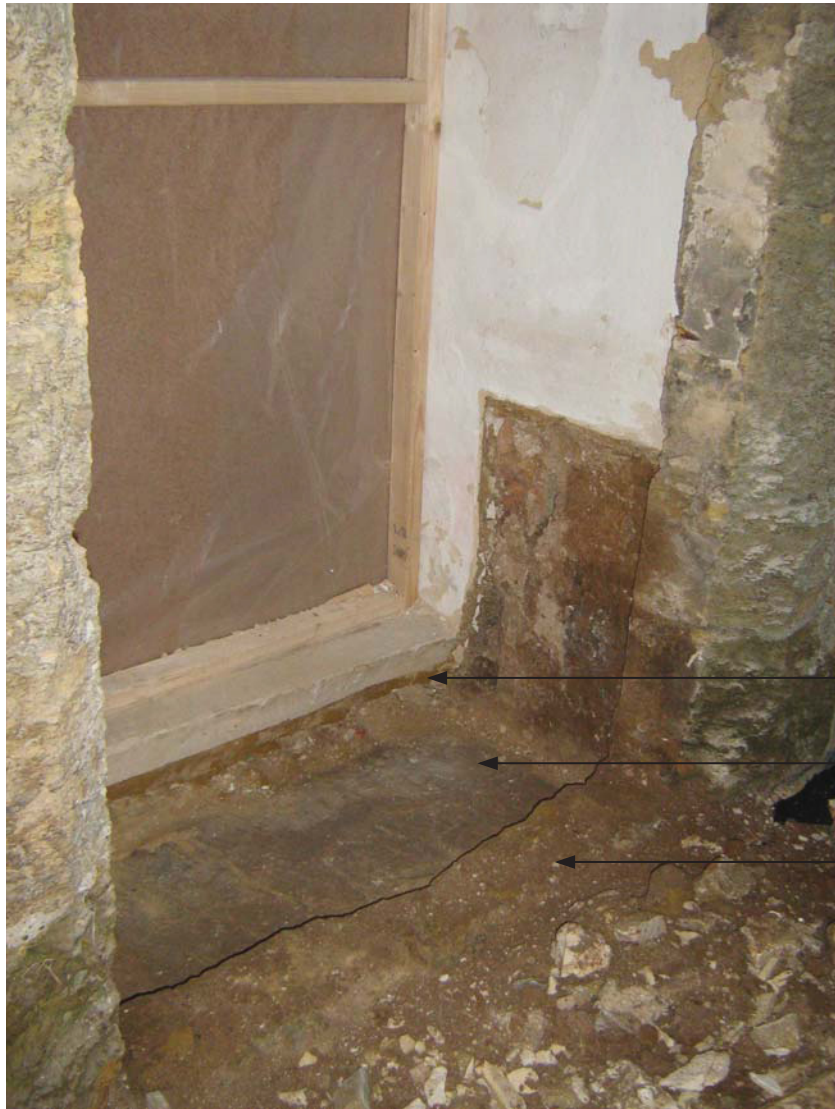
© Archaeology South-East		St Mary Magdalene's Church, Lyminster	Fig. 13
Project Ref: 3432	Nov 2008		
Report Ref: 2008138	Drawn by: MH

Current floor level of tower interior

Flagstone

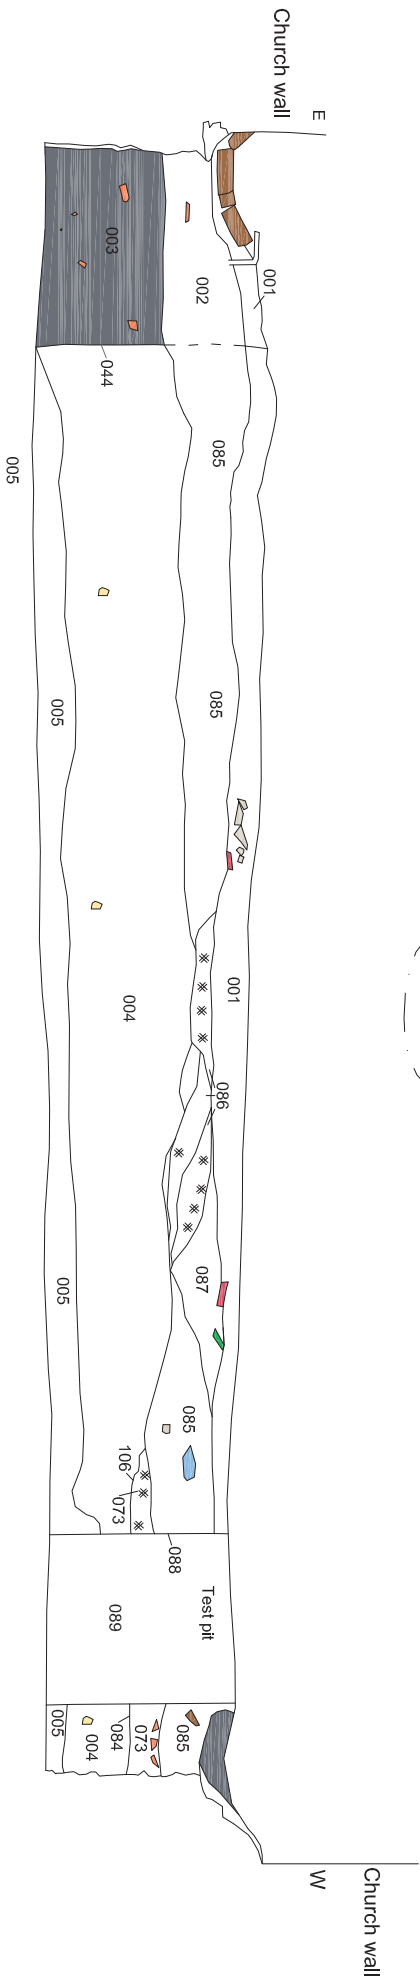
© Archaeology South-East Project Ref: 3432 Report Ref: 2008138	St Mary Magdalene's Lyminster Curved North Facing Section of Footing Trench	Feb 2009 Drawn by: HLF
		Fig. 14

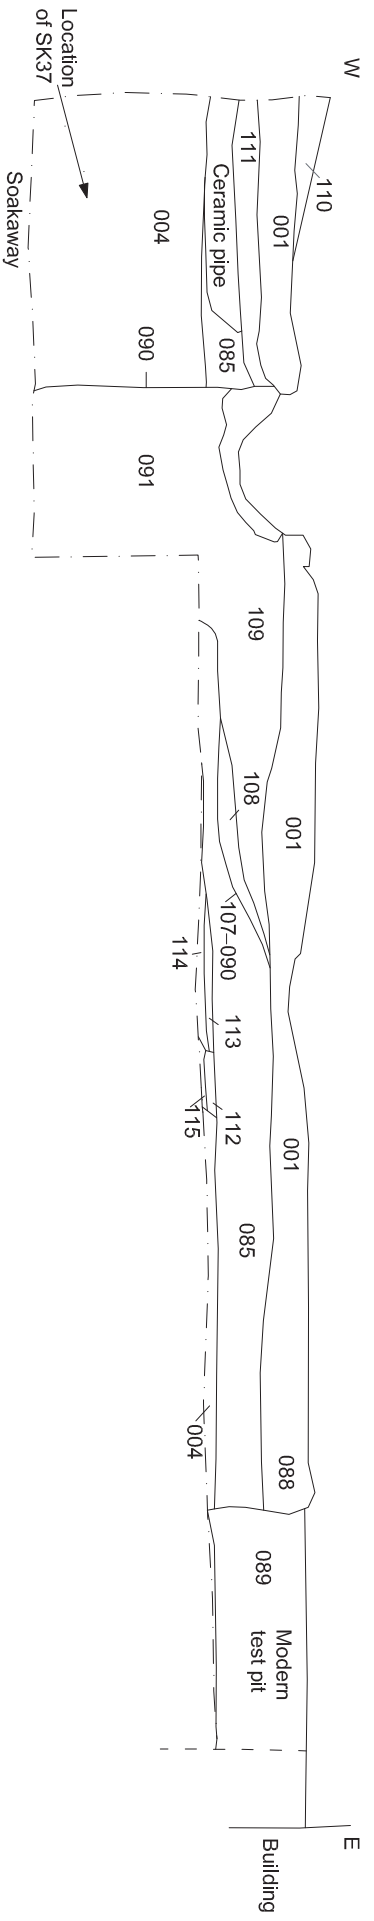
© Archaeology South-East		St Mary Magdalene's, Lymminster	Fig. 15
Project Ref: 3432	Feb 2009	South Facing Section of Drain Run to Soakaway	
Report Ref: 2008138	Drawn by: HLF

- 4.5.1 Cut into deposit [085] was a roughly c. 1.50m deep rectangular-shaped 20th century soak-away [090] with steep, near-vertical sides measuring 2.20m east to west and approximately 1.50m north to south. The eastern construction cut of this was backfilled with a clay deposit and wire meshing of 0.05m thickness [108] and was sealed by a yellowish brown silty sand deposit [109] of 0.30m thickness. The backfill of the main part of the soak away was loose rubble containing 20th century rubbish deposit [091].
