An Enhanced Archaeological Watching Brief at St. John the Baptist Church, Southover High Street, Southover, Lewes, East Sussex

Planning Reference: LW/07/1339

Project No: 3587 Site Code: SJB 08 Report No: 2009017 OASIS ID: archaeol6-56419

May 2009

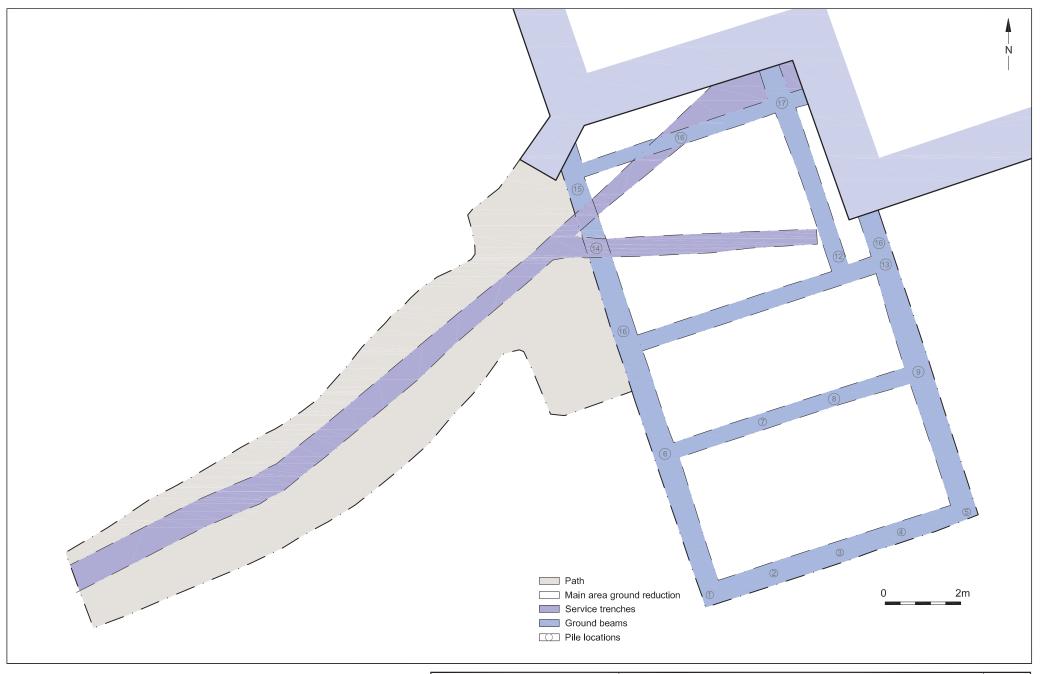
© Archaeology South-East		St John the Baptist Church, Southover, Lewes	Fig. 3
Project Ref. 3587	May 2009	Manitanad Craundurado	1 19. 5
Report Ref: 2009017	Drawn by: HLF	Monitored Groundworks

The surface of the main area footprint for the proposed new build lay between 11.18m AOD in the south and 11.68m AOD in the north (by the tower). The formation level required for the construction of the new build was 10.47m AOD requiring a ground reduction of almost one meter. During these works abundant disarticulated human bones were recovered and bagged for re-interment. At this stage a couple of possible grave outlines were observed and planned so that the location of piles could be considered.

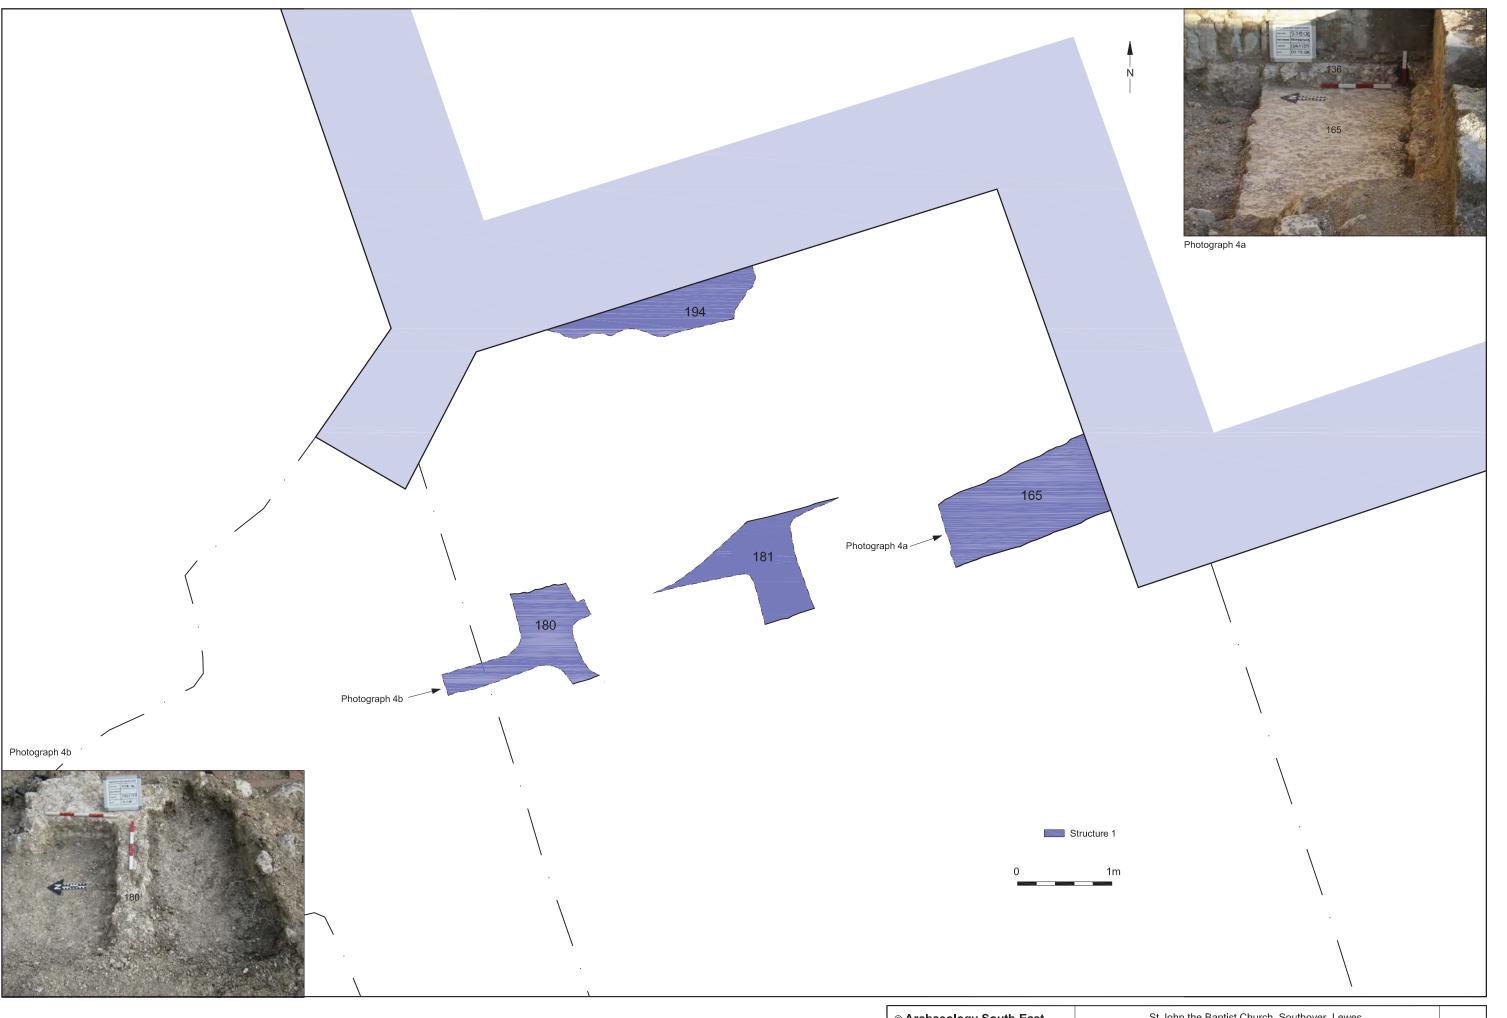
© Archaeology South-East		St John the Baptist Church, Southover, Lewes	Fig. 4
Project Ref. 3587	May 2009	Phase 1	119.4
Report Ref: 2009017	Drawn by: HLF

Structure 1 was a substantial foundation on an east-west alignment, measuring nearly 1.0m in width, comprising laminated deposits of rammed chalk. The full depth of the foundation was not revealed during these ground works. When the initial layer [136] was uncovered by the South Aisle, it was thought to be a rammed chalk surface or floor, particularly due to its location within the east-west and north-south walls of Structure 2 (see 4.3). Cleaning of this potential floor surface revealed that the foundation was constructed in distinct layers or 'lifts' (e.g. [136] peeled off onto [165] – see photograph 4a on Figure 4). Further excavation and cleaning to the west revealed more of the rammed chalk foundations (individually numbered [165], [181] and [180] during excavation) which had been heavily truncated by a series of c. 18<sup>th</sup> century graves (Burials 13-17) (see photograph 4b on Figure 4). Structure 1 was truncated by Structure 2 and therefore predates, or is at least roughly contemporary, to it.

A further section of masonry [194] (Figure 4), comprising laminated layers of alternating rammed chalk and flints was observed along the northern edge of the site and had been clearly truncated by the construction of the tower in 1714. Due to the location of these remains and the incorporation of flint, which differs to the other rammed chalk uncovered at the site, it is worth considering the possibility that the remains uncovered within the ground-beam trench may in fact have been part of the original steeple foundations before it collapsed in 1698. Since only a small portion of this masonry survives, it is difficult to fully understand its original function and its association to other masonry uncovered at the site.

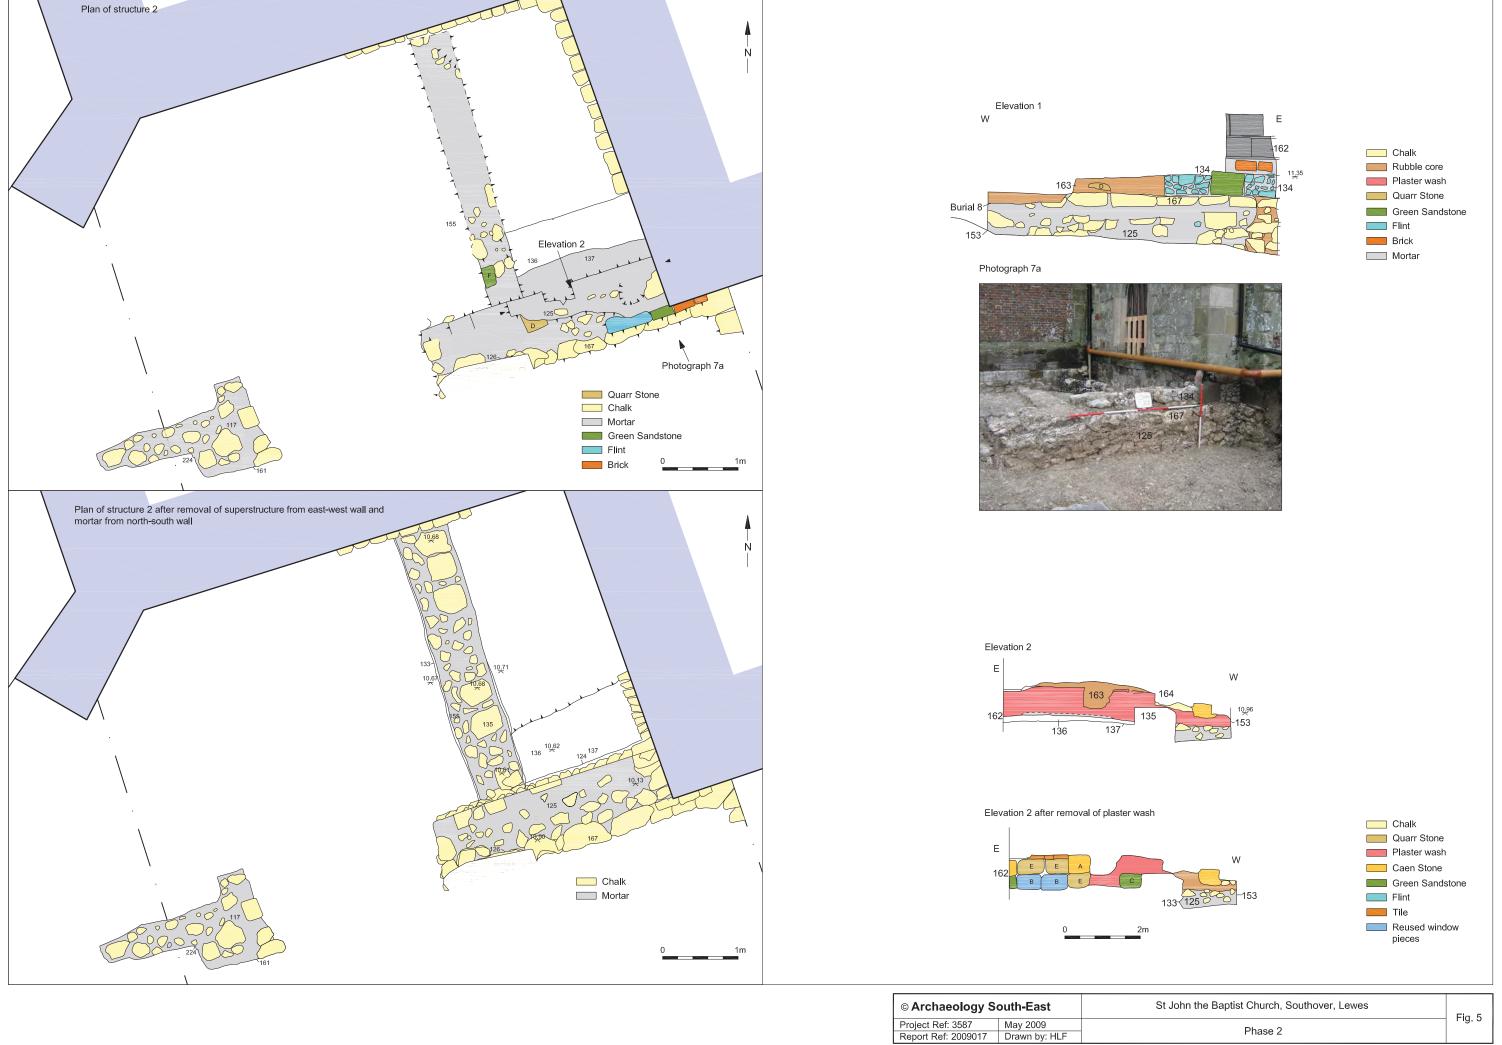
© Archaeology South-East		St John the Baptist Church, Southover, Lewes	Fig. 5	
Project Ref: 3587 May 2009	9	Phone 2		
Report Ref: 2009017 Drawn by	/: HLF	Phase 2

The westernmost end of the east-west wall was initially uncovered during the reduction of the main area to the required formation level (at 10.47m AOD) revealing only the chalk rubble foundations [117] (same as [125]). This part of the wall was also observed during the initial watching brief in TP7. The eastern stretch of this E-W wall was revealed underlying large stone slabs located under the door to the South Aisle of the church (Figure 8). This part was uncovered during the excavation of Burial 8, which truncated the chalk foundations. The E-W wall of Structure 2 (measuring 0.8m wide) was constructed on a foundation of roughly hewn chalk blocks [167] (one course at top of foundations/base of superstructure on external face) and mixed

The north-south orientated wall [135] (the internal return of Structure 2) comprised only chalk rubble foundations bonded with a very hard yellow sandy mortar. This compacted mortar made the excavation of the wall extremely difficult. Figure 5 illustrates the wall after the removal of some of this mortar, which was required to reduce the foundations to formation level. A re-used moulded piece of Eastbourne Greensand (marked 'F' on Figure 5) with chamfer and hollow was uncovered at the southern end of this wall, where it butts up against the E-W orientated external wall. Five large roughly-hewn sub-square chalk blocks, measuring approximately  $0.30m^2 - 0.40m^2$  were revealed during reduction of the foundations. No superstructure survives for this wall.

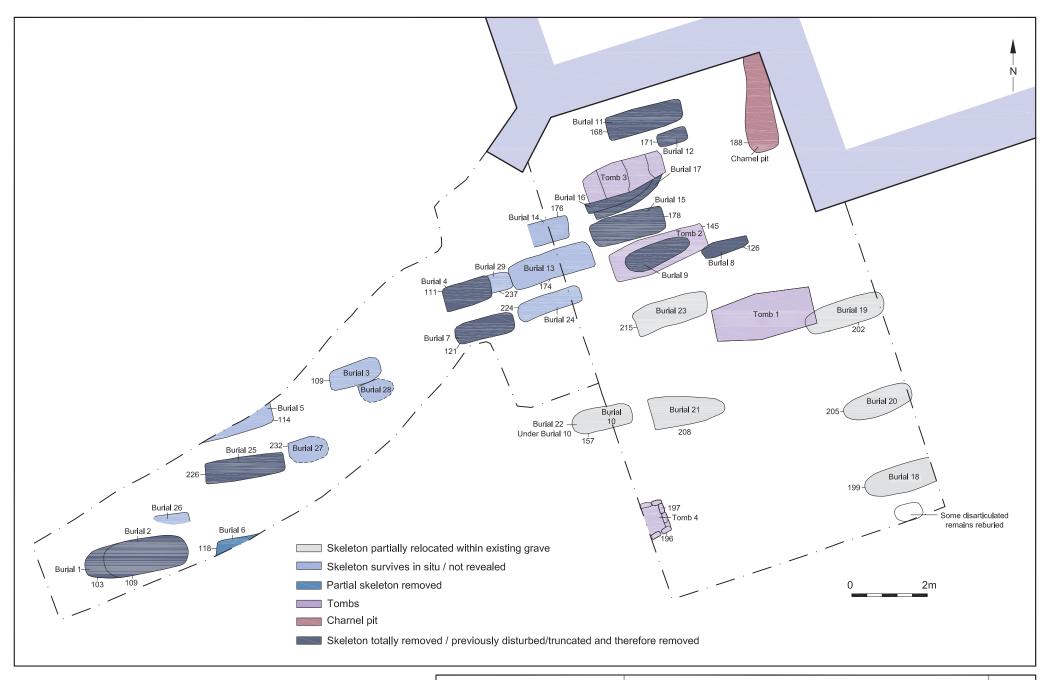
© Archaeology South-East		St John the Baptist Church, Southover, Lewes	Fig.6
Project Ref: 3587	May 2009	Phase 3	1 19.0
Report Ref: 2009017	Drawn by: HLF

Burials 25-28 (and Burials 7, 13 and 24) were revealed during the excavation of the drainage trench along the path (Figure 6). However, only the skeleton (an older adult male) in Burial 25 was directly impacted by the trench and therefore, required full-excavation. Although the grave cuts and backfill for the other burials were observed in the trench sections (and were therefore recorded), since they were not impacted by the works, the burials could be preserved *in situ*.

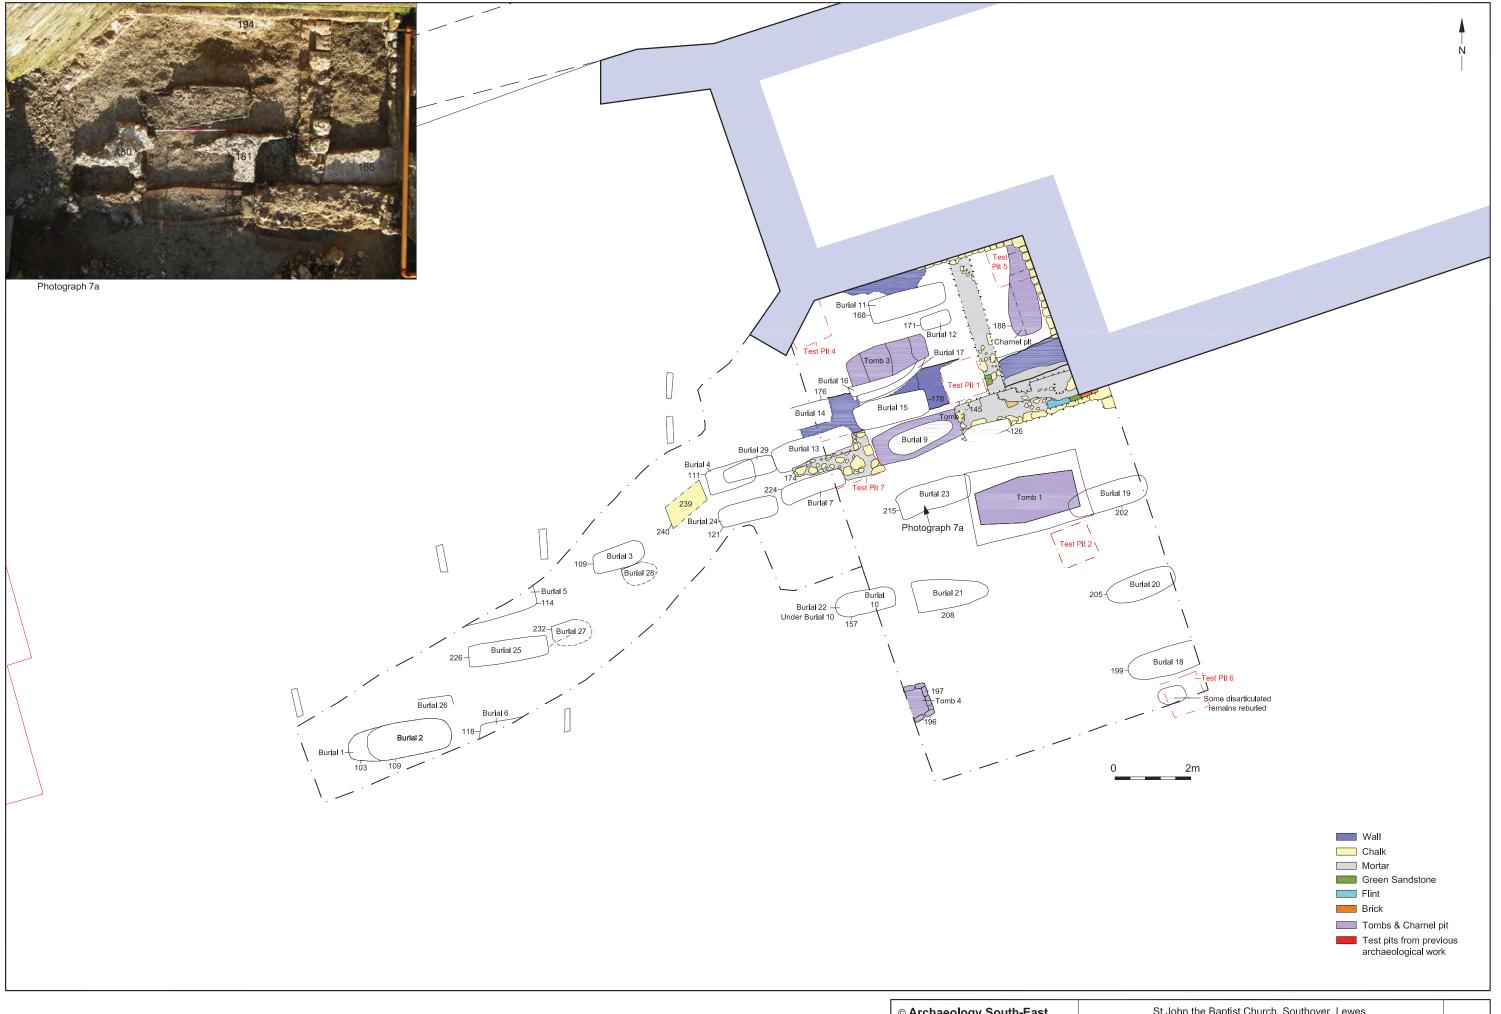
© Archaeology South-East		St John the Baptist Church, Southover, Lewes	Fig. 7	ı
Project Ref: 3587	May 2009	Multi phased plan	i ig. i	
Report Ref: 2009017	Drawn by: HLF	Multi-phased plan		ı

During the excavation of the service trench for the drainage along the path (Figure 7), a possible segment of wall foundations [239] (construction cut 240) was uncovered at a depth of c.9.70m AOD. Its alignment with the western end of [117] suggests that it may have been a north-south return. The foundations comprised chalk rubble with flints and measured approximately 1m in width and extended to the limit of excavation 8.35m AOD. The limits and depth of the trench made it difficult to investigate the relationship between [117] and this wall segment, which had also been truncated by [121] (Burial 7). It is also possible that this wall is a return of Structure 1, which has been almost entirely truncated by burials at this end.

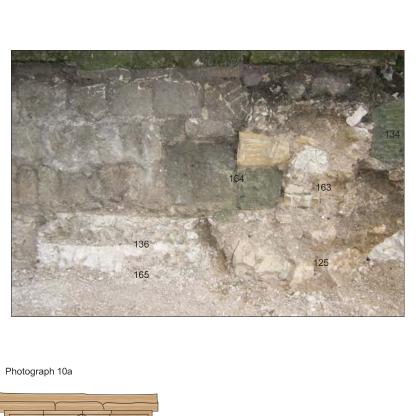
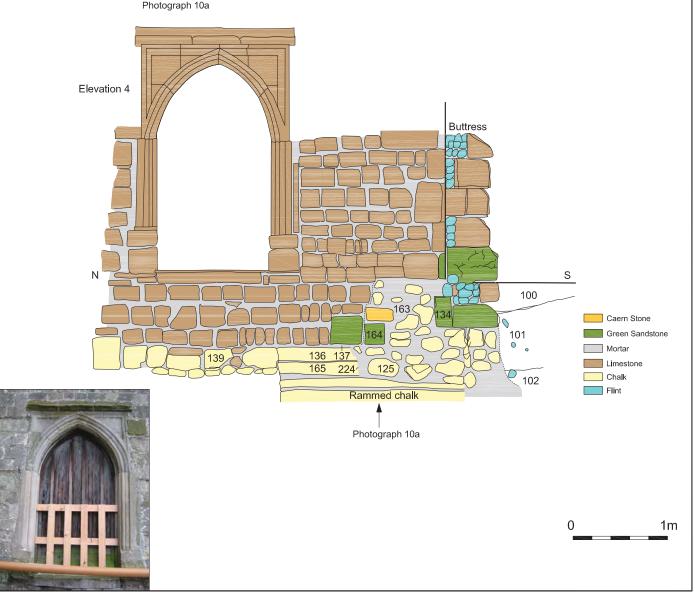
© Archaeology South-East		St John the Baptist Church, Southover, Lewes	Fig. 8
Project Ref: 3587	May 2009	Floyation of South Aisla	1 19.0
Report Ref: 2009017	Drawn by: HLF	Elevation of South Aisle

- 3.1.4 The final visit to site on 22<sup>nd</sup> April 2009 was undertaken to monitor the alterations made to the doorway of the South Aisle, which were necessary to accommodate the new doorway into the church from the new build. The works comprised the removal of the internal steps and the removal of stones within the foundations below the actual door. The archway surrounding the door was not affected by these works. The arch is being incorporated into the new building. The steps were removed so that the finished floor level within the new building is level with the existing floor level within the church. Photographs and drawings are stored within the archive for reference to these changes. An elevation of the south aisle wall before these works has been included within this report (Figure 8).

Although Structure 2 cuts through Structure 1, part of the rammed chalk remains under the foundations of Structure 2 (see elevation, Figure 8) which suggests that the later wall has incorporated the earlier foundations during its construction. Datable finds (e.g. CBM, and stone fragments) from the surrounding contexts [138] and [155] suggest that these walls were partially demolished in the late medieval/early post-medieval period (perhaps in the 18<sup>th</sup> century when the church tower was built).

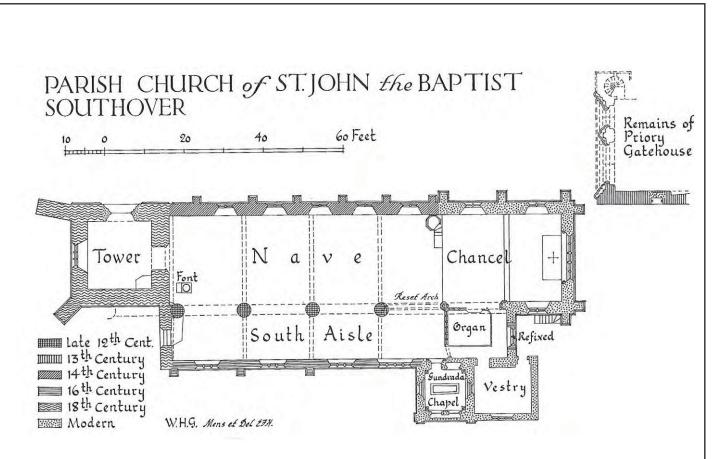
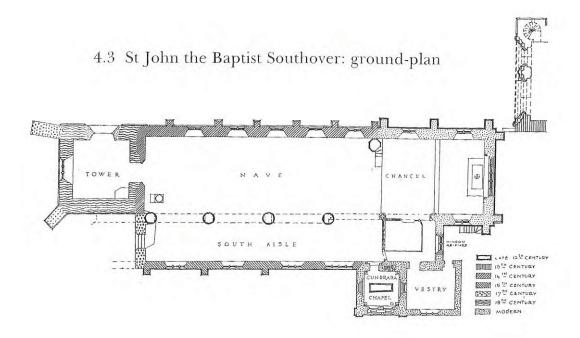
© Archaeology South-East		Southover, Lewes	Fig. 10	l
	Project Ref: 3587	April 2009	Plans of Church	1 1g. 10	l
-	Report Ref: 2009017	Drawn by: HLF

- Figure 10 reproduces two earlier plans of the church: one found in 'The Victorian History of the Counties of England' (Salzman 1973: 49) and the other in Brent's 'Pre-Georgian Lewes' (Brent 2004: 97). Both plans show the position of surviving late 12<sup>th</sup> century pillars and arches in forming an east to west arcade currently dividing the nave from the south aisle. It is suggested that this arcade originally continued westwards from the west wall of the south aisle, as indicated by the continuation of the dashed line on both plans. It is worth considering the possibility that masonry [194] may represent a surviving section of these foundations. However, it is also possible that this masonry represents the steeple foundations.

- 6.4 The later plan (Brent 2004) shows an additional, parallel wall foundation, extending westwards from the southern wall of the south aisle. The position of this wall appears to correspond to the location of the east-west phase 2 structure. Based on the evidence of reused architectural and CBM fragments within the later Phase 2 east-west wall, in addition to the medieval date of the
