**A POST-EXCAVATION ASSESSMENT REPORT AND
UPDATED PROJECT DESIGN
ON ARCHAEOLOGICAL EXCAVATIONS AT
HIGH ST, SNODLAND, KENT**

**Project No. 3243
Site Code: SFS08**

**ASE Report No. 2009050
OASIS ID – archaeol6-57274**

April 2009

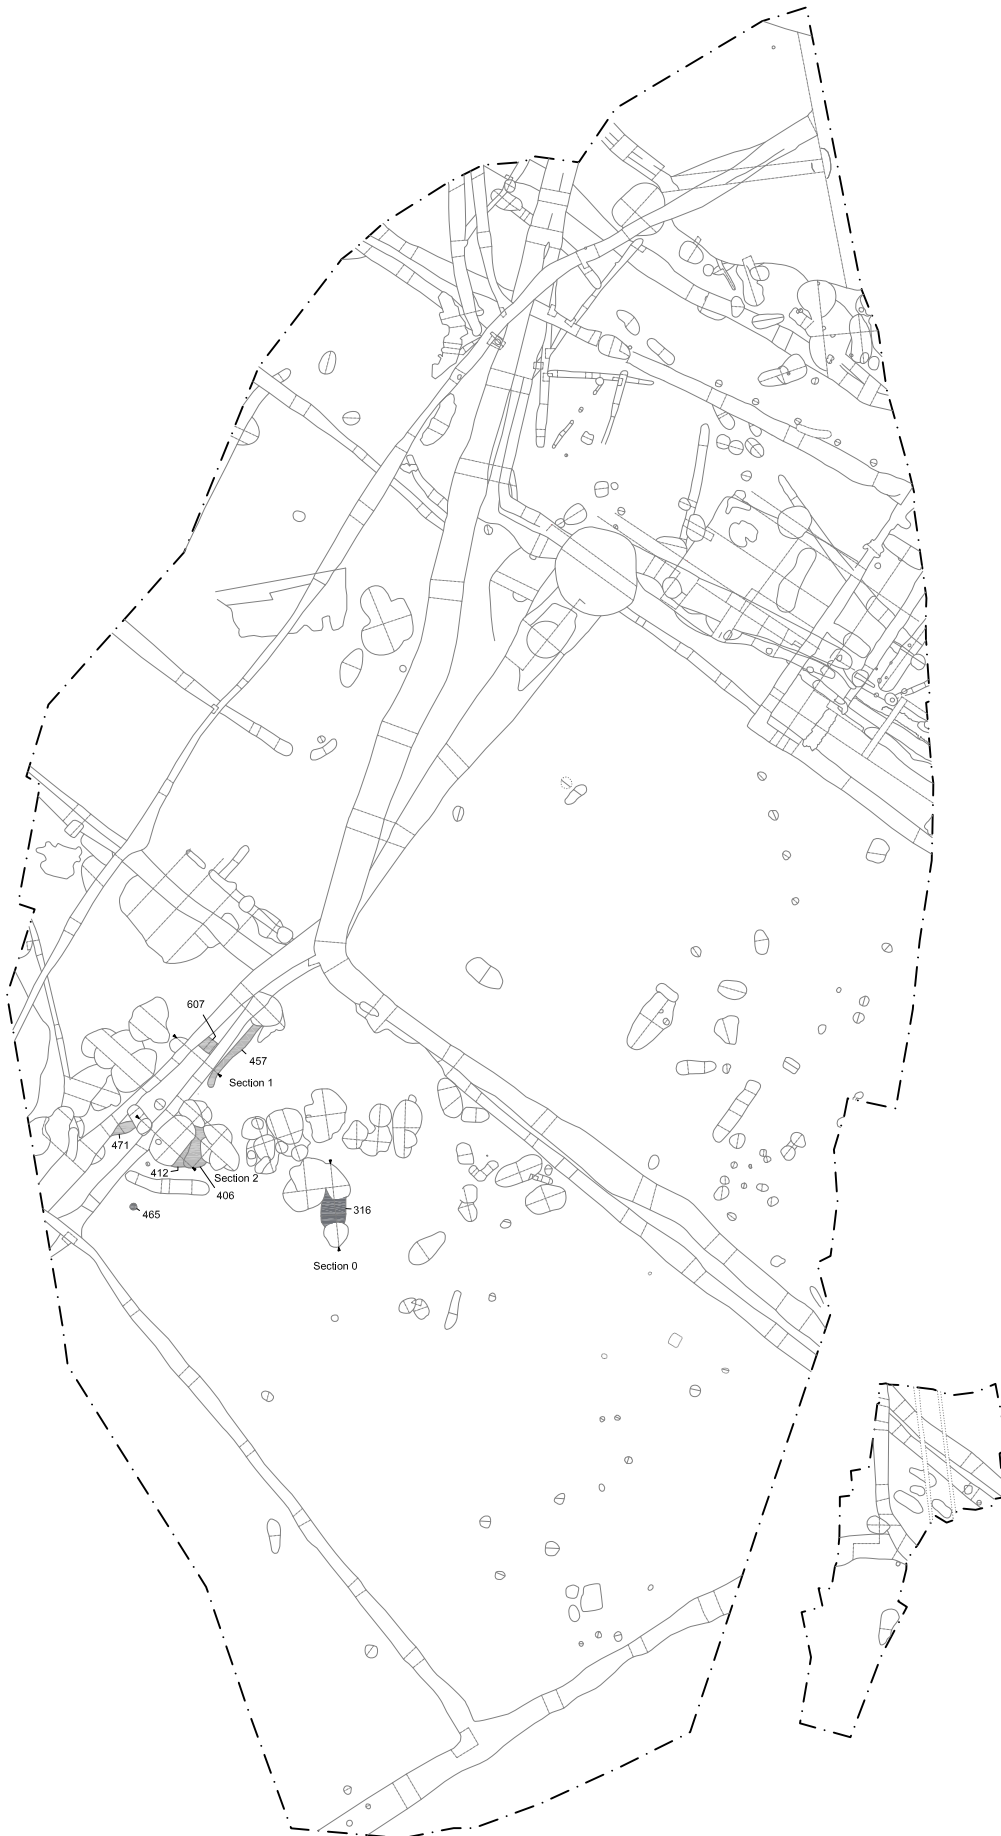
© Archaeology South-East		Snodland	Fig. 2
Project Ref: 3243	April 2009	Site plan	
Report Ref: 2008190	Drawn by: JR

Phase 1 Mesolithic
Phase 2 Early Neolithic

together with at least one free-standing ancillary structure. The main body was the north-west range with the frontage to the south-east. The buildings were multi-phased and elements of a hypocaust and a bath-house were identified (Fig 2).

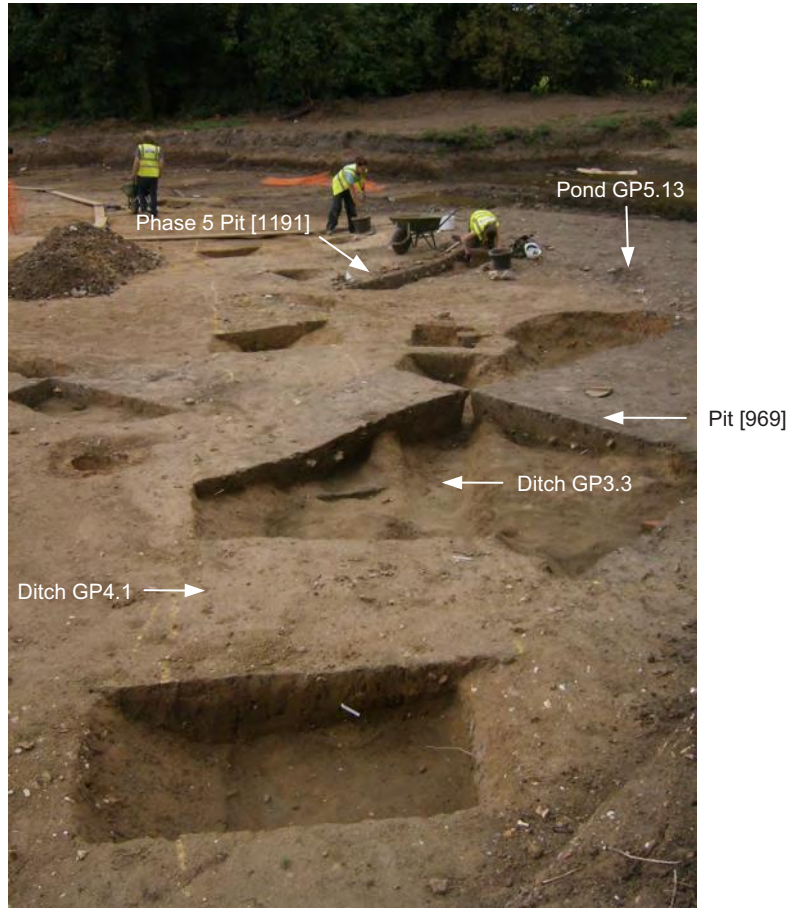
© Archaeology South-East		Snodland	Fig. 7
Project Ref: 3243	April 2009	Phase 3 droveway ditch GP3.3 and later features facing north-west	
Report Ref: 2008190	Drawn by: JLR

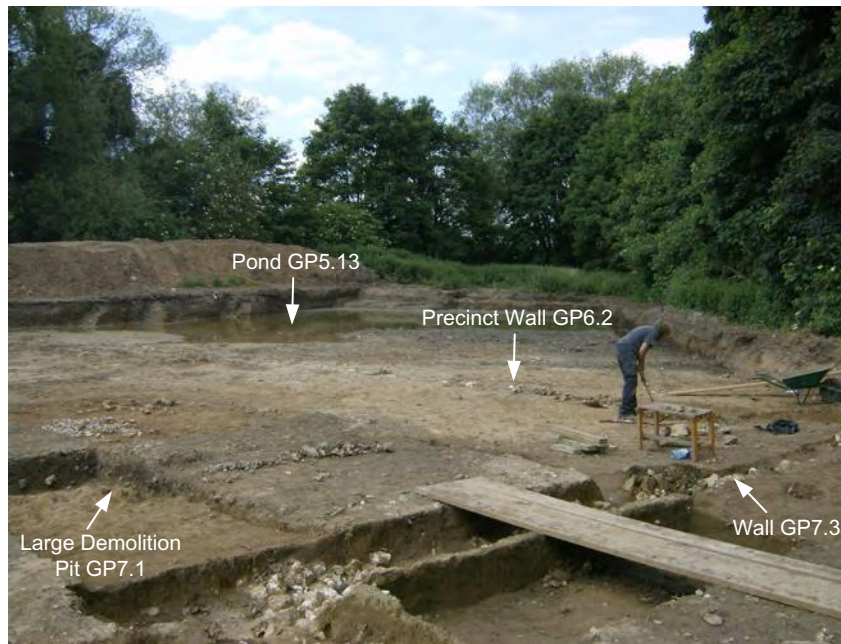
Fig. 14: Phase 5 Pond GP5.13, Large Demolition Pit GP7.1 and Wall GP7.3, facing north-west

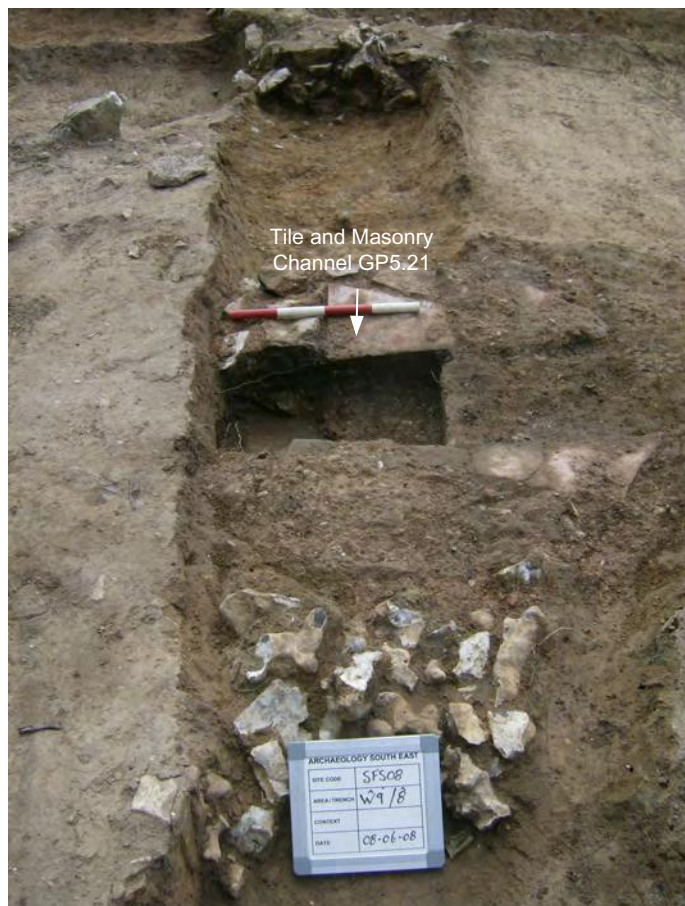
Fig. 15: Phase 5 Wall GP5.3 and Phase 7 Tile and Masonry Channel GP5.21, facing south

- 4.7.7 A short portion of wall (GP5.3) survived *in situ* and included a contemporary tile and masonry hypocaust flue (GP5.21), 3m long, 0.5m wide and aligned north-west to south-east. The hypocaust flue vented hot air from under the floor of the room to the east to wall (GP5.21), where the hot air was vented upwards within, a now missing, box flue built into the wall. The east end of the flue had been truncated by the digging of later robbing trenches in Phase 7.

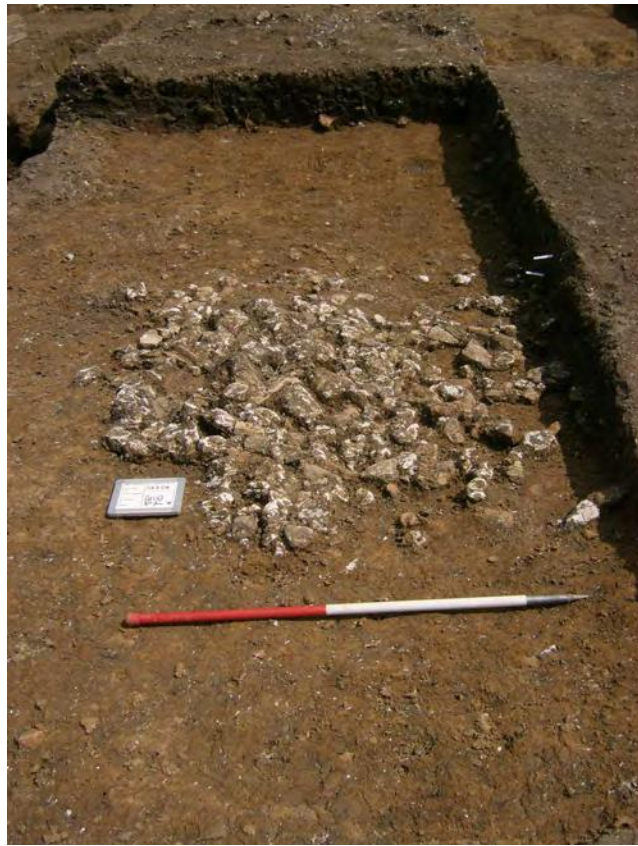
Fig. 16: Phase 5 Rammed Chalk Precinct Floor [813] and Large Demolition Pit GP7.1, facing east

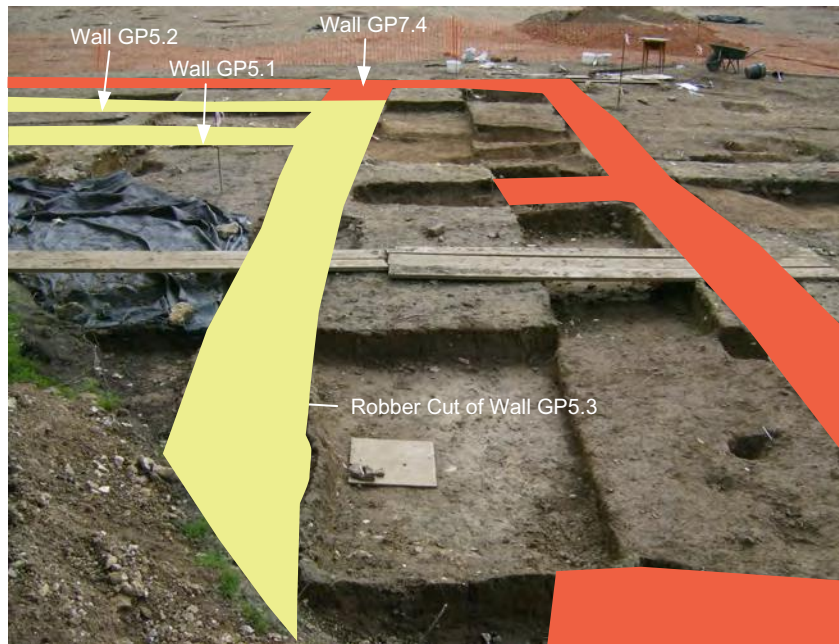
Fig. 18: Phase 5 Detail of Phase 5 and 7 Buildings facing south-west

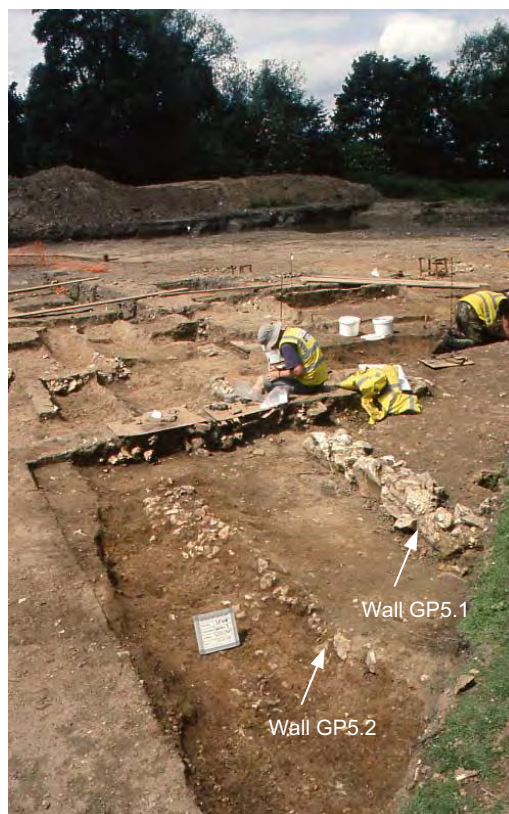
Fig. 19: Phase 5 Walls GP5.1 and GP5.2 under excavation, facing west. Note the difference between *in situ* masonry of Wall GP5.1 and the robbed fill of Wall GP5.2

4.7.5 Parallel to wall (GP5.2) was an internal wall (GP5.1), forming a corridor approximately 1m wide. The foundation of this wall survived largely intact and was at least 6m long and 0.8m wide. The wall was trench-built with the base founded on a stiff clay layer [620 & 1022] containing finds of 1st century CBM and a large mortarium sherd dating to AD40-140. The wall foundation was constructed of unmortared and uncoursed ragstone blocks with a central rubble core of large flint cobbles and chalk blocks. These blocks were all unfaced.

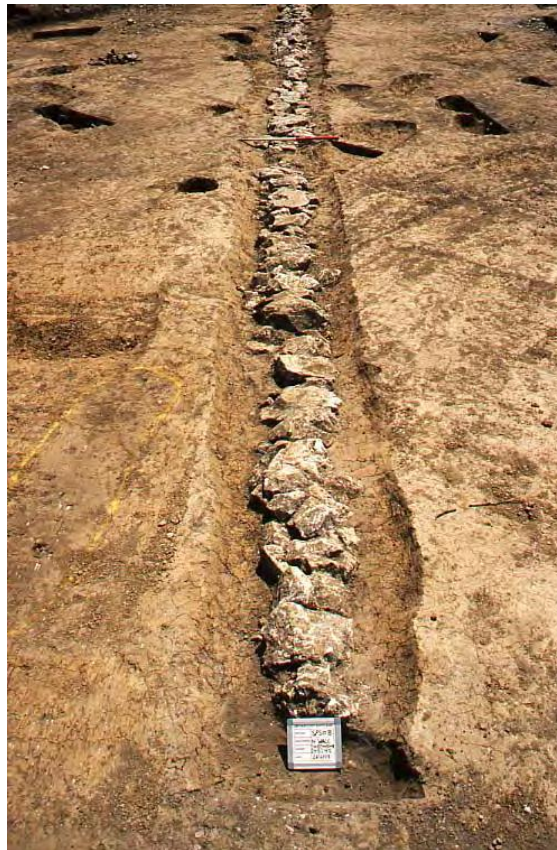
Fig. 24: Phase 6 Enclosure North Wall GP6.2 facing west

4.8.3 Immediately west of the bath-house was an area enclosed by a wall to the north and ditches elsewhere. North enclosure wall (GP6.2) was aligned north-west to south-east and was at least 20m long and 1m wide. It was largely unaffected by robbing and the foundations survived as uncoursed and unmortared chalk blocks [816], up to 0.4m in length with occasional fragments of CBM and flint. The construction cut backfill [815] contained finds of pottery dating to AD120-200.

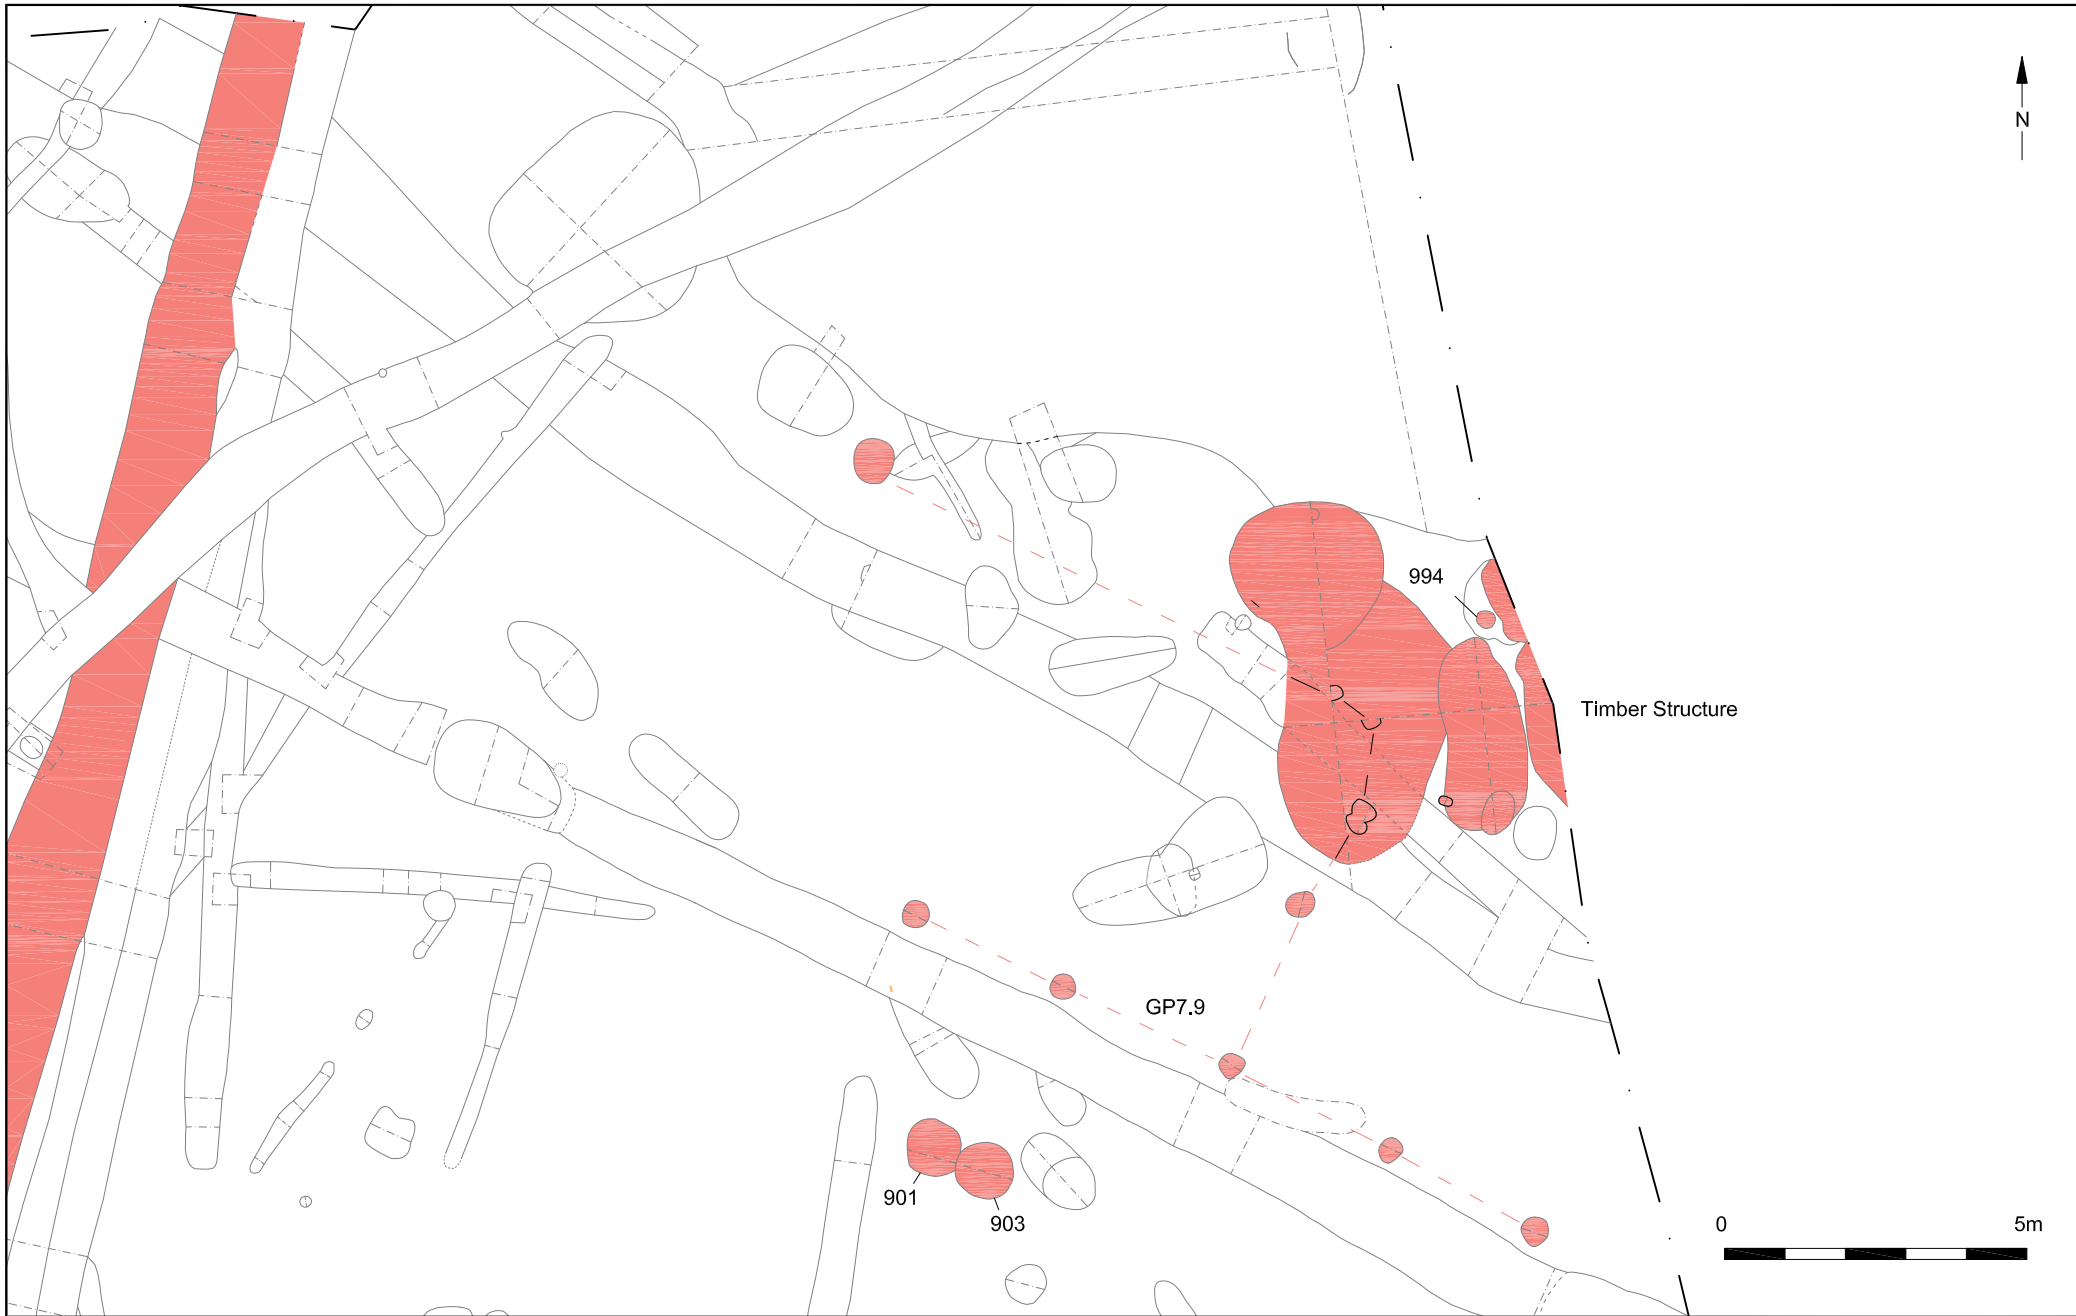
© Archaeology South-East		Snodland		Fig. 25
Project Ref: 3243	April 2009	Phase 7 Plan: Mid/Late 3rd Century AD to Mid/Late 4th Century AD		
Report Ref: 2008190	Drawn by: JR

4.9 Phase 7: Mid/Late 3rd Century to Mid/Late 4th Century (Figs 25 - 32)

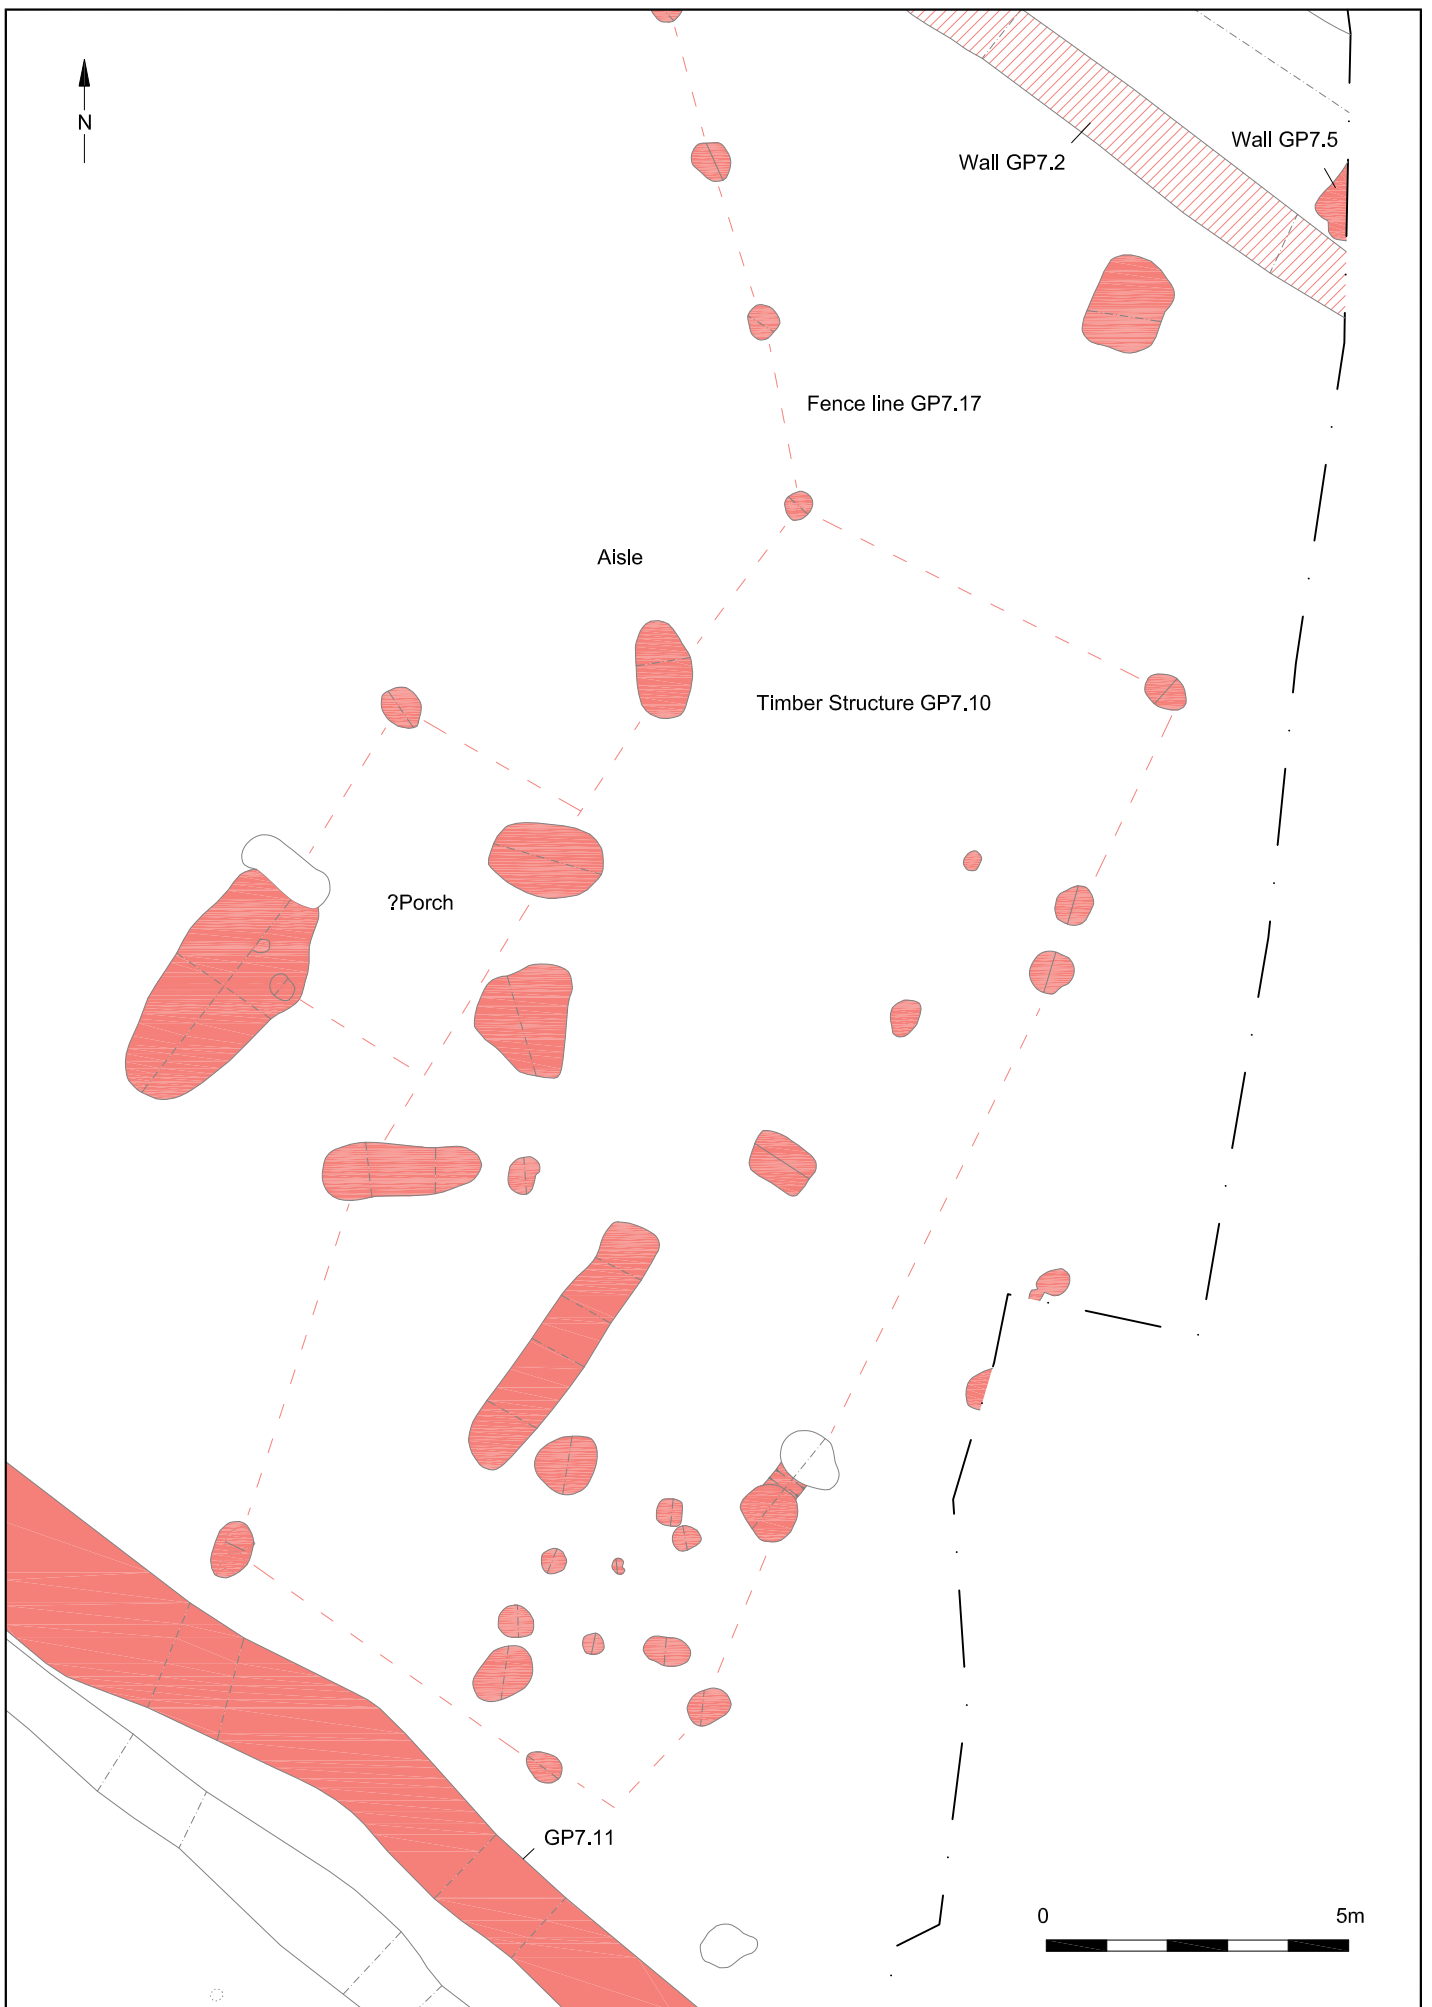
© Archaeology South-East		Snodland		Fig. 28
Project Ref: 3243	April 2009	Phase 7 Plan: Timber Structure GP7.10		
Report Ref: 2008190	Drawn by: JR

- 4.9.14 South-west of the masonry building was a second rectangular timber structure, (GP7.10), approximately 19m long by 7.5m wide. The building was aligned north-east to south-west, like the masonry building, and contemporary ditch (GP7.11) respected the south-west end. The building was built with at least 11 earth-fast posts and large chalk block post-pads, one of which [876] had a find of a worn coin dating to AD268-270 beneath the block. The building had a possible porch entrance on the north-west frontage and fence line (GP7.17) appeared to run between the corner of the masonry building and the timber structure.
- 4.9.15 The numerous internal postholes and pits may well relate to the use of the building. Samples of fills [113 & 139] contained burnt building remains and the environmental remains were dominated by wheat grains, and occasional

chaffs and pulses (see 5.3.23) suggesting that this building was in use as an agricultural storage building when it burnt down.

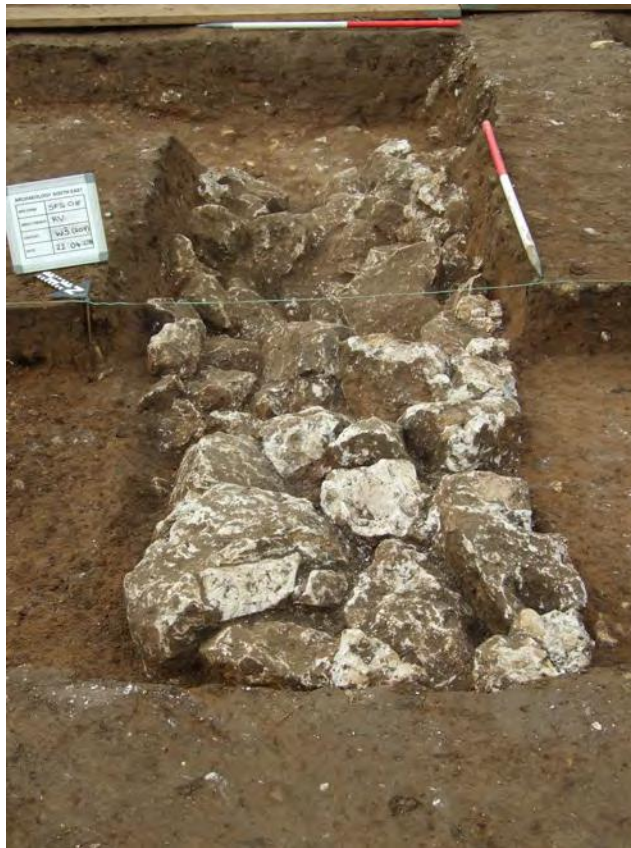
Fig. 30: Phase 7 Detail of Internal Partition Wall GP7.4

- 4.9.9 Four internal masonry wall foundations were identified (GP7.4, GP7.5, GP7.6 & GP7.7). These probably indicate the position of partition walls for internal rooms of the building which may have been set around a central courtyard. As with most other foundations and walls, these were also largely robbed-out. Where masonry did survive, however, it was found to be constructed from chalk and flint cobbles set within a clay matrix.

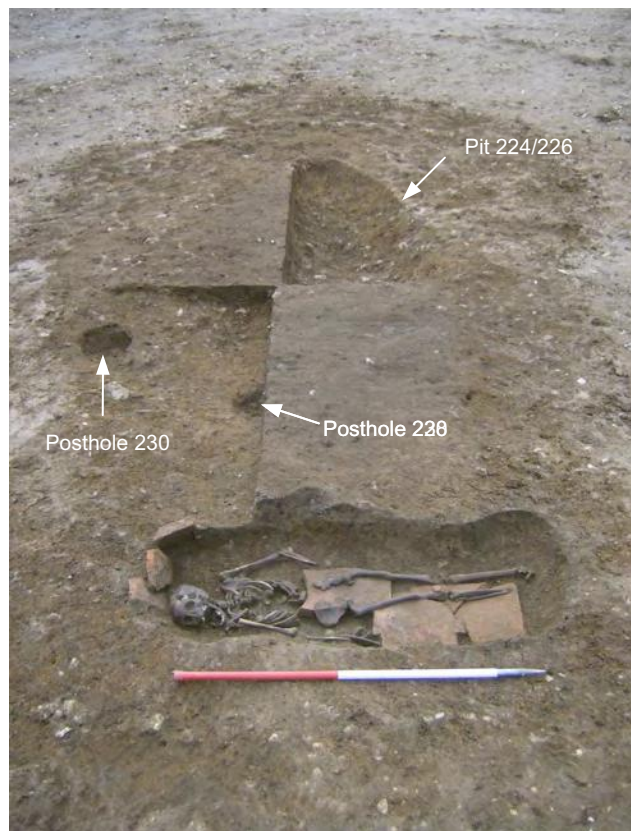
Fig. 31: Phase 7 Pit [224/226] and Postholes [230] and [228] of Timber Building GP7.10, cut by Phase 8 Skeleton [267] facing south-west

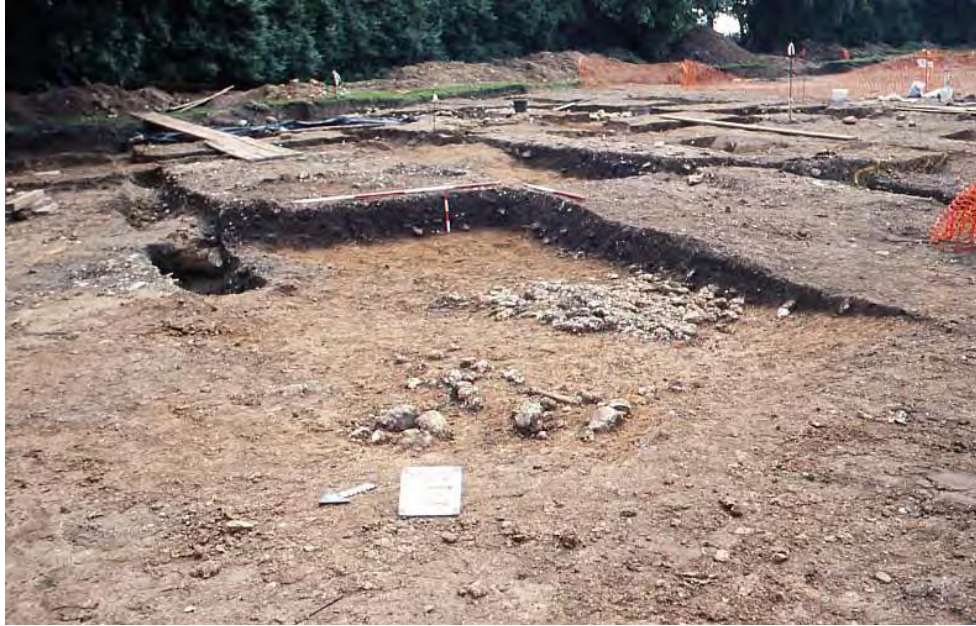
Fig. 32: Phase 7 Demolition Pit GP7.1 facing south-west

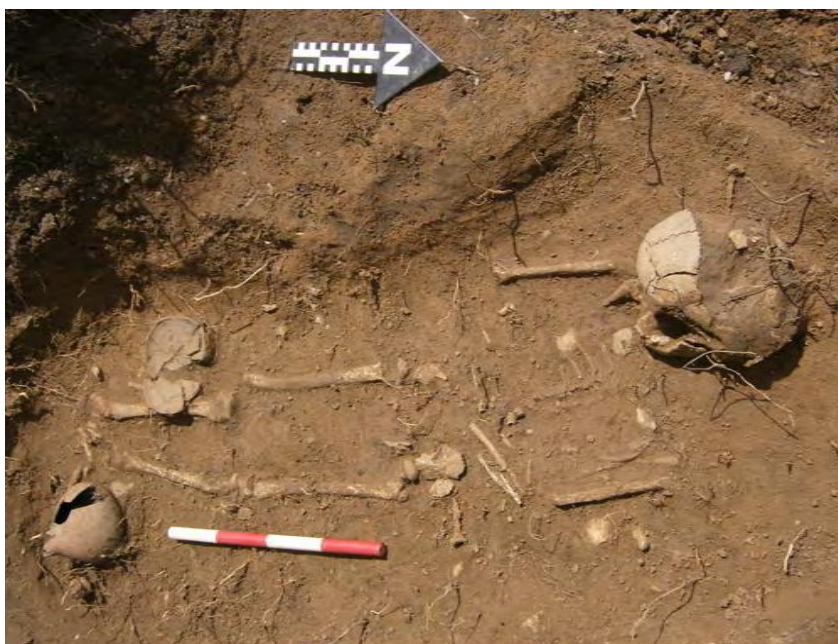
Fig. 37: Phase 8 Skeleton [085] and Accessory Vessels, facing west

4.10.3 The bones of one infant [825] were very fragmentary and were found buried on a *tegulae* tile. Infant [085] appeared to have been interred in a wooden coffin with a pottery accessory vessel dated to AD250-400.

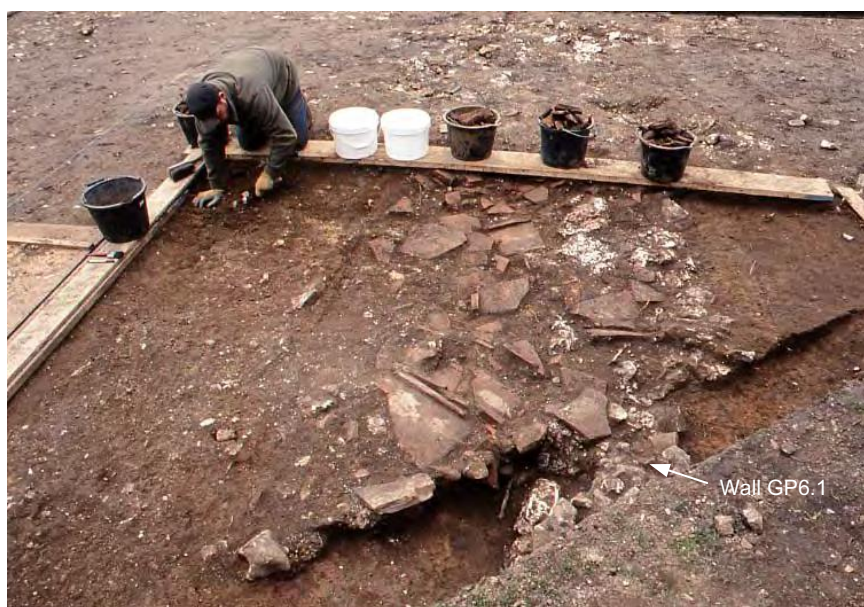
Fig. 38: Phase 8 CBM rich Demolition Dumps under excavation, facing west

- 4.10.9 All the buildings were completely destroyed by the middle of the 4th century and various demolition deposits [007, 017, 283, 602, 618, 725, 305 & 811] sealed the area of the masonry building. Pond [705], well [860], ditches (GP7.11) and (GP7.12) were also filled-in by demolition dumps. The upper fills of the south-east portion of ditch (GP7.11) contained burnt demolition material from the timber building located to the immediate north-east. Demolition deposit [017] contained over 250kg of CBM, a large assemblage of pottery, and a worn coin dating to AD354-361.

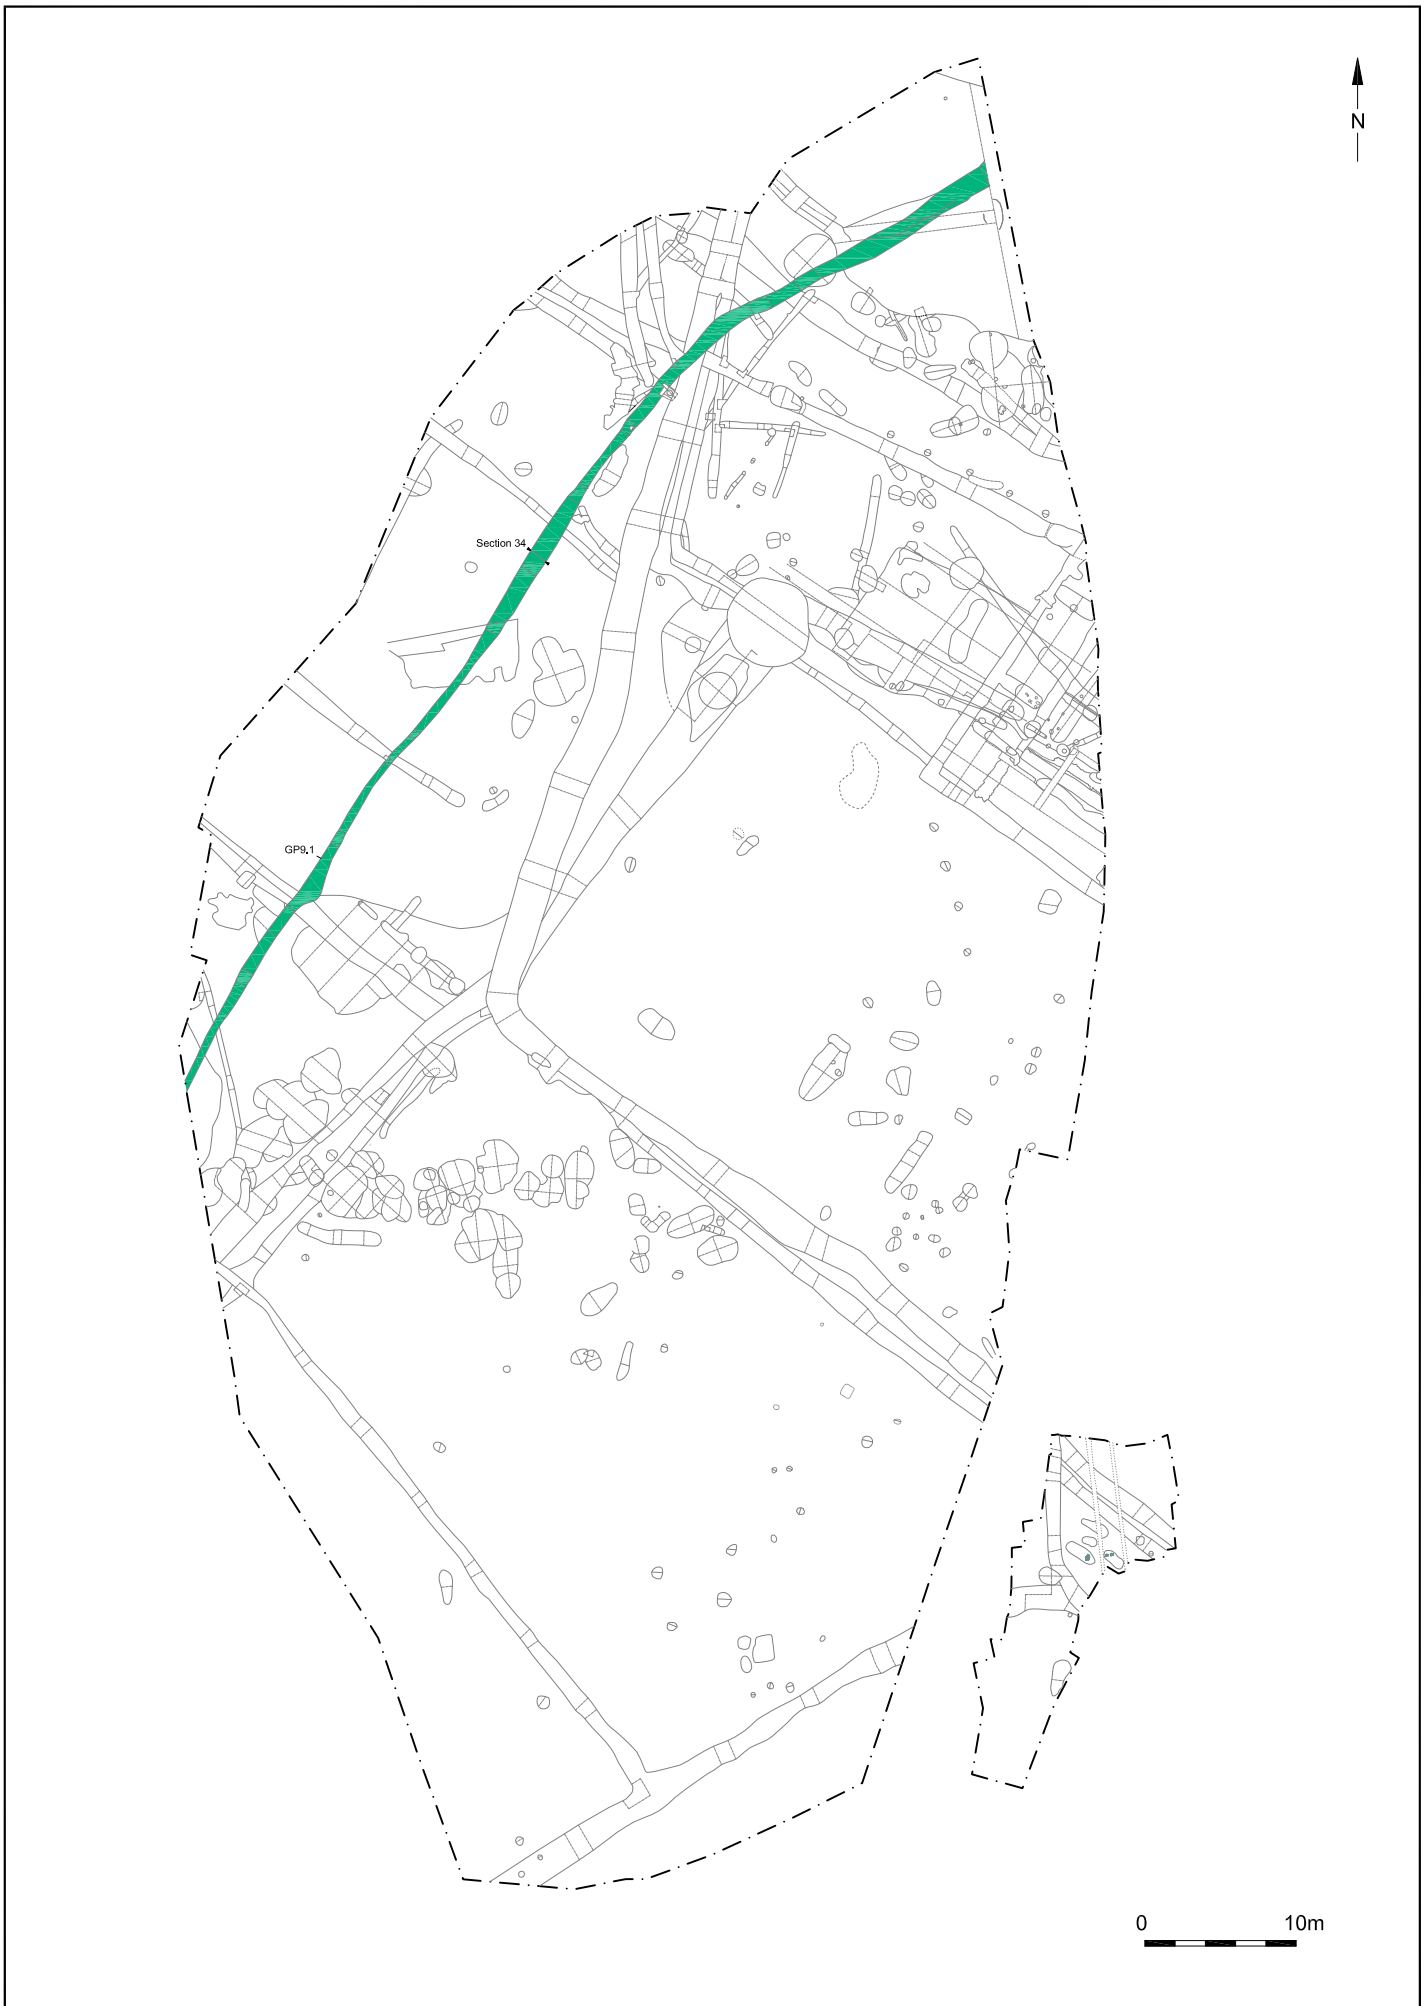
© Archaeology South-East		Snodland	Fig. 39
Project Ref: 3243	April 2009	Phase 9 Plan: Medieval	
Report Ref: 2008190	Drawn by: JR

4.11 Phase 9: Medieval (Figs 39 & 40)
