**AN ARCHAEOLOGICAL WATCHING BRIEF
AT
DEVILS DYKE HILLFORT,
POYNINGS, WEST SUSSEX**

Scheduled Ancient Monument No. 27080

Project No. 2690

**ASE Report No. 2009079
OASIS ID: archaeol6-59741**

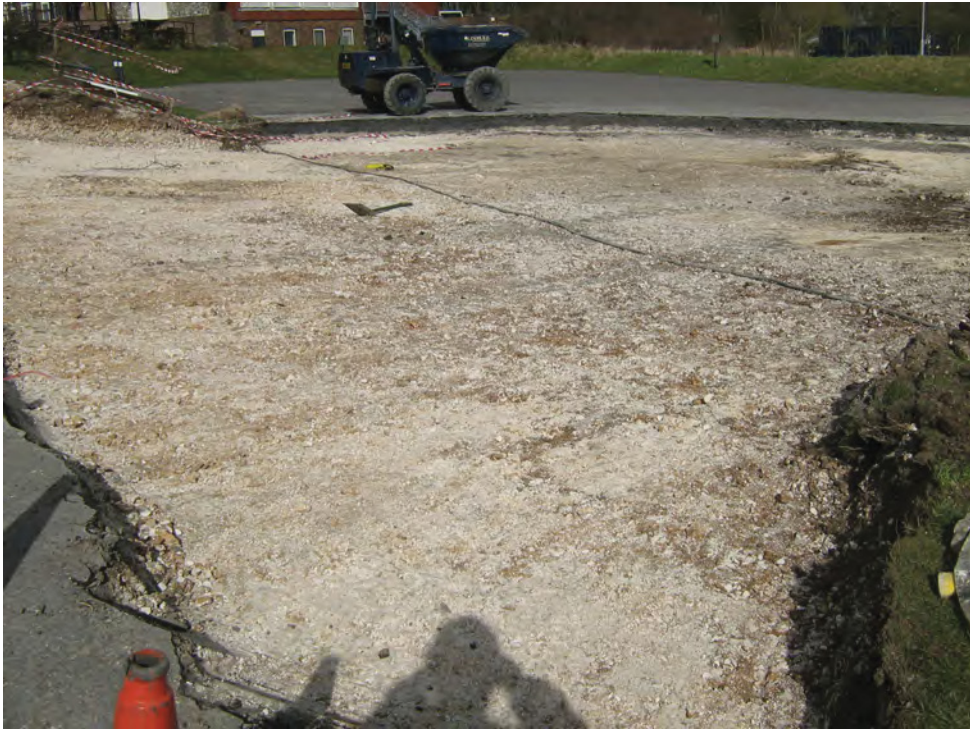
© Archaeology South-East		Devil's Dyke, Hilfort	Fig. 3
Project Ref: 2690	July 2009		
Report Ref: 2009079	Drawn by: JLR

Area 1.1 was situated in the so-called southern car-park and included excavations for a bus turning circle and comprised an approximately semi-

circular area measuring c. 25.50m by 23.40m, up to 0.30m deep (Figs. 2 and 3).

Fig. 3: Area 1.1 under excavation, looking north-east

Natural chalk (004/003) was encountered at a maximum height of c. 211.51m AOD at the far north-western corner of Area 1, where the creation of a grassed bund to the west of the existing carpark had preserved the original natural topography of the site (Fig. 4). Here, the natural chalk (004) was sealed by a horizon of subsoil (011), in turn overlain by a deposit of 20th century made ground (010) that formed the bund itself. A thin layer of topsoil (009) sealed the bund and represents the final landscaping of this modern landscape feature.

The remainder of Area 1.1 showed obvious signs of 19th-20th century levelling. In the western half of the area, ground reduction had resulted in the complete removal of the pre-existing subsoil and topsoil horizons and substantial truncation of the underlying natural chalk to a height of c. 210.35 AOD. In the eastern half of the area, on the other hand, the ground level had been artificially raised to c. 210.38m AOD with the deposition of layers of modern made ground (006) and (007). Here, the pre-existing topsoil horizon (008) survived beneath the sequence of made ground and suggests that the underlying natural topography may also survive here intact. This entire area was sealed with a layer of tarmac and associated makeup (005) for the existing carpark itself.

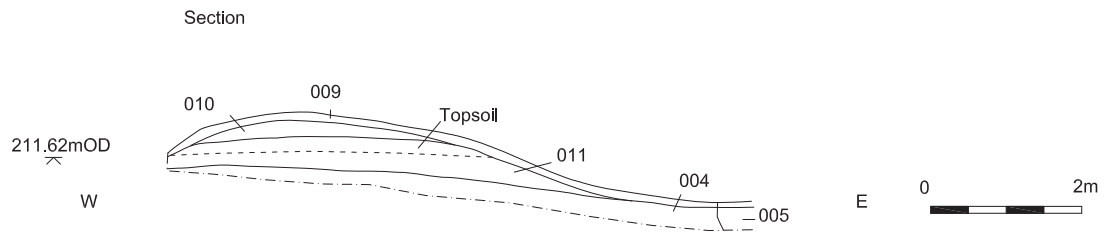
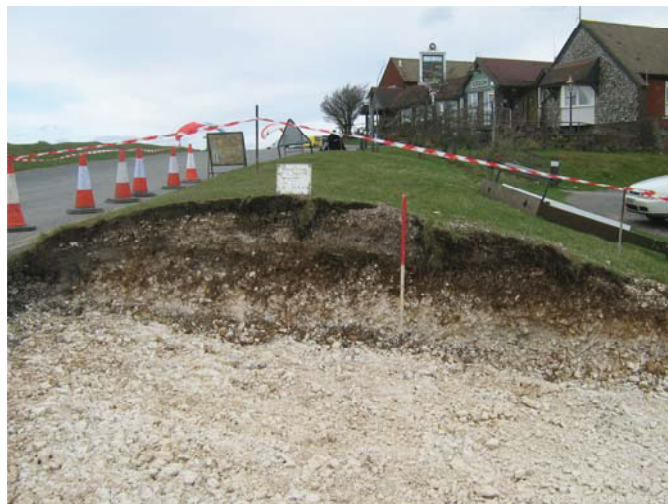
© Archaeology South-East		Devils Dyke, Hillfort	Fig. 4
Project Ref: 2690	May 2009	Plan and Section of Area 1.1	
Report Ref: 2009079	Drawn by: HLF

Section through Area 1.1

- 6.3** Secondly, the one must also consider the deleterious effect exerted on the archaeological resource by previous activity on the site. This is particularly well illustrated in the two larger excavations monitored in the existing southern car park (Area 1.1) and road (Area 1.2), both of which show evidence for removal of subsoil and topsoil horizons and truncation of the underlying natural chalk. The disturbance of the site caused by the construction of the hotel and the various tourist attractions of the 19th century pleasure resort has already been noted (see Section 2.1 above) and it is probable that much of the truncation observed is the result of this activity.

- 6.5** A final point worth noting here is that not all monitored excavations were of sufficient depth to reveal archaeological deposits, notably towards the eastern half of Area 1.1, where the ground-raising deposits observed appear to seal an intact buried topsoil. Here one may surmise that any archaeological features are preserved beneath any such topsoil horizon.

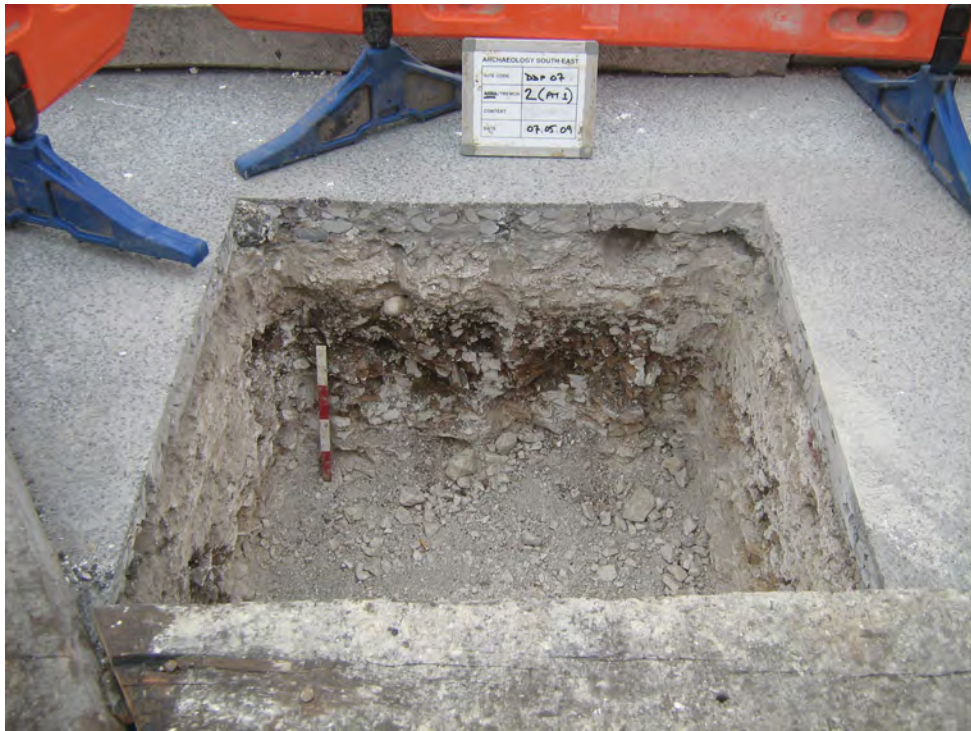
Area 2.1 comprised a small excavation measuring c. 1.00m by 1.00m for the installation of a parking meter (Fig. 5). No height information is available for this area at the time of writing and levels are given below ground level.

Natural chalk geology (018) was encountered 0.60m below ground level. This was sealed by a deposit of chalk rubble in a matrix of dark yellowish brown silty clay (017), in turn sealed by the tarmac and associated makeup of the present carpark (016).

The origin of deposit (017) remains difficult to determine within the confines of the excavation area. No finds were recovered from the deposit and while it is possible that it is archaeological in origin it may represent little more than solifluction or otherwise natural disturbance of the underlying natural chalk.

Fig. 5: North-east facing section, Area 2.1

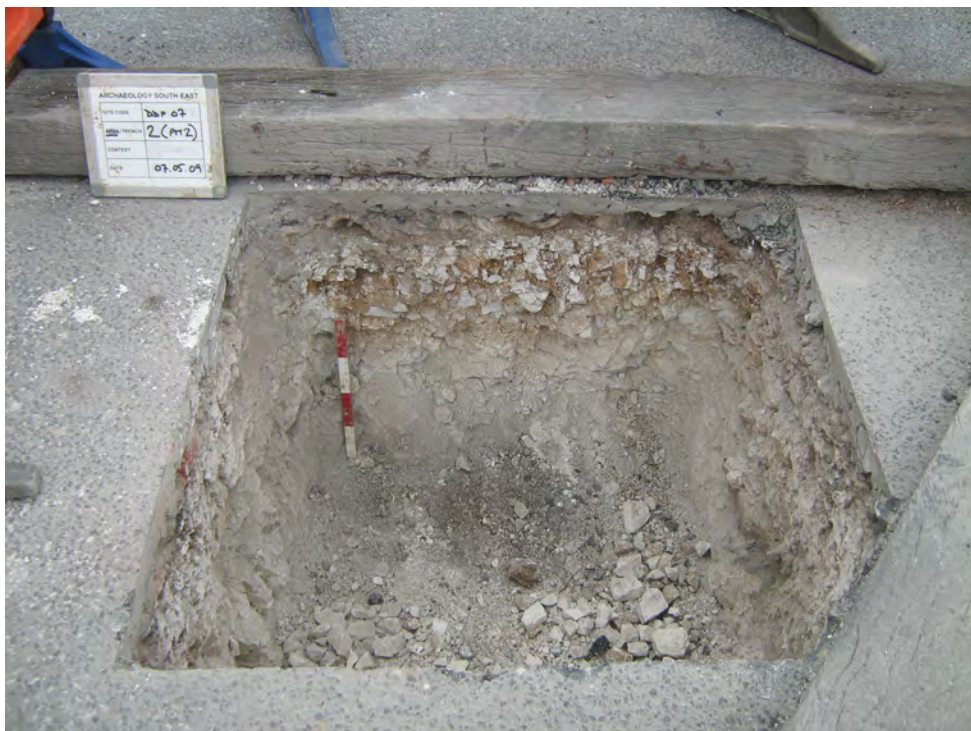
Area 2.1 comprised a small excavation measuring c. 1.00m by 1.00m for the installation of a parking meter (Fig. 6). No height information is available for this area at the time of writing and levels are given below ground level.

Natural chalk geology (021) was encountered 0.34m below ground level. This was sealed by a deposit of chalk rubble in a matrix of light brownish yellow silty clay (020), in turn sealed by the tarmac and associated makeup of the present carpark (016).

As with deposit (017) above, the origin of deposit (020) remains unknown, though it is possible that it represents an area of solifluction or weathering of the underlying natural chalk.

Fig. 6: North-east facing section, Area 2.2
