**An Archaeological Watching Brief at  
Northeast Manor School, Lewes,  
East Sussex**

**Planning ref: LW/09/0259**

**Project No: 3909  
Site Code: NMS 09**

**ASE Report No: 2009088  
OASIS id: archaeol6-59997**

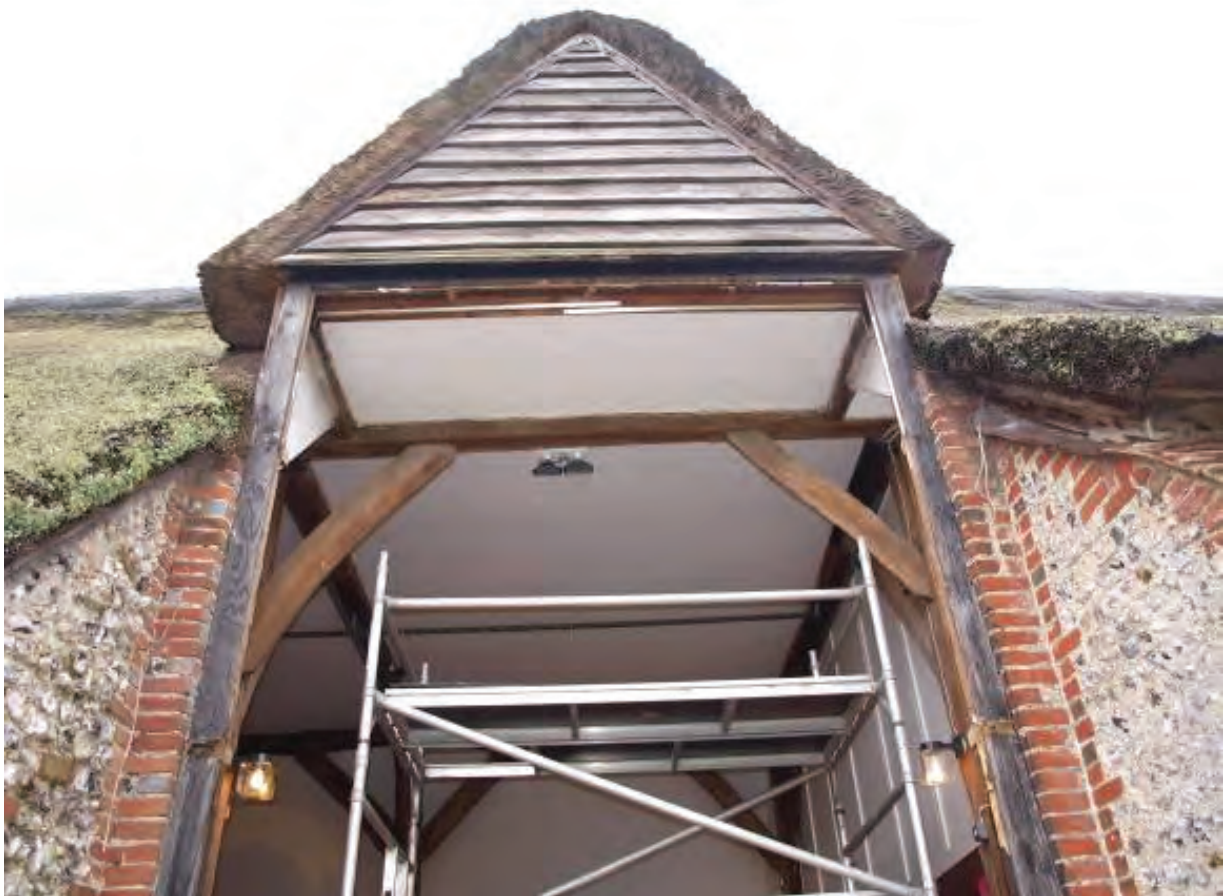
- 4.3.2 The projecting possible former entrance is central to the current full extent of the former barn which is a typical location for a midstrey. The projecting bay has a gabled roof (Figure 3) which is currently under thatch and is weatherboarded to the front from apex to plate. The window was situated below the weatherboarded area, the timber frame of the window extended down from a plate parallel to and at the same height as the *in situ* arcade plate within the barn, to the top of the supporting wall. The wall stood to a height of 590mm from the present interior floor surface. The sides of the window frame directly abutted brick quoins which extended from the base of the gable to the ground level. A clear straight joint was visible between the added buttress to the northwest and the quoins of the former opening.

Figure 3: Detail of the top of the opening after the removal of the window.

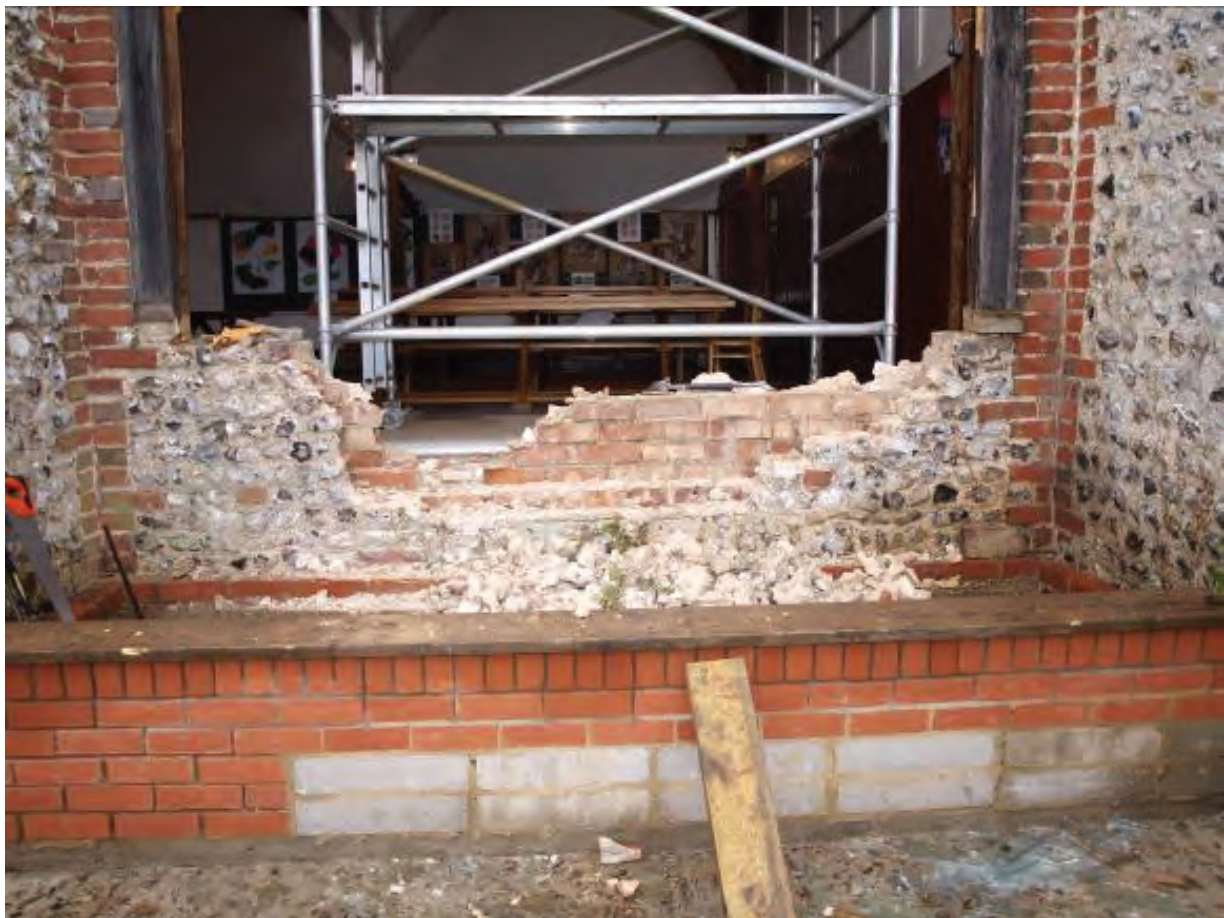
- 4.3.4 The wall was constructed with a cavity at 90mm wide between two separate brick skins giving an overall width of 410mm (Figure 4). The bricks utilised in the construction were pale pinkish fabric with dimensions of 230mm by 110mm by 70mm, bedded on a hard cement mortar. The outer face of the north-eastern skin, facing onto the lawn and entrance to the property had been faced in flint in the same style as the fabric of the surrounding buildings; the skin on the interior of the structure had a thick cement-based render 30mm thick. The two skins were tied back to each other using metal cavity wall ties and at the top of the wall, occasional breeze blocks bonded into each skin and bridging the cavity between (Figure 5). Upon removal of the wall it was clear that the base stood upon a lead capped foundation just below the level of the interior of the former barn (Figure 6).

Figure 4: view of the wall during demolition showing the flint facing of the outer (northeastern) skin and exposing the brickwork of the inner (southwestern) skin.

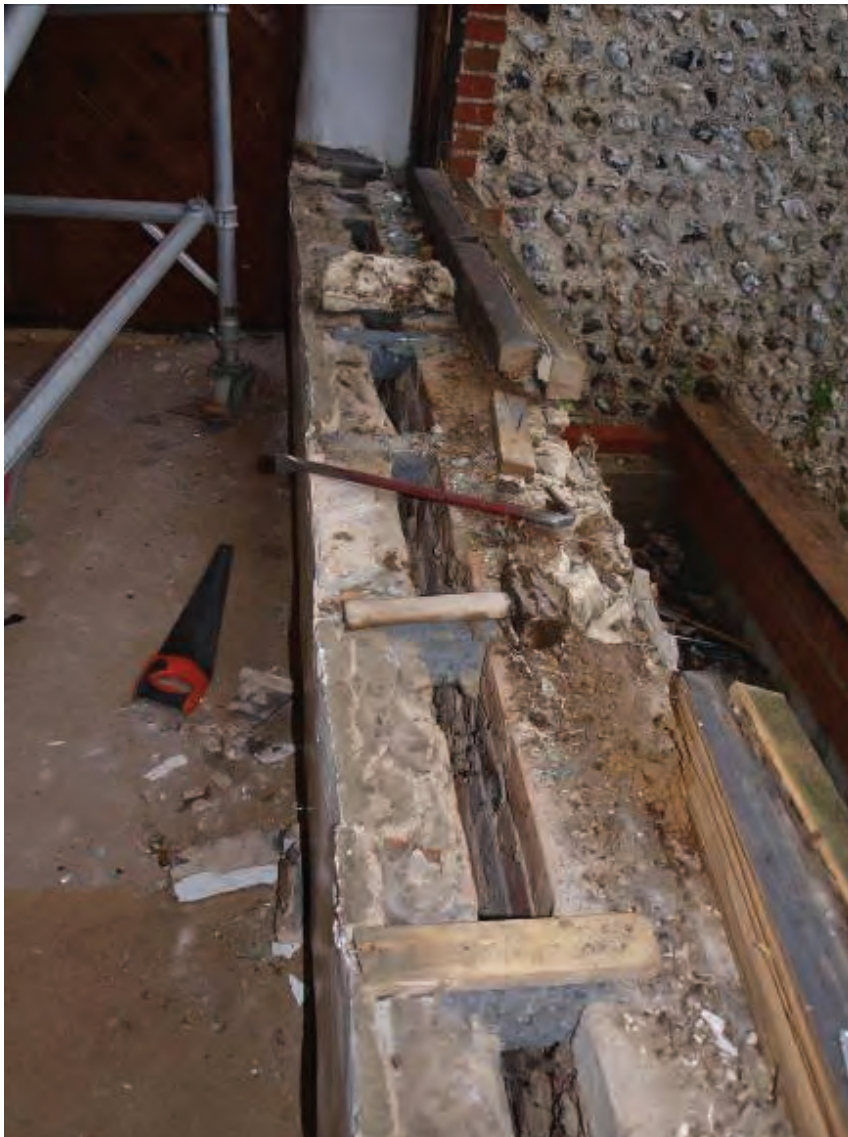
Figure 5: Detail of the wall construction from the top, just prior to demolition. View shows the two skins and the breeze block bridges.

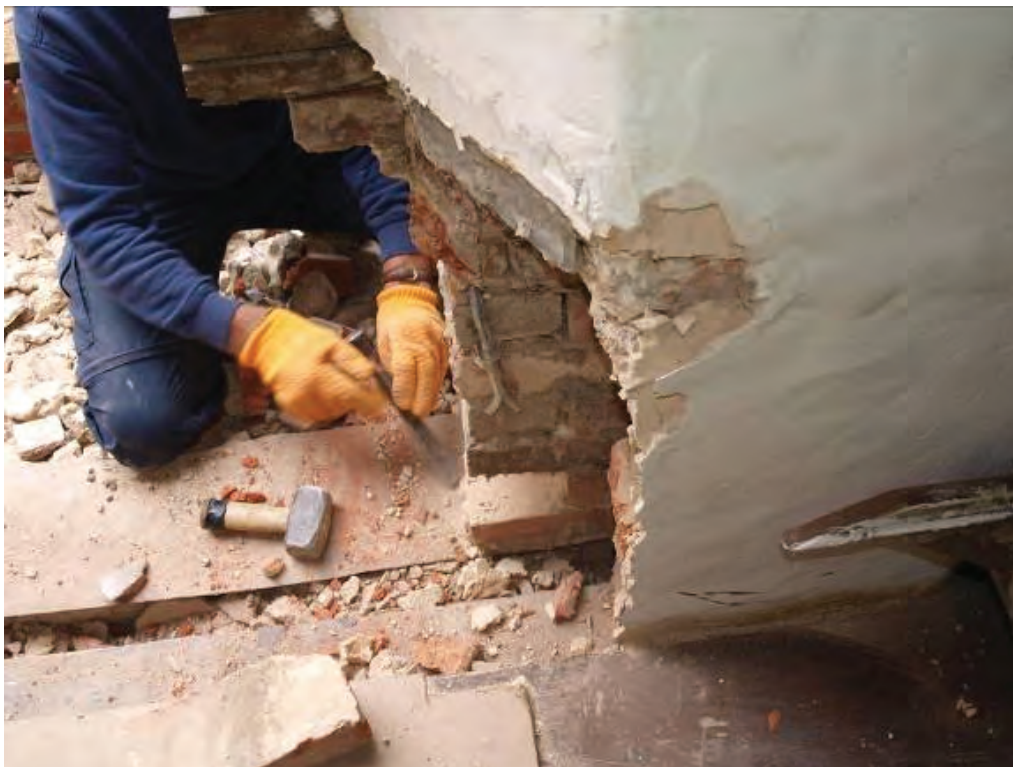
Figure 6: The lead lining to the foundation of the wall exposed after demolition
