**An Archaeological Watching Brief on the Lewes Cliffe
Flood Alleviation Scheme, East Sussex**

**Project no. 3873
ASE Report Number: 2009165**

**Planning Reference: LW/08/1288
Site Code: LCF 09
Oasis id: archaeol-6-66682**

November 2009

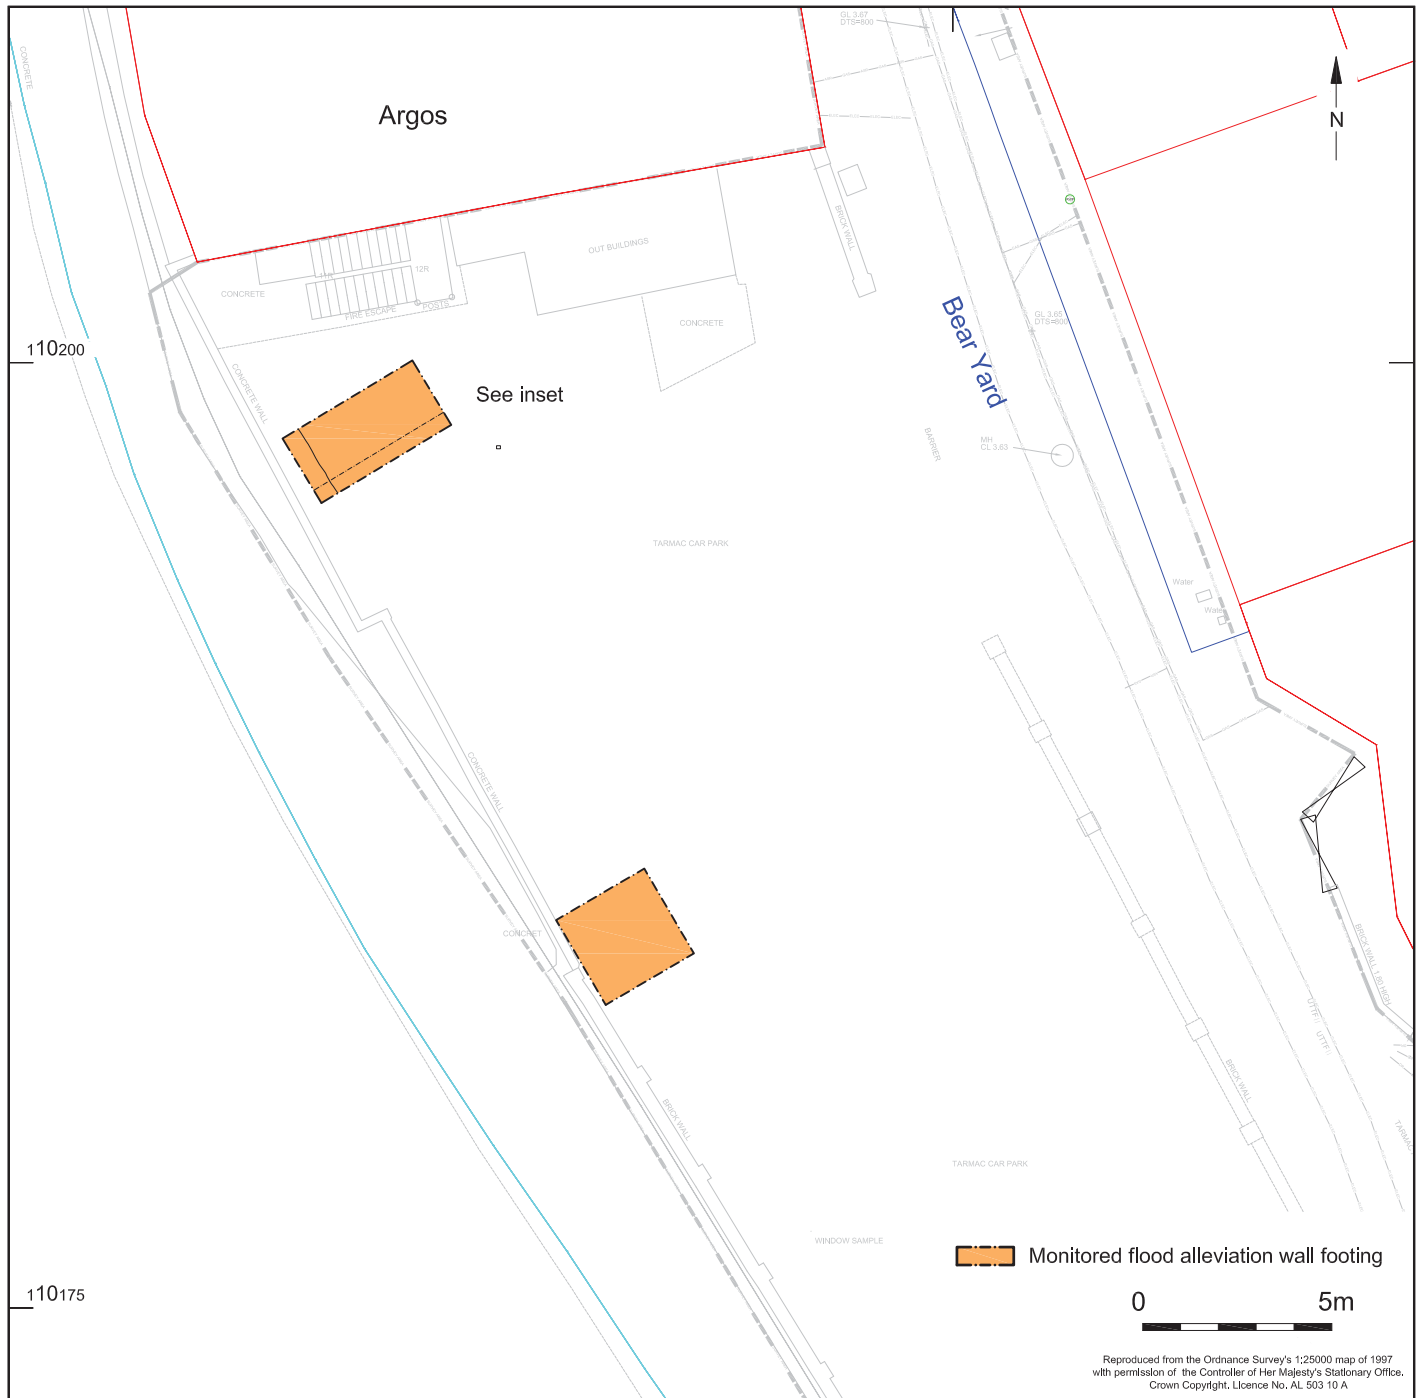
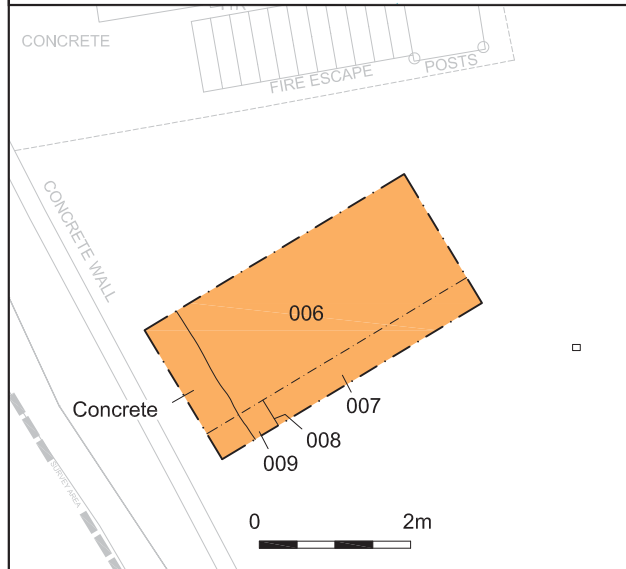
© Archaeology South-East		Lewes Cliffe Flood Alleviation Scheme		Fig. 3
Project Ref: 3873	Nov 2009	Bear Yard Area		
Report Ref: 2009165	Drawn by: JLR

4.3.1 As a result of monitoring the excavations of two trenches in Bear Yard, four context numbers were issued. The first trench measured approximately 2.6m by 2.7m and revealed layers of made ground [006]/makeup to a depth of 1.35m beneath the asphalt surface covering the area. This was to be expected, as the results of the borehole data demonstrated that made ground was present to depths of 2.9m in the car park area of Bear's Yard (BH1). The second trench, measuring 4m by 2m, was located slightly north (approximately 5.0m from the rear of the Argos building). In the western part of this trench (closest to the river) adjacent to the existing river bank wall was a concrete slab with a north-south brick wall footing [008]/[009] to its east. East of this was a single layer of alternate red and greyish yellow bricks [007]. When these bricks were revealed at a depth of 0.8m below the ground surface it was not clear what they were part of and due to the narrow width of the trench it was not possible to expose any edges to the possible surface. It was necessary to carefully remove a couple of the bricks to investigate and identify the possible feature. The contractors had not reached their required depth within the trench. When a couple of bricks were removed it became clear that this was likely to be a fairly recent pathway/yard surface as only a single layer was present and they were surrounded by modern made ground [006]. The date of these bricks to the 18th- to mid 19th- century may suggest a relationship to the rectangular building (19) seen on a 1788 plan of Lewes and discussed within the DBA (Figure 3). The layout of these bricks was similar to the riverside brick path observed at nearby Jenner's Lane, which may also be indicative of more recent use. The made ground revealed in this trench was sealed by an asphalt surface.

4.3.2 No significant archaeological remains were discovered during the excavations in the Bear Yard area. The only archaeology uncovered was a section of possible 18th to mid 19th brick surface.

- 5.1** Two complete bricks were recovered from [007]. Both are well-made, well-fired, frogless and of 18th- to mid 19th- century date. Included is a yellow example measuring 217mm long, 107mm wide and 56mm high. The second piece retains stack marks and measures 220mm, 105mm wide and 60mm high. Both are in a sparse to moderate fine sand-tempered fabric with no other visible temper or inclusions.
