An Archaeological Evaluation at Lower Hoddern Farm, Peacehaven, East Sussex

Planning Ref: LW/09/0640

Project No: 4059 Site Code: LHF 09

ASE Report No: 2010010 OASIS ID: archaeol6-71419

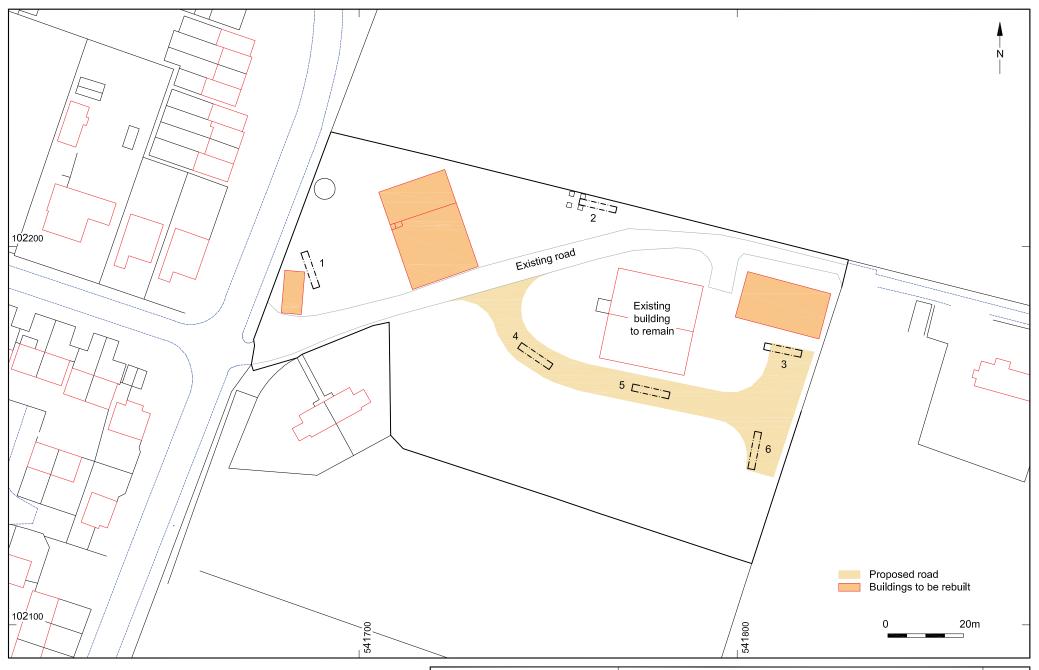
© Archaeology South-East		Lower Hoddern Farm, Peacehaven	Fig. 2
Project Ref. 4059	Jan 2010		1 19.2
Report Ref: 2010010	Drawn by: JLR	Trench location

- 3.1.2 The methodology comprised the mechanical excavation, under archaeological supervision, of 6 evaluation trenches each 10 metres in length (Figure 2).

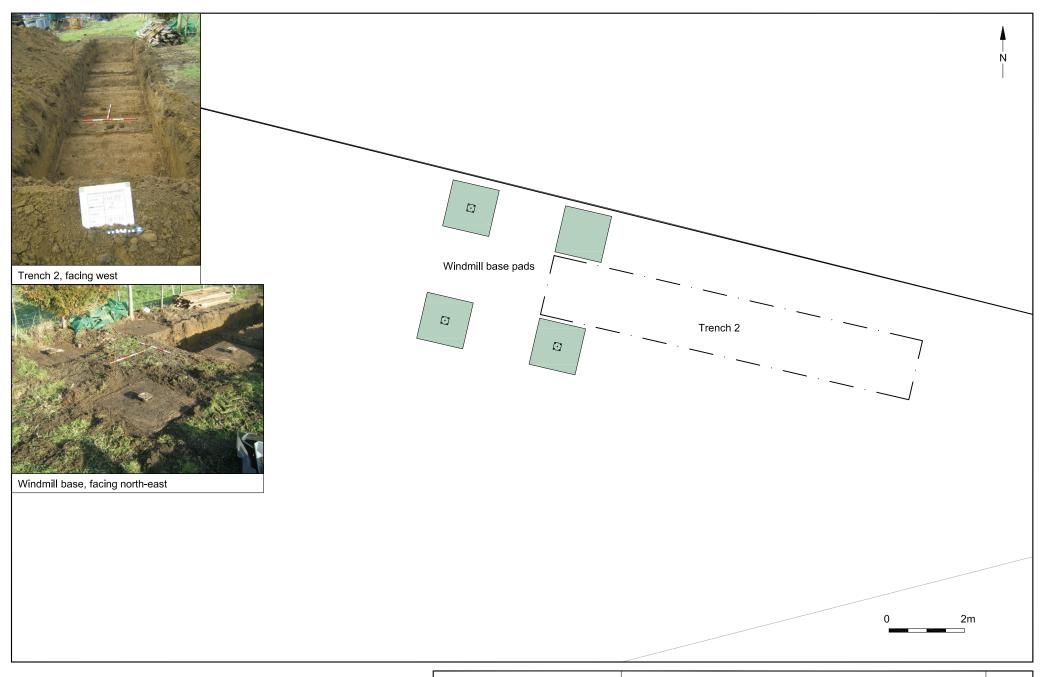
© Archaeology South-East		Lower Hoddern Farm, Peacehaven	Fig. 3
Project Ref: 4059	Jan 2010	Trench 2: Plan and photographs	1 19. 5
Report Ref: 2010010	Drawn by: JLR	Trench 2. Flan and photographs

The natural brickearth (2/005) was encountered between 52.79m and 53.12m AOD. This was overlain by a buried soil layer (2/004), which comprised a friable mid orangey brown silty clay with occasional flecks of chalk which is analogous to the subsoil/topsoil layers observed elsewhere on the site.

The buried soil layer was overlain by a layer of mid yellowy brown fine sand (2/003), this made ground was observed across the trench 0.14m deep,

was very clean and appeared to have been deposited as a single levelling dump.

A second deposit of made ground sealed this sand, this was mid brown sandy silt which contained pieces of tarmac and rubble (2/002), and was up to 0.30m in depth.

Layers 2/003 and 2/002 appear to have been levelling deposits retained behind a 0.80m high breezeblock wall.

The deposit sequence was sealed by a 0.23m deep layer of friable mid brown sandy silt topsoil.

At the western end of the trench are four concrete foundation pads with inserted iron bolt fixture plates. Each concrete pad measured 1.25m x 1.25m and was 0.62m in depth, they were spaced 1.80m apart internally with overall planned dimensions of 4.35m by 4.35m. These pads formed the foundations of a windmill which had been erected on the site during the period in the 1960's when the land was a MAFF farm (Colin Appleton *pers. comm.*). The superstructure of the windmill had been removed from site after it had blown over in high winds, and possible evidence of this event survives as the north-eastern iron fixing plate is missing.

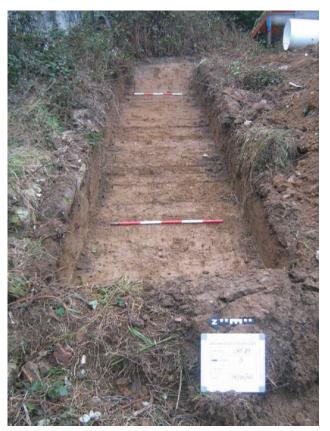
Fig. 4: Trench 1, facing east

The natural brickearth (1/003) was encountered between 52.38m and 52.78m AOD. This was overlain by the subsoil (1/002) and topsoil (1/001) of the site. No archaeological features were recorded and a single land drain was observed.

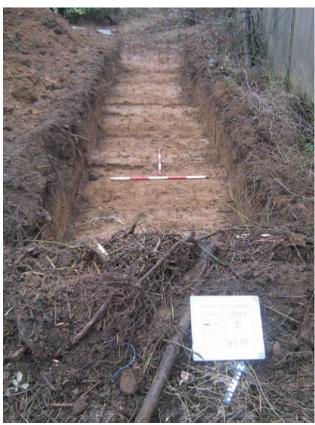
Fig. 5: Trench 3, facing north

The natural brickearth (3/003) was encountered between 51.85m and 51.90m AOD. This was overlain by the subsoil (3/002) and topsoil (3/001) of the site.

No archaeological features were encountered.

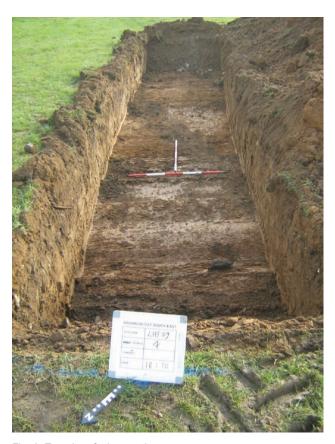
Fig. 6: Trench 4, facing south-east

The natural brickearth (4/003) was encountered between 51.91m and 51.74m AOD. The natural was overlain by the subsoil (4/002) and topsoil (4/001) of the site. A single modern service cut was observed cutting the sequence obliquely across the site and is likely to have been connected to the former greenhouses that are known to have been previously located in the vicinity of this trench. There were no potential archaeological features that warranted investigation.

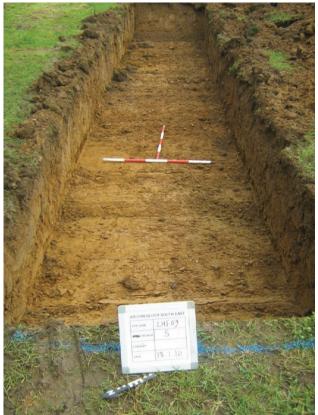
The natural brickearth (5/003) was encountered between 51.71m and 51.74m AOD. The natural was overlain by the subsoil (5/002) and topsoil (5/001) of the site and no archaeology was observed.

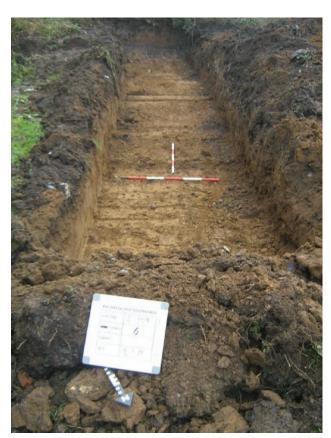
Fig. 8: Trench 6, facing south

The natural brickearth (6/004) was encountered between 52.37m and 52.37m AOD. The natural was overlain by the subsoil (6/003) and topsoil (6/002) of the site. Overlying the location of this trench was a large mound of dark brown silty clay with a high organic content and large amount of refuse which had been deposited with lenses of tipped dumping, no archaeology was observed in this trench.
