**An Archaeological Watching Brief at
St. Peter and St. Paul's Church, Ashington, West Sussex**

May 2010

Project No: 3631

**Site Code: SPP 09
Report No: 2009164**

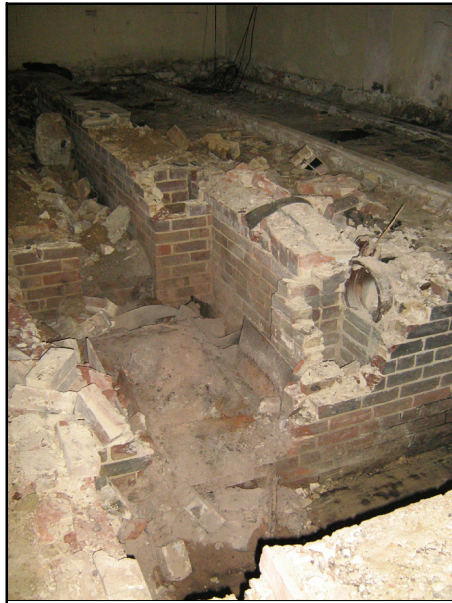
Fig. 3.1: Victorian disturbance

The western half of the nave was heavily disturbed during the installation of an under floor heating system in the late Victorian period (Figure 3.1).

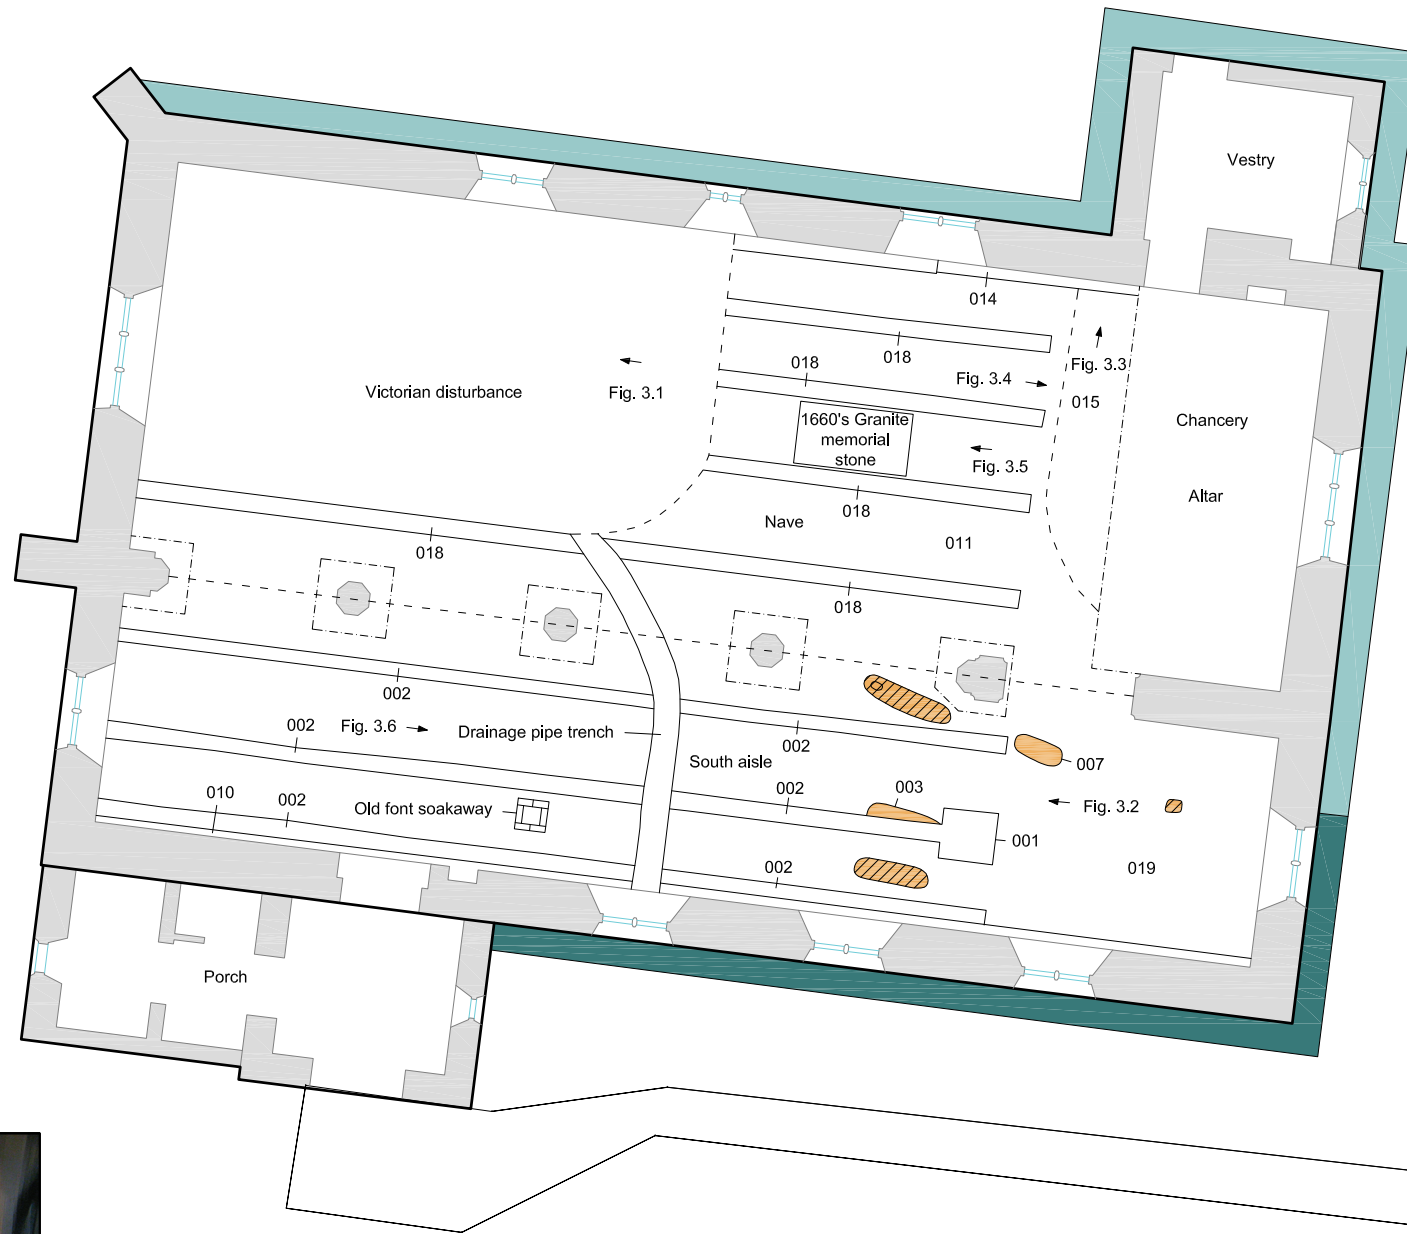
- Existing perimeter drain
 - Monitored trench for French drain
 - Existing walls
 - Excavated and recorded graves
 - Graves preserved in situ
- 0 2m

4.1.4 Summary of Contexts: The South Aisle (Figure 3)

4.1.5 Summary of Contexts: The Nave (Figure 3)

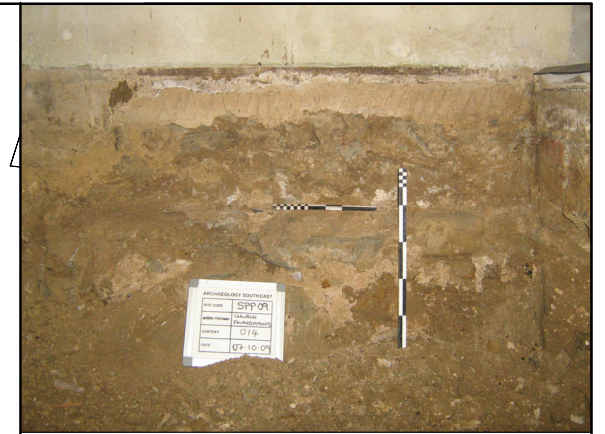
Fig. 3.3: Church foundations

The foundations of the church [014] (Figure 3.3) were recorded in the north western corner of the Nave. They consisted of four courses of roughly hewn stone blocks (measuring approximately 200mm by 100mm) mixed with some irregular chalk blocks and bonded with light yellow-orange sandy mortar.

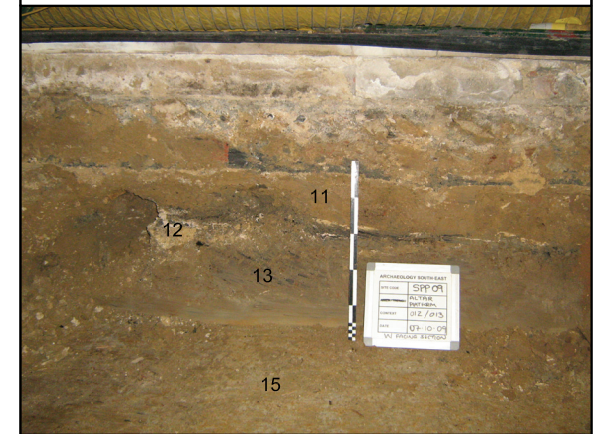
Fig. 3.4: Altar platform

A soft dark grey silty clay deposit [013] (Figure 3.4) with occasional charcoal flecks and medieval pottery sherds was revealed beneath the pulpit in the north-eastern most corner of the nave against the raised altar platform. This

was sealed by a lens of chalk [012]. Context [013] peeled straight off onto undisturbed natural geology and no cut for a feature was observed. Overlying the chalk and across the rest of the nave was the layer of made ground/make-up [011] which was deposited after the late 19th century developments. This was overlain by floor tiles.

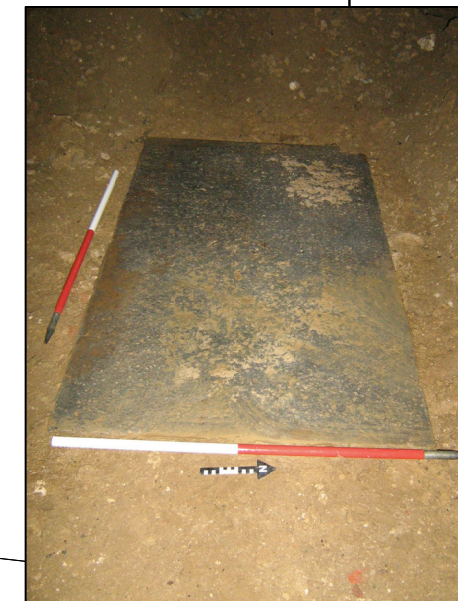
Fig. 3.5: 1660's granite memorial stone

A granite memorial stone [016] (Figure 3.5), measuring 1.9m (east-west) by 1.10m (north-south) with a thickness of 0.13m, was encountered in a central position in the nave. The size of the slab and its central position within the church suggest that it commemorates important/wealthy individuals. It is possible that the slab overlies a burial tomb. The inscriptions on the stone were fairly worn, but the words 'Christopher' and 'Margret' and the date '1665' were observed. According to another inscribed memorial slab, placed high up on the wall of the south side of the nave, it is likely that the granite slab commemorates the daughters, Mary and Margaret, of Christopher Minshull who was the Rector sometime between 1581 and 1614. The two women died in June 1661 and July 1665 respectively. Although the slab was uncovered approximately 5cm above the required formation level it was agreed that the memorial would remain *in situ*. The memorial slab was respected by the sleeper walls [017]/[018] during their construction in the late 19th century

- 6.4** The monitored excavations revealed a large, granite memorial slab located in the centre of the Nave approximately 3.5m west of the altar platform. Inscriptions in the stone suggest that it commemorates the daughters of a Rector of the church in the late 16th to early 17th century. The two daughters died in 1661 and 1665. It is possible that the granite stone seals an underlying tomb. The excavations did not impact on the memorial stone, which has been preserved *in situ*.

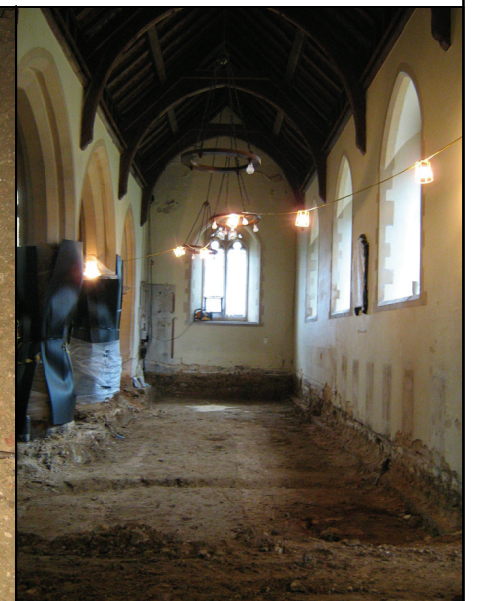
Fig. 3.6: South aisle (facing east)

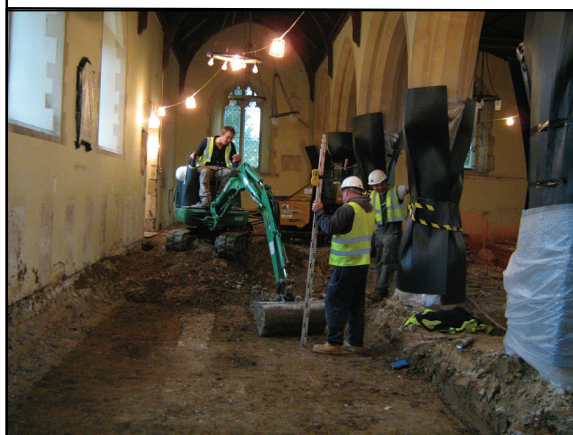
Fig. 3.2: Ground reduction (south aisle)

Four grave outlines were encountered during the ground reduction within the South Aisle. Before 1871-2 when the South Aisle was constructed this area would have been located outside of the church building within the churchyard which explains the presence of these graves within a light greyish brown friable silty clay cemetery soil [019]. Two of the four graves, [003] and [007], were encountered above the required formation level and as a result, required recording and lifting for reburial. The skeletal remains within the other two graves were deeper and were therefore not impacted by the development. These graves were preserved *in situ*. Context [003] was a

disturbed grave cut for an adult individual [004]. This grave had been disturbed during the construction of the east-west lime plaster sleeper walls [001]/[002] in the late 19th century and the central wall had truncated part of the burial. Although the skeletal remains had been moved and were therefore disarticulated they had been left *in situ* within what remained of the original grave cut. The grave fill [005] comprised loose mid brown silt. The grave was recorded and the skeletal remains were lifted for re-burial to avoid further impact. Context [007] was the grave cut for an infant [008] uncovered northeast of grave [003]. The cut measured 0.65m east-west and was 0.25m wide. Most of the moderately preserved bones were present and were undisturbed in an extended supine position with the head at the western end of the grave. The burial was located 0.55m below the floor level in the South Aisle. The fill [009] was the same as [005]. As with [003], the grave was recorded and the skeletal remains were lifted for re-burial to avoid further impact.
