**An Archaeological Investigation into the former East Grinstead Pottery site,  
Garland Road, East Grinstead, West Sussex**

**Planning Refs: 08/1617/FUL; APP/D3830/A/08/2070768**

**Project Nos. 3970 / 4288  
Site Code: EAG 10**

**ASE Report No. 2010074  
OASIS ID: archaeol6-78543**

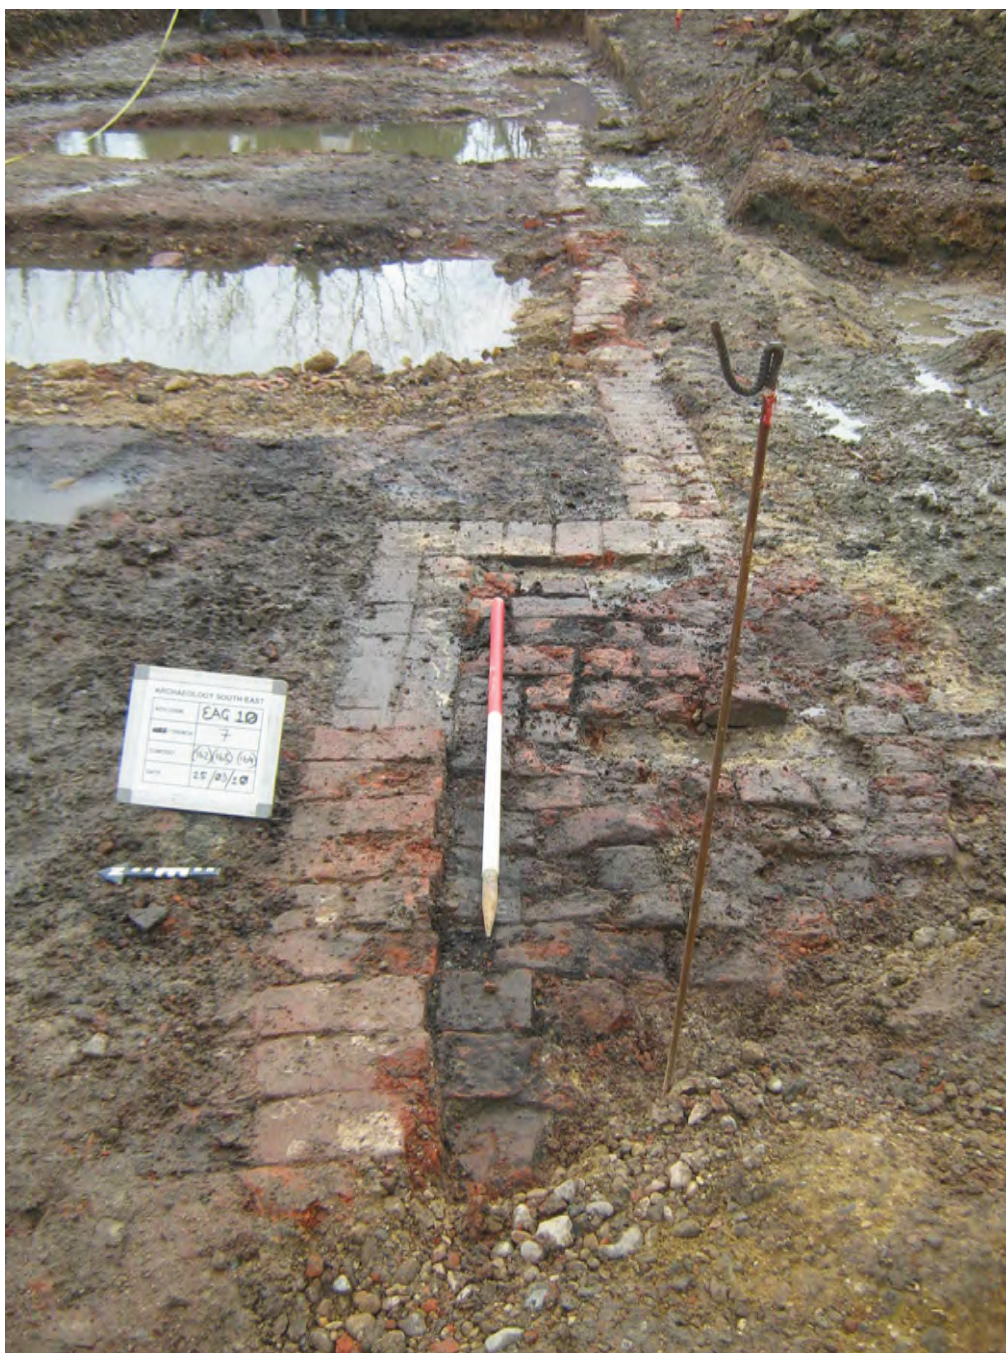
| © Archaeology South-East | | Garland Road | Fig. 10 |

Wall [164] of pottery workshop (top) and bottle kiln (bottom), showing internal kiln floor [162] (central right).  
Viewed from the west

- 4.4.3 The western bottle kiln room occupied the area where the back wall, [164] can be seen to make a slight dogleg to the north and a north-south aligned wall in trench 8, [055] (Figs 7 and 10). These elements formed a room with an external east-west width of 6.98 metres. Map evidence and photographic sources suggest that the form of this room was roughly square, with a central kiln structure (Figs 11; 12; and 13). The foundations of the kiln, [156], were substantial, with a wall thickness of 0.80 metres and external extrapolated diameter of 5.00 metres (Figs 14, 15 and 16). Some elements of internal kiln furniture were also observed, [206], [207] and [227] as well as the internal brick floor [162] which survived in the north-east corner of the room. This floor had become disturbed either through use or during demolition and was in a poor condition in the north-western corner of the room [058] [155] [208] [209] (Fig. 25, Section 2).

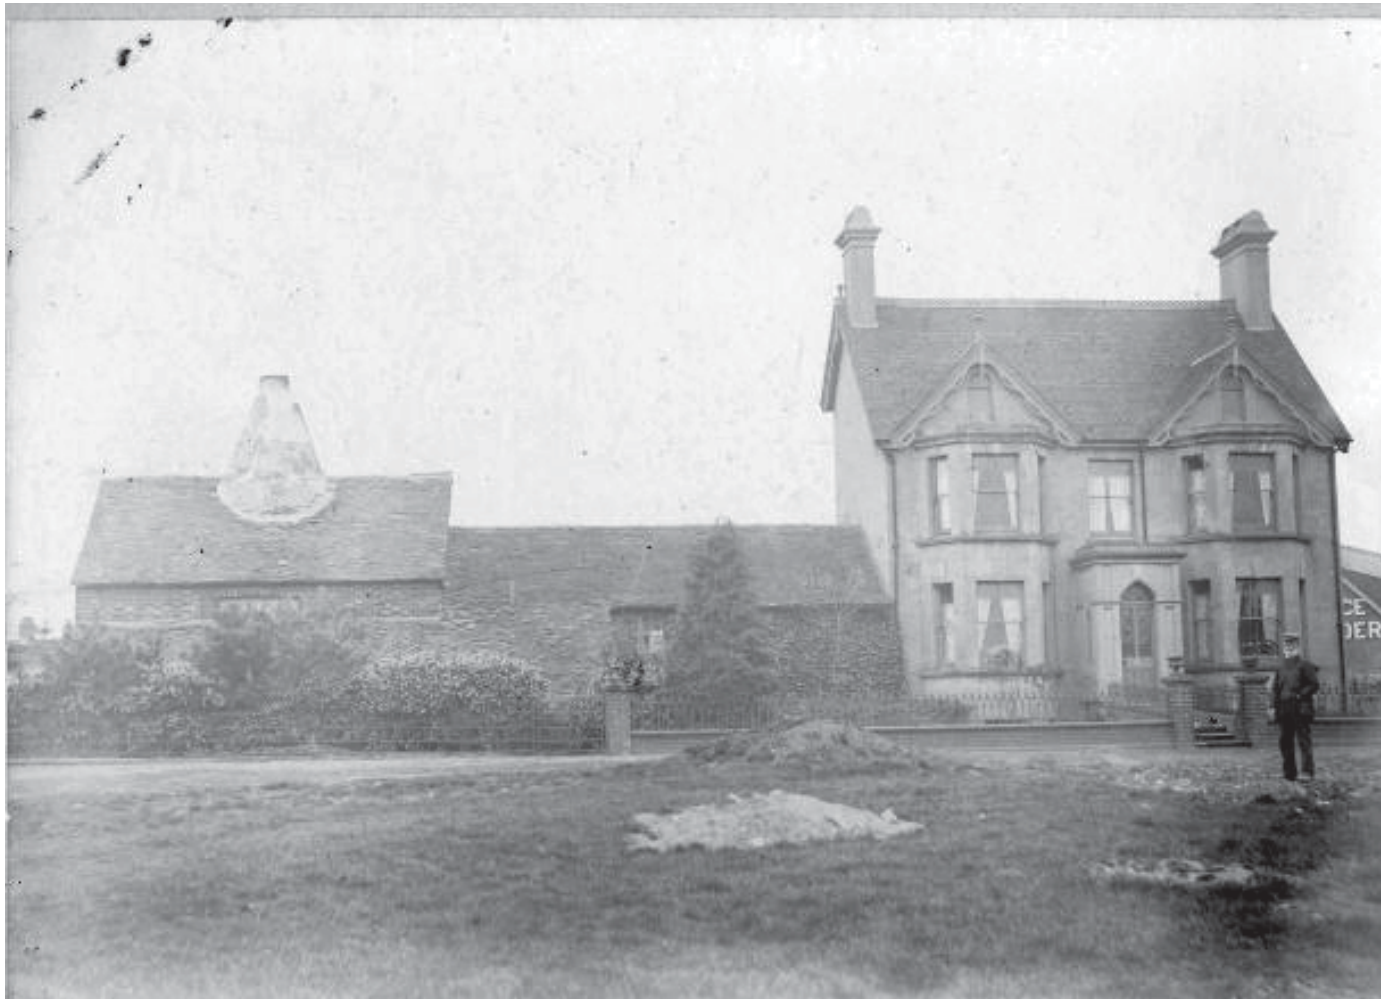
| © Archaeology South-East | | Garland Road | Fig. 11 |

The bottle kiln (left); workshop (centre); and potters house (right); viewed looking north from Park Road (East Grinstead Museum Collection)

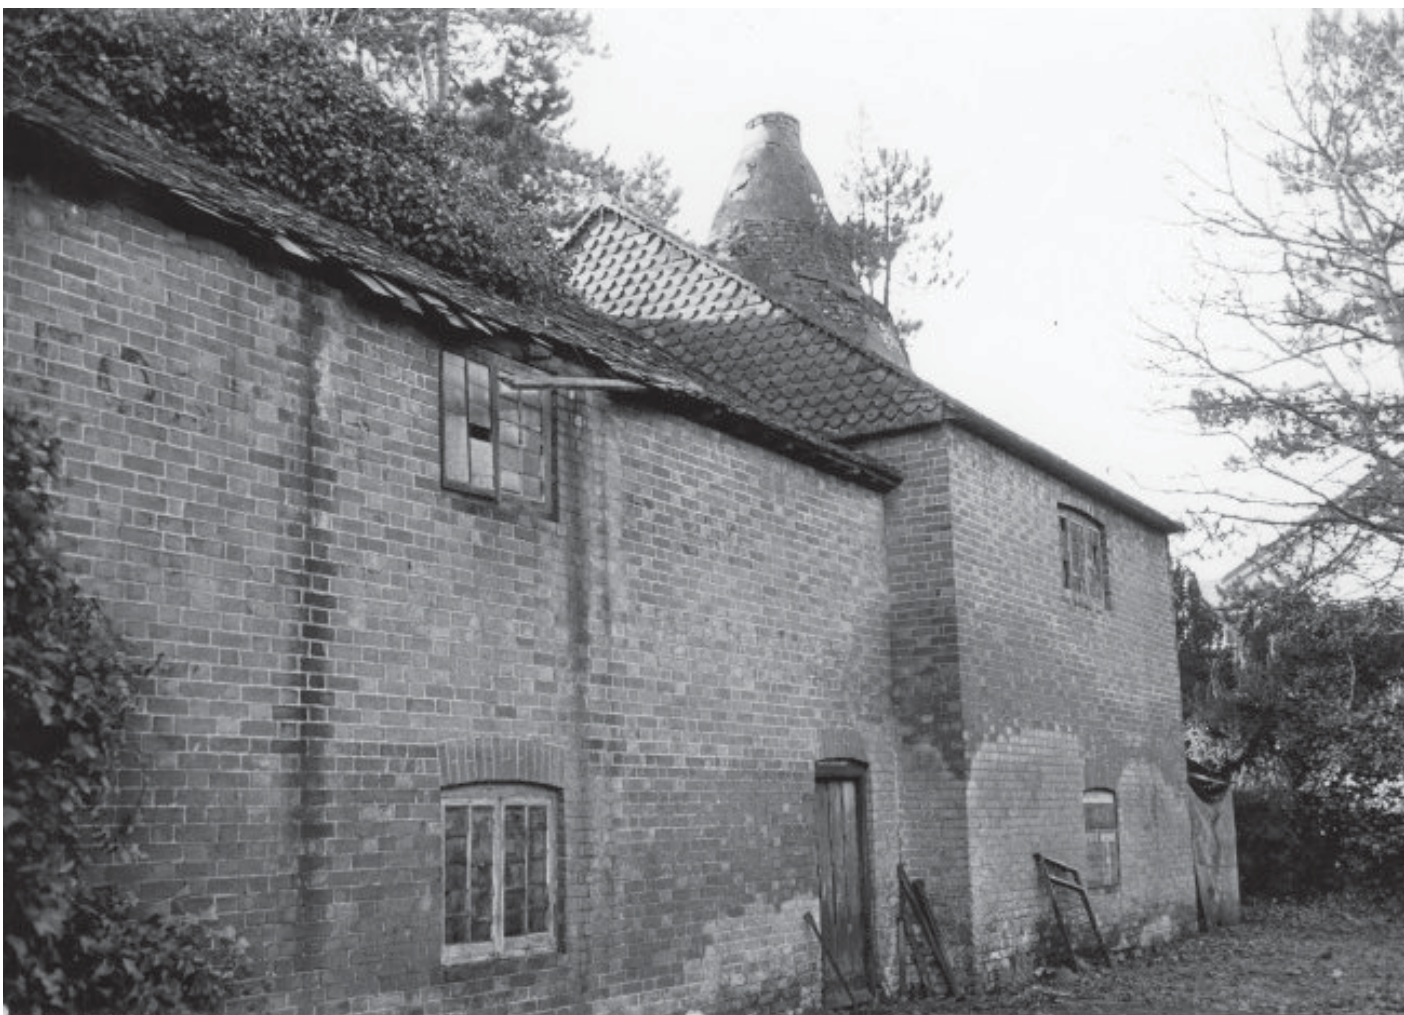
The rear of the pottery buiildings looking west with the bottle kiln (right) and workshop (left) (East Grinstead Museum Collection)

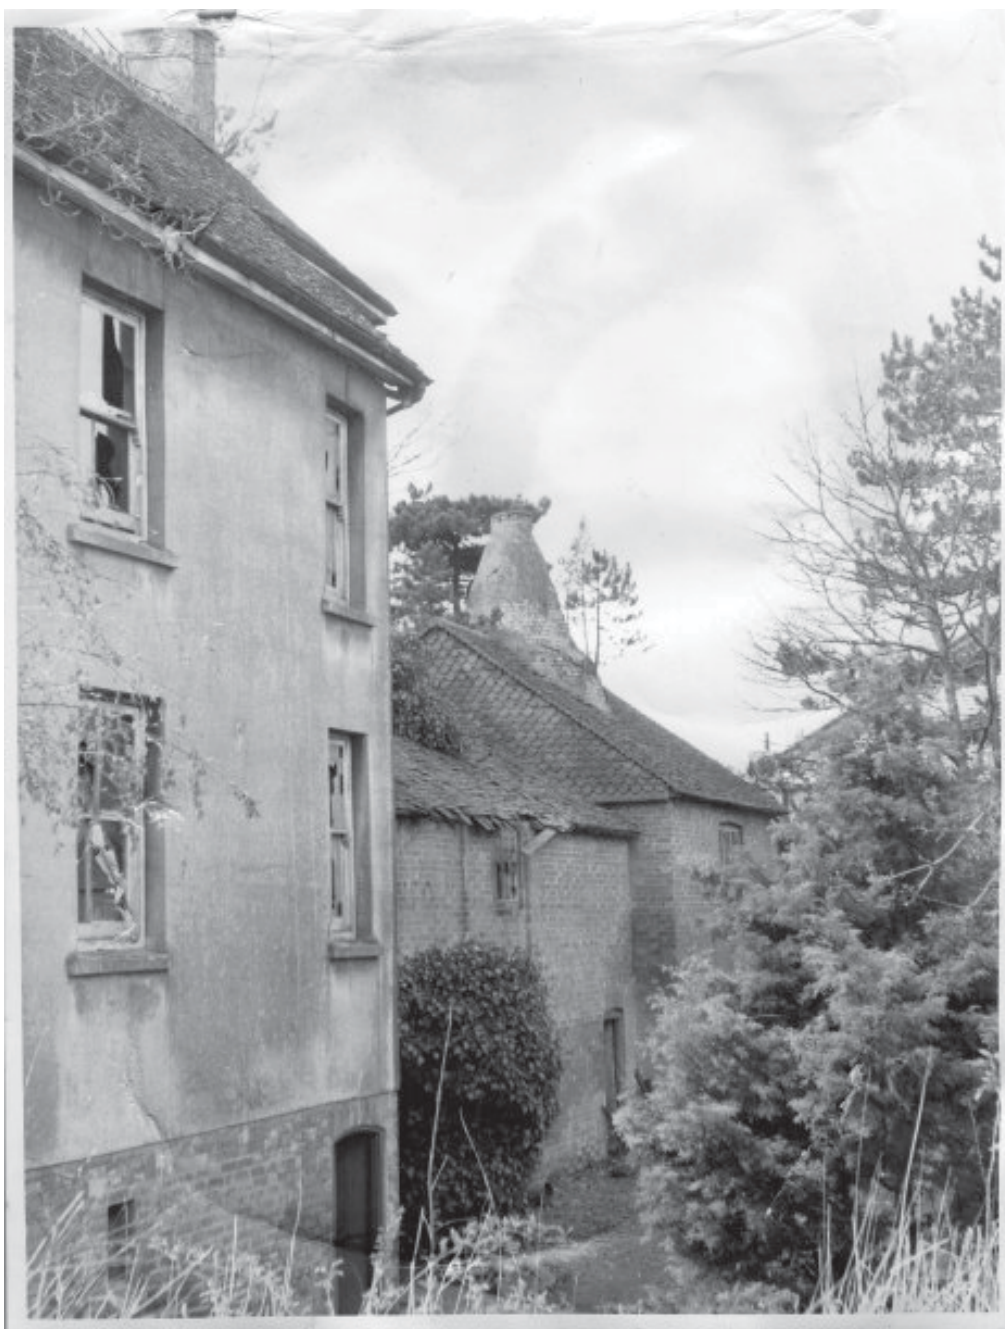
| © Archaeology South-East | | Garland Road | Fig. 13 |

The rear of the pottery buildings looking west with the potter's house in the foreground  
(East Grinstead Museum Collection)

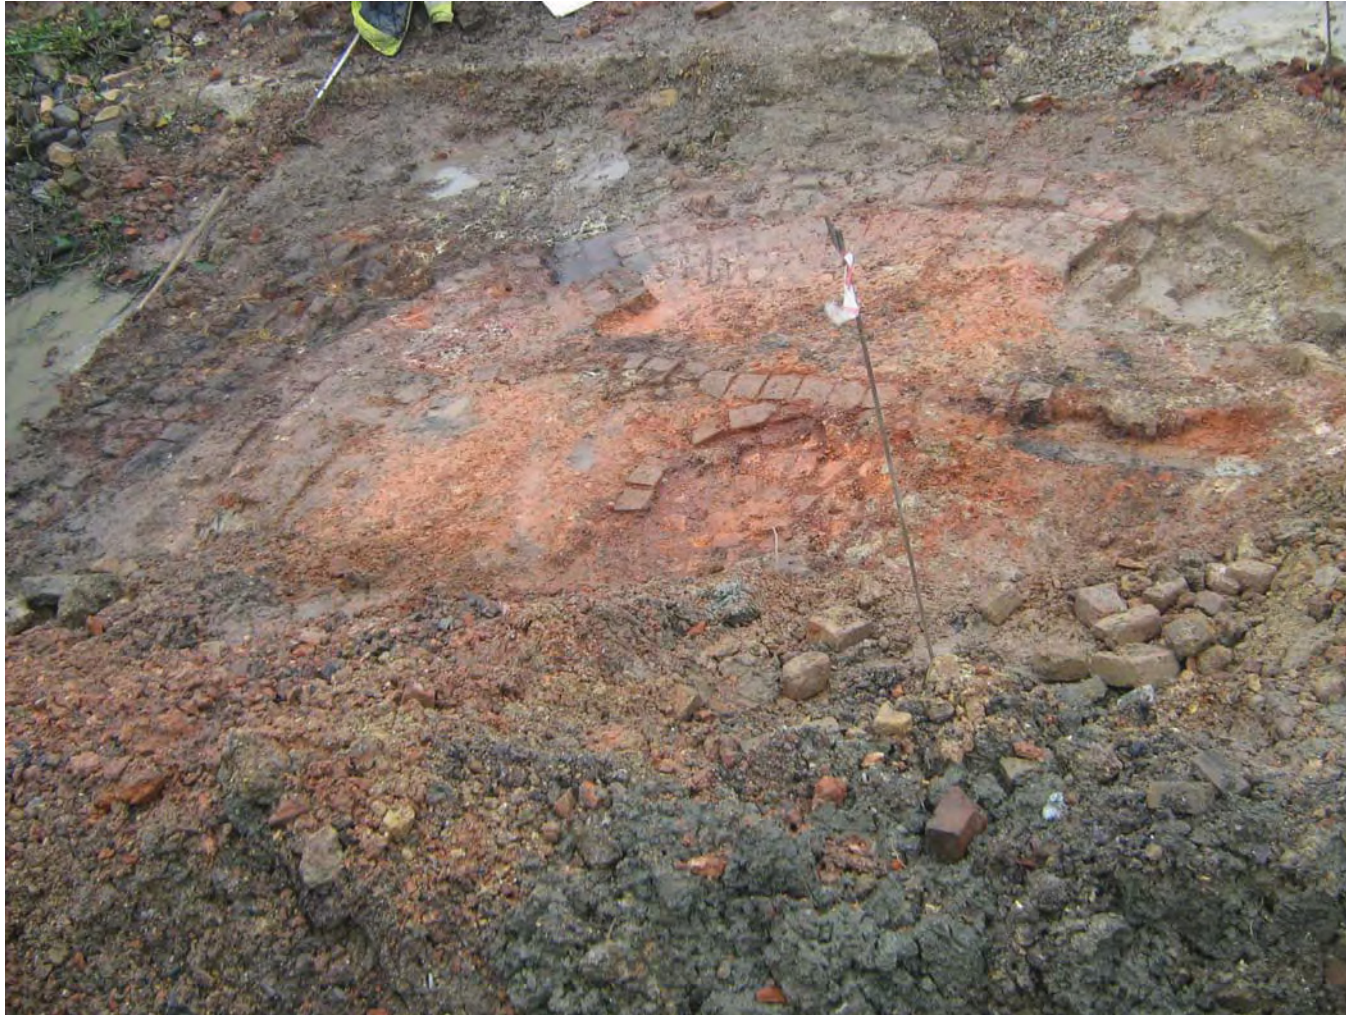
Bottle kiln foundations [156] and kiln furniture [206; 207; 213] with damaged brick floor [155; 208; 209] (top right) viewed from south

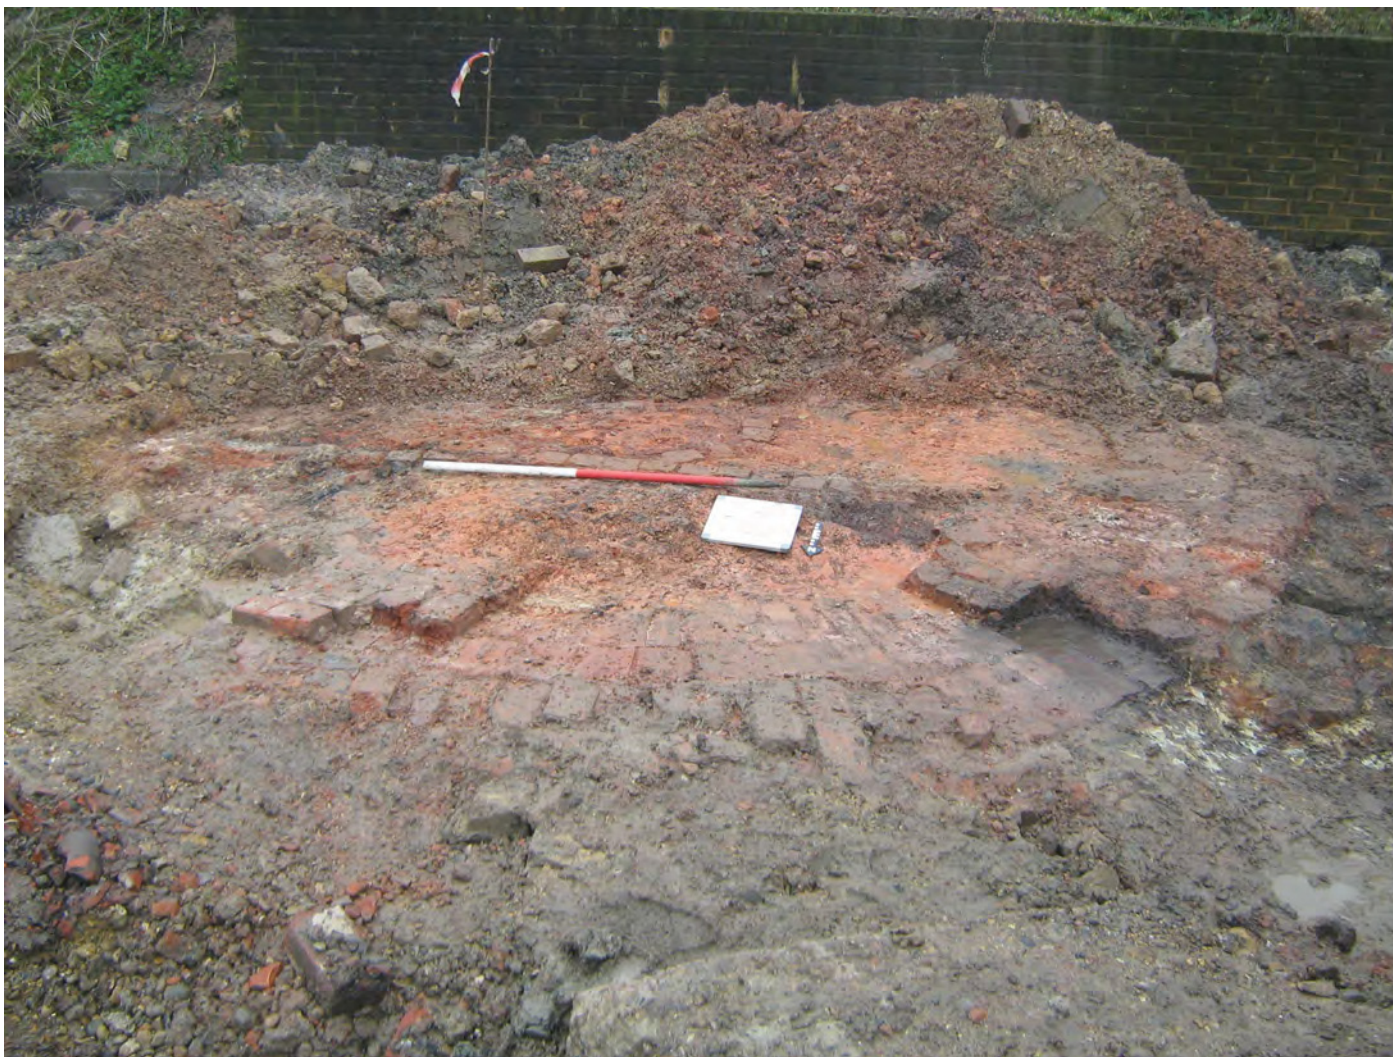
Bottle kiln foundations [156] and kiln furniture [206; 207; 213] viewed from north

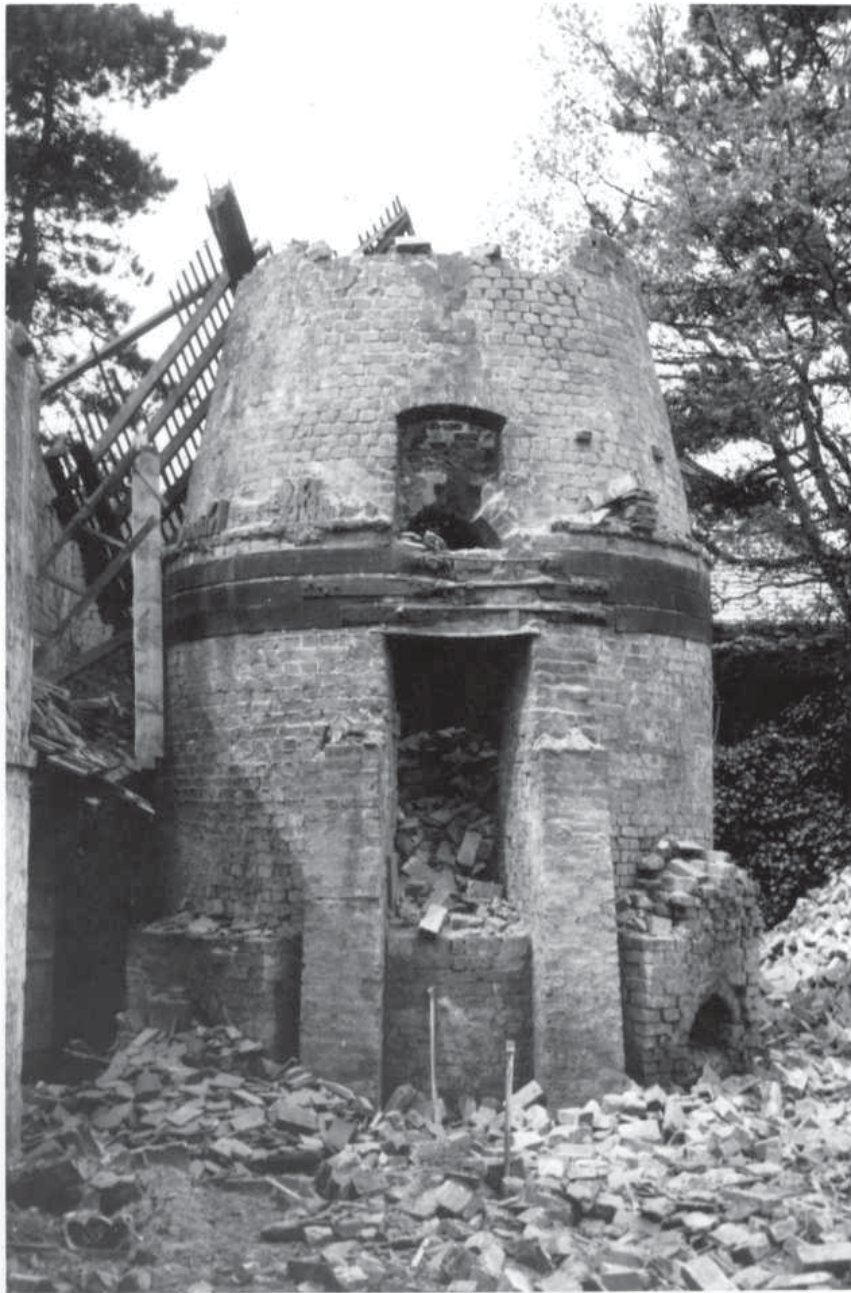
| © Archaeology South-East | | Garland Road | Fig. 16 |

The bottle kiln during demolition in 1971, viewed from the east (East Grinstead Museum Collection)

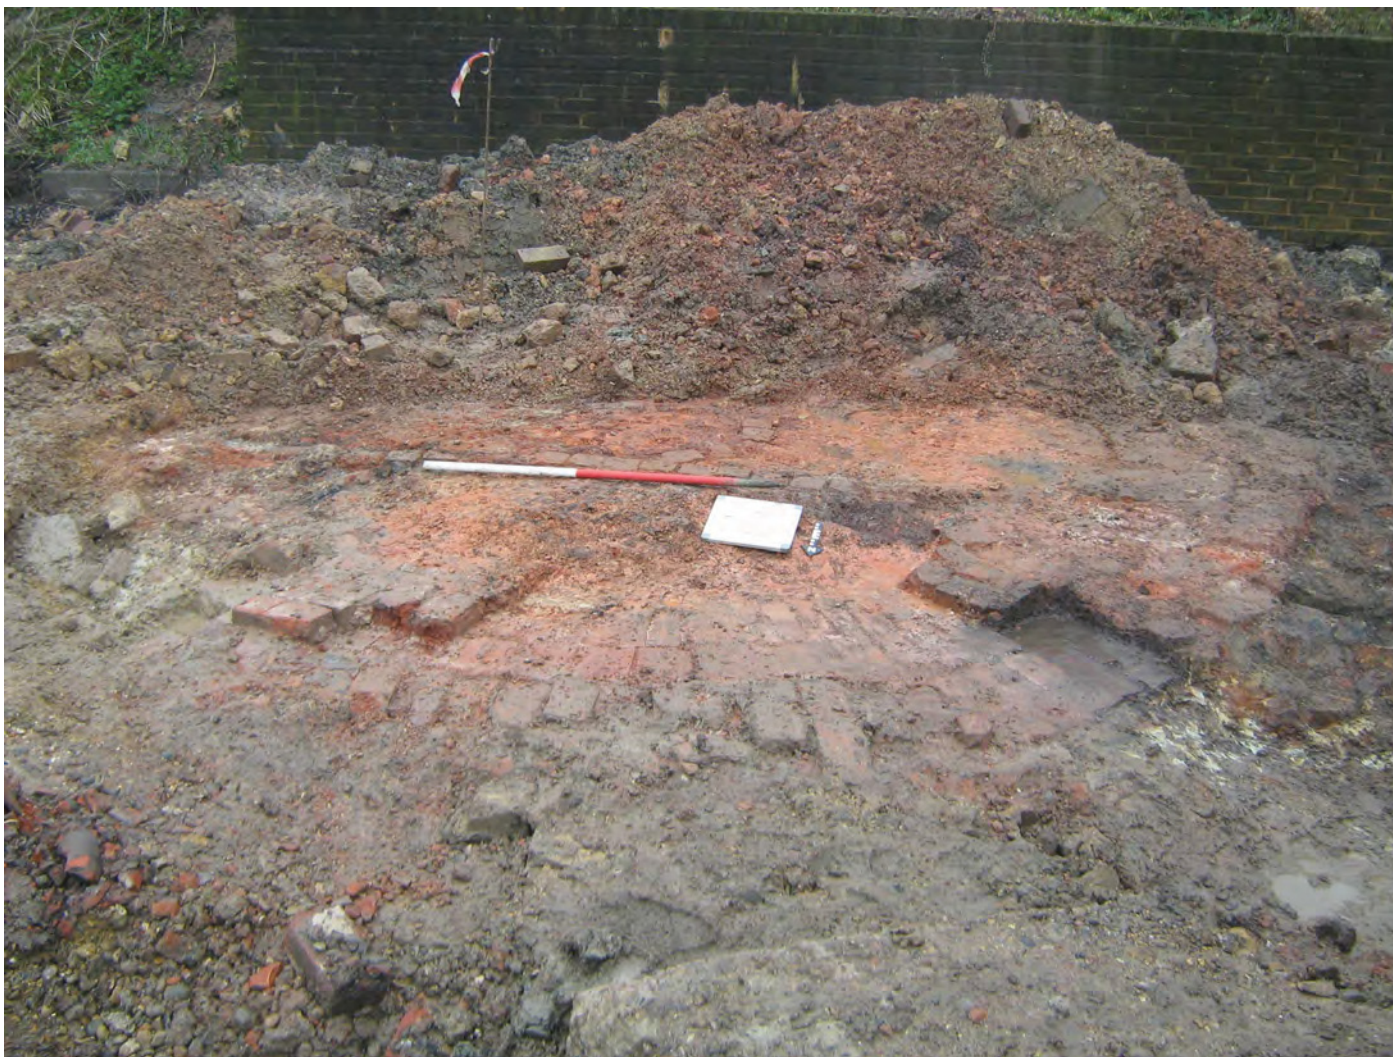
Elevation of wall [164] on north side of bottle kiln after the excavation of small sondage, and bricks of internal floor [162] (top left)

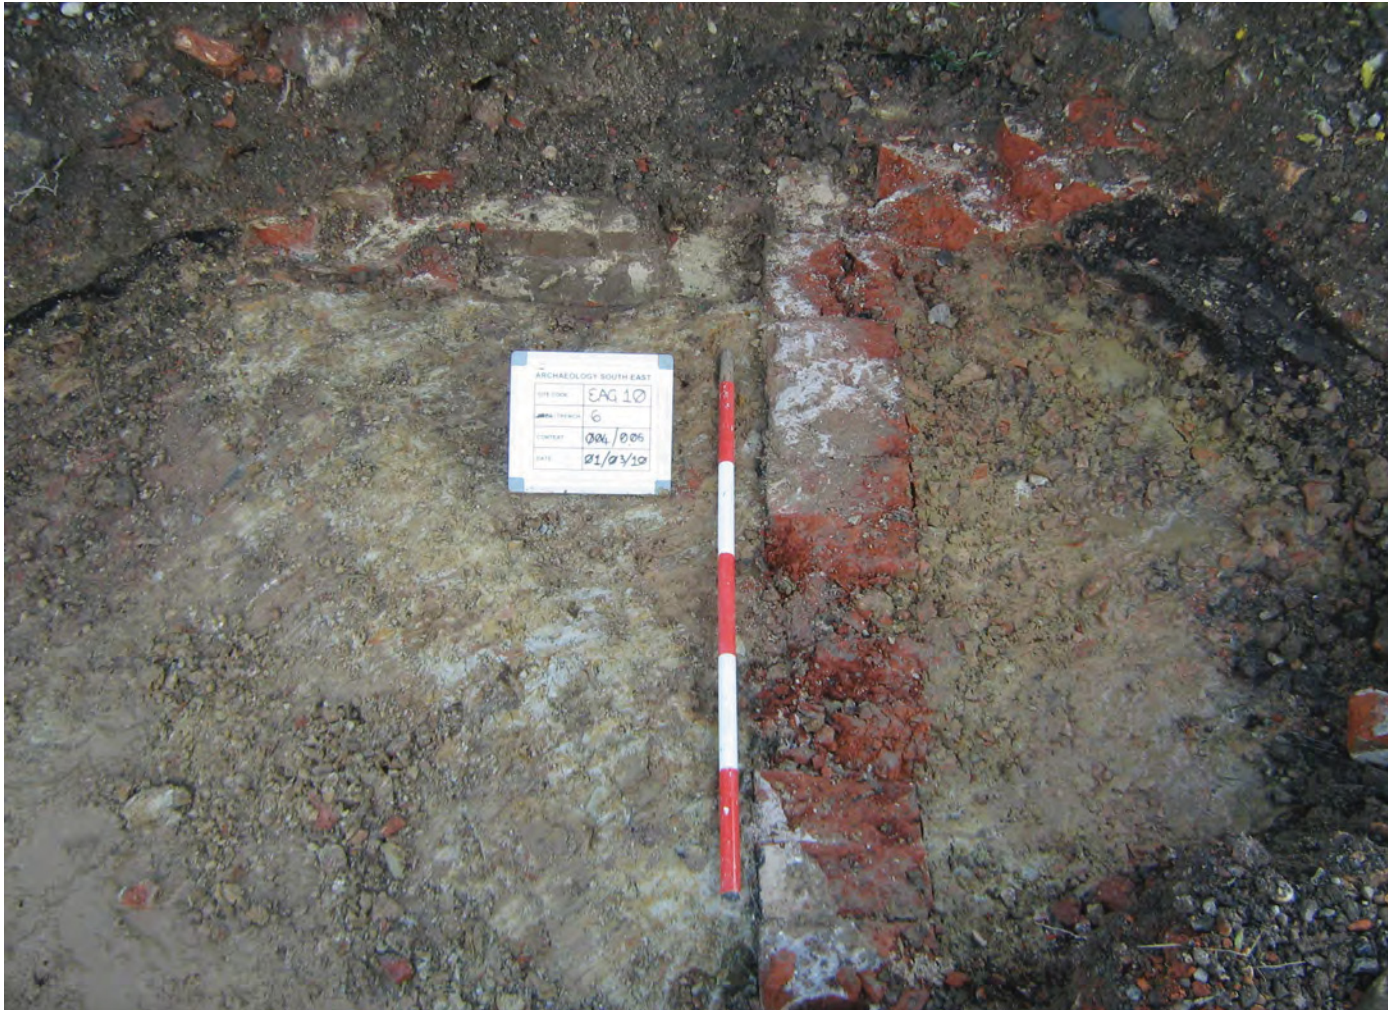
| © Archaeology South-East | | Garland Road | Fig. 18 |

Walls [004; 006] forming the south east corner of the workshop, with wall of house [012] butting against them (right).  
Viewed from north in evaluation trench 6

- 4.5.1 To the east of the workshop building, a short section of east-west aligned wall foundation was identified within evaluation trench 6, [012] (Fig 18 and Fig. 25, Section 4). This wall abutted the south-eastern corner of the workshop at a slightly different alignment and as such was interpreted as part of the later building that Henry Foster had built as a family home when he took ownership of the pottery in 1884.

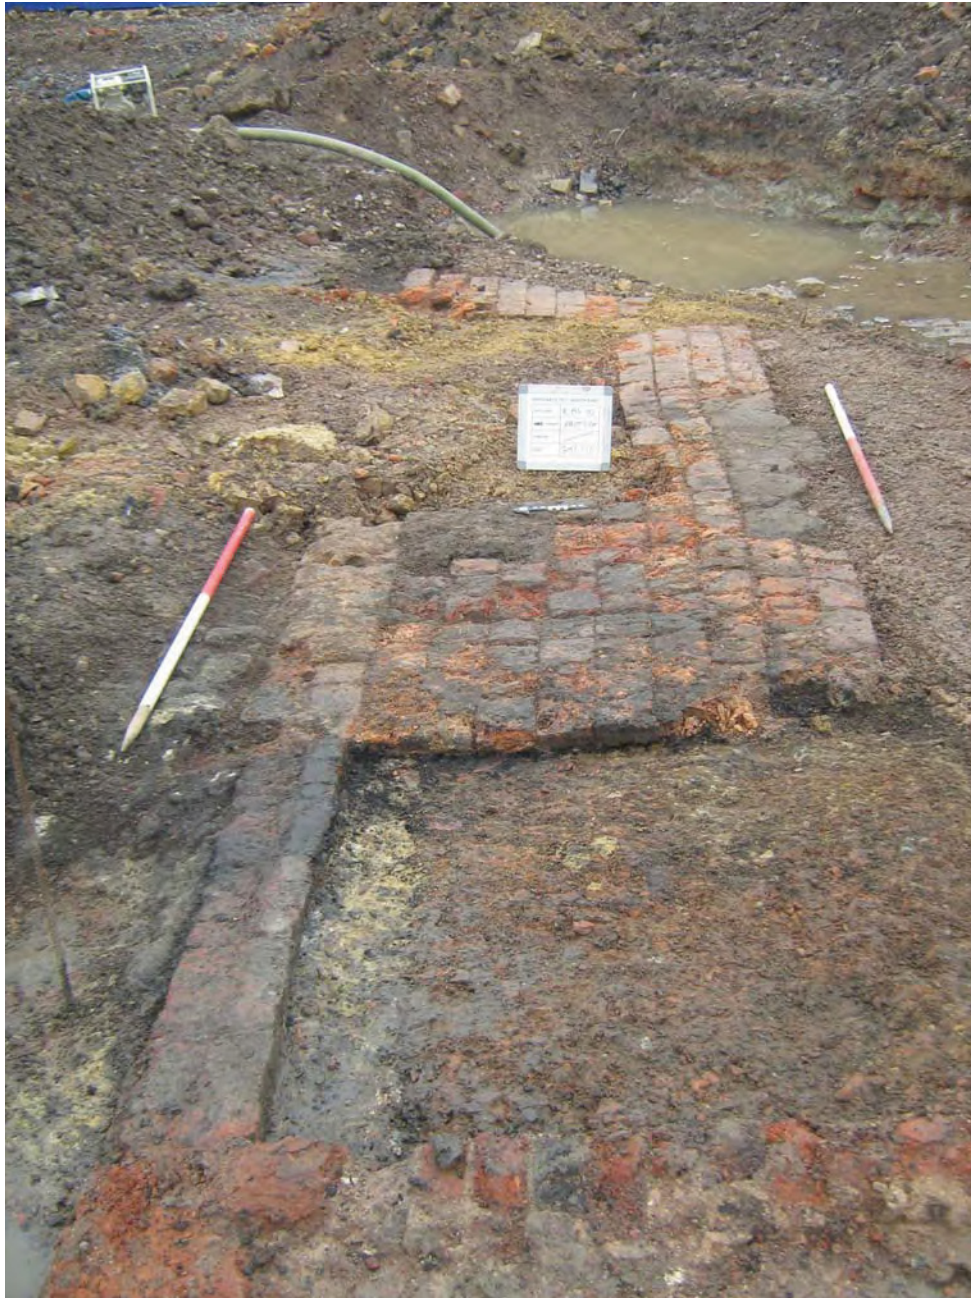
| © Archaeology South-East | | Garland Road | Fig. 19 |

Remains of the rear of the potter's house viewed from the west. Walls [189 - bottom; 186; 203 - left] and floors [195; 196; 197; 198]

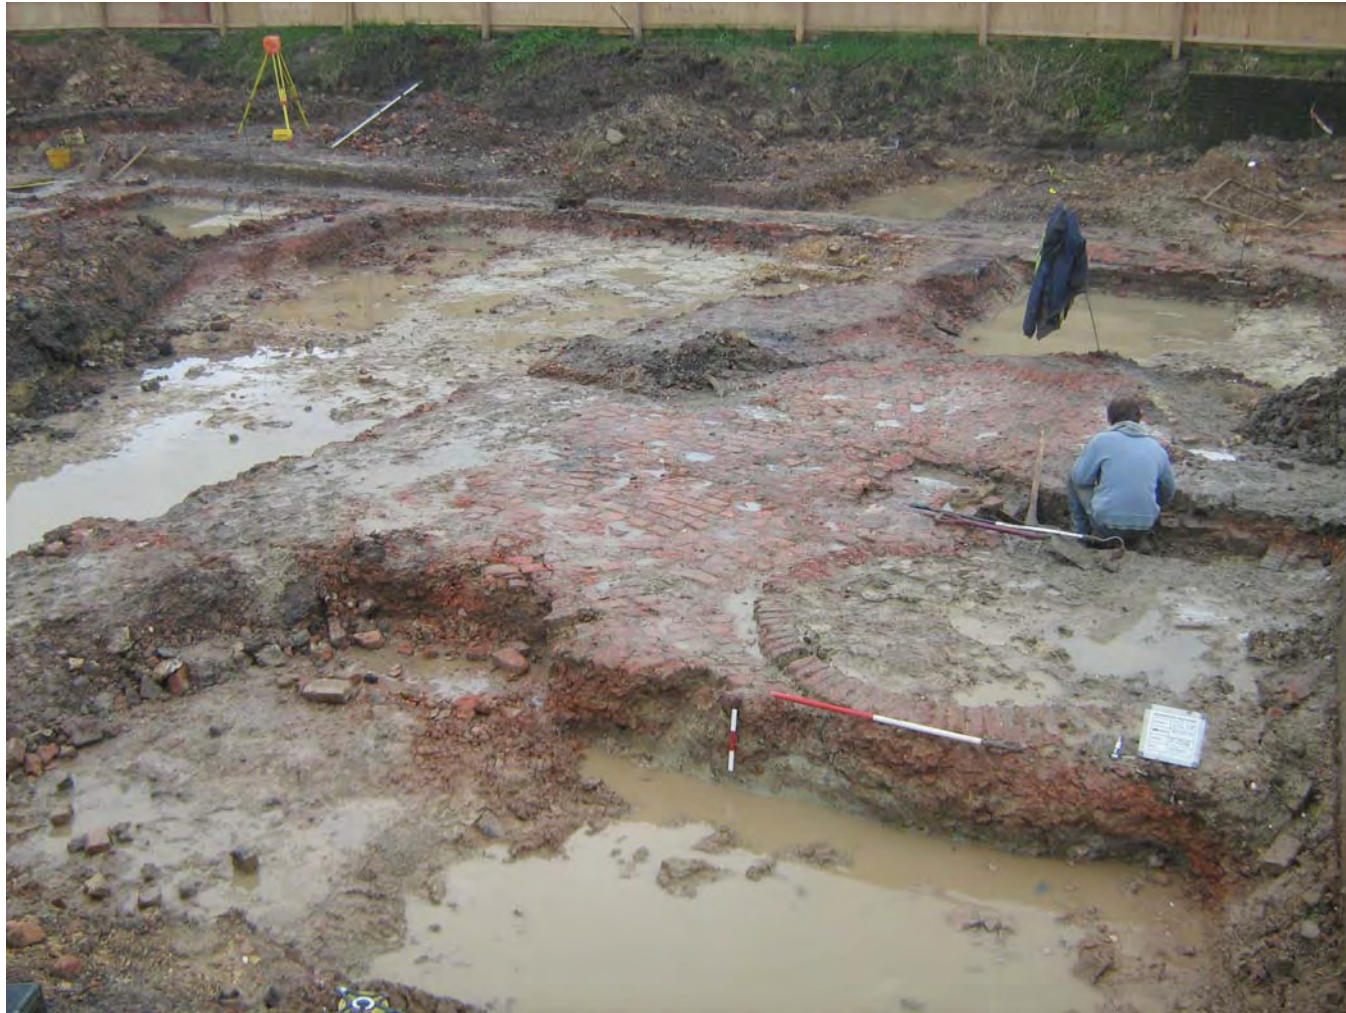
View of excavation after re-machining of yard surfaces, showing the east-west aligned wall of the pottery [164 - top], brick surface [167 - centre], and brick lined pit [180 - right]; with the robber cut [240] under excavation

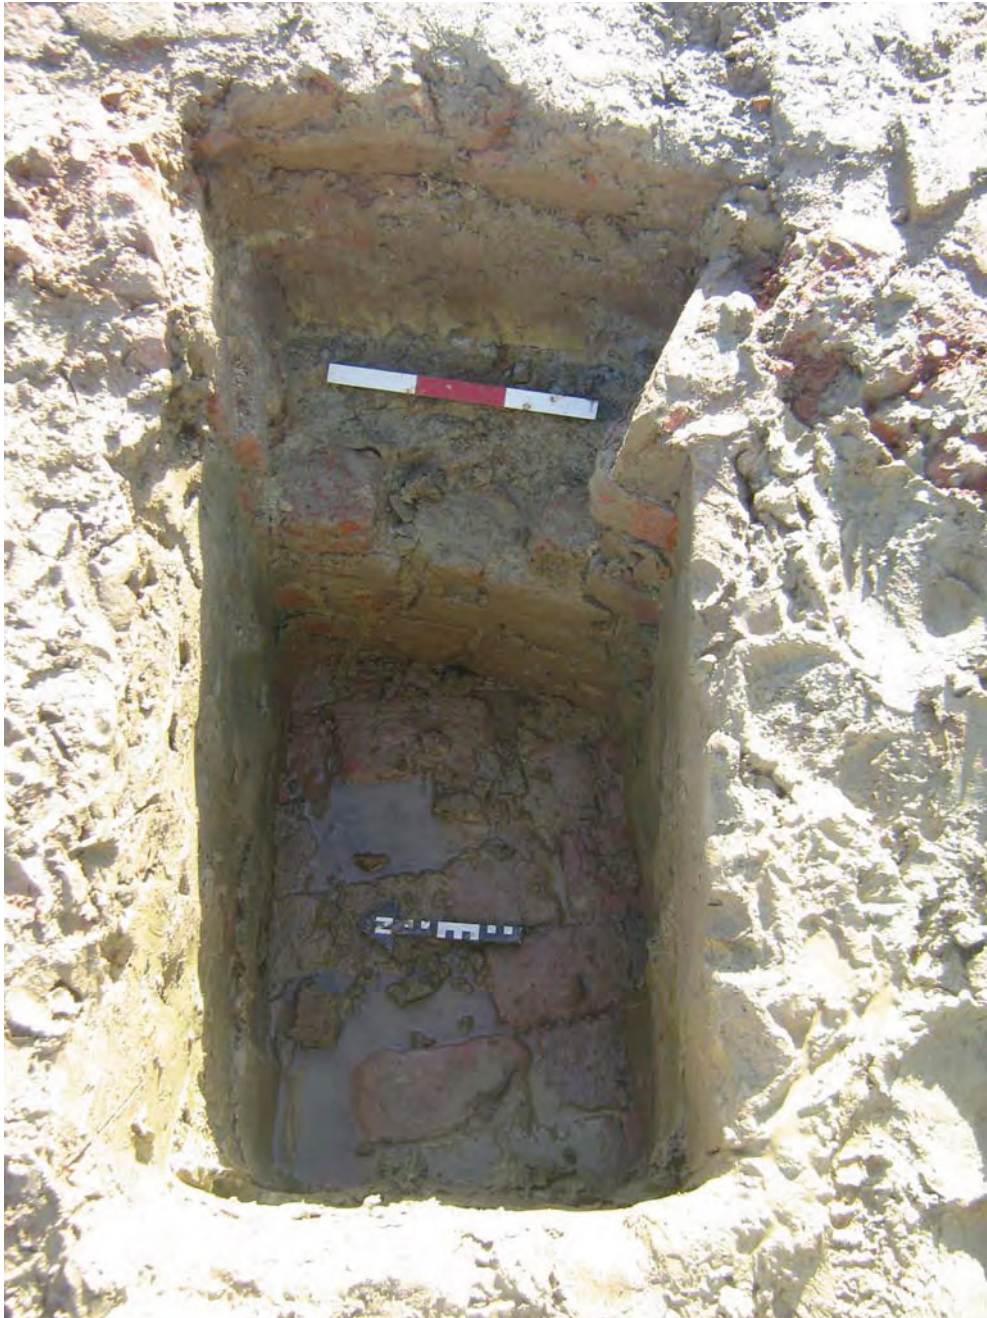
| © Archaeology South-East | | Garland Road | Fig. 21 |

A slot excavated through the stored clay [072] in the brick lined pit, showing walls [224] and brick floor [225]. View looking east.

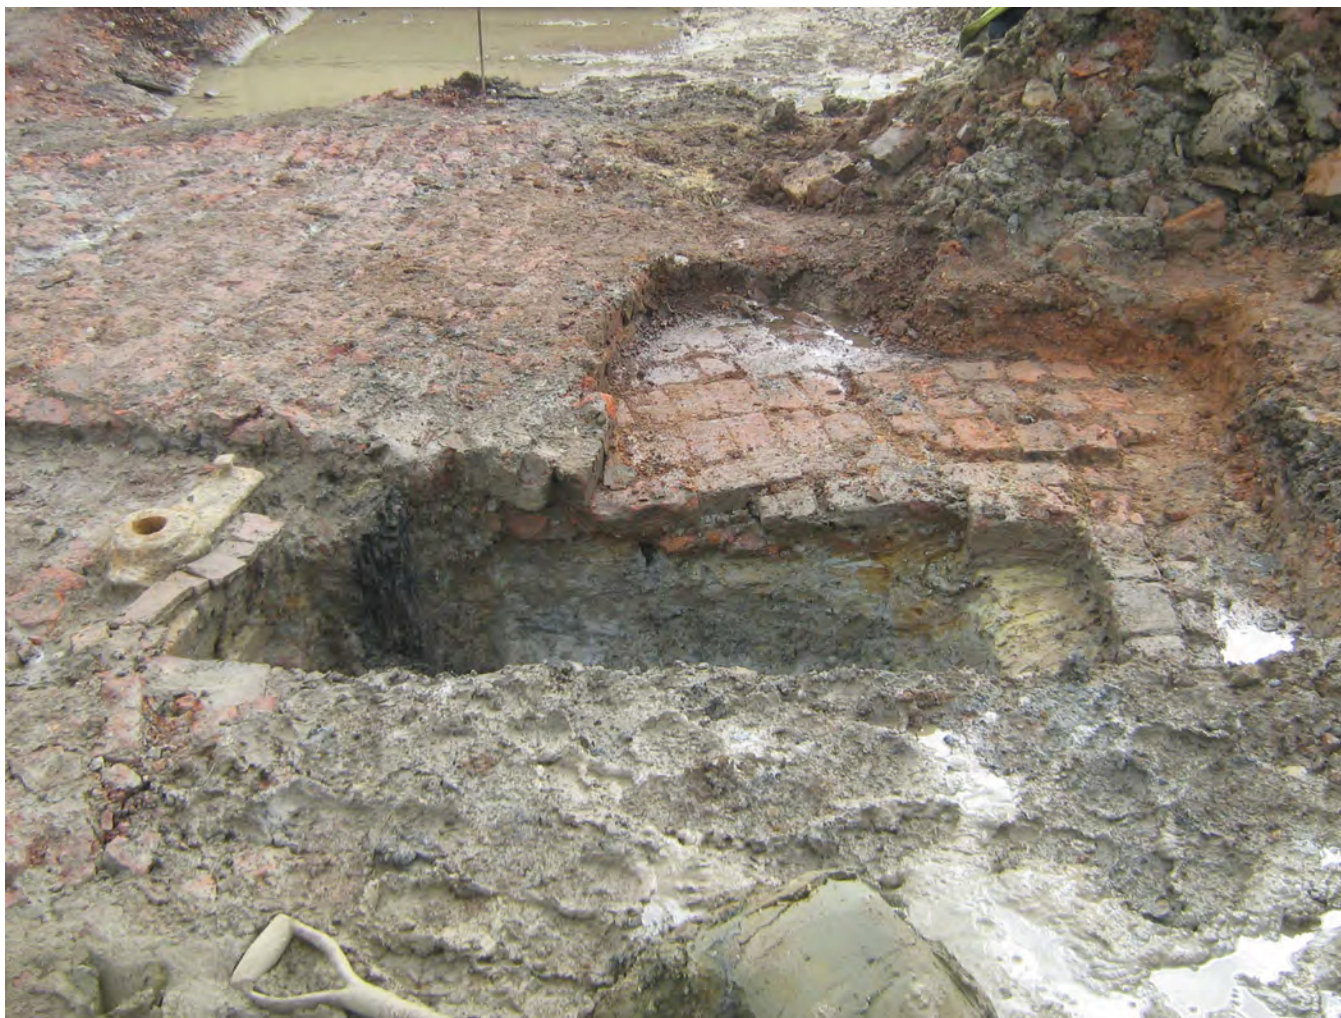
Excavated robber cut [240] viewed from the north, showing brick floors [222 - right; 167 - top left]; and the iron socket and wooden baseplate [191] of clay processing machinery

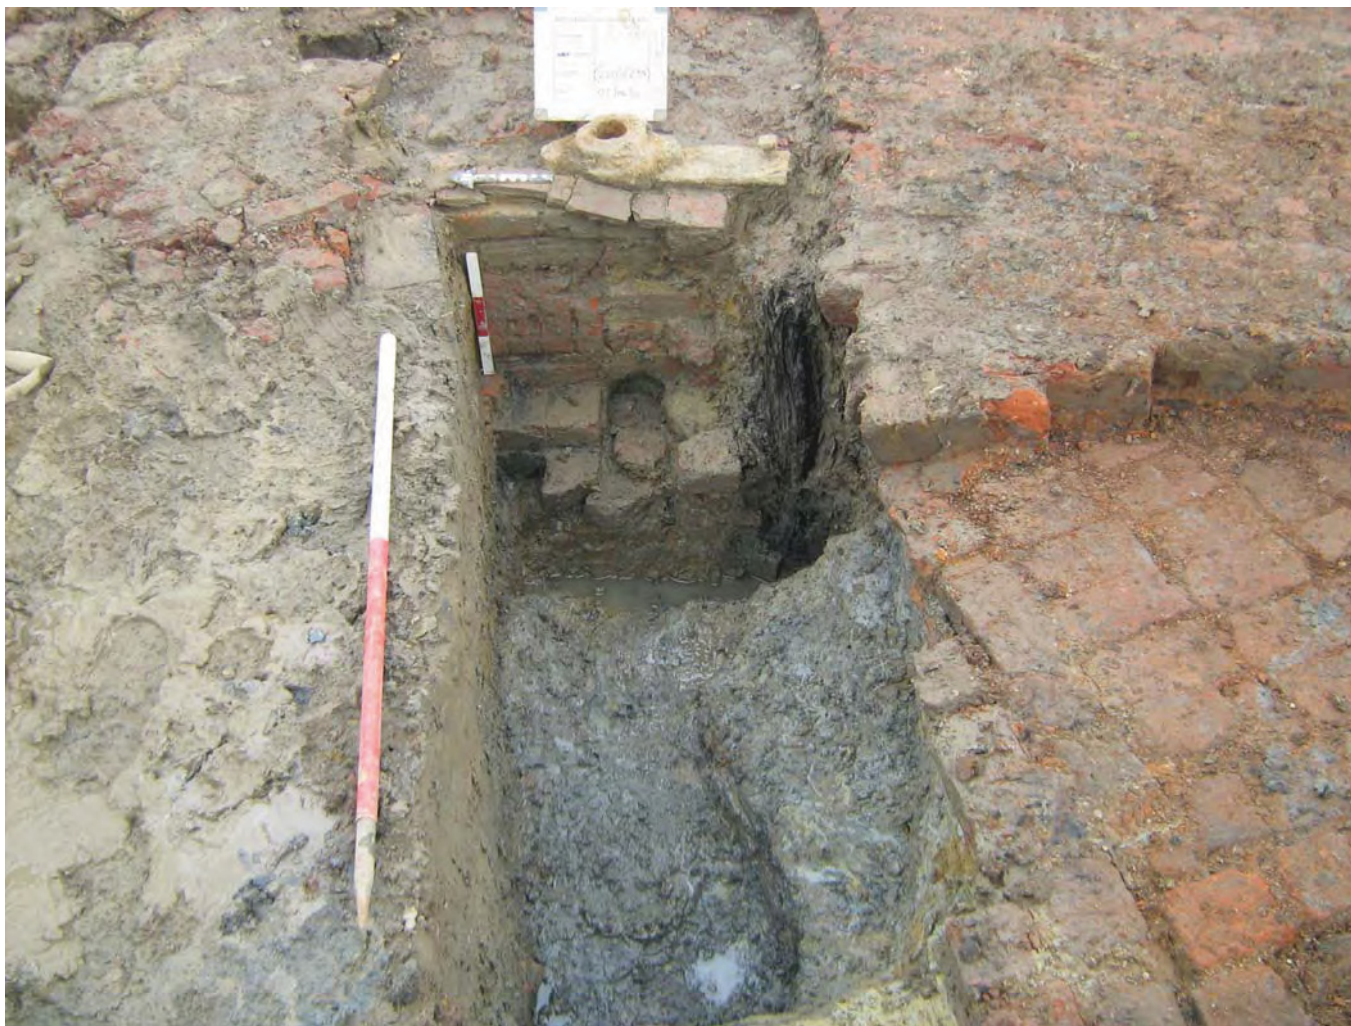
Robber cut [240] showing the weight bearing plinth [220] and one of the retaining wooden posts [241]. Brick floors [222 - bottom right] and [167 - top right] are also shown. Viewed from the west.

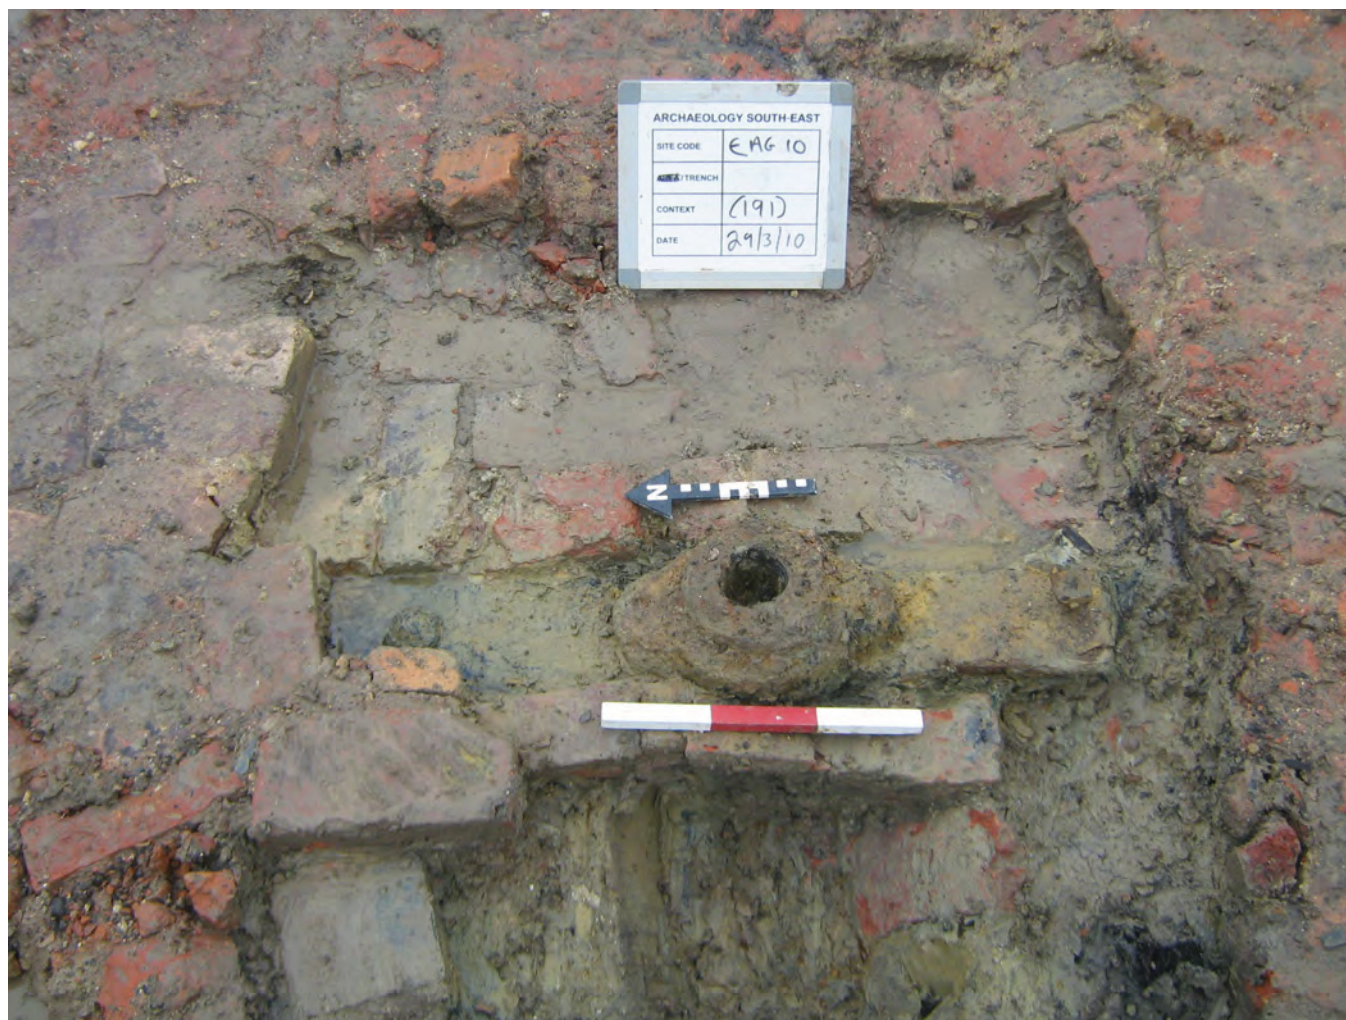
Wooden baseplate and iron socket [191] of the partially robbed away clay processing machinery.

- 4.7.5 There was evidence however that this mechanism had originally been installed into an earlier floor, [222], partially preserved directly below the one used in the final days of the pottery and that this later floor surface had been damaged and repaired during its use, ([074] and [075]). There was also evidence from beneath the truncated northern edge of this brick floor of a series of intercutting pits.

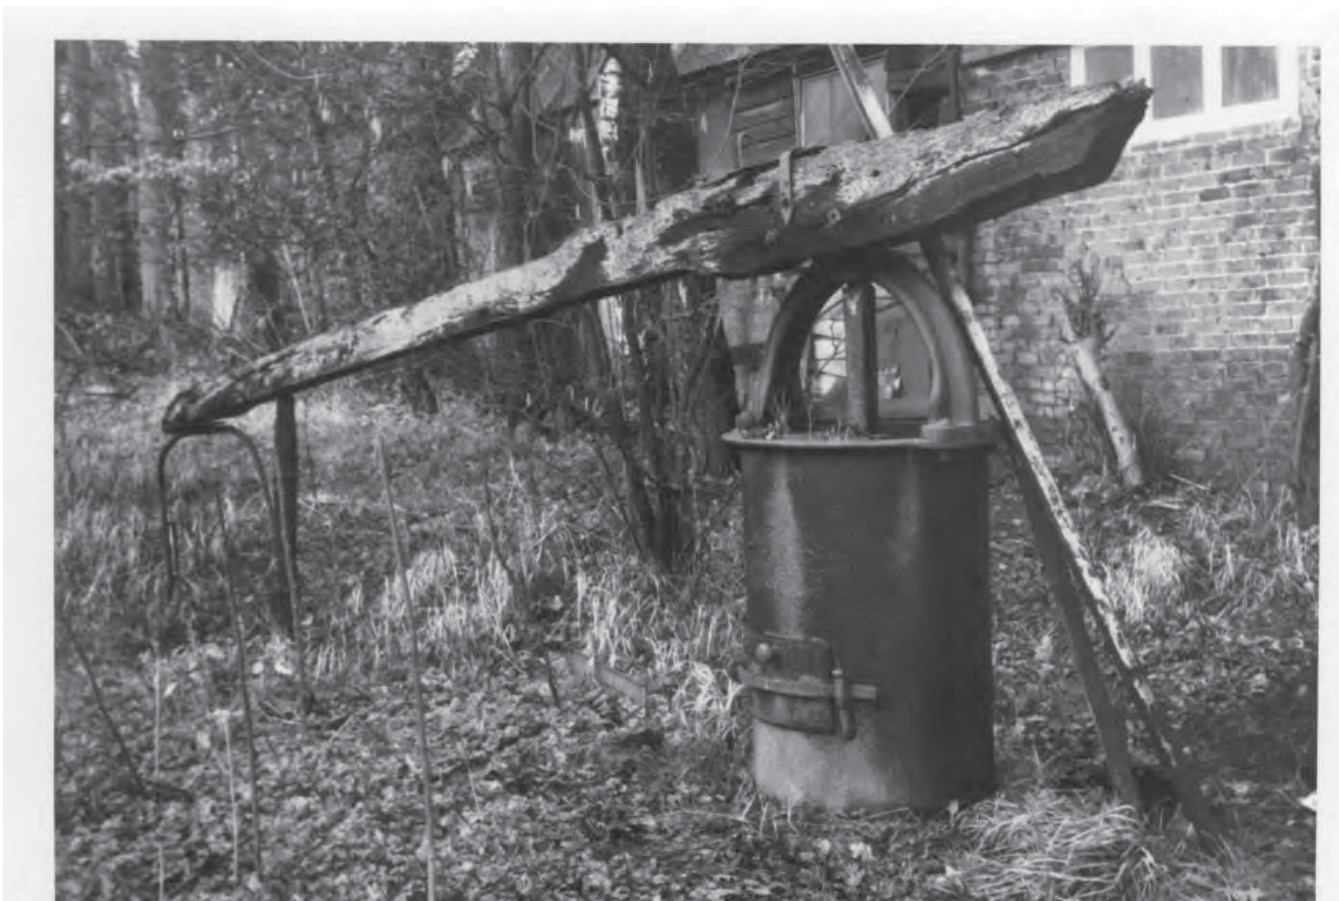
The horse driven 'pug-mill' from the East Grinstead Pottery showing the horse harnessing at the end of the wooden arm. This image was taken at the East Grinstead pottery site but it is thought unlikely that the pug-mill is in situ. Image by C.W.Goolden from the East Grinstead Museum collections.
