**An Archaeological Investigation into the former East Grinstead Pottery site,  
Garland Road, East Grinstead, West Sussex**

**Planning Refs: 08/1617/FUL; APP/D3830/A/08/2070768**

**Project Nos. 3970 / 4288  
Site Code: EAG 10**

**ASE Report No. 2010074  
OASIS ID: archaeol6-78543**

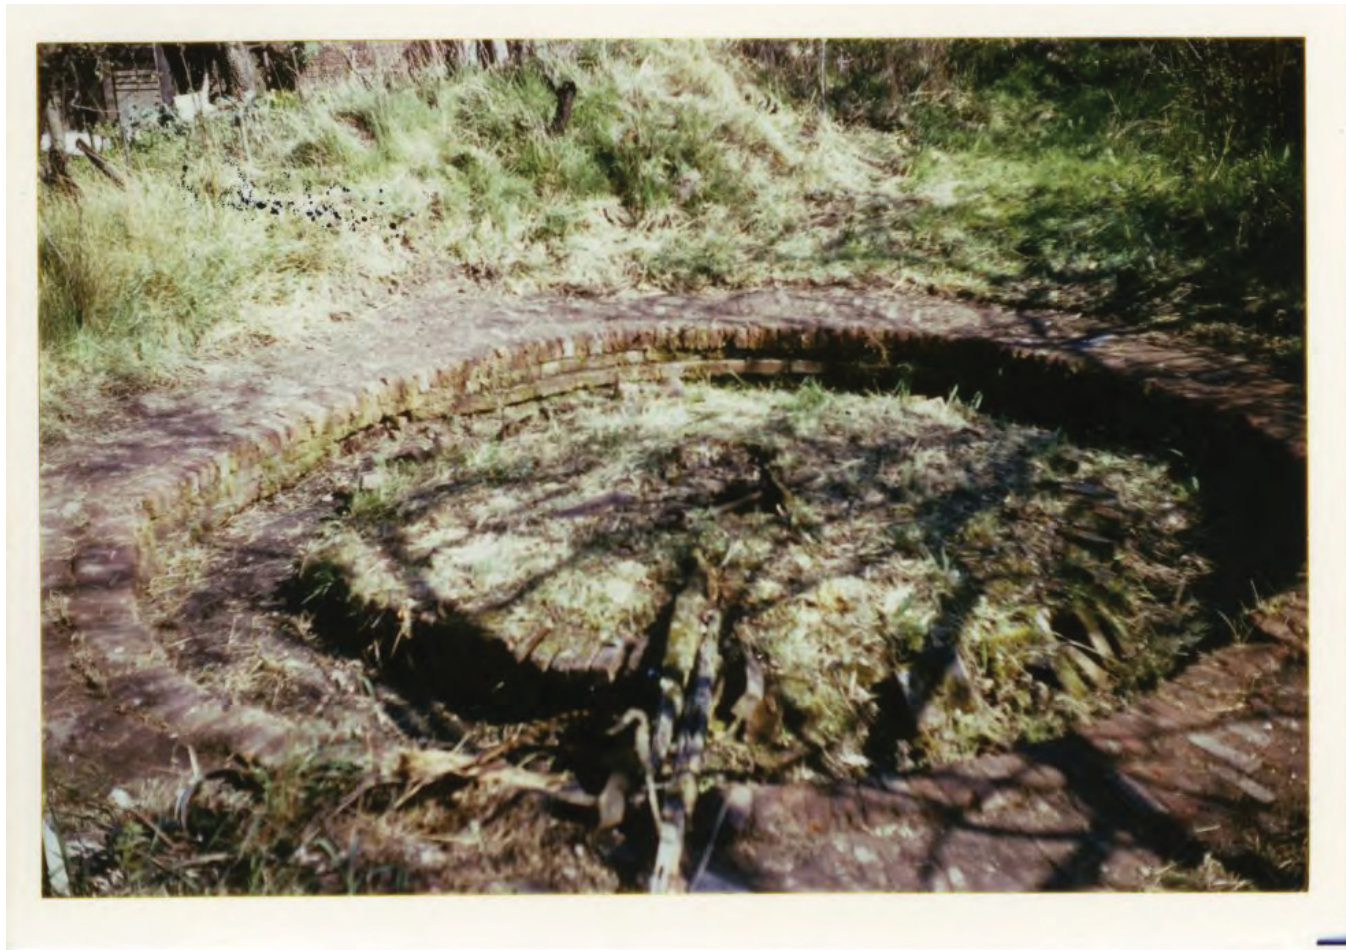
| © Archaeology South-East | | Garland Road | Fig. 30 |

The horse gin from the East Grinstead Pottery showing the inner and outer brick structures that created a trough that held unprocessed clay. Image by S.F Knowles from the East Grinstead Museum collections.

- 6.2.3 The horse gin is thought to have been an 'edge runner mill' where a heavy circular 'wheel' was pulled round a circular trough that contained the unprocessed clay to be broken up. No trace of this was identified on site and the photograph from the East Grinstead Museum (Fig. 30) gives little insight into its location or scale. However, based on the size of bricks it appears to be in the order of 5.00 metres in diameter.
