**Holy Trinity, Cuckfield, West Sussex**

**Archaeological Watching Brief**

**Commissioned by The Nicholas Rowe Practice  
on behalf of Cuckfield Parochial Church Council**

**Project No. 3620  
Report No. 2009003**

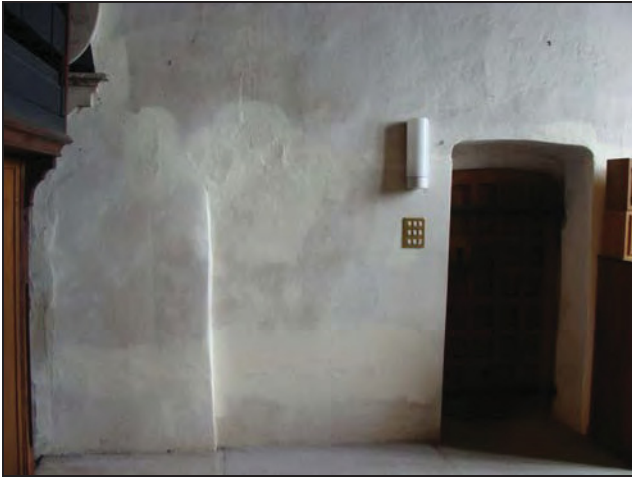
Plate 1

- 5.2 The Tudor-arched form of the extant doorway between the North Chapel and Sergison Chapel suggests that it was inserted at the time that the latter was added to the church in the 16<sup>th</sup>/17<sup>th</sup> century. It is framed by masonry on its north face although now contains a modern door. At a distance of 1.6m to the west of this doorway, the south wall face steps out by c. 80mm and gradually batters inwards as it rises to ultimately lie flush with the remainder of the wall face above. Both sides of the wall are finished with a rough cement-based plaster with several areas of repair and patching evident, particularly on the south (Plate 1).

South face of the wall prior to the commencement of work, taken from the south

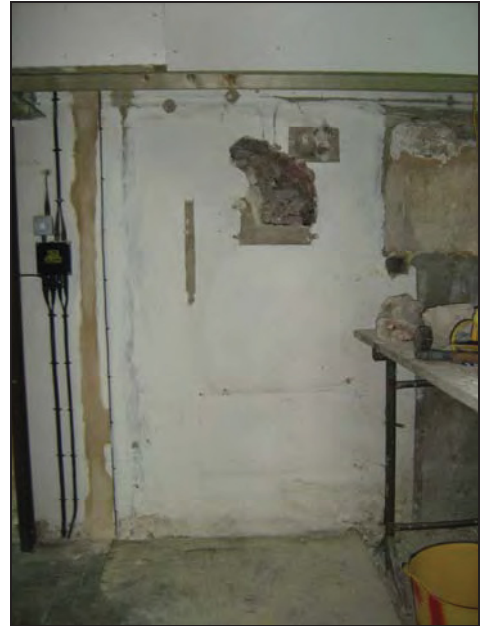
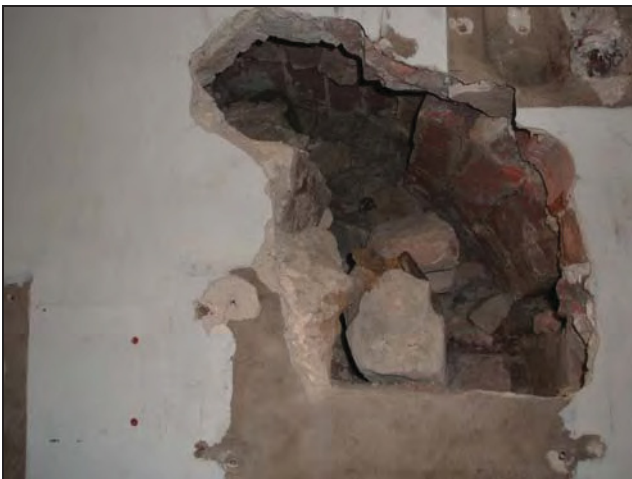
- 5.3 Some time prior to the commencement of work, a small area of the wall surface on the north side had been removed during electrical works, revealing the presence of a brick arch within the wall fabric (Plates 2 and 3).

North face of the wall prior to the commencement of work, showing hole introduced during electrical works, taken from the north

Brickwork arch revealed during electrical works, taken from the north

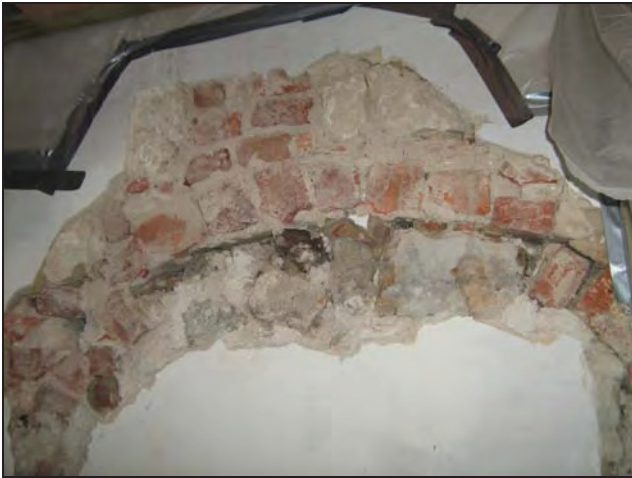
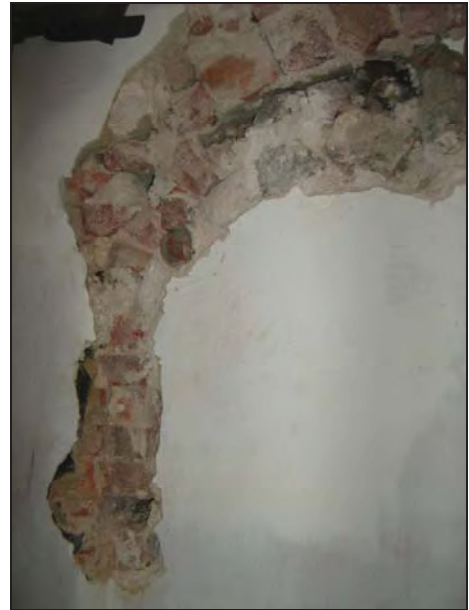
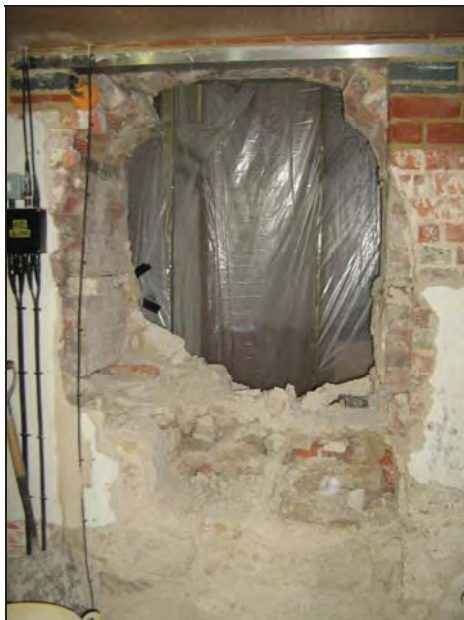
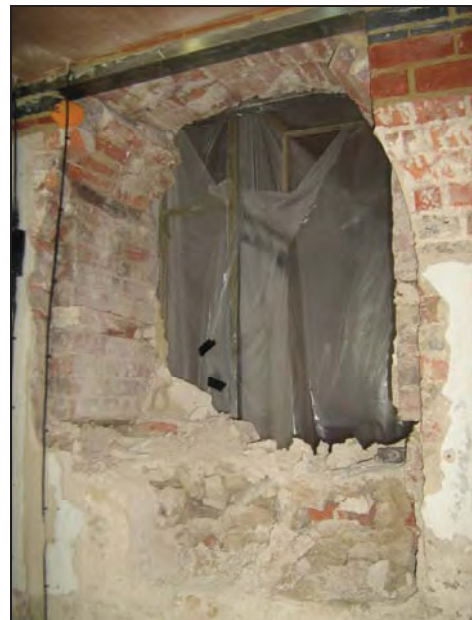
- 5.4 As part of the works associated with the creation of the new doorway, the plasterwork on each face of the wall was carefully removed to the proposed extent of the new doorway, revealing an earlier door aperture with a crudely formed segmented arched head (Plates 4-8). The aperture is two brick-lengths in depth and measures 1.07m wide by 2.05m high (Fig. 6), the easternmost jamb abutting the stone jamb of the extant doorway. It is constructed in orange-red brickwork, the bricks being slightly creasy and measuring on average 225mm x 110mm x 65mm (8¾" x 4¼" x 2½"). They are bonded in a hard cement mortar. Each jamb contains several timber bearers; although the uppermost bearer of the west jamb has rotted away and is now represented by a void in the brickwork. The brickwork appears 19<sup>th</sup> century in date.

North face of the wall during removal of plaster, showing brickwork opening and infill material, taken from the north

South face of the wall during removal of plaster, showing brickwork arch and infill material, taken from the south

Photograph taken during the removal of infill material, taken from the north

Photograph taken during the removal of infill material, taken from the north-west

- 5.6 The form and dimensions of the aperture leave no doubt that it was intended as a doorway. It is not absolutely clear as to why it was later infilled, although it may be that the arch had begun to fail, as some of the brickwork of the inner section is missing, perhaps having fallen away. The material infilling the doorway consisted largely of sandstone rubble set in generous amounts of a relatively crumbly cementitious mortar. The larger pieces of stone were located predominantly towards the base of the opening, while smaller, looser rubble was located at the upper level. The majority of the stone is un-worked, although included a small assortment of dressed pieces. The largest of these measures 400mm x 350mm x 340mm and has a wide hollow with a fillet to one side and a roll-moulding to the other (Plate 9). It was noticed by Mr. Peter Newson that this piece is similar in profile to the interior face of the vestry window jambs. The Victoria County History (Salzman 1940, 161) records that both these windows are modern. A smaller piece of masonry measuring 300mm x 220mm x 200mm appears to represent the curve of part of an arch, perhaps for a doorway or window, and has a chamfer to one face (Plate 10), while two other pieces appear to be part of the outer face of a window, having a broad chamfer (Plates 11 and 12), similar examples being visible elsewhere on the church. Other pieces are difficult to identify, but are illustrated (Plates 13-17).

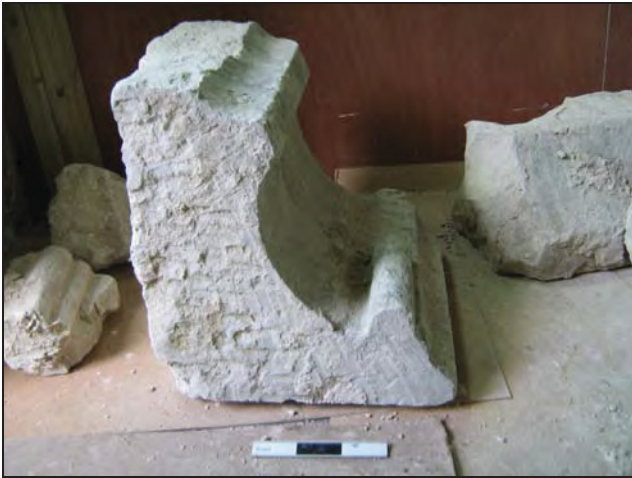
Plate 9

Dressed stone found within infill. Profile matches that of the vestry window jambs.

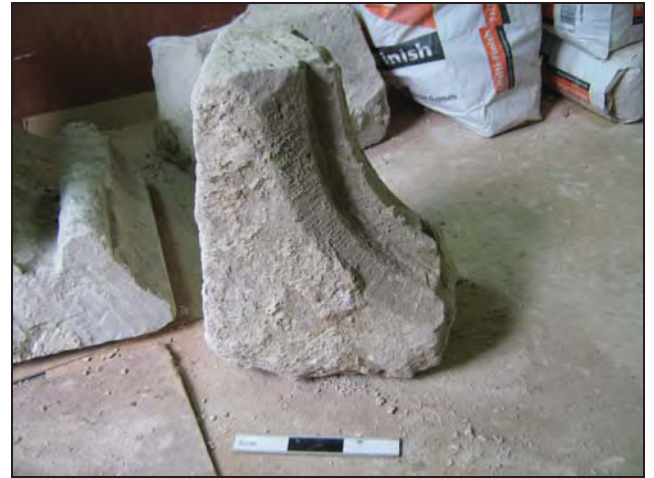
Plate 10

Dressed stone found within infill. Possibly part of a doorway or window.

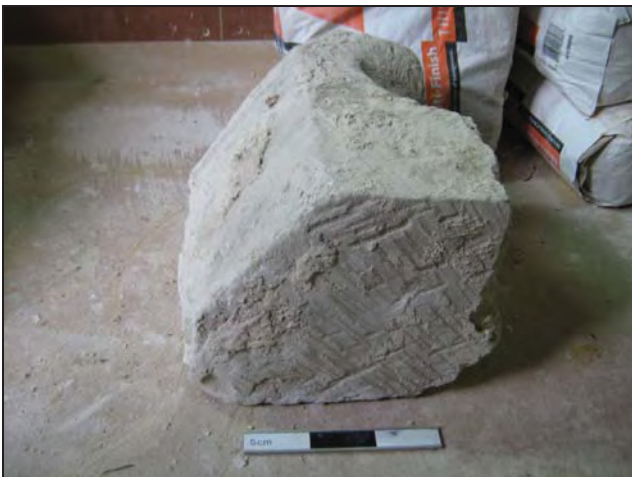
Plate 11

Dressed stone found within infill. Possibly part of a window opening.

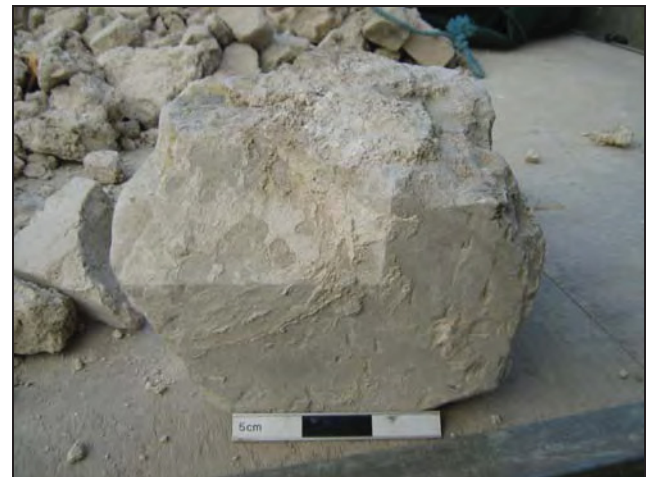
Plate 12

Dressed stone found within infill. Possibly part of a window opening.

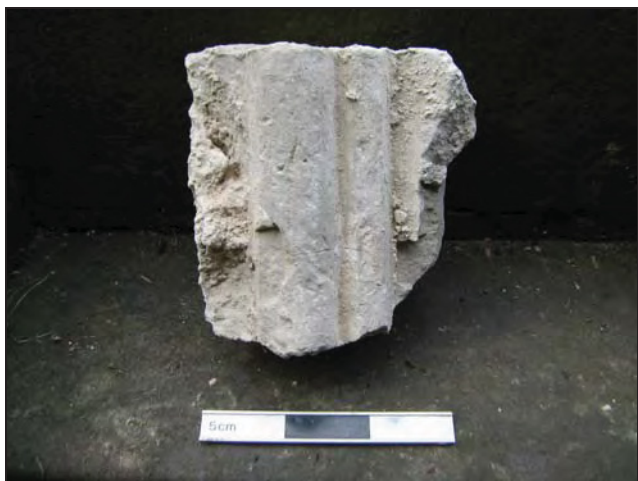
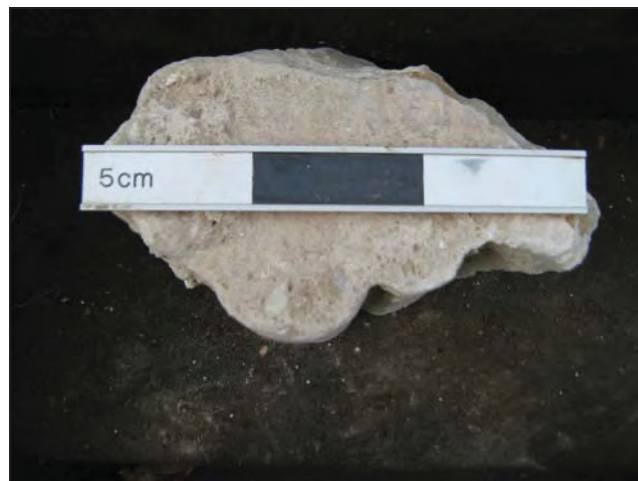
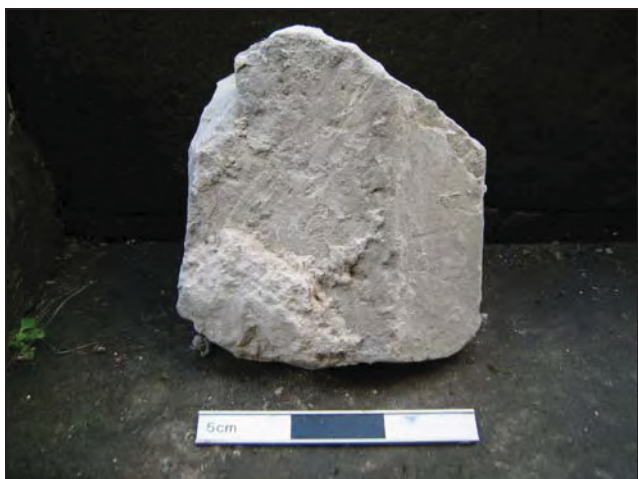
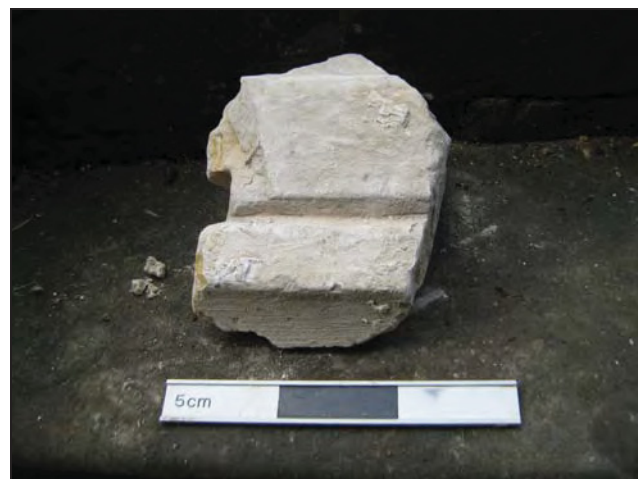
Dressed stone found within infill.

Dressed stone found within infill (same as previous).
