**An Archaeological Watching Brief at
Iping Road, Milland**

**Project No. 3151
Site Code: IRM08**

**ASE Report No. 2010217
OASIS id: archaeol6-88640**

January 2011

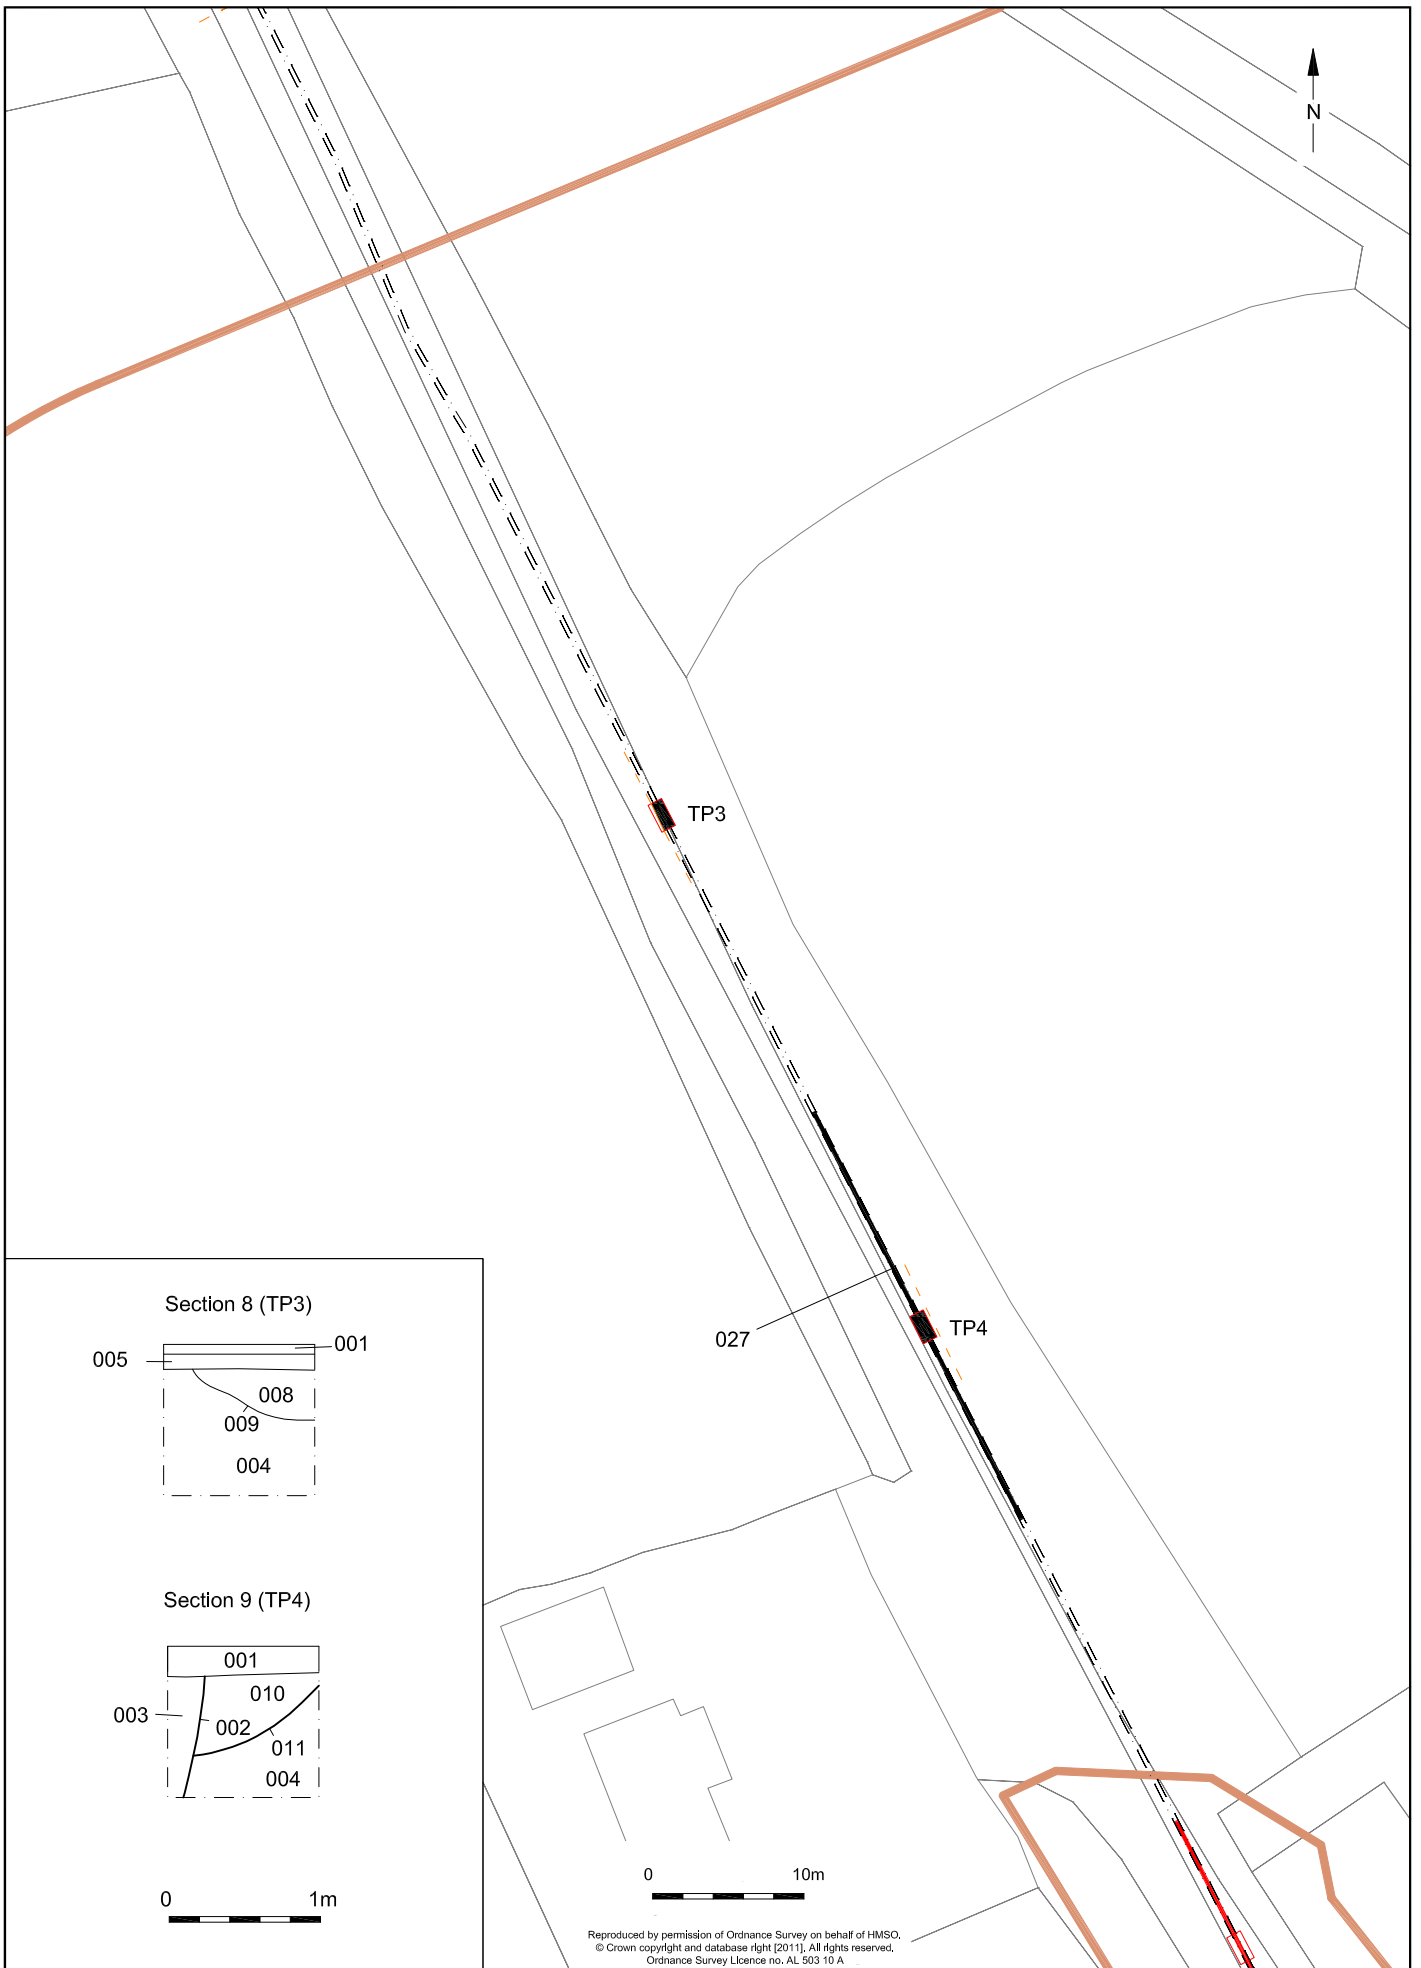
© Archaeology South-East		Iping Road, Milland	Fig. 5
Project Ref: 3151	Jan 2011	Plan segment 3	
Report Ref: 2010217	Drawn by: JLR

4.1.3 Test pit 3 (Fig. 5, Section 8)

Test pit 3 was excavated within the scheduled area. Cut into the natural was possible ditch ([009]), not noted in the excavation of the pipe trench. This feature was orientated north to south, with gently sloping sides, and was

exposed for a length of 2.0m, was at least 0.8m in width and 0.35m in depth. It was filled with loose dark brown grey silt [008], similar to the topsoil noted at the road edge. No finds were recovered from [008].

4.1.4 Test pit 4 (Fig. 5, Section 9)

Test Pit 4 was also situated within the scheduled area. Natural [004] was located at the base of the test-pit. A linear feature [011] approximately 0.40m in depth was orientated north to south through the test pit. This was filled with yellow silty sand containing occasional sandstone cobbles and boulders. This feature had been cut by a continuation of the modern service trench originally located in test pit 1, and was sealed by the road bedding and surface layers.

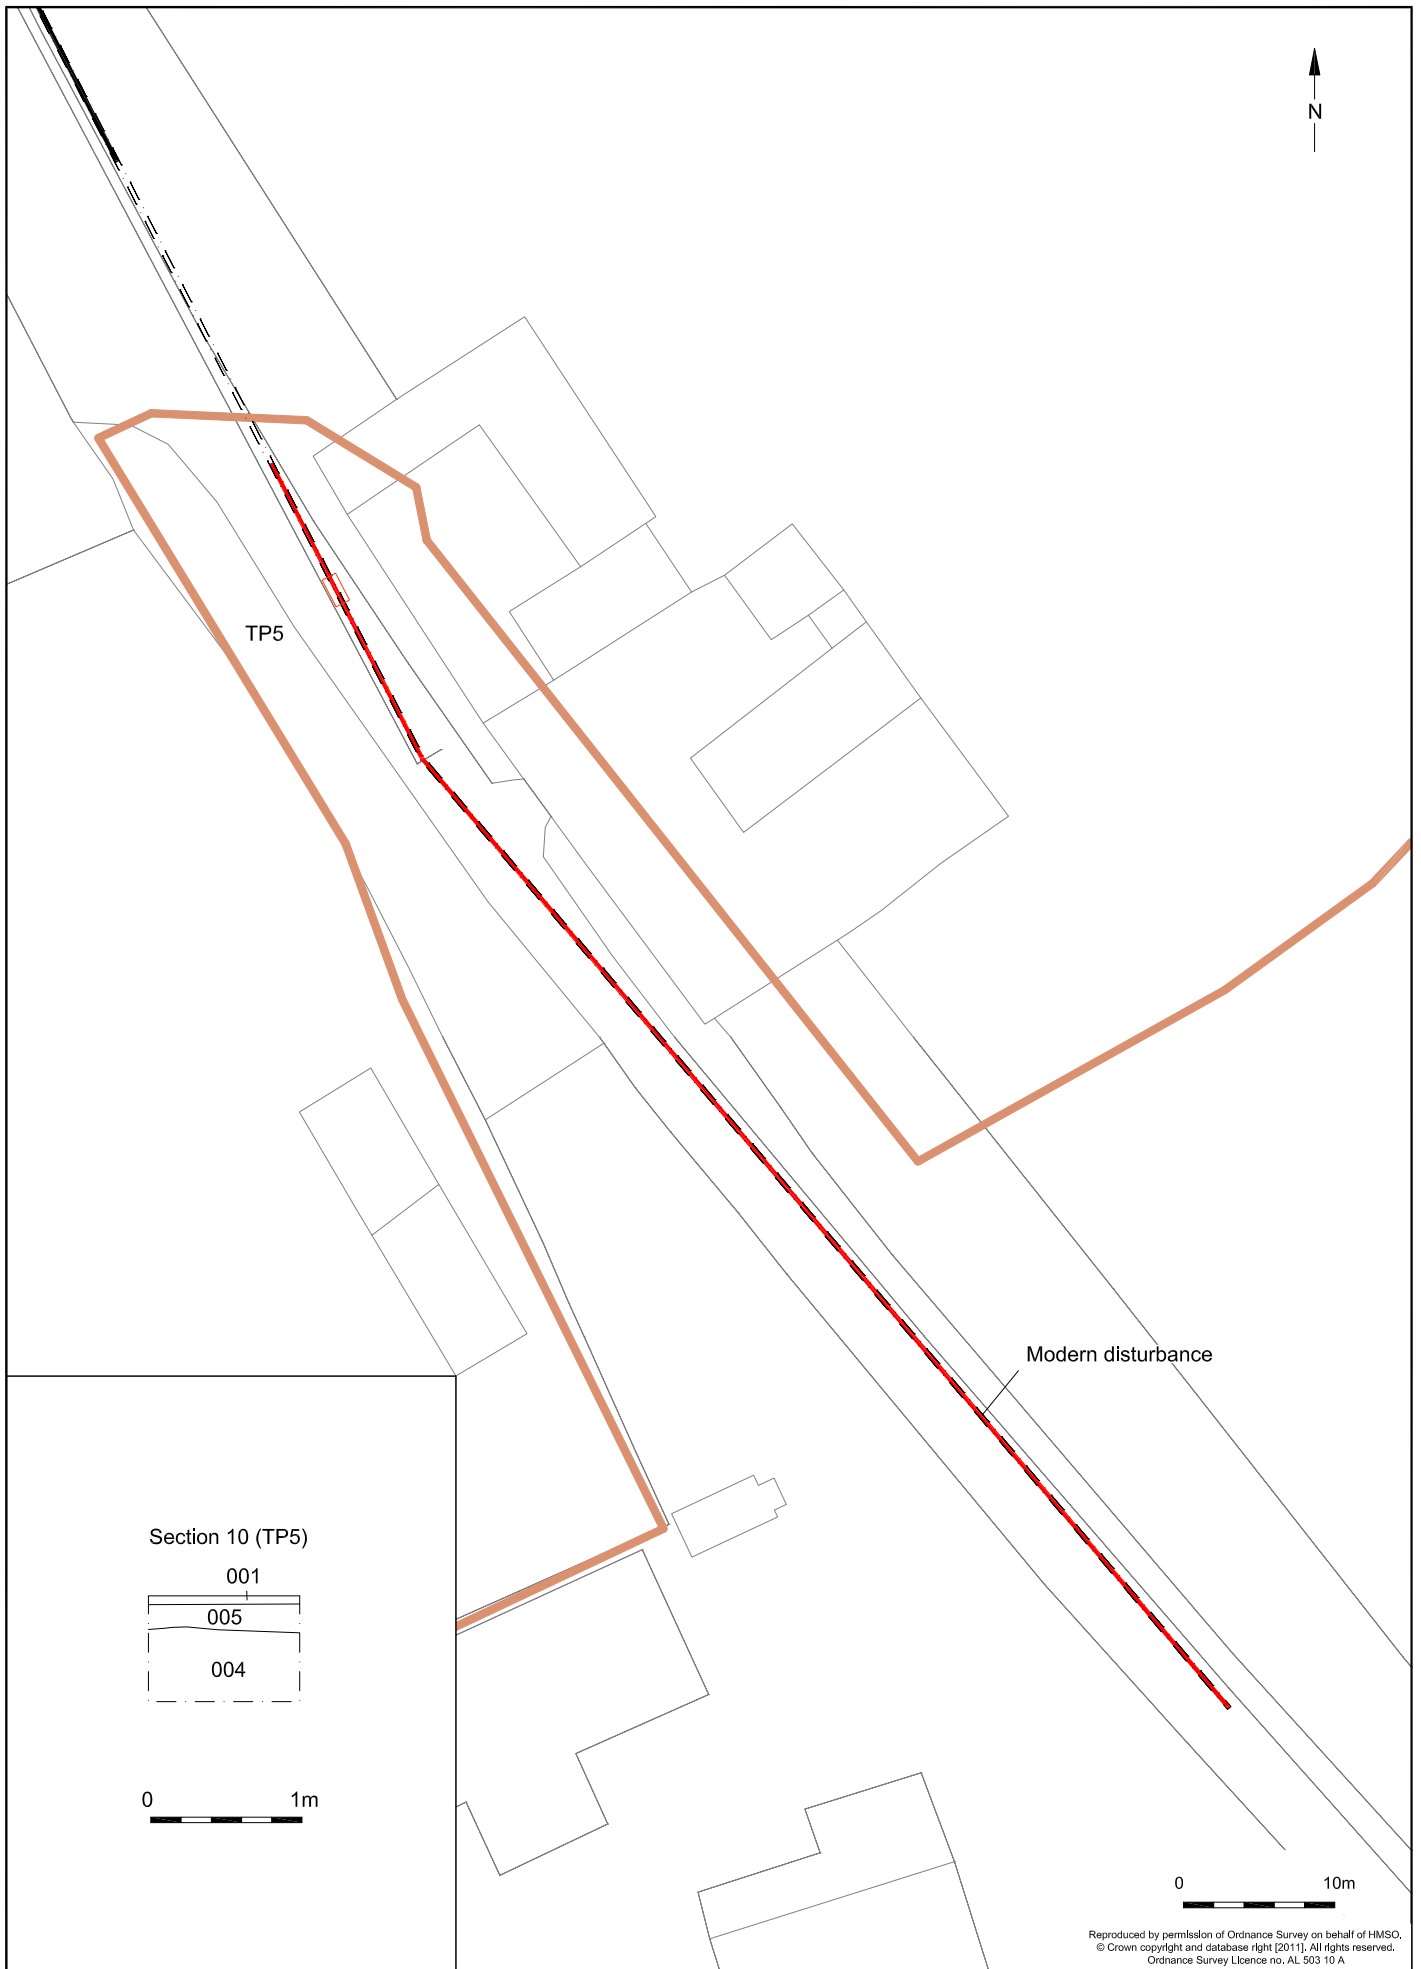
© Archaeology South-East		Iping Road, Milland	Fig. 6
Project Ref: 3151	Jan 2011	Plan segment 4	
Report Ref: 2010217	Drawn by: JLR

4.1.5 Test pit 5 (Fig. 6, Section 10)

Test pit 5 was situated to the south of the scheduled area. The natural geology [004] was located directly beneath the road surface and bedding, and no archaeological features or artefacts were located in this test pit.
