**An Archaeological Investigation at  
Lewes Priory, Lewes, East Sussex**

**Project No: 4197  
Site Code: LPR 10**

**ASE Report No. 2010189  
OASIS ID: archaeol6-91252**

**January 2011**

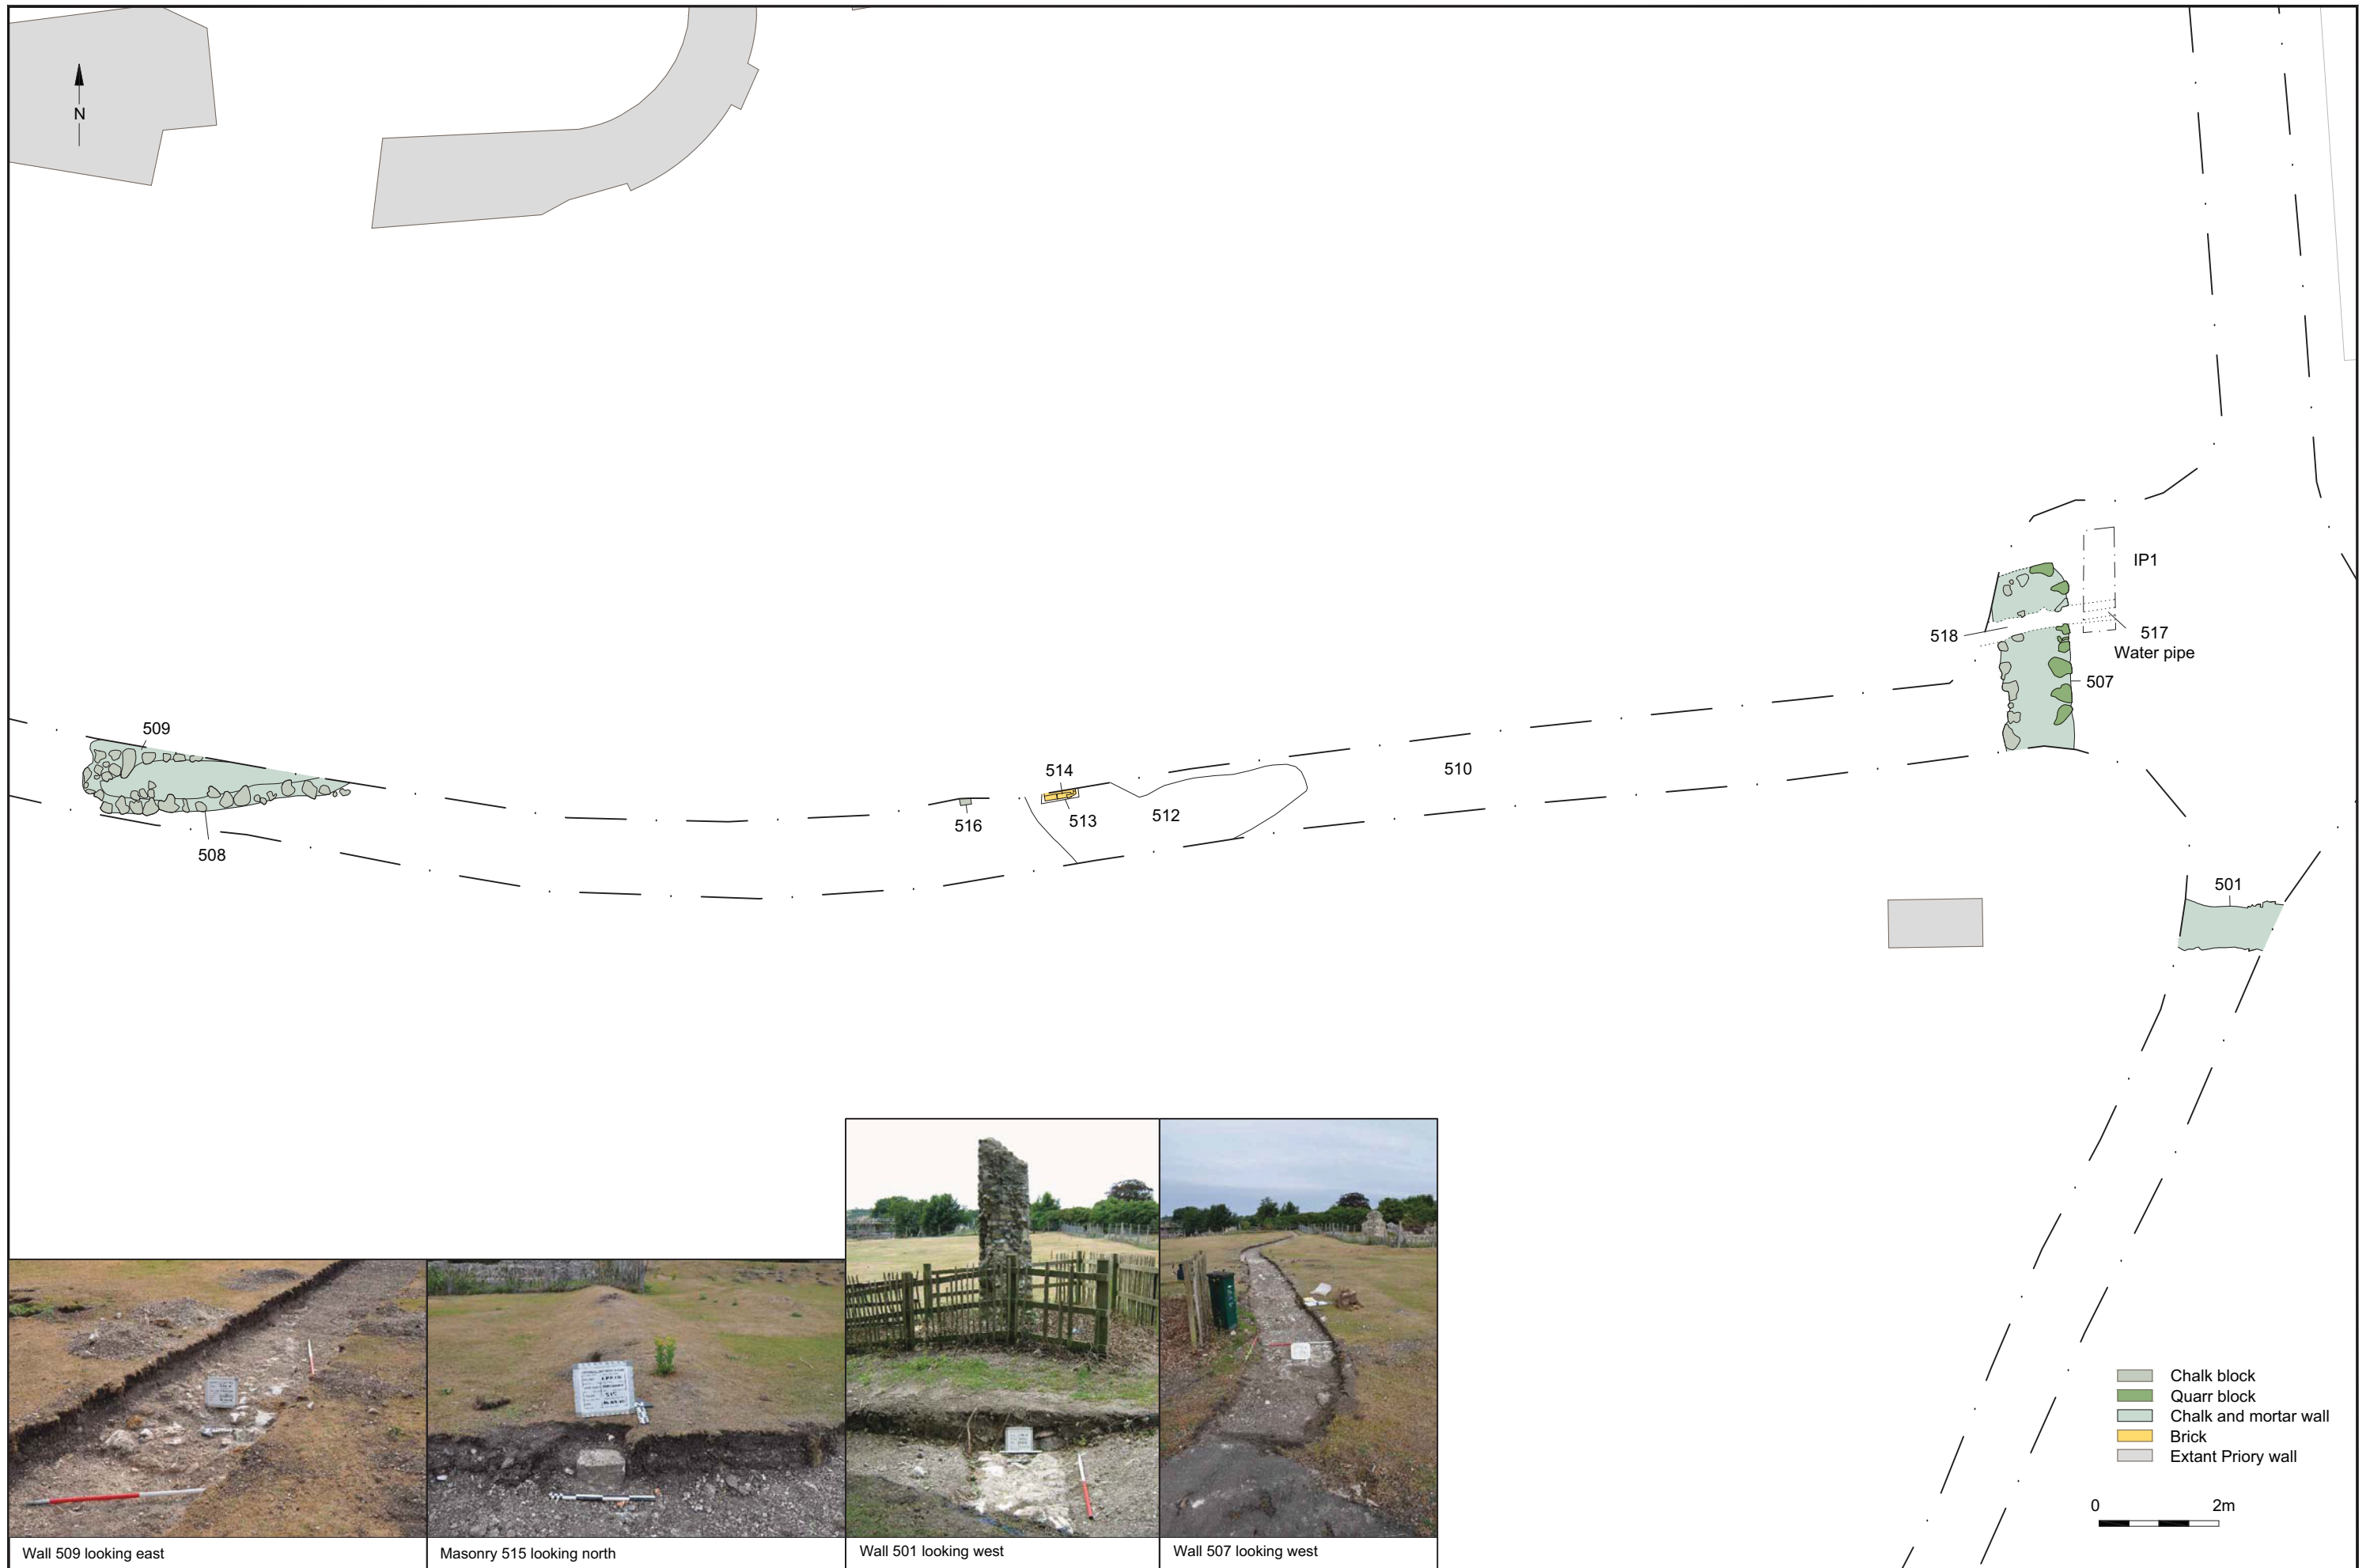
| © Archaeology South-East | | Lewes Priory | Fig. 6 |

| Project Ref: 4197 | Feb 2011 | Detail of paths A and C | |

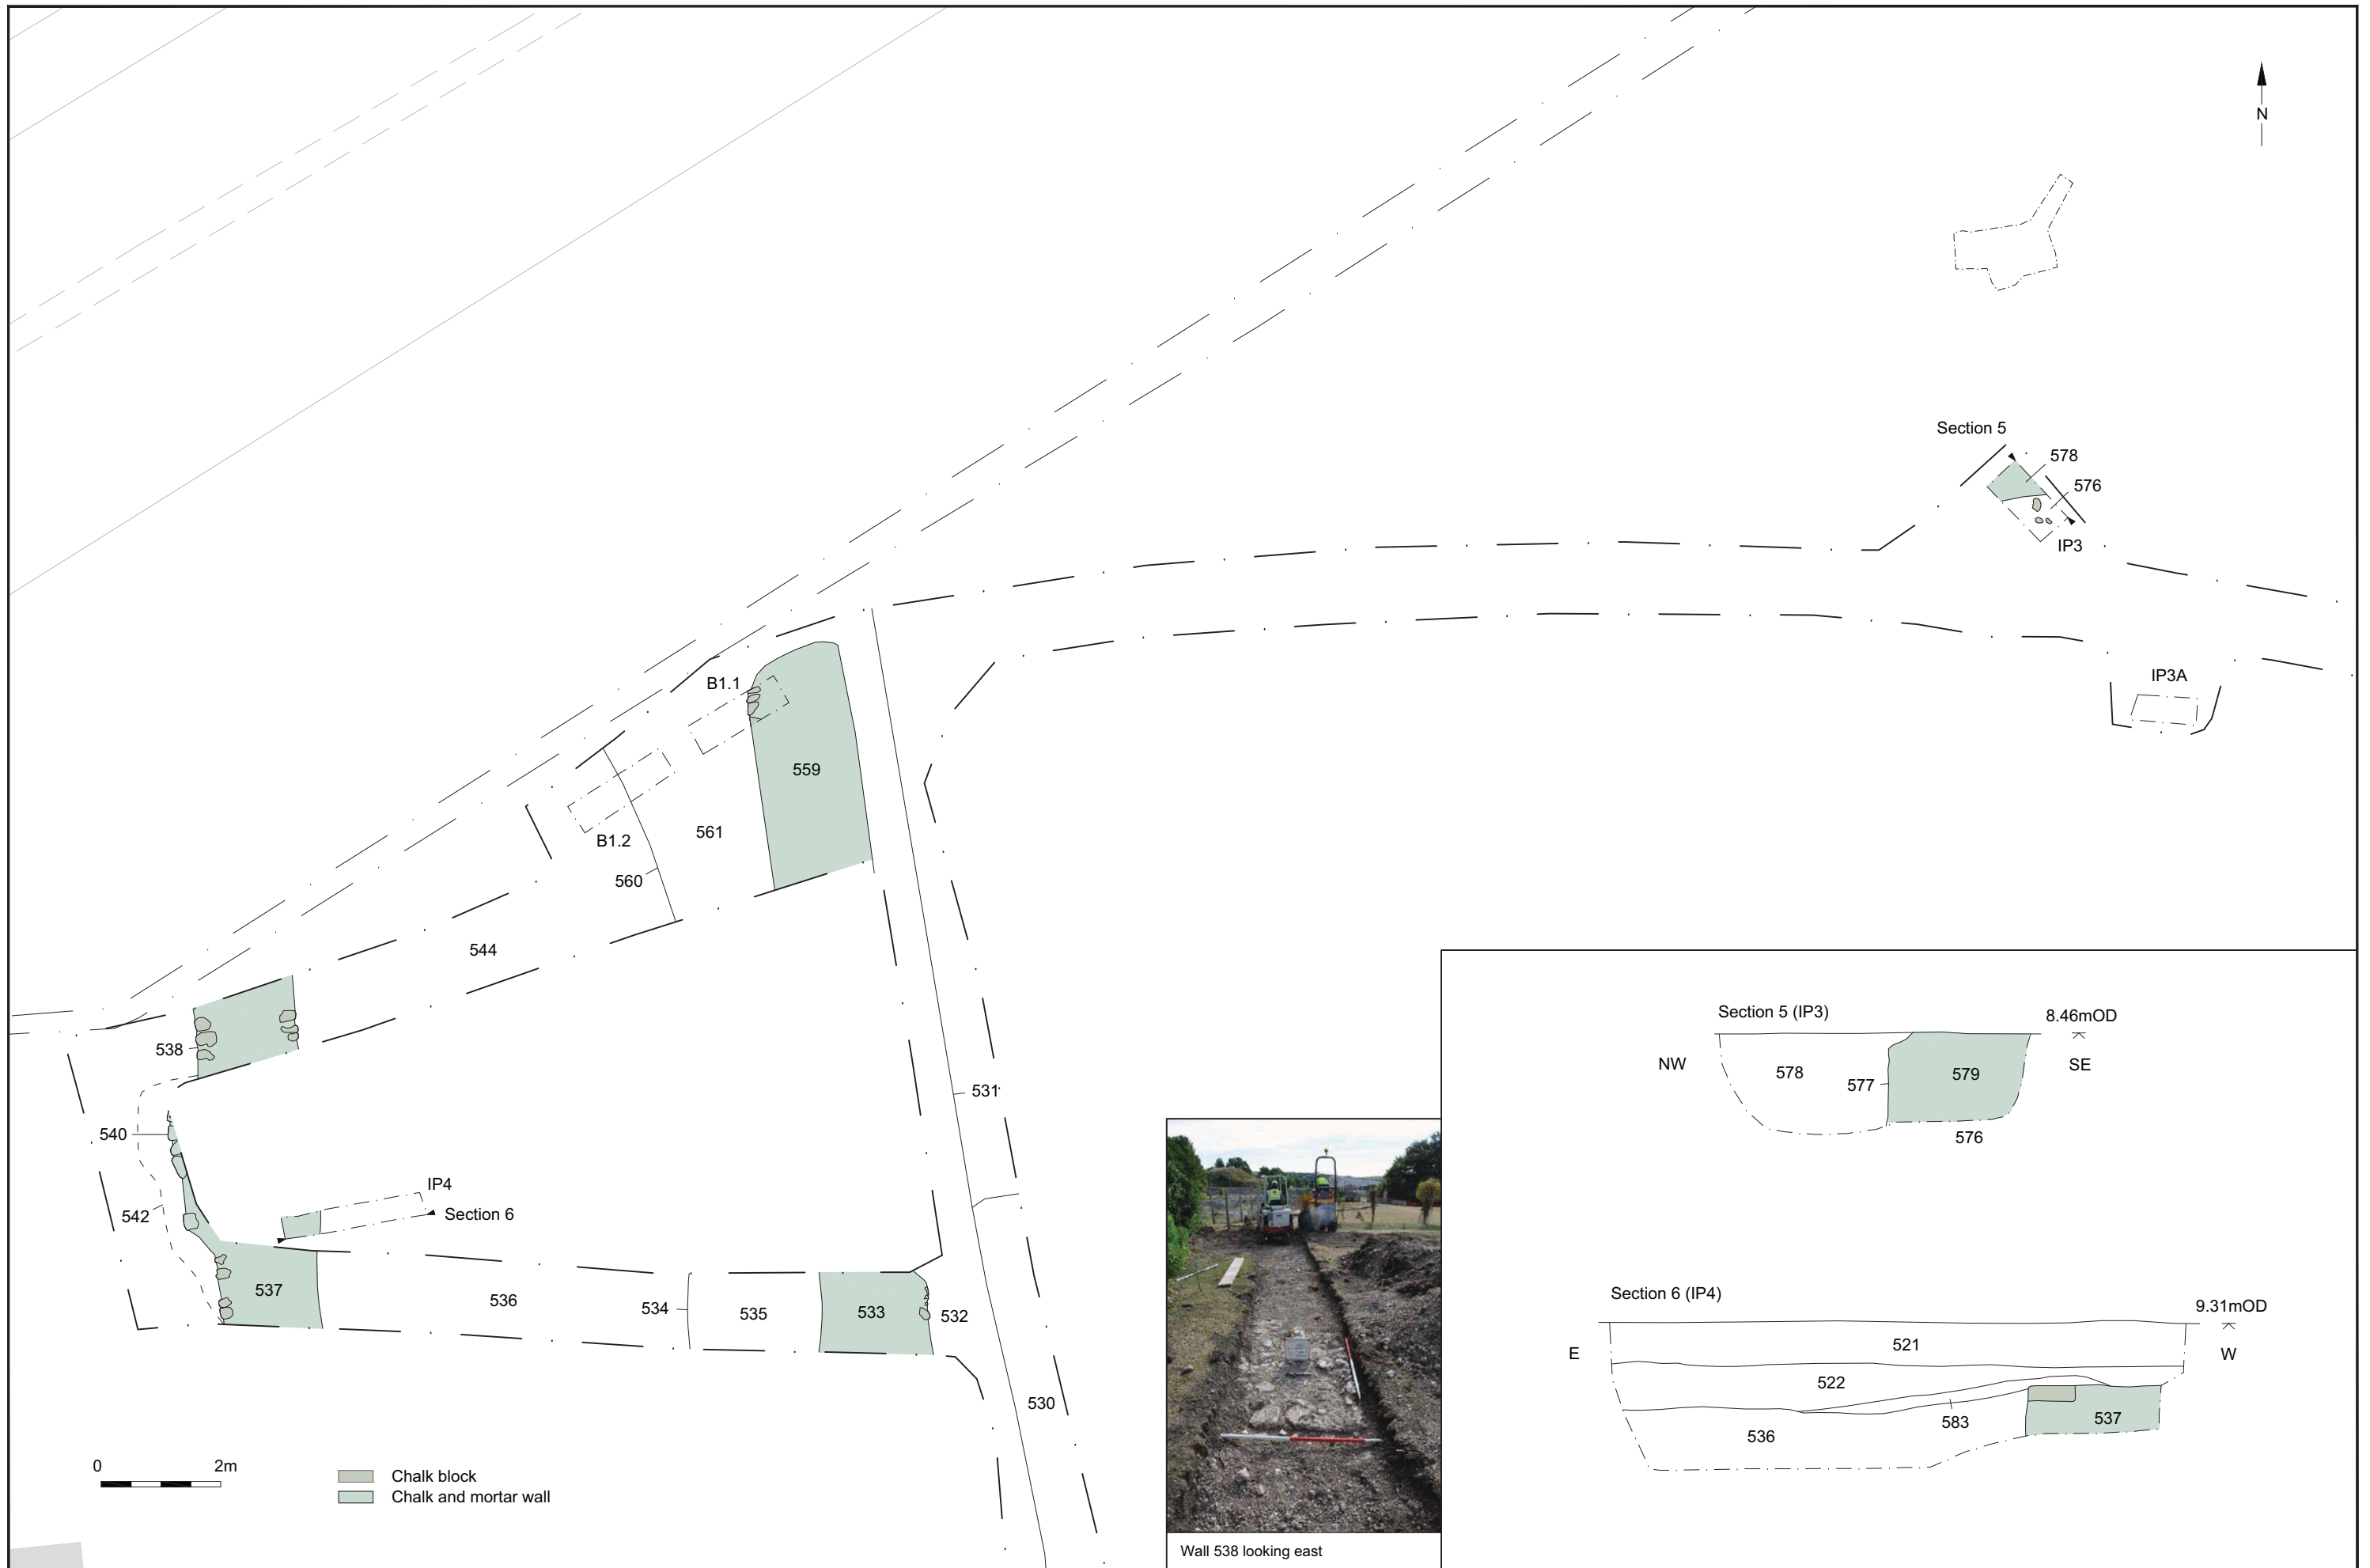
| © Archaeology South-East | | Lewes Priory | Fig. 7 |

| Project Ref: 4197 | Feb 2011 | Detail of paths C and D | |

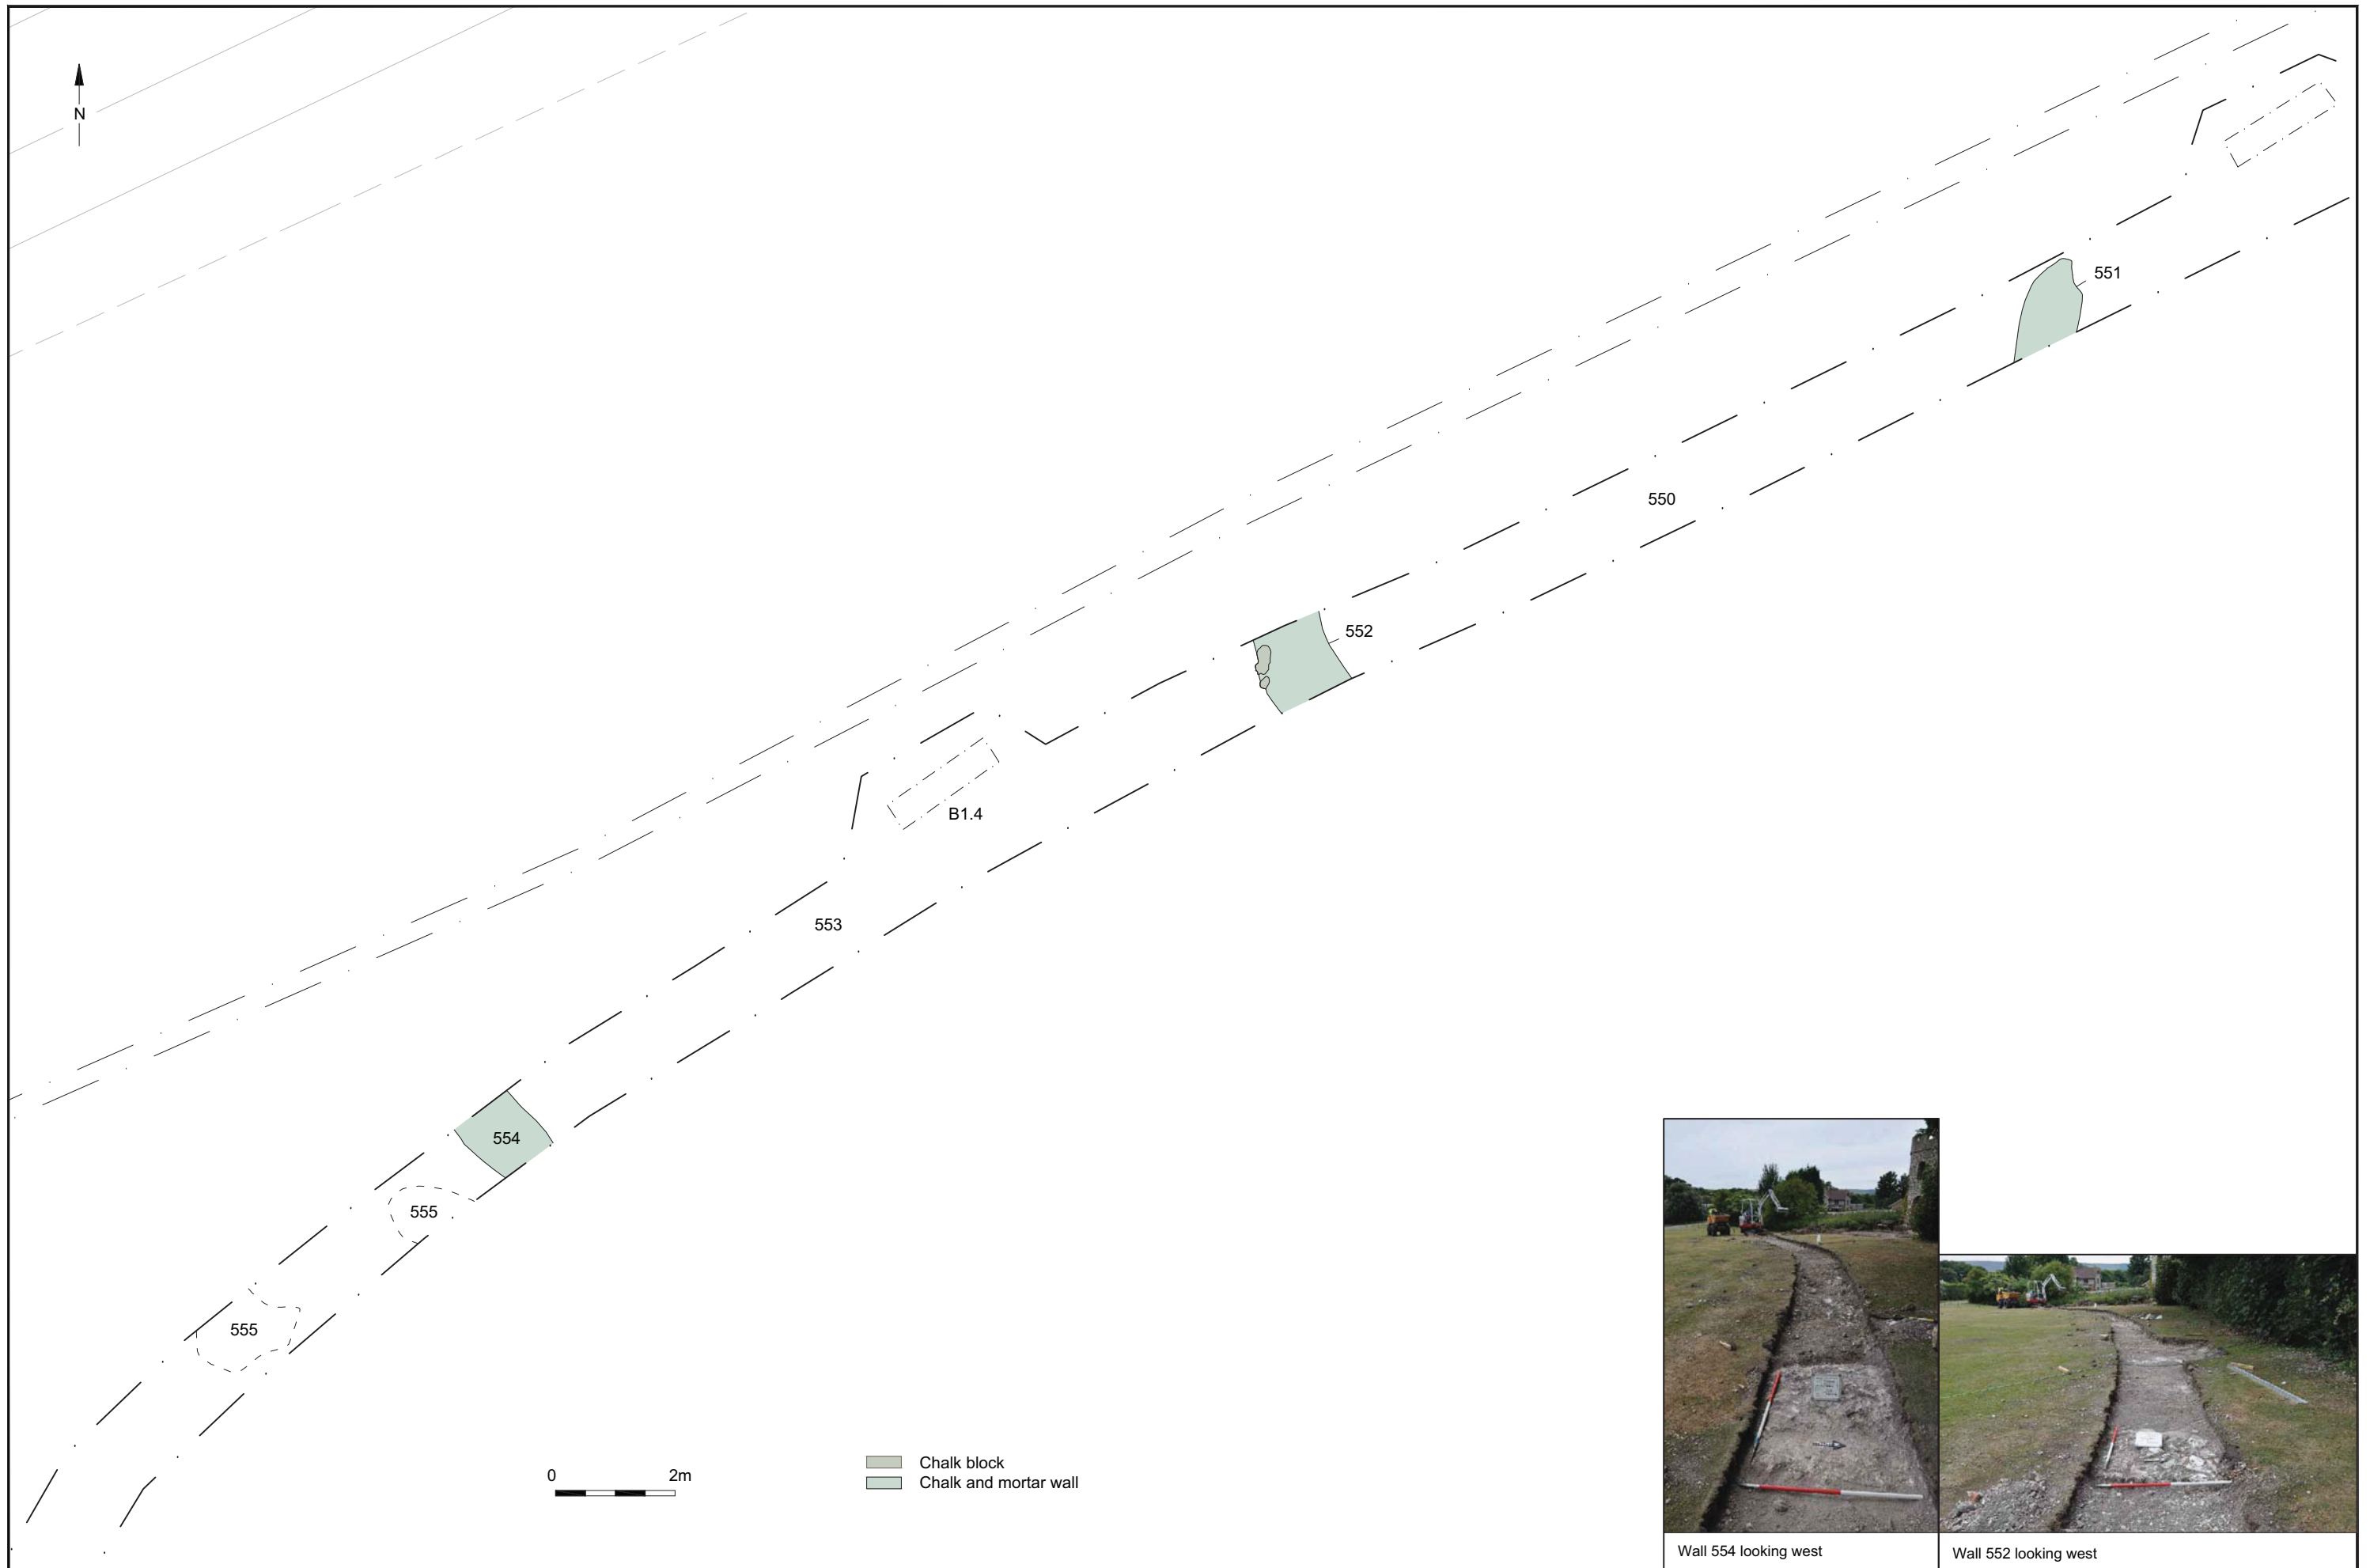
| © Archaeology South-East | | Lewes Priory | Fig. 9 |

| Project Ref: 4197 | Feb 2011 | Detail of path E | |

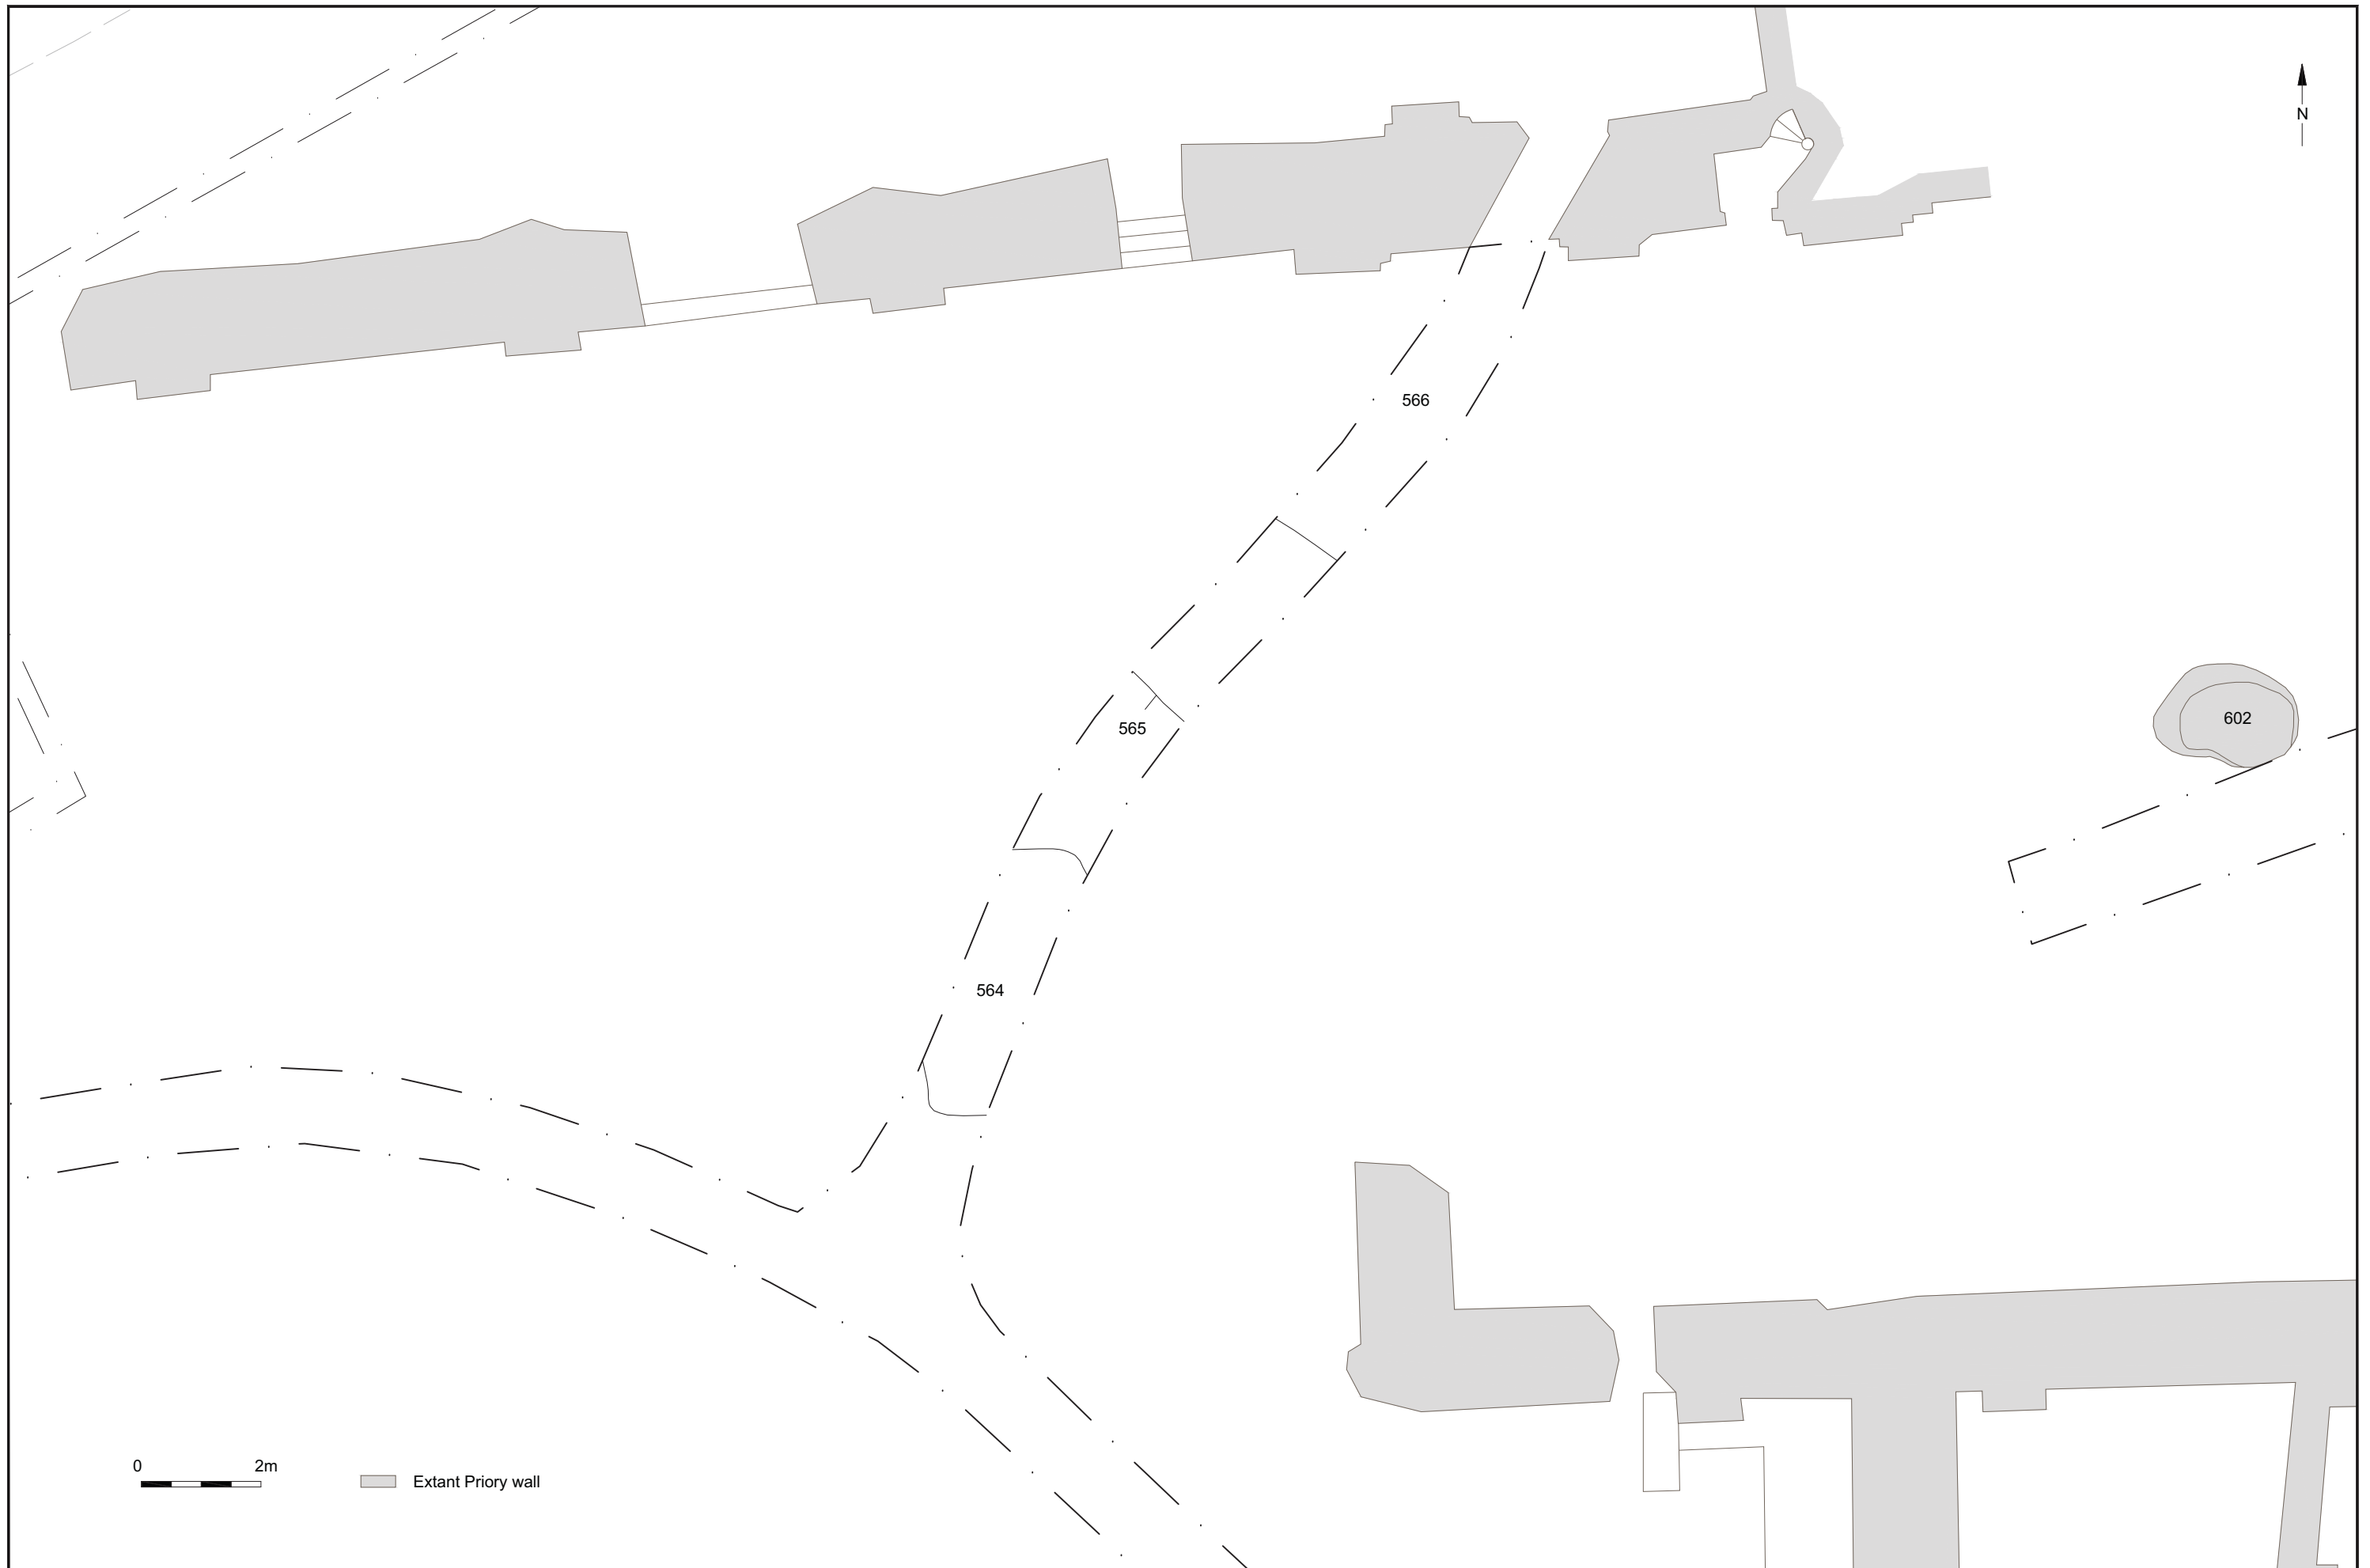
| © Archaeology South-East | | Lewes Priory | Fig. 10 |

| Project Ref: 4197 | Feb 2011 | Detail of path F | |

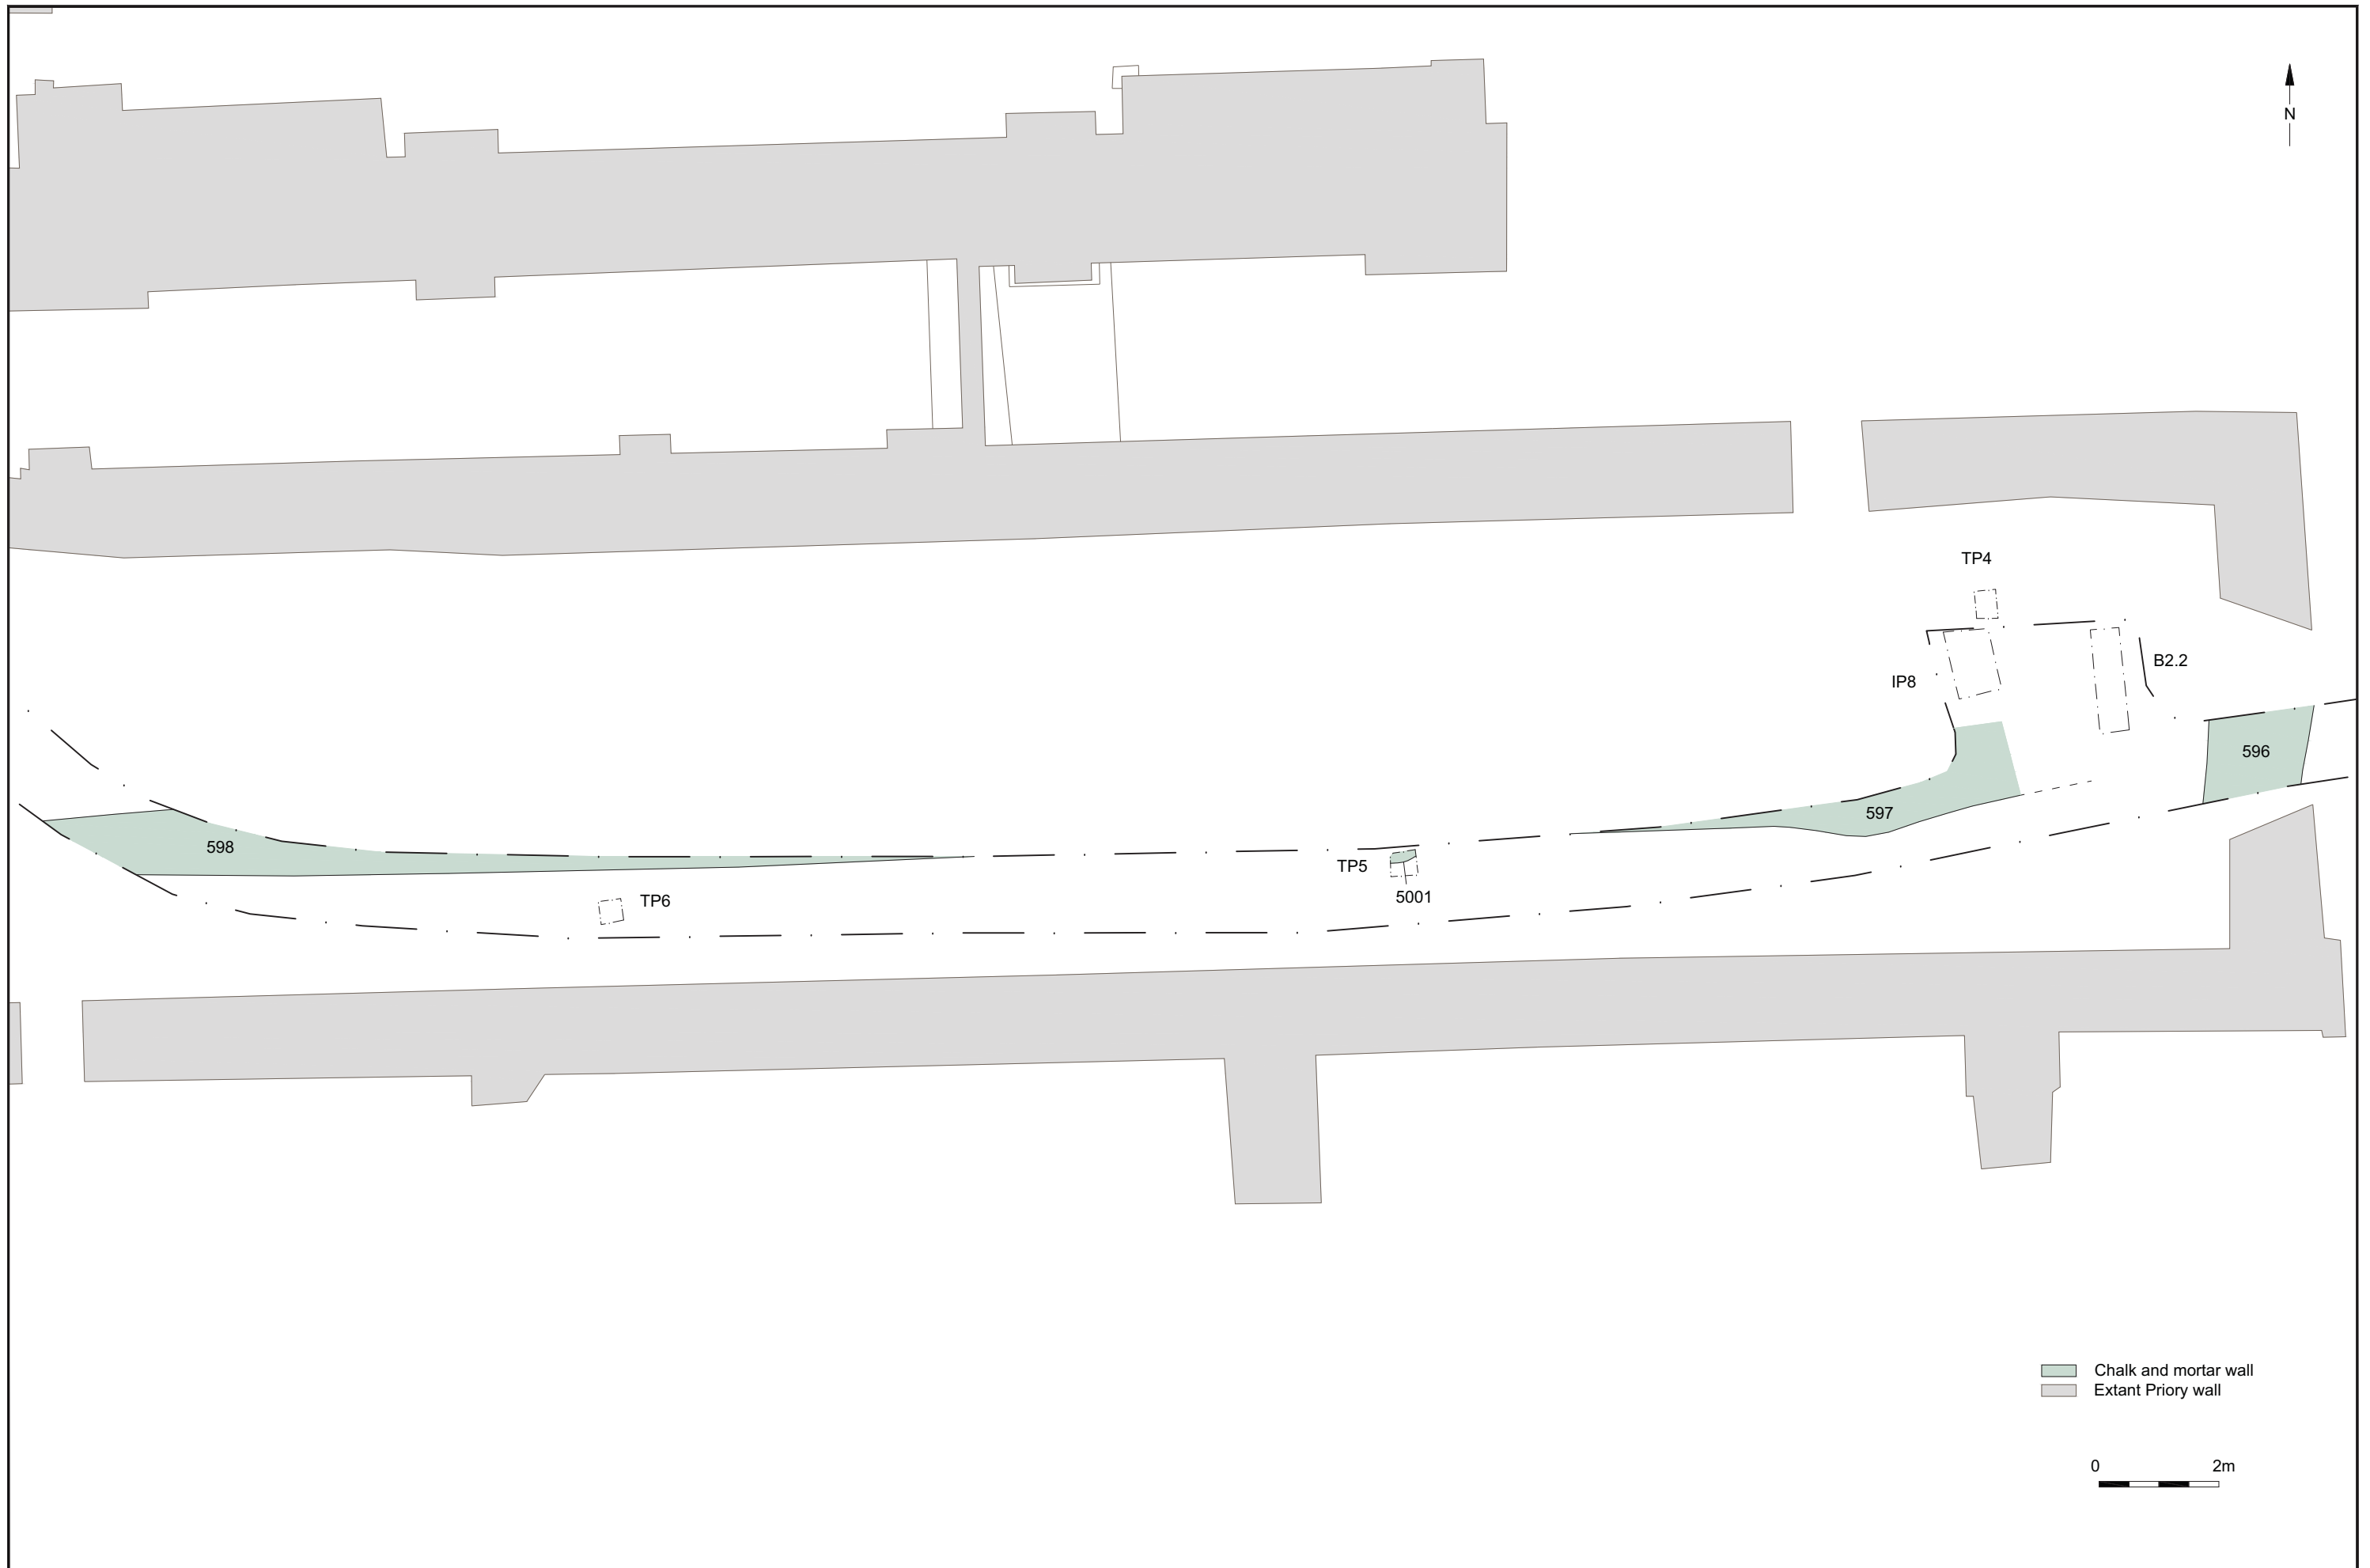
| © Archaeology South-East | | Lewes Priory | Fig. 11 |

| Project Ref: 4197 | Feb 2011 | Detail of path G | |

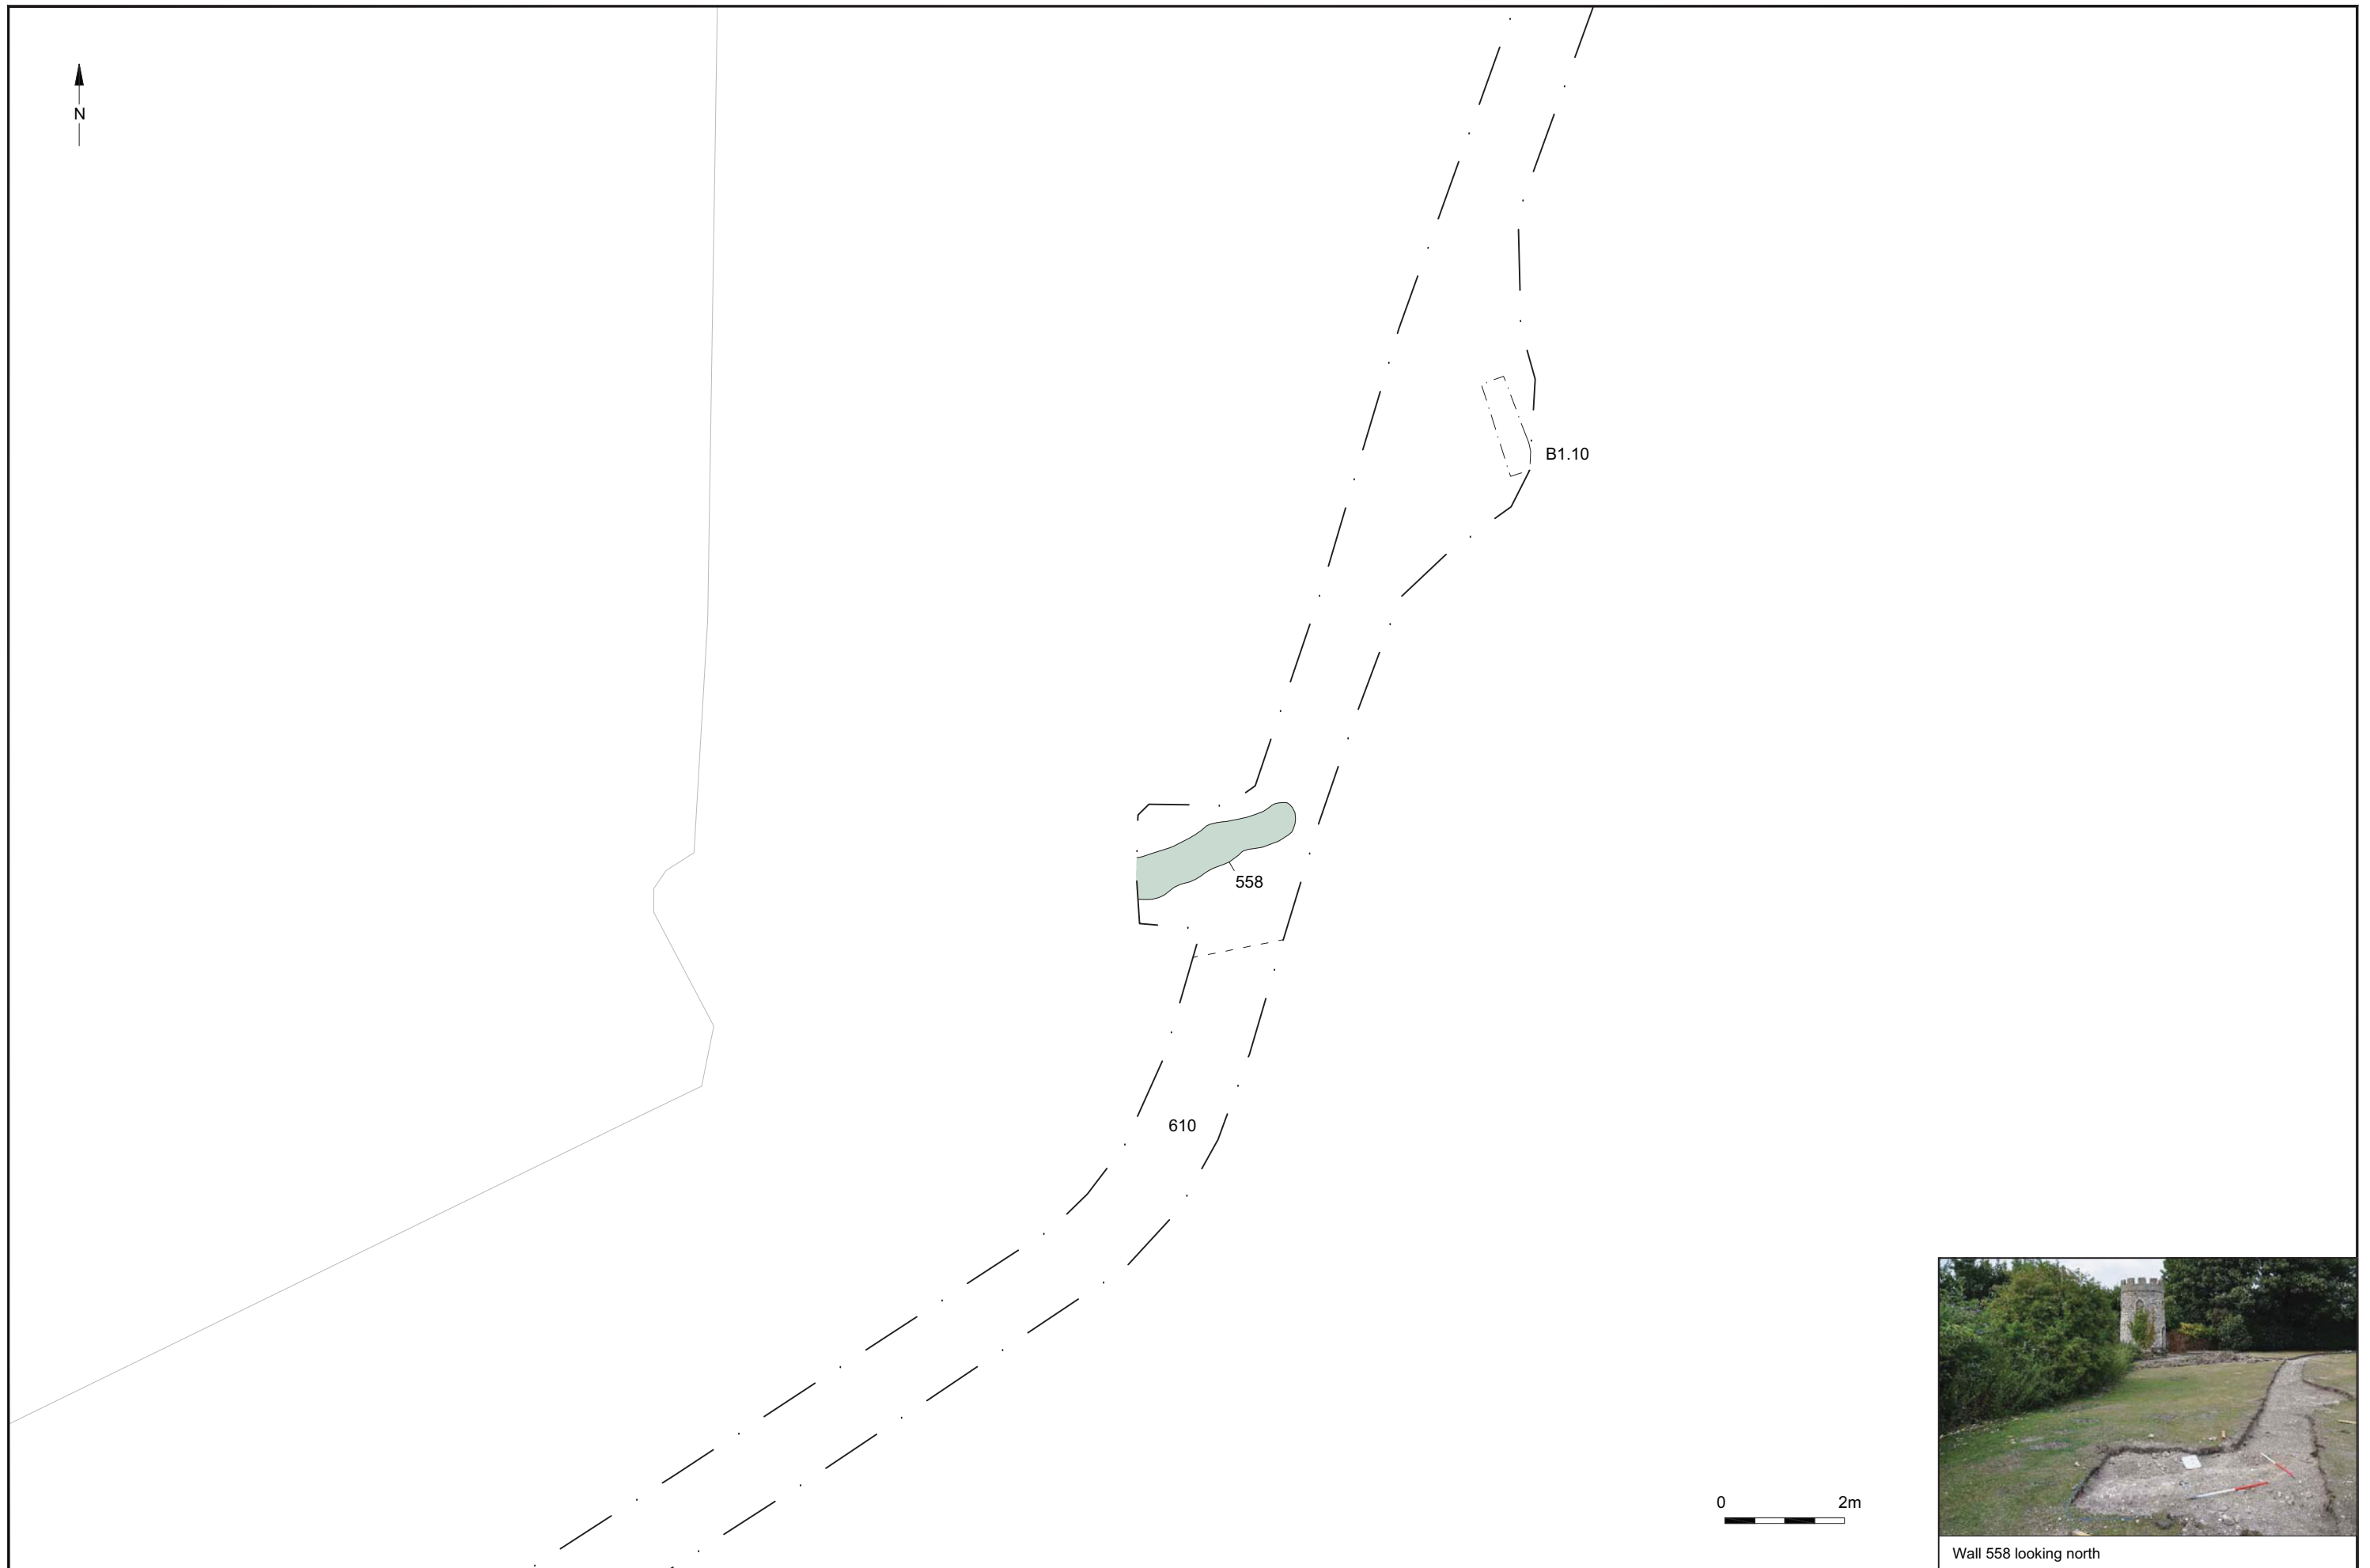
| © Archaeology South-East | | Lewes Priory | Fig. 12 |

| Project Ref: 4197 | Feb 2011 | Detail of path I | |
