**1 SCOUT LANE, CLAPHAM,
LONDON SW4 0LA**

**ARCHAEOLOGICAL
MONITORING AND RECORDING**

Authors: Zbigniew Pozorski MA (field work & report)	
NGR: TQ 29165 75590	Report No. 3759
District: London Borough of Lambeth	Site Code: SCO 11
Approved: Claire Halpin MIFA	Project No. 3960
Signed:	Date: March 2011

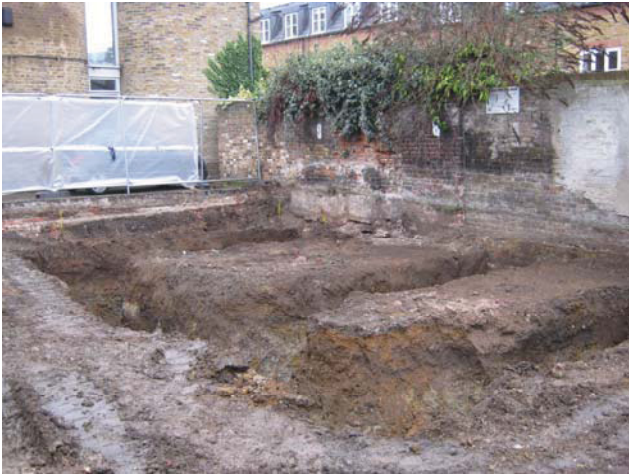
DP 3. Foundation trenches. View W.

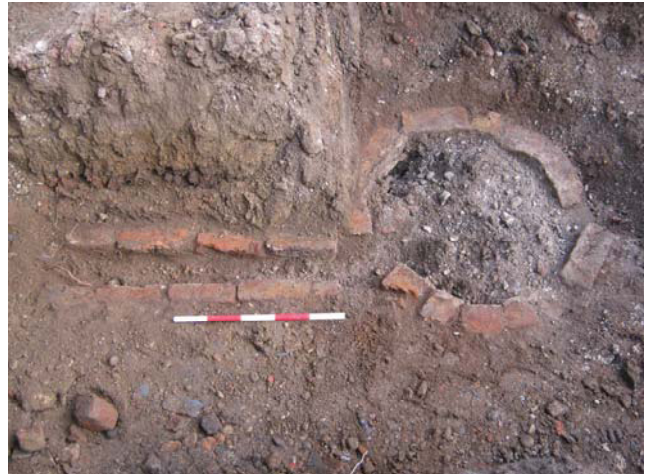
DP 4. W foundation trench. Soakway with associated drain. View ENE.

The soakway, M1010, was located within the western foundation trench and 1.60m to the south of the boundary wall (Fig. 3; DP 4). It was roughly circular in plan (0.69-0.76m in diameter) and was present at c. 0.50m below ground level. It was constructed of red bricks (0.217 x 0.100 x 0.068m), full-size and halves, with no bond but with plastering on the inside of the ring comprising light grey cement mortar. Three courses of bricks were revealed. At the basal level and on its northern side, the soakway was connected with Drain M1011 (DP 4). The drain (0.94 x 0.25m) was constructed of the same bricks as the soakway laid on edges to create an open channel leading to the soakway. The drain appeared to be cut by the boundary wall or connected to the other drainage which may have existed along the northern site boundary.

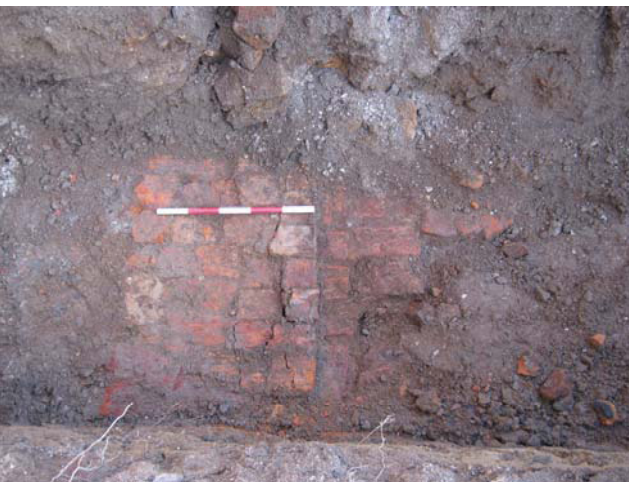
DP 5. W foundation trench. Possible footpath. View ENE.

Below the soakway and drain and within L1005, the remains of what may have been a footpath were found (DP 5). M1012 (1+ x 1.30m) was present

1m below ground level and 1.05m south of the boundary wall and may have consisted of two adjacent parts (each 0.65m wide) laid symmetrically along the northern site boundary. The southern part was severely damaged whilst the northern element was intact. Also the southern part was positioned c. 3cm lower creating a small step. The path was constructed of red bricks, fragmented into irregular parts of c.half size (0.105 x 0.06m) and laid horizontally with no bonding material. Some of the bricks appeared to have been re-used.

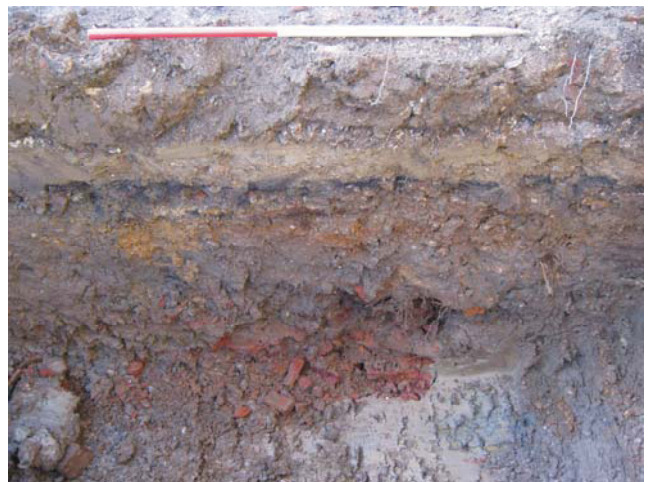
DP 6. W foundation trench. Sample section. View WSW.

<i>W foundation trench, N end. Sample section 1, facing E</i>		
<i>0.00 = 16.57m AOD</i>		
0.00 – 0.23m	L1000	Modern Made Ground. Light brown, loose, clayey silt with sand and moderate CBM fragments.
0.23 – 0.28m	L1001	Grey, loose, fine gravel.
0.28 – 0.42m	L1002	Greenish brown, friable, silty sand.
0.42 – 0.47m	L1003	Black, soft, clayey silt with ash.
0.47 – 0.65m	L1004	Reddish brown, loose, gravel with sandy silt.
0.65 – 1.05m	L1005	Mid grey, friable, clayey silt with frequent CBM fragments.
1.05m+	L1006	Natural. Mid grey, compact, clay with sand and gravel.

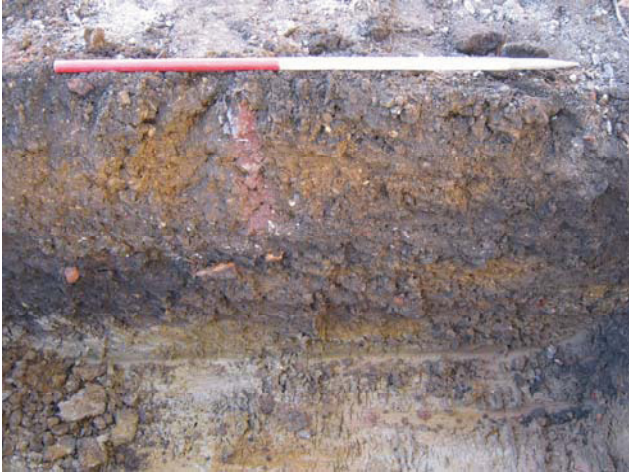
DP 7. W/central foundation trench. Sample section. View WSW.

<i>W/central foundation trench, N end. Sample section 2, facing E</i>		
<i>0.00 = 16.67m AOD</i>		
0.00 – 0.16m	L1000	Modern Made Ground. As above.
0.16 – 0.36m	L1007	Mid to dark yellow, loose, sand.
0.36 – 0.50m	L1008	Mid grey, compact, clayey silt with frequent CBM fragments.
0.50 – 0.88m	L1005	As above.
0.88m+	L1006	Natural clay. As above.

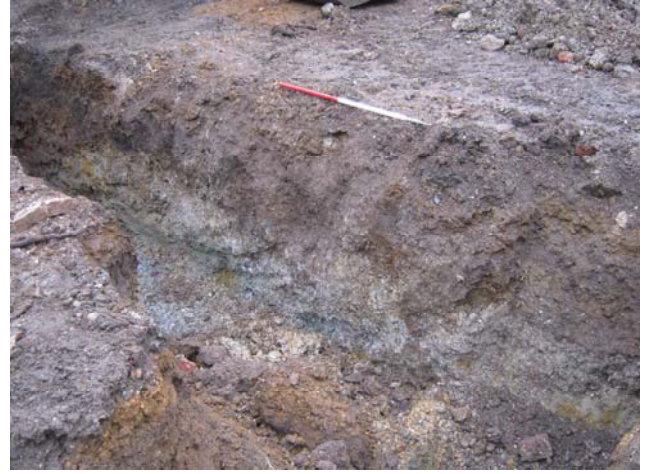
DP 8. Central foundation trench. View NNE.

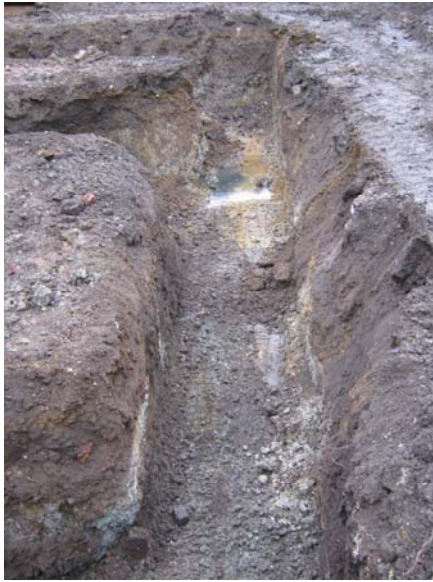
DP 9. S foundation trench. View ENE.

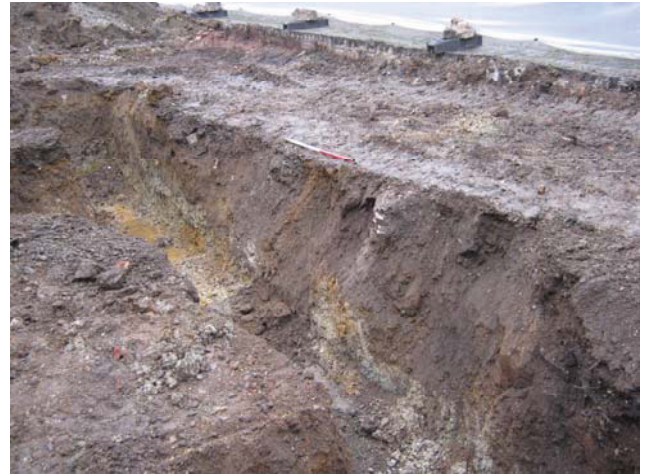
DP 10. S foundation trench. View E.
