**COOMBE END FARM HOUSE, GORING HEATH,
OXFORDSHIRE**

HISTORIC BUILDING RECORDING

Authors:	Lee Prosser BA PhD Lisa Smith BA Kate Higgs MA
NGR: SU 6291 7915	Report No. 3875
District: South Oxfordshire	Site Code: AS 1372
Approved: Claire Halpin MIFA	Project No. 3944
Signed:	Date: July 2011

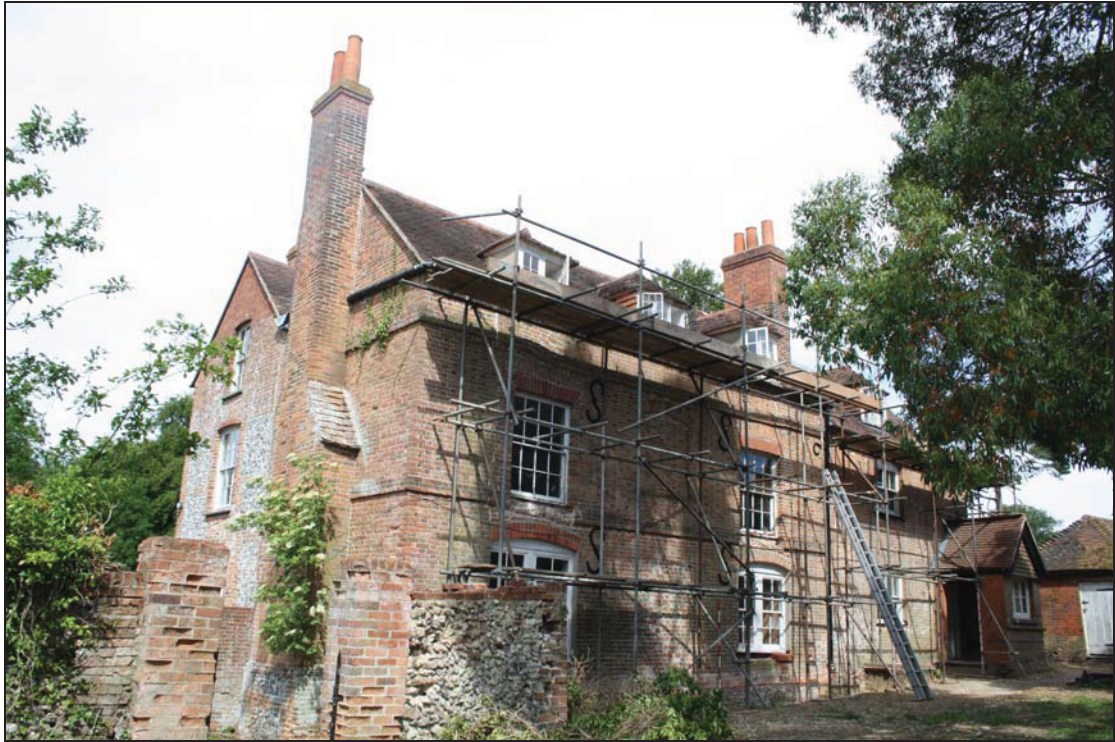
Plate 1 Principal east façade, taken from the south-east (DP 08)

5.3 The east elevation (Plate 1) is entirely of brickwork laid in Flemish bond over a flint base; this lower section was once rendered and either buried or not intended to be seen. A pattern of over-burnt headers has been used in a chequerboard arrangement across the façade. A string-course divides the ground and first floors and wraps around the south return. The original arrangement had a central doorway with a blind window above and wide flanking windows, but this doorway has since been blocked and is now hardly discernible. Three attic dormers set beneath their own gablets follow the symmetry displayed below, the central being wider with three lights. All are iron casements with leaded comes.

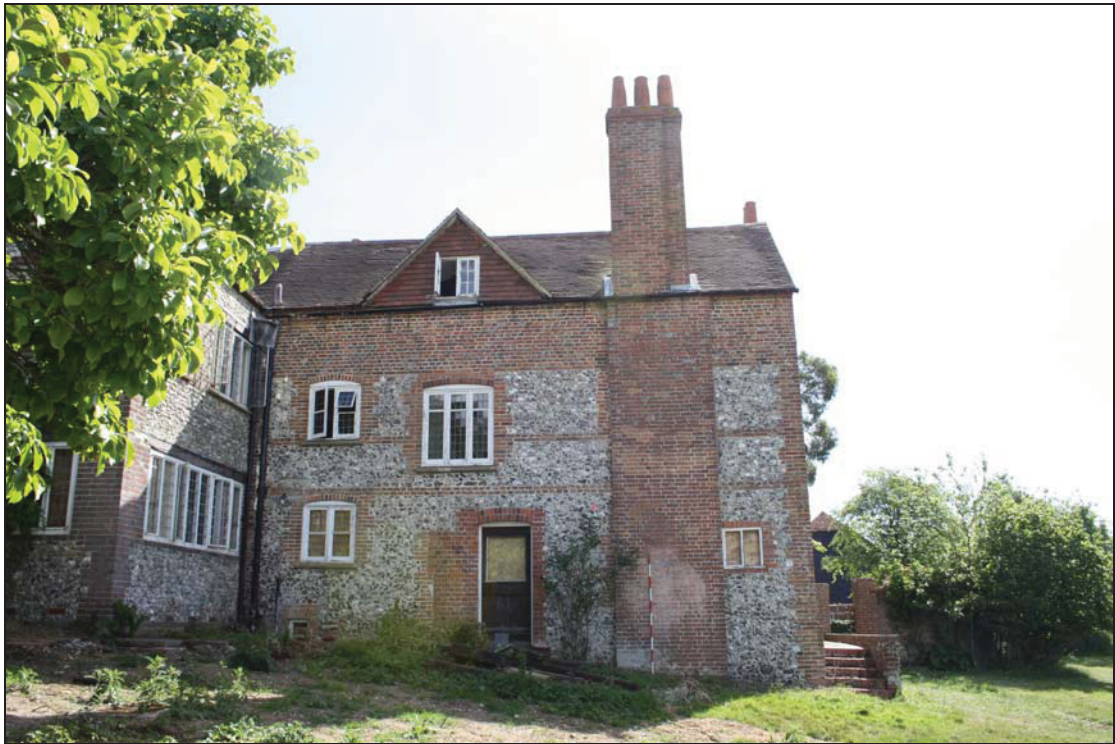
Plate 3 West elevation of the historic core, taken from the west (DP 03)

5.7 The western façade was extended with the new range to the north in the early 20th century. The historic core (Plate 3) is mostly of flint to the heads of the first floor windows, rising thereafter in brickwork to the eaves. It is broken by a slightly projecting chimney stack offset to the south. The flintwork is divided into panels by flush brick string-courses. An asymmetrical arrangement of windows and doors pierces the façade.

5.8 At ground floor level a rear door from the staircase hall replaces an earlier example in this position as an earlier surviving jamb with dressed and rusticated quoins survives. The door is early 20th century with Arts and Crafts hinges and drop handle, probably part of C.R. Ashbee's refurbishment. A small cellar light with a little gauged arch sits at lower level to the north. Two-light casements in timber surrounds light the ground and first floors, framed by brick rusticated jambs and cambered brick arches, while a contemporary but larger three-light stair window in similar style sits to the south above the door. Some repair can be seen in the replacement of the arch above the stair light but the window does seem to be in its original position with the characteristic flush brick jambs.

5.9 A modest two-light casement window abuts the south side of the chimney stack. Traces of a rusticated window jamb on the same alignment at upper level lie to the north suggests that the stack is a later addition which interrupted an original, fairly symmetrical arrangement of windows.

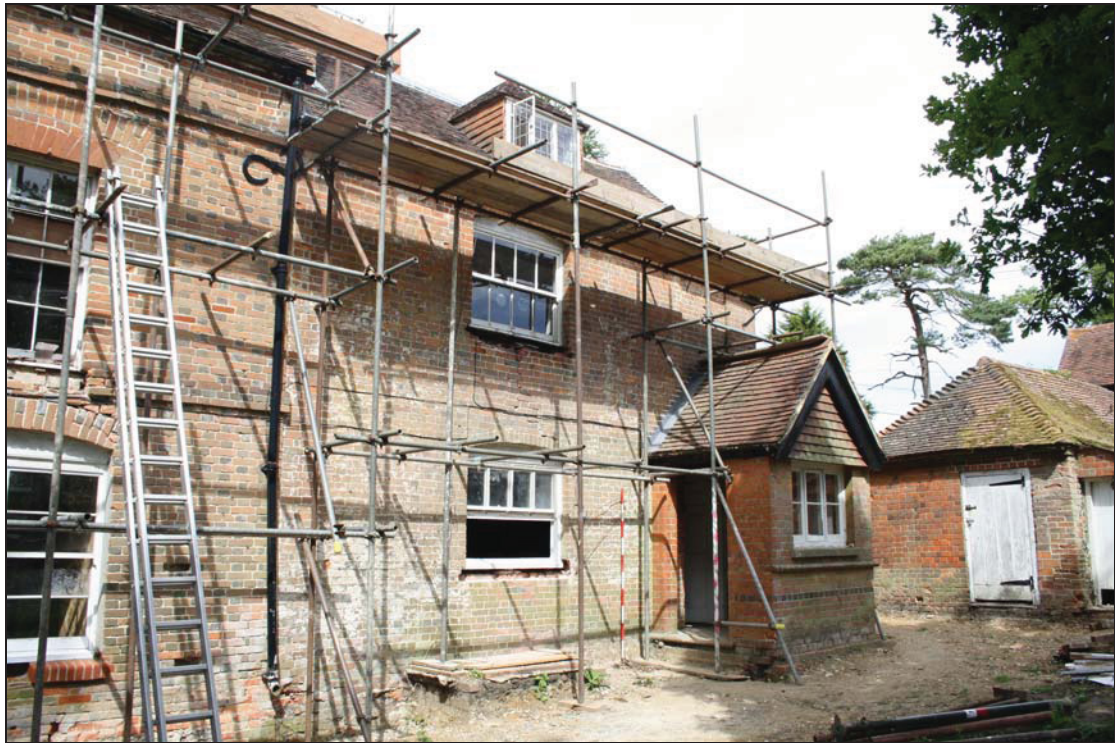
Plate 5 19th century service range, east elevation, taken from the south-east (DP 10)

5.13 Returning to the eastern elevation, the 19th century service range (Plate 5) to the north of the historic core is, as noted above, slightly lower and more modest in proportion though copies the architectural detail such as the chequerboard patterning. Wide four-over-four sashes beneath cambered arches survive at ground and first floor level, while a cellar light is protected by an iron grille. A small porch gives access into the existing kitchen. This is constructed of large, early 20th century red bricks, with a tile-hung gable. It is lit on the east by a three-light casement window.

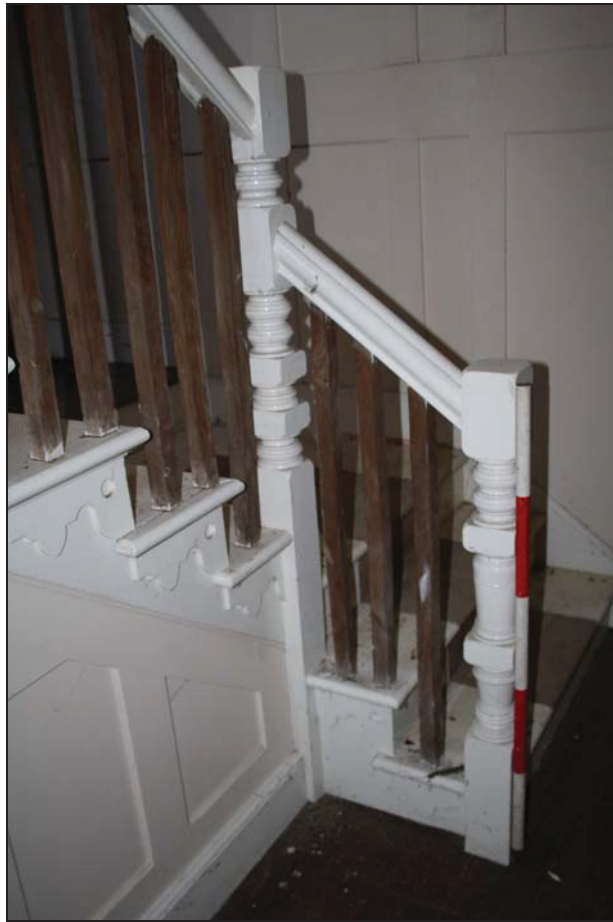
Plate 9 Turned newels and staircase configuration, GF03, taken from the south-west (DP 47)

5.36 The staircase (Plate 9) rises to the first floor with two half-pace landings and a three-step return at the base. It comprises robust turned newels and a heavily shaped grip handrail, all on an open string adorned with plain shaped bracket-ends, all painted. Robust oak stick balusters probably replace an earlier horizontal baluster-rail which can be traced as marks on the newels.

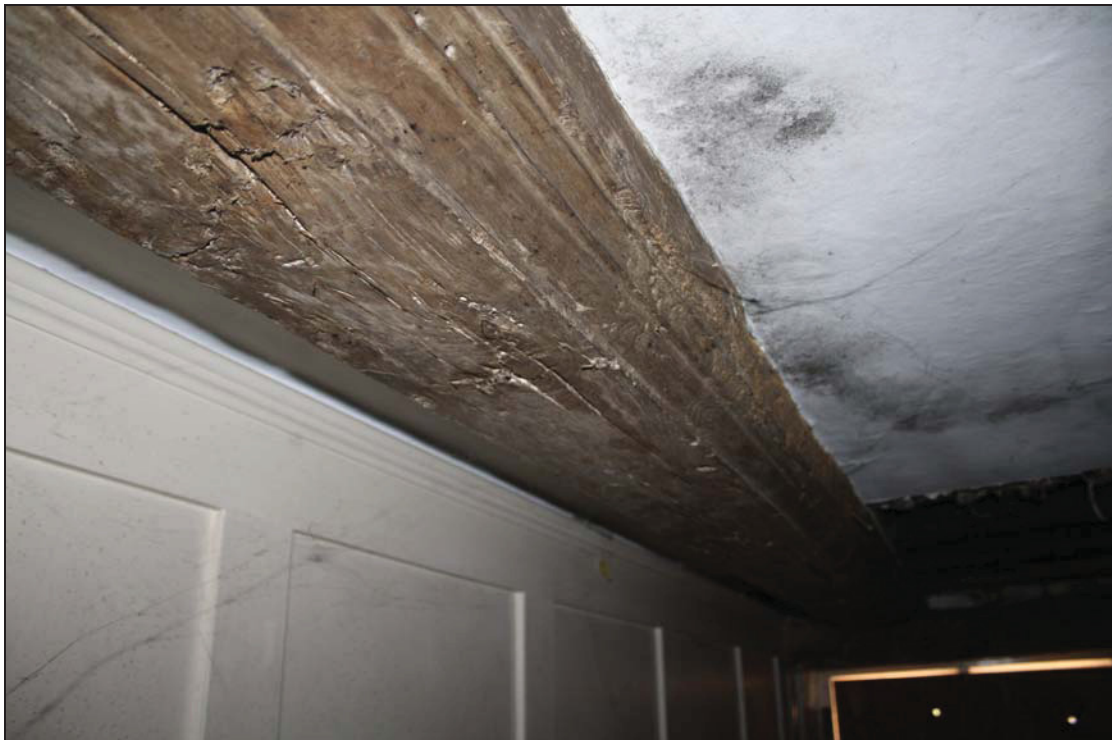
Plate 10 Moulded ceiling joist, GF03a, taken from the north-east (DP 55)

5.39 The ceiling is particularly low and is partly exposed at the western end where water damage has brought down a section of plaster. A principal joist (11" x 10") with cyma ovolo mouldings on each side is exposed (Plate 10). Above the passage way to the stair hall it appears that the mouldings have been applied to a more waney timber joist. The common-joists, where visible are morticed to the principal using a lower spur, a mid- to late 17th century technique. Notably, the principal rests on a timber in the outer wall.

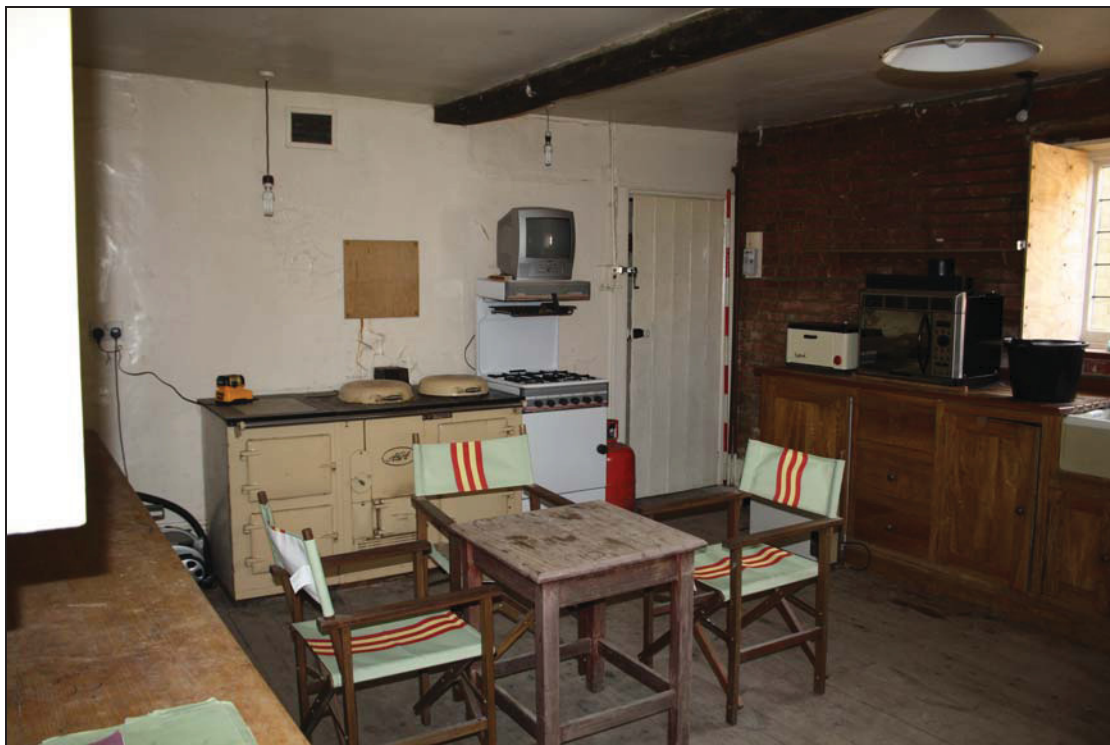
Plate 11 GF04, taken from the south-east (DP 60)

5.41 A large farmhouse kitchen (Plate 11) occupies the 19th century service range to the north and connects the reception rooms on the south-east, and utility rooms on the west. As noted above, an external door gives access from the east. The floor is boarded with 6½" Victorian floor boards.

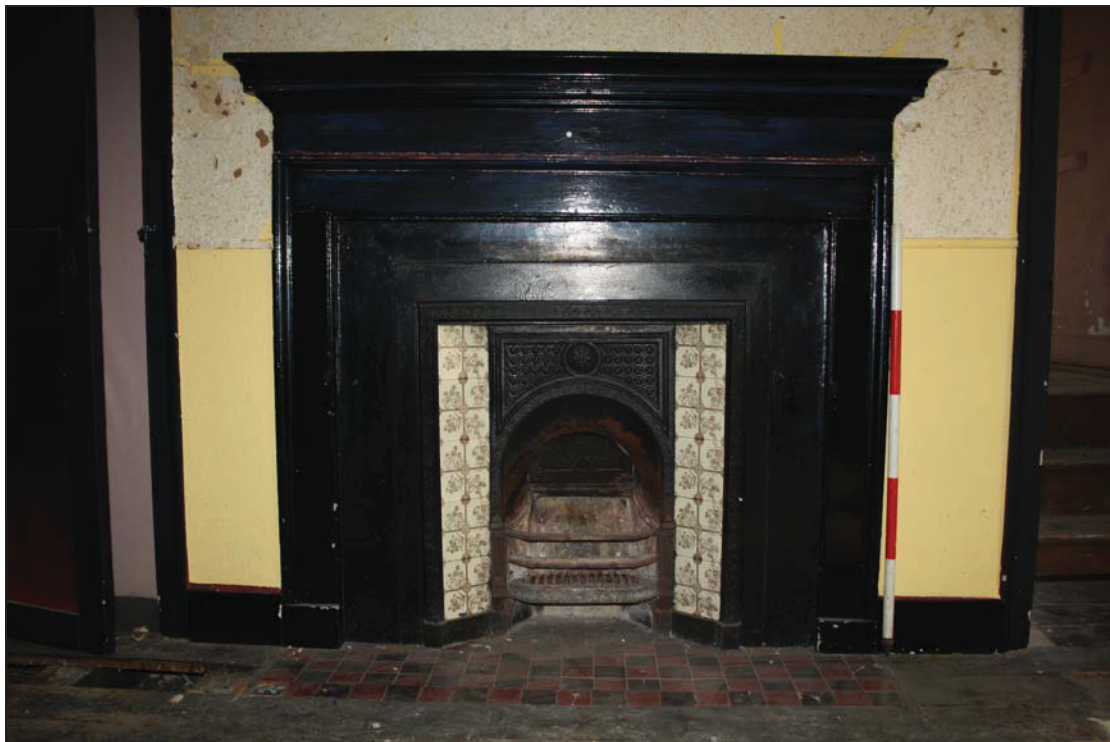
Plate 17 Fireplace with 18th century timber surround with later Victorian inset and hearth, FF02, taken from the south (DP 112)

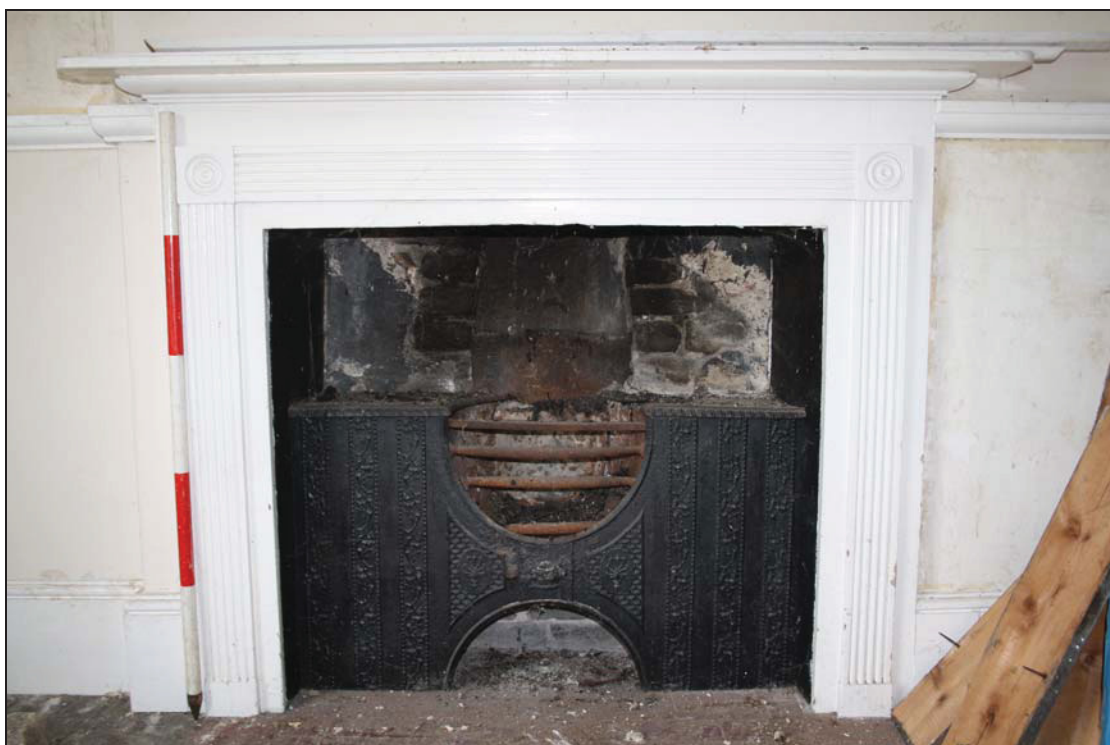
5.68 The fireplace (Plate 18) on the west is framed by a timber surround of about 1820-1840 with reeded jambs and circular paterae. The shelf appears to have been extended in the 20th century. An early 19th century hob grate with classical decoration survives in good condition.

Plate 18 Fireplace with early 19th century surround and hob grate, FF03, taken from the east (DP 105)

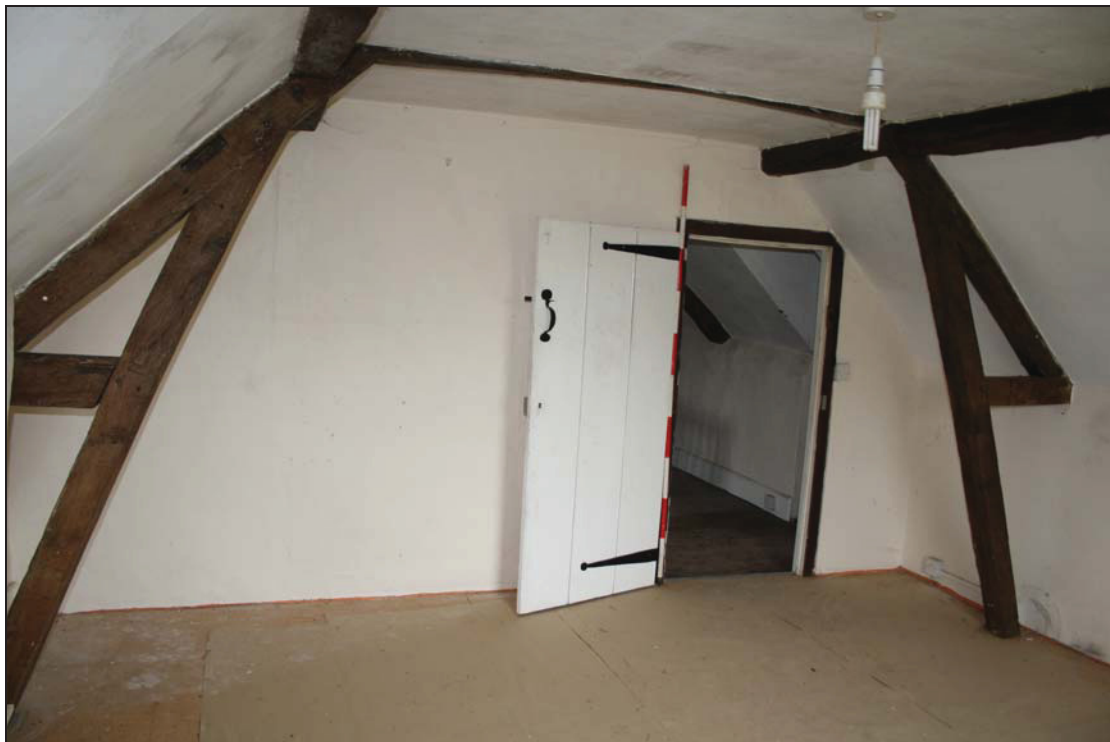
Plate 21 SF03, taken from the north-east (DP 123)

5.91 The roof structure, as noted above is well-preserved (Plate 21). On the western side a number of assembly marks in the form of chiselled 'II' remain on the principal members.

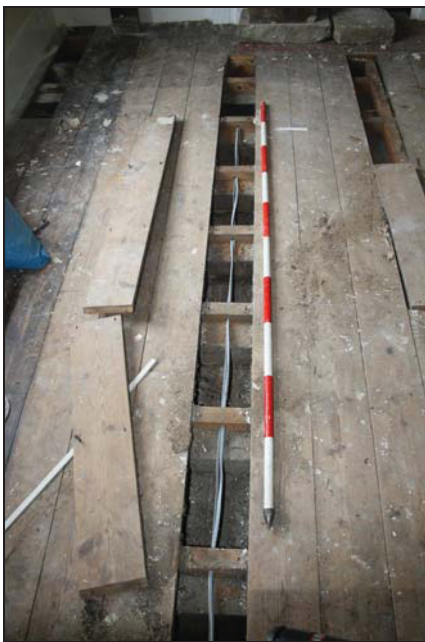
101

Secondary joisting revealed after removal of floorboards, FF03, taken from the east

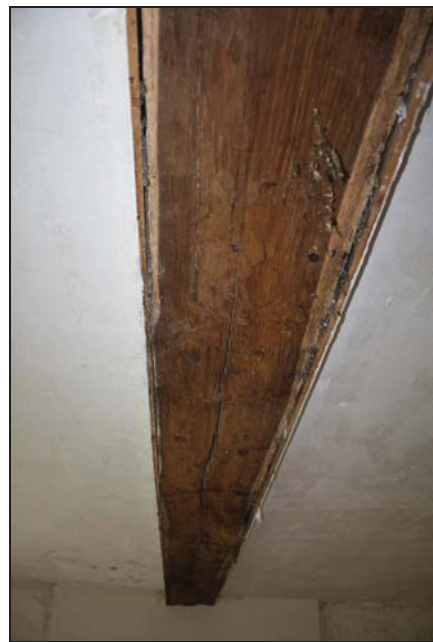
102

Hacked-back ceiling joist previously boxed in, FF03, taken from the east
