**THE OUTER WALLED GARDEN, DANESBURY PARK,
DANESBURY PARK ROAD, WELWYN,
HERTFORDSHIRE**

AN ARCHAEOLOGICAL EVALUATION

Authors: Zbigniew Pozorski MA (field work & report)	
NGR: TL 2342 1725	Report No. xx
District: Welwyn Hatfield	Site Code: AS 1369
Approved: Claire Halpin MIFA	Project No. 4154
Signed:	Date: December 2010

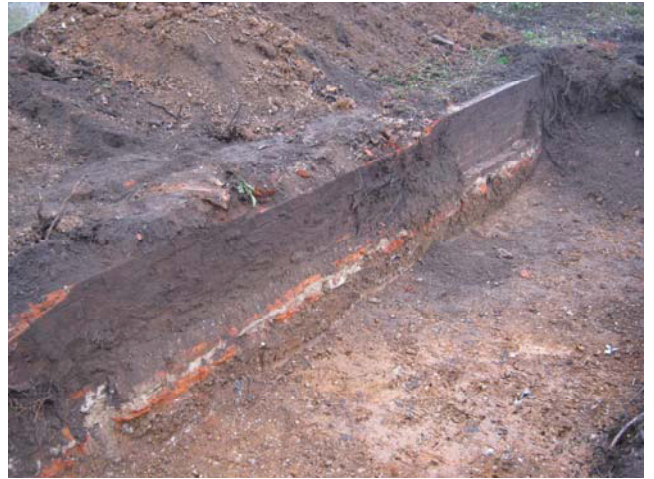
DP 4. Wall M1007. View E.

Along the northern edge of the trench a wall M1007 was present (DP 4-5). The wall measured 17+ x 0.72 x 0.22m and was made of dark red, fropped bricks (0.225 x 0.101 x 0.066m) with OSTA mark, bonded with mid grey cement mortar and with regular finish. Seven courses of bricks survived below the ground level, set in irregular Stretcher bond. Another single course of bricks was a base of the wall and formed a ledge (0.06m). Below an irregular layer of brick fragments bonded with mortar was present, serving as a foundation.

9.2 In the event the only archaeological feature found was the greenhouse, probably the melon house, located between the trench and the garden wall. Materials used to construct the greenhouse indicate it was built during the first half of the 20th century. The bricks marked OSTA have been made between 1899 and 1940 in Hill End Brickworks, St Albans (Website 1). The glasshouses depicted on the late 19th century maps may have consisted the melon house; however, it was revealed it was constructed/rebuilt in 20th century. The structure matches that mentioned in the 1919 sales particular which listed, among the other features, a span-roof double melon house.

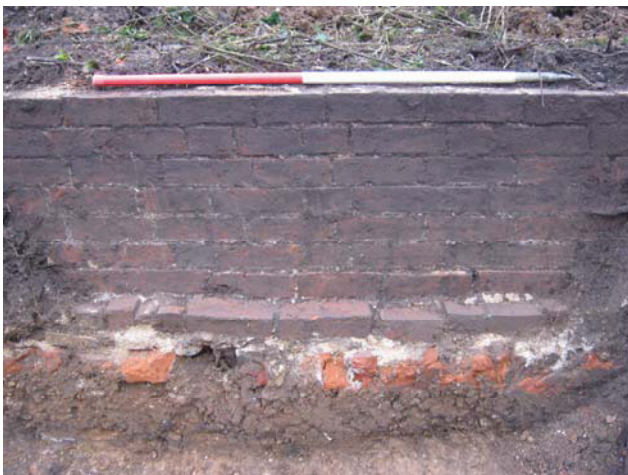
DP 5. Wall M1007. View NE.

M1007 was a part of the rectangular building (c. 20 x 3m) located along the northern part of the garden wall. The building contained concrete floor M1006

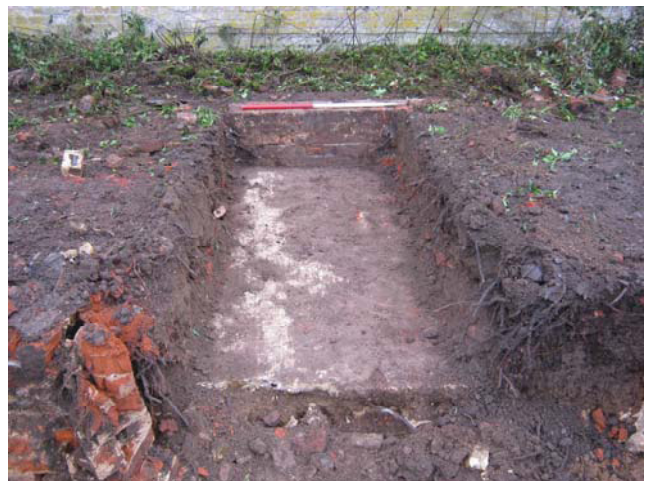
DP 6. Greenhouse interior. View NE.

(DP 6) at 0.42m below existing ground level and below five courses of bricks in its walls. The floor was 2.50m wide.

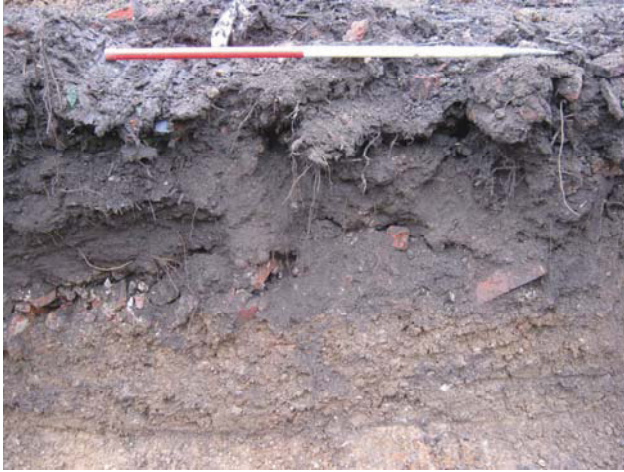
DP 7. Trench 1, NW end. Sample section.
View SW.

<i>Sample section 1 (DP 7): NW end, NE facing</i> 0.00 = c. 112m AOD		
0.00 – 0.65m	L1000	Made ground. Blackish dark grey, soft, sandy silt with moderate CBM fragments.
0.65 – 1.00m	L1001	Subsoil. Mid yellow, compact, clayey silt with occasional gravel.
1.00m +	L1002	Natural mid to dark yellow, compact, clay with frequent flint gravel.

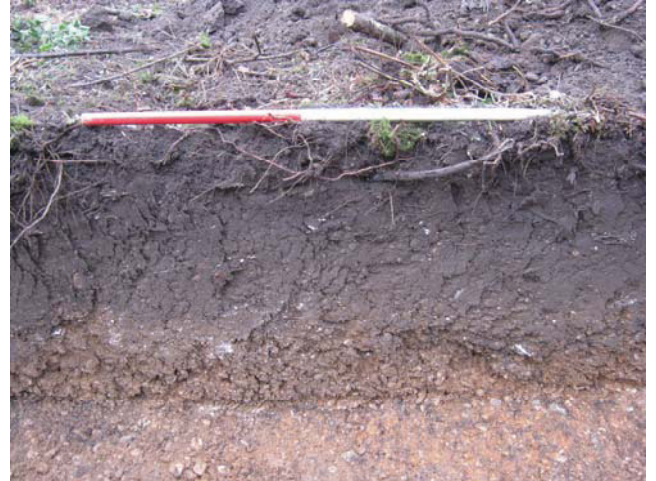
DP 8. Trench 1, SE end. Sample section.
View SW.

<i>Sample section 2 (DP 8): SE end, NE facing</i> 0.00 = c. 112m AOD		
0.00 – 0.58m	L1003	Topsoil. Blackish dark grey, soft, sandy silt.
0.58 – 0.80m	L1001	Subsoil. As above.
0.80m +	L1002	Natural clay. As above.
