**THE PRIORY, CHURCH ROAD,  
HATFIELD PEVEREL, BRAINTREE,  
ESSEX**

**ARCHAEOLOGICAL EVALUATION**

Authors: Chris Leonard (field work & report) Peter Thompson MA (Desk-based assessment)	
NGR: TL 7970 1090	Report No: 3831
District: Braintree	Site Code: HPTP11
Approved: Claire Halpin	Project No: P4213
Signed:	Date: June 2011

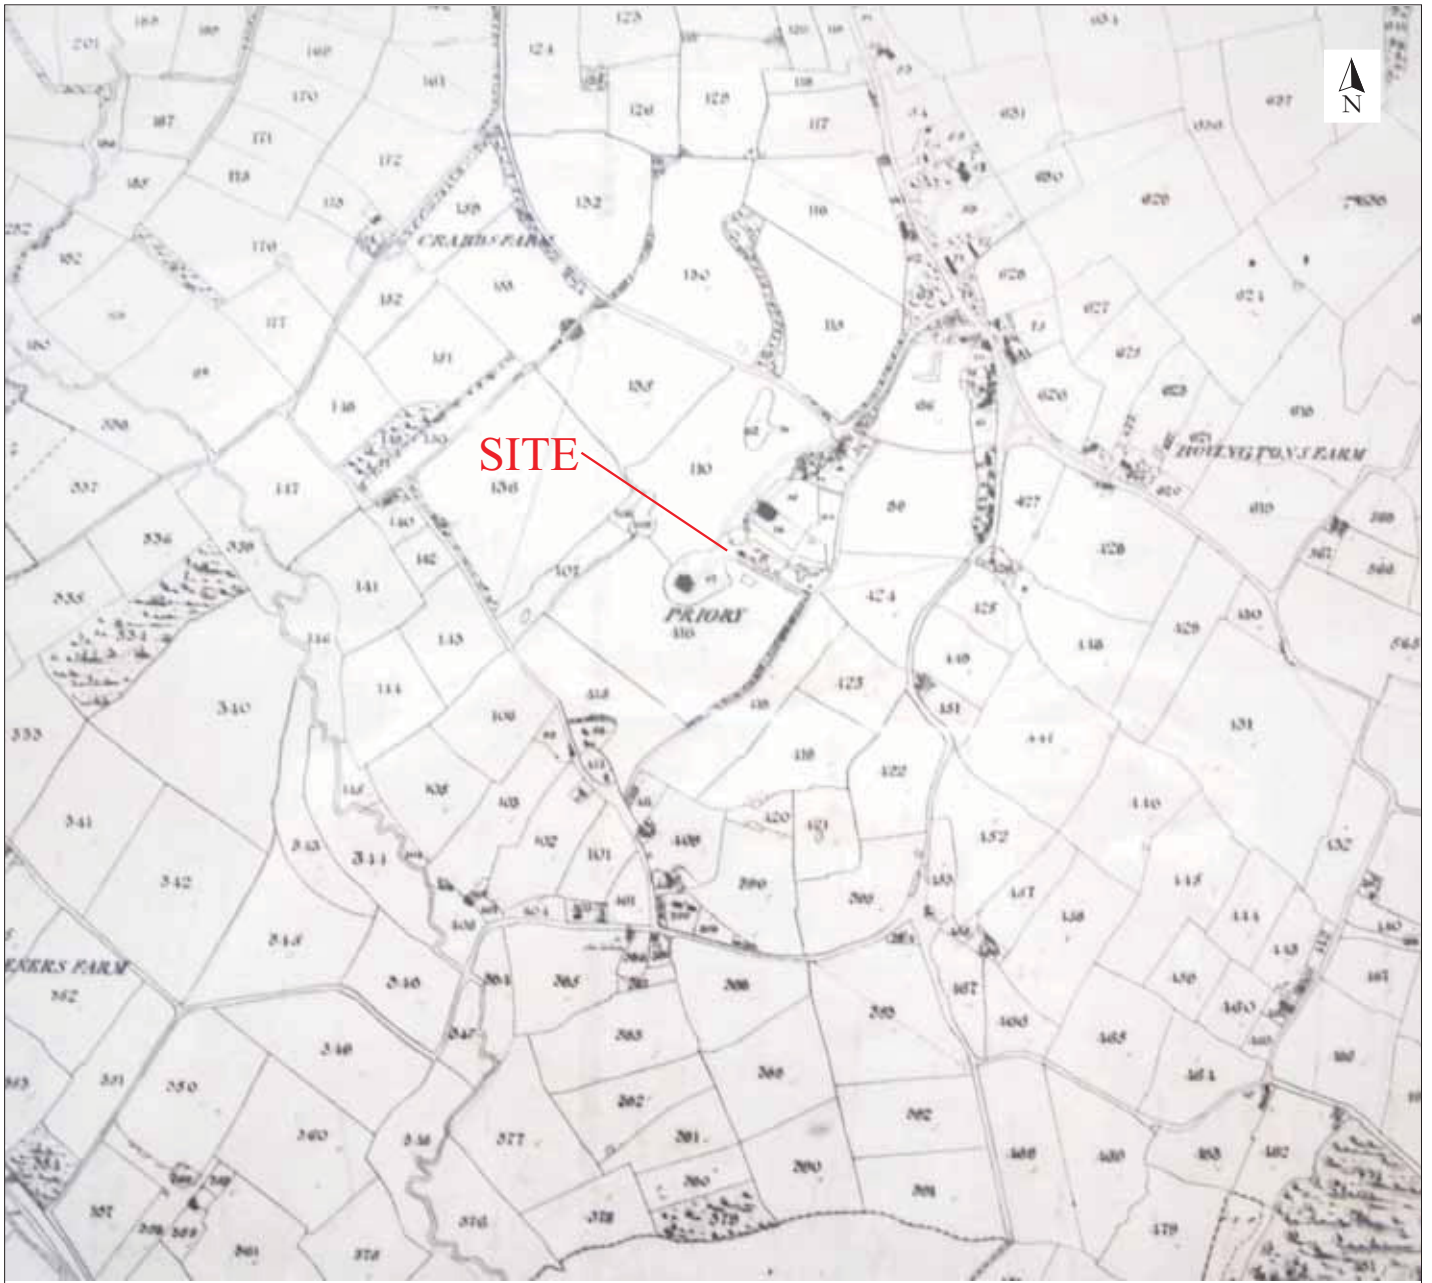
*Archaeological Solutions Ltd*  
Fig. 5 Tithe map, 1841  
Not to scale

4.3.1 A map of the estate dated to 1765 shows the church in plan with the “old priory” attached to the south-east end and a detached “kitchen” to the east (Fig 4 & EHER 6052). The 1840 Tithe map award shows that Peter Wright owned and occupied the Hatfield Priory House estate including the church and medieval priory site. The main house lies within a circular enclosure with buildings and landscaped area features to the north, the church is in the north-west corner of a rectangular enclosure (Fig 5). The c.1872 first edition OS map shows no significant changes to the Tithe map and records good detail of the buildings and landscaped woodland and ponds north of Priory House (Fig. 6). The second edition OS map shows no further changes (Fig. 7).

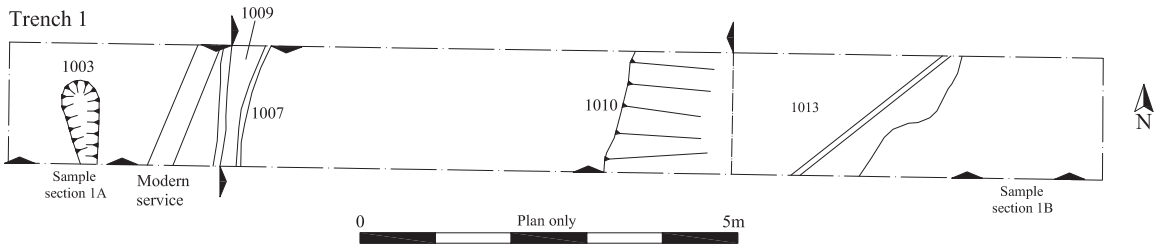
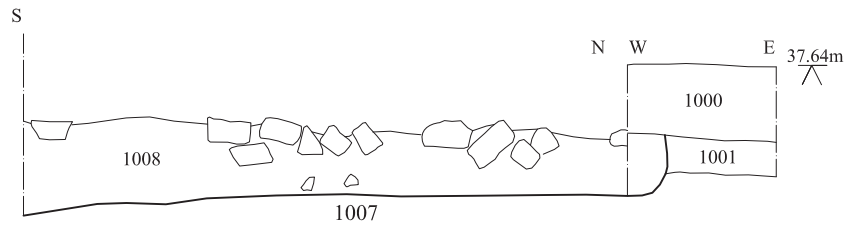
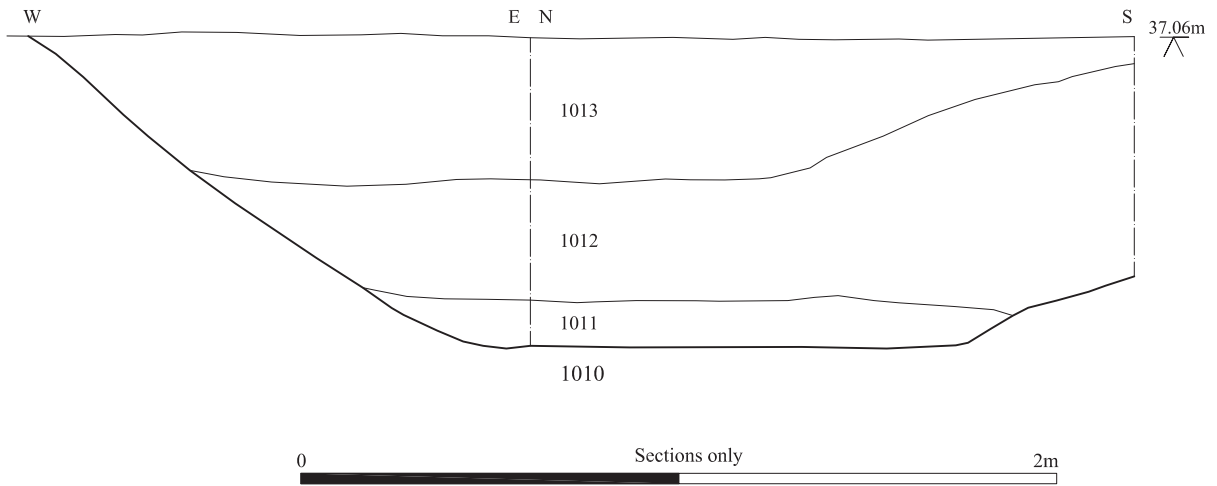
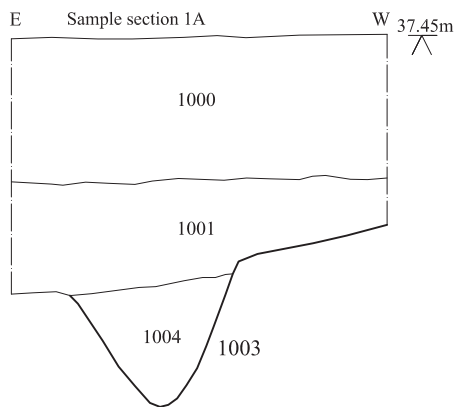
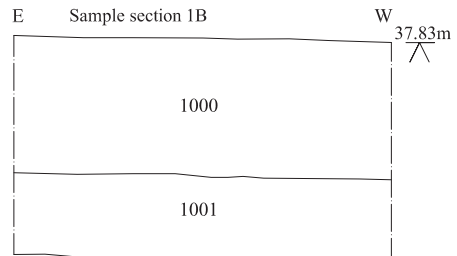
**Fig. 8 Plan & sections**

<i>Sample Section 1A</i> <i>West end, north facing</i> <i>0.00m = 37.45m AOD</i>		
0.00 - 0.39m	L1000	Topsoil. Dark brownish grey, friable, sandy silt with frequent flint gravel and occasional CBM.
0.39 – 0.68m	L1001	Subsoil. Mid yellowish grey, friable, sandy silt with frequent flint gravel and occasional CBM
0.68m+	L1002	Natural. Mid yellowish orange, friable, silty sand and gravel

<i>Sample Section 1B</i> <i>East end, north facing</i> <i>0.00m = 37.83m AOD</i>		
0.00 - 0.36m	L1000	Topsoil. As above.
0.36 – 0.58m	L1001	Subsoil. As above.
0.58m+	L1002	Natural. As above.

*Description: An undated ditch (F1003), late post-medieval wall (M1009) and a late post-medieval extraction pit (F1010) were recorded in Trench 1. Modern services traversed the trench.*

Ditch F1003 (1.10m+ x 0.45m x 0.38m) was linear, orientated N/S. It had steep sides and a concave base. Its fill (L1004) was a dark grey brown, friable, clayey silt with frequent gravel. No finds were present.

F1007 was the foundation cut for Wall M1009 (1.60m+ x 0.60m x 0.26m). It had vertical sides, a sharp break of slope and a flat base. Its fill, L1008, was a compact, mid greyish brown sandy silt and gravel. It contained late post-medieval CBM (642g). The foundations of Wall M1009 were constructed of unfroged red bricks (none complete) and rubble. No courses of the wall were present.

Extraction Pit F1010 (1.60m+ x 4.35m x 0.82m) was irregular in plan with steep sides and a concave base. It contained three fills. The basal fill (L1011) was a mid bluish grey, loose, sandy silt with moderate gravel. Late post-medieval CBM (1674g), glass (189g) and an iron fragment (28g) were present. The middle fill (L1012) was a mid brownish grey, friable, sandy silt with frequent flint gravel. It contained late post-medieval CBM (2500g), animal bone (109g) and glass (99g). The upper fill (L1013) was a mid yellowish brown, friable, sandy silt with frequent gravel. It contained no finds.
