**HILLS ROAD SIXTH FORM COLLEGE SPORTS  
PAVILION, CAMBRIDGE**

**AN ARCHAEOLOGICAL EVALUATION**

Authors: Zbigniew Pozorski MA	
NGR: TL 4585 5572	Report No: 3978
District: Cambridge	Site Code: AS 1457
Approved: Claire Halpin	Project No: 4461
Signed:	Date: December 2011

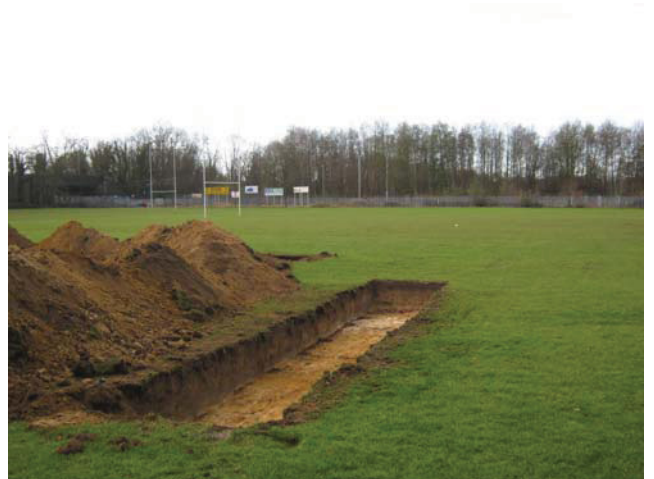
DP 2. Trench 1. Looking west-south-west.

<i>Sample section 1A (DP 5): western end, south facing</i> <i>0.00 = 14.00m AOD</i>		
0.00 – 0.24m	L1000	Topsoil. Mid to dark greyish brown, soft, silty loam.
0.24 – 0.52m	L1001	Light to mid yellow, compact, sand with occasional charcoal, chalk and pebbles.
0.52m +	L1002	Natural mid to dark yellow, compact, silty sand and, locally, white chalk.

<i>Sample section 1B (DP 6): eastern end, north facing</i> <i>0.00 = 14.07m AOD</i>		
0.00 – 0.20m	L1000	Topsoil. As above.
0.20 – 0.44m	L1001	Subsoil. As above.
0.44m +	L1002	Natural sand and chalk. As above.

*Description:* No archaeological remains or finds were present.

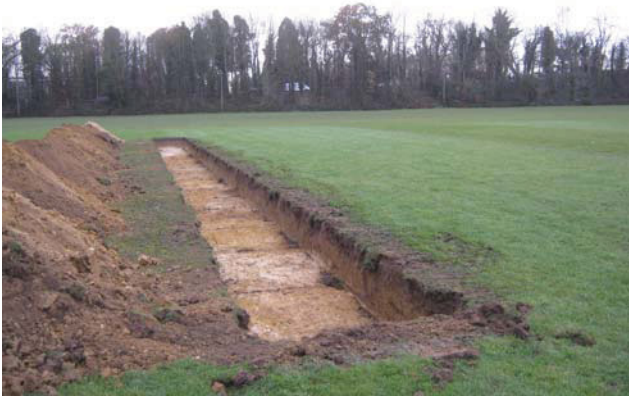
DP 7. Trench 2. Looking south-south-west.

*Description:* No archaeological remains or finds were present.

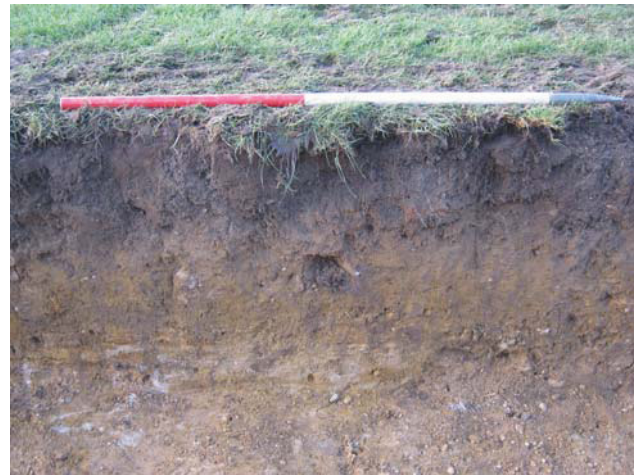
DP 10. Trench 2, northern end. Sample section 2A. Looking west.

<i>Sample section 2A (DP 10): northern end, east facing</i> <i>0.00 = 14.03m AOD</i>		
0.00 – 0.29m	L1000	Topsoil. As above, Tr. 1.
0.29 – 0.53m	L1001	Subsoil. As above, Tr. 1.
0.53m +	L1002	Natural sand and chalk. As above, Tr. 1.

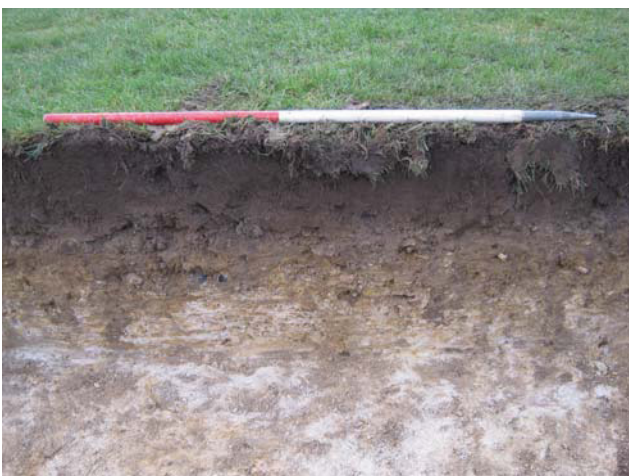
DP 11. Trench 2, southern end. Sample section 2B. Looking west.

<i>Sample section 2B (DP 11): southern end, west facing</i> <i>0.00 = 13.96m AOD</i>		
0.00 – 0.26m	L1000	Topsoil. As above, Tr. 1.
0.26 – 0.48m	L1001	Subsoil. As above, Tr. 1.
0.48m +	L1002	Natural sand and chalk. As above, Tr. 1.

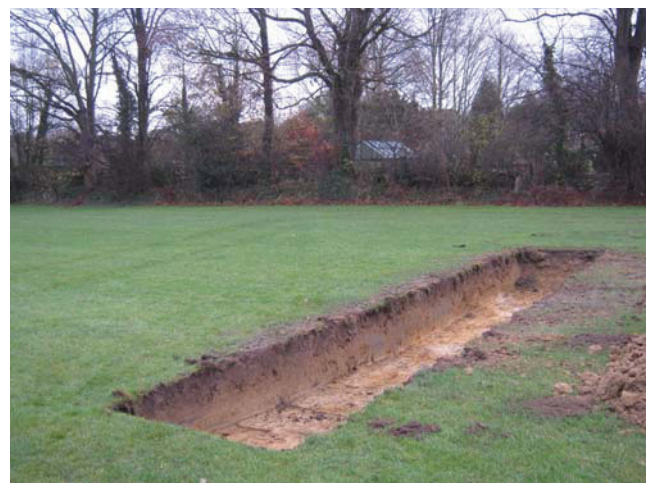
DP 12. Trench 3. Looking north-east.

*Description:* No archaeological remains or finds were present.

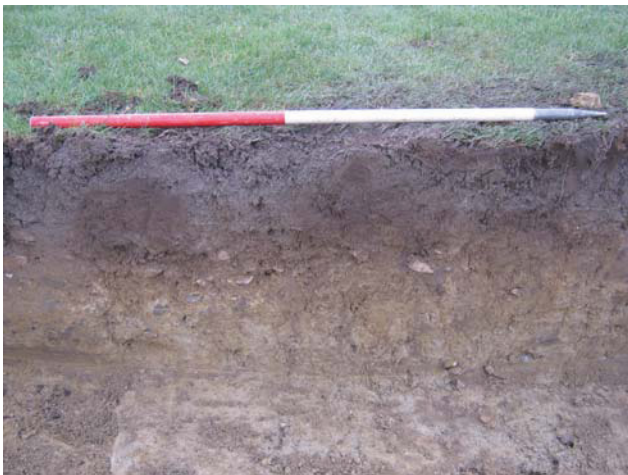
DP 15. Trench 3, western end. Sample section 3A. Looking north.

<i>Sample section 3A (DP 15): western end, south facing</i> <i>0.00 = 13.99m AOD</i>		
0.00 – 0.27m	L1000	Topsoil. As above, Tr. 1.
0.27 – 0.58m	L1001	Subsoil. As above, Tr. 1.
0.58m +	L1002	Natural sand and chalk. As above, Tr. 1.

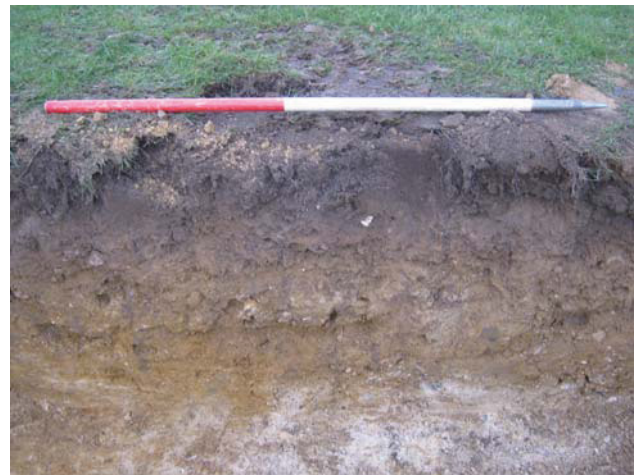
DP 16. Trench 3, eastern end. Sample section 3B. Looking north.

<i>Sample section 3B (DP 16): eastern end, south facing</i>		
<i>0.00 = 14.10m AOD</i>		
0.00 – 0.28m	L1000	Topsoil. As above, Tr. 1.
0.28 – 0.56m	L1001	Subsoil. As above, Tr. 1.
0.56m +	L1002	Natural sand and chalk. As above, Tr. 1.
