**JACKSONS FARM, LITTLE BURSTEAD, BILLERICAY,
ESSEX**

**ARCHAEOLOGICAL EXCAVATION
& MONITORING**

Authors: Tom Janes & Chris Leonard (fieldwork & report) Peter Thompson (research) Antony Mustchin (Editor)	
NGR: TQ 66980 92506	Report No. 3968
District: Basildon	Site Code: BLJF11
Approved: Claire Halpin MIFA	Project No. 4380
Signed:	Date: November 2011

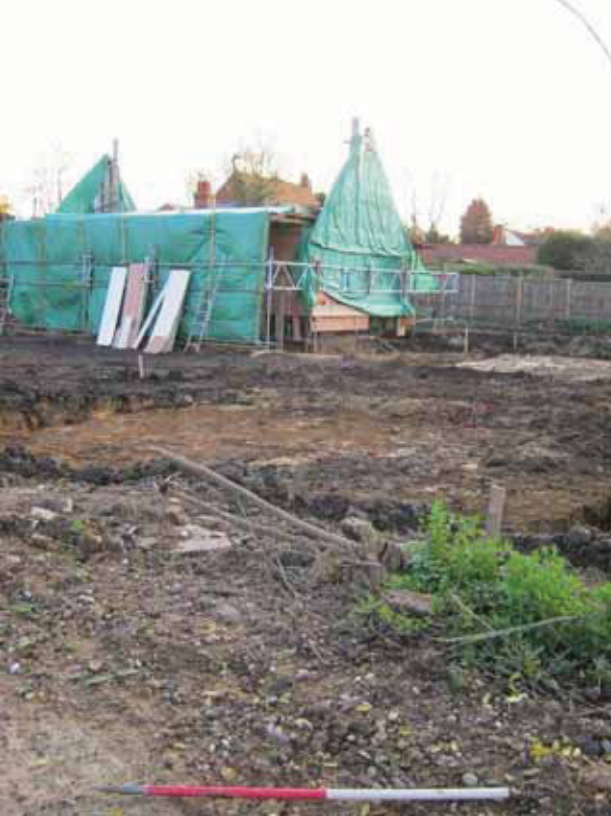
DP1
Both stripped areas, timber hall to left, looking SW

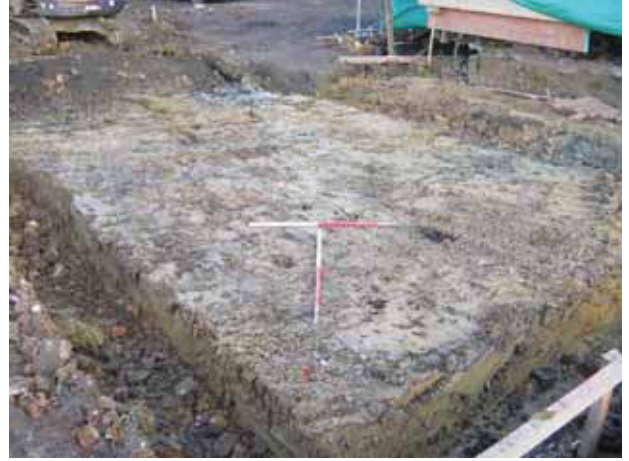
Description: Made Ground L1000 was present across site and comprised a mixture of silty clay topsoil, demolition rubble and construction debris, compacted by the passage of machinery. A greater concentration of rubble was noted within the extension footprint; this represented the remains of a concrete ramp and brick yard surface that had been associated with the recent use of the timber framed building as a barn/shed.

DP2
Footprint of extension, looking NE

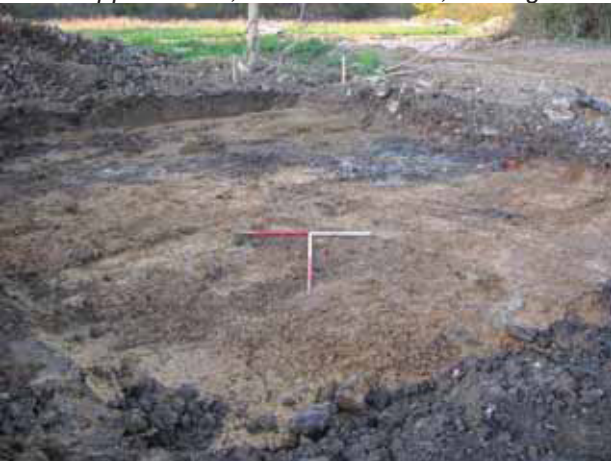
Within the footprint of the cart lodge, the rubble content of L1000 was sparse; when the modern outbuildings had been demolished most of the material produced had been reused elsewhere on site in drainage works (Geoff Fall, *pers. comm.*). Traces of modern building footings were also noted on the site of the proposed cart lodge, these were the foundations of the recently-demolished outbuildings (DP 4).

DP3
Footprint of cart lodge, looking N

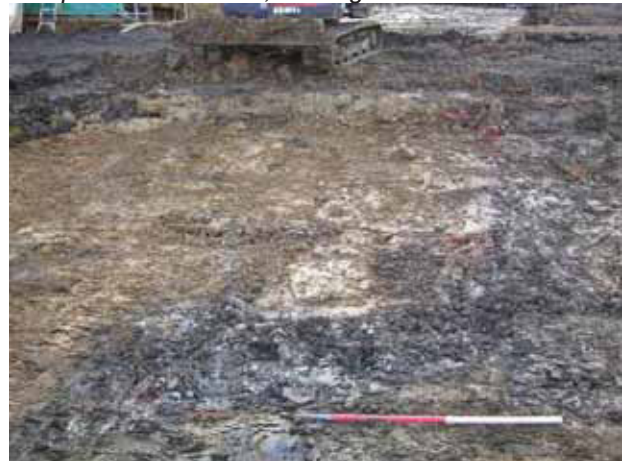
DP4
Trace of modern footings in cart lodge footprint, looking SW

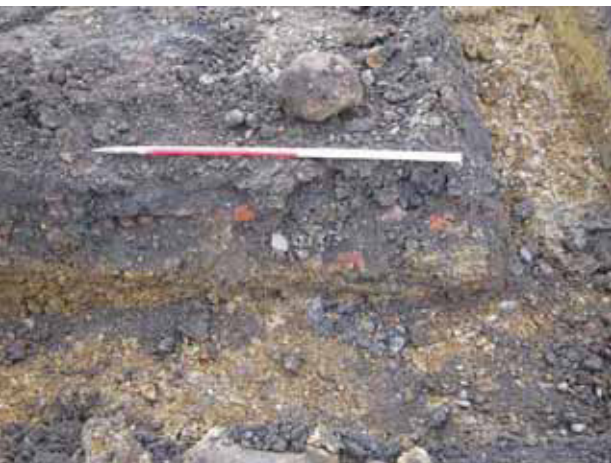
Sample Section 2 (Fig. 3, DP 5)

<i>NE facing</i> 0.00m = 70.37m AOD		
0.00 – 0.20m	L1000	Made Ground. As Section 1
0.20m +	L1001	Natural Geology. As Section 1

DP5
Sample section 2, looking SW

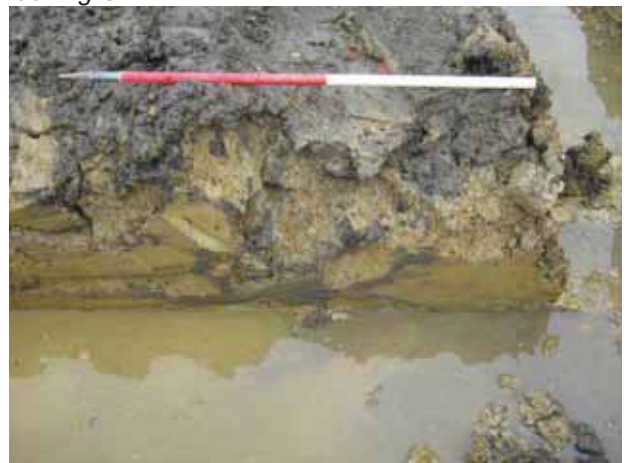
Sample Section 4 (Fig. 3)

<i>SW facing</i> 0.00m = 70.42m AOD		
0.00 – 0.04m	L1000	Made Ground. As Section 1
0.04m +	L1001	Natural Geology. As Section 1

DP6
Sample section 4, looking NE
