**CHURCH OF THE HOLY CROSS  
STATION ROAD, FELSTED  
ESSEX**

**ARCHAEOLOGICAL MONITORING & EXCAVATION**

Authors: Lisa Smith BA (Report) Chris Leonard MA (Fieldwork) Antony Mustchin (Editor)	
NGR: TL 6765 2039	Report No. 3985
District: Uttlesford	Site Code: FLHC10
Approved: Claire Halpin MIFA	Project No. 4100
Signed:	Date: December 2011 Revised: February 2012

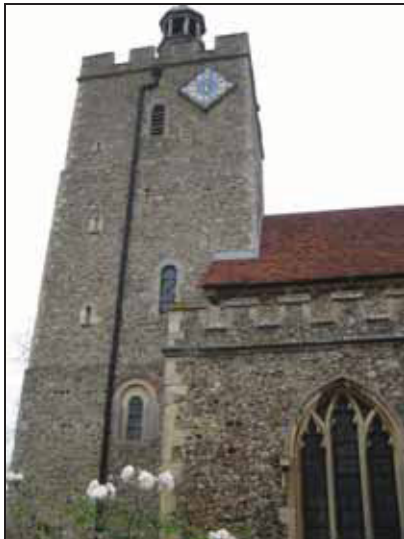
1  
*Felsted church. 12<sup>th</sup> century tower. Looking North-West*

4.1 The Church of the Holy Cross (EHER 37028) is Grade I listed and built of rubble and flint, with stone dressings and brick and tile in places (DP 1&2). Some of the latter is re-used Roman material indicating a building of that date

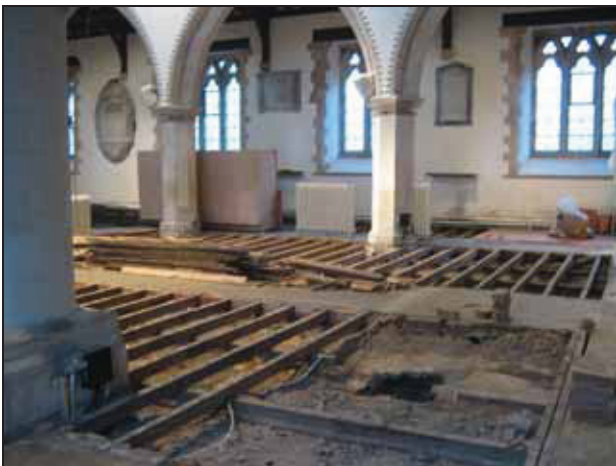
3  
*Existing modern floor within the nave. Looking North-West*

5.1 The project comprised the removal of the existing modern flooring (DP 3) within the church and the reduction of the ground level by the building contractor to incorporate a layer of insulation, under floor heating system, and new floor surface. The modern floor consisted of floor boards overlying closely-set wooden joists resting on brick dwarf walls. A mini-digger with rubber tracks and a ditching bucket was used to remove the old flooring and reduce the ground level, under close archaeological supervision.

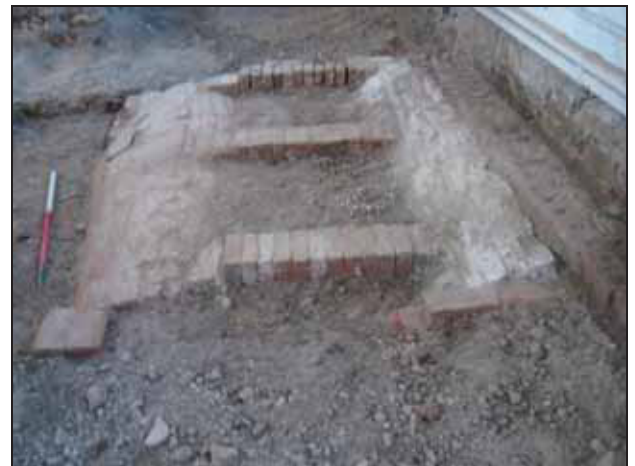
Brick-lined Grave M2012 (2.96m x 0.70m) is located at the western end of the north aisle immediately adjacent to the north wall of the church and with M2013 located to the south (DP 4). It is constructed of unfrosted red bricks (9" x 4 1/8 " x 2 1/2") laid in stretcher bond and mortar bonded. This feature was unexcavated and remains *in situ*. Three walls (M2023, M2024 and M2025) of loosely-stacked bricks link M2012 and M2013. Against the north wall the grave has been truncated to accommodate a modern brick pew support. Two fills are contained between M2012 and M2013 and M2023, M2024 and M2025. L2014 is a dark orange brown, sandy silt with frequent small rounded flint. L2015 is a dark orange brown, sandy silt with frequent small rounded flints. Both deposits remain *in situ*.

Brick-lined Grave M2013 (2.36m x 0.88m) is located at the western end of the north aisle to the south of M2012. It is constructed of unfrosted red bricks (9" x 4 1/8 " x 2 1/2") laid in stretcher bond and mortar bonded. This feature is unexcavated and remains *in situ*.

4  
*Brick-lined graves M2012 & M2013. North Aisle. Looking West*

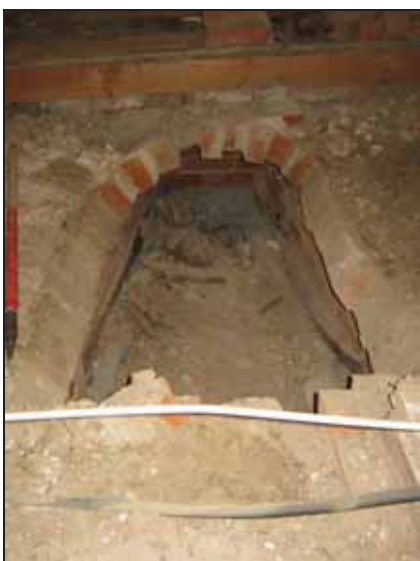
Brick-lined Grave M2001 (>1.64m x 0.62m x >0.76m) is located at the south-eastern corner of the nave. It is rectangular in plan and constructed of unfrosted red brick (9" x 4 1/8 " x 2 1/2") laid in stretcher bond and mortar bonded (DP 5). The grave is capped by a brick arch (M2000) of unfrosted mortar-bonded red bricks which has been damaged allowing modern debris to accumulate within the grave and cause damage to the coffin within. The coffin is wooden with a secondary lead lining and a thinner wooden interior containing some charnel bone. The inhumation was below the depth affected by the development and therefore remains *in situ*. The backfill of M2001, L2026, is a loose dark greyish brown sandy silt with frequent small rounded flints and contained a large quantity of human remains. Brick samples from M2001 are of 18<sup>th</sup> – early 19<sup>th</sup> date (CBM Report below).

5  
*Brick-lined graves M2001. Nave. Looking East.*

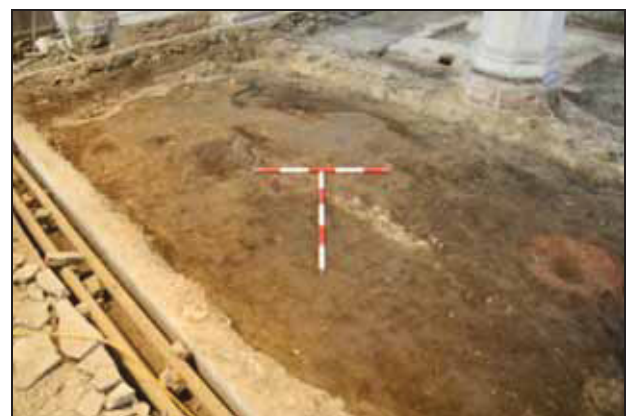
Mortar Floor L2007 (>2.72m x 2.18m x 0.05m) is located in the western part of the nave and consists of a mid brownish grey hard-packed surface (DP 6). It is cut by Pits F2008, F2010 and F2016.

6  
*Floor F2007, Wall Foundations M2027 & M2028. Nave. Looking North-West*

9.3 Enclosed within the confines of the wall foundations at the western end of the nave a compact mortar floor surface (F2007) partially survives. It is cut by small pits (F2008, F2010 and F2016) which contained evidence of intense *in situ* burning and quantities of lead, nails and other metal fragments indicating they may have been used for smelting possibly for the construction of the windows during the 14<sup>th</sup> century expansion. The pits contained sparse, but consistent, dating evidence suggesting a medieval date. The pottery from F2034 is derived from a vessel form similar to that of a skillet or shallow vessel with a pouring lip which suggests the possibility of an industrial function associated with metal working.

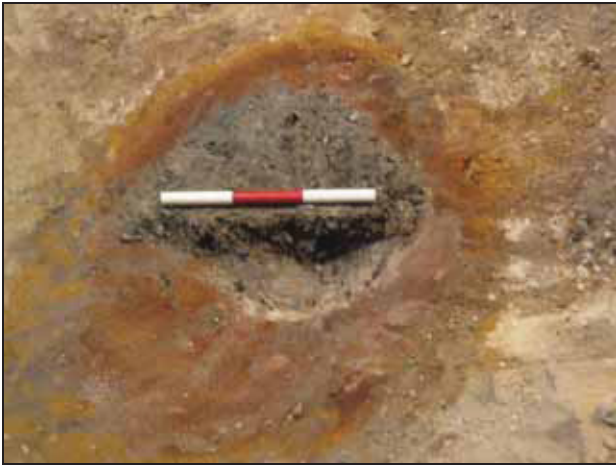
Pit F2008 (0.60m x 0.60m x 0.09m) was circular in plan with moderately steep sides and a flat, irregular base (DP 7). It had two fills. The upper fill, L2009, was a black loose charcoal matrix with frequent iron nails (166g) and lead fragments (161g) throughout. It contained a ?medieval pottery sherd (93g). The basal fill, L2019, was a mid orange red compact sand which lined the pit.

7  
*Pit F2008. Nave. Looking East*

A large red-brown base fragment of crudely made sand tempered pottery came from Pit F2008 (L2009). Its date is uncertain but it is probably medieval and may be from an industrial vessel such as a cupel, purpose-made for metal refining. Cupels are generally described as thick-walled and of crude appearance (MPRG 1998, 9.7), and this interpretation is supported by associated fragments of iron and lead within the pit.

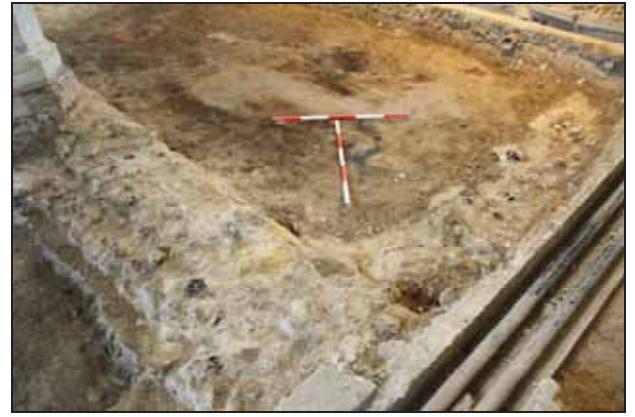
Wall Foundation M2027 (14m x 0.76 – 1.30m) is located beneath the columns supporting the northern arcade, and aligned east/west. It comprises small, medium and large flint nodules with occasional tile fragment roughly bonded with mortar (DP 8, 13 & 14). M2027 is associated with Wall Foundations M2028, M2030 and M2031.

8  
*Floor F2007, Wall Foundations M2027 & M2028. Nave. Looking South-East*

9.2 Wall foundations (M2027, M2028, M2030 and M2031) encountered during this investigation form a rectangular structure extending from the tower at the western end of the nave and beneath the northern and southern arcades. It appears that the 12<sup>th</sup> and 14<sup>th</sup> century columns supporting the arcades were constructed on earlier footings suggesting that the structure represents the early 12<sup>th</sup> century outline of the church before the later expansion.

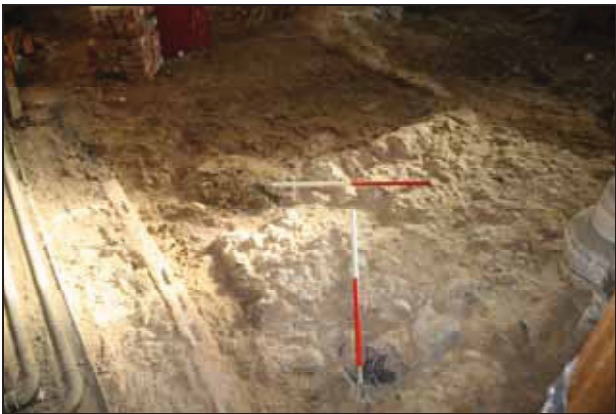
Wall Foundation M2028 (6.28m x 0.39 – 1.60m) is located beneath the arch leading to the tower at the western end of the nave and is orientated north/south (DP 9). It comprises small, medium and large flint nodules with occasional tile fragment inclusions roughly bonded with mortar. M2028 is associated with wall foundations M2027, M2030 and M2031. The wall is cut by F2034 and has been truncated by modern services.

9  
*Wall Foundation M2027, Nave. Looking South-East*

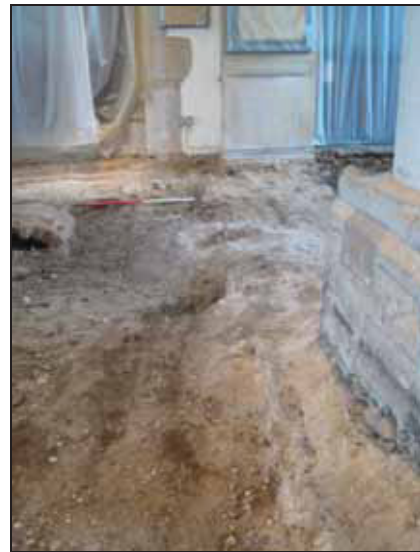
Wall Foundation M2030 (>1.80m x >0.40m) is located beneath the rood screen between the nave and the chancel extending on a north-south orientation (DP 10). It is comprised of small, medium and large flint nodules with occasional tile fragment inclusions roughly bonded with mortar. M2028 is associated with wall foundations M2027, M2028 and M2031.

10  
*Wall Foundations M2030 & M2031. Nave. Looking East*

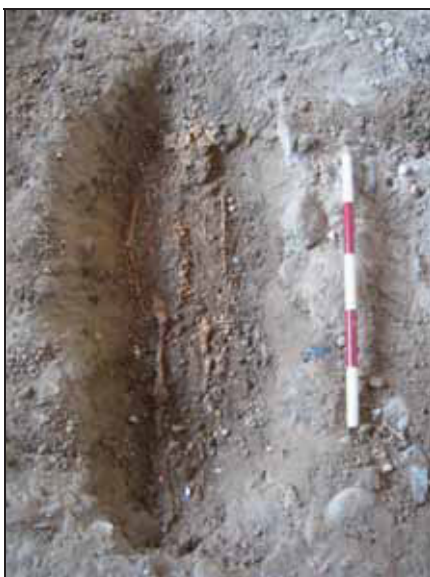
Grave F2032 (1.14m x 0.50m x 0.23) is located at the eastern end of the nave cuts M2031 (DP 11). It is ovoid in shape with steep sides and a flat base. F2032 contains Infant Skeleton SK1 and has been backfilled with L2033, a mid orange brown sandy silt with frequent small rounded flints. SK1 was a very young infant in poor condition, supine and extended, orientated east-west

with the head located at the western end. It was cleaned and recorded and was left *in situ* and backfilled. No coffin or furniture were present.

11  
*Grave F2032 and SK1 cut into M2031. South Arcade. Looking West*

9.4 The graves revealed throughout the church were housed within brick-lined tombs often capped with brick arches though some had been damaged by modern intervention. Grave F2032 contained a very young infant buried without a coffin, and it cut the earlier foundations (M2031). No identification was evident during the investigation however in many cases the inhumations were buried deep within the tombs and were left undisturbed. It may be possible to identify some of the graves by ornate plaques mounted on the walls of the church and covered at the time of the works for their own protection.

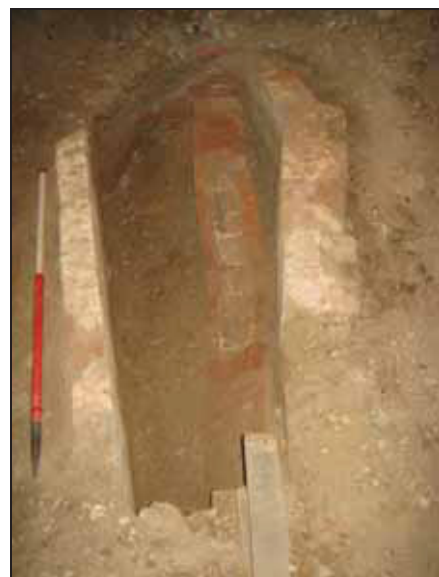
Brick-lined Grave M2002 (2.20m x 1.05m x >0.46m) is located within the south aisle and is irregular in shape (DP 12). It is constructed of unfrosted red bricks (9" x 4 1/8 " x 2 1/2") laid in stretcher bond and mortar bonded. This grave is not capped and a modern brick support has collapsed into the grave. It contains two fills. L2003 is a mid yellowish brown silty sand with moderate small chalk pieces and frequent small rounded flints. L2004 is a mid brownish yellow, compact, sandy clay with frequent small chalk pieces and occasional small rounded flints and may relate to the later modern brick support. The inhumation is located below the level of development and therefore remains *in situ*.

12  
*Brick-lined grave M2002. South Aisle. Looking West*

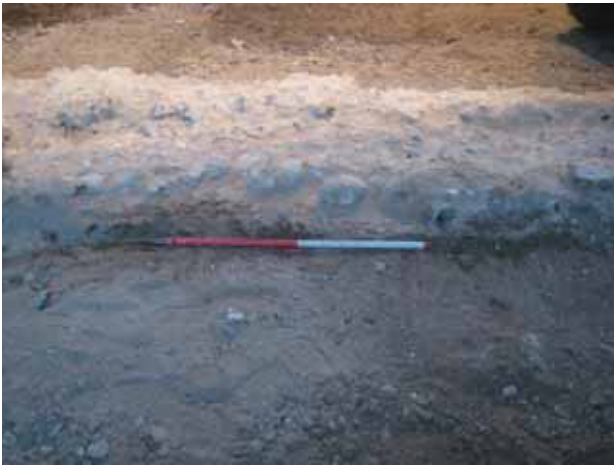
13  
*Wall Foundation M2027. Looking South.*

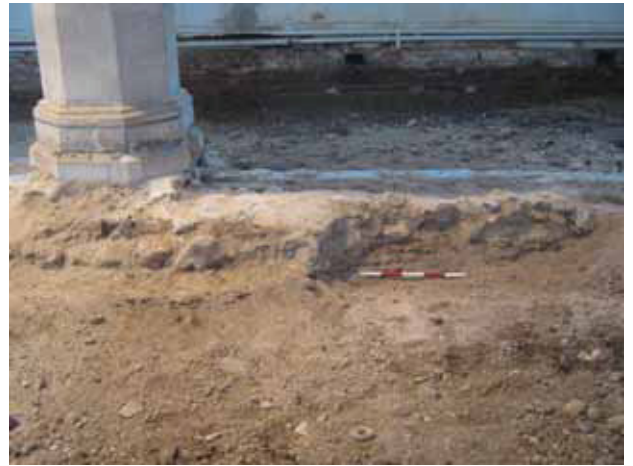
14  
*Wall Foundation M2027. Looking N*

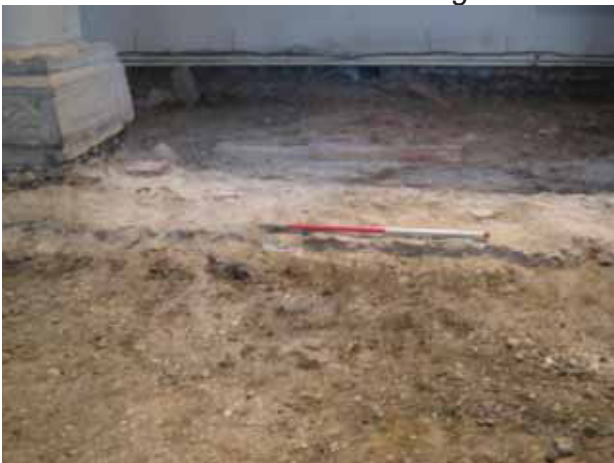
Wall Foundation M2031 (15.60m x 1.20m) is located beneath the columns supporting the southern arcade aligned east-west. It is comprised of small, medium and large flint nodules with occasional tile fragment inclusions roughly bonded with mortar (DP 15). M2028 is associated with wall foundations M2027, M2028 and M2031. It has been cut by F2032.

15  
*Wall Foundation M2031. Looking South.*
